A REPORT ON THE CAUSE OF DETERIORATION  
OF SECTIONS OF FLEXIBLE I 94 PAVEMENT

E. C. Novak, Jr.

Research Laboratory Section  
Testing and Research Division  
Research Project 77 TI-433  
Research Report No. R-1081

Michigan State Highway Commission  
Peter B. Fletcher, Chairman; Carl V. Pellonpaa,  
Vice-Chairman; Hannes Meyers, Jr., Weston E. Vivian  
John P. Woodford, Director  
Lansing, February 1978

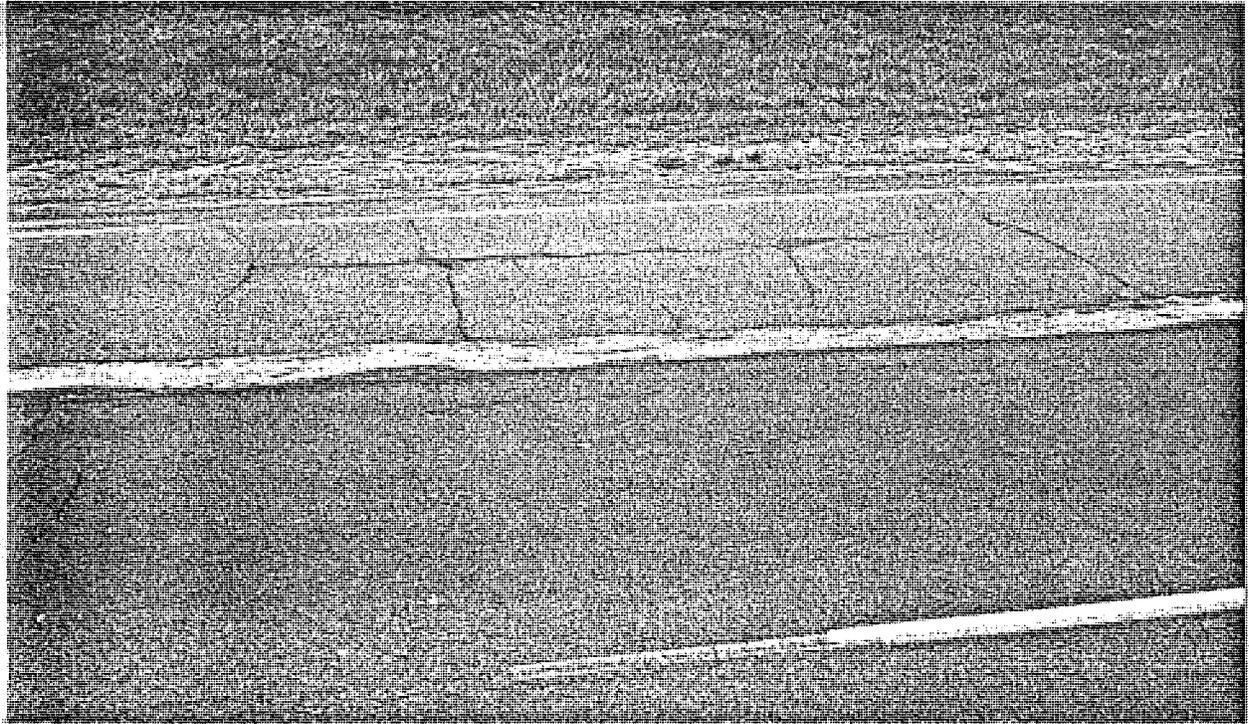
Transverse cracking, such as that shown in Figure 2, indicates that the bituminous concrete is temperature-sensitive in these areas. This form of cracking tends to develop equi-dimensional blocks since thermal

Figure 2a. Typical example of a crack susceptible bituminous concrete and a good performing base.

stresses are equi-dimensional (Fig. 2). Thus, longitudinal cracks will normally accompany advanced stages of transverse cracking. The transverse cracks in themselves do not influence riding quality but they do permit the entrance of surface water which can cause softening of the aggregate base and localized failure around each thermal crack. Figure 2a indicates the base in this area is performing very well while the area shown in Figure 2b indicates the base is softening, allowing traffic to develop alligator cracking in the area around both transverse and longitudinal cracks.

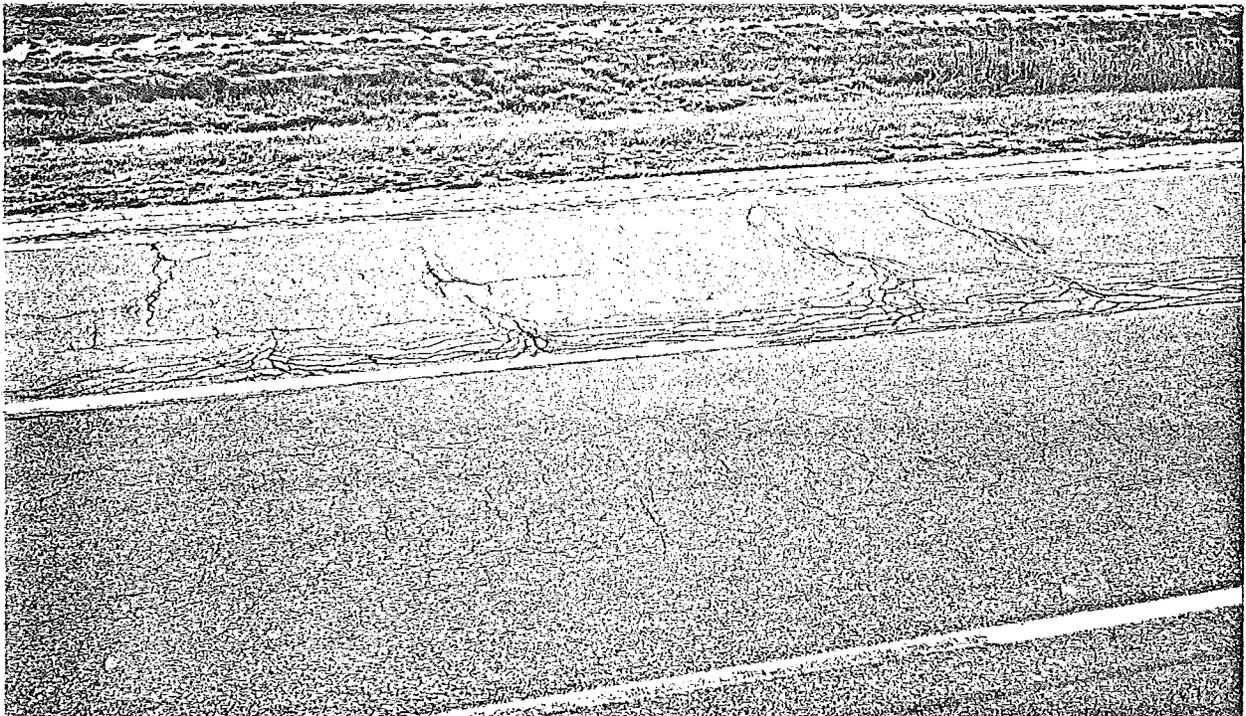
Figure 2b. Typical example of a crack susceptible bituminous concrete and a poor performing base.

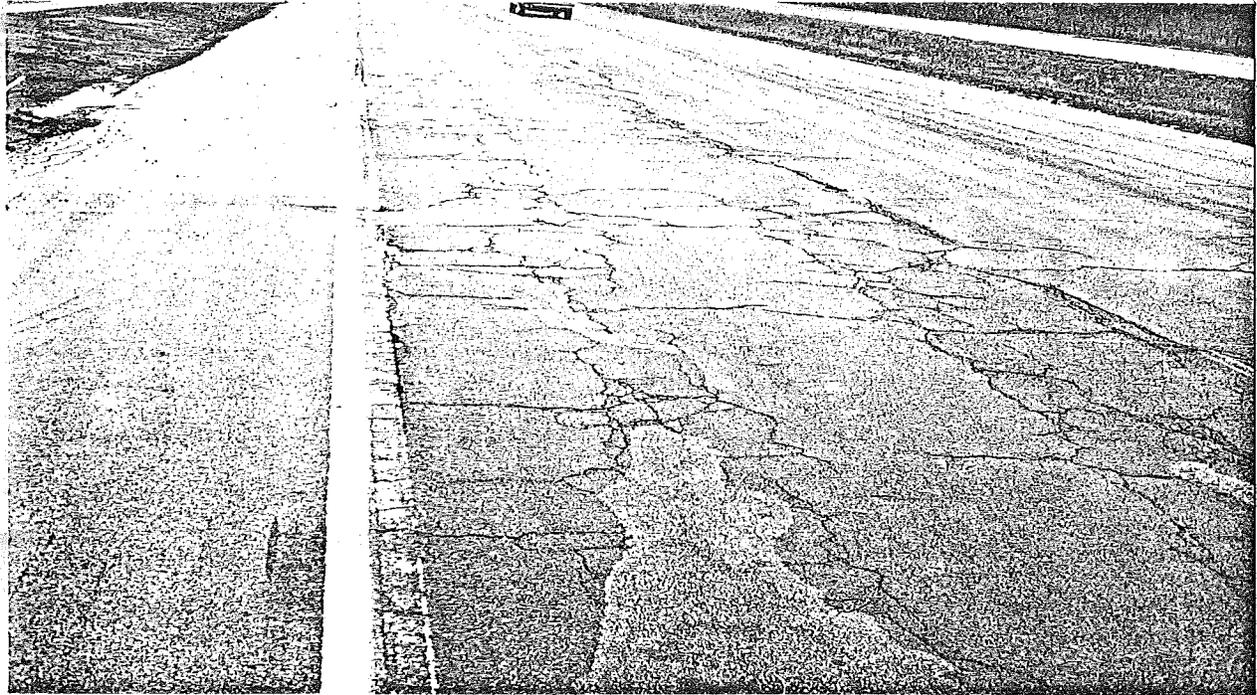
Figure 5a. Typical example of very crack susceptible bituminous concrete on a good aggregate base.

Figure 5. Typical example of distress in locations where the bituminous concrete is crack susceptible and the aggregate base performs well. Poor bituminous concrete performance is characterized by extensive cracking of the entire pavement surface and only slight, if any, rutting.

Figure 5 is an example of a poorly performing bituminous concrete since its penchant for cracking is indicated by numerous transverse cracks and increased cracking in the wheelpath area which is the result of combined thermal and fatigue cracking. Good base support is indicated because only slight rutting is occurring. The slight rutting that is occurring is primarily a result of pumping of base fines through the cracks (Fig. 5b).

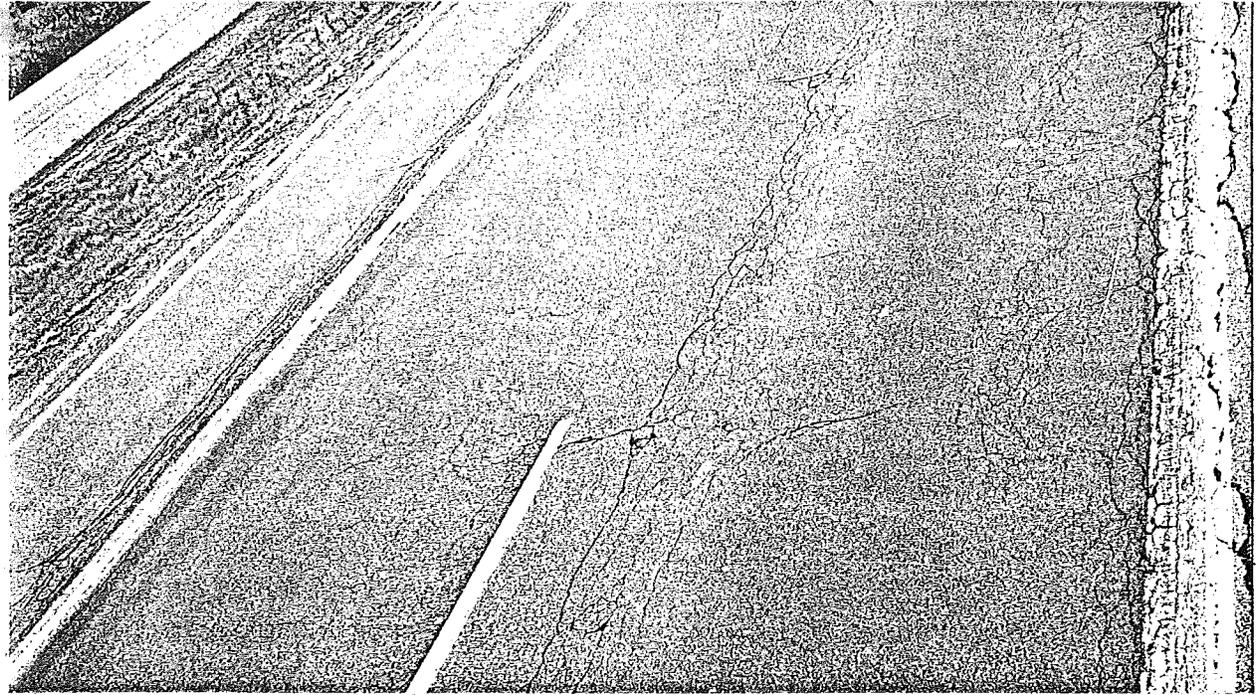
Figure 6 illustrates a good performing bituminous concrete over a base which tends to soften when wet. The cracking is generally confined to the wheelpaths and rutting is more severe, as shown in Figure 6a, due to a combination of lateral displacement of the base and some pumping of the fines. An example of more severe base problems is shown in Figure 7 where rut depths range between  $3/4$  and  $1-1/4$  in. A large percentage of the traffic lane is rutted in this manner. The poor performance of the base

Figure 6a. Typical example of a good bituminous concrete on a poor aggregate base.

Figure 6. Typical example of distress when bituminous concrete has good crack resistance and the aggregate base performs poorly. The saturated base is pumping fines and softening, to a moderate degree, under freeze-thaw conditions. The poor base performance is characterized by deep rutting and alligator cracking which is generally confined to the wheelpaths.

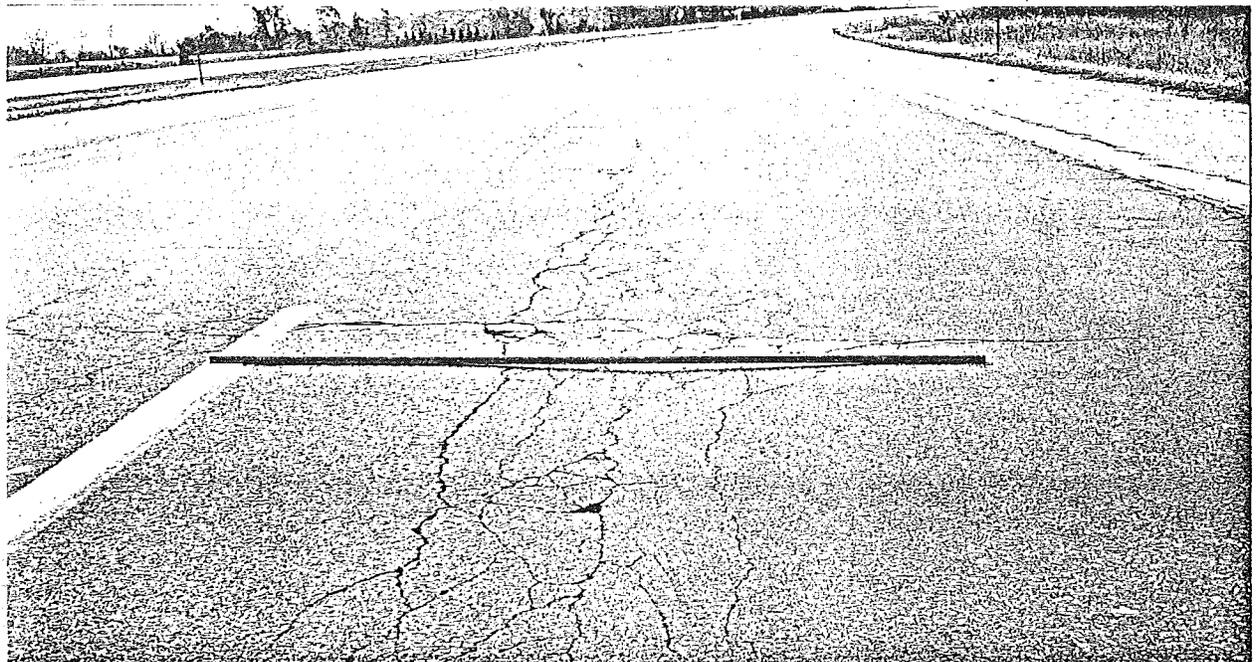
Figure 6b. Typical example of the severe rutting that occurs with poor aggregate bases.

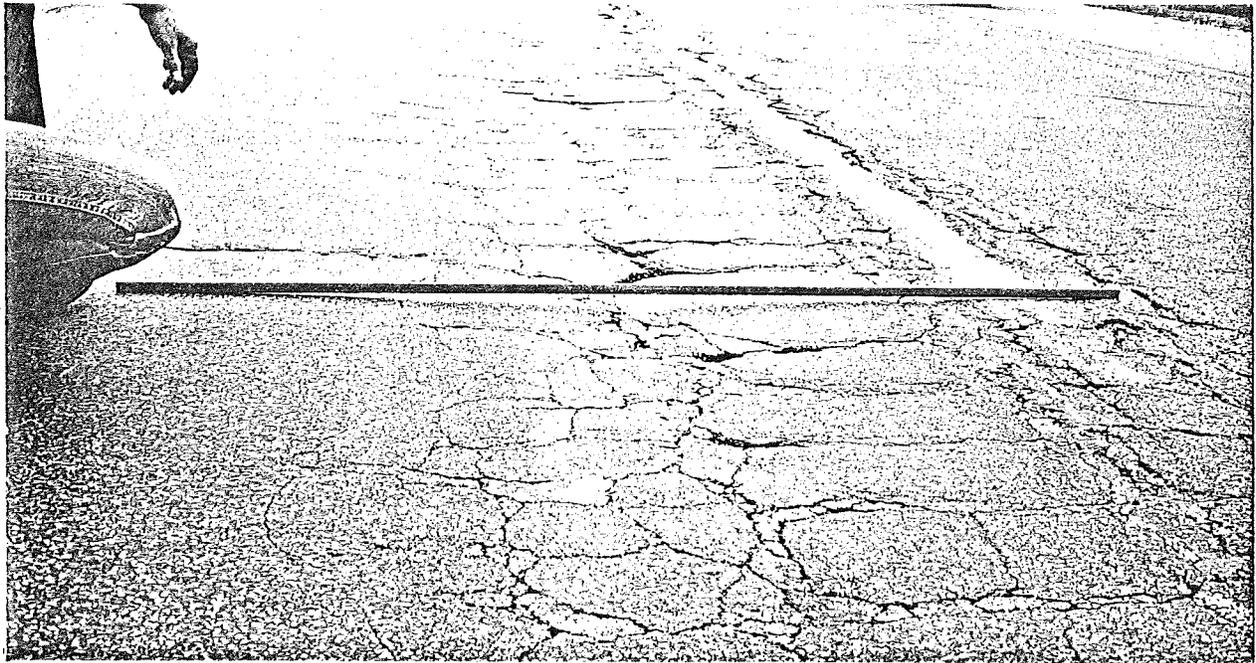
Figure 7a. Typical example of a very poor performing aggregate base.

Figure 7. Example of the performance of crack susceptible bituminous concrete on a poor performing base. The severe alligator cracking and rutting is attributed to pumping of base fines and softening of wet base under freeze-thaw action.

shown in Figure 7 occurs whenever the base is both impervious, permeability is less than 0.5 ft/day, and it is over 90 percent water saturated when gravity drained.

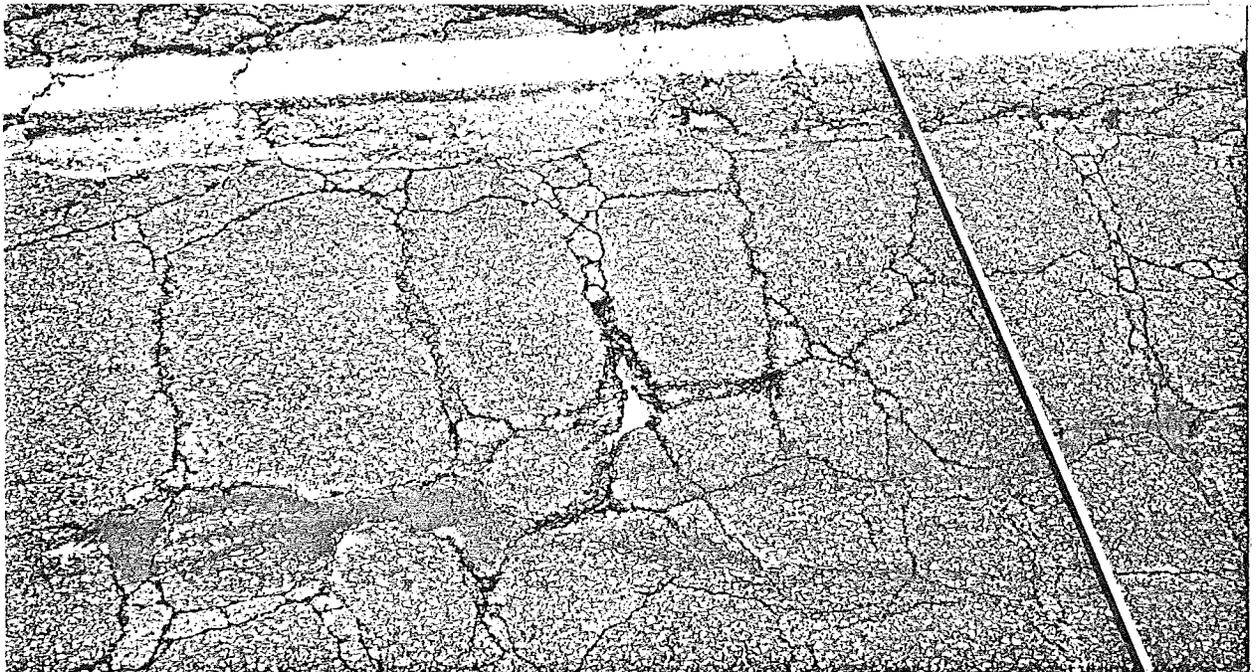
Figure 7b. Although the pavement surface is dry, water in the cracks is unable to penetrate the relatively impervious base.

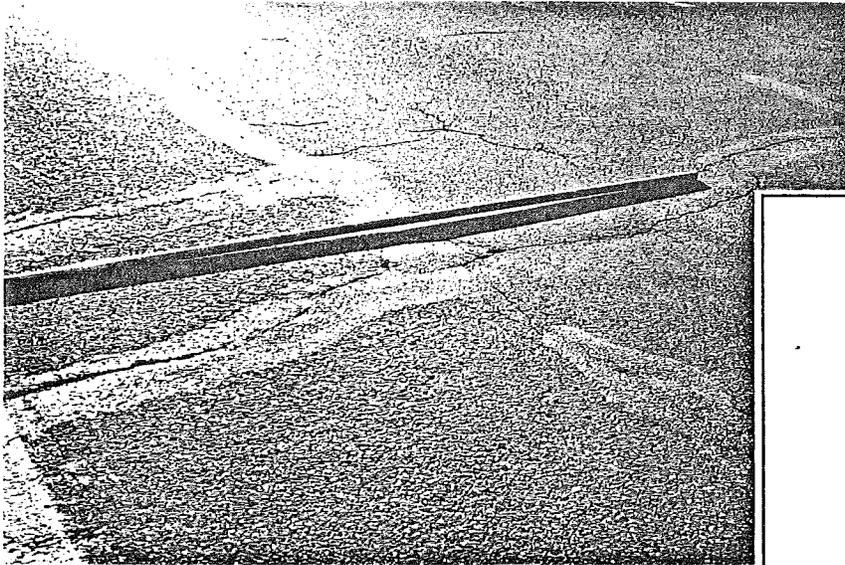
▲ Shallow rutting of RWP.

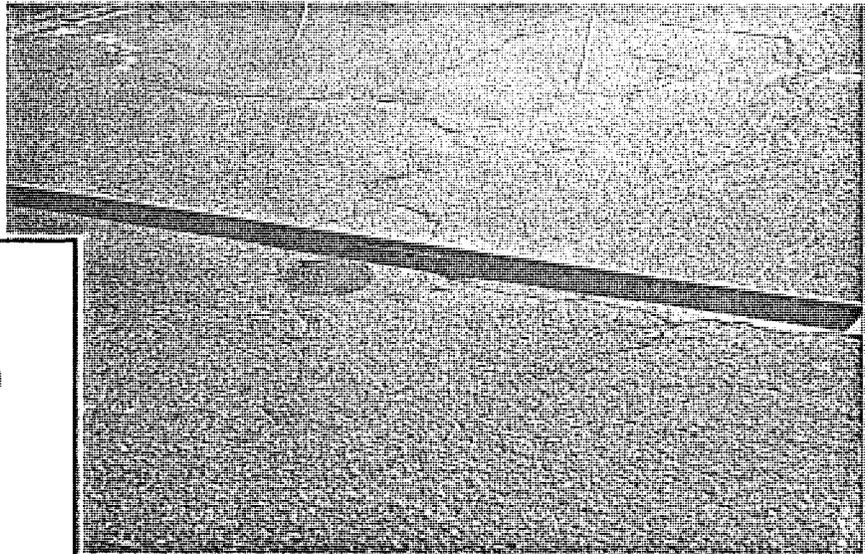
▲ No rutting, but slight pumping of base fines.

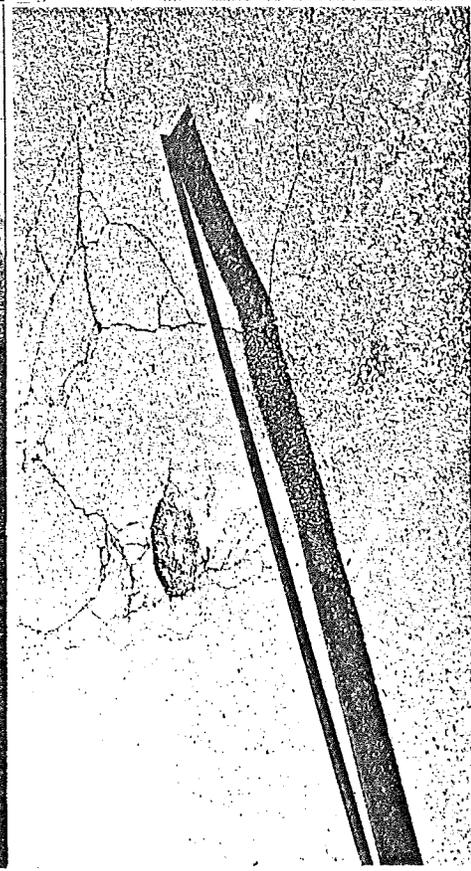
Rutting of LWP.

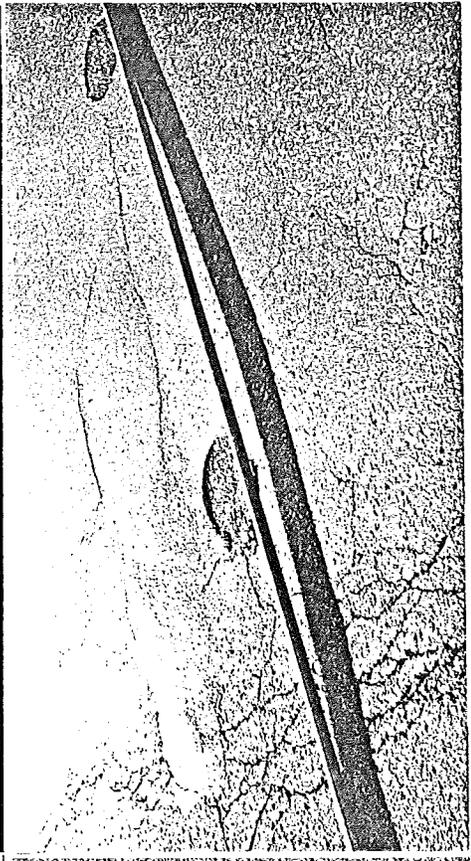
Rutting of RWP.

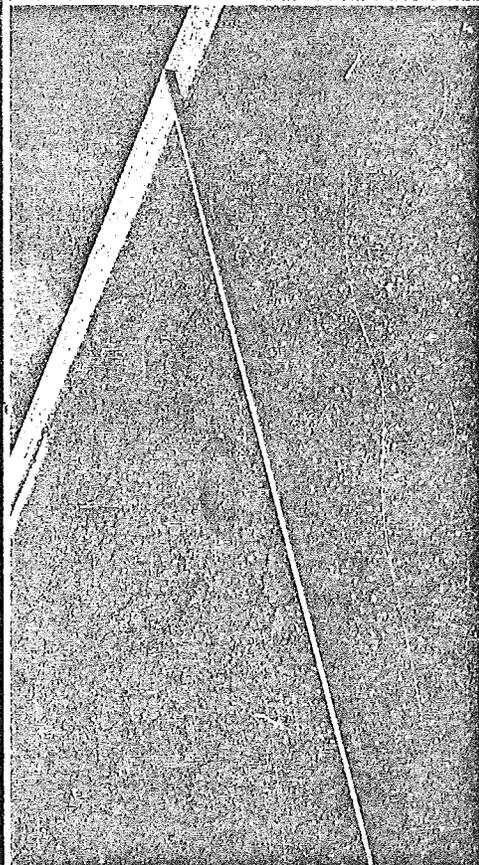
Rutting of LWP.

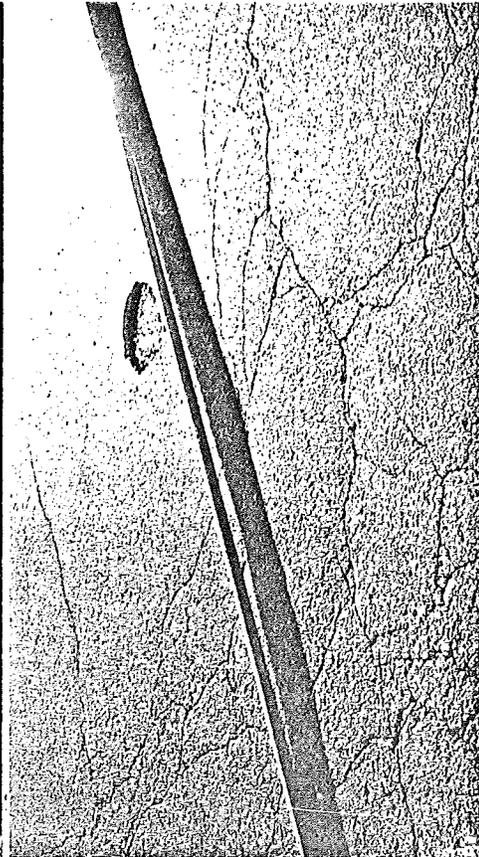
Rutting of RWP.

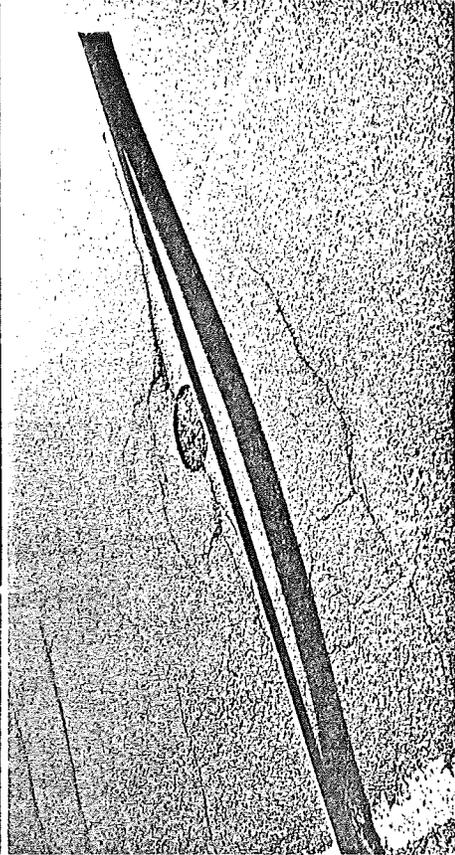
Indicates moderate rutting of the RWP.

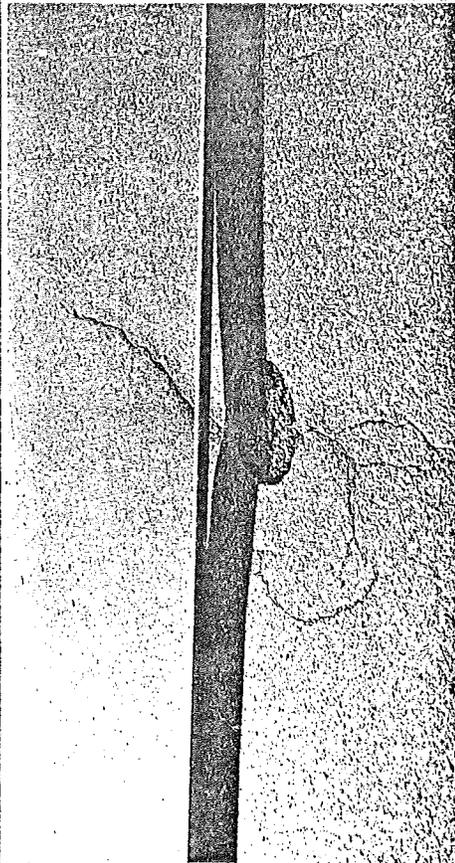
Transverse trough developed by pumping of base fines.

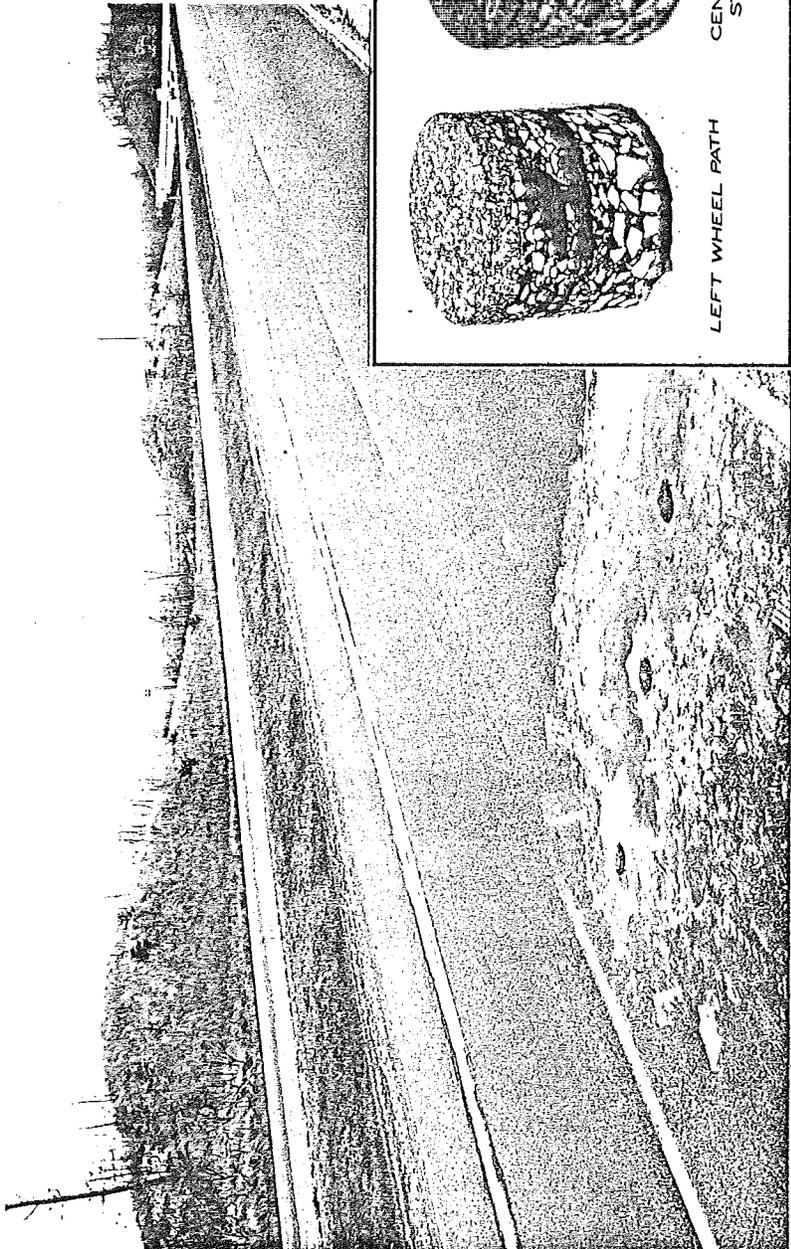
Cores taken from test site, note high bitumen content.

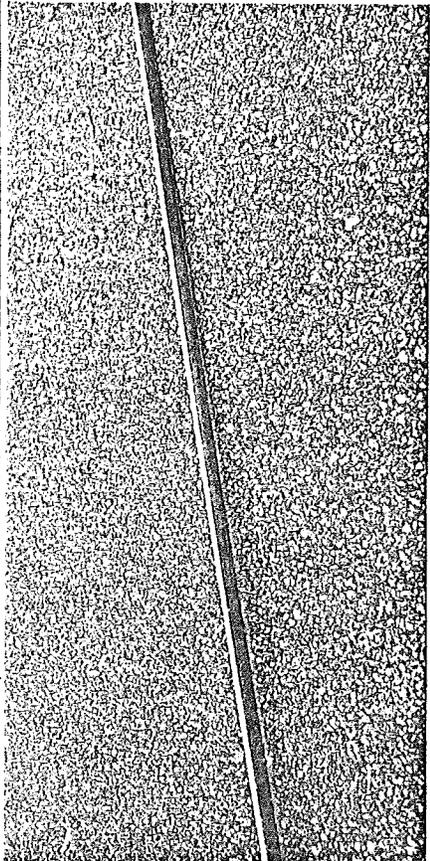
Indicates slight rutting in the LWP.

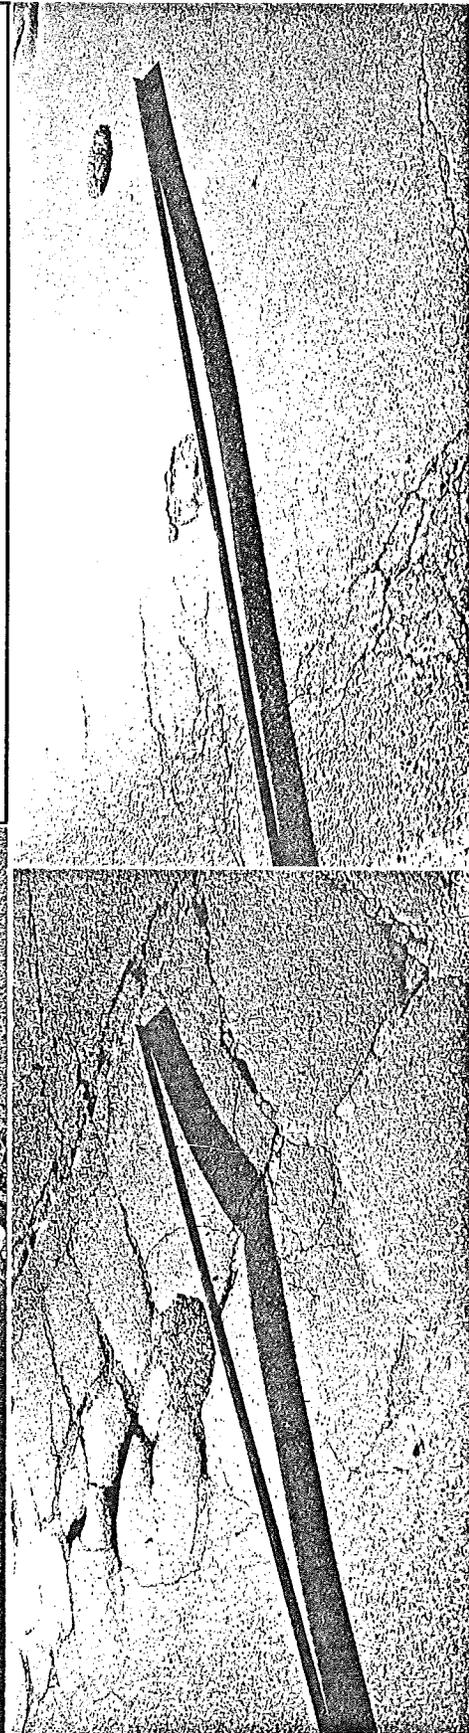
Rutting in the LWP.

Rutting in the RWP.

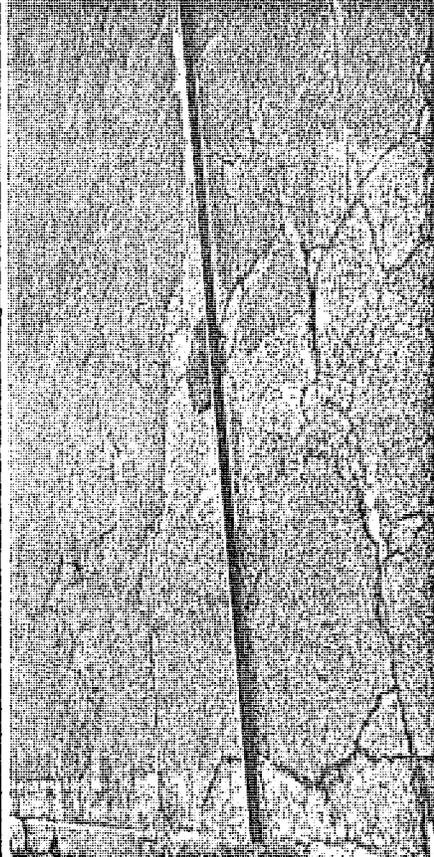
Rutting of the RWP.

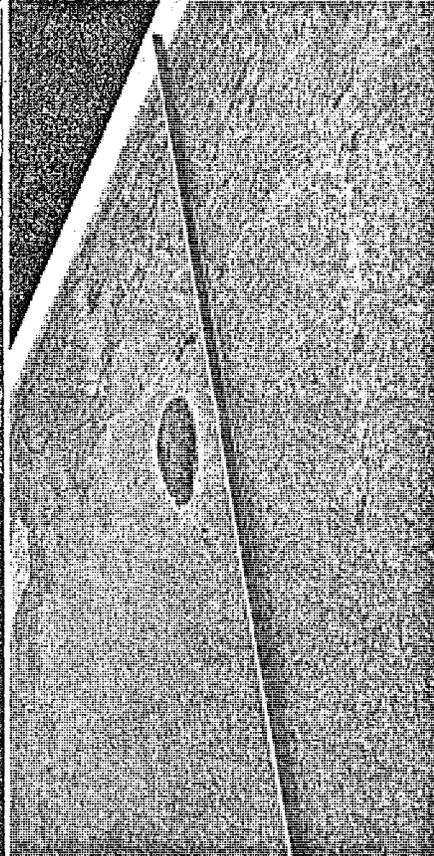
Rutting of the LWP.

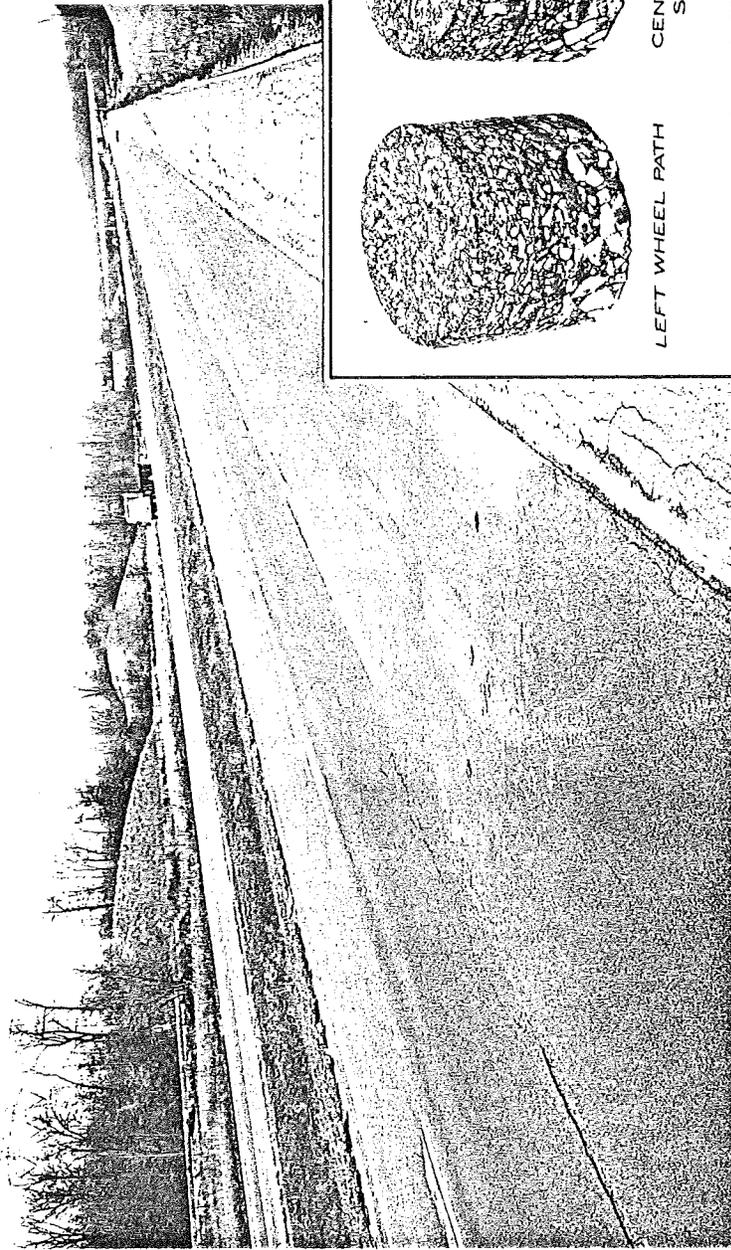
Cores taken from test area, note high bitumen content.

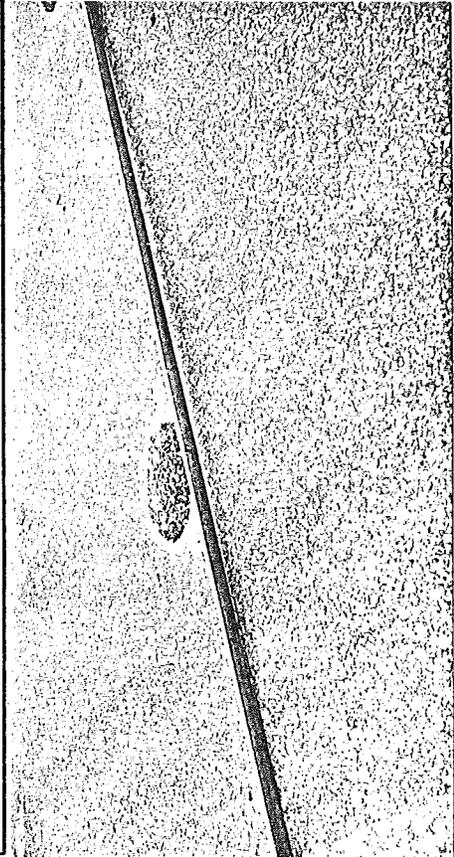
Rutting of RWP.

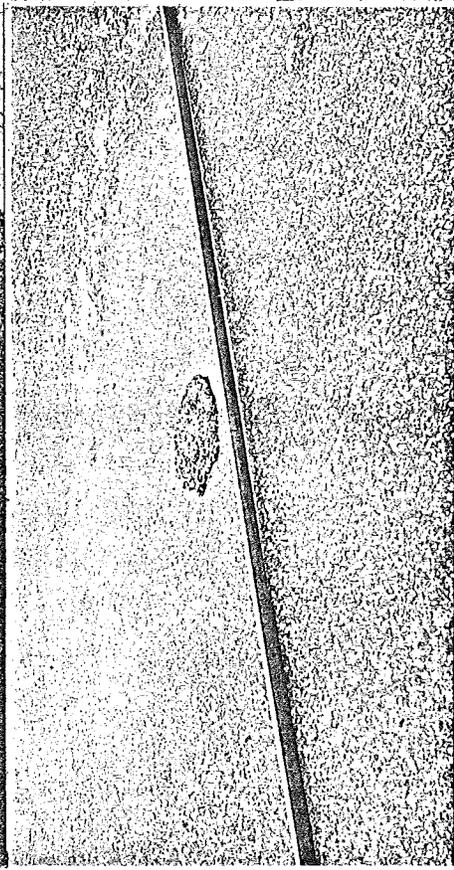
Rutting of LWP.

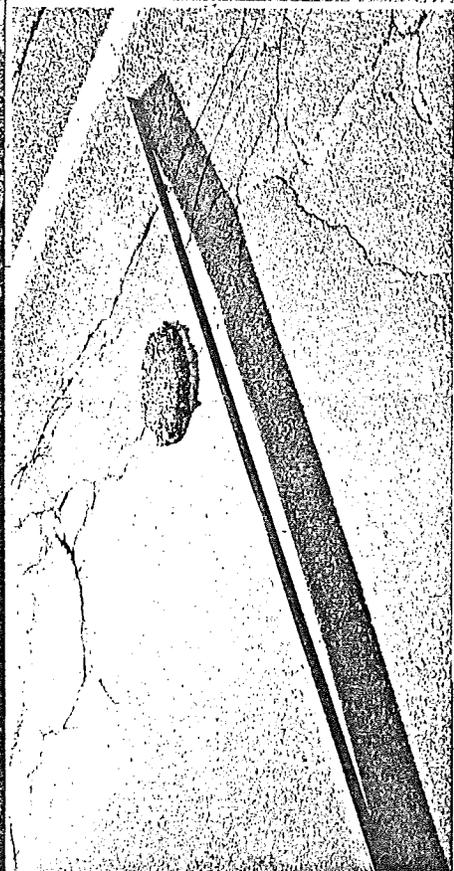
Rutting of LWP.

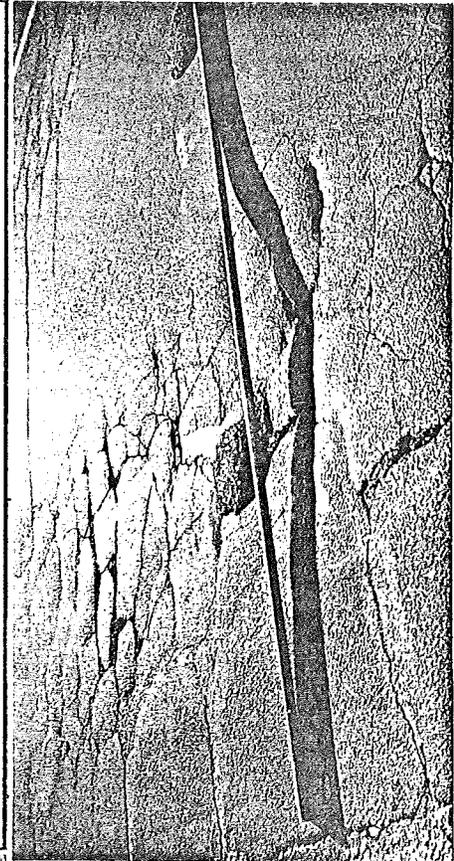
Rutting of RWP.
