OFFICE MEMORANDUM

DATE: September 20, 1978

SUBJECT: Study of Latex Modified Concrete Deterioration on Wiard Rd over US 12 (S04 of 81063), Research Project 78 TI-508, Research Report No. R-1097

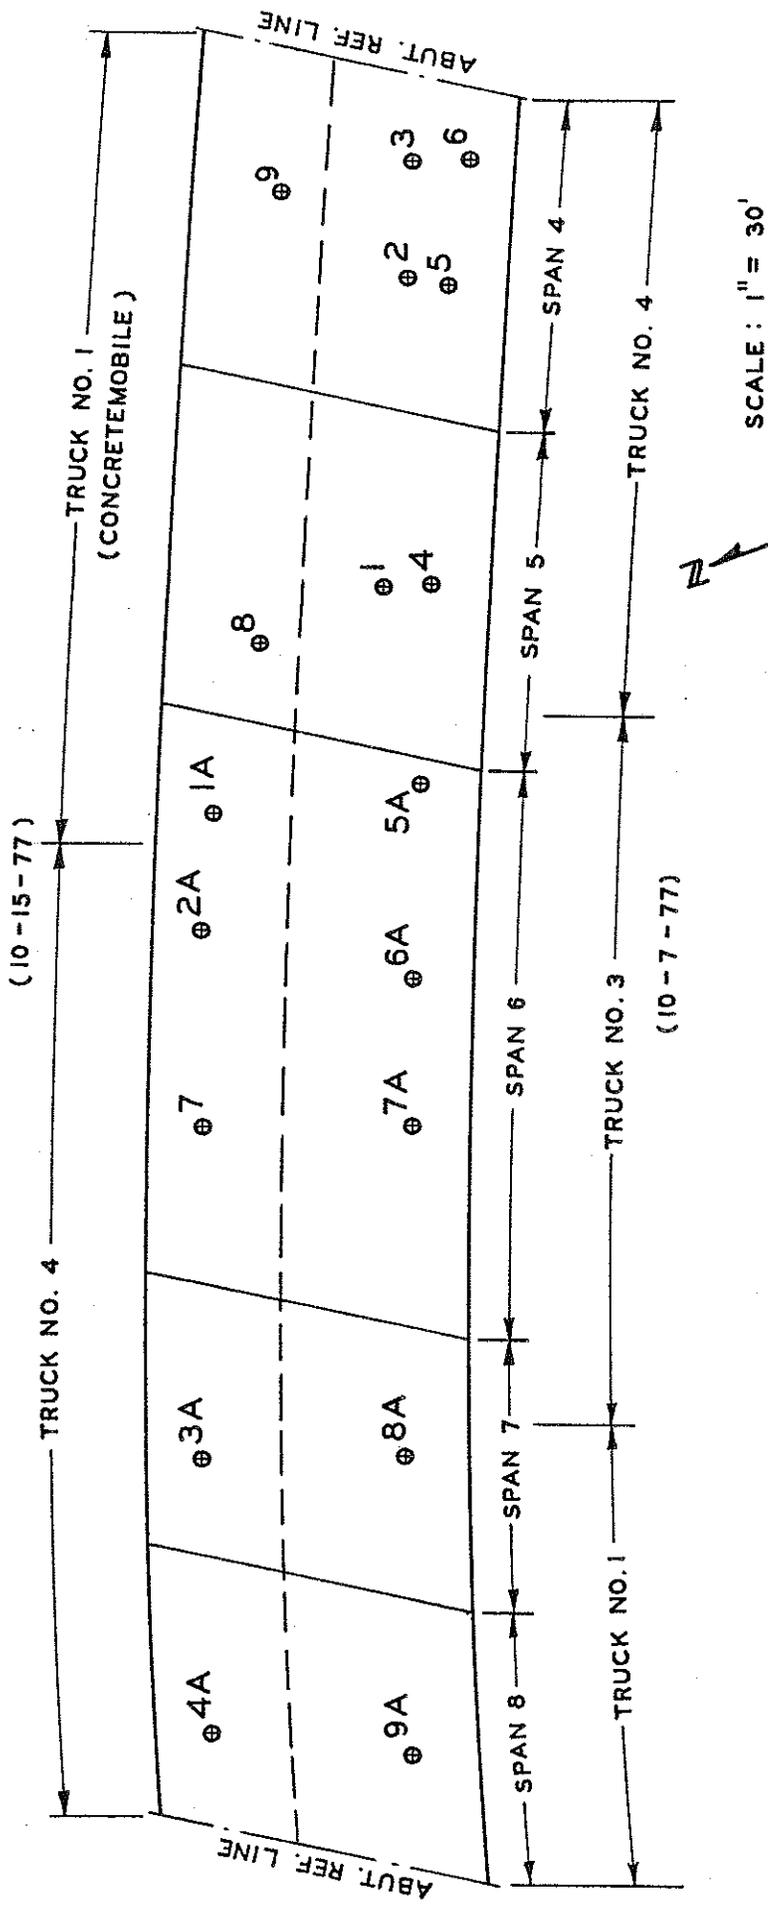
determined that three different trucks were used on the October 7th pour and only two of these were used in the October 15th pour. The truck numbers and approximate limits of latex concrete from each are shown in the attached diagram. It became more evident that the latex concrete from truck No. 4 in both the October 7th and 15th pours had resulted in a much lighter color than the latex concrete from trucks No. 1 and 3.

Therefore, nine additional cores were obtained on August 14 and 15 in spans 6, 7, and 8 to complete the sampling of all five spans. The locations of the latter nine cores, numbered 1A to 9A, plus the initial nine cores are also shown in the attached diagram. The results of testing on all 18 cores are given in Table 1. The most significant data in this table are the cement contents of 10 selected cores which include the limits of pours from truck No. 4 and the other two trucks for comparison. It is evident there is a definite deficiency of cement in the latex concrete from truck No. 4. The cement content ranged from 3.9 to 5.1 sack/cu yd in the south half of spans 4 and 5, and 4.8 to 4.7 sack/cu yd in the north half of spans 6, 7, and 8, which were placed with truck No. 4. The 6.1 sack value for core 5A is thought to be in the area of transition from truck No. 4 to No. 3. Due to problems in cutting small cube sections from the overlay part of the cores, and testing in compression, we feel that a number of the compressive strength results are low. In particular, the values from cores 6A through 9A, and also 1A, should be higher to be commensurate with their cement contents.

Location diagram for cores in latex concrete overlay and limits of concrete mobile discharge areas, Wiard Rd over US 12 (S04 of 81063).

In summary, we feel the areas poured from truck No. 4 have a significant shortage in cement from the 7 sacks/cu yd called for in Table 7.04-4 of the 1976 Standard Specifications. We believe the only proper corrective measure would be to remove the existing overlay in the south half of spans 4 and 5, and the west 3/4 of span 6, and all of spans 7 and 8, in the north half only. This could then be replaced with acceptable latex modified concrete and the spalled joints at piers 4, 5, and the west abutment could be reformed.
