**CONTINUOUSLY REINFORCED CONCRETE
PAVEMENT IN MICHIGAN
A HISTORICAL SUMMARY**

J. E. Simonsen

**Research Laboratory Section
Testing and Research Division
Research Projects 61 F-64,
57 F-46, and 73 F-129
Research Report No. R-1120**

**Michigan Transportation Commission
Hannes Meyers, Jr., Chairman; Carl V. Pellonpaa,
Vice-Chairman; Weston E. Vivian, Rodger D. Young,
Lawrence C. Patrick, Jr., William C. Marshall
John P. Woodford, Director
Lansing, June 1979**

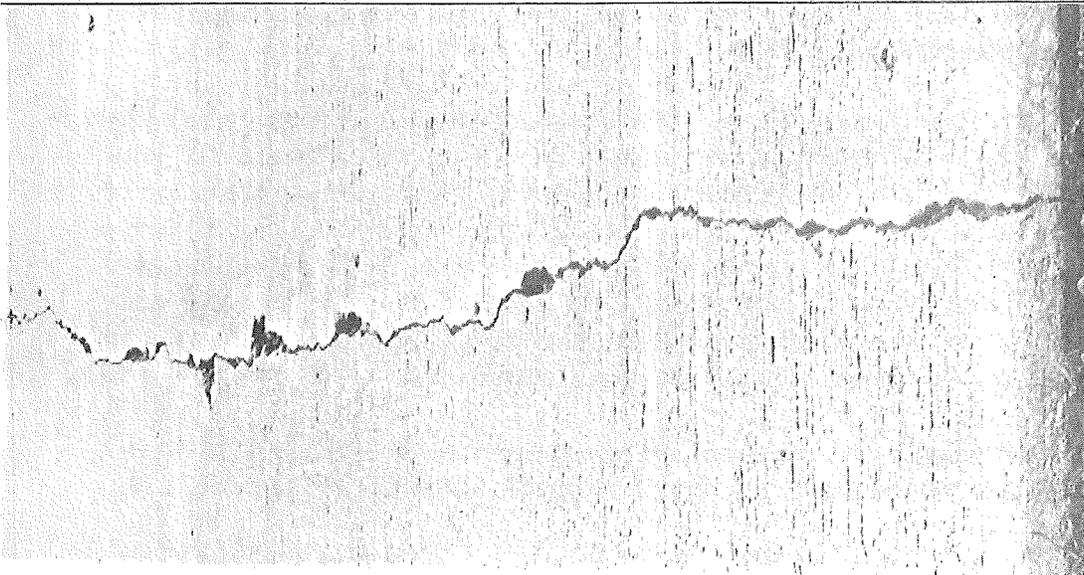
Lap Failure - Lap failures result in wide cracks forming in the pavement surface (Fig. 2), and in some cases, the slab breaks up over the lap area (Fig. 3). Investigations of this type of failure have shown that the cause of failure is a combination of insufficient lap lengths, failure of weld between crosswire and longitudinal wires, concrete bond failures to the steel, and horizontal separation of the concrete in the lap area.

Lap problems have been confined to the I 96 CRC pavements built in 1958 and 1962. Except for one lap failure that occurred after 18 years service in a section reinforced with deformed bar mats all failures have occurred in the sections reinforced with smooth welded wire mesh. By discontinuing the use of smooth welded wire mesh, increasing the lap length and staggering of the laps, lap failures have been eliminated from pavements constructed since 1962.

Figure 2. Lap failure in CRC pavement. Surface crack extends to steel level where a horizontal crack has formed and extends to the end of the lap where the bottom portion of the slab has cracked vertically.

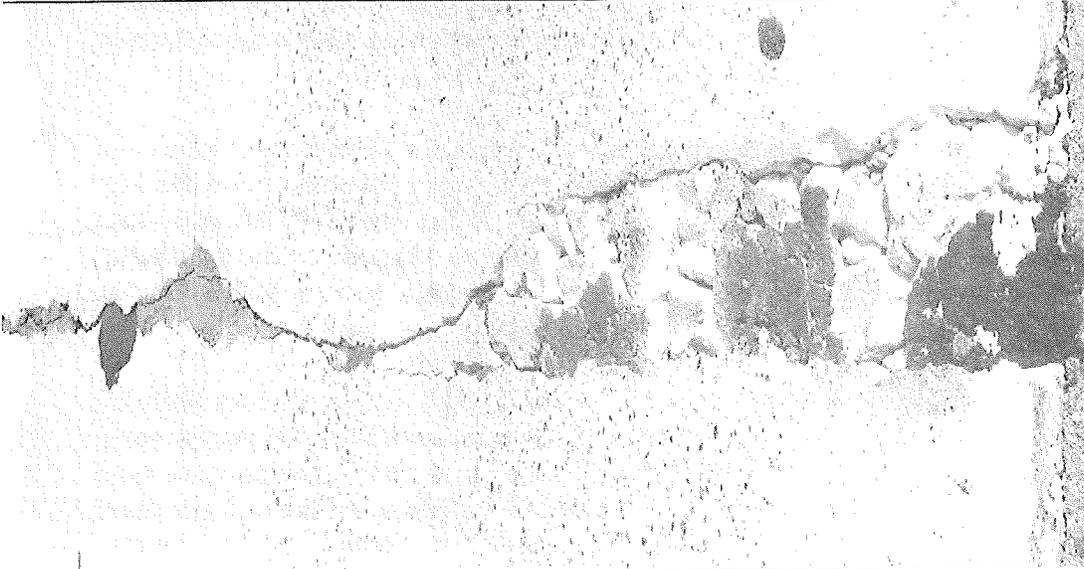
Figure 3. Spalling and breakup of the concrete develops at lap failures as a result of climatic changes and traffic loads.

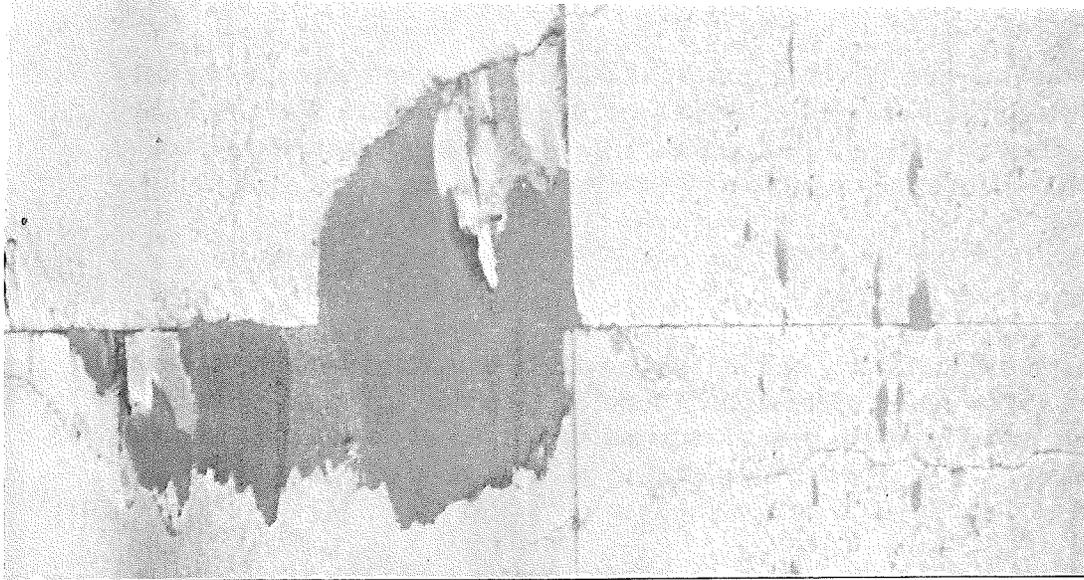
Construction Joint Failure - Construction joint failure is typified by the cracking and breaking up of the slab on one or both sides of the joint (Fig. 4). The failure normally occurs relatively soon after construction of the pavement. The cause of failure on the night side of the joint is attributed to depositing the soupy concrete mixture carried in front of the screed in the pavement adjacent to the joint. On the morning side, a poorly consolidated, lean concrete mixture and reinforcement lap problems have been diagnosed as the primary cause for pavement failure.

Construction joint problems were common in the earlier CRC pavements. The requirement that soupy concrete would not be allowed in the

Figure 4. Typical construction joint failure in CRC pavement.

slab, the use of additional cement in the concrete mixture at the morning side, positive reinforcement support, and more careful attention to consolidation have basically eliminated construction joint problems since 1970.

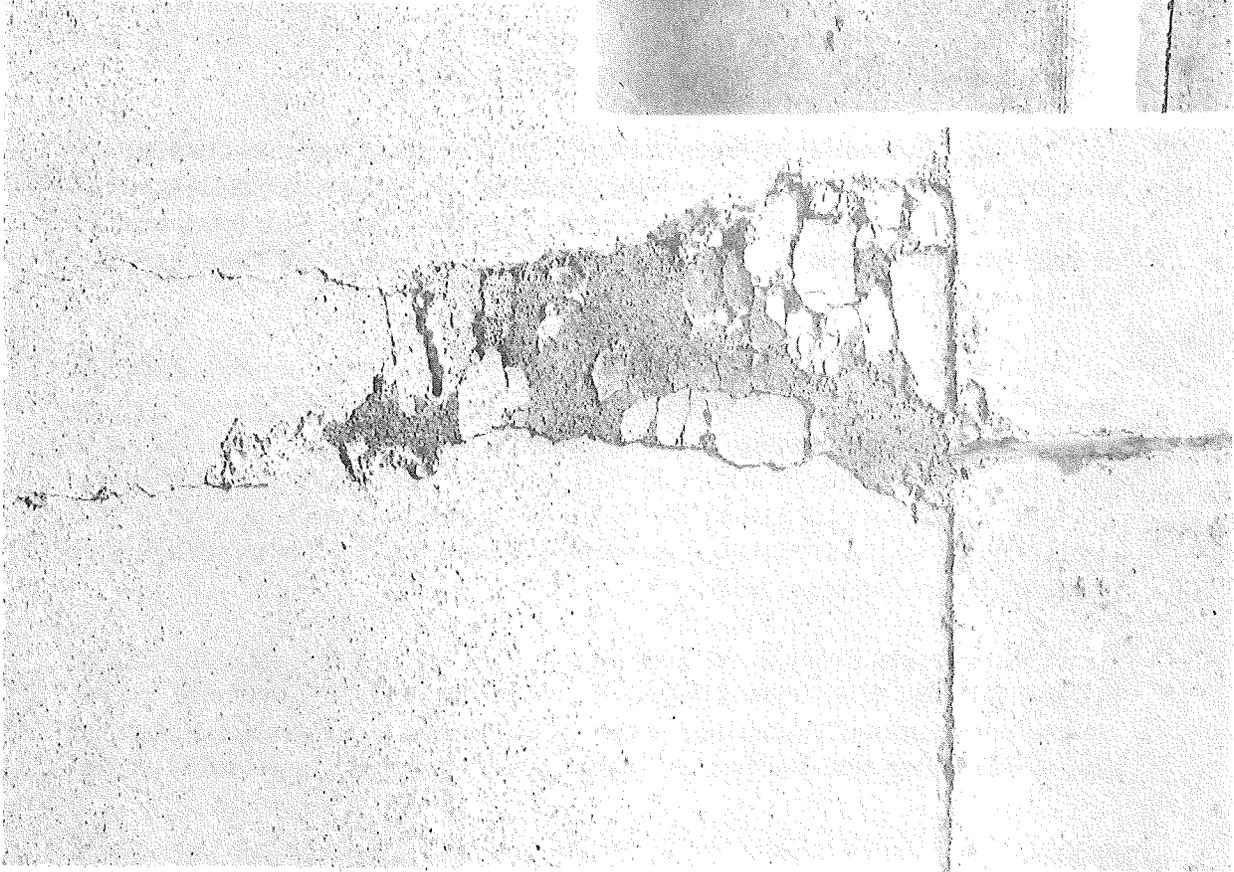
Failures at Joints in Adjacent Pavements - A wide crack forms in the CRC pavement in line with a joint in the adjacent jointed pavement and in time the concrete breaks up between this crack and an adjacent one (Fig. 5). Apparently, the adjacent jointed pavement, which is tied into the CRC pavement, induces sufficient tension in the CRC when the jointed slabs change length, to allow the crack to open excessively at the edge. Eventually, the concrete separates at the steel level, and then fractures under load.

This type of failure has occurred only on the I 96 pavement built in 1962 and then only at two ramps that were tied to the CRC pavement. A change in design that allows the adjacent jointed concrete to change length without inducing excessive tension in the CRC pavement accounts for the absence of this type of failure on other CRC pavement projects.

Figure 5. Failure in CRC pavement adjacent to conventionally jointed pavement.

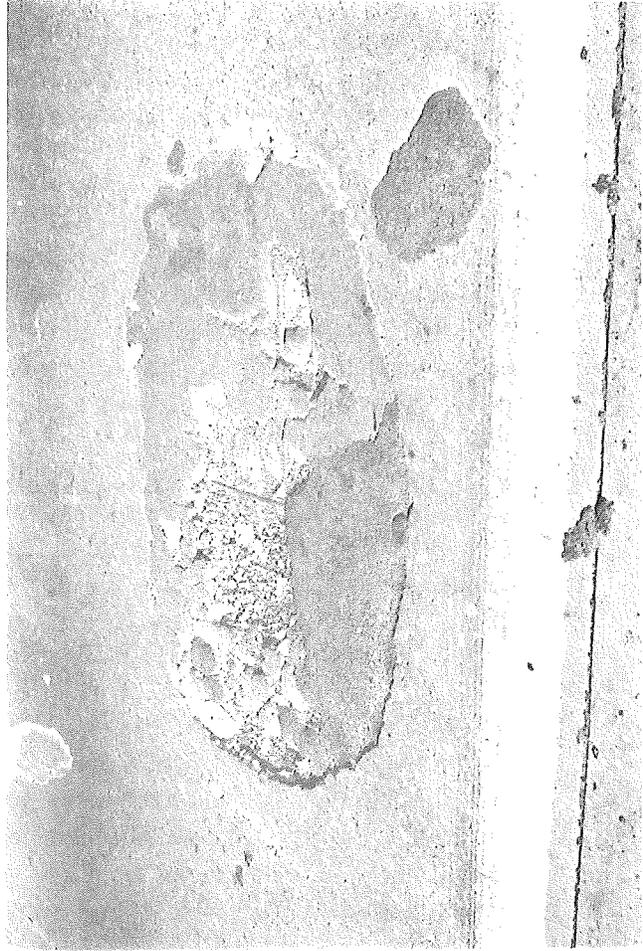
High Steel Failure - The shallow layer of concrete above the steel fractures and is kicked out by traffic, thus, exposing the reinforcement (Fig. 6). High steel failures occur after several years service and are normally preceded by rust stain on the pavement surface. This indicates that corrosion of the steel induces fracture planes and once separation of the concrete occurs, traffic breaks the concrete into pieces.

To date, high steel failures have not occurred in pavements constructed with loose steel bars nor have they appeared on pavements built between 1970 and 1973 when the steel was vibrated into position. The total number of this type of failure is relatively small and nearly all of them are on a 3 mile section of I 75 built in 1966.

Figure 6. CRC pavement failures caused by the reinforcement placed too high during construction.

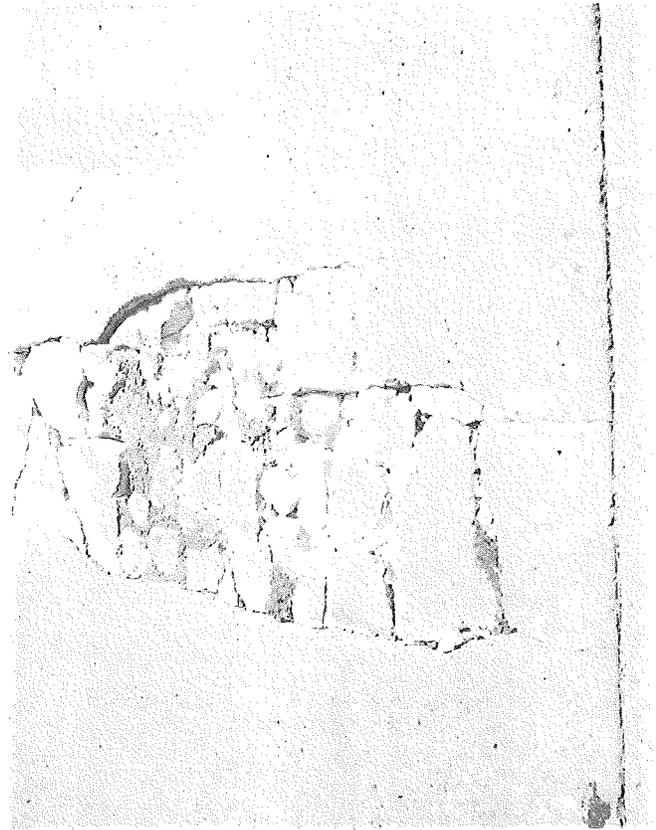
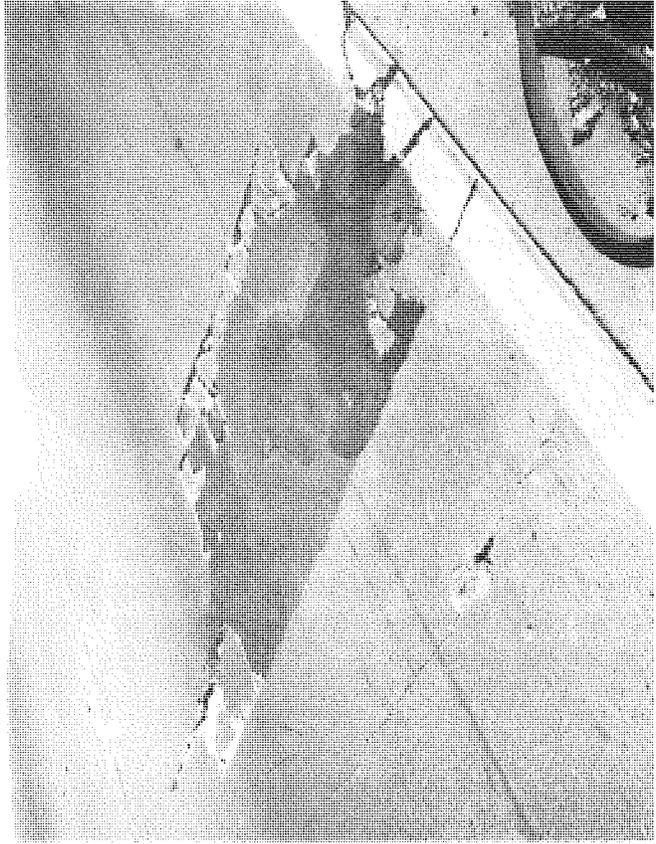
Concrete Breakup Failure - The concrete above the reinforcement is fractured (Fig. 7). Concrete breakup normally occurs in areas of narrow crack spacing and on pavements with more than five years of service. It is generally found in the wheel track areas of the most heavily traveled lanes. All failures of this type are in CRC pavements constructed by the two-layer method and nearly all of them are on depressed sections where drainage is provided by use of edge drains.

The concrete breakup failures appear to be caused by a combination of several factors: poor consolidation of the two concrete layers used in two-course construction, corrosion of the reinforcement, a base condition that allows excessive slab deflection, short crack spacings, and traffic loads.

Figure 7. Typical concrete breakup failures in CRC pavement.

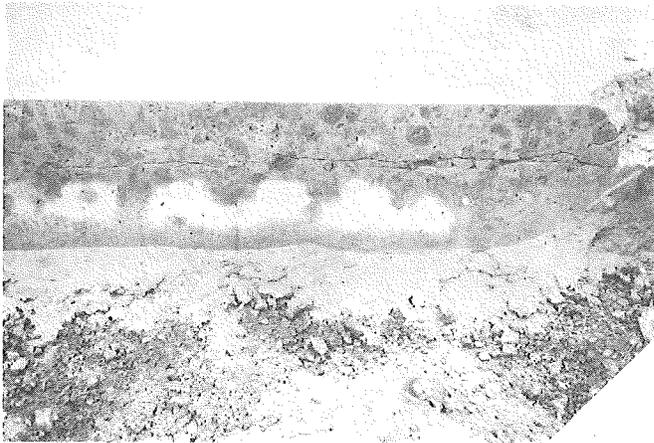
Figure 8. Horizontal crack at steel level in lane under repair.

During repairs of failures it was found that the concrete had separated at the steel level. Figure 8 shows the separation crack at the end of a repair and Figure 9 shows separation of the concrete in an adjacent lane.

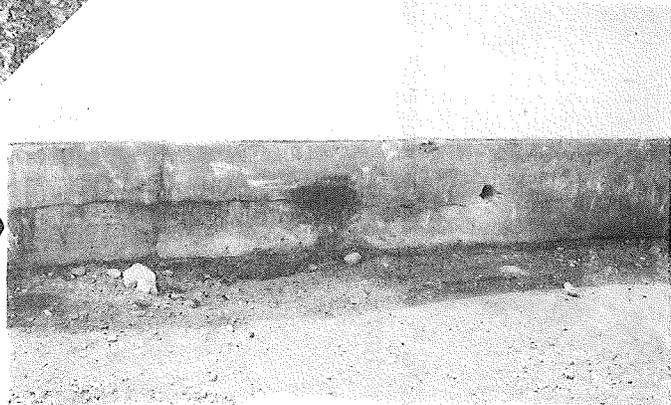
Figure 9. Horizontal crack at steel level in lane adjacent to the one being repaired. Note excellent condition of pavement surface.

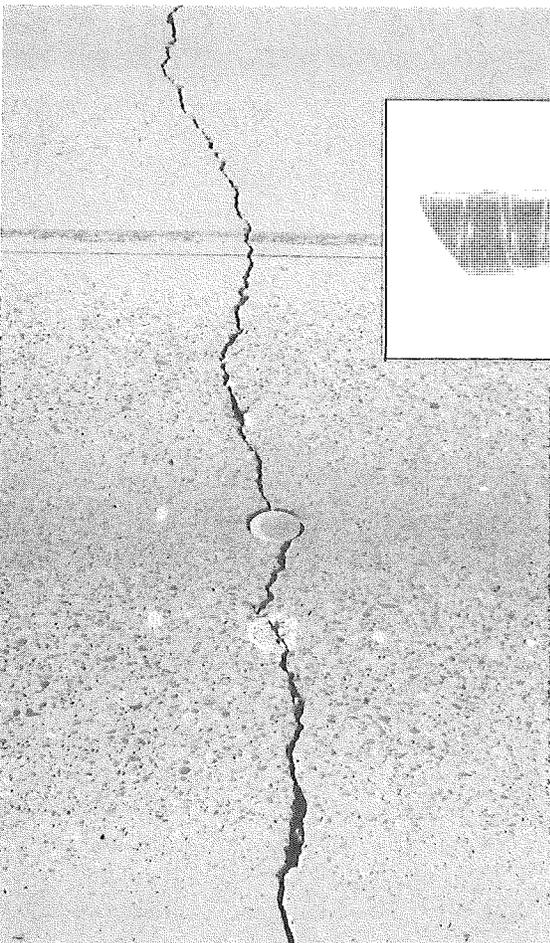
Figure 10. Steel failure in CRC pavement 16 years old. Reinforcement is No. 5 deformed bars, 8-in. pavement with 0.60 percent steel.

Steel Corrosion Failure - The steel has corroded and fractured and a wide crack is noticeable in the pavement surface (Fig. 10). Corrosion failures are caused by rusting of the steel at cracks where high tensile stresses occur. These failures have been observed where the crack spacing is unusually large which, of course, means the cracks are wider than normal, and thus, saltwater from ice and snow removal can easily penetrate to the steel level.

Steel corrosion failures have occurred only on the 16 year old pavement between Phillips and Meridian Rd on I 96. Examination and tension tests conducted on steel samples removed from repair areas on 14 and 19 year old pavements indicate corrosion of the steel will eventually cause continuity failures of the pavement. A detailed description and discussion of the study concerning steel corrosion of the removed samples are given in the Appendix.

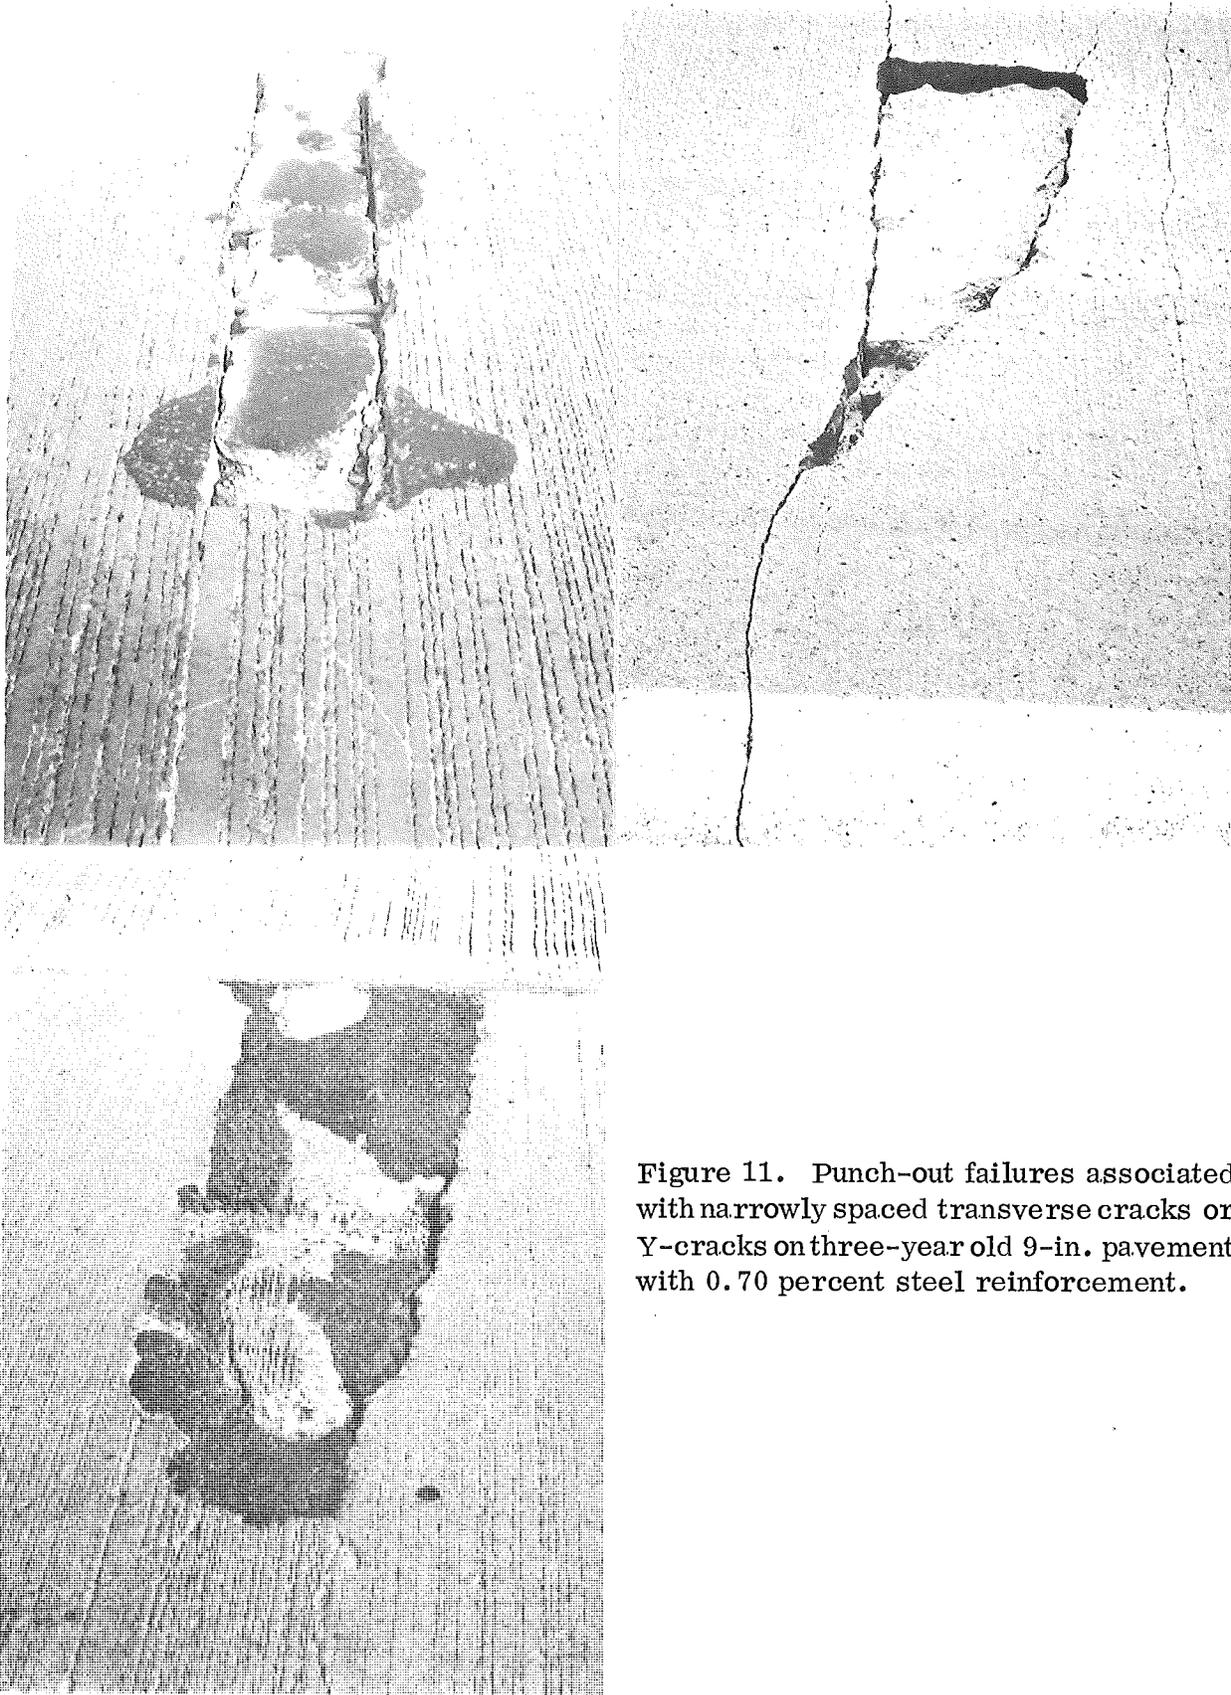
Punchout Failures - The settlement and breakup of a small section of pavement bounded by intersecting cracks (Fig. 11). On the basis of examination of the failures and cores taken through punchout areas, it appears that the cause of failure is related to localized loss of base support, heavy truck traffic, poor consolidation of the concrete around the steel bars, narrow transverse crack spacing, or Y-type cracks intersected by longitudinal cracks.

Figure 11. Punch-out failures associated with narrowly spaced transverse cracks or Y-cracks on three-year old 9-in. pavement with 0.70 percent steel reinforcement.

The failure process apparently starts by a longitudinal crack or cracks forming between two narrowly spaced transverse cracks located over a weak spot in the base. Once the concrete piece is surrounded by cracks the wheel loads destroy the aggregate interlock and then the concrete is supported only by the rebars going through it. The continued application of wheel loads fails the concrete bond to the steel and eventually the concrete wears away around the bars. The concrete now settles into the base equal to the thickness of concrete worn away over the rebars. In some cases, the concrete piece breaks into smaller ones and some spalls off at the steel level.

Punchout failures have occurred only on I 94 which was constructed in 1975.

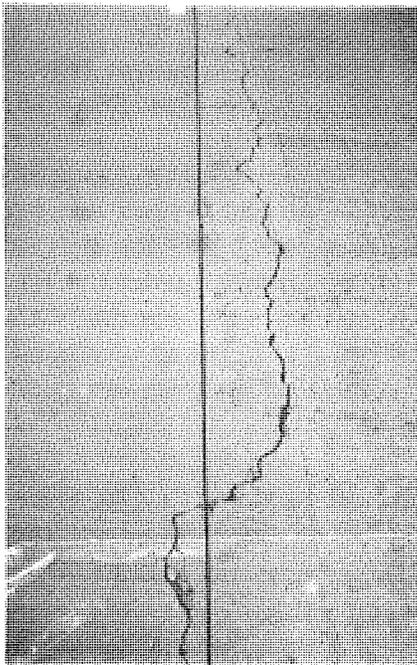
Longitudinal Crack Failure - There are two types of longitudinal cracks: one type is where the crack parallels the centerline joint (Fig. 12) and the other one is where the crack is located somewhere in the center 8 ft of a 12 ft lane (Fig. 13). It is generally agreed that the crack along the sawed centerline joint is caused by late sawing or loading the slab before sawing. Crack formation in the interior portion of a lane is normally associated with base problems. It should be noted that longitudinal cracks of both types occur in conventional reinforced concrete pavements as well as in CRC pavement.

Figure 12. Longitudinal crack paralleling centerline sawcut.

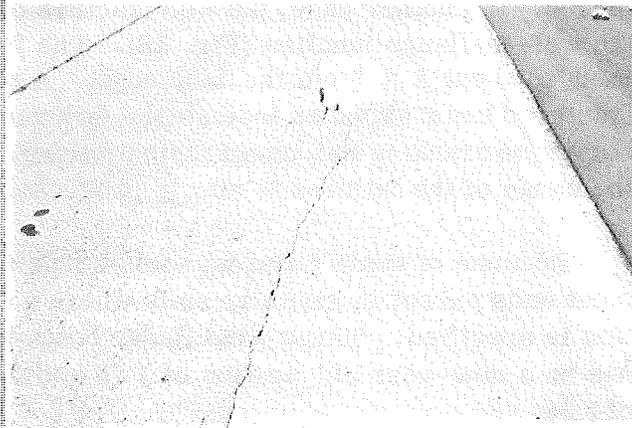
Figure 13. Longitudinal crack in the interior portion of the lane.

Other than minor spalling along the crack that follows the centerline joint, no problems have been experienced to date. The tie bars through the joint prevent the crack from opening excessively. At the interior cracks in CRC pavement, punchout failures have occurred (Fig. 14). They occur where a second longitudinal crack forms close to the main crack and then develops in the manner described earlier for this type of failure at transverse cracks.

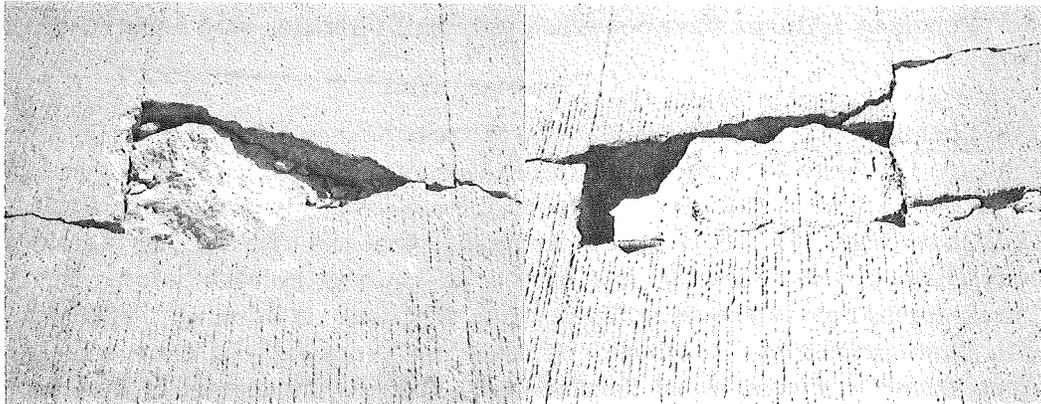
Figure 14. Punch-out failures associated with longitudinal cracks.

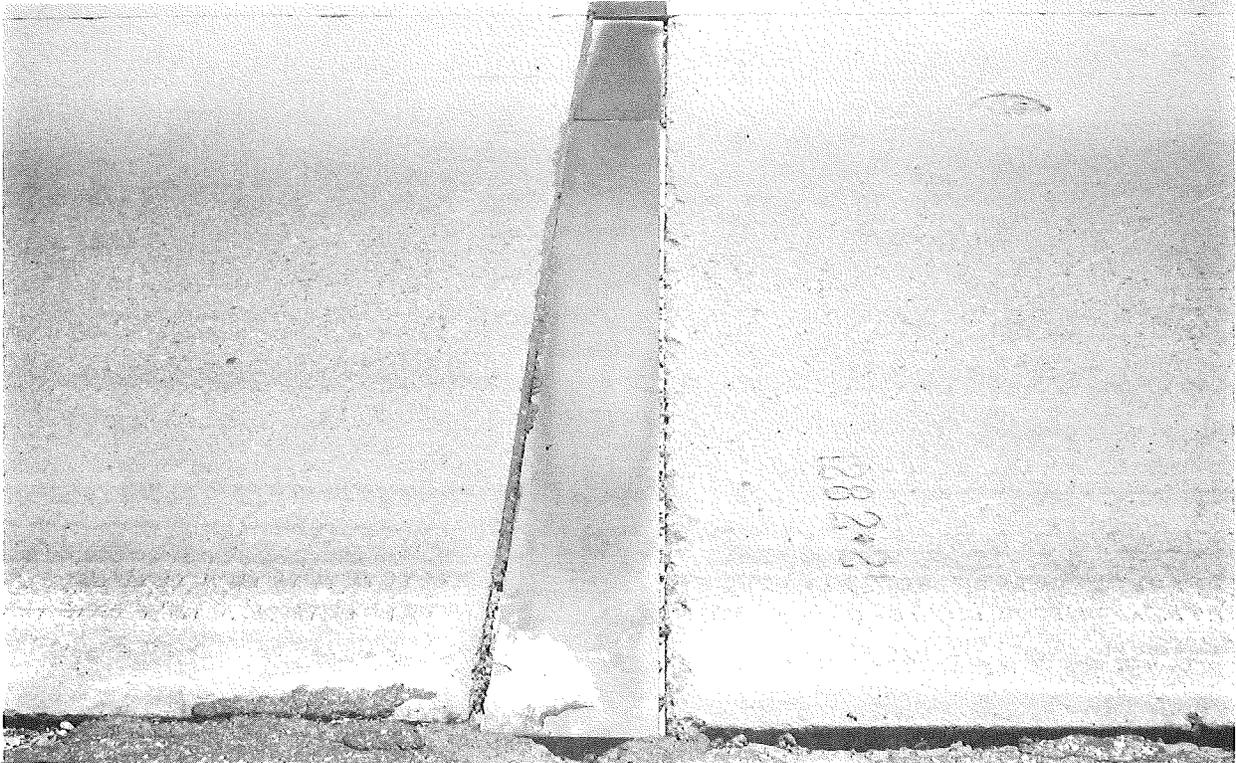
Wide Flange Beam Joint Failure - This type of joint failure results from the web of the wide flange beam fracturing. In one case (Fig. 15), the fracture occurred in the web just above the sleeper slab. The web had fractured for its entire length and the beam would bounce when traffic passed over it. Before the failure was discovered the beam had broken into two pieces. In another case, the web fracture occurred just below the fillet at the web-to-flange junction (Fig. 16). The fracture extended from the lane joint to about 1 ft from the lane edge. A preliminary examination of the fractured beam surfaces indicate the failures could be the result of stress-corrosion cracking and/or corrosion fatigue. A detailed study to determine the cause of the failures is now in progress.

Figure 15. Wide flange beam failure. Web is broken at the sleeper slab level and the flange is broken 3 ft from centerline joint.

Because of these failures, anchor lugs are now required at CRC pavement ends except in granular soils where a six-expansion joint relief section is specified. Three wide flange beam failures have occurred to date: one on a nine-year old section of I 75 and two on a three-year old portion of I 94.

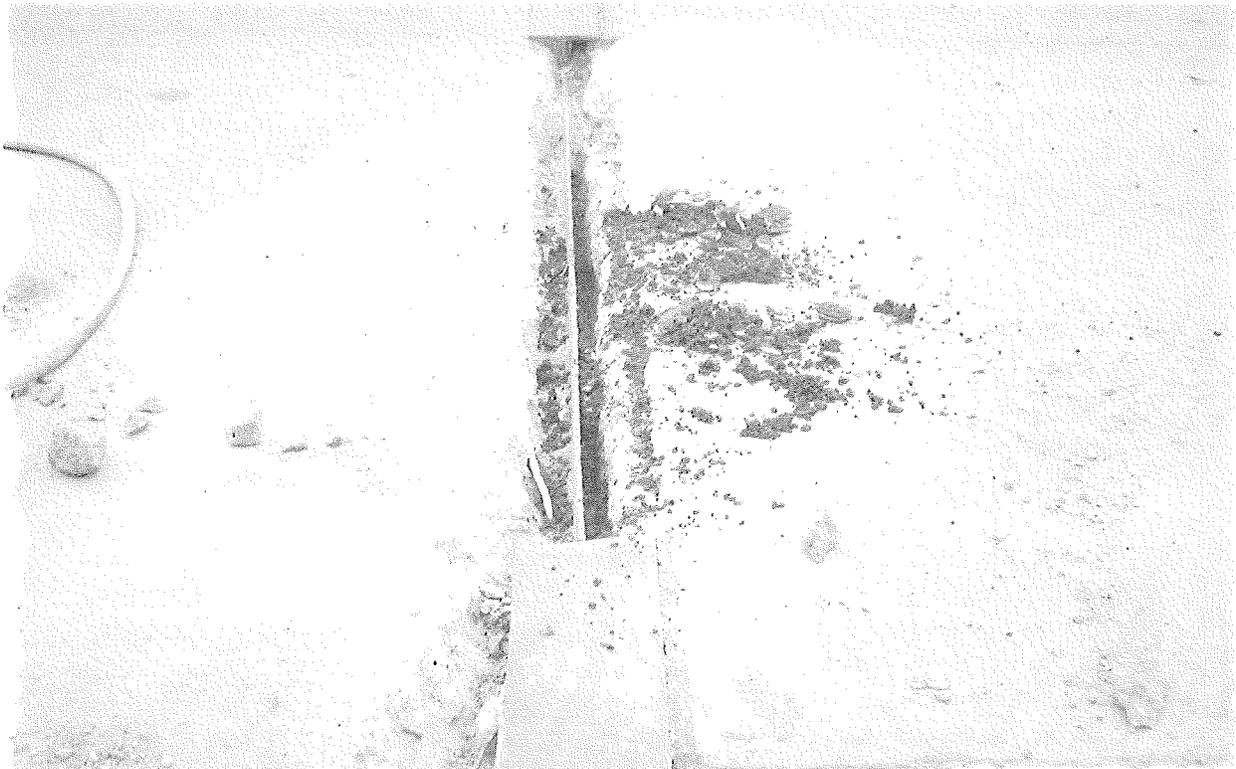
Figure 16. Wide flange beam failure. Web failed just below the fillet at the web to flange junction.

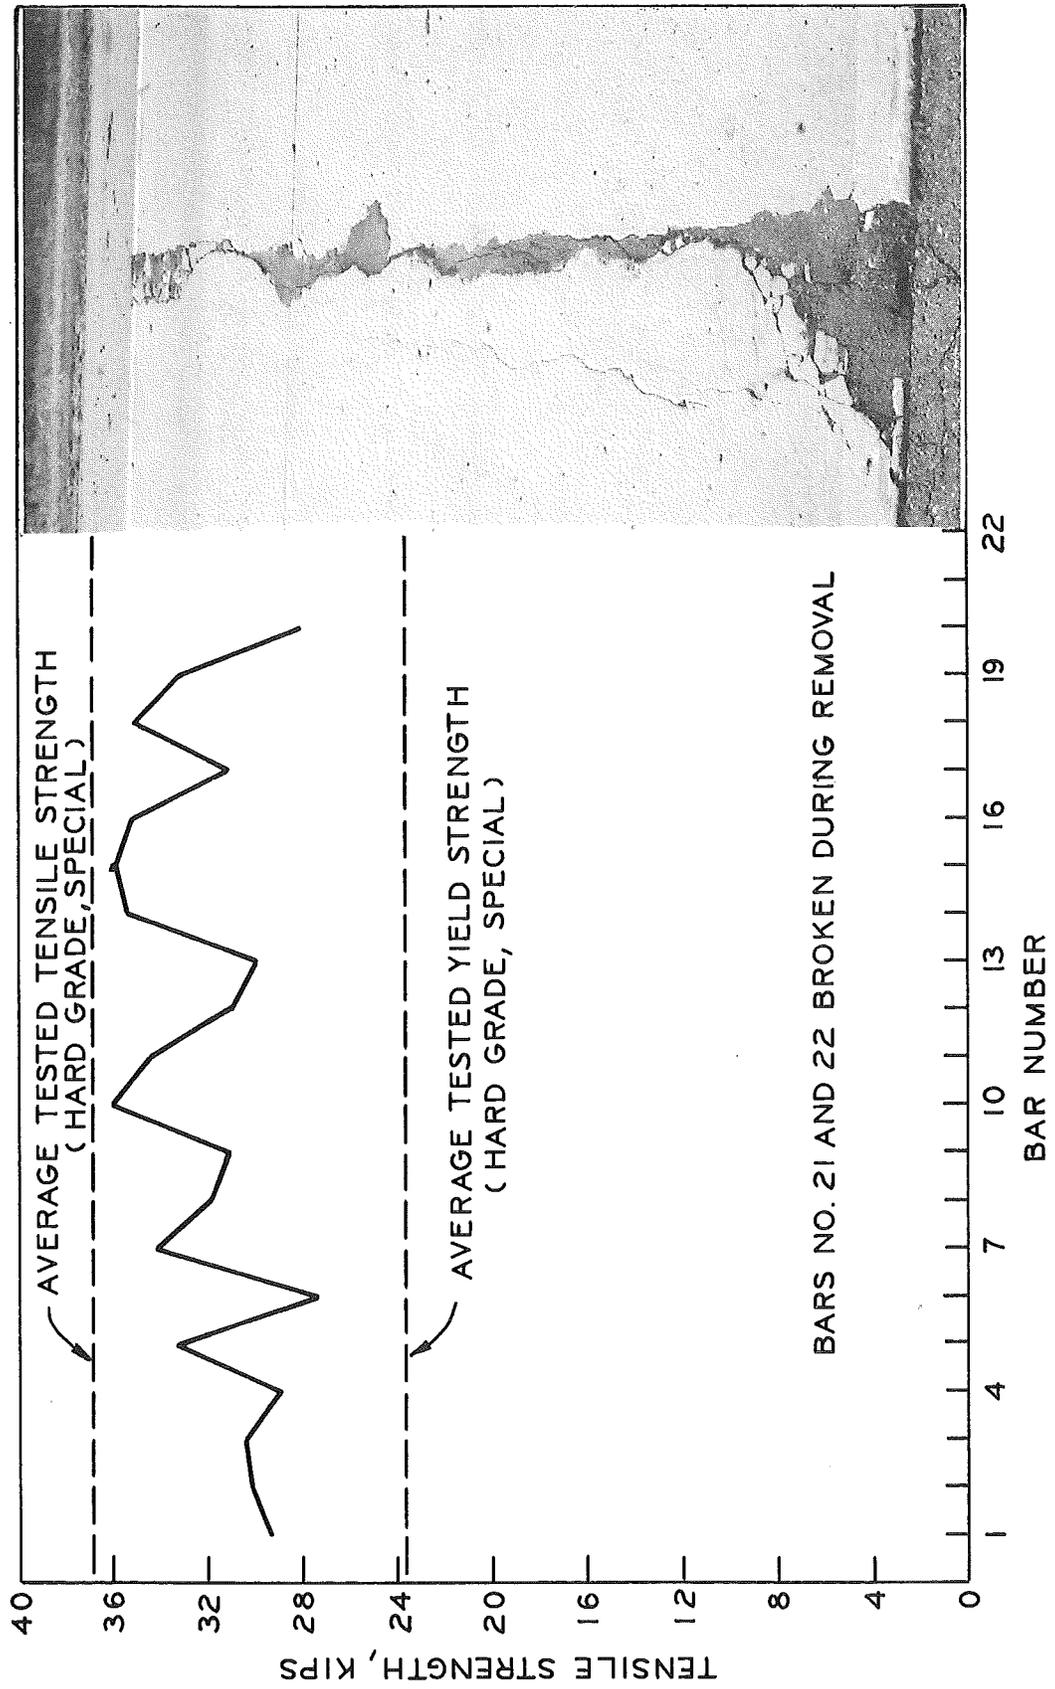
Figure 3A. Tensile strength of deformed No. 5 bars after 19 years service (Sta. 999+50) through lap failure shown at right.

At the three locations all bars broke at strengths below the 36,900 lb value obtained during testing in 1958. The average tensile strengths were 32,000, 32,900, and 24,500 lb at Stations 999+50, 929+00, and 929+06, respectively. This corresponds to a 13, 11, and 34 percent reduction in average tensile strength. At the construction joint, 32 percent of the bars broke at strengths below the average yield strength of the bars before installation.

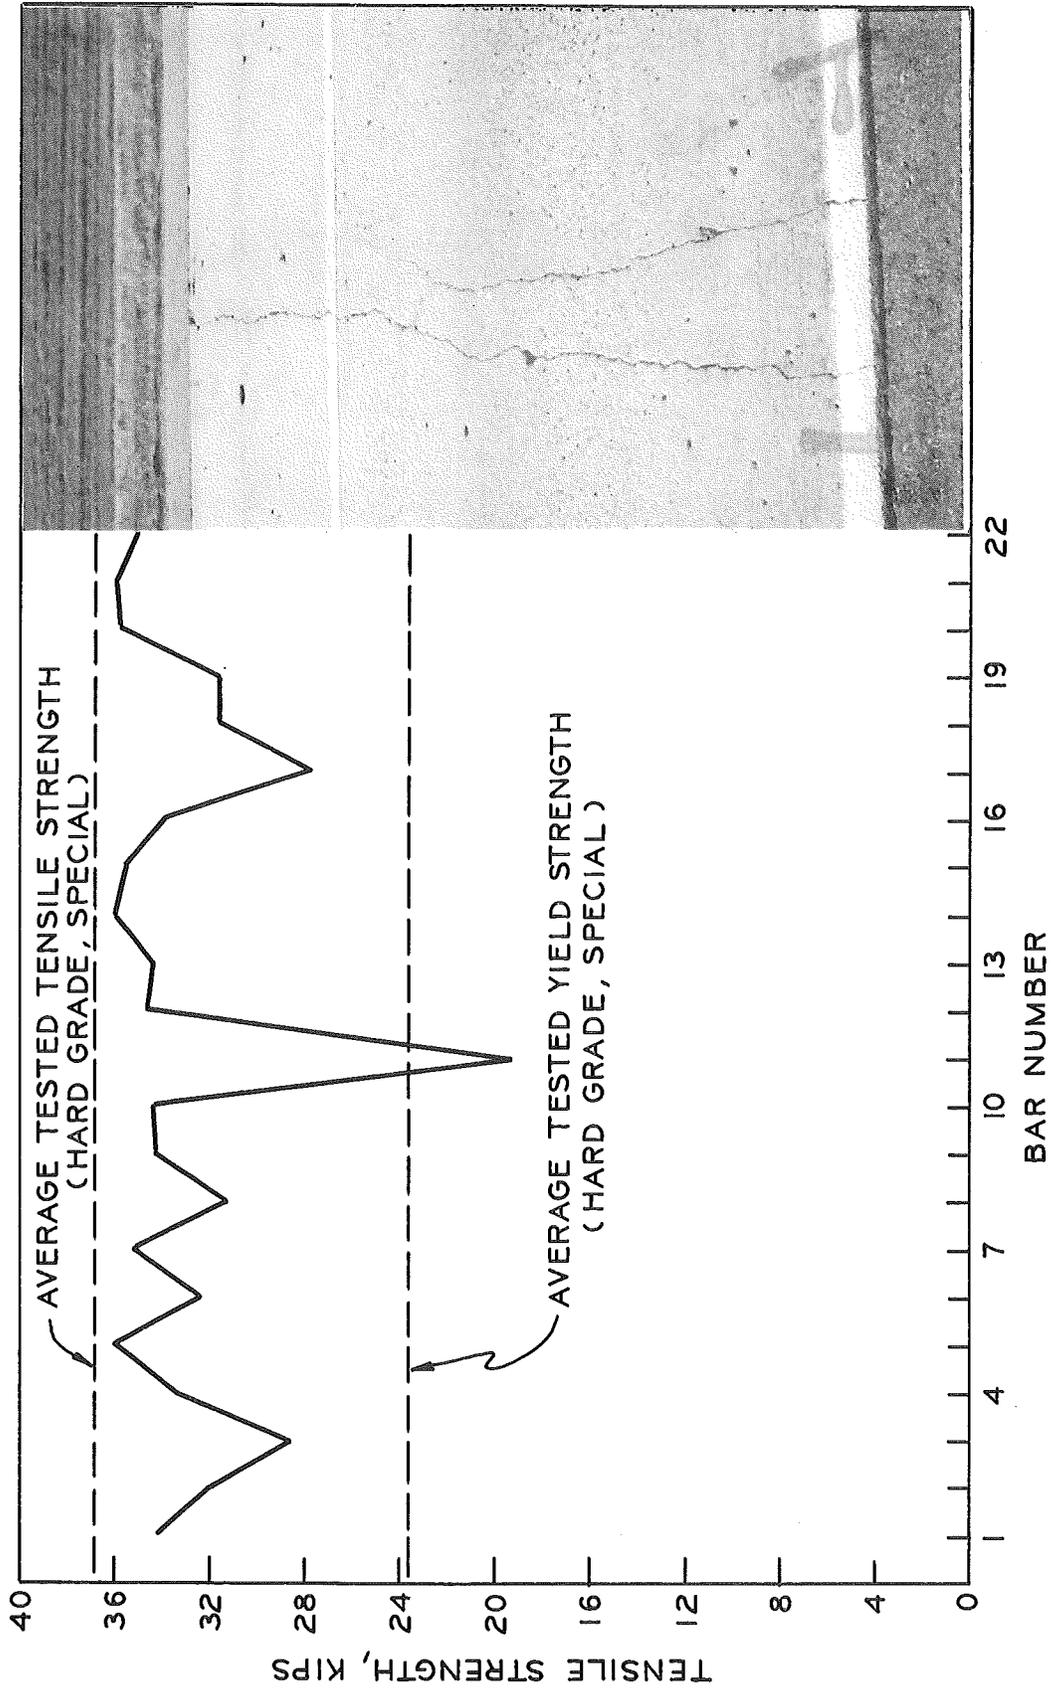
Figure 4A. Tensile strength of deformed No. 5 bars after 19 years service (Sta. 929+00) through crack shown at right.

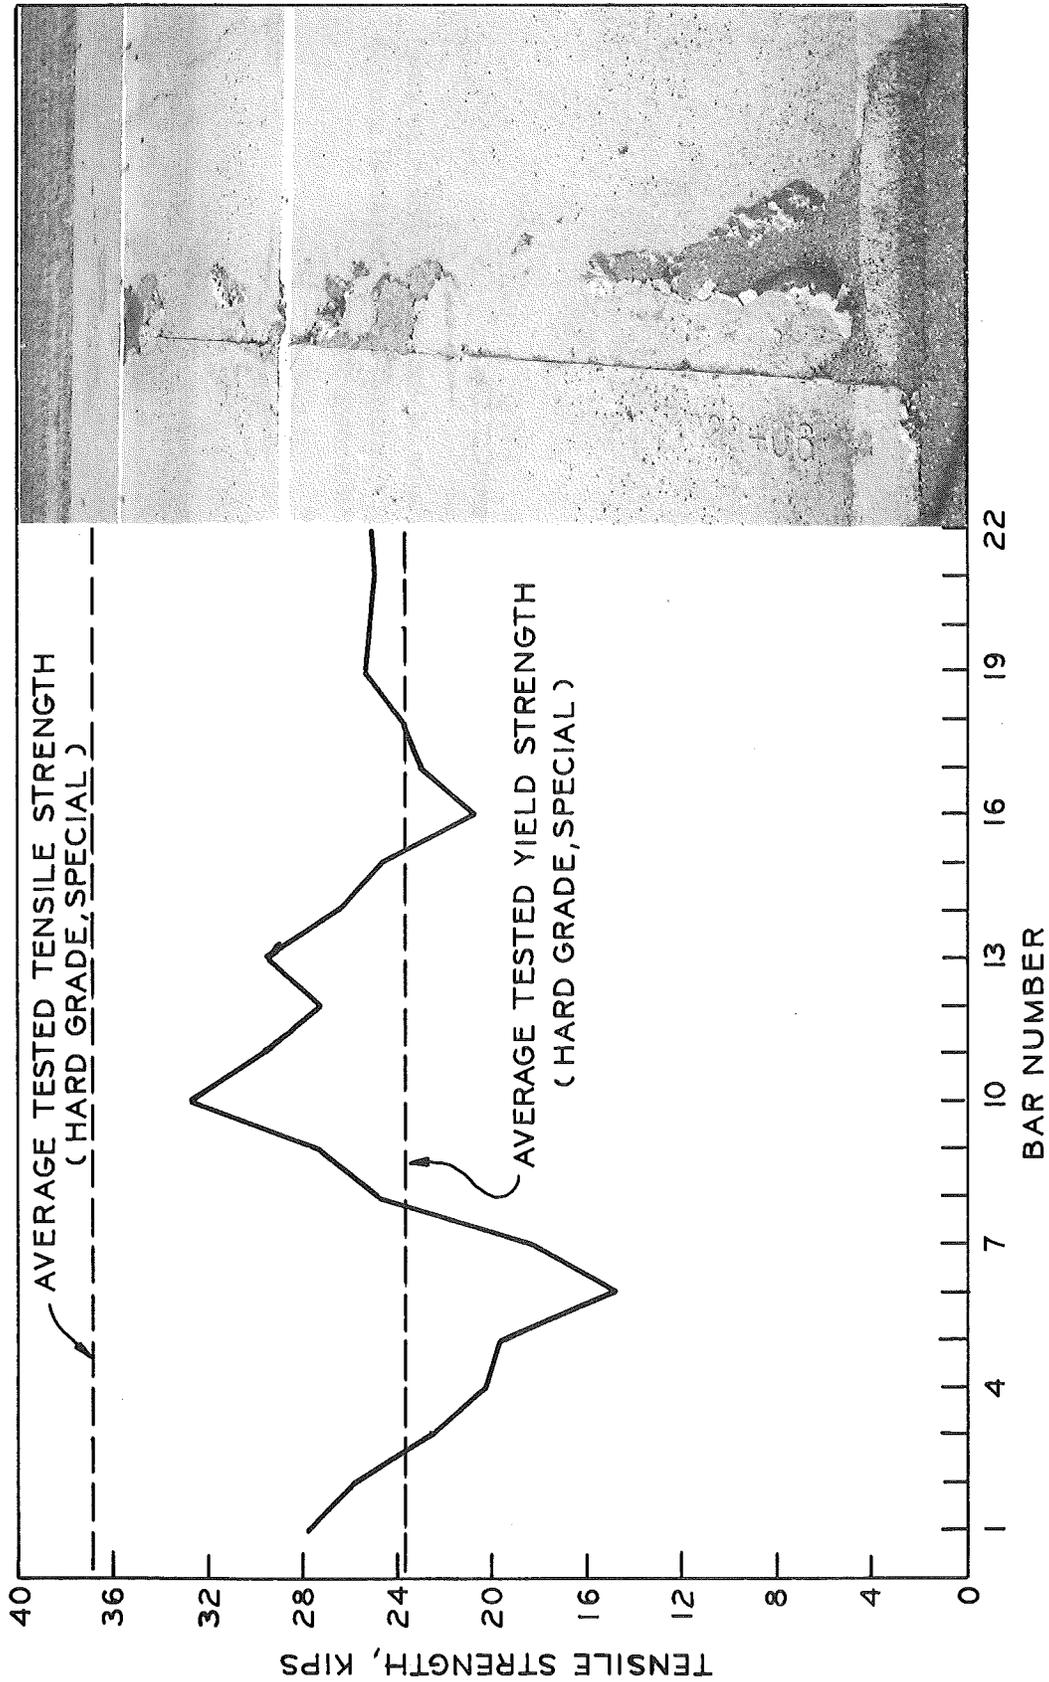
Figure 5A. Tensile strength of deformed No. 5 bars after 19 years of service (Sta. 929+06) through construction joint shown at right.

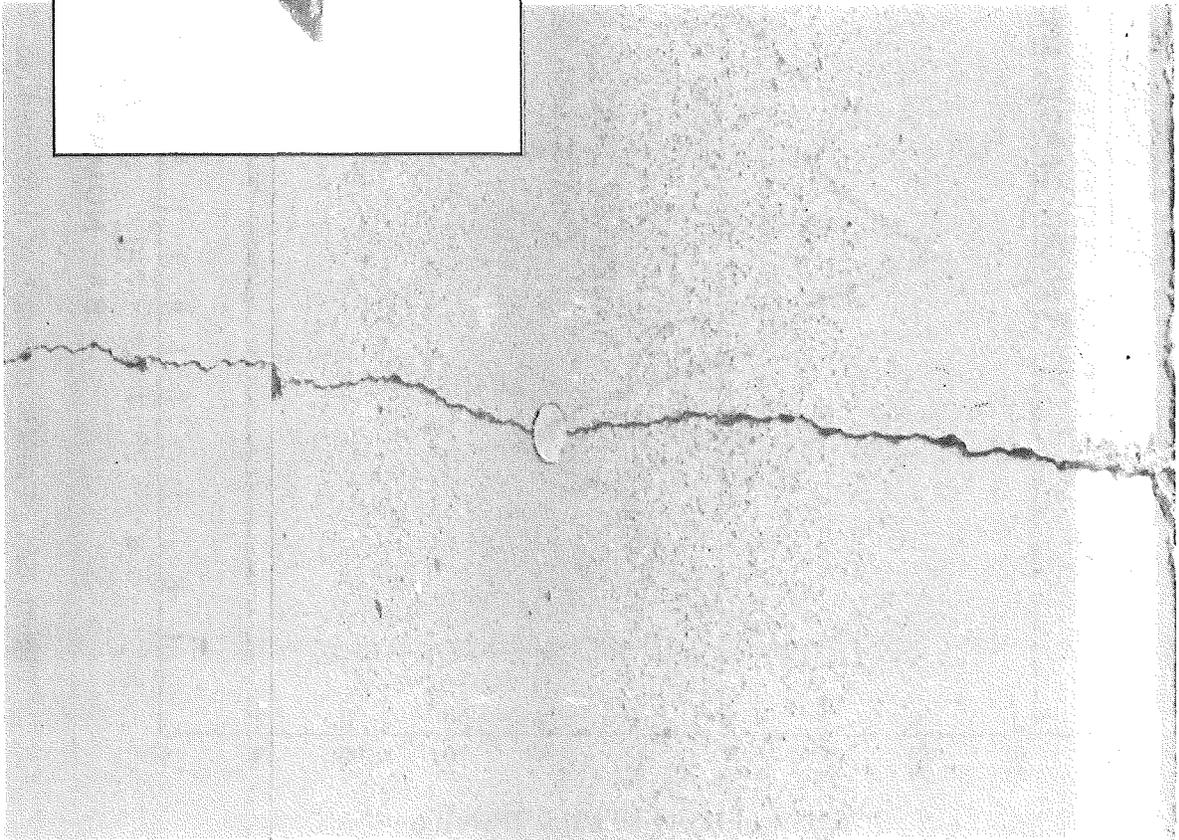
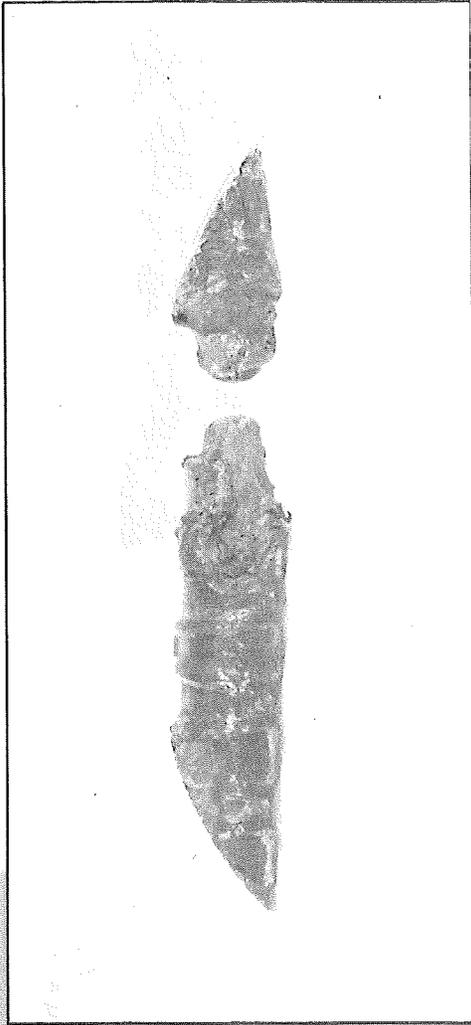
Figure 6A. Appearance of crack with fracture steel in 15 year old CRC pavement. Fractured steel sample removed from core is shown above.

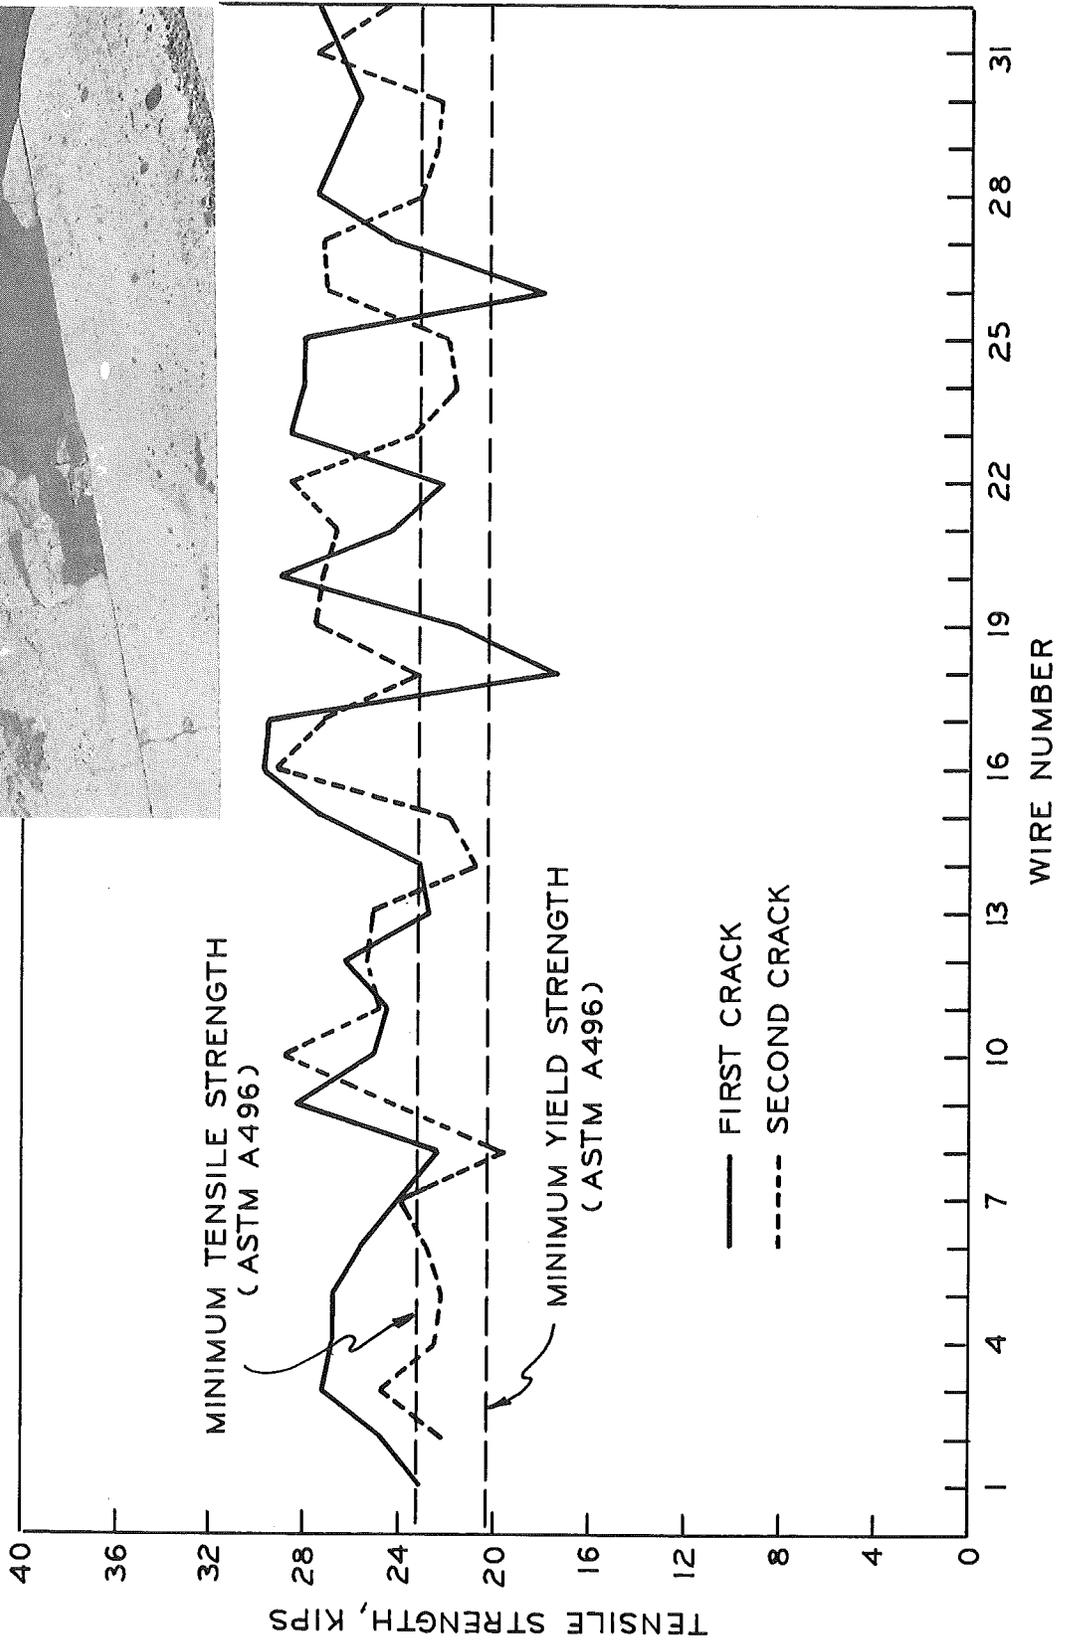
Figure 8A. Tensile strength of deformed D-29 wires after 11 years of service (Sta. 819). Condition of pavement from which the samples were removed is shown at right.
