**CONTINUOUSLY REINFORCED CONCRETE
PAVEMENT IN MICHIGAN
A HISTORICAL SUMMARY**

J. E. Simonsen

**Research Laboratory Section
Testing and Research Division
Research Projects 61 F-64,
57 F-46, and 73 F-129
Research Report No. R-1120**

**Michigan Transportation Commission
Hannes Meyers, Jr., Chairman; Carl V. Pellonpaa,
Vice-Chairman; Weston E. Vivian, Rodger D. Young,
Lawrence C. Patrick, Jr., William C. Marshall
John P. Woodford, Director
Lansing, June 1979**

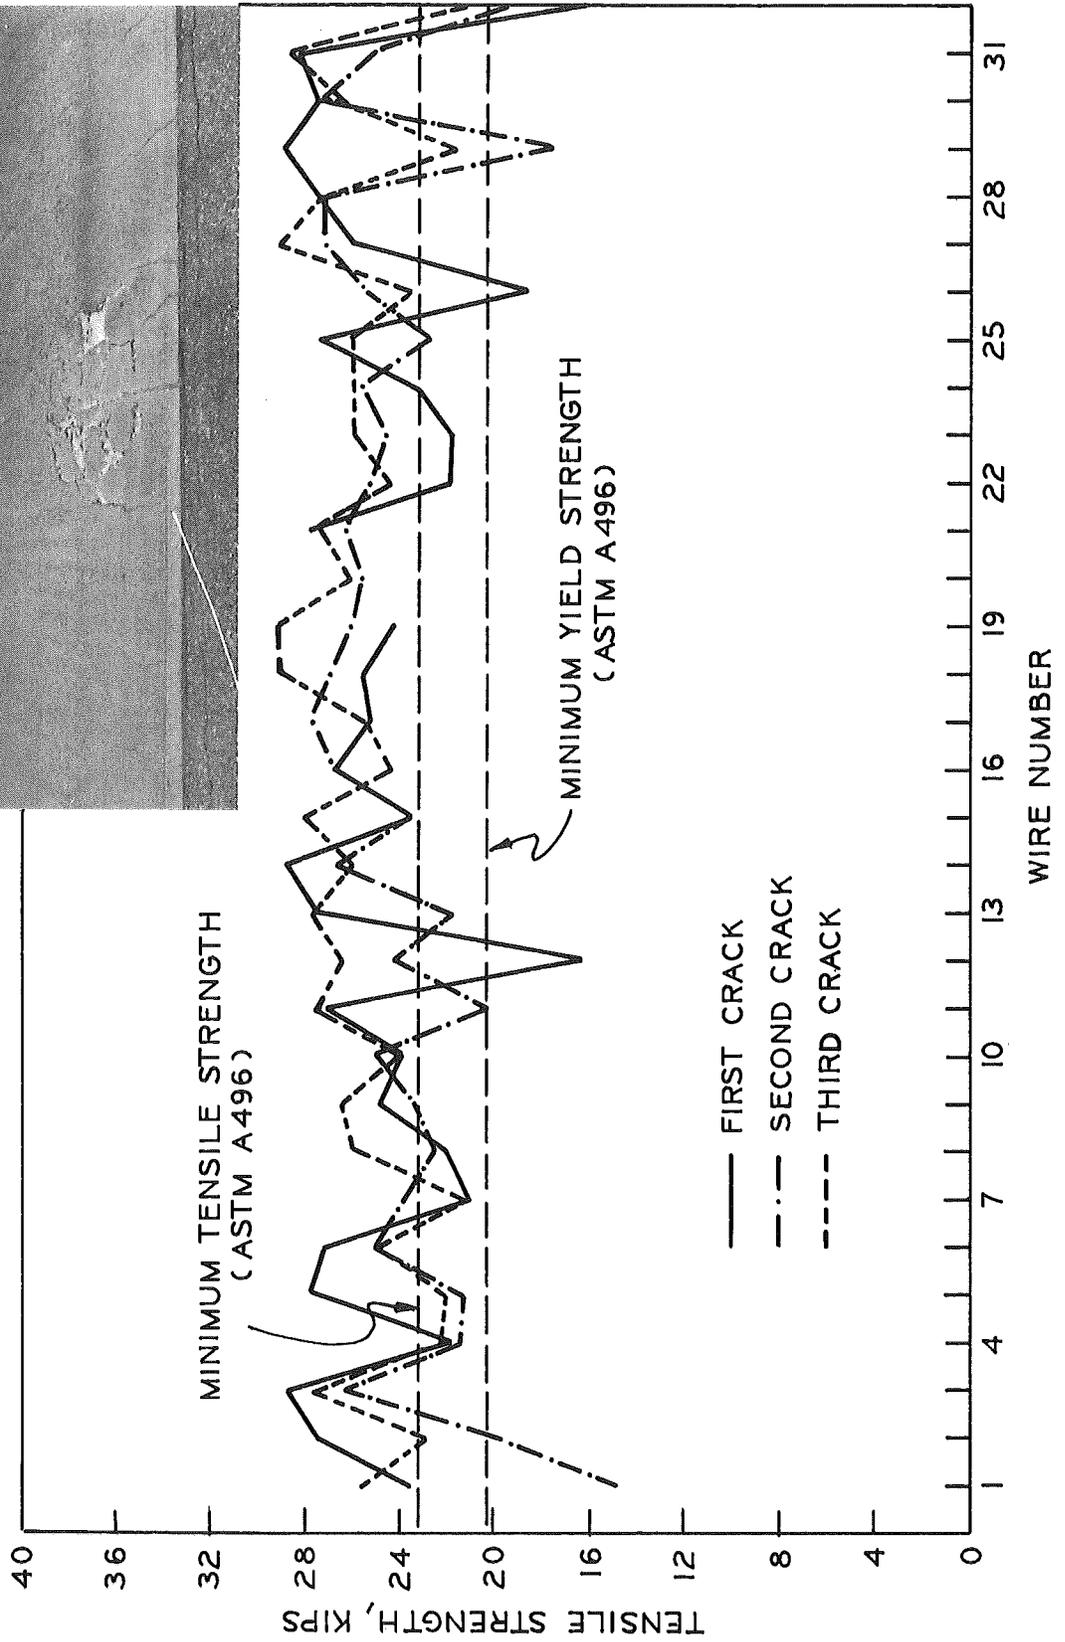
Figure 9A. Tensile strength of deformed D-29 wires after 11 years of service (Sta. 812). Condition of pavement from which the samples were removed is shown at right.
