INVESTIGATION OF PAVEMENT
PROBLEMS ON I 275

Research Laboratory Section
Testing and Research Division
Research Project 79 F-158
Research Report No. R-1126

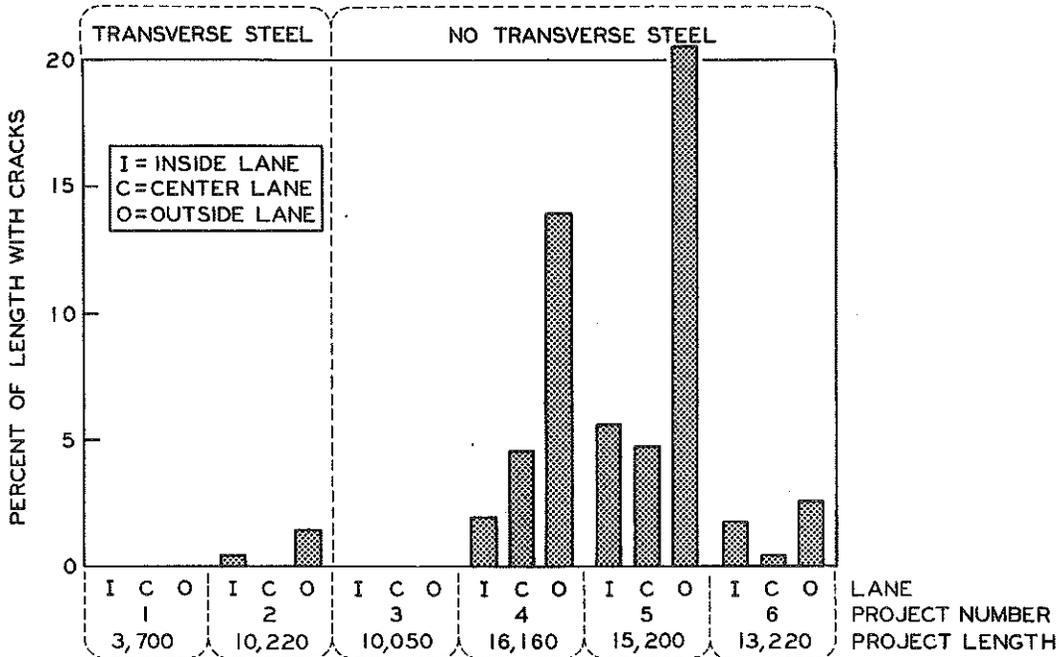
roadway which were selected for this investigation. As can be seen in the figure, Projects 1 and 3 are free of cracks, but the remaining four projects all contain longitudinal cracking in varying amounts.

Figure 2. Percent of lane with longitudinal cracks on Projects 1 through 6 as of March 1979.

The lane with the most cracks is the outside (traffic) lane, ranging from 1.5 percent on Project 2 to 20.6 percent on Project 5. The inside lane on three projects is cracked more than the center lane; whereas, on Project 4 the reverse is true. Since most trucks travel the outside lane, traffic loads are suspected to be one of the factors contributing to the formation or propagation of longitudinal cracks.

As can be noted in Figure 2, most cracking is located in projects without transverse steel, with the exception of Project 3 where no cracking has occurred. In terms of percentage, the pavement without transverse steel has cracked for a total of 2.7 percent of its equivalent lane length. The pavement with transverse reinforcement contains cracks totaling 0.3 percent of its equivalent lane length. Although the absence of transverse steel should not cause longitudinal cracking, its use will hold existing cracks tightly together, thus minimizing the progressive distress that is associated with cracked unreinforced concrete pavement.

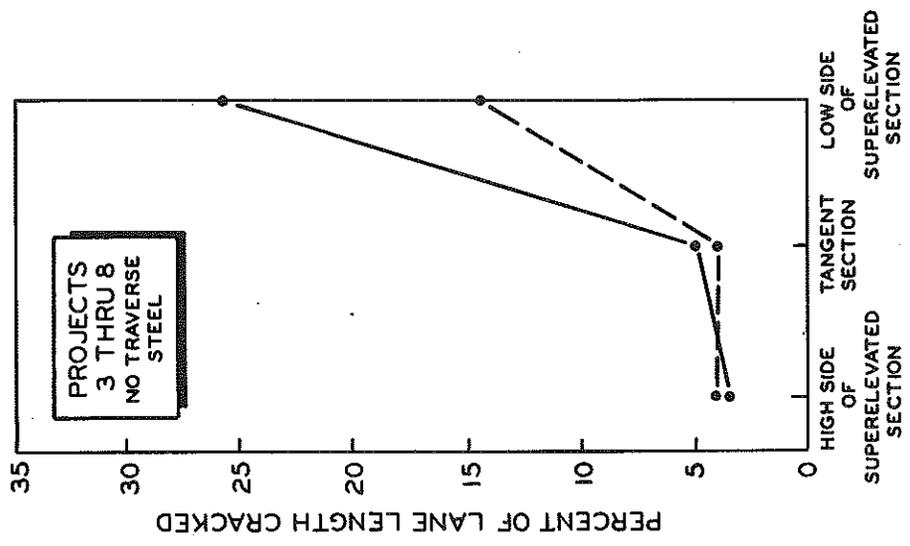
Figure 4. Percent longitudinal cracking on the traffic and in-side lane on Projects 3 through 8, southbound roadway.

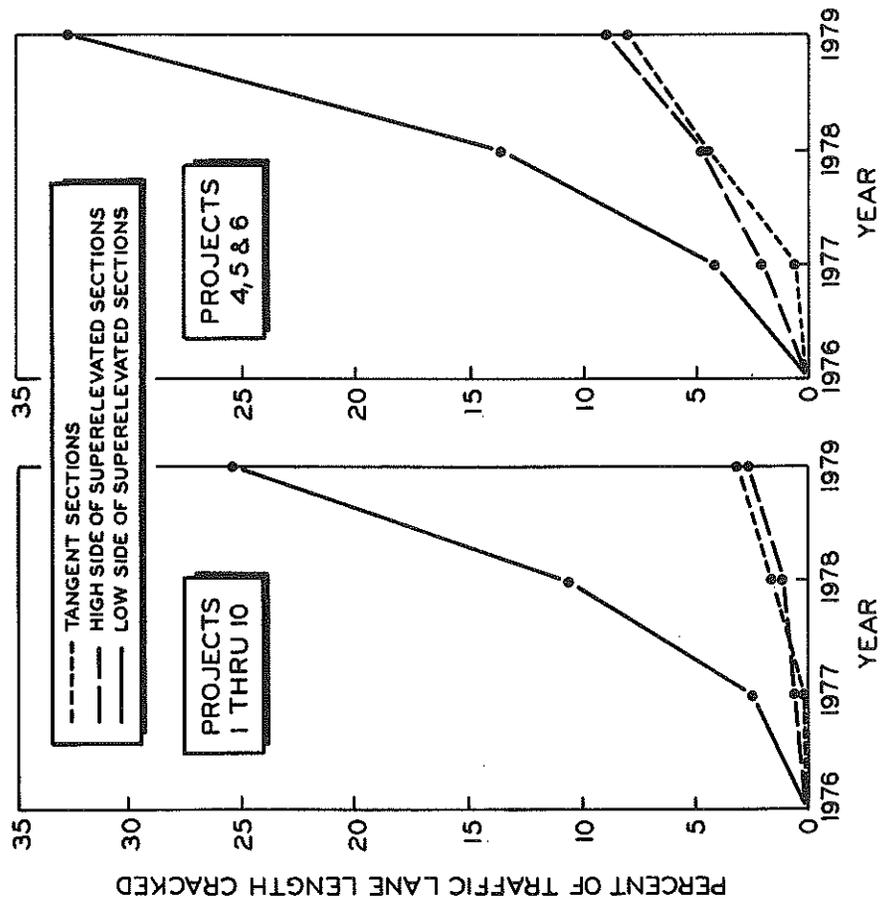
Figure 3. Percent longitudinal cracking in the traffic lane with respect to tangent and superelevated sections on three-lane pavements on Projects 4, 5, and 6 and on Projects 1 through 10, southbound roadway.

The effect of the roadway alignment on cracking is shown in Figure 3. The graph at the left illustrates that for Projects 4, 5, and 6, the low sides of superelevated sections contain more than three times as much cracking as the tangent sections and the high sides of superelevated sections. The graph at the right shows that the same pattern is true for all the three-lane pavement on southbound I 275, except that there is about eight times as much cracking on the low sides of the superelevated sections as compared to the other alignment types. It should also be noted that the increase in amount of cracking has been much higher on the low sides of the superelevated sections than on tangent sections or on the high sides of superelevated sections. While this phenomenon is most dramatic for the traffic lane (Fig. 3), it is also true for the inside (median) lane (Fig. 4). The center lane, which cannot be classified as to high or low, nevertheless shows slightly more cracking on curves as opposed to tangents. These observations on the correlation of cracking with superelevation hold for both the percent longitudinal length cracked as well as for the number of new cracks occurring each year.

One difference between a tangent and superelevated section is the surface drainage, and in some cases the drainage path, in the base and subbase layers. In superelevated sections, the surface water runs across all lanes to the low side; whereas, on tangent sections the crown point is 24 ft from the traffic lane edge. On some curves the subgrade is designed to slope from one lane edge to the ditch bottom at the opposite side which increases the drainage length by 12 ft. It is suspected that the increased drainage path and the additional surface water available for entering the bases through the shoulder joint may be one of the reasons why more cracking occurs on the low side of superelevated sections.
