TEXTURING EXISTING CONCRETE PAVEMENT

P. T. Luce

Research Laboratory Section
Testing and Research Division
Research Project 78 TI-537
Research Report No. R-1127

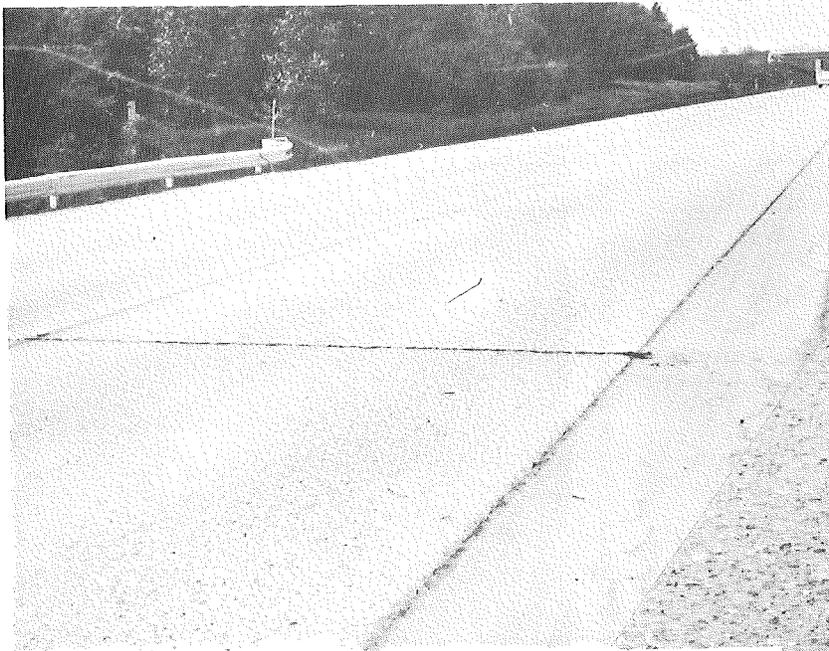
The milling operation crossed 10 mortar-filled transverse joints without inducing spalling along joint faces. Figure 1 shows an overall view of the site and a mortar-filled joint after milling. One open transverse crack, also mortar filled, did not change significantly as a result of the milling operation (Fig. 2). However, other closed transverse cracks, unfilled, became slightly 'dished' at the pavement surface from minor spalling of leading and trailing edges. When milling extends full width, free pavement edges spalled and rounded off (Fig. 3). This type of spalling presents no immediate problem and is probably an advantage at this location since it reduced the sudden transition between pavement and shoulder. The contractor elected not to mill across the longitudinal centerline joint. The longitudinal ridge created by this procedure is shown in Figure 4. In this case, the ridge was too small to affect vehicle behavior. A small longitudinal ridge was also created by overlapping cuts on the inside lane (Fig. 5).

Figure 1. General view demo site (looking north) and close-up of mortared joint after milling.

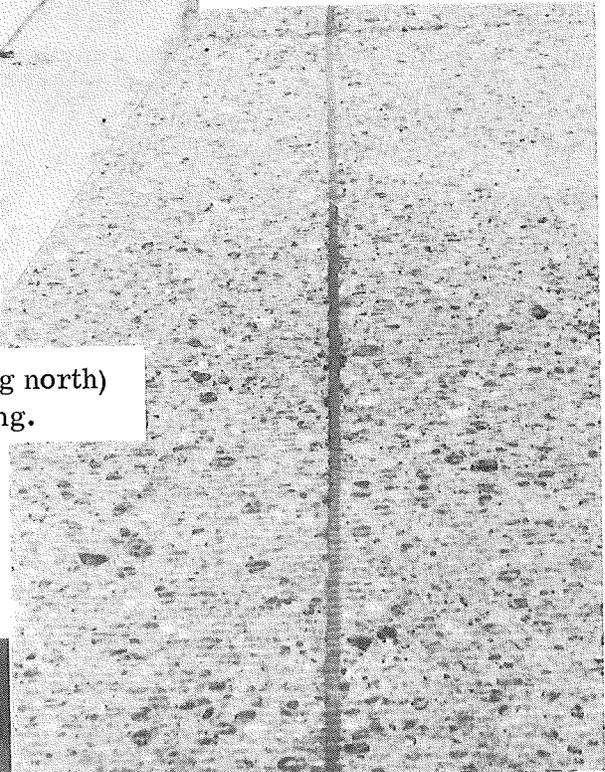
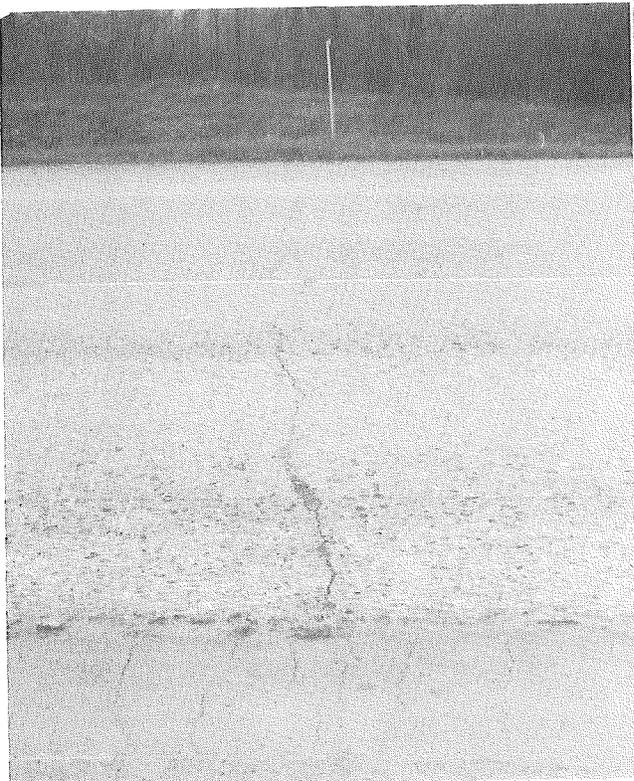
Figure 2. Mortar-filled transverse crack.

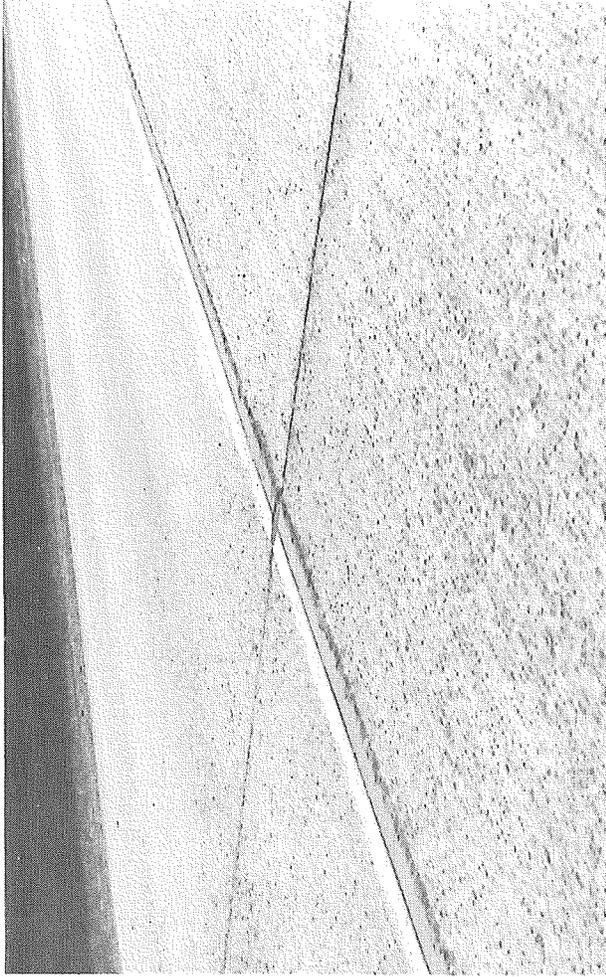
Figure 4. Longitudinal ridge along centerline.

Although any type of surface irregularity is undesirable, ridging, gouging, etc., can be controlled to an acceptable tolerance by close coordination between equipment and ground control operators and prompt replacement of worn or broken cutting tools.

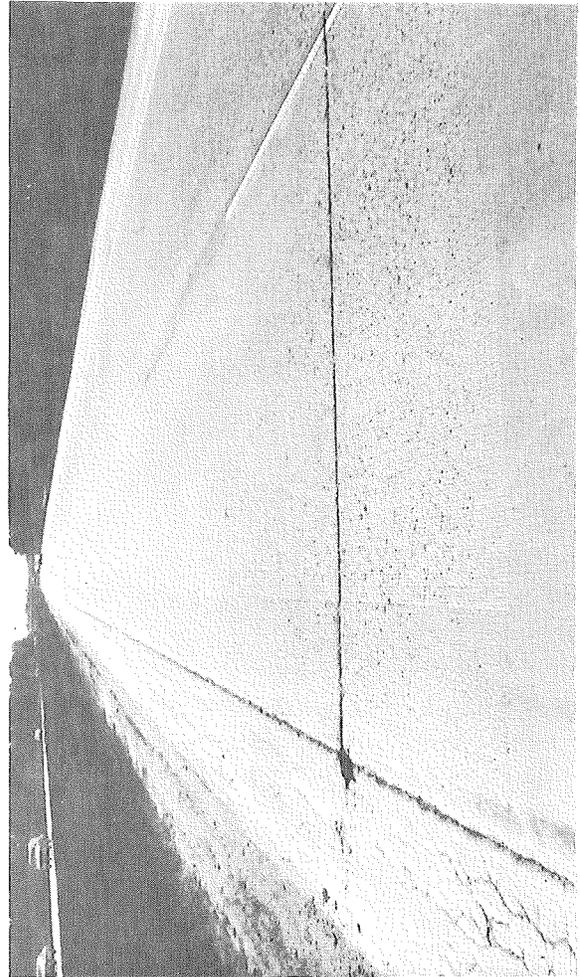
Figure 5. Longitudinal ridge at overlapping cuts.

Whenever possible, the width of the cutter should extend across the entire lane. This would minimize the matching of adjacent cuts, thus reducing the possibility of longitudinal ridges along overlapping cuts. Another obvious benefit is the reduction of milling time required for a single, as opposed to multiple, milling passes per lane.
