EVALUATION OF WEATHERING STEEL
IN A DETROIT FREEWAY ENVIRONMENT
-SECOND EIGHT-YEAR STUDY-

G. L. Tinklenberg

Research Laboratory Section
Materials and Technology Division
Research Project 62 G-122
Research Report No. R-1277

Michigan Transportation Commission
William C. Marshall, Chairman;
Rodger D. Young, Vice-Chairman;
Hannes Meyers, Jr., Carl V. Pellonpaa,
Shirley E. Zeller, William J. Beckham, Jr.
James P. Pitz, Director
Lansing, August 1986

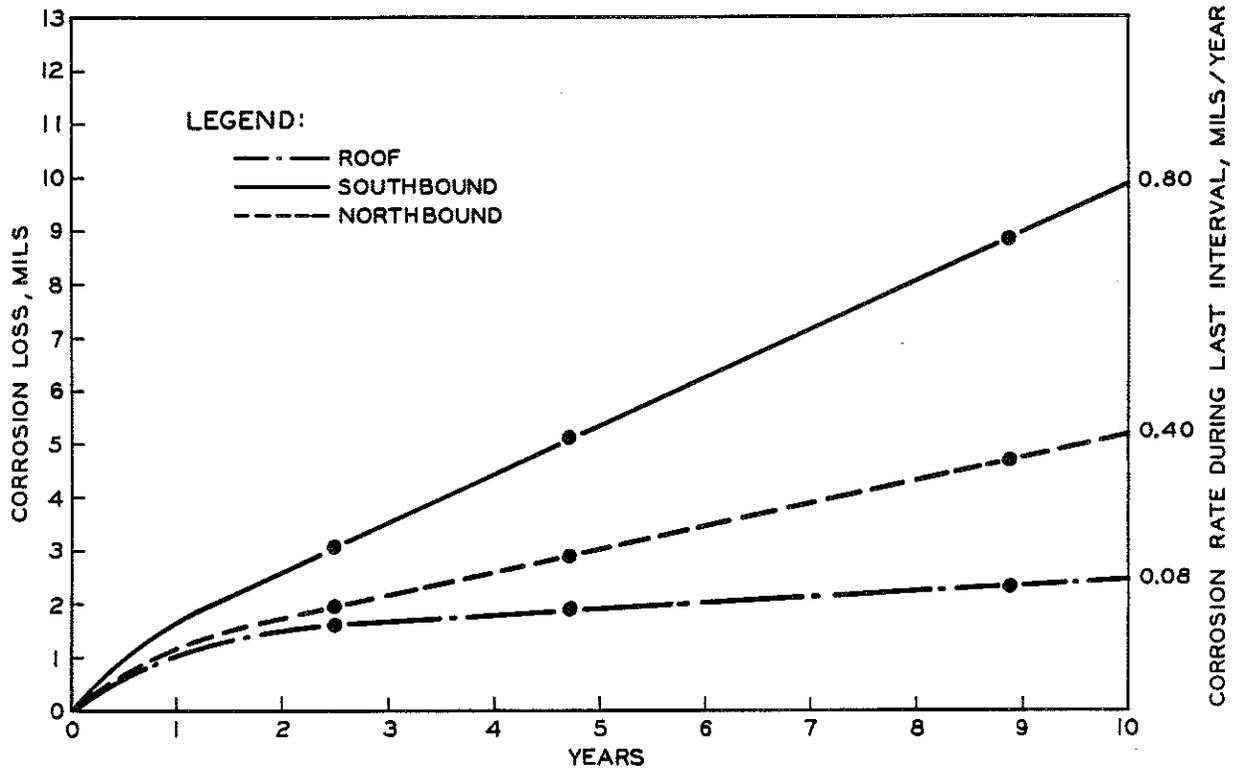
Figure 2. Corrosion curves from the second 8-Year study for A588 at all exposure sites.

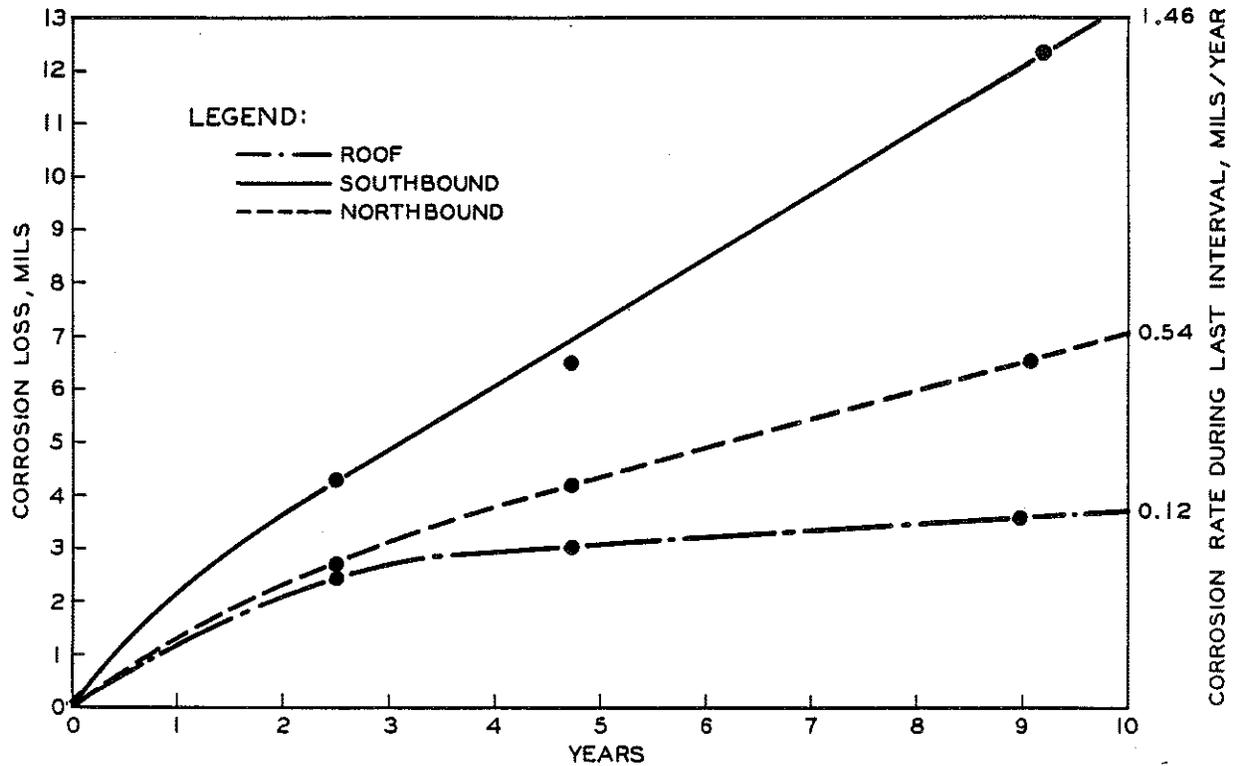
Figure 3. Corrosion curves from the second 8-year study for A36 at all exposure sites.

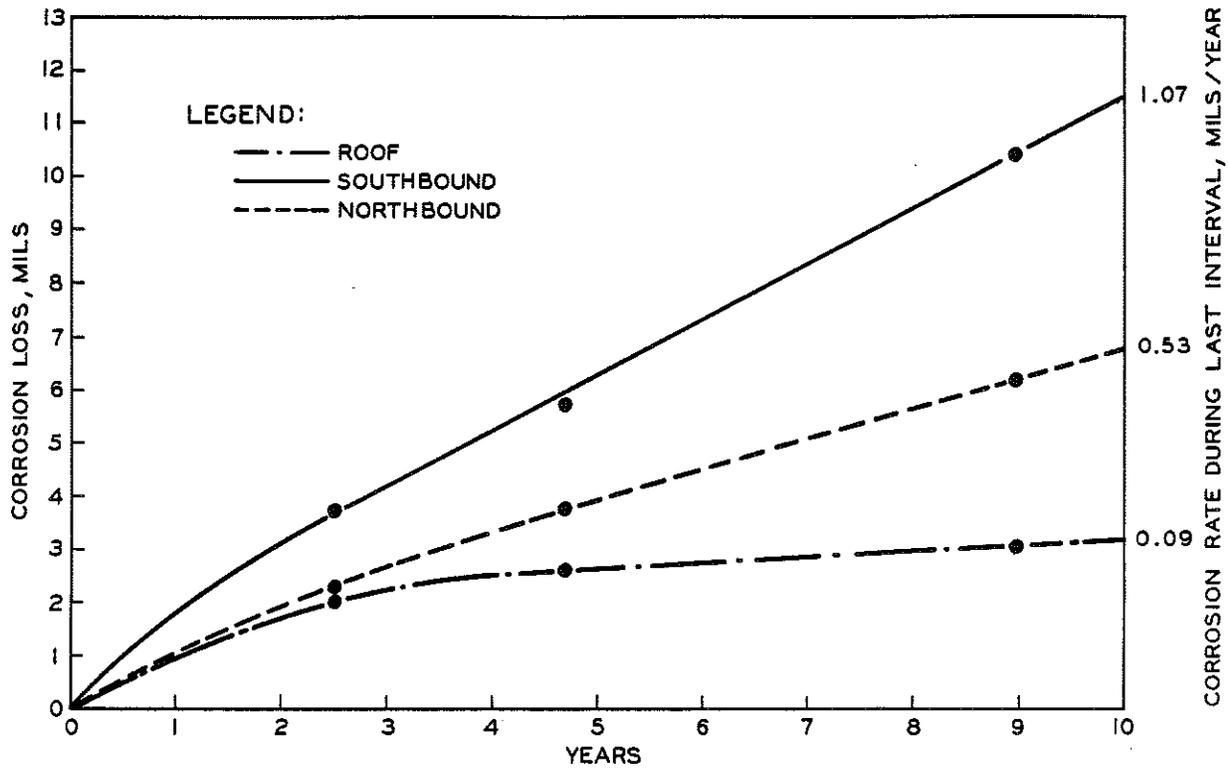
Figure 4. Corrosion curves from the second 8-year study for Copper Bearing at all exposure sites.

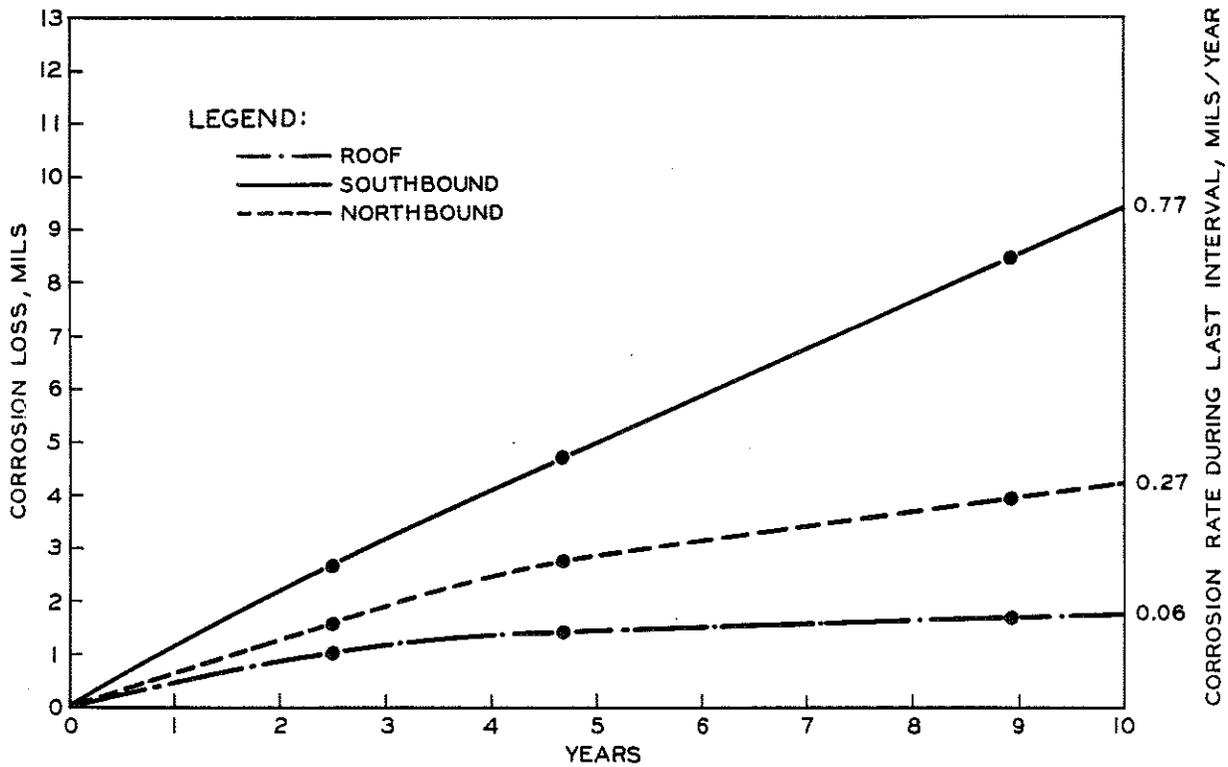
Figure 5. Corrosion curves from the second 8-year study for A242, Type 1 at all exposure sites.

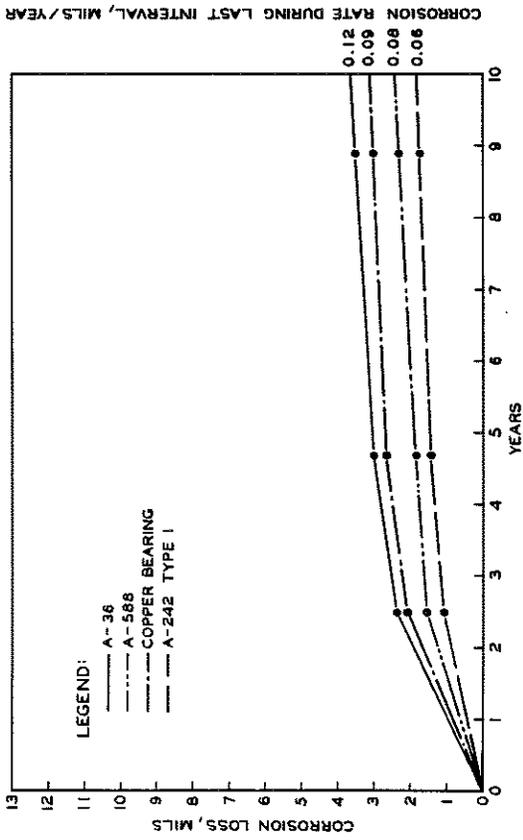
Figure 6. Corrosion curves from the second 8-year study for all steels at the Roof exposure site.

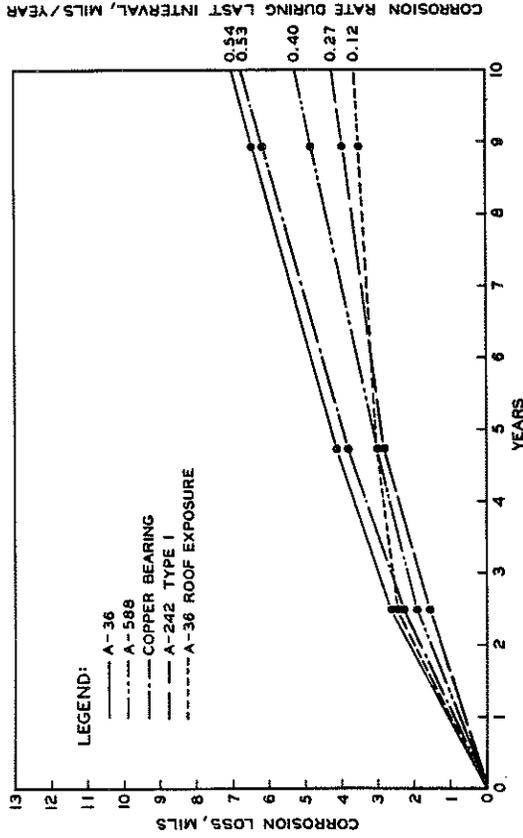
Figure 7. Corrosion curves from the second 8-year study for all steels at the Northbound exposure site.

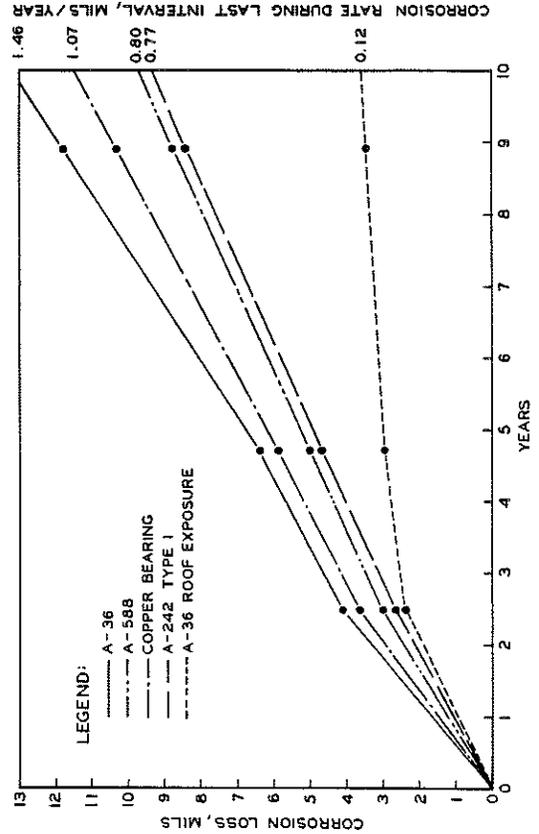
Figure 8. Corrosion curves from the second 8-year study for all steels at the Southbound exposure site.

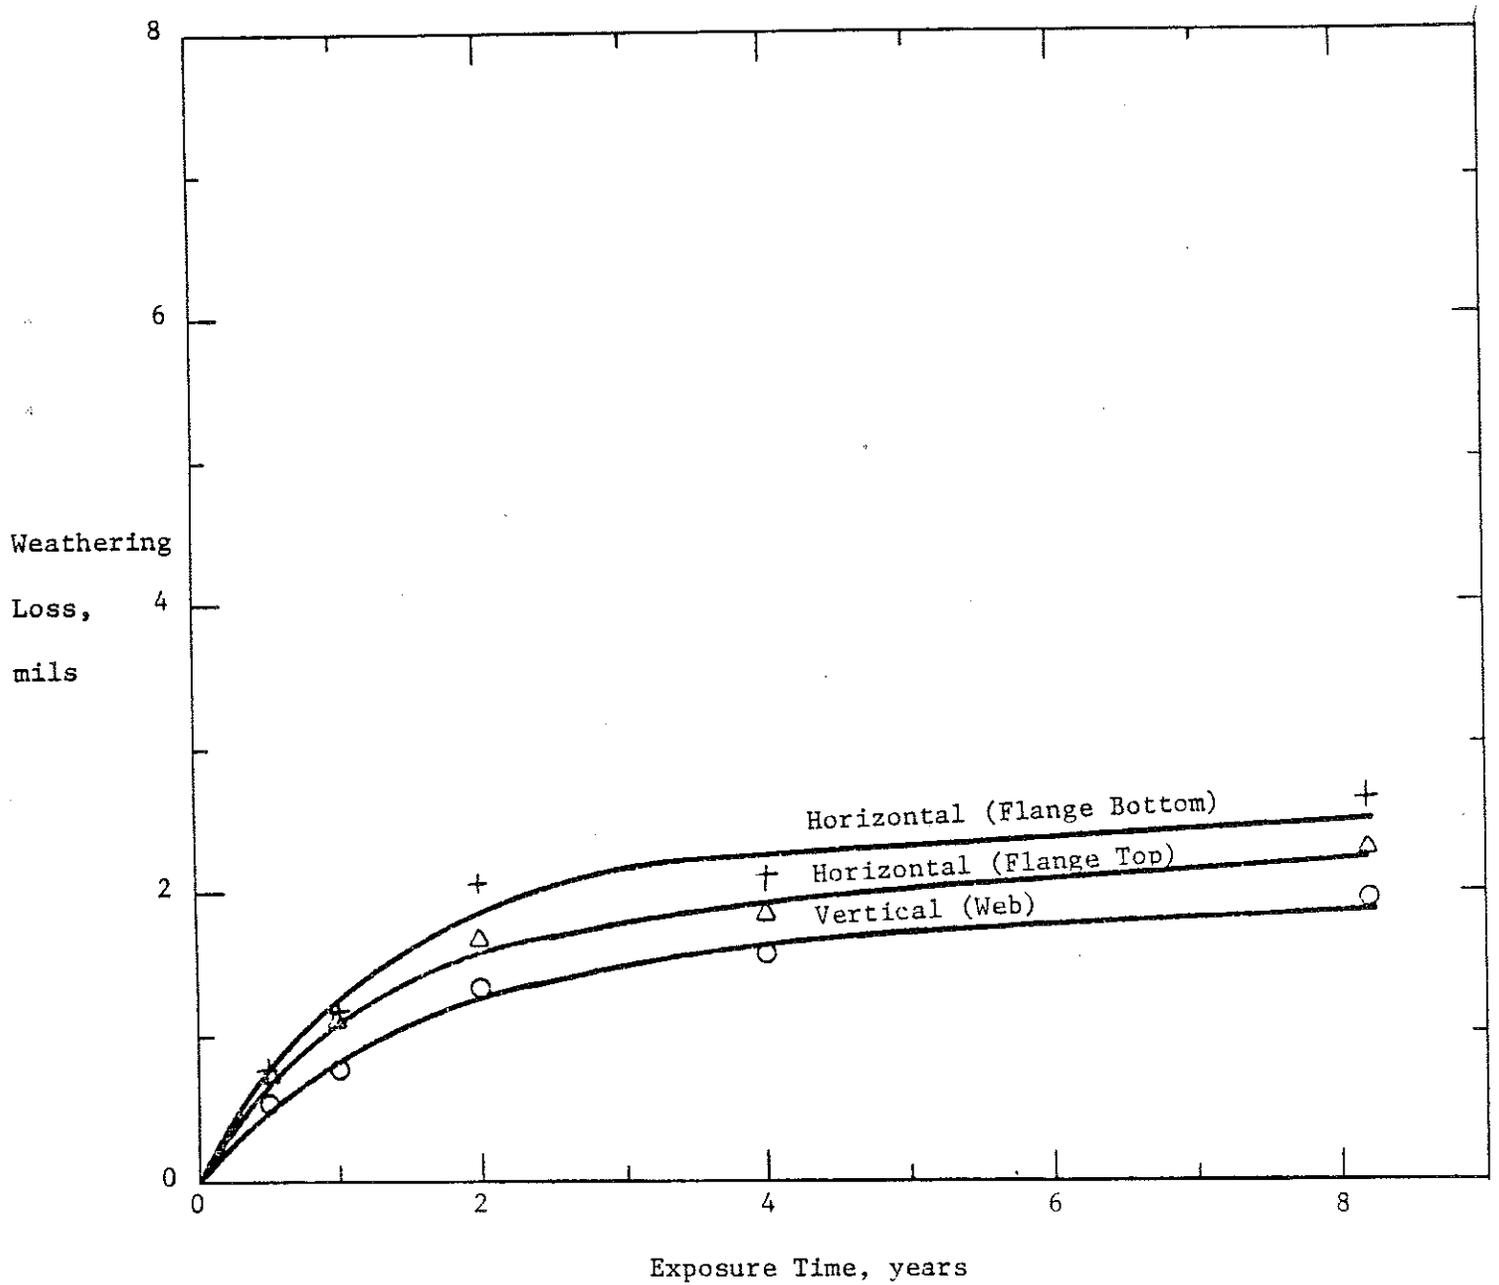
Eight-year corrosion specimens were removed from corrosion racks on the Westbound Service Bridge and nearby National Guard Armory Roof for inspection, determining corrosion losses and for chloride analyses of the intermingled rust and soil on the panels. Figure 1 illustrates the appearance of specimens on painted corrosion racks. As on the 4-year panels, the 8-year specimens on the bridge continue to show flaking rust, a high corrosion rate (average of 1.23 mils per year) with corrosion increasing with time of exposure, while those on the Armory Roof have a uniform, tight protective rust layer,

a low corrosion rate (average of 0.28 mil per year) with corrosion decreasing with time of exposure, cf. Tables 4 and 5 and Figures 2 and 3. As expected, the horizontal-top panels on the bridge, when there is greatest accumulation of solids, show the most corrosion.

FIGURE 2. WEATHERING-TIME CURVES OF MAYARI R STEEL SPECIMENS ON THE BUILDING ROOF IN DETROIT, MI (Test No. 1)

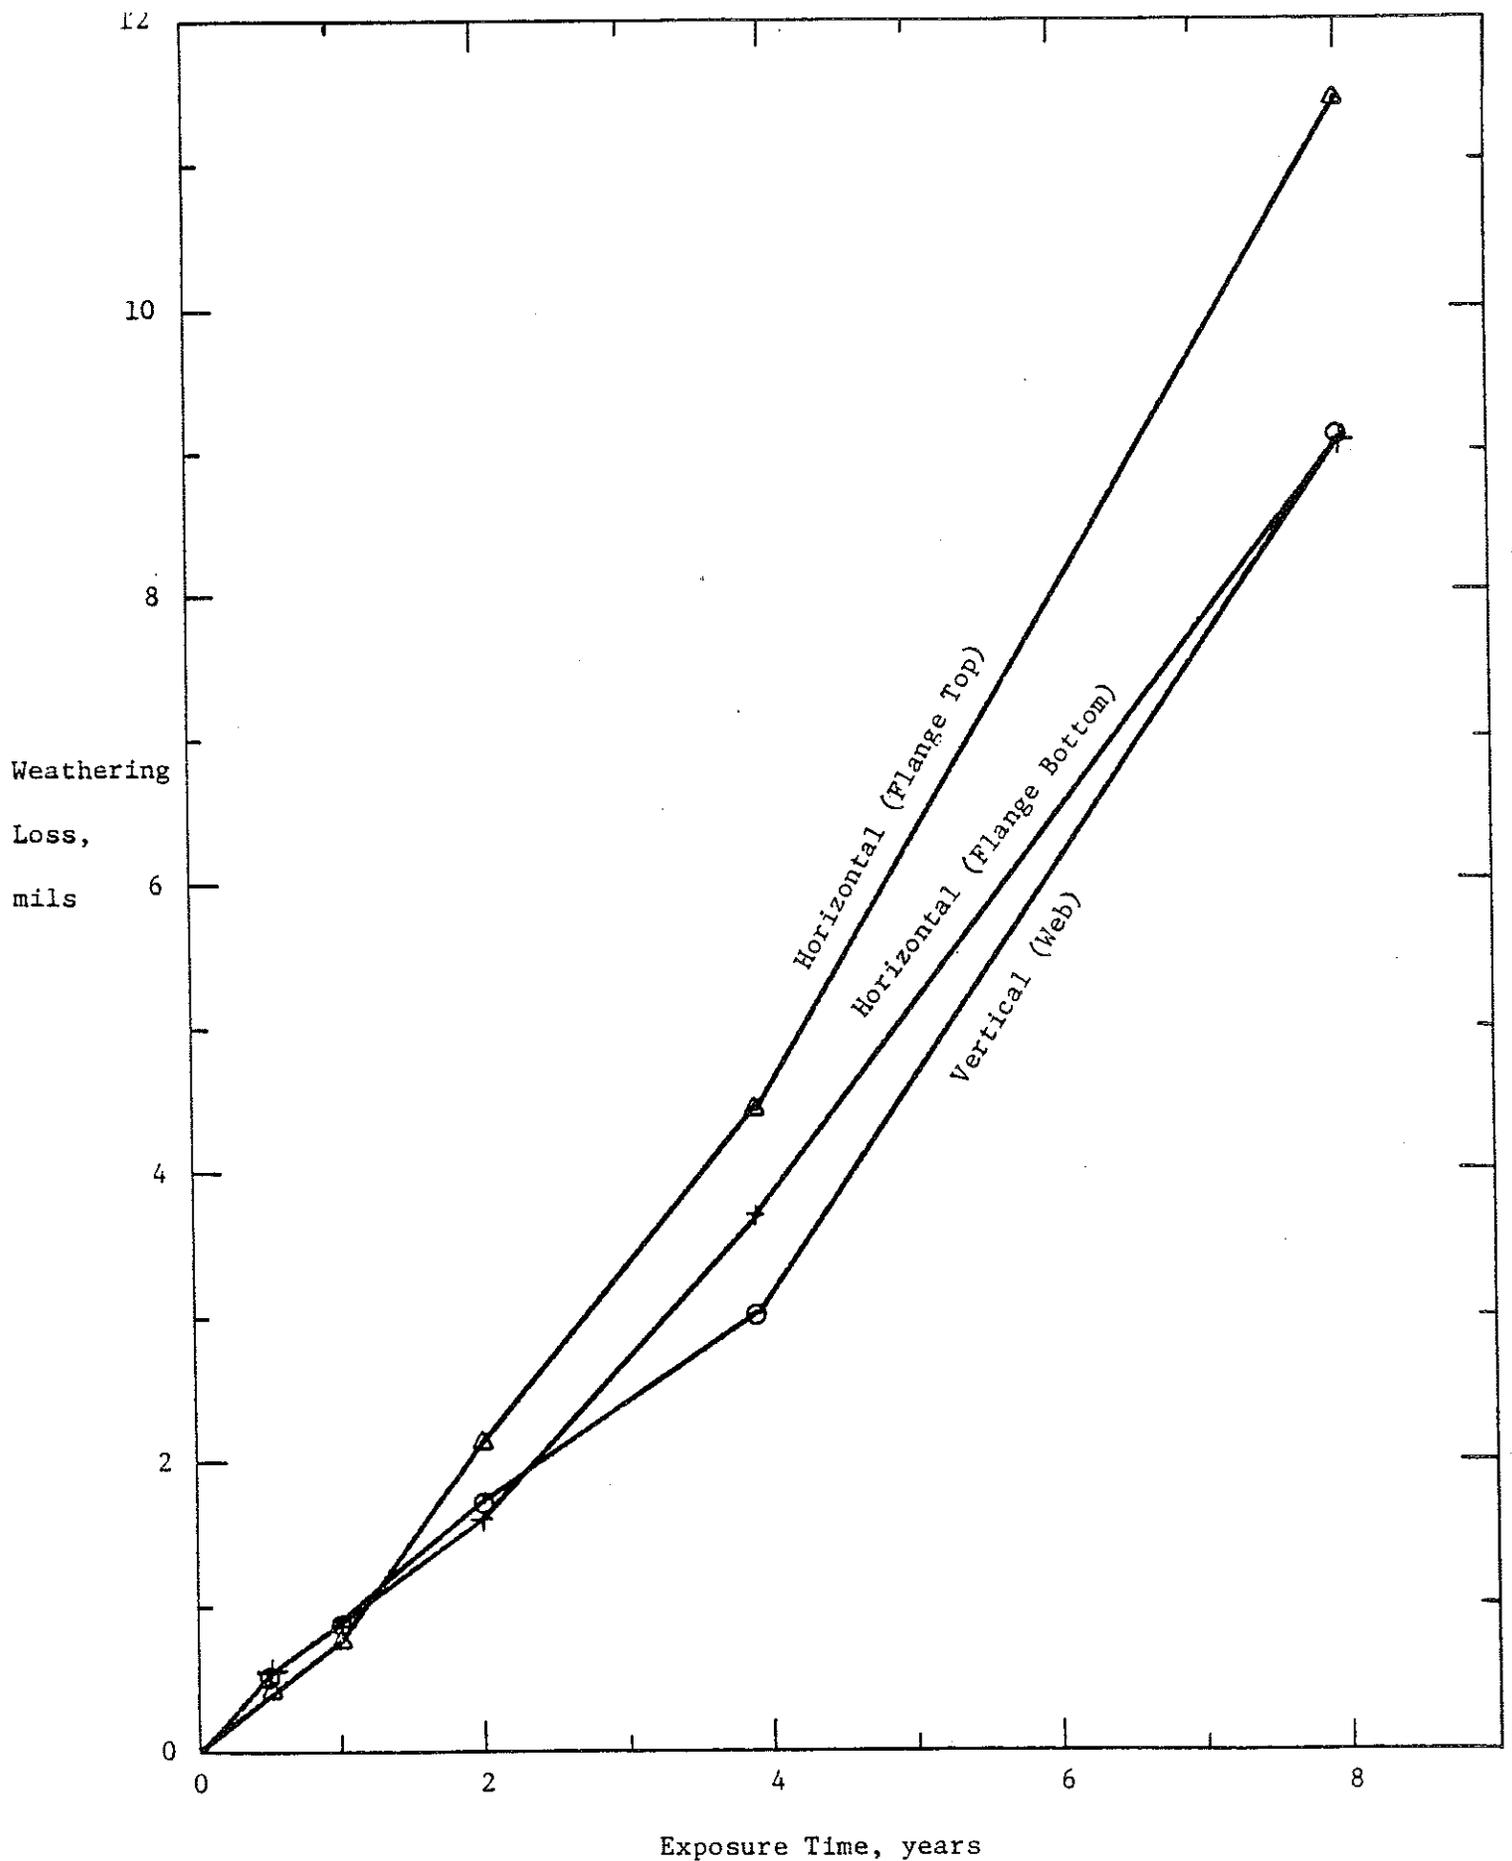
FIGURE 3. WEATHERING-TIME CURVES OF MAYARI R STEEL SPECIMENS BENEATH THE WESTBOUND SERVICE BRIDGE, DETROIT, MI (Test No. 1)

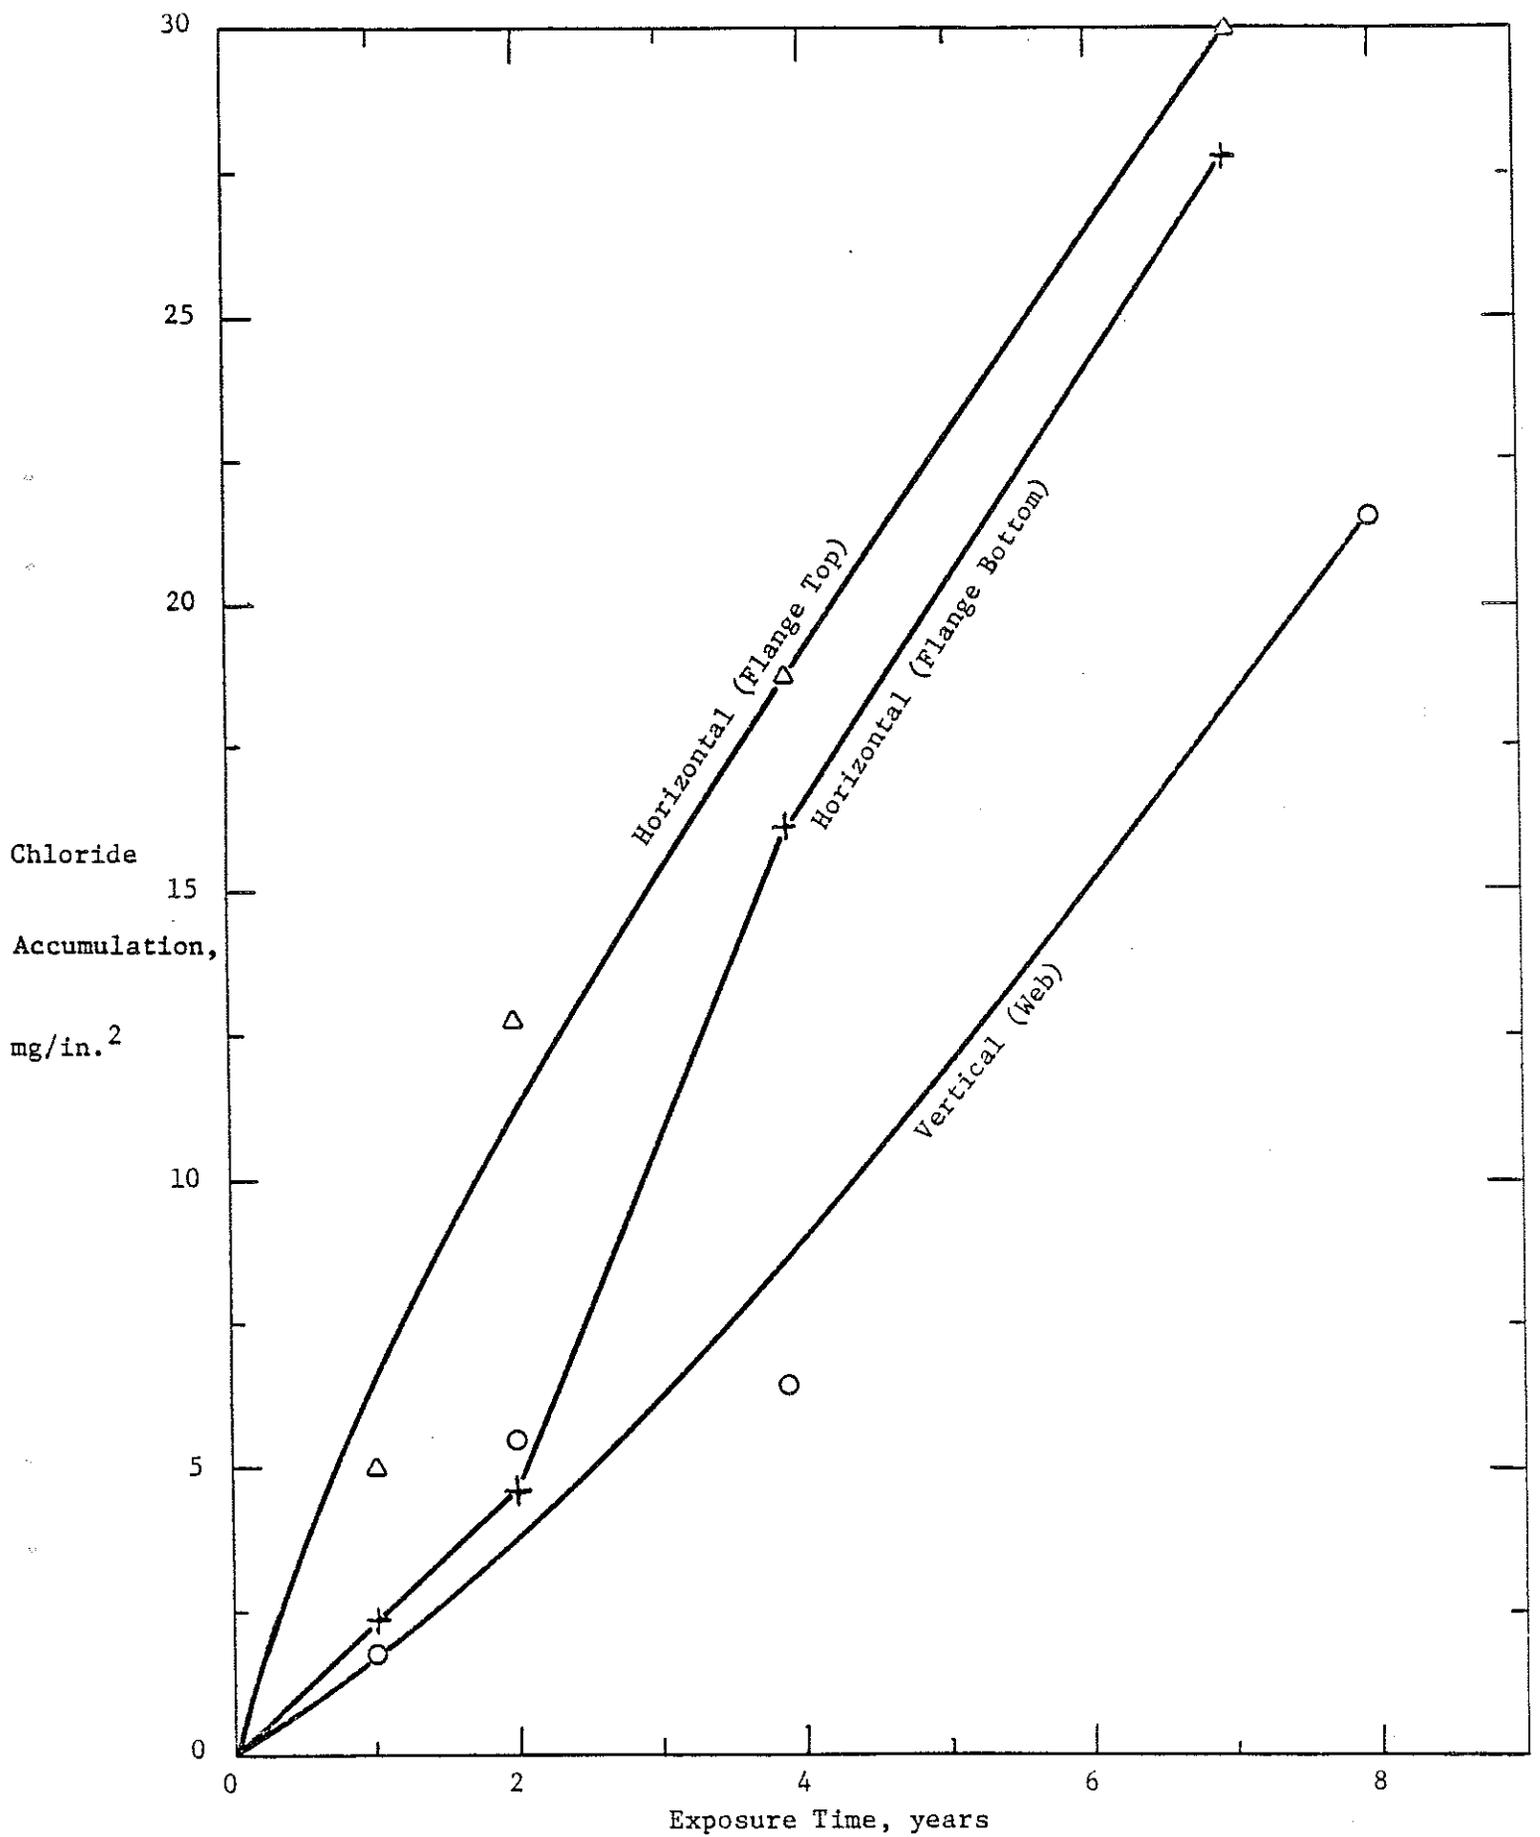
The accumulation of chlorides on the surface of the bridge panels over the 8-year period is shown in Figure 4. The chlorides increase with time as did the corrosion shown in Figure 3. Chlorides, being held in close proximity to the steel by the soil and cement dusts, are probably the major source of corrosion. In this respect, flaking rust and scale on the webs and bottom flanges may be beneficial as the corrosive agents are removed with flaking and scaling of rust. Unfortunately, the new surfaces are quickly contaminated again by road spray, salts and dirt, and deposits are not removed from ledges and horizontal surfaces.

FIGURE 4. CHLORIDE ACCUMULATION ON STEEL PANELS BENEATH THE WESTBOUND SERVICE BRIDGE, DETROIT, MI (Test No. 1)

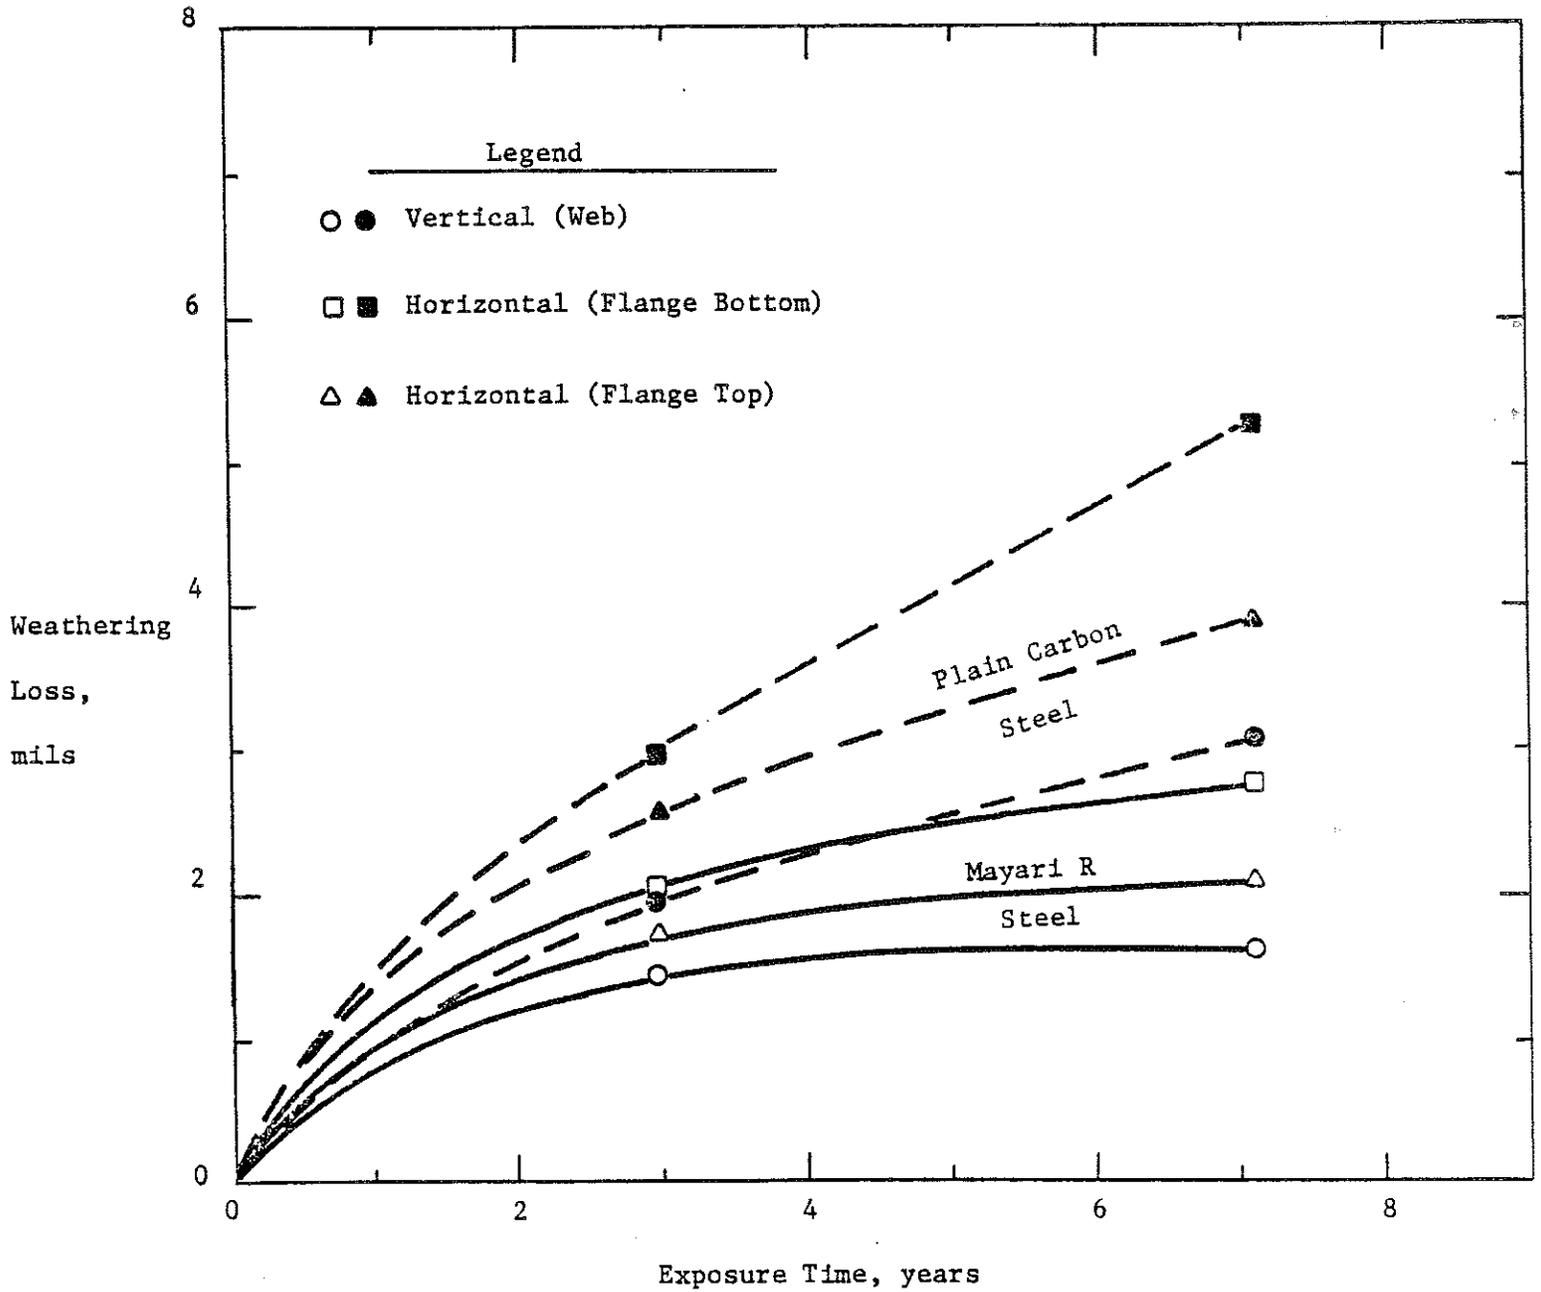
Based on a comparison of 3- to 7-year slopes, the Mayari R steel shows an average of 4 times the corrosion resistance of plain carbon steel. Moreover, on the basis of the curvatures evident in Figure 5, we expect the superiority of Mayari R to increase further with time.

FIGURE 5. WEATHERING-TIME CURVES OF MAYARI R AND PLAIN CARBON STEEL SPECIMENS ON THE BUILDING ROOF IN DETROIT, MI (Test No. 2)
