MICHIGAN DEPARTMENT OF TRANSPORTATION
M•DOT
EVALUATION OF TENSAR BITUMINOUS
PAVEMENT REINFORCEMENT
Final Report

Research Laboratory Section
Materials and Technology Division
Research Project 84 NM-718
Research Report No. R-1307

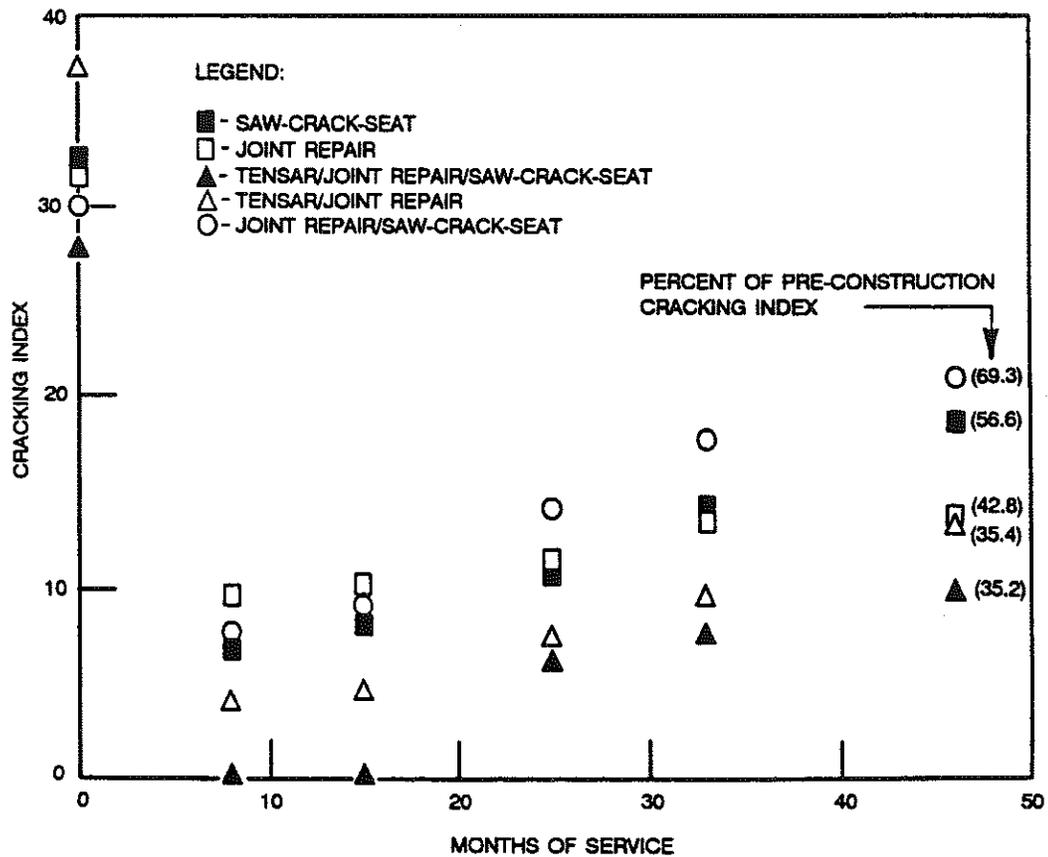
Figure 2. Relative effectiveness of various treatments to prevent reflective cracking.

The relative effectiveness of the five rehabilitation treatments are compared in Figure 2. As can be seen from the data in Table 1 and Figure 2, none of the treatments completely eliminated reflective cracking. Tensar, however, was more effective than other treatments in delaying reflective crack propagation with the next best treatment being the conventional (MDOT Detail 8) joint repairs. The relative effectiveness of

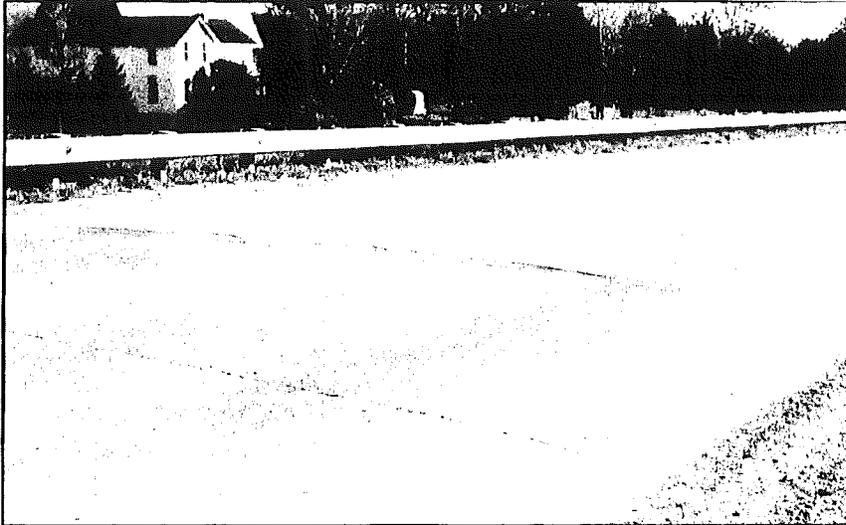
Reflection cracks at saw cut and old joint typical of the saw-crack-seat treatment.

The condition of the reflected joints and cracks is as important as crack reflection itself. Each joint in the saw-crack-seat portions of the project not only reflected through the new overlay but also heaved and formed a bump over each old joint at 99-ft intervals, resulting in an extremely rough ride.

Typical reflection cracks occurring in the non-Tensar stretches of the project are illustrated in Figure 4. The upper photo shows a typical joint which is badly heaved (center of picture) along with one of the four cracks that occur in each slab over the saw cuts. The middle and lower photos show the cracking that developed at the conventional (MDOT Detail 8) joint repairs. Of the distresses shown in Figures 3 and 4, only the heaved joints are severe enough to cause serious ride discomfort. The height of the heaved joints averaged 1/2 in. and, occurring every 99 ft, caused a very rough ride. Measurements of the height of the heaved joints are summarized in Table 2.

Reflective cracks in all sections have not yet started to break-off at the edges. The exceptions to this, however, are the reflected and heaved joints in the saw-crack-seat areas where chunks of bituminous material are loosened and frequently missing due to snow plow and other traffic action.

Joint repairs should be made prior to overlayment to eliminate the roughness due to heaving at the old joints.

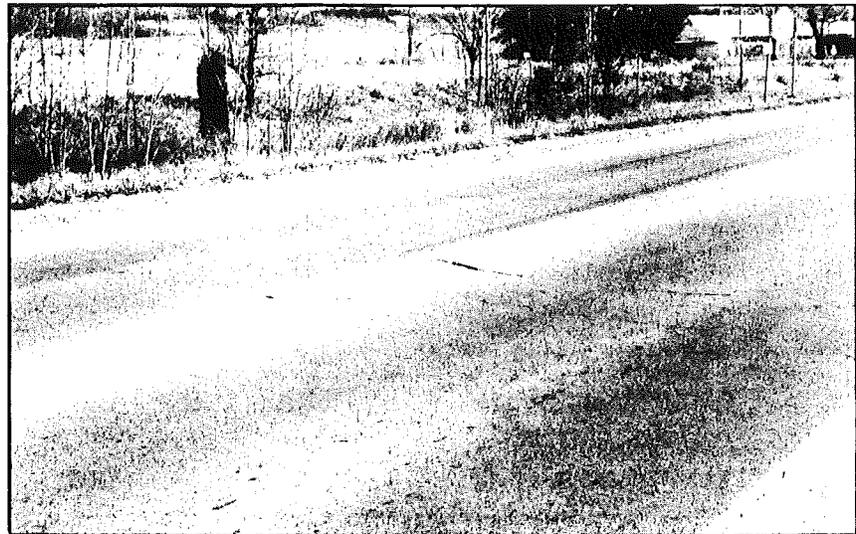
Reflection cracks at Detail 8 joint repair in control section.

Joint repair, such as the conventional full depth (MDOT Detail 8) used on sections of this job, is the only method that can be recommended on the basis of this evaluation.

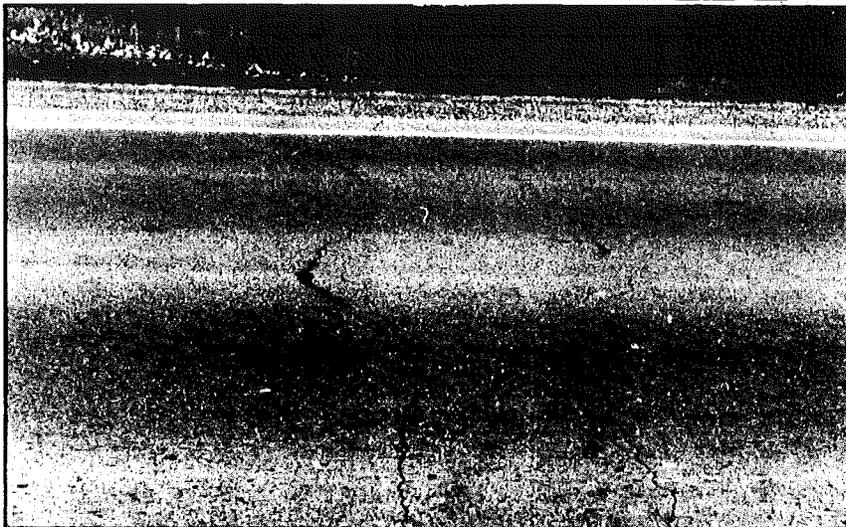
Reflection cracks at joint repair in a saw-crack-seat section.

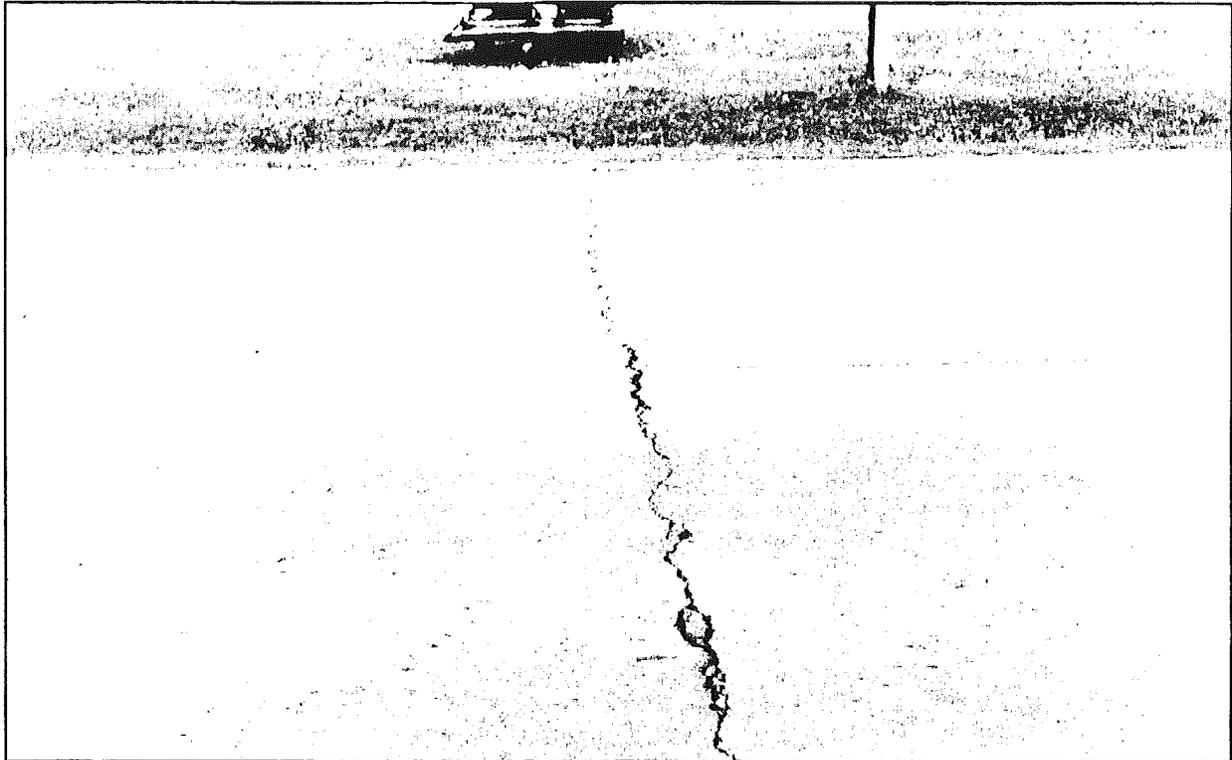
Reflection crack over joint in Tensar treated saw-crack-seat section.

Figures 3 and 4 show typical reflective cracking in the several comparative situations on this project after five years of service. The upper photo in Figure 3 shows a typical reflection crack in the portion of the Tensar section which had been sawn, cracked, and seated; the lower photo depicts one of several reflection cracks in the non-cracked-and-seated portion of the Tensar section.

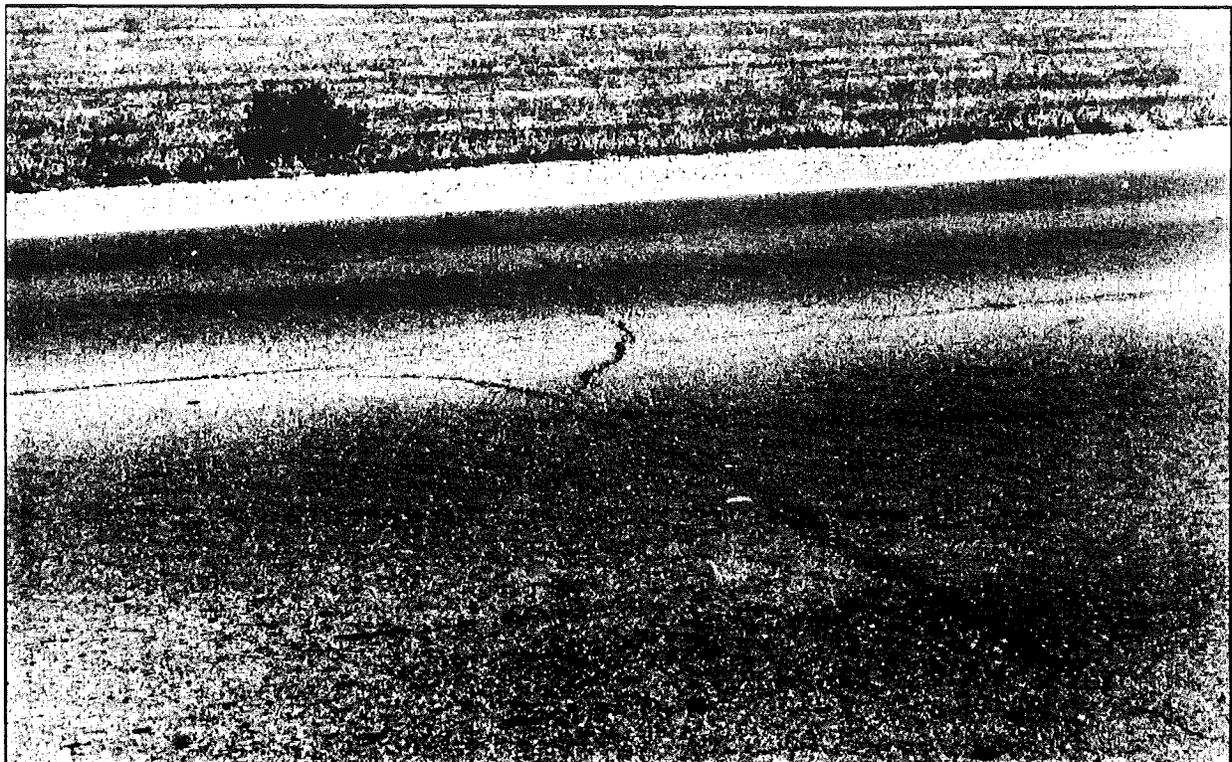
Reflection cracks in Tensar treated section.
