***A-588 BRIDGE MOUNTED SIGN
FAILURE INVESTIGATION***

CONSTRUCTION AND TECHNOLOGY DIVISION

A-588 BRIDGE MOUNTED SIGN FAILURE INVESTIGATION

**TESTING AND RESEARCH SECTION
CONSTRUCTION AND TECHNOLOGY DIVISION
RESEARCH PROJECT TI - 1976
RESEARCH REPORT R-1408**

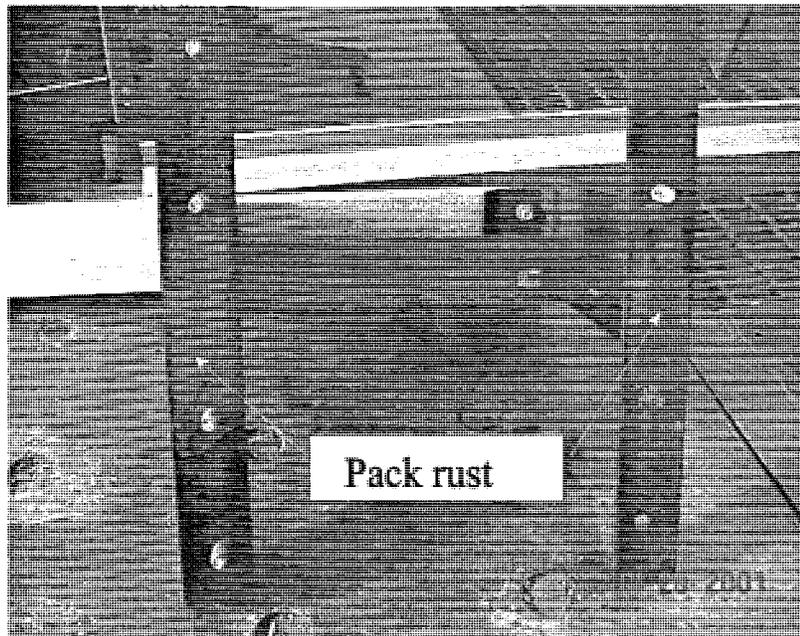
The pack rust in the interface between the steel angles and the beam web introduced large tension (prying) forces in the bolted connection. There was insufficient engagement of the nut's threads to the bolts connecting the beam web to the steel angles of the sign support. Without sufficient thread engagement length, a bolt cannot develop its full capacity. The pack rust induced tensile forces in the bolts great enough to strip the threads on the inadequately engaged nuts.

Figure 2 - Pack rust on the back side of the steel angles on sign connection that was attached to Structure Number S07 of 63191.

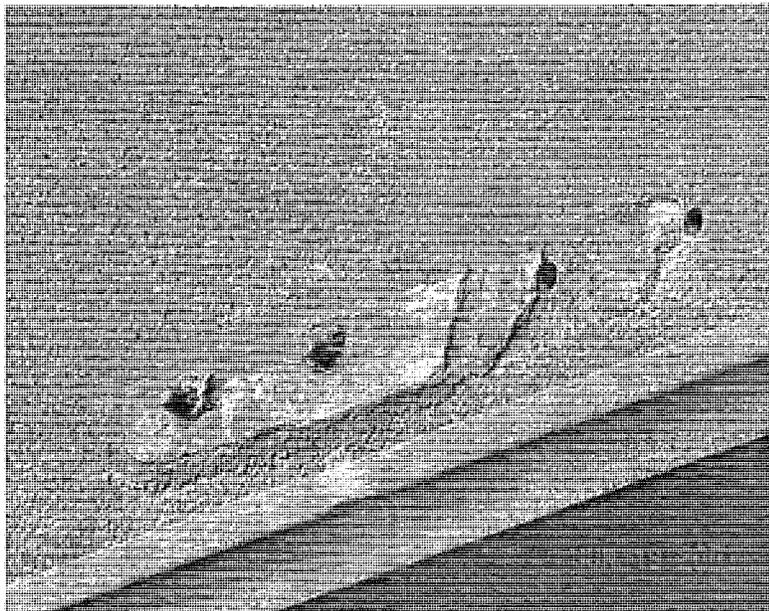
Figure 4 - Close-up of pack rust on beam web. Structure Number S07 of 63191.

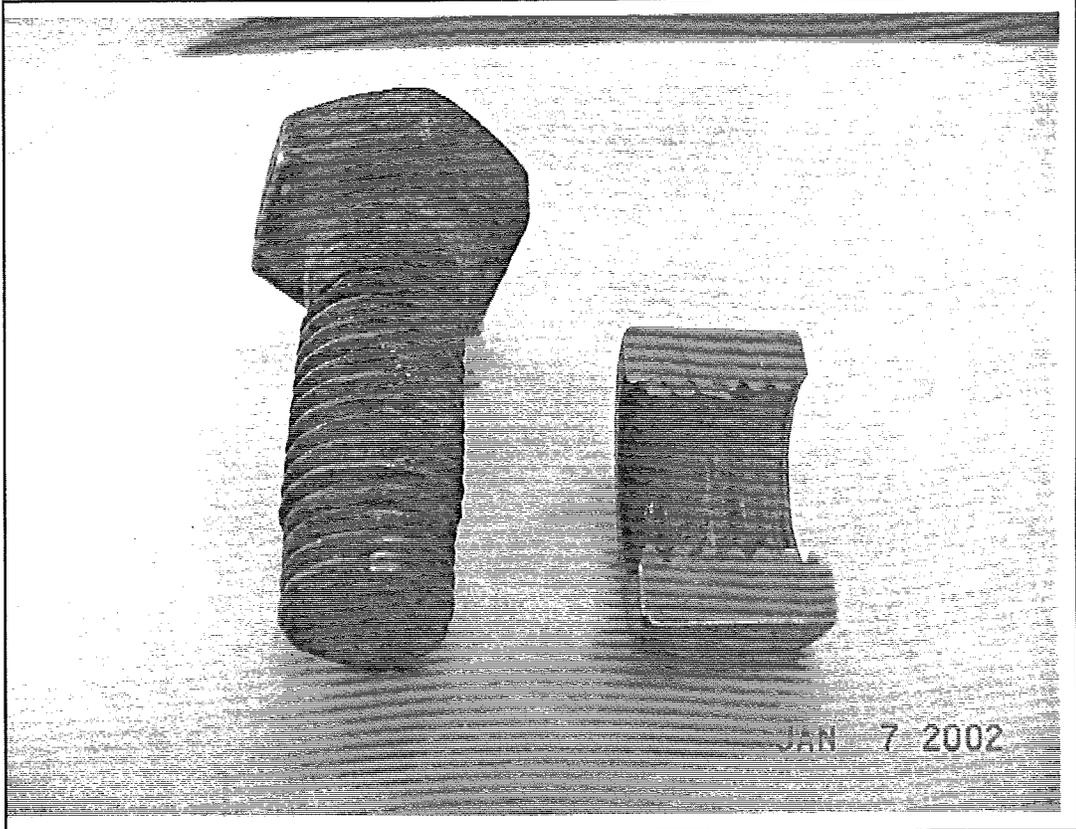
1. The bridge beams were manufactured from ASTM A-588 steel. A-588 steel is a high-strength low-alloy structural steel that is formulated to have better atmospheric corrosion resistance capabilities. Advocates of this steel claim that it does not need to be painted. The cantilevered sign support was also manufactured of A-588 steel. We found an extensive build-up of rust (approximately 0.225 inch thick) between the contact surfaces of the beam web and the sign connection's steel angles (see Figures 2 through 4).
2. All the bolts that we were able to recover were stripped, (see Figure 5), and the engagement length on the bolt thread was smaller than the depth of the connecting nut.

Figure 5 - Photograph of one bolt and nut showing stripped threads.

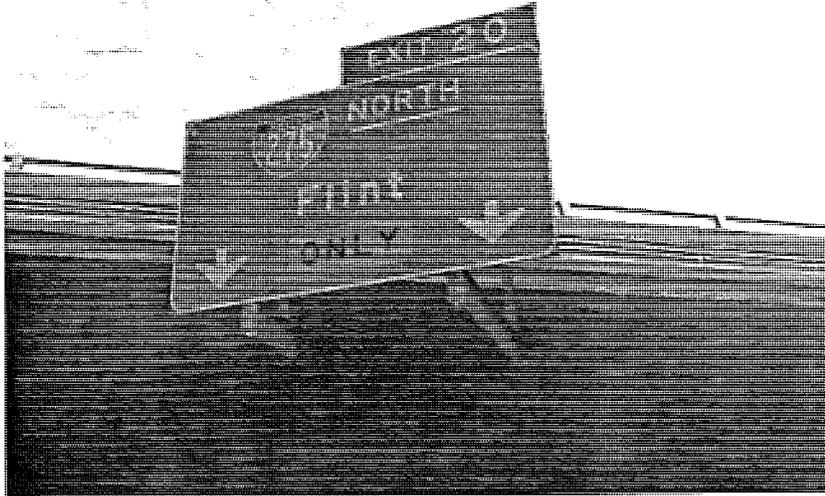
Figure 6 - Structure Number S04 of 58152 (Post Road over I-75). Most of the bolts connecting this sign to the bridge beam were missing (shown in Figures 7 through 9). On one of the angle connections, all of the bolts were gone. The sign was supported by only a few bolts and the vertical hanger straps. The University Region was immediately notified and Department maintenance crews replaced the bolts on the same day.

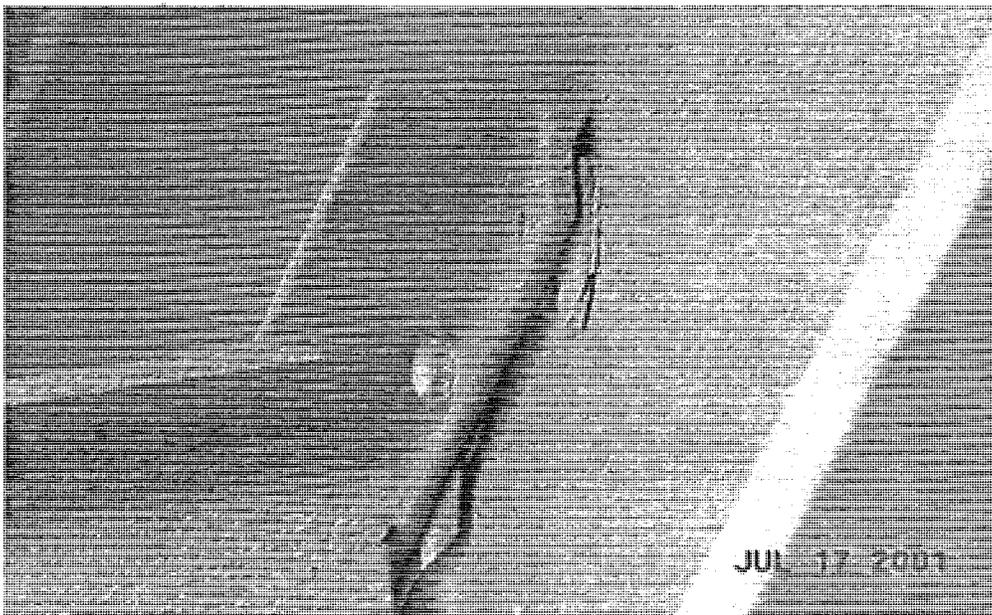
Figure 8 - Structure Number S04 of 58152 (Post Road over I-75). Showing pack rust and the connection angle separating from the beam web, which means all the bolts on this angle are most likely fractured.

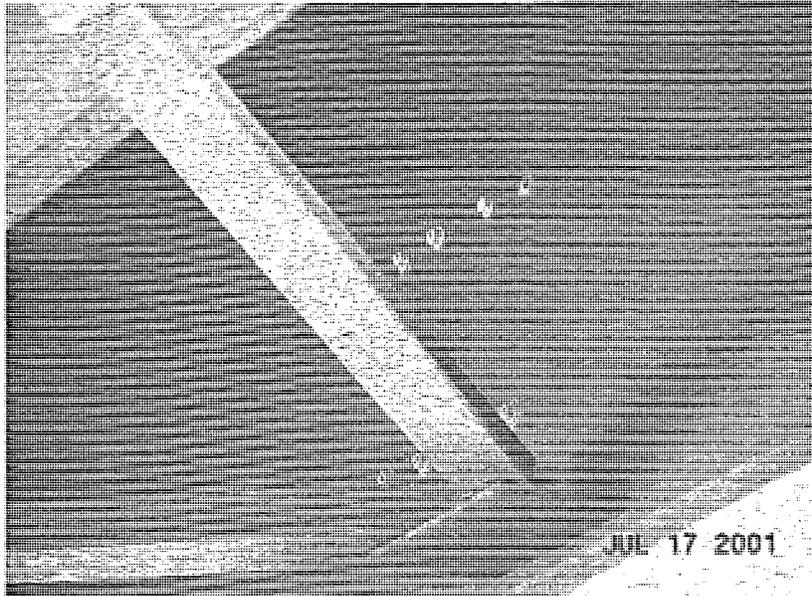
Figure 11 - Structure Number S02 of 82291 (Willow Street over I-275). Back side of beam web, showing missing bolt.

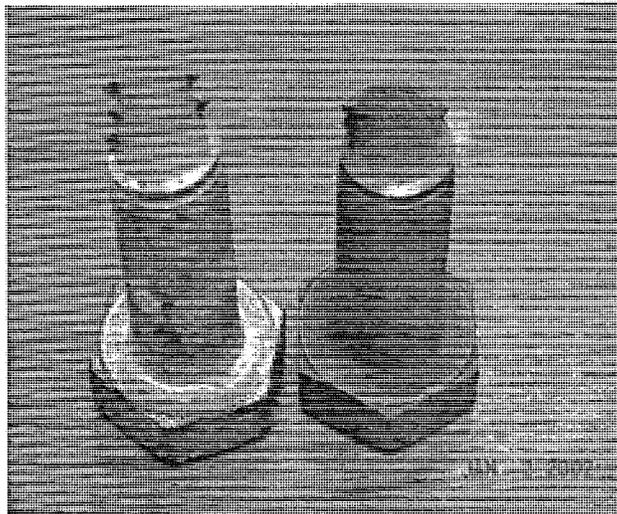
Bolts from Structure Number S04 of 81062, which carries I-94 over Saline Road were tested in accordance to ASTM A-370, Section A3, "Mechanical Testing of Steel Products, Annex 3.2.1.5 - Tension Testing of Full Size Bolts with a Wedge." The bolts were 5/8-inch diameter, galvanized ASTM A-325 Type 2. Five bolts were tested, achieving tensile values of 33.5, 32.6, 31.7, 34.8, and 34.6 kips. All bolts met the required tensile strength of 27.1 kips. As shown in Figure 14, the failure surface of the tested bolts were similar to the failure surface observed on fractured bolts taken from a sign support, indicating a similar wedge effect produced by the corrosion product. Three tension tests, without a wedge, were also done, with tensile values of 33.1, 33.3, and 32.6 kips, and head displacement values at fracture of 0.171, 0.152, and 0.164 inches. Note that the pack rust measure on the failed sign connection was 0.225 inches, more than enough to fracture the bolts.

Figure 14Figure 14 - Failure surface of bolts. The bolt on the left is a bolt tested in the laboratory. The bolt on the right is a fractured bolt taken from a sign connection (The galvanizing from the bolt on the right was removed during the cleaning process.).
