# CAUSES & CURES FOR PRESTRESSED CONCRETE I-BEAM END DETERIORATION

AUGUST 2002

WAYNE STATE  
UNIVERSITY

TESTING AND RESEARCH SECTION  
CONSTRUCTION AND TECHNOLOGY DIVISION  
RESEARCH REPORT NO. RC-1412

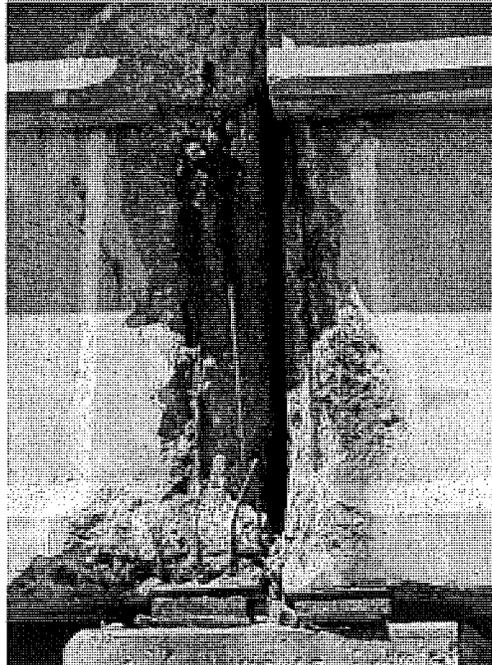
Photo 1-1. End deterioration of prestressed concrete I-beam ends

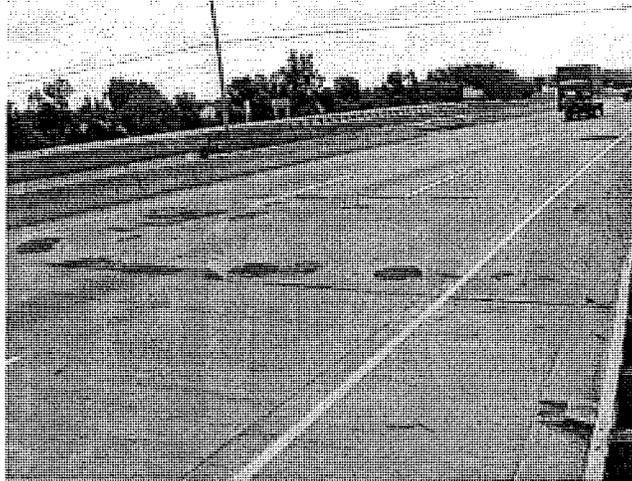
Deck shoulders are covered with debris. Main span deck is in good condition. Side span decks have cracks and potholes with some rust and efflorescence stains. Expansion joints have leakage. Spalls are noted along construction joints. The construction joint filler is missing at the barriers. Drainage system is clean and operable. The general view of the deck is shown in Photo 3-1.

**Photo 3-1. Deck Condition of 41029 S23**

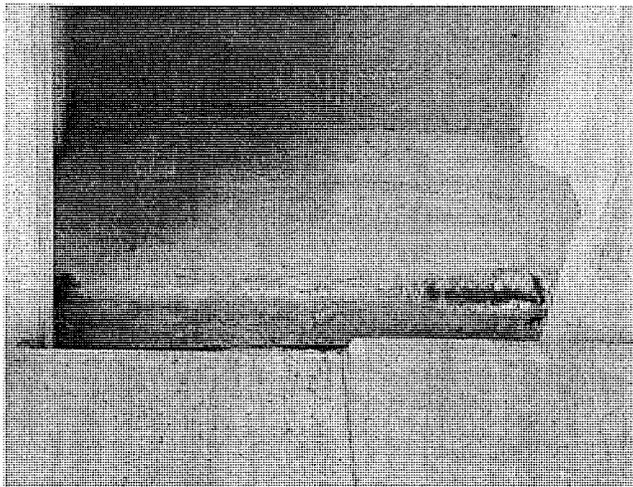
Most of the sole plates on the piers are rusted. Several diaphragms on both piers are cracked and delaminated. One concrete diaphragm between beams W5 and W6 on pier S1 was partially spalled with exposed shear reinforcement (see Photo 3-4).

**Photo 3-4. Diaphragm condition with exposed rebar**

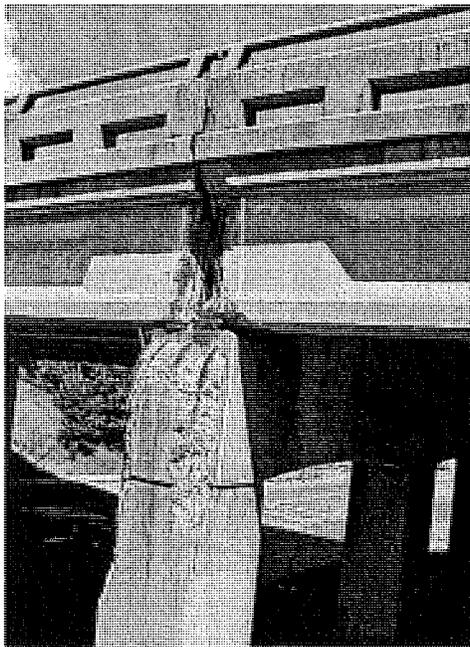
Both abutments have a few vertical cracks. All piers have random cracks, spalls, delamination, and rust stains. Heavy rust stains and exposed reinforcement are observed on the east fascia of pier S1 and west fascia of pier S3. The severe pier and stringer conditions are shown in Photo 3-5.

**Photo 3-5. Documenting severe deterioration of the pier and beam end**

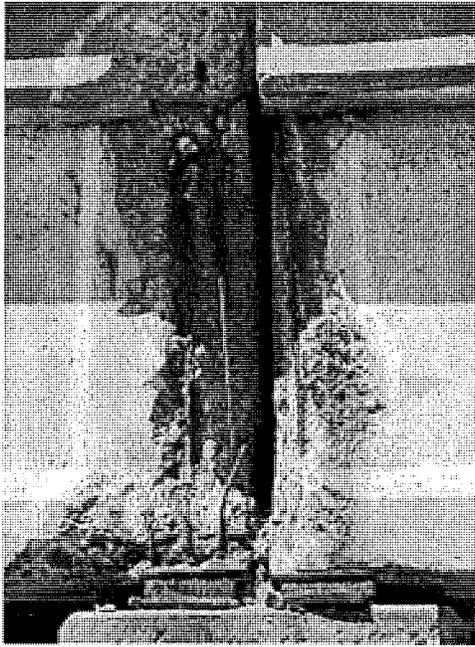
Most of the beam-ends are partially delaminated and spalled showing exposed shear reinforcement. The example of severe beam-end deterioration is shown on Photo 3-6:

**Photo 3-6. Severe deterioration of beam-end**

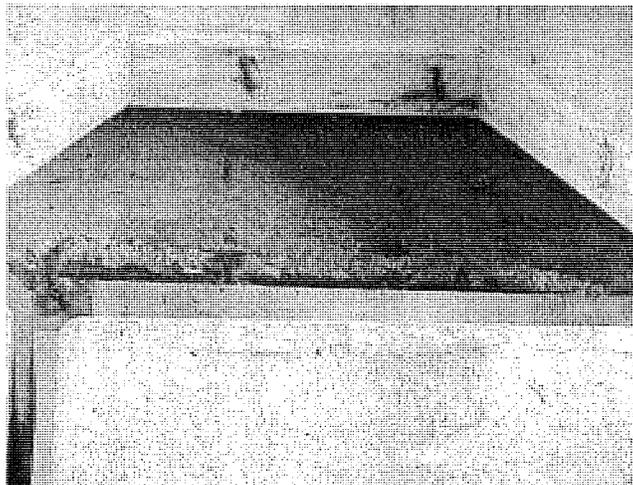
The diaphragms on both piers are cracked, spalled, and delaminated. The concrete diaphragms on pier W1 between beams S4 and S5 and on pier W2 between beams S2 and S3 are heavily spalled with exposed shear reinforcement (see Photo 3-7).

**Photo 3-7. Diaphragm condition with some deterioration**

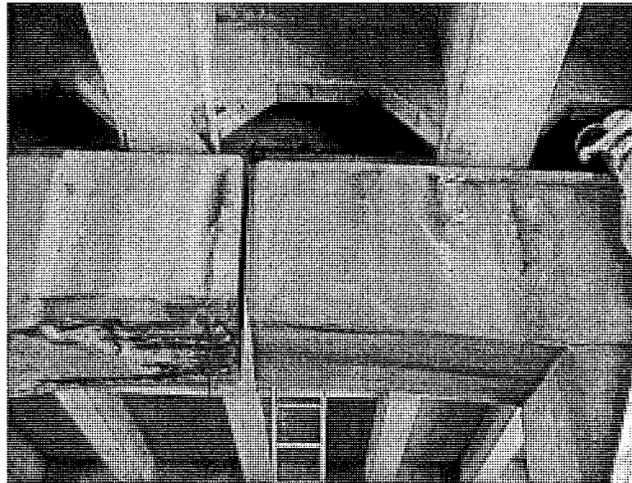
The abutments have a few vertical cracks and minor water and rust stains. Elastometric bearings are deformed. Piers have cracks, spalls, rust, and water stains. Shear reinforcement is exposed, and concrete has spalled at the bottom of the pier cap W1 (see Photo 3-8). Also, notice the difficulty of accessing the beam end behind the diaphragm for visual inspection.

**Photo 3-8. Exposed reinforcement and some spalls at piers, beam-end and diaphragms**

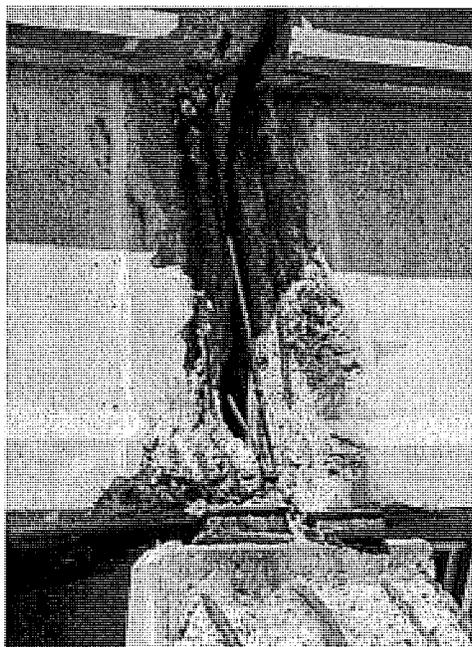
Most of the beam-ends display major cracking and spalls, rust and/or efflorescence stains, and exposed shear reinforcement. An example of the most severe deterioration of a beam-end and pier cap is shown in Photo 3-10:

**Photo 3-10. Beam-end and pier cap deterioration**

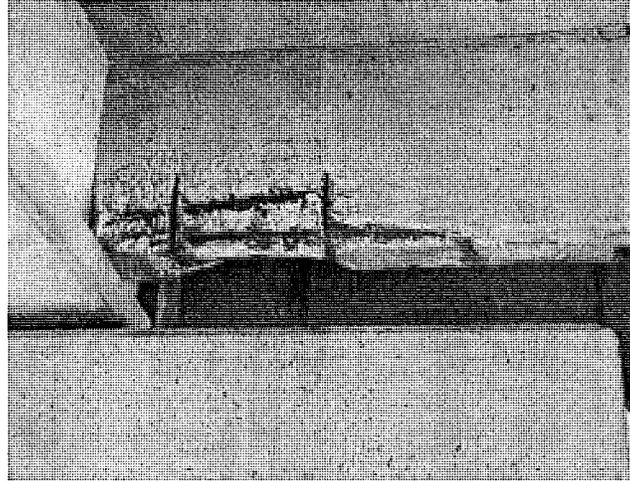
Some of the sole plates are corroded and neoprene pads deformed with the ends curling. Some diaphragms have cracks, spalls and delaminations. The concrete diaphragm on pier W1 between beams S2 and S3 shows spalls with exposed shear reinforcement (see Photo 3-11).

**Photo 3-11. Spall with exposed reinforcement at diaphragm**

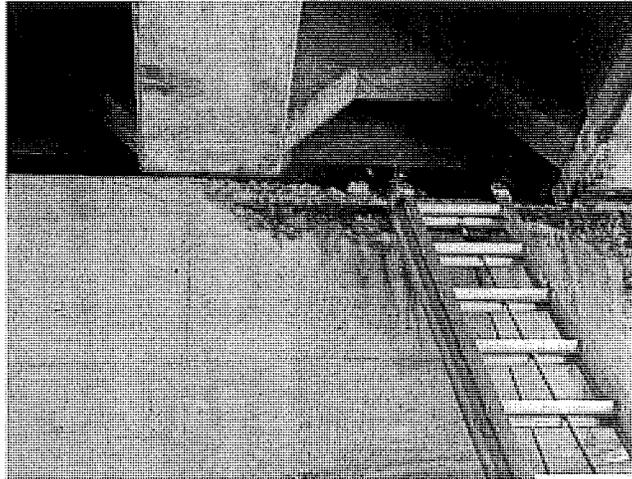
Pier S1 has rust stain, delamination, spalls and rusty cracks. The north fascia of the pier is spalled with exposed reinforcement as shown in Photo 3-12.

**Photo 3-12. Spall at the North fascia of pier S1**

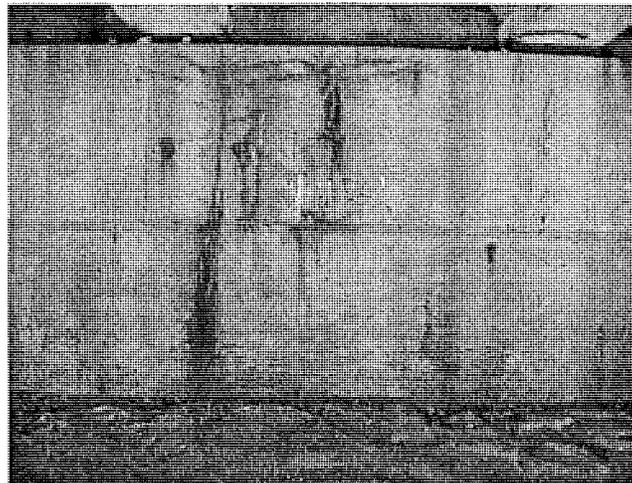
The east abutment has some vertical and horizontal cracks, delamination, and rust, water and efflorescence stains. The sole plates are corroded. The severe condition on the east abutment and delamination at the end of beam S3 are shown in Photo 3-13.

**Photo 3-13. Condition of east abutment**

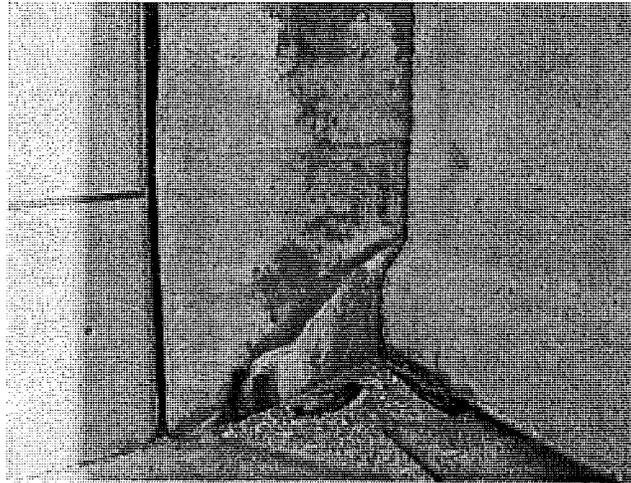
The example of the most severe deterioration of beam-end and diaphragm is shown in Photo 3-14.

Photo 3-14. Beam-end and diaphragm condition

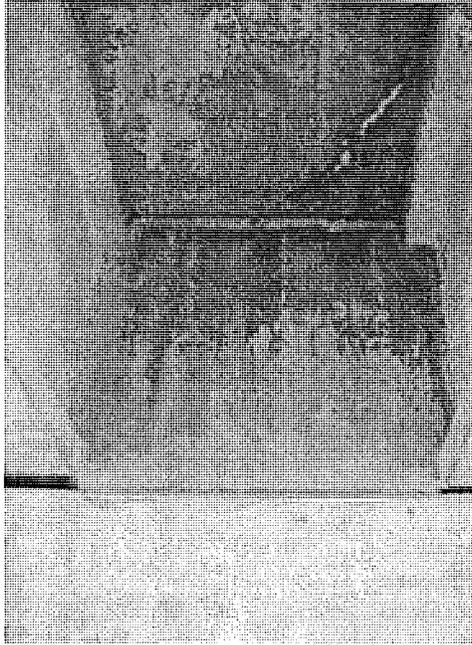
Both abutments have a few hairline vertical cracks through all retaining walls. Rust and efflorescence stains, spall and delamination noted. Efflorescence stain is noted at the bottom of the deck next to abutment as shown in Photo 3-15.

**Photo 3-15. Rust and efflorescence stain on the deck**

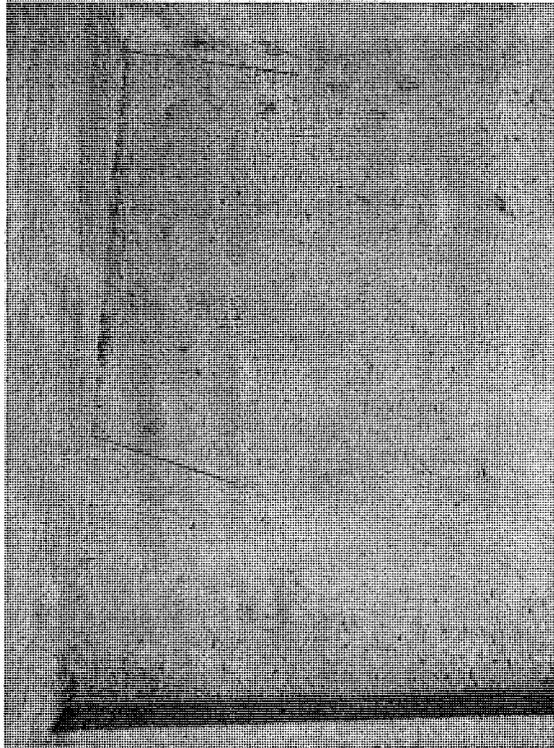
Most of the beam-ends display minor cracking, spalls and rust stains. The common crack pattern is as shown in Photo 3-16.

**Photo 3-16. Beam-end common crack pattern (cracks outlined in blue)**

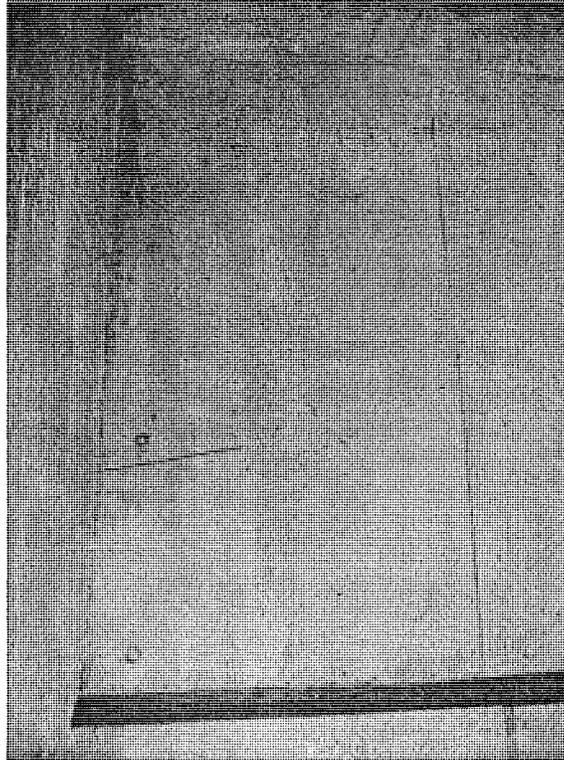
Most of the beam-ends display minor cracking, spalls, rust and water stains next to the bearings. The common crack pattern is as shown in Photo 3-17.

Photo 3-17. Beam-end common crack pattern (cracks outlined in blue)

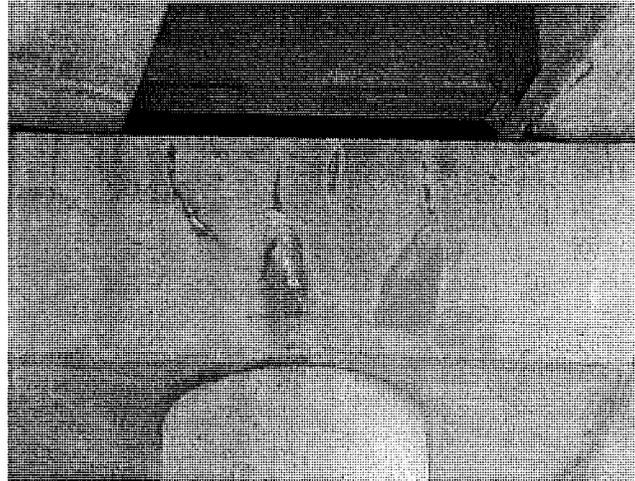
Cracks, efflorescence, rust and water stains are noted at the piers caps. All pier caps are sealed with resin. The pier columns do not display any kind of deterioration. The common pier condition is shown in Photo 3-18.

**Photo 3-18. Pier condition with leaching from stress cracks**

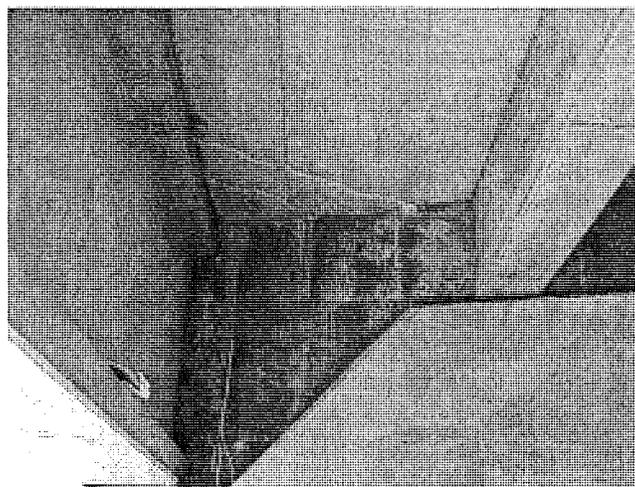
The bottom of the deck has some efflorescence staining mostly near the back wall as shown in Photo 3-19.

**Photo 3-19. Efflorescence stain at bottom of the deck**

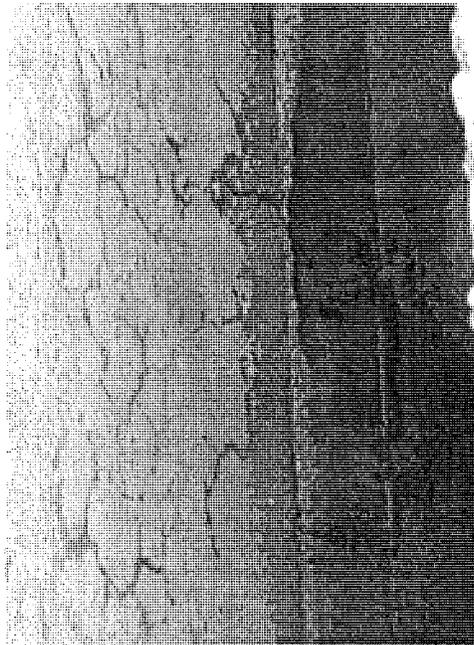
Most of the beam-ends display minor water and rust stains and micro and hairline cracks. The example of map cracking is shown in Photo 3-20.

**Photo 3-20. Example of map cracking at a beam-end**

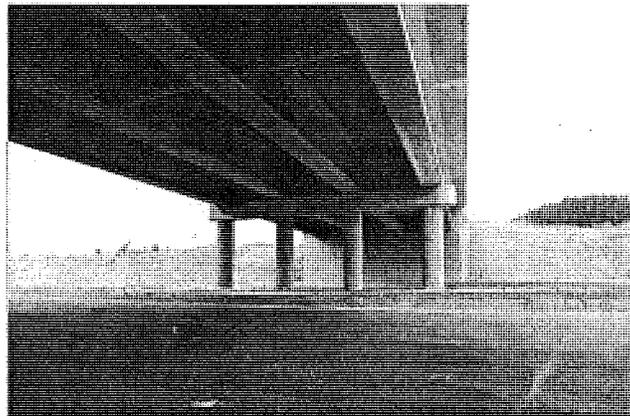
Water stain and few patches are noted on both the West and East fascias at the caps of the middle pier. Several pier columns have water stain (see Photo 3-23).

**Photo 3-23. Water stain on the piers and caps**

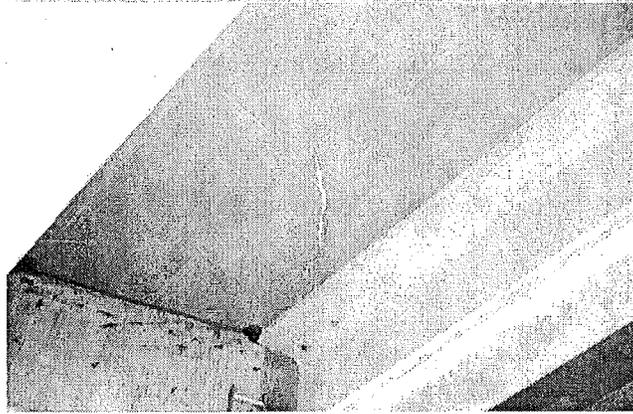
The bottom of the deck has efflorescence stain at the South corner of the West abutment and the North corner of the East abutment (see Photo 3-24).

**Photo 3-24. Efflorescence stain at South corner of West abutment and deck**

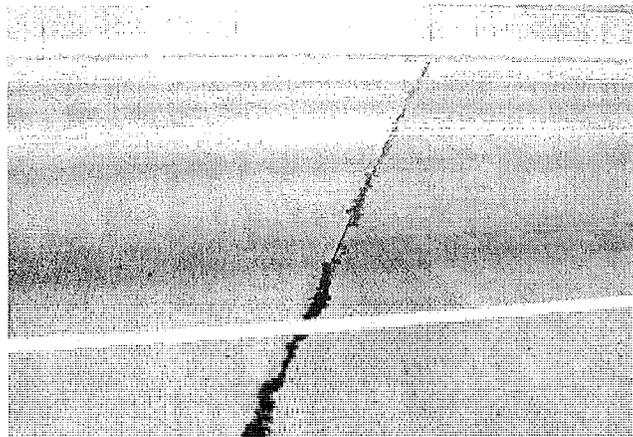
The construction joints are cracked and filled with sand. An example of a control joint with hot-pour joint sealant is seen in Photo 3-25.

**Photo 3-25. Condition of Deck Control joint**

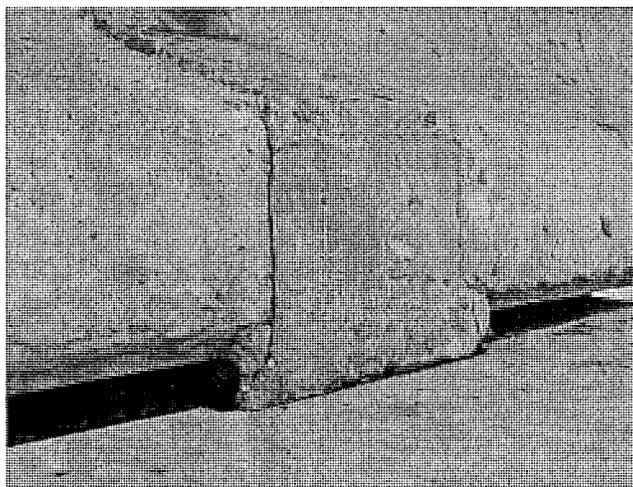
Some of the beam-ends have incipient spalls as shown in Photo 3-27.

**Photo 3-27. Beam-end restraint detail**

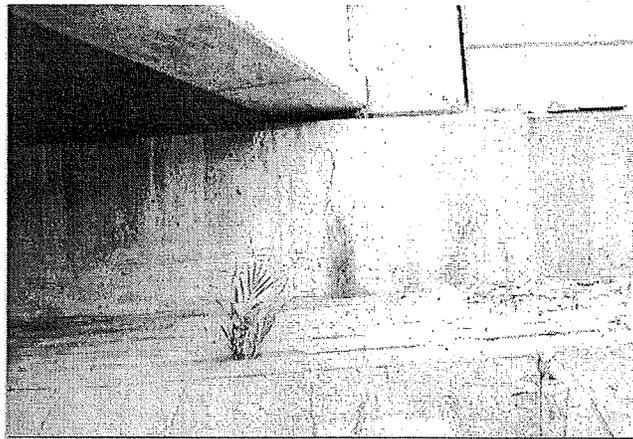
The West abutment has several vertical cracks with water and rust stains (see Photo 3-28).

**Photo 3-28. Vertical crack with moisture and rust stain at West abutment**

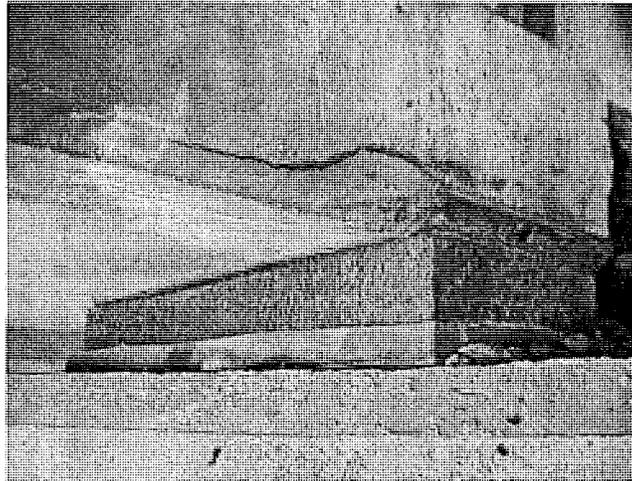
Most of the beam-ends are delaminated, cracked, spalled and some exhibit exposed shear reinforcement as shown in Photo 3-29 and Photo 3-30 (at pier W1, beam S1; at pier W2, beams S1, S2, S4 and S6; at pier W3, beams S2 and S6).

**Photo 3-29. Delamination at the beam-end and bearing with sole plate**

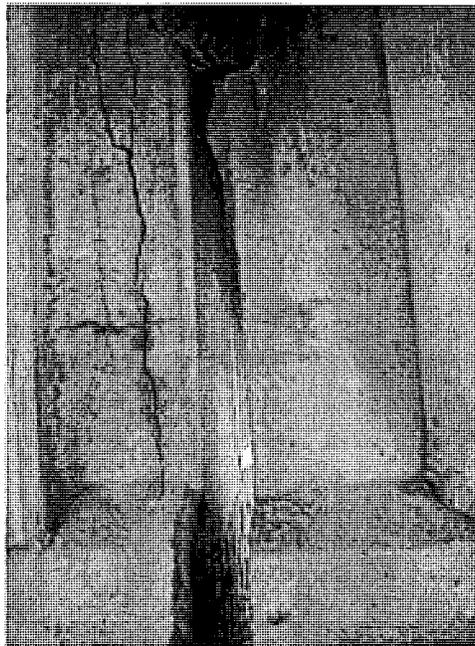
**Photo 3-30. Beam-end cracking**

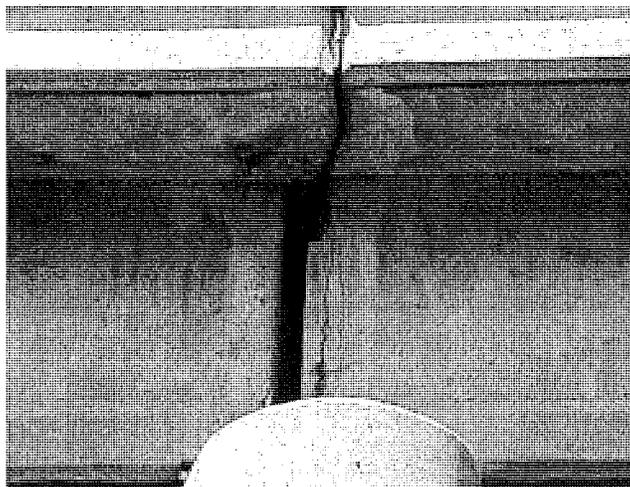
The beam-ends are cracked, delaminated, and spalled. Also, there is evidence of rust, water and efflorescence stains. The beam-ends of eight beams out of 22 are spalled with exposed shear reinforcement evident. The beam-ends at the abutment have hairline cracks with some rust and water stain. The sole plates are rusted and the pads appear to have lost flexibility and are deformed. The diaphragms between beams S5, S6 and S7 at pier W1 are delaminated. The diaphragm between beams S1 and S2 at pier W3 is delaminated at the bottom and partially spalled with exposed reinforcement. The condition at the beam-ends at the pier caps is shown in Photo 3-31.

Photo 3-31. Condition at the beam-ends at the pier

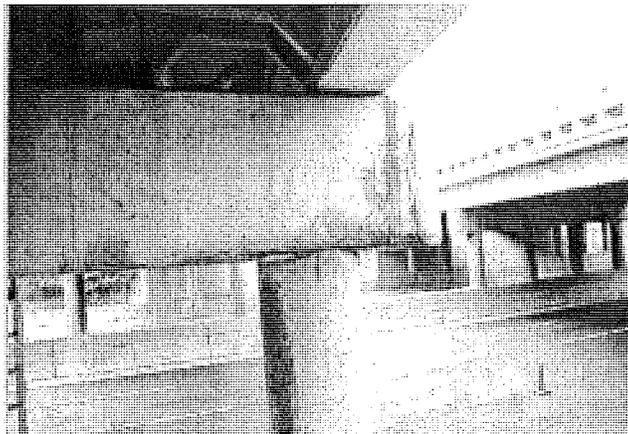
All of the pier caps have water and rust stains. Delamination, cracks, and rust stains are noted at the fascia and bottom of all pier caps (see Photo 3-32).

**Photo 3-32. Delamination, cracks and rust stain at pier and pier cap**

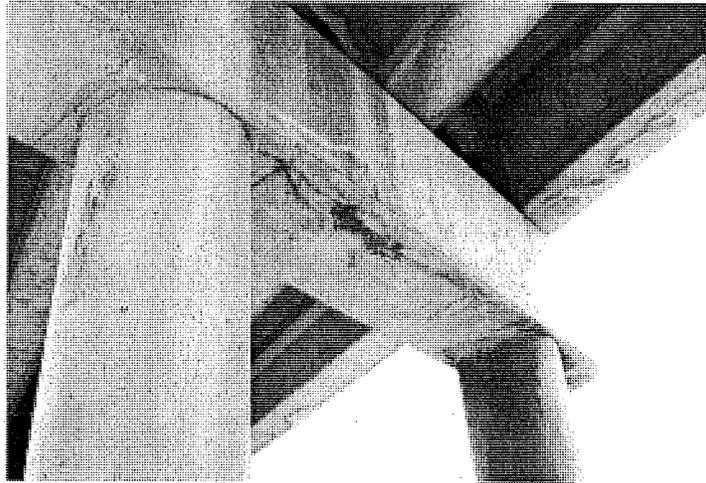
The bottom of pier W1 is spalled showing exposed reinforcement (see Photo 3-33).

**Photo 3-33. Exposed reinforcement at the bottom of the pier W1**

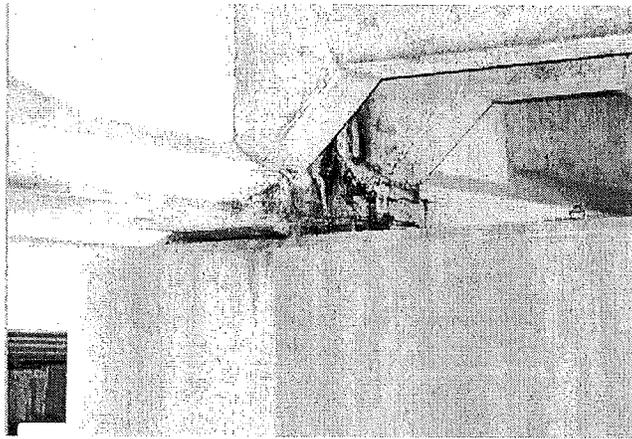
All of the beam-ends are cracked. Many of the beam-ends have moisture leaching from the cracks. Some of the beam-ends are delaminated or spalled showing exposed shear reinforcement as shown in Photo 3-34.

**Photo 3-34. Deterioration at the beam-ends in between diaphragms**

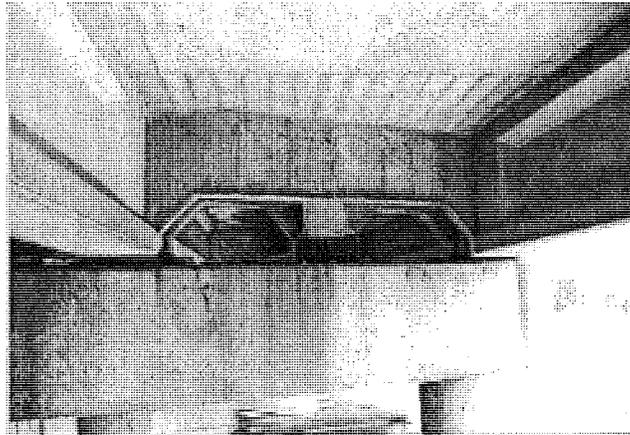
Pier W1 has minor rust and water stain, spalls and cracks at both fascias (see Photo 3-35).

**Photo 3-35. Rust and water stain, spalls and cracks at Pier W1**

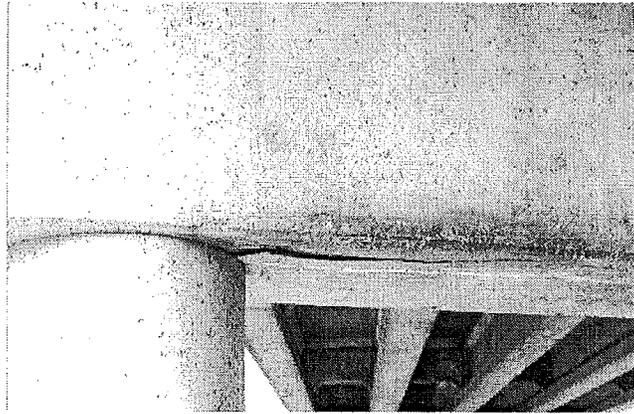
The East fascia of pier W1 has areas of delamination, cracks, and efflorescence stains. Piers W2 and W3 have water and rust stains. Pier W3 displays crack and delamination at the bottom of the pier cap (see Photo 3-36).

**Photo 3-36. Crack and delamination at the bottom of the pier W3**

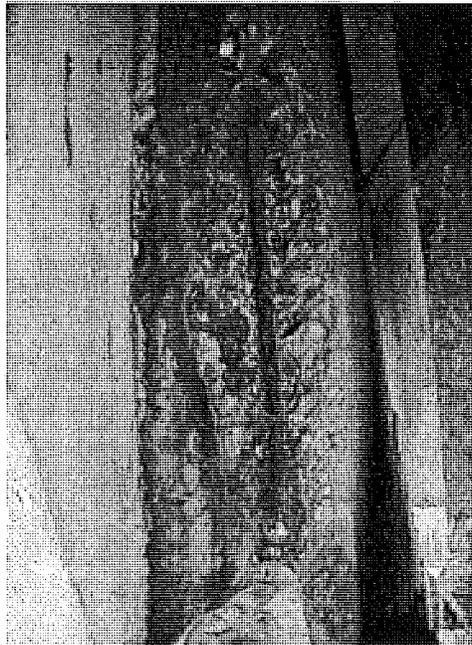
The beam-ends at the piers are cracked, delaminated and spalled. Some of the beams have rust and efflorescence stain. Eleven beams out of twenty are spalled with exposed reinforcement. The beam-ends at the abutments have hairline cracks, water, and rust stains. The typical beam-end condition is shown in Photo 3-37.

**Photo 3-37. Beam-end exhibiting significant deterioration**

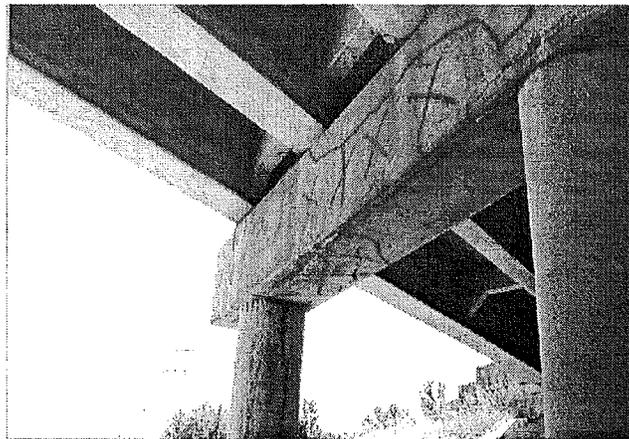
All pier caps have delamination, rust, and water stain. The worst condition at the piers is shown in Photo 3-38.

**Photo 3-38. Condition of pier and pier cap**

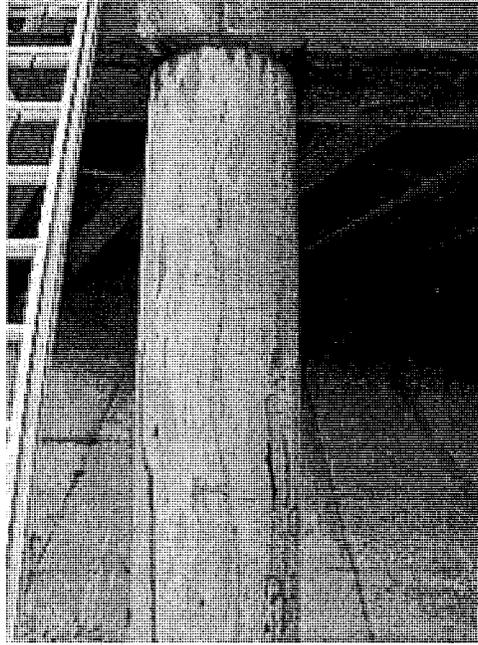
**Photo 3-39. Vertical cracks at column S4 of the pier W1**

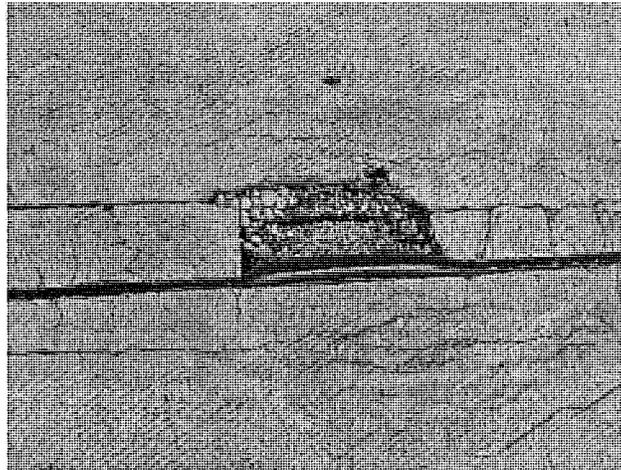
**Photo 3-40. Spall with exposed reinforcement at the deck joint**

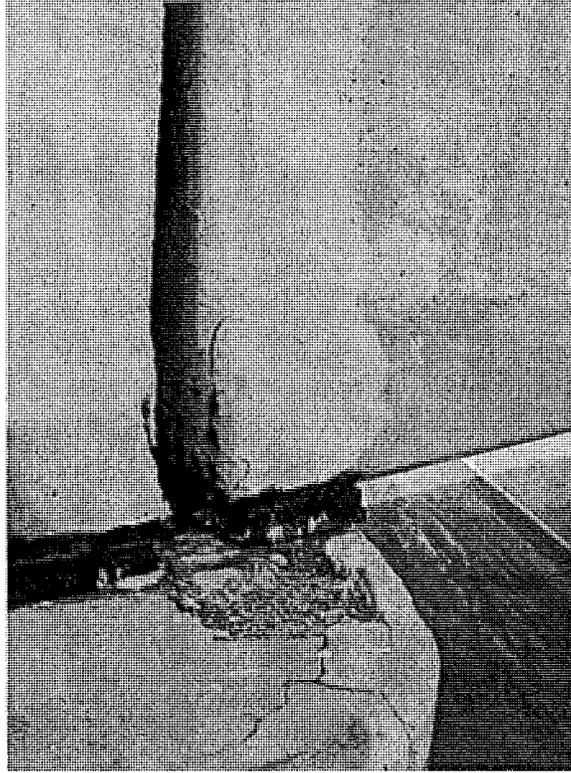
**Photo 3-41. Cracks at the beam-end and pier cap**

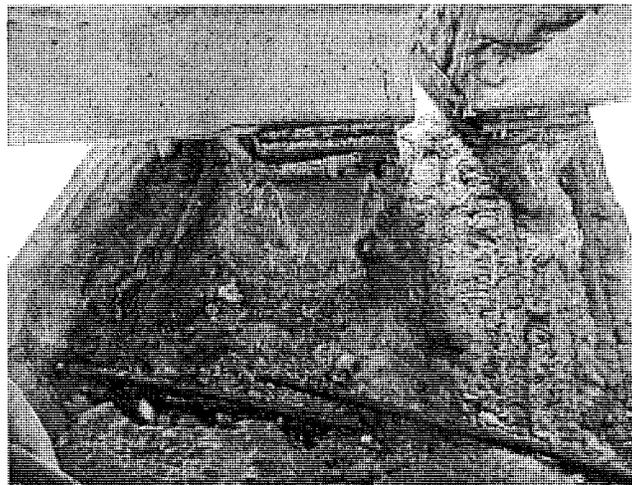
**Photo 3-42. Delaminated beam-end and pier**

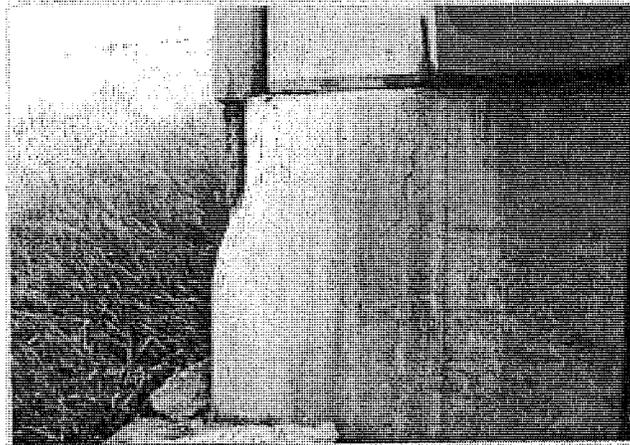
**Photo 3-43. Spall at North corner of East abutment**

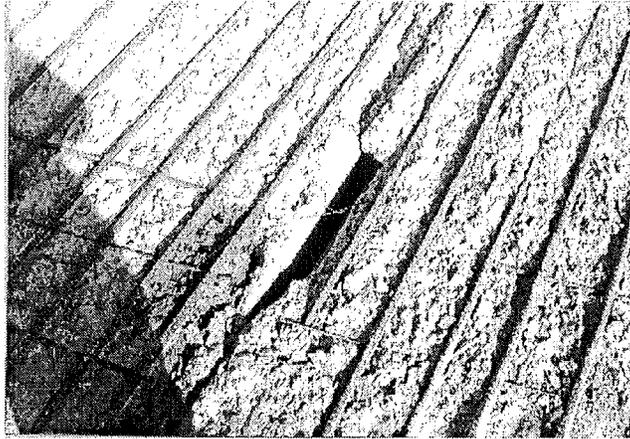
**Photo 3-44. Hole at the deck West approach**

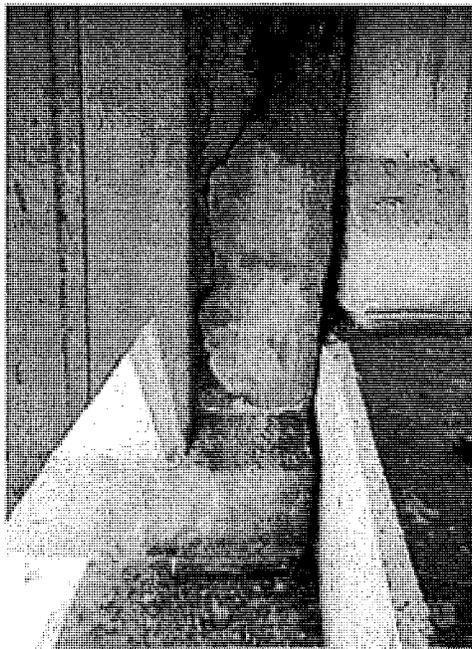
**Photo 3-45. Typical beam-end condition**

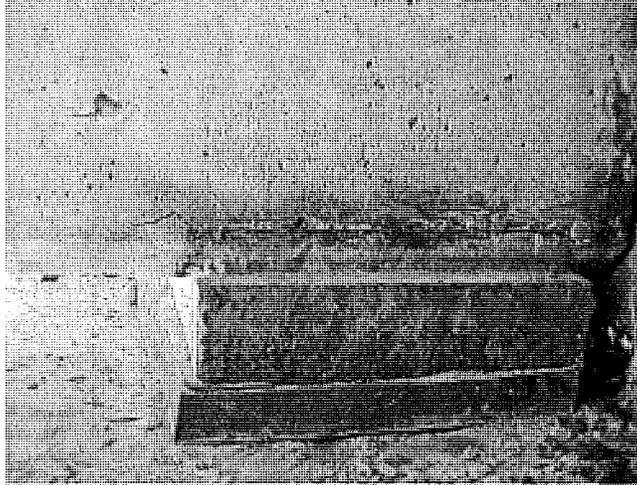
**Photo 3-46. Rust crack at beam-end**

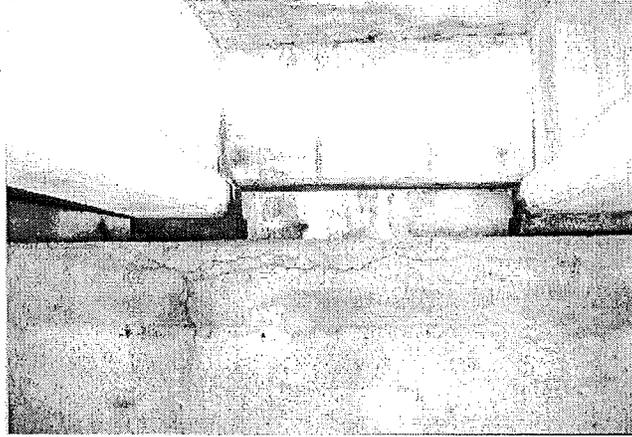
**Photo 3-47. Condition of South abutment**

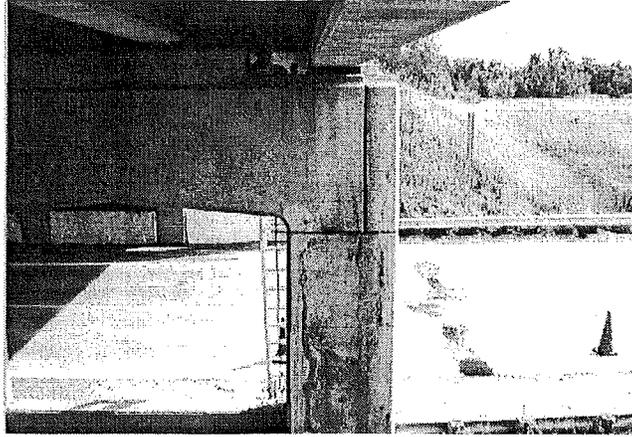
**Photo 3-49. Deterioration observed at pier W2**

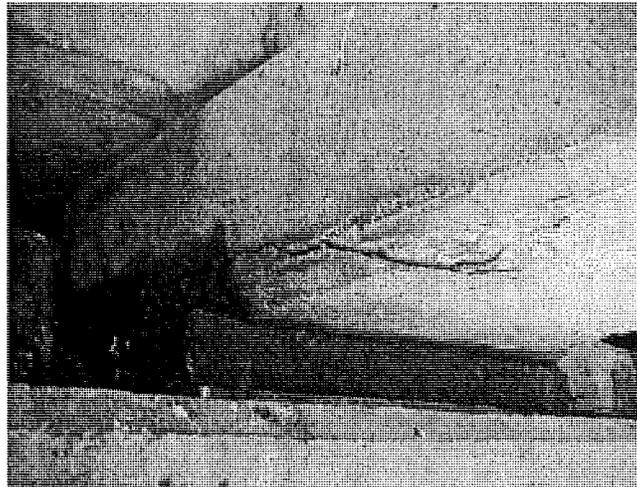
**Photo 3-50. Rust and spall at beam-end**

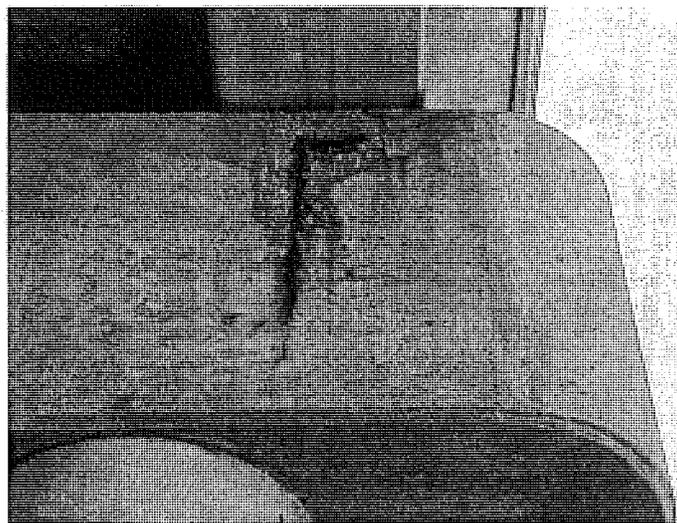
**Photo 3-51. Spall with exposed reinforcement at pier S1 under beam W1**

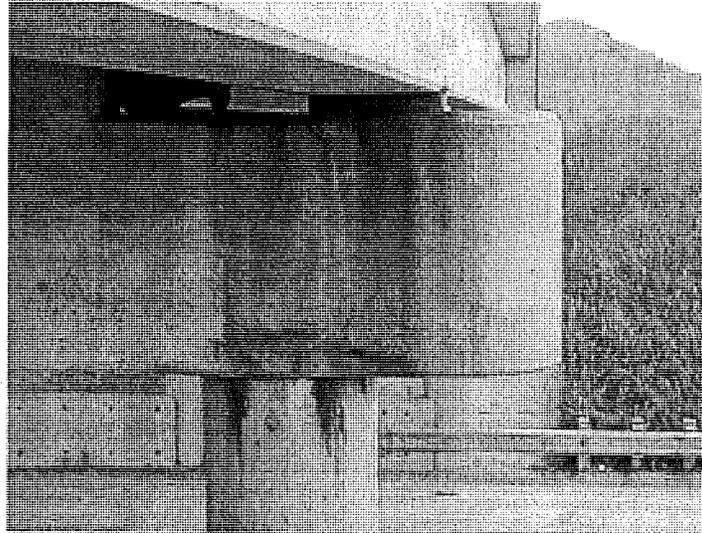
**Photo 3-52. Rust stain and wet spots at pier S2**

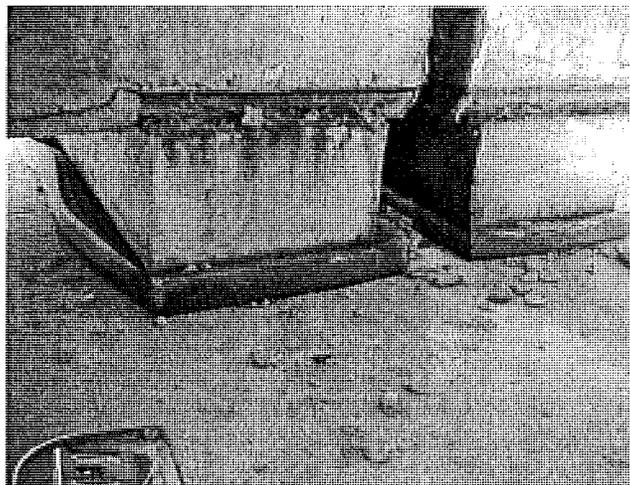
**Photo 3-53. Condition of the bearings on pier**

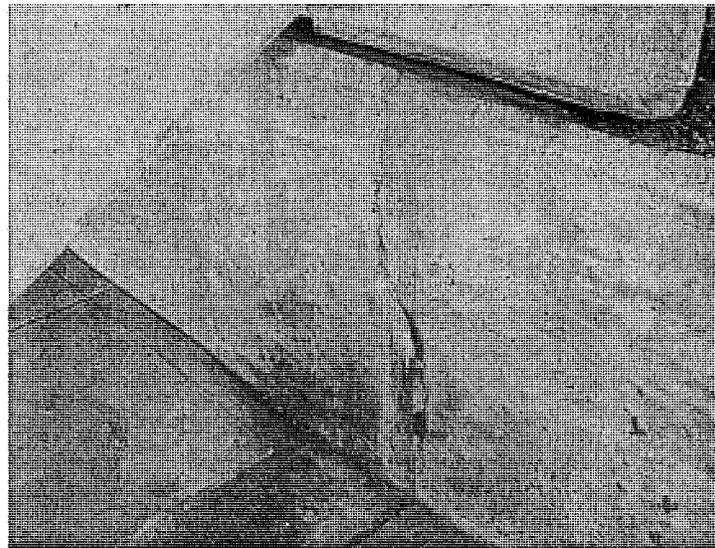
**Photo 3-54. Leaching crack at the North side of West abutment**

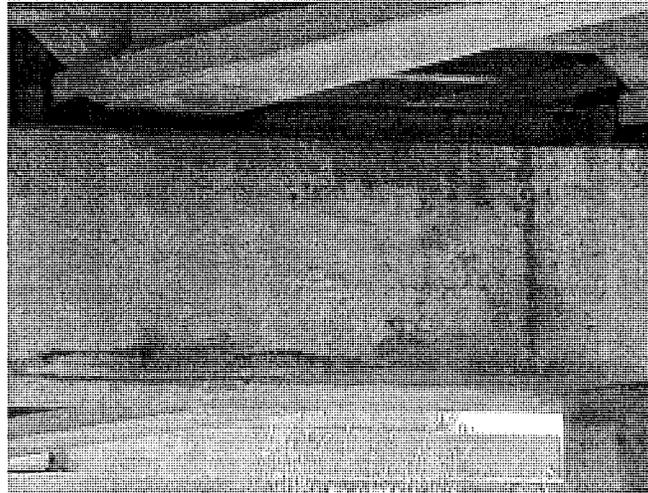
**Photo 3-55. Typical pier cap beam condition**

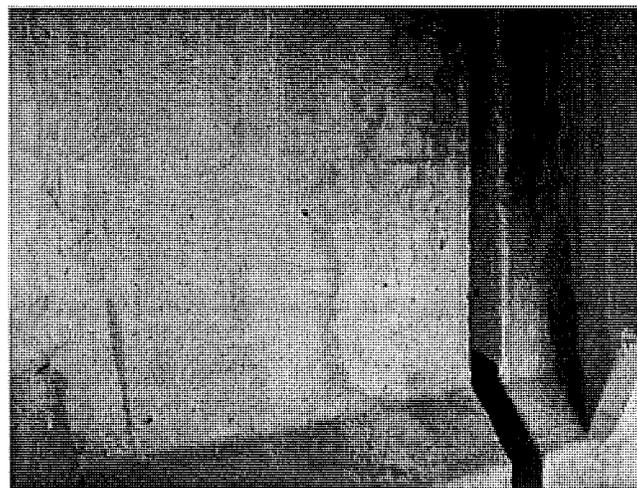
**Photo 3-56. Cracks and water stain at the beam end**

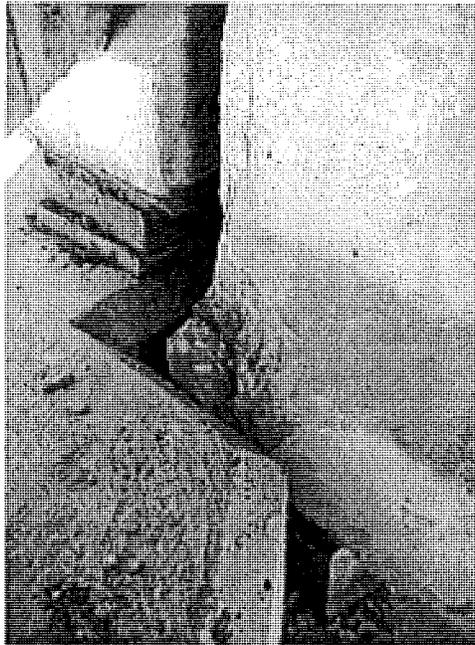
Photo 3-57. Cracks, spalls and exposed reinforcement at some of the beam-ends

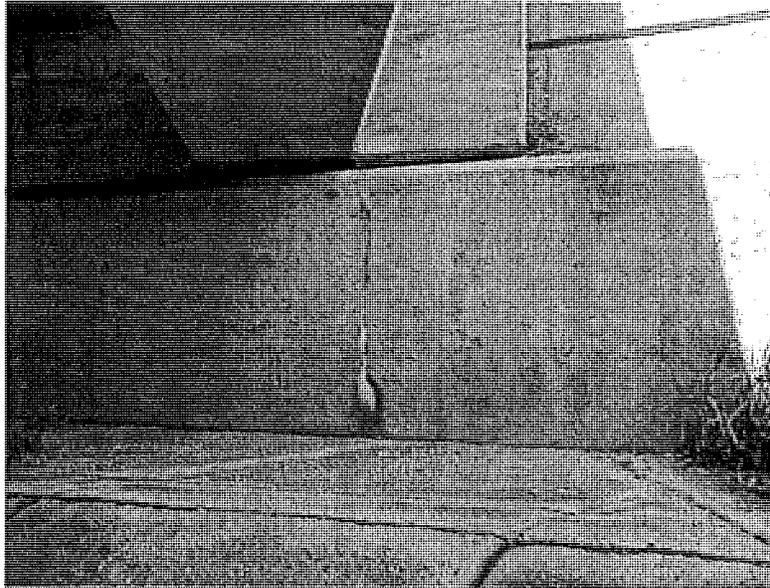
**Photo 3-58. Cracks with evidence of moisture and efflorescence at the abutments**

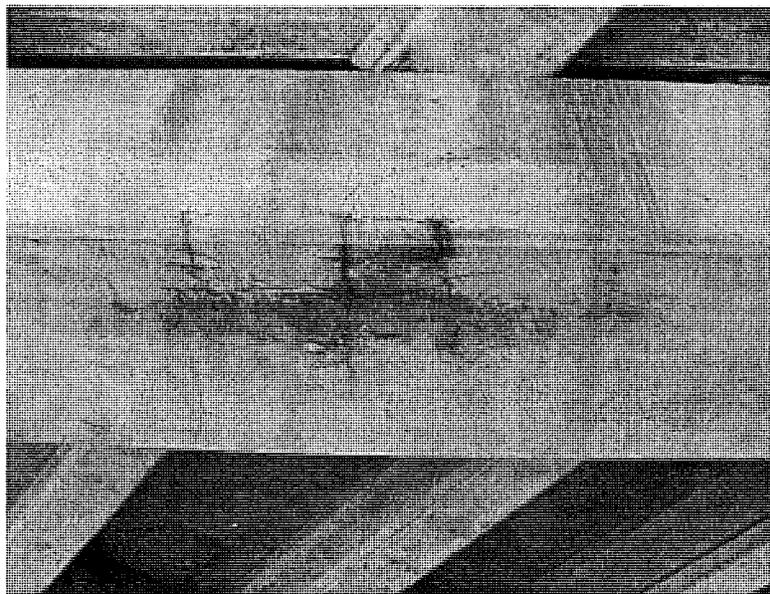
**Photo 3-59. Exposed reinforcement, rust and efflorescence at W. fascia of pier cap beam W2**

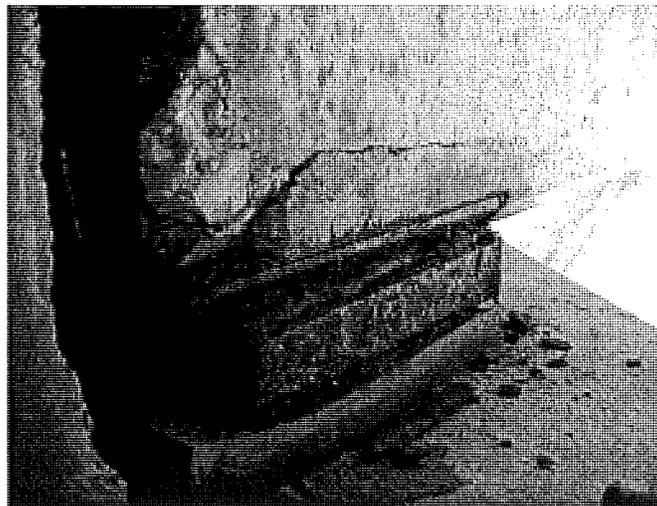
**Photo 3-61. Common beam-end condition**
