## **APPENDIX A: PHOTOGRAPHS**

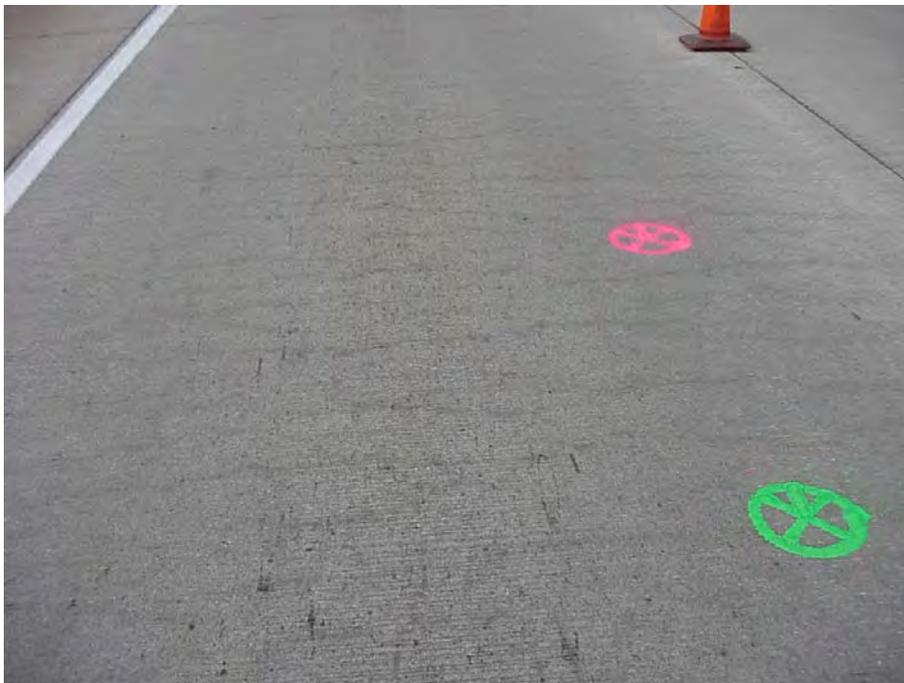
Site 0: US-23 SB, Section A of MDOT Aggregate Study. Four-inch core locations. Note the presence of shrinkage cracking in test slab.

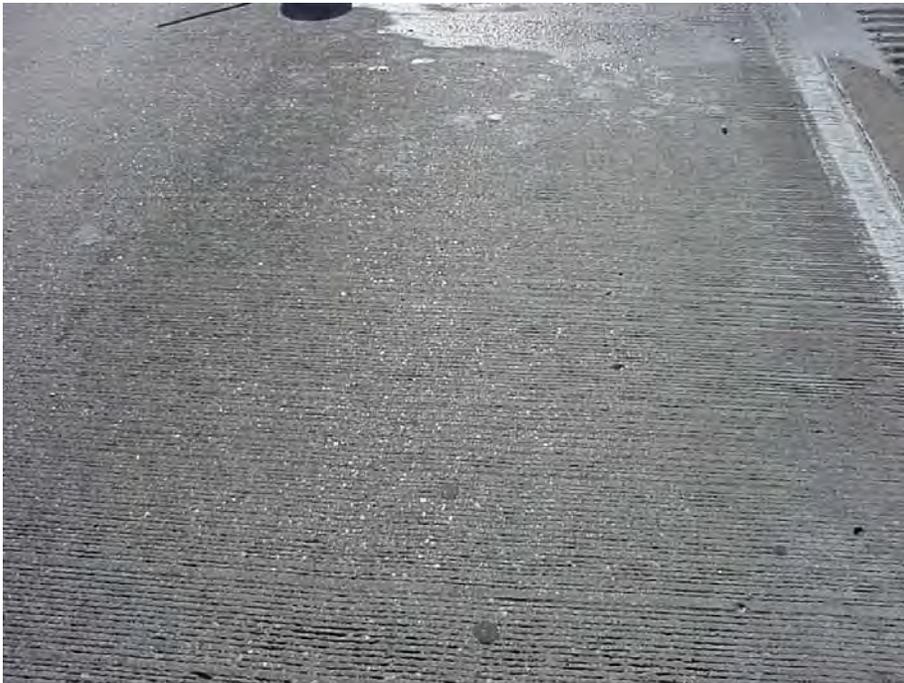
Site 2: US-23 SB, Section C of MDOT Aggregate Study. Surface of traveling lane. Note the popouts in the lower right corner.

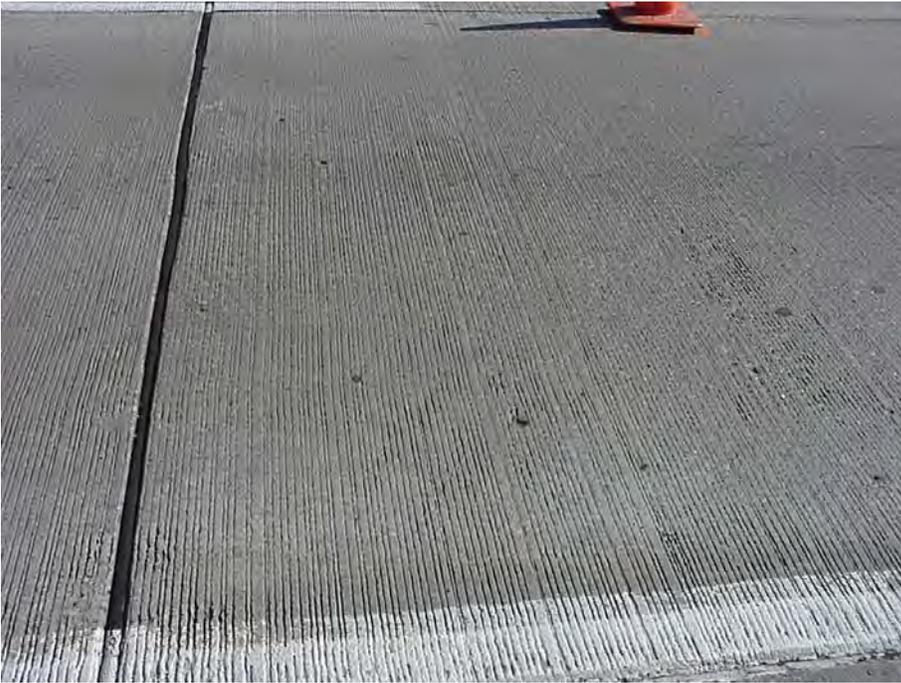
Site 2: US-23 SB, Section C of MDOT Aggregate Study. Surface of outside traveling lane including expansion joint. Note the excellent condition of the joint.

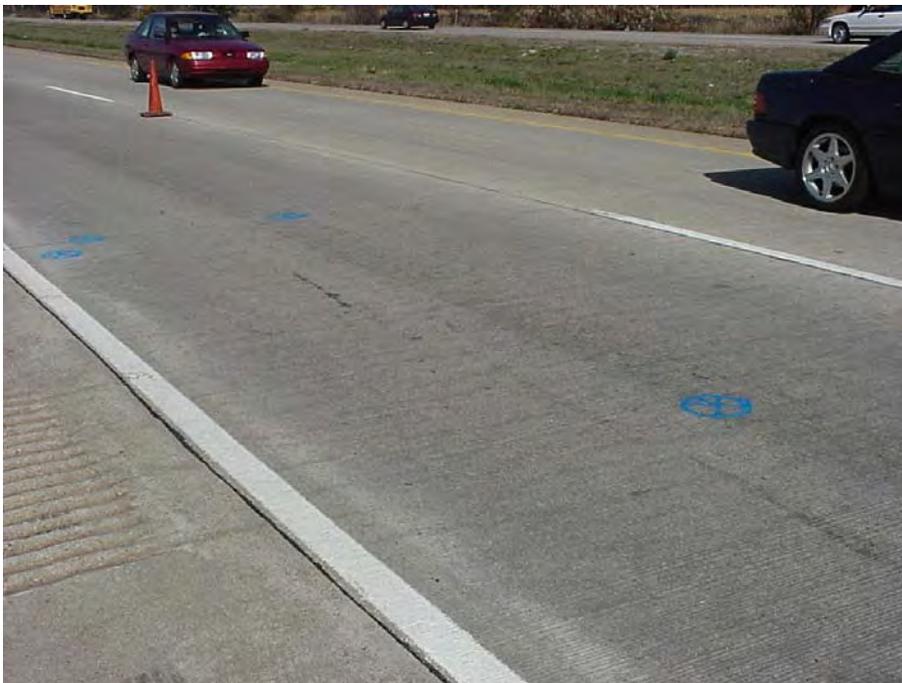
Site 3: US-23 SB, Section D of MDOT Aggregate Study. Surface of traveling lane showing the position of the six-inch cores. Note the shrinkage cracking throughout the site.

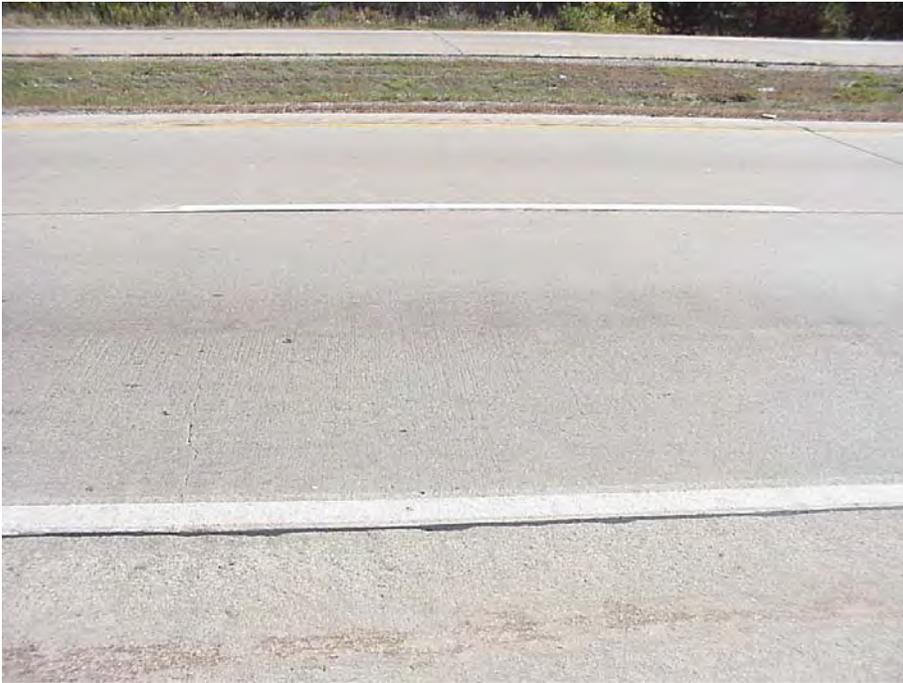
Site 4: US-23 SB, Sta 610+56. Surface of traveling lane showing transverse cracking, map cracking, and popouts.

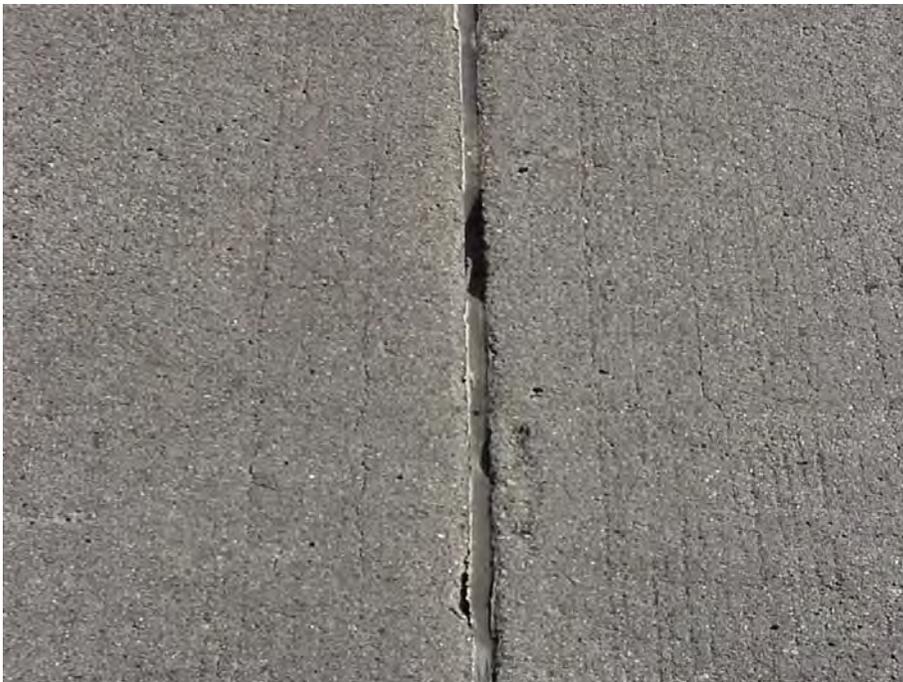
Site 4: US-23 SB, Sta 610+56. Pavement surface and transverse joint. Note the seal of the transverse joint is failing.

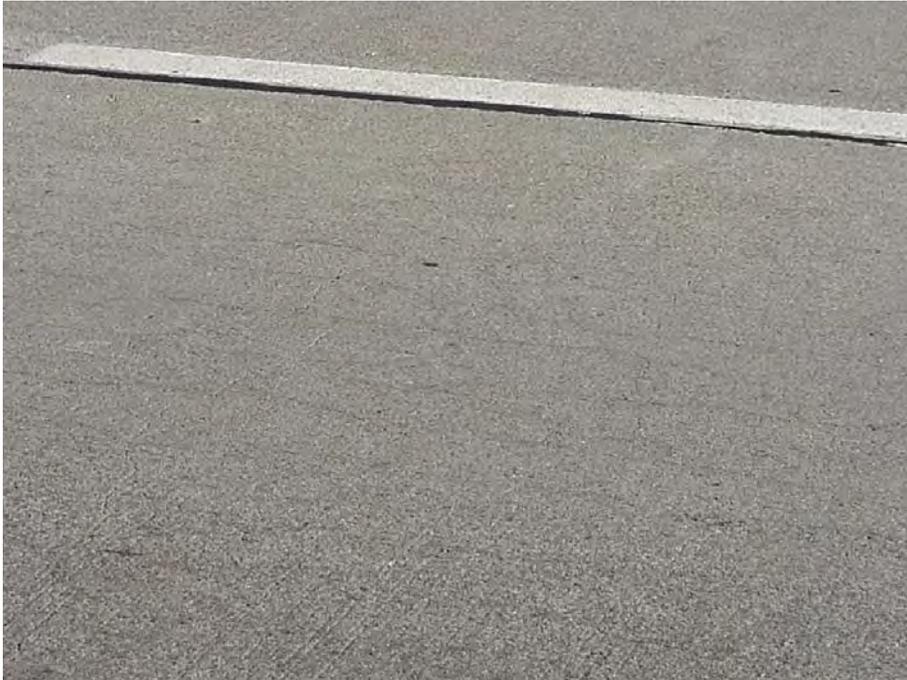
Site 4: US-23 SB, Sta 610+56. Surface of traveling lane showing map cracking.

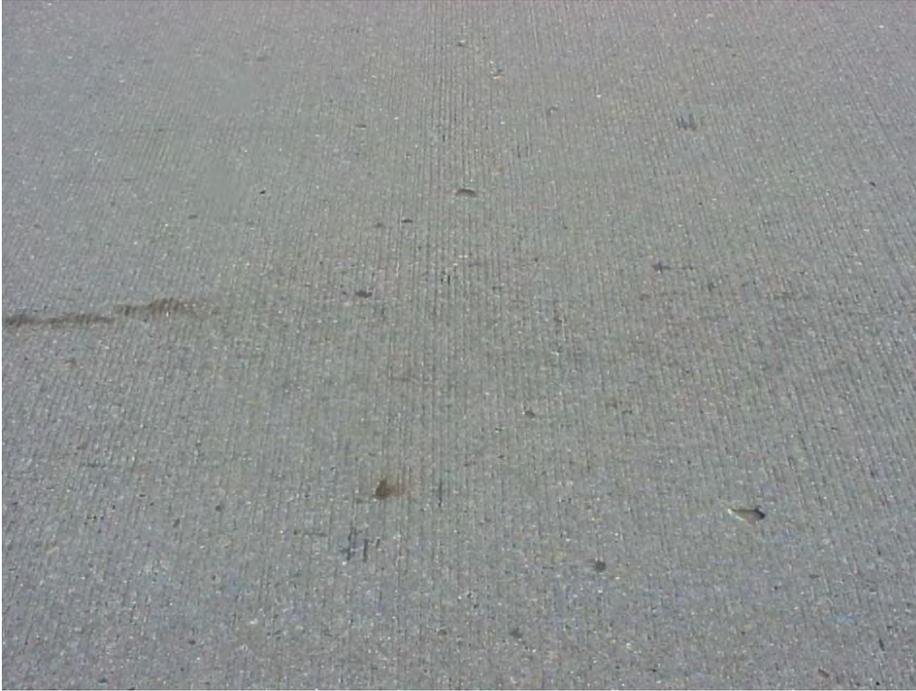
Site 4A: US-23 SB; Starts @ Sta 176+36. Surface of traveling lane-showing Popouts.

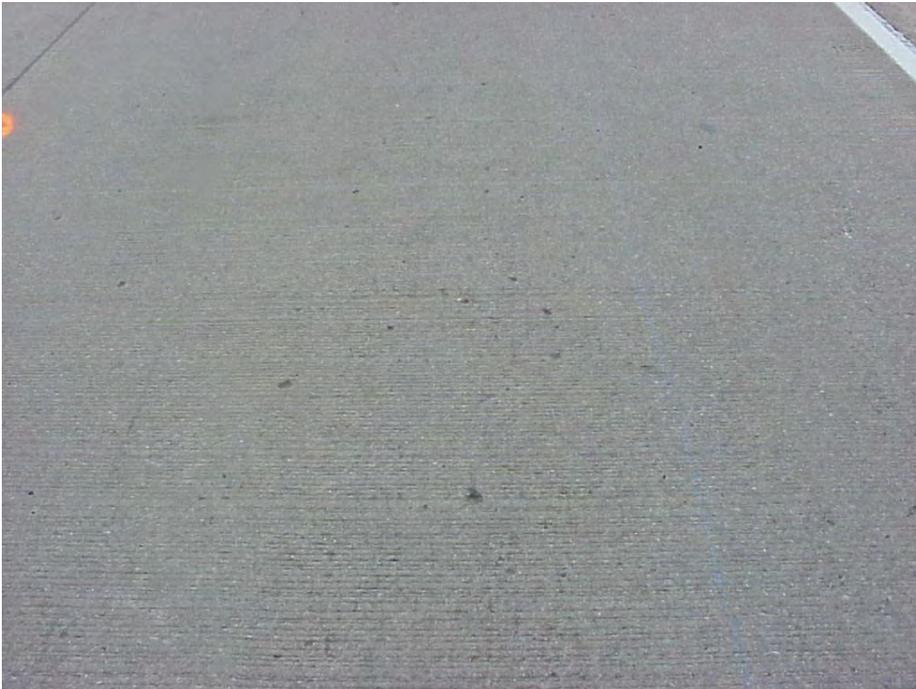
Site 4A: US-23 SB; Starts @ Sta 176+36. Surface of traveling lane showing popouts.

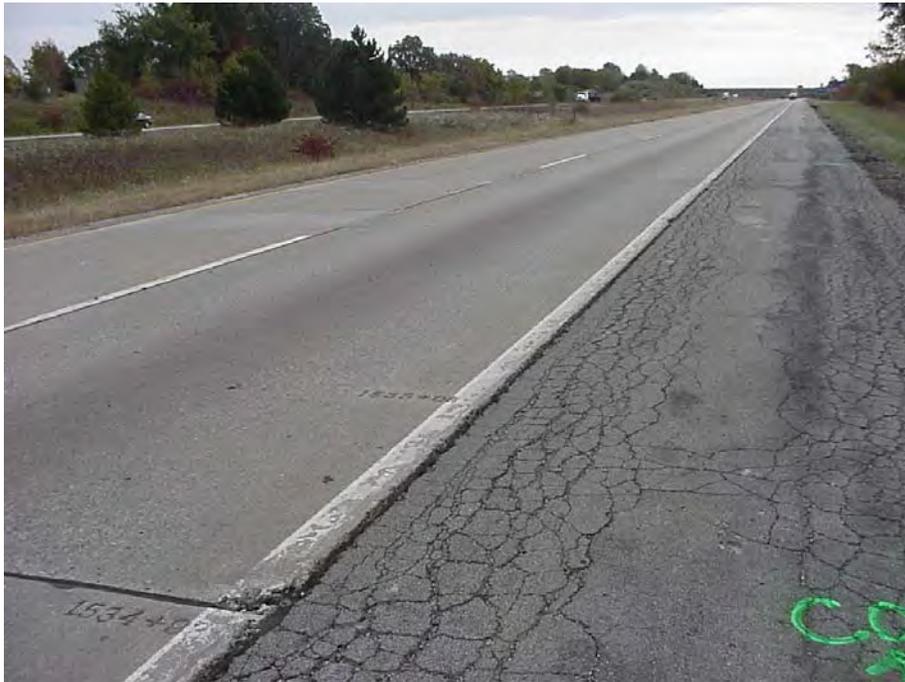
Site 6: I-69 EB, Sta 1534+93. View showing the pavement surface, bituminous shoulder and several concrete patches.

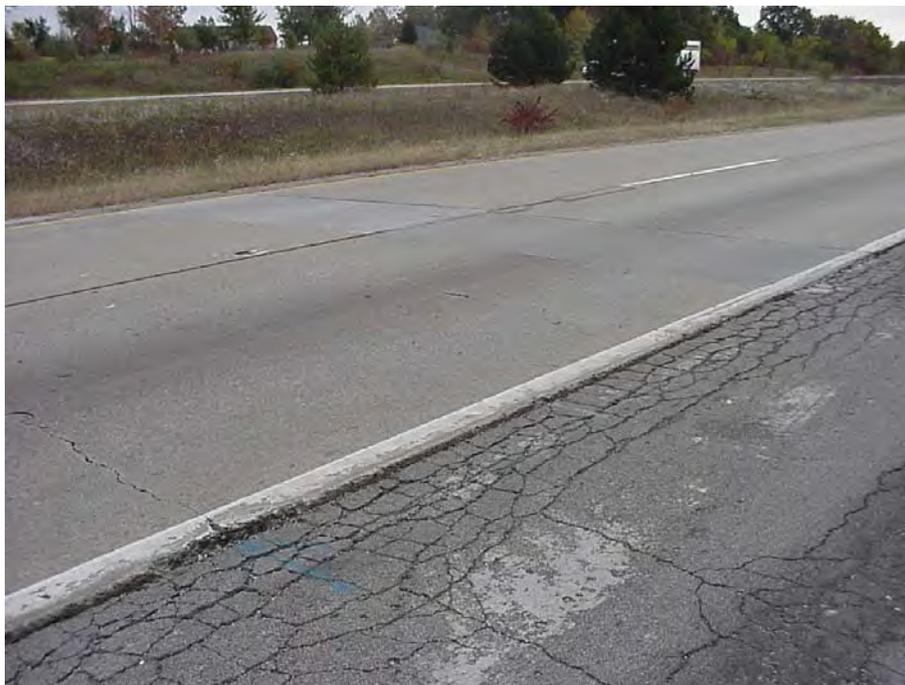
Site 6: I-69 EB, Sta 1534+93. View showing the pavement surface. Note the transverse crack (lower left) and the alligator cracking of the bituminous shoulder.

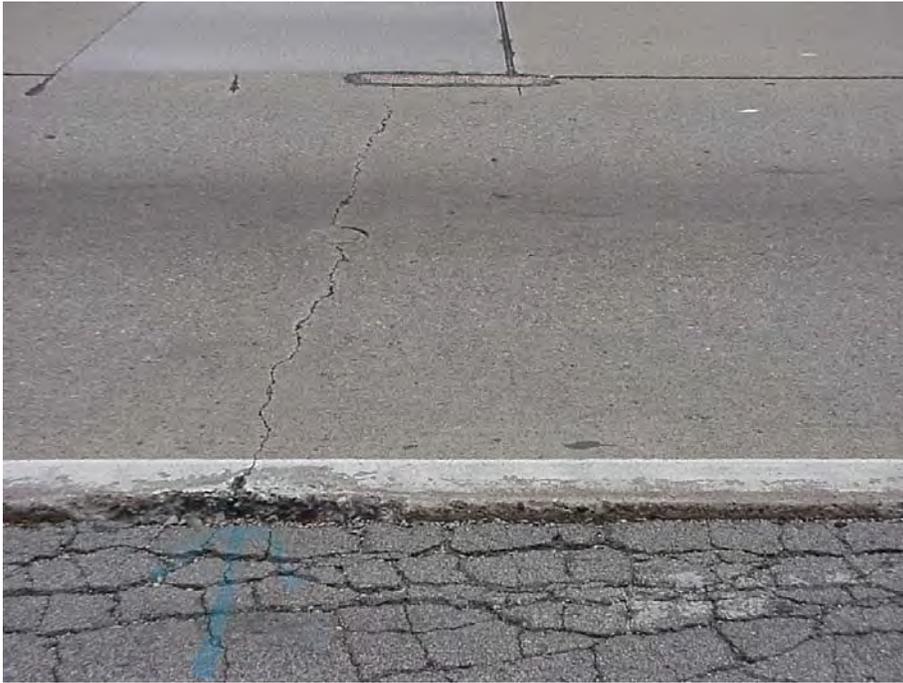
Site 6: I-69 EB, Sta 1534+93. View showing the pavement surface. Note the transverse crack, concrete patch, and the spalling at the lower right edge of the concrete patch.

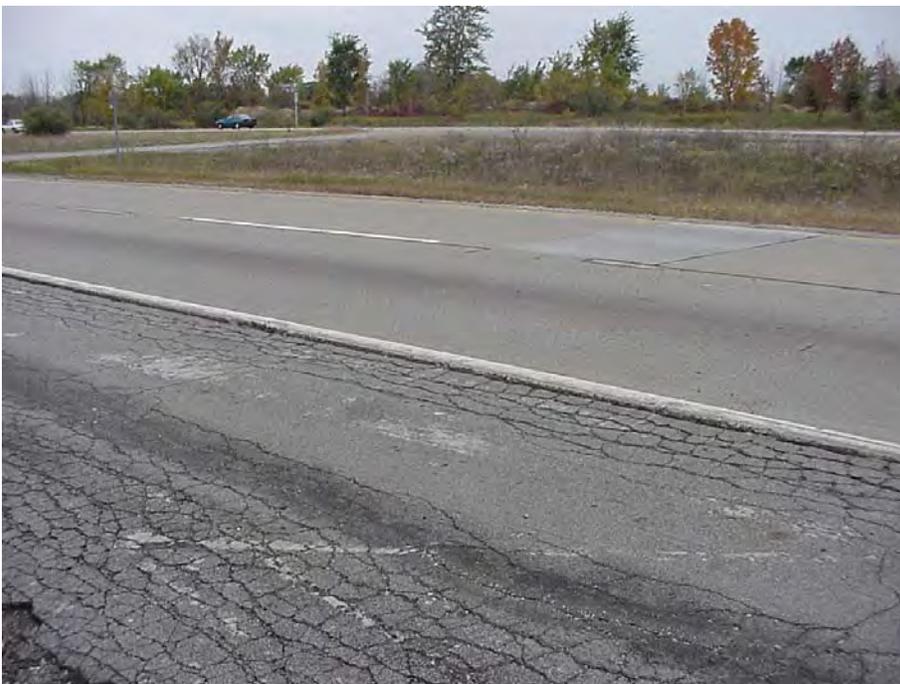
Site 6: I-69 EB, Sta 1534+93. View showing the pavement surface. Note the vertical separation between the traveling lane and the bituminous shoulder.

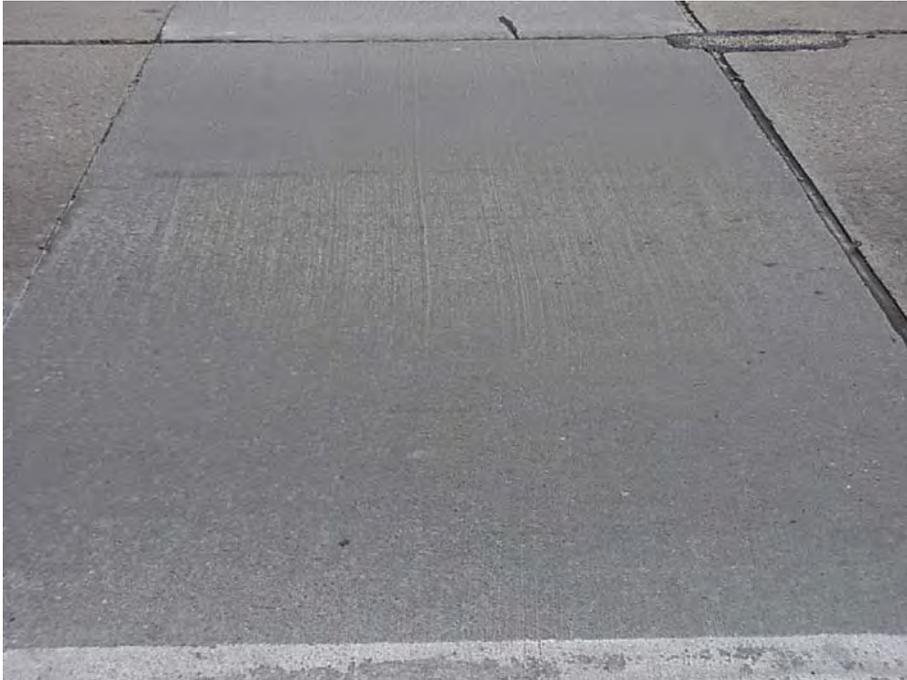
Site 6: I-69 EB, Sta 1534+93. View showing a concrete patch. Note the expansion joint on the right side of the patch and the spalling at the upper right corner.

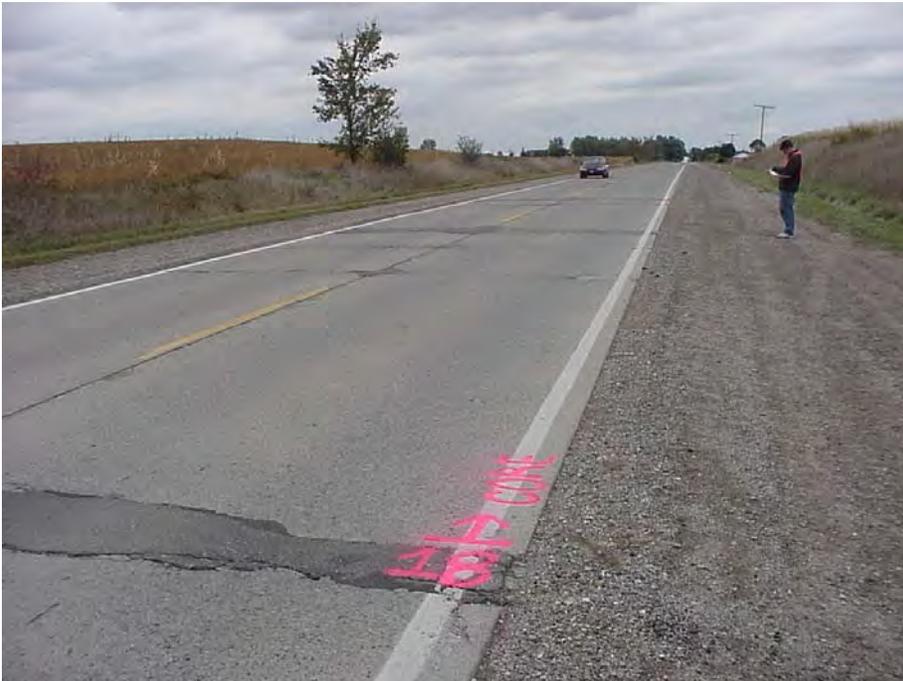
Site 14: M-81 EB. View showing the pavement surface, gravel shoulder and several joint repair patches.

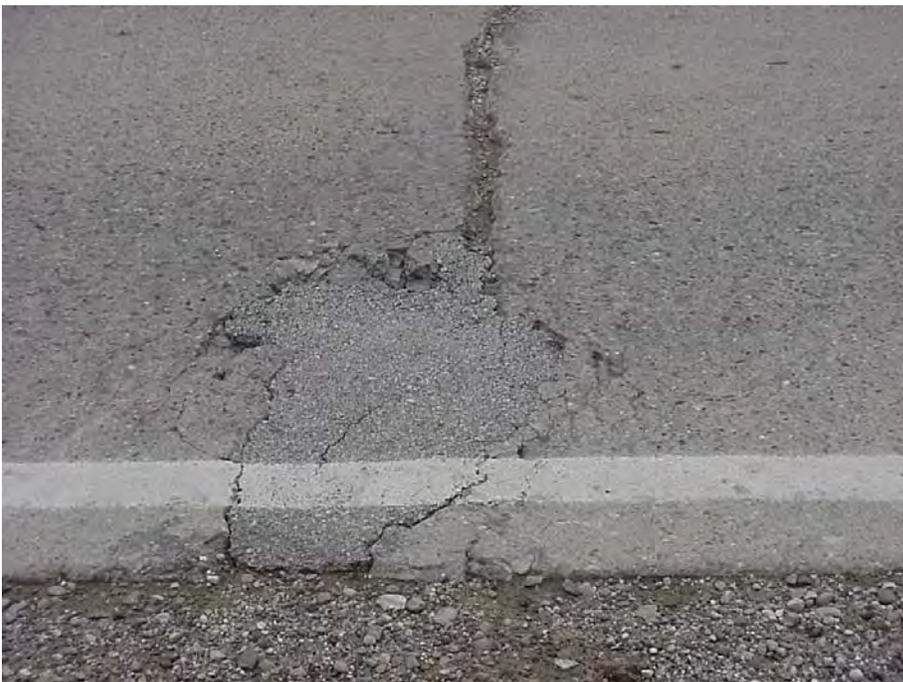
Site 14: M-81 EB. View showing spalling at the end of a transverse crack.

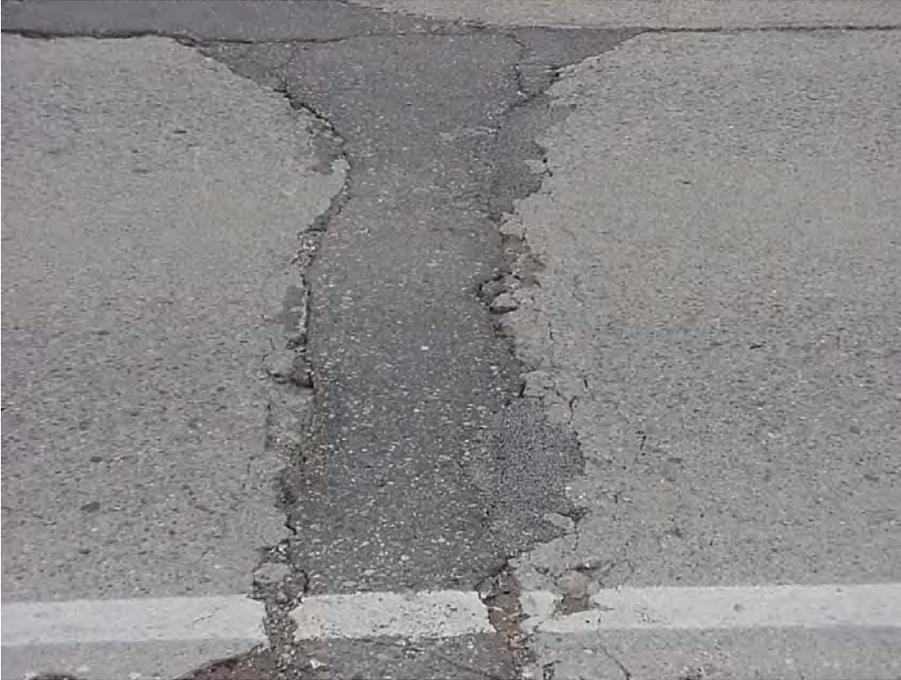
Site 14: M-81 EB. View showing spalling along a severe transverse crack.

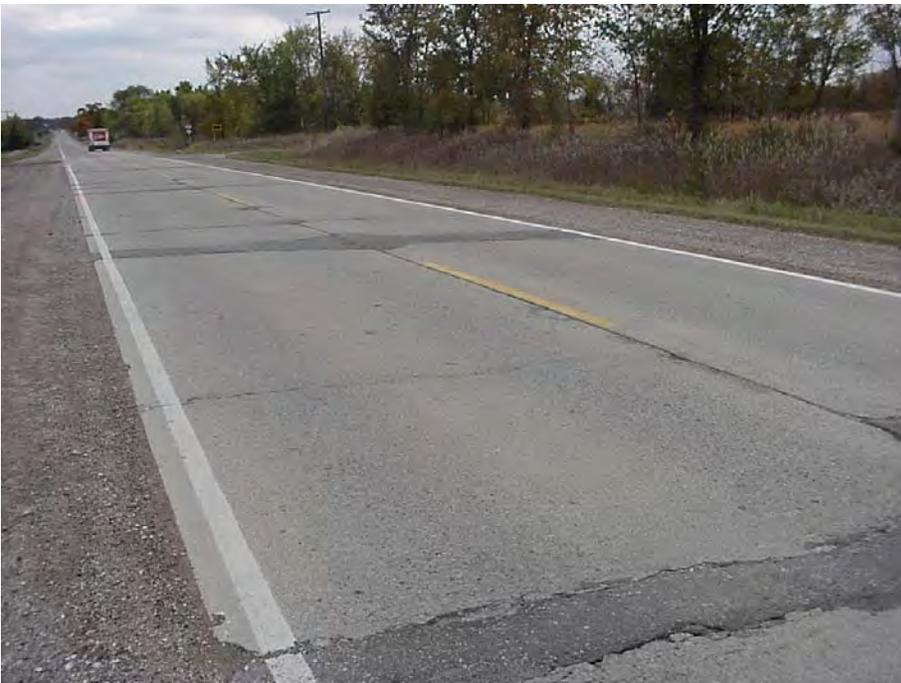
Site 14: M-81 EB. View showing the pavement surface, gravel shoulder, transverse cracks and several joint repair patches.

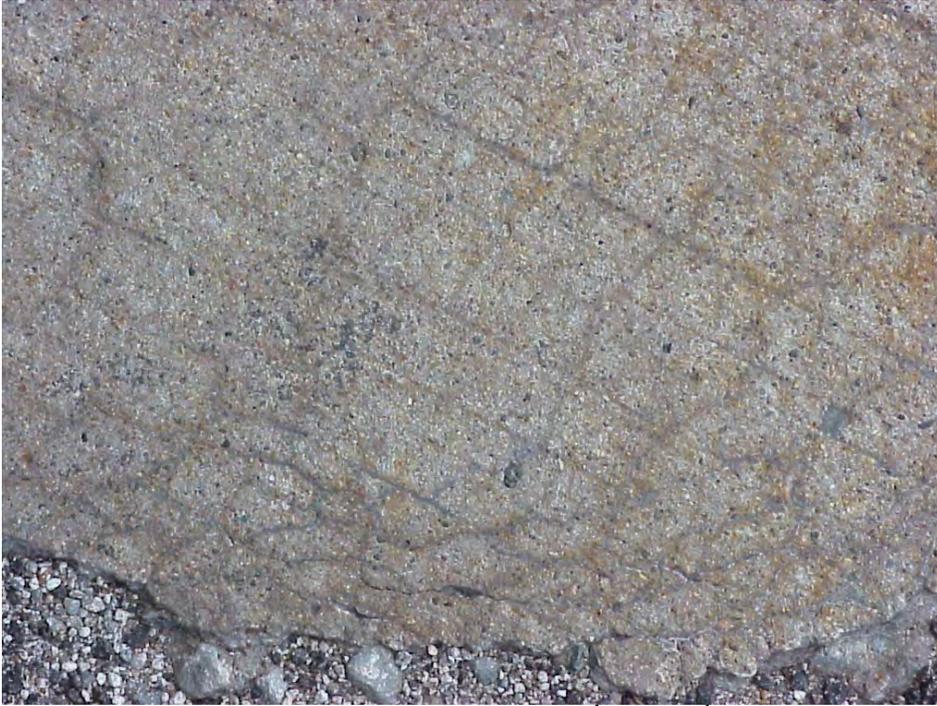
Site 19: M-53 NB @Station 520. Between 17<sup>th</sup> and 18<sup>th</sup> Mile road, view showing the cracking pattern near a transverse joint.

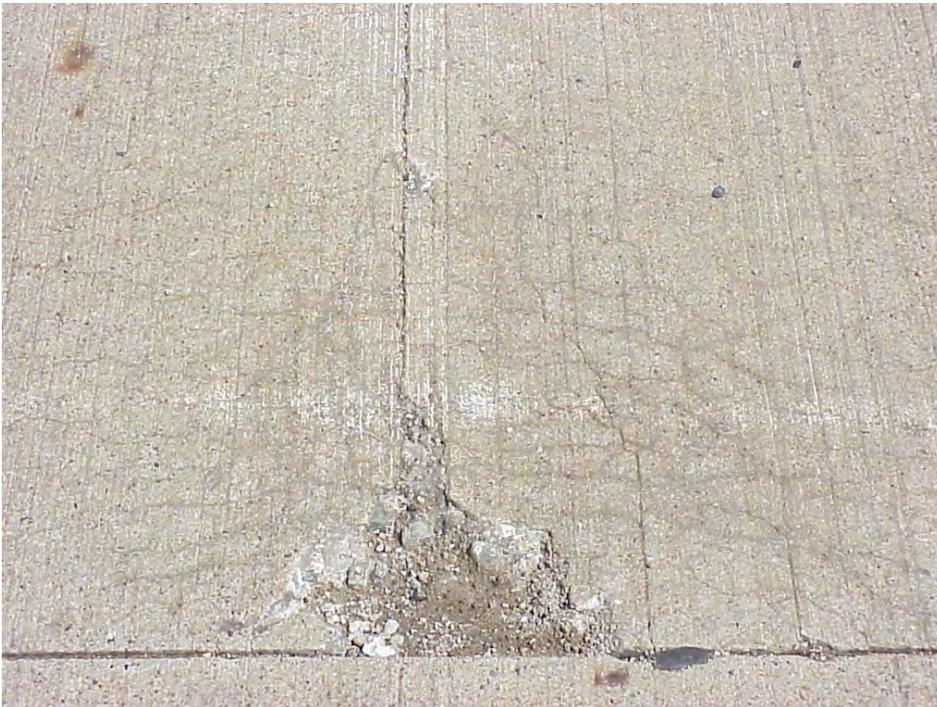
Site 19: M-53 NB @Station 520. Between 17<sup>th</sup> and 18<sup>th</sup> Mile road, view showing the cracking pattern near a transverse joint.

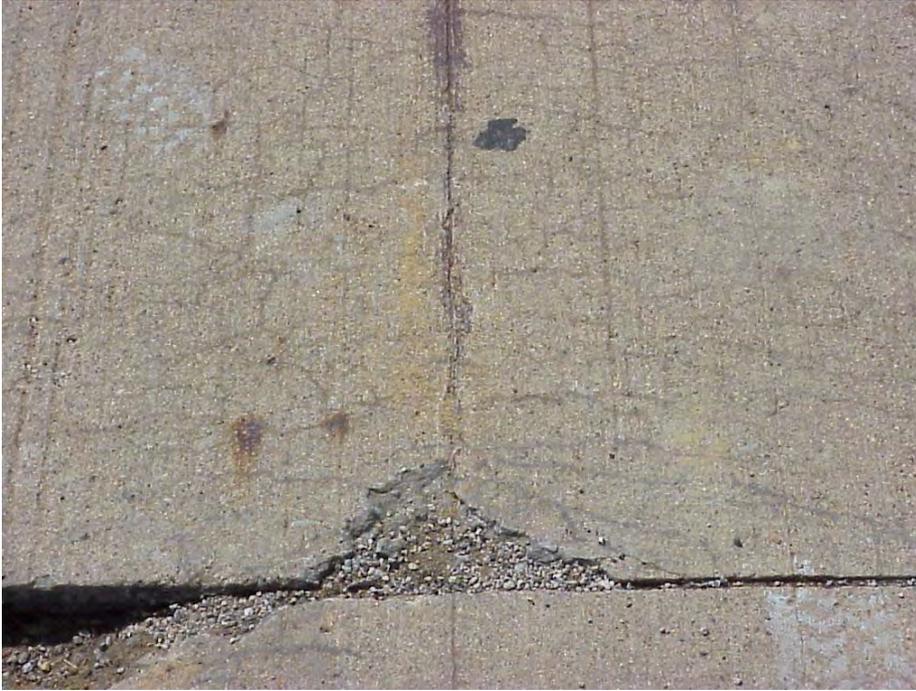
Site 19: M-53 NB @Station 520. Between 17<sup>th</sup> and 18<sup>th</sup> Mile road, view showing the cracking pattern near a transverse joint.

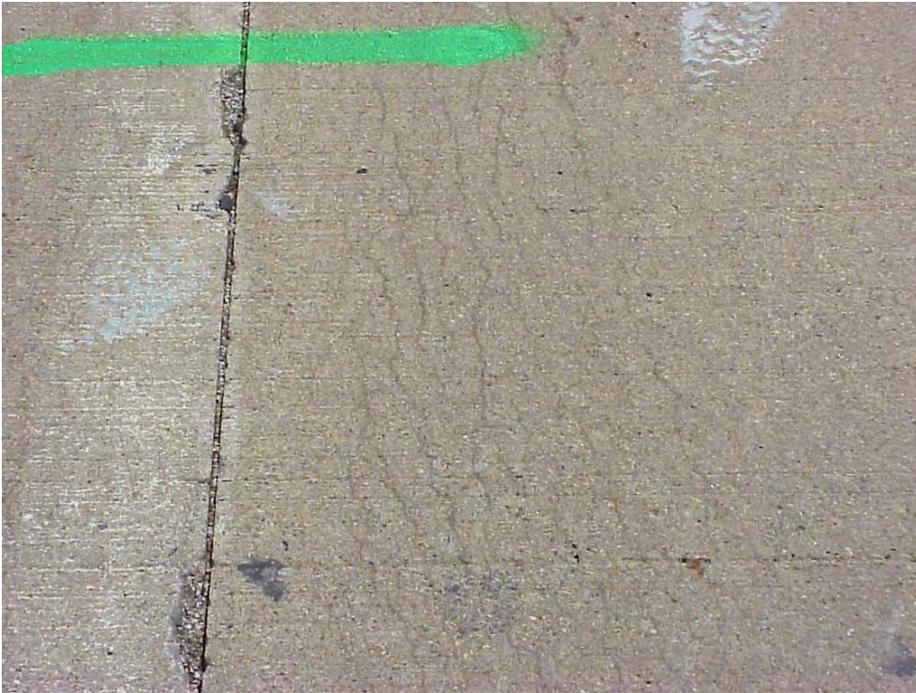
Site 19: M-53 NB @Station 520. Between 17<sup>th</sup> and 18<sup>th</sup> Mile road, view showing the cracking pattern near a transverse joint

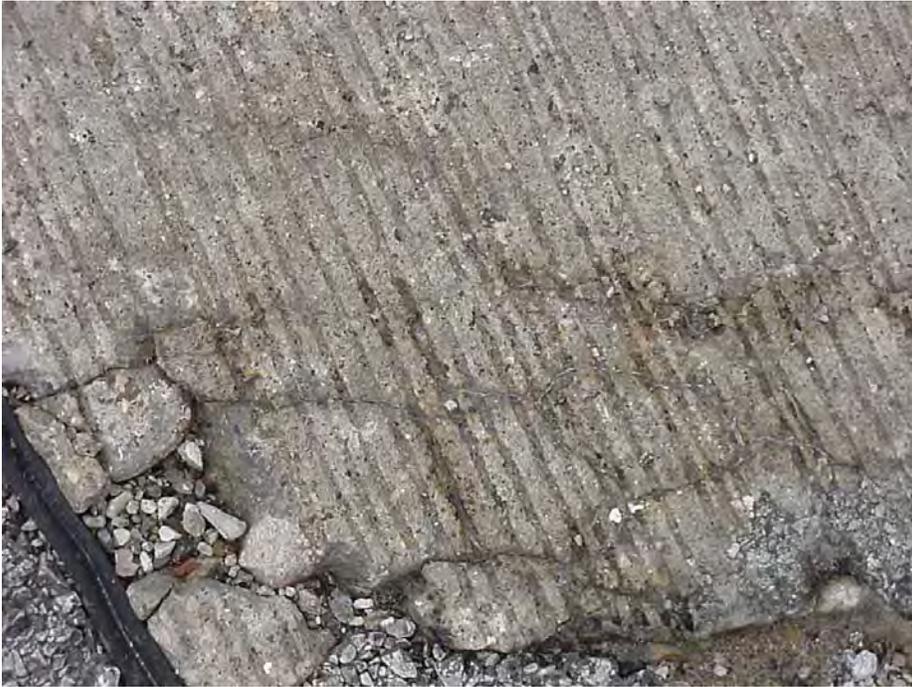
Site 26A: US-10 WB, Sta 137+08. View showing the cracking pattern pavement surface and loose particles.

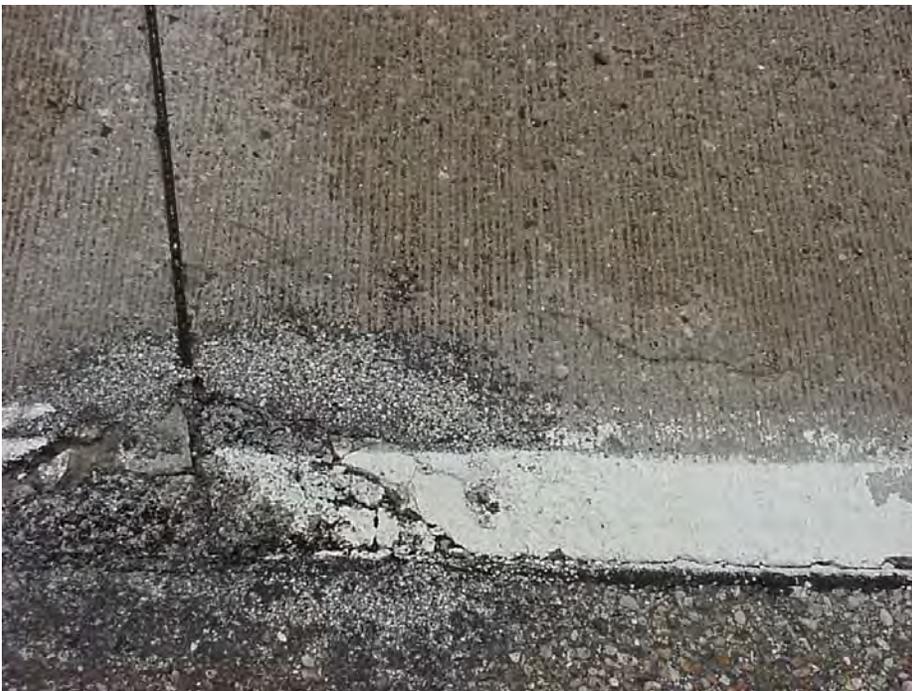
Site 26A: US-10 WB, Sta 137+08. View showing the popouts, cracking pattern and spalling on the pavement. The spalling has already been patched with asphalt.

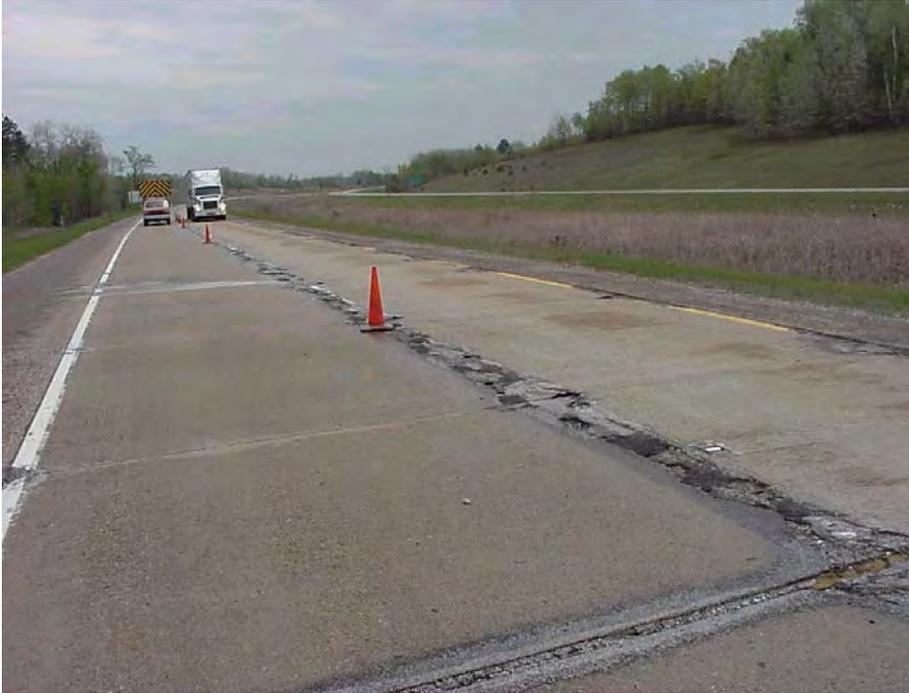
Site 26A: US-10 WB, Sta 137+08. View showing the spalling along the longitudinal joint which has been patched by asphalt. Lower right corner shows a view of expansion joint.

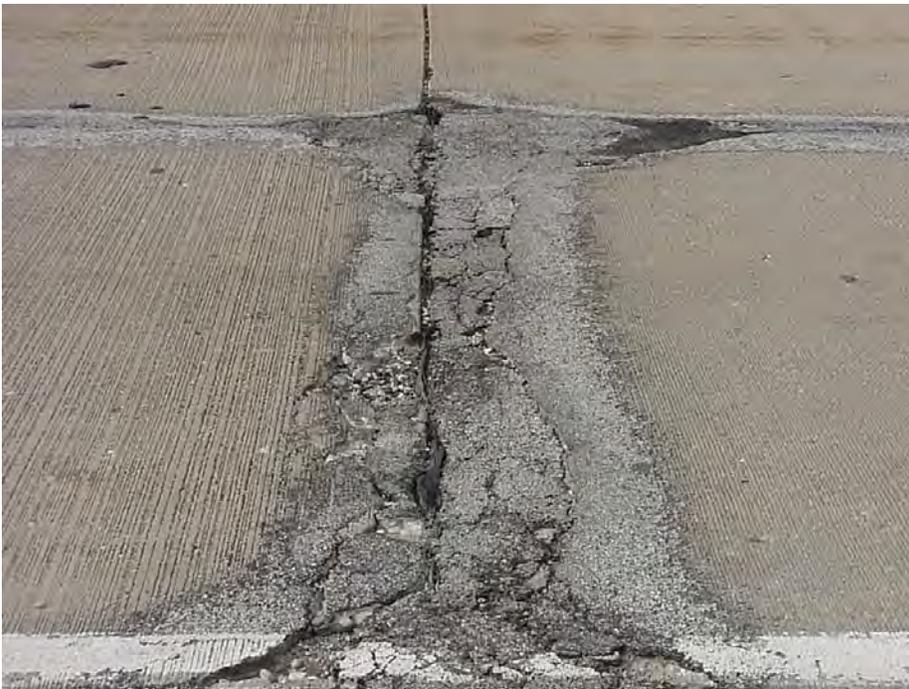
Site 26A: US-10 WB, Sta 137+08. View showing the transverse joint completely spalled and patched with asphalt.

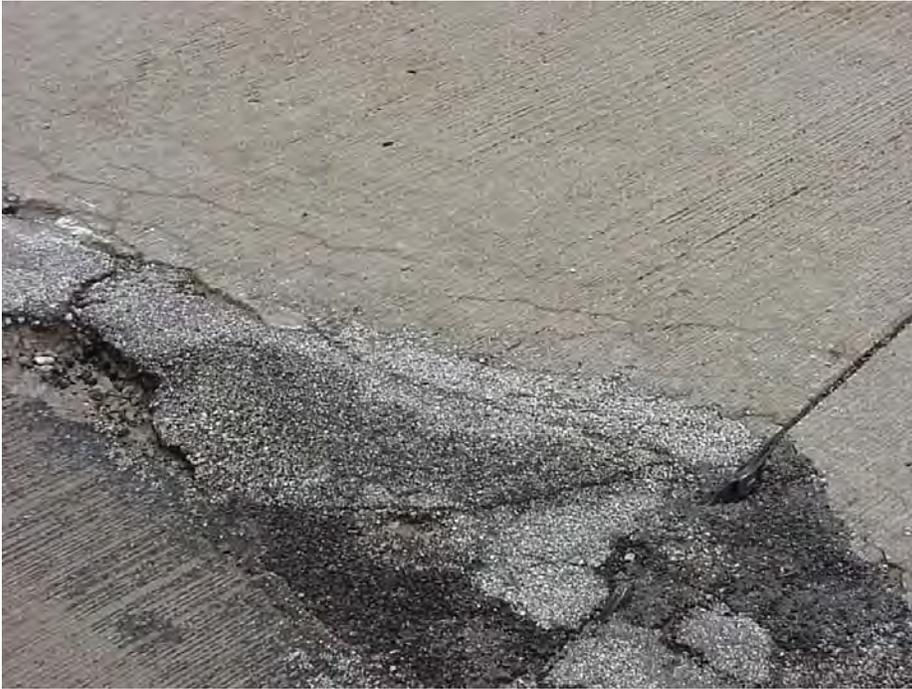
Site 26B: US-10 WB, Sta 137+08. View showing the cracking pattern pavement surface and completely spalled longitudinal joint.

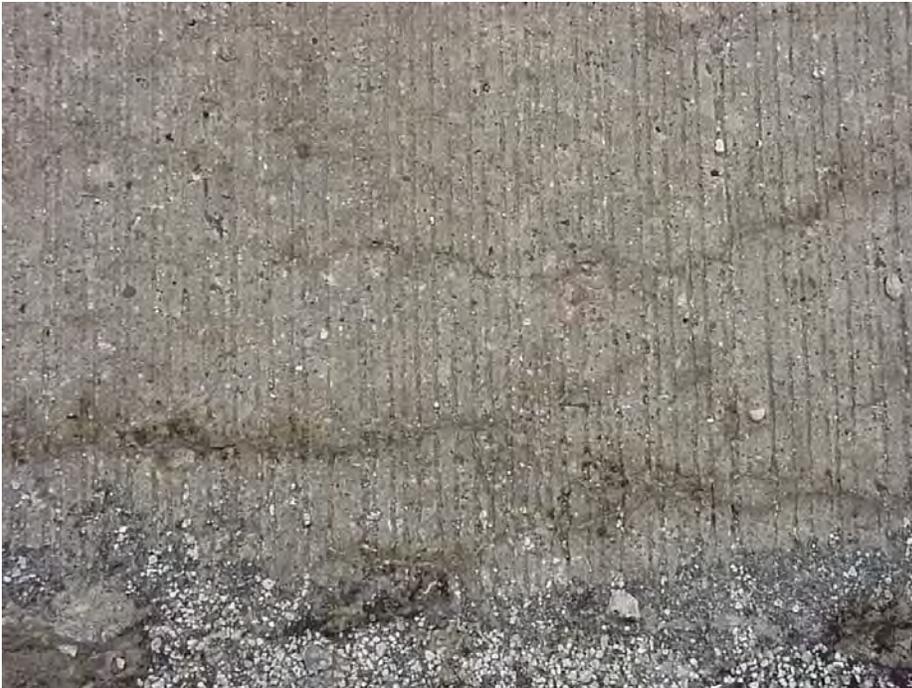
Site 26B: US-10 WB, Sta 137+08. View showing the popouts, cracking pattern and loose particles.

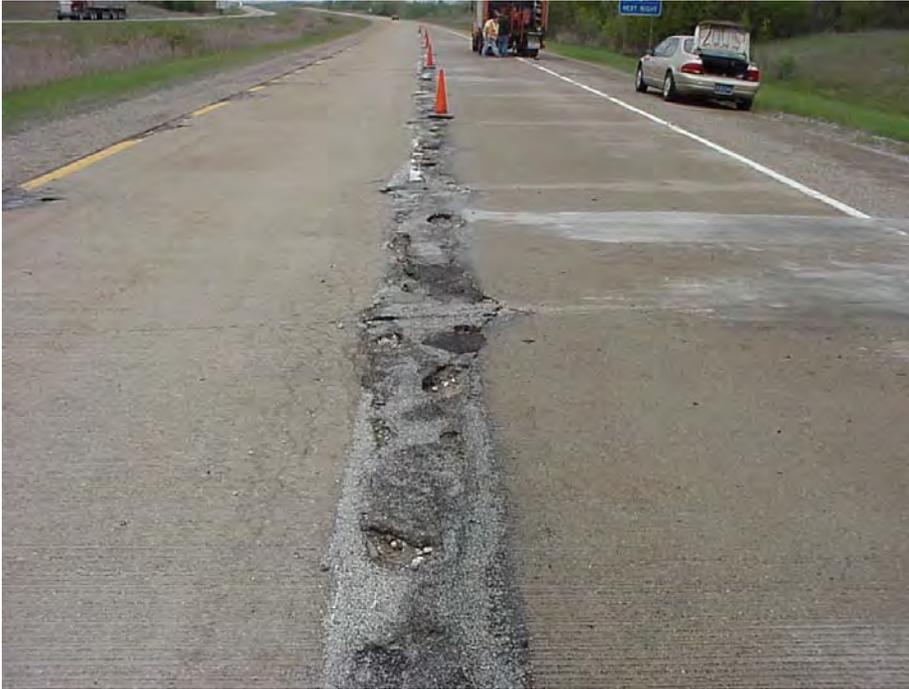
Site 26B: US-10 WB, Sta 137+08. View showing spalling along the longitudinal joint which has been patched by asphalt.

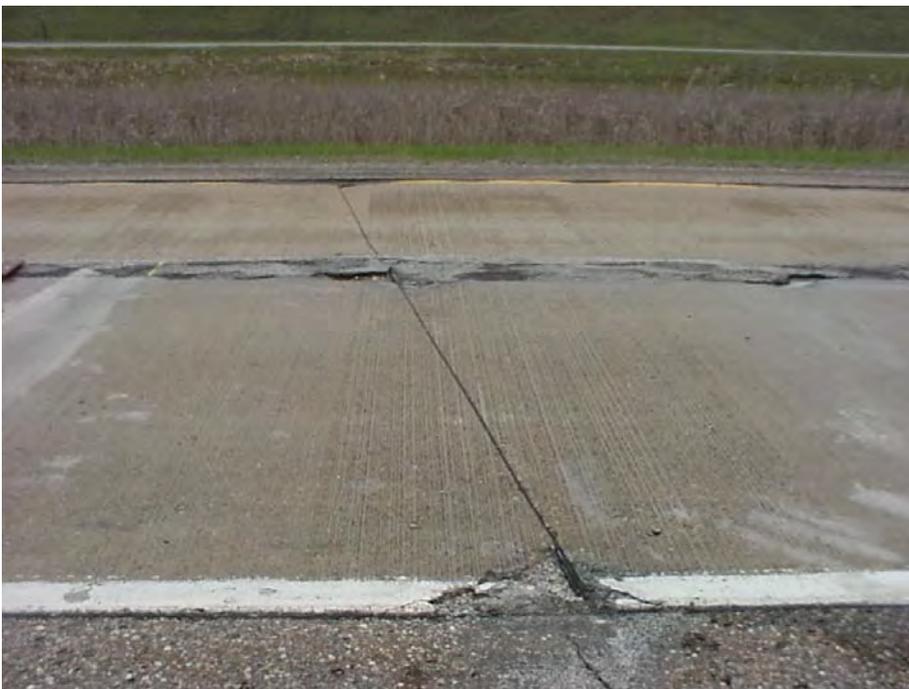
Site 26B: US-10 WB, Sta 137+08. View showing the skewed joint. Also showing spalling at the corners of joint.

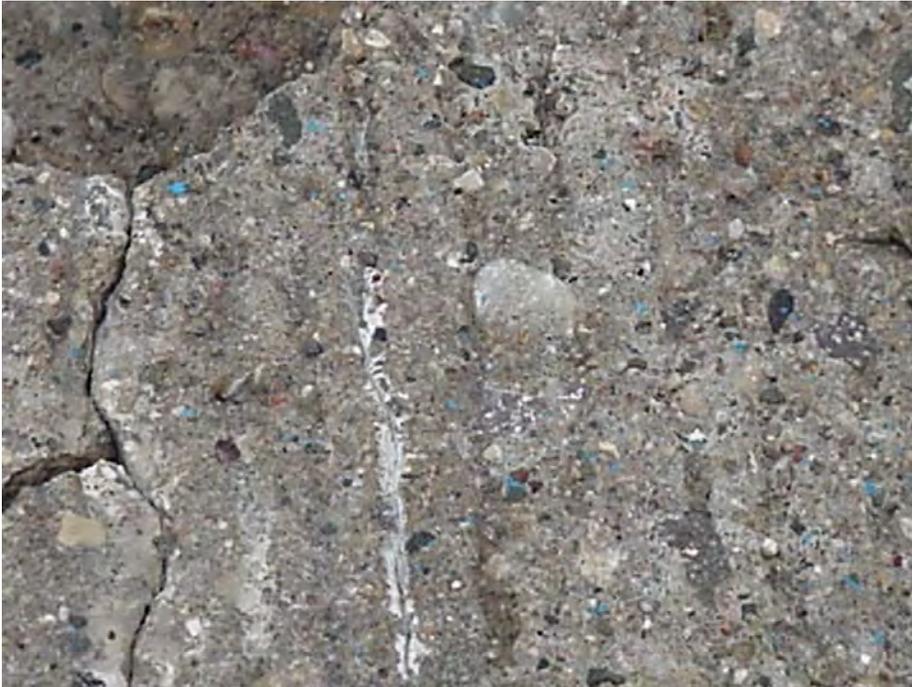
Site 27: US-10 WB, Sta 114+00. View showing the cracking pattern on pavement surface with breakup of the pavement.

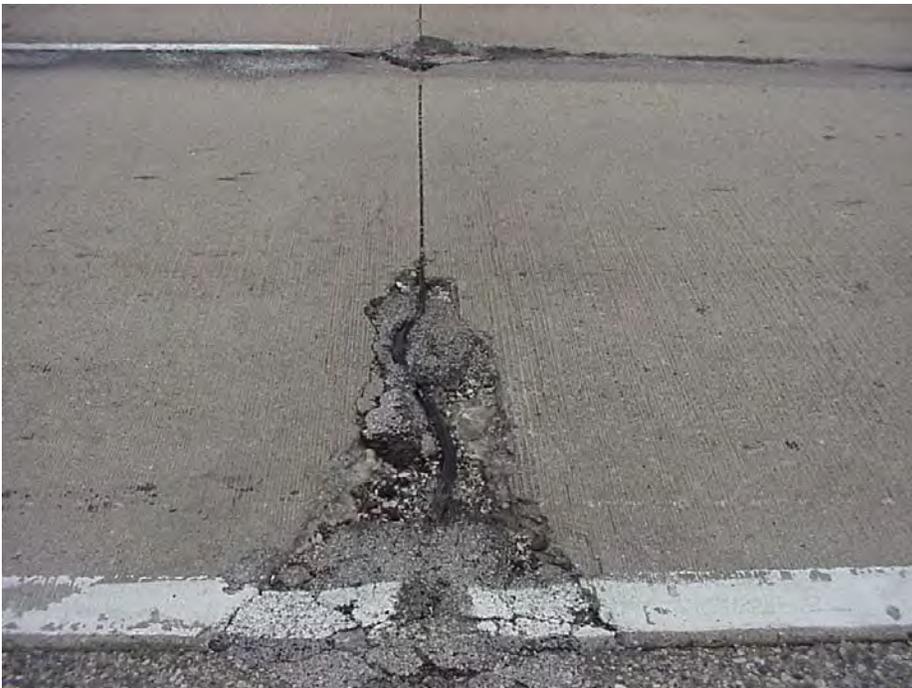
Site 27: US-10 WB, Sta 114+00. View showing the Popouts, cracking pattern and spalled transverse joint.

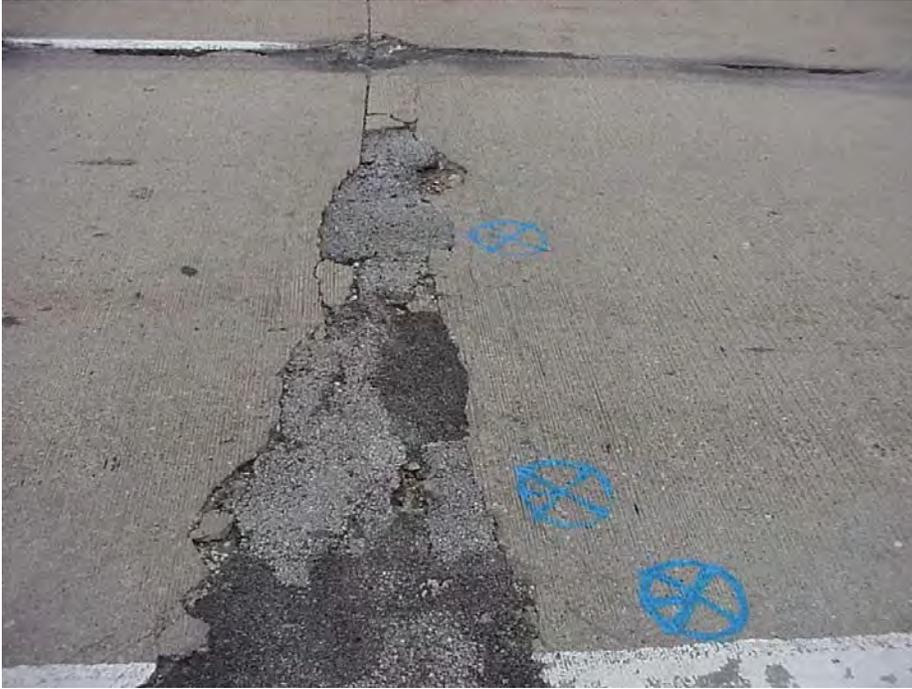
Site 27: US-10 WB, Sta 114+00. View showing spalling along the transverse joint and coring locations for petrographic analysis.

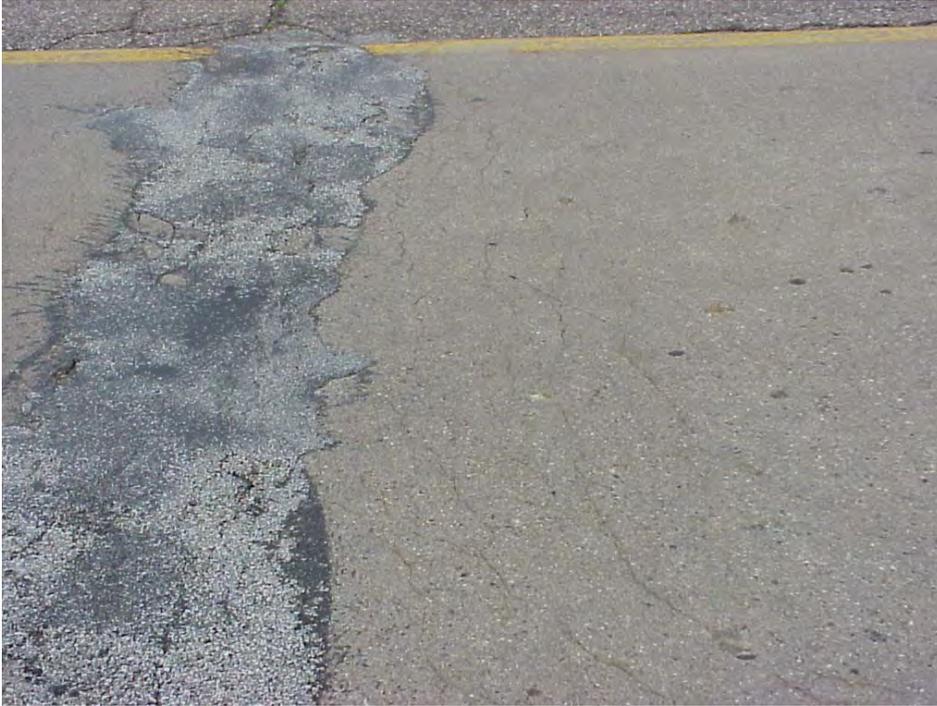
Site 28: US-27 SB Starts @ Station 519+07, View showing the cracking pattern along the poorly done asphalt patching.

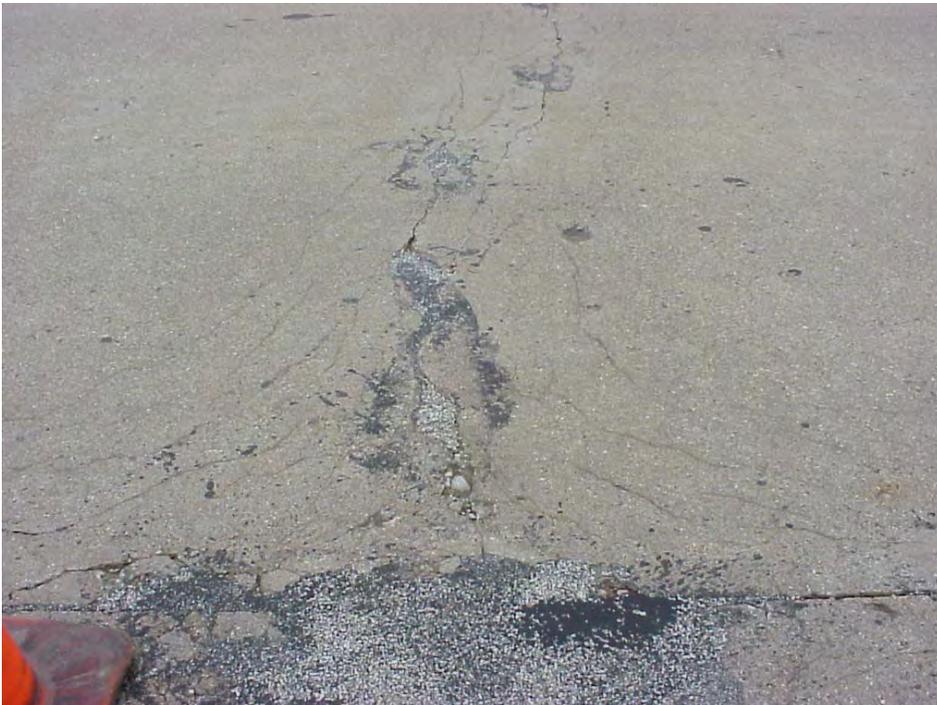
Site 28: US-27 SB Starts @ Station 519+07, View showing the cracking pattern along the transverse cracking.
