## **APPENDIX A: PHOTOGRAPHS**

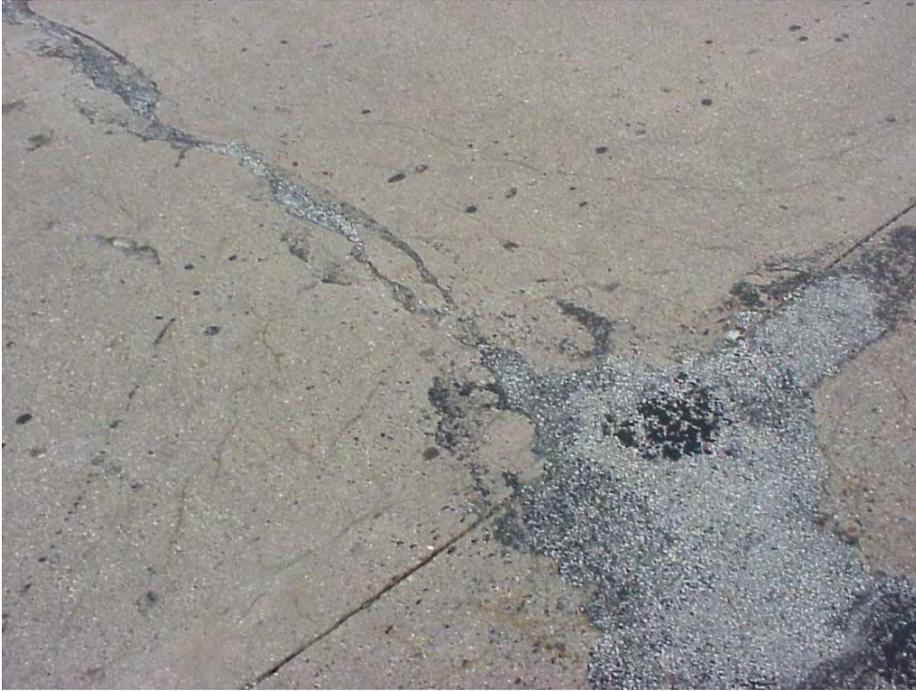
Site 28: US-27 SB Starts @ Station 519+07, View showing the cracking pattern near the longitudinal joint.

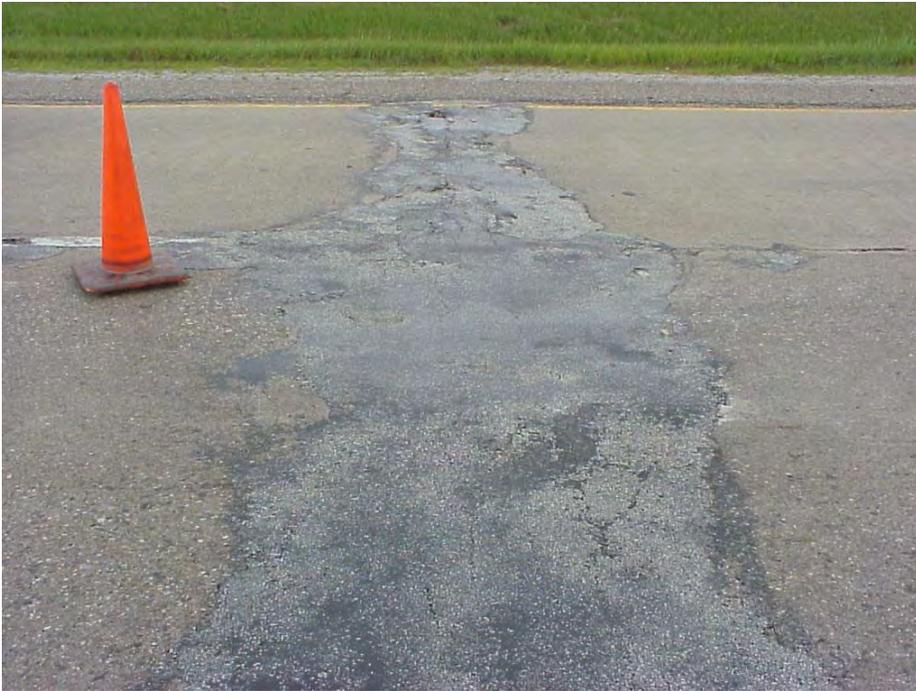
Site 28: US-27 SB Starts @ Station 519+07, View showing the asphalt patching done on transverse joint.

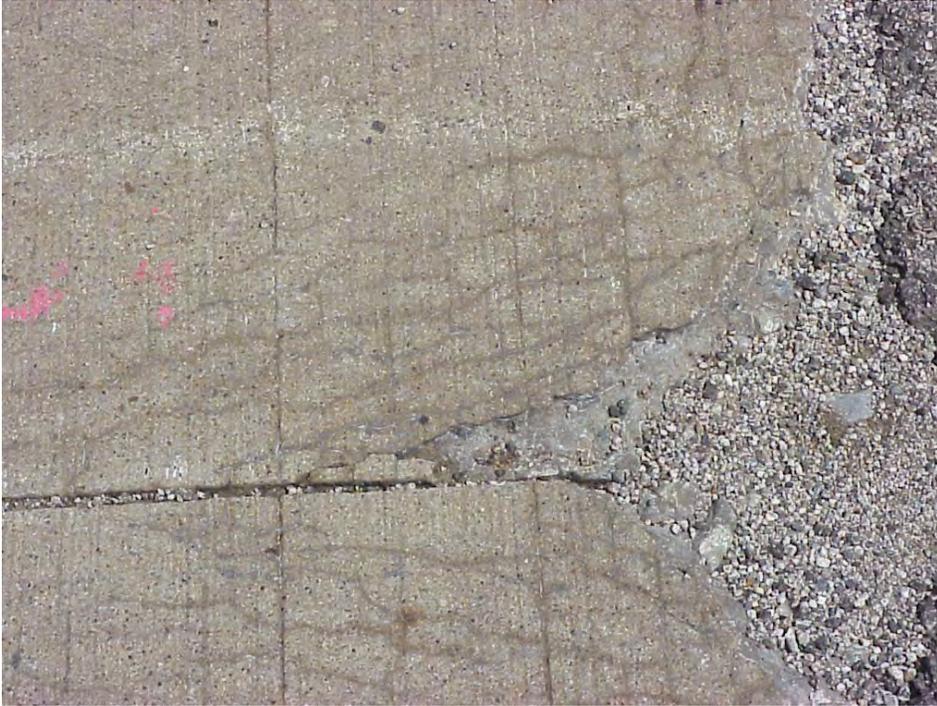
Site 29: I-275 SB, View showing the cracking pattern pavement with white staining coming out of the cracks. Also showing poorly done asphalt patching.

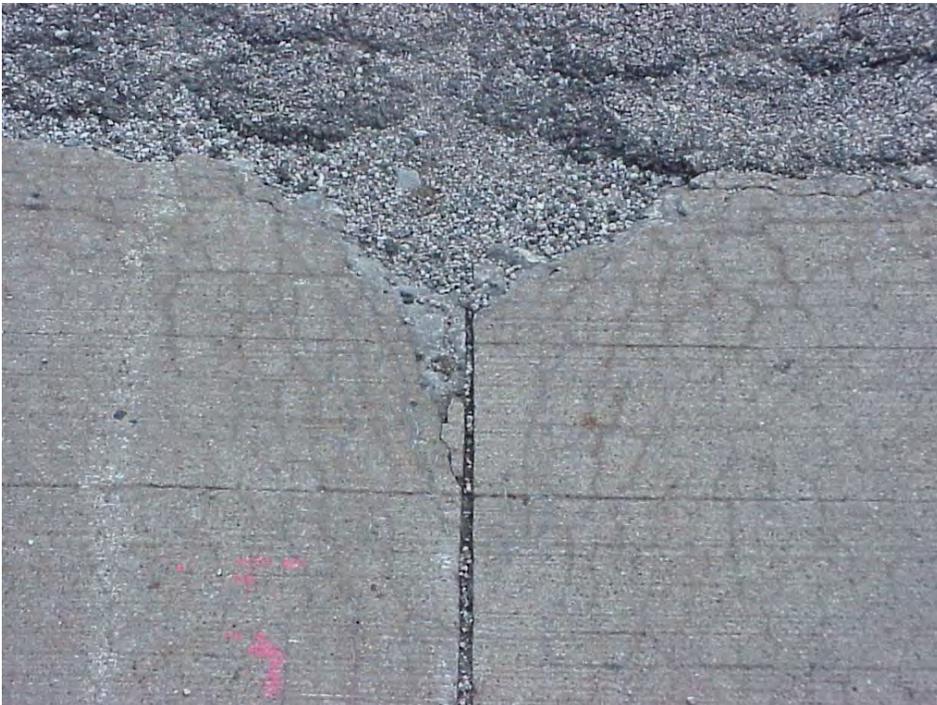
Site 29: I-275 SB, View showing the cracking pattern and asphalt patching at the transverse joint.

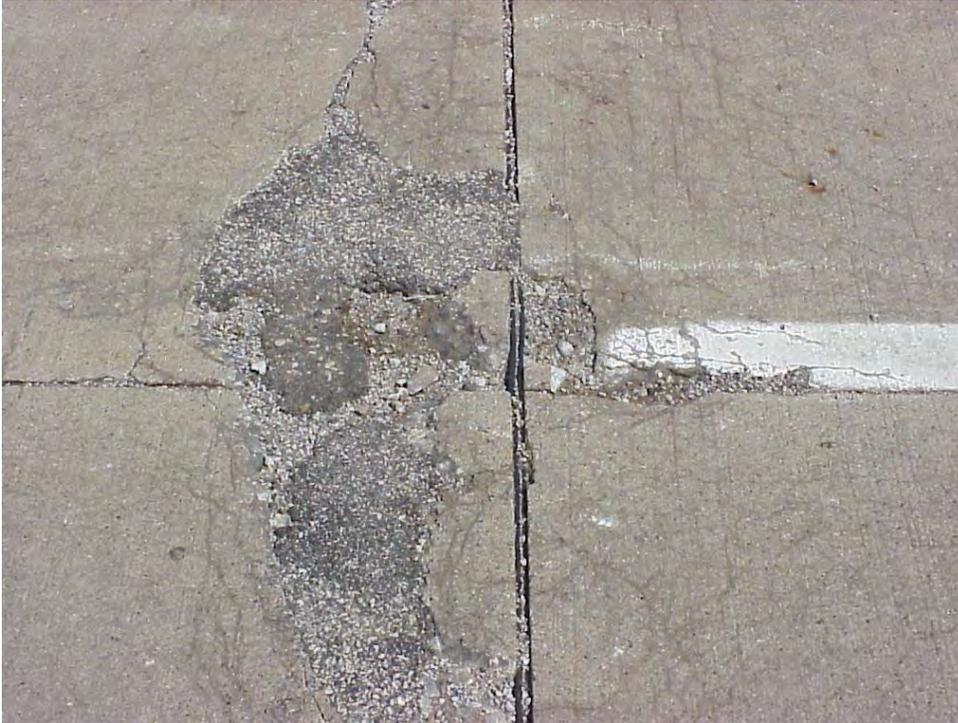
Site 29: I-275 SB, View showing asphalt patching along the transverse joint and also the cracking pattern.

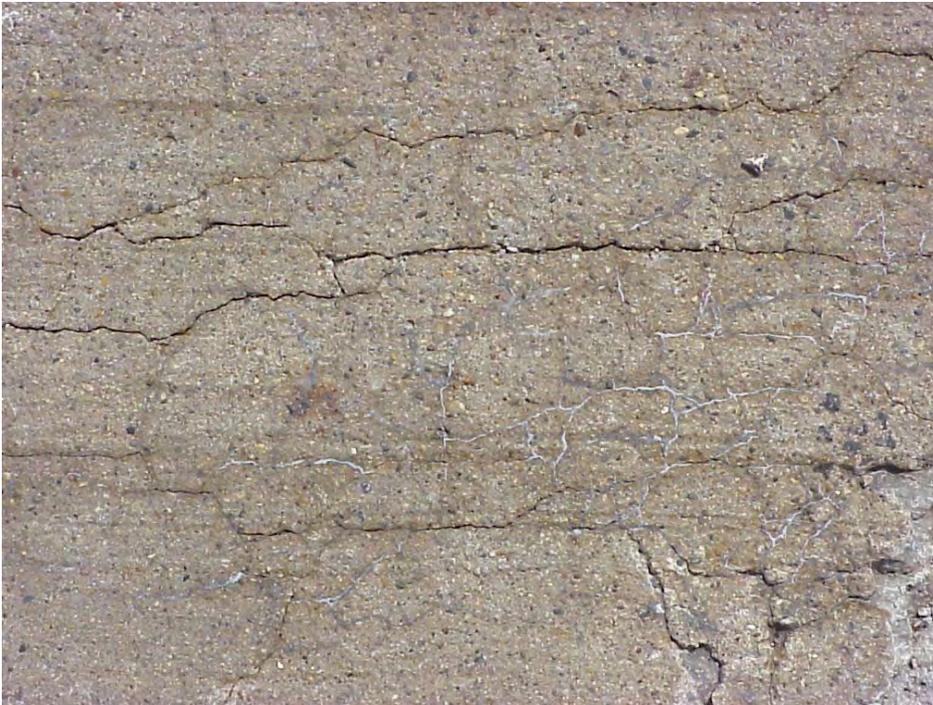
Site 29: I-275 SB, View showing cracking pattern with white exudate coming out of the cracks.

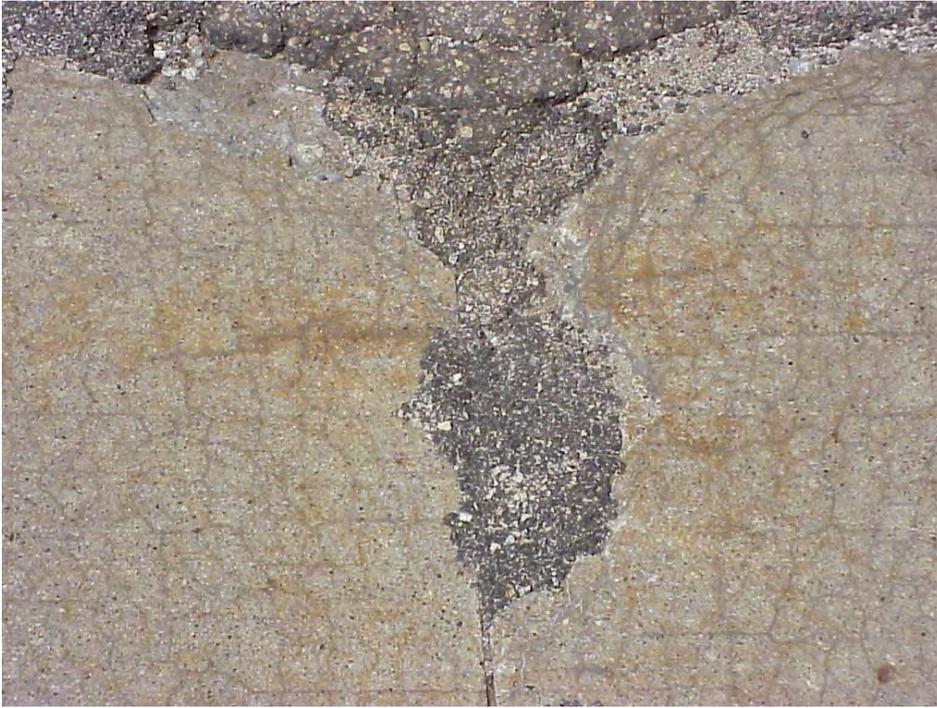
Site 29: I-275 SB, View showing the cracking pattern near the asphalt patching.

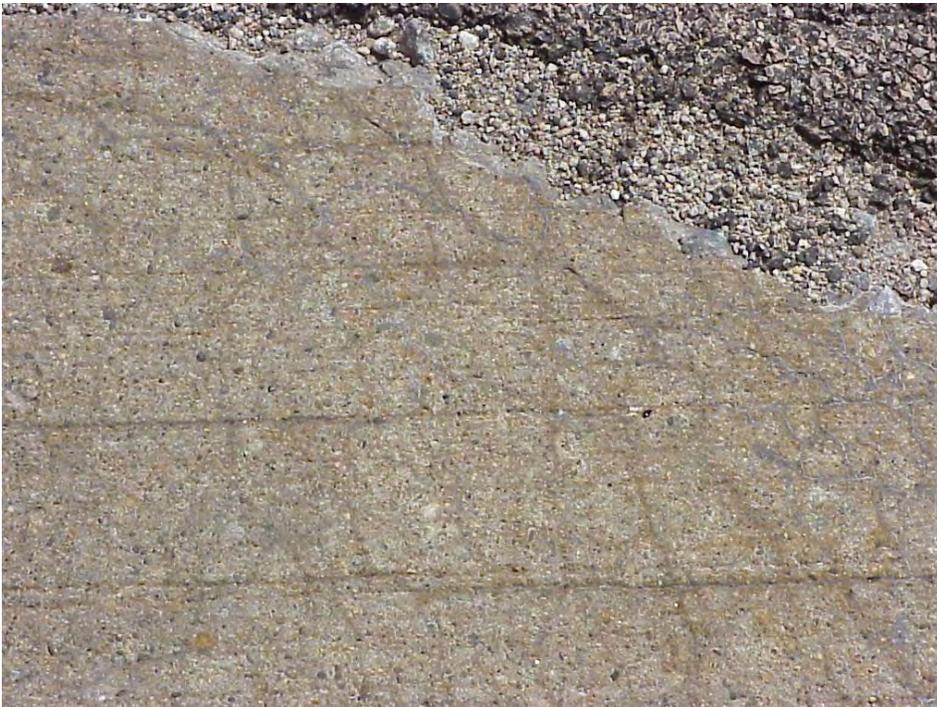
Site 29: I-275 SB, View showing the cracking pattern with white exudate coming out of the cracks (right side of the picture).
