APPENDIX B: TEST SITE INSPECTION DATA

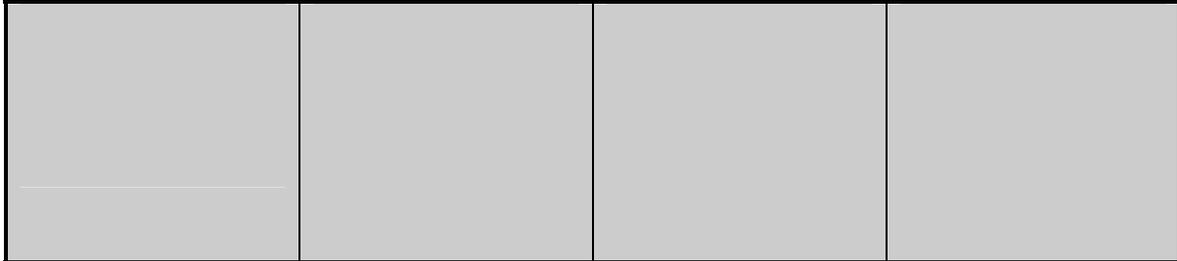
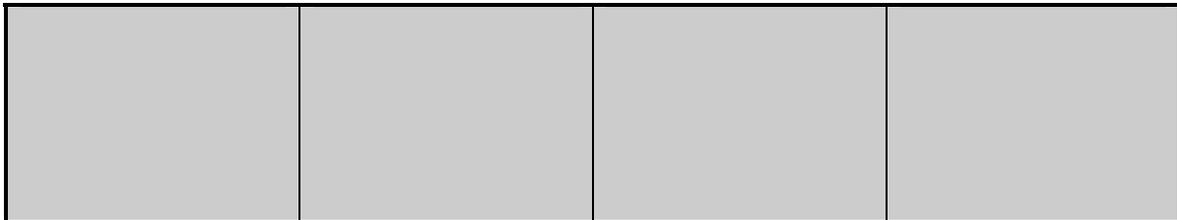
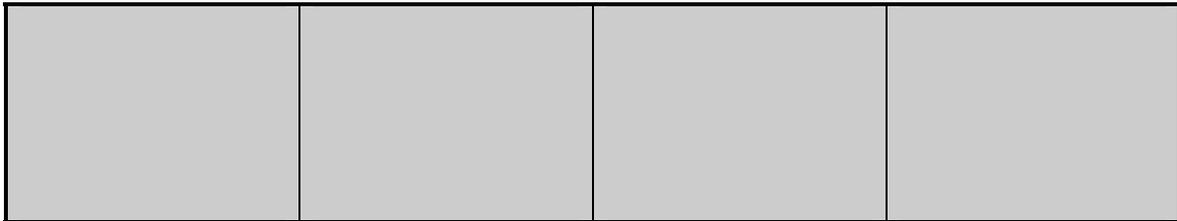
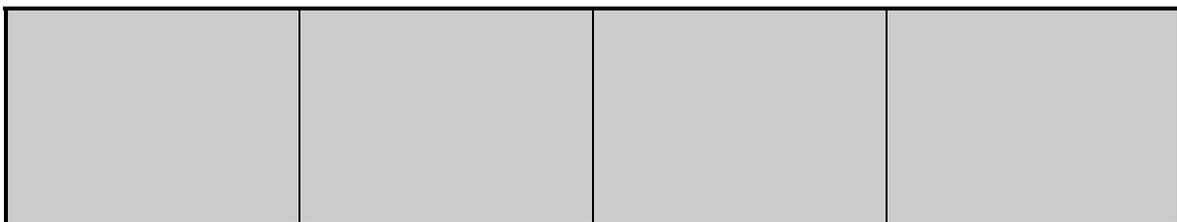
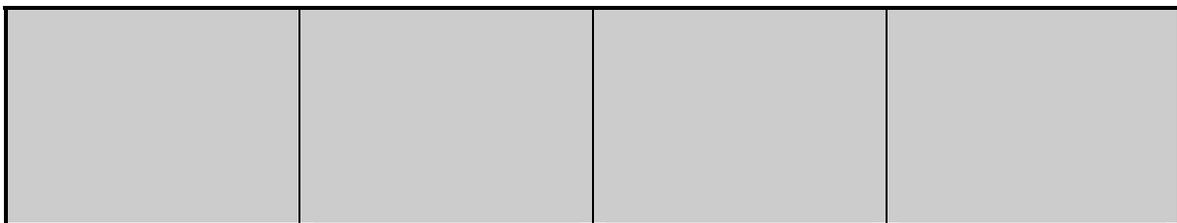
COMMENTS: Shrinkage cracking every 6-8"; shoulder is different concrete type than mainline pavement (different color)

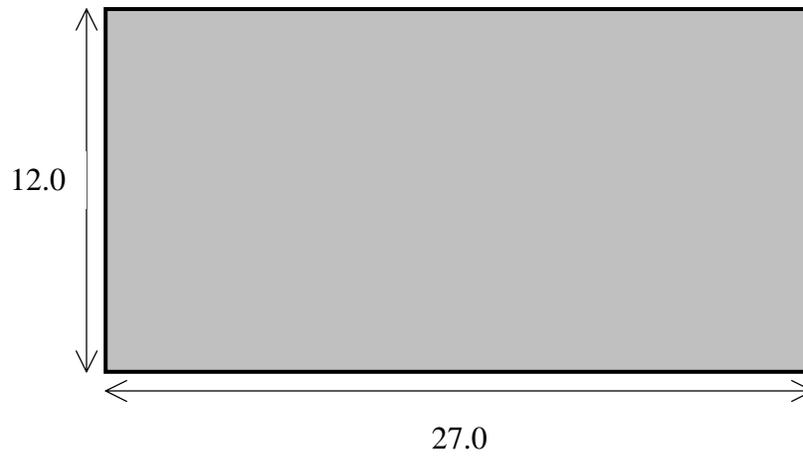
TYPICAL MRD SLAB: Slab 1

COMMENTS: Shrinkage cracking typically 6-8" apart and very tight, predominantly transverse; No Popouts.

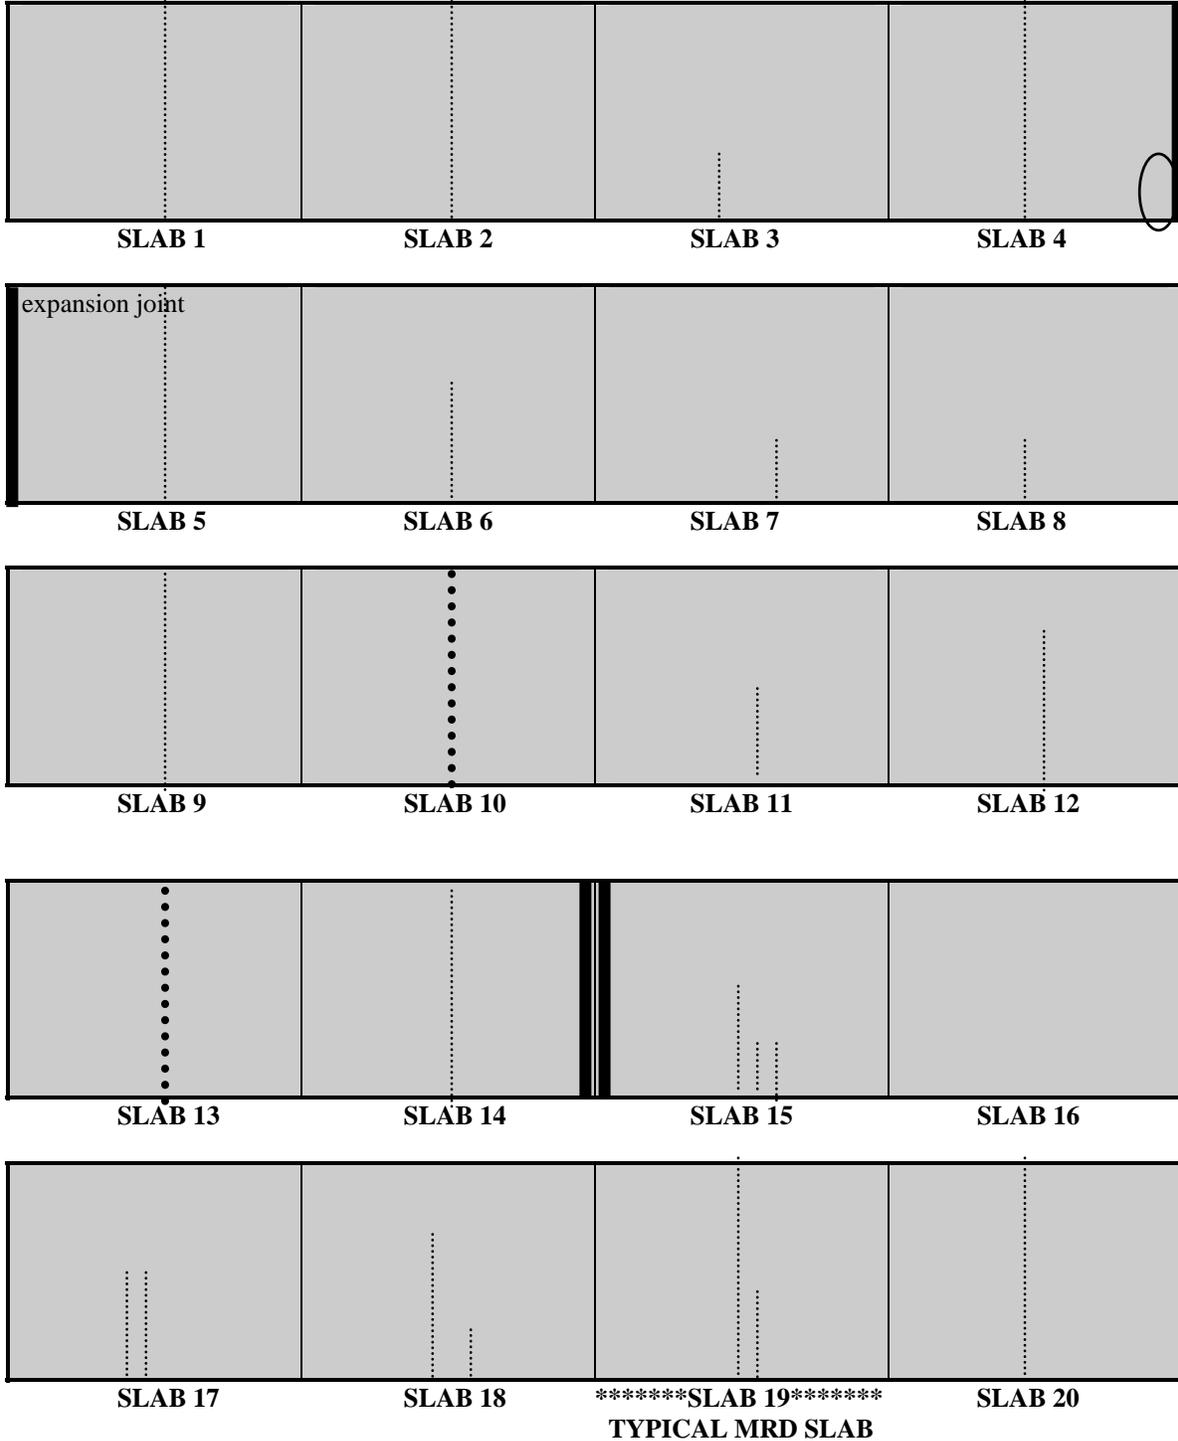
COMMENTS: Small hole in Slab 7, Construction repairs (exopy) on Slab 15; Slag Coarse Aggregate

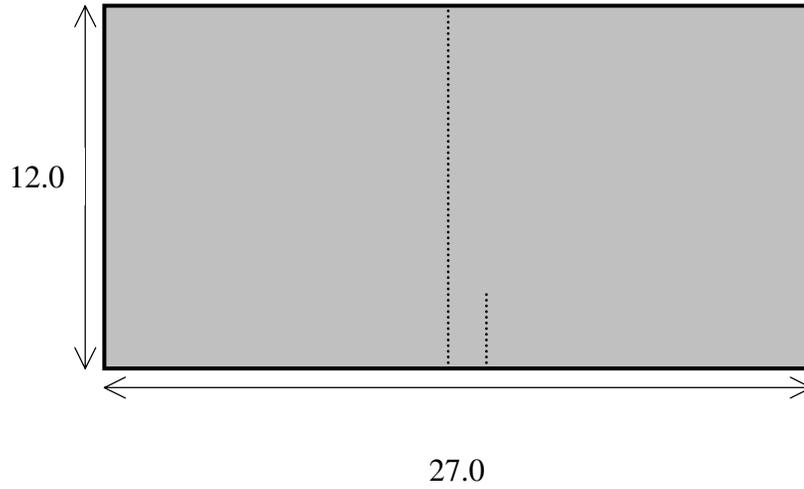
TYPICAL MRD SLAB: Slab 19

COMMENTS: A slight amount of staining on Crack 2

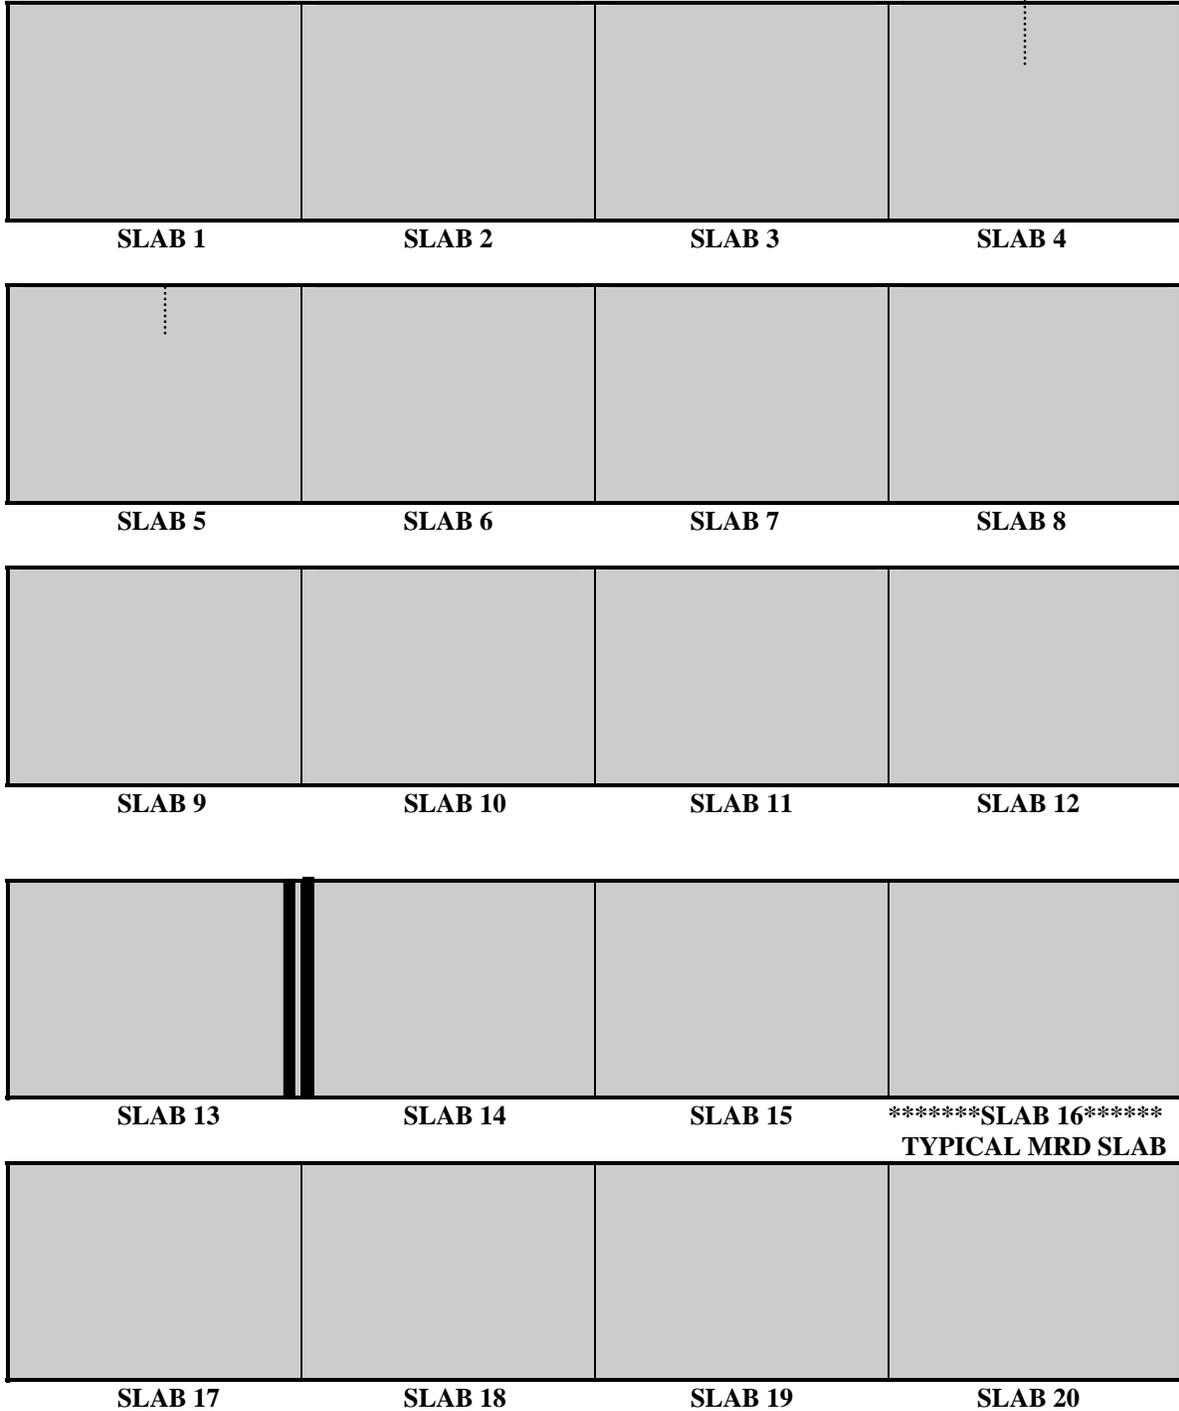
COMMENTS: Stain on Crack 1 of Slab 5, Poor construction grooving on entire site, Coring hole on Slab 10, Construction repairs (exopy) on Slabs 13 and 14; Natural Gravel Coarse Aggregate

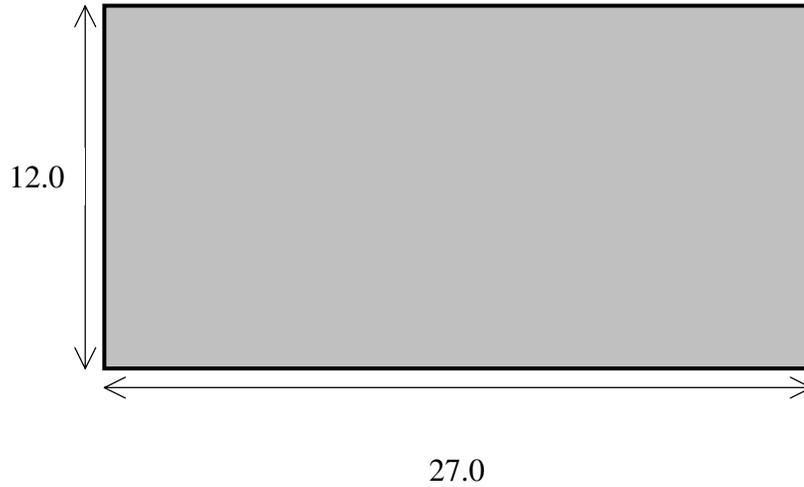
TYPICAL MRD SLAB: Slab 16

COMMENTS: Surface texture irregularities; popouts: 2-3 per m²

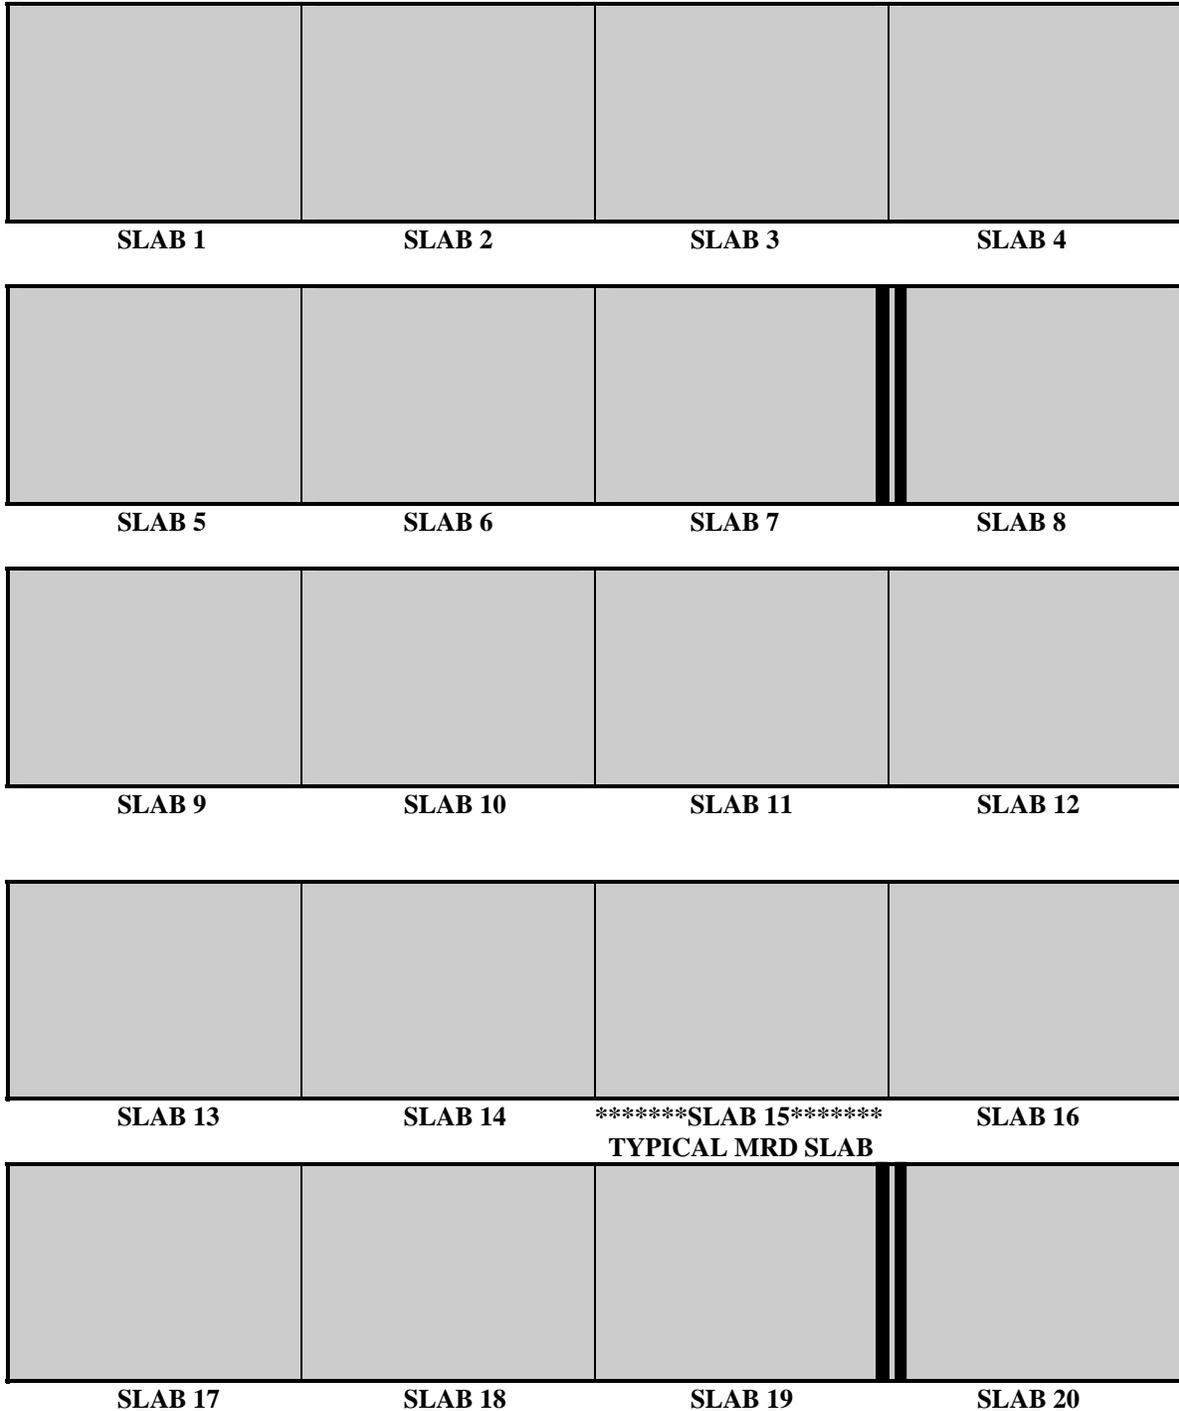
COMMENTS: Joint sealant drop between Slabs 14 and 15, Poor construction grooving on entire site, Coring hole on Slab 9, Possible dowel misalignment cracks on Slabs 2 and 3; Crushed Limestone Coarse Aggregate

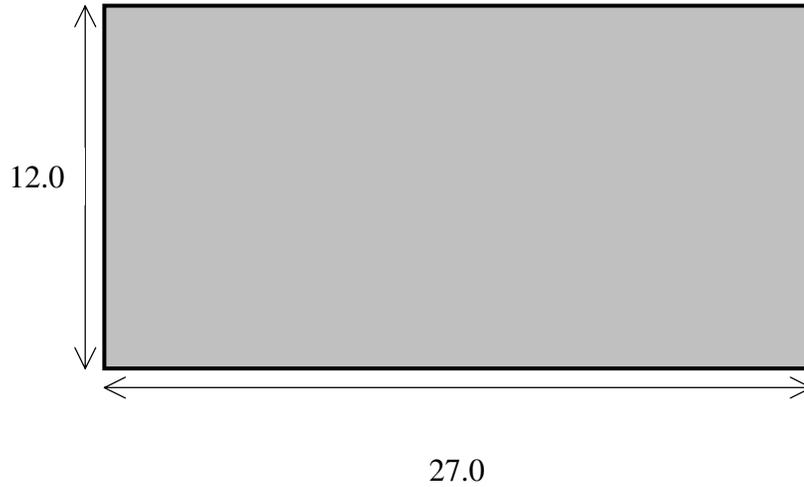
TYPICAL MRD SLAB: Slab 15

COMMENTS: Shrinkage cracking typically 6-8" apart and very tight, predominantly transverse;
Popouts: ~ 1 per m²

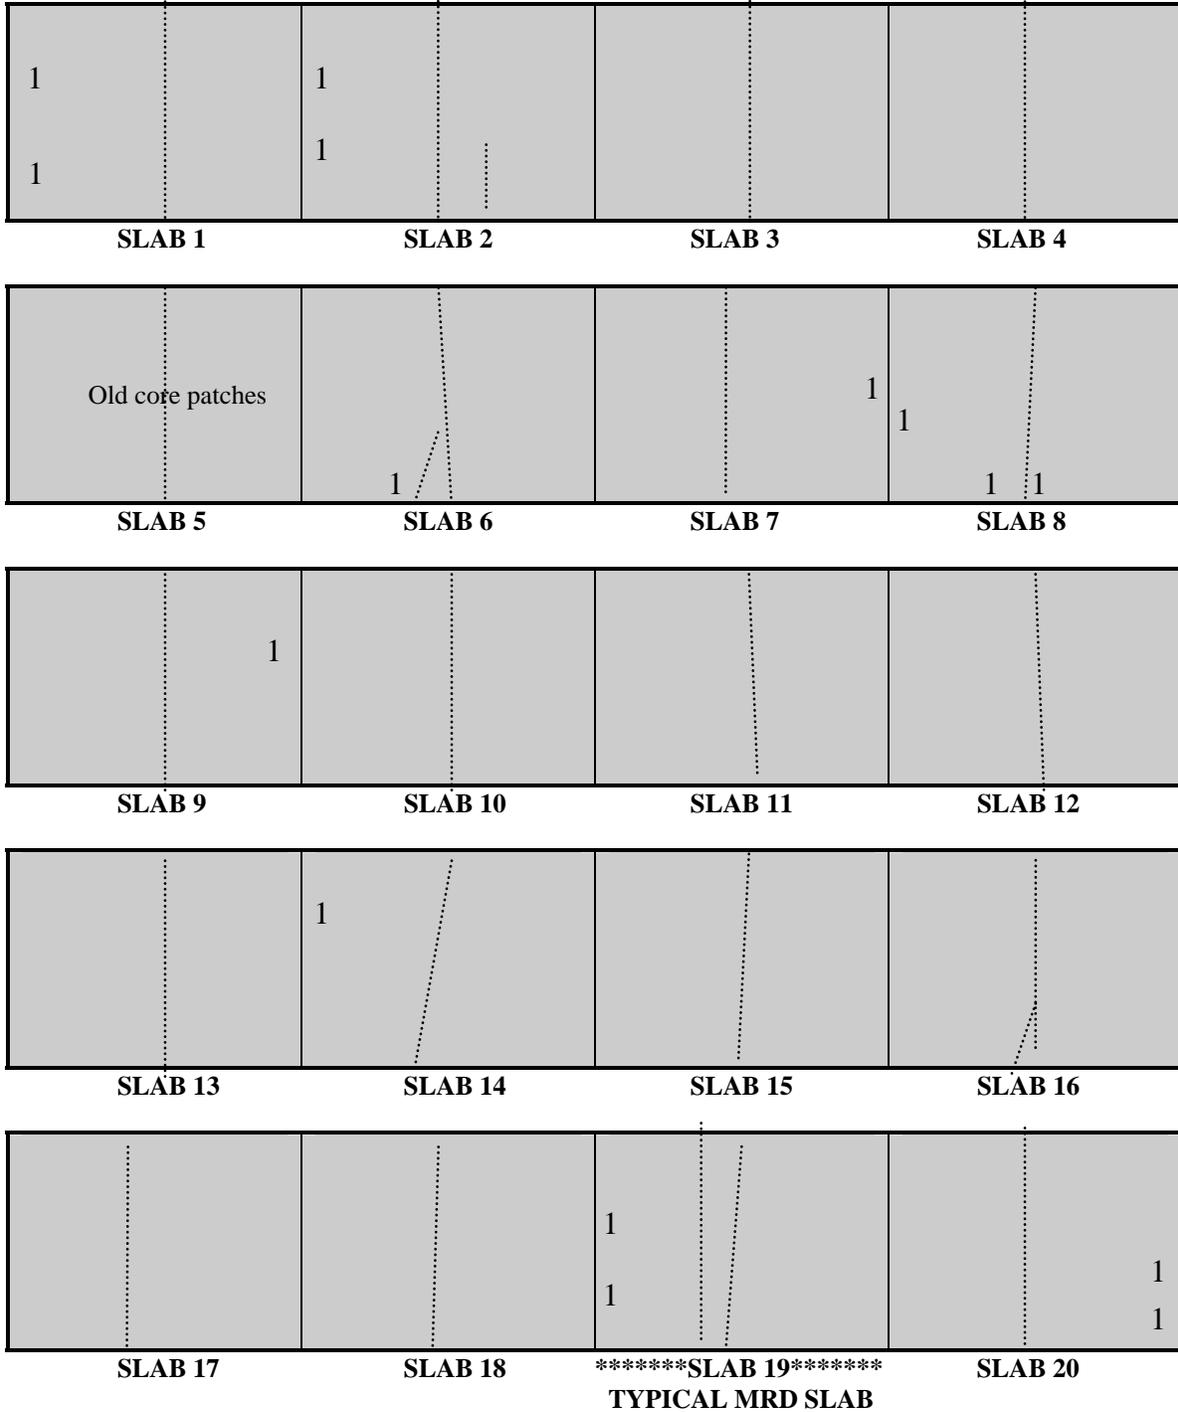
COMMENTS: ASR-like cracking in shoulder near joints; ASR-like cracking on entire mainline pavement; All joints sealants are deficient; Slag coarse aggregate

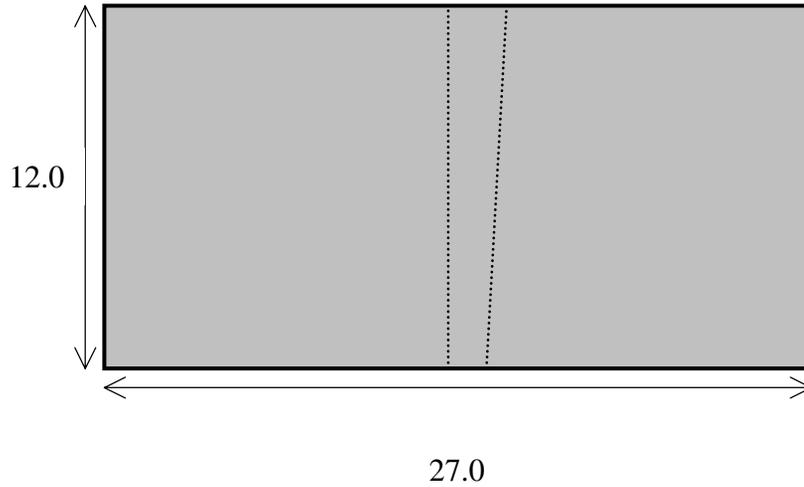
TYPICAL MRD SLAB: Slab 19

COMMENTS: Longitudinal cracking (~ 6" spacing) in slab due to connecting ASR-like cracks;
Severe ASR-like cracking throughout entire slab; Popouts: 0.5 per m²

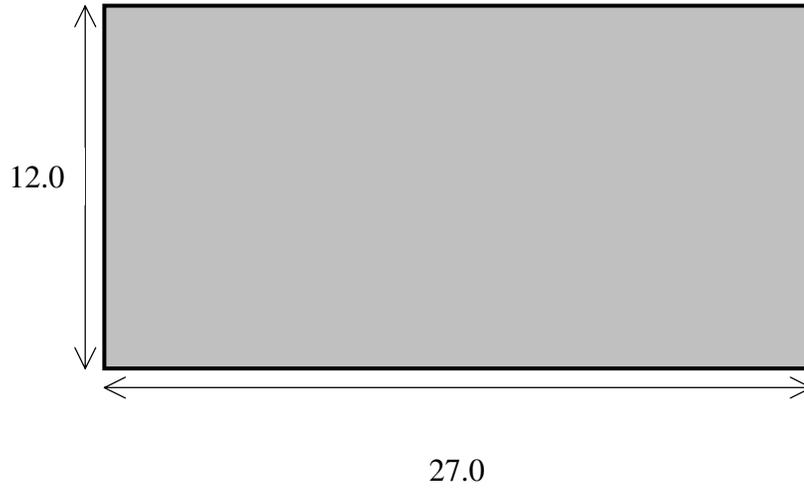
TYPICAL MRD SLAB: Slab 4

COMMENTS: Popouts: 3 per m²

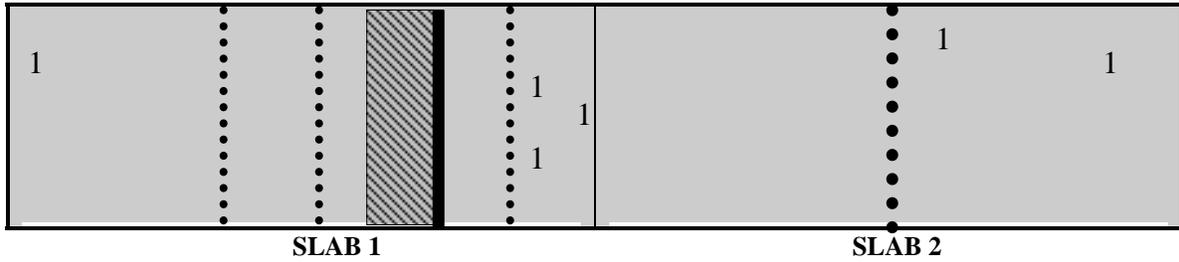
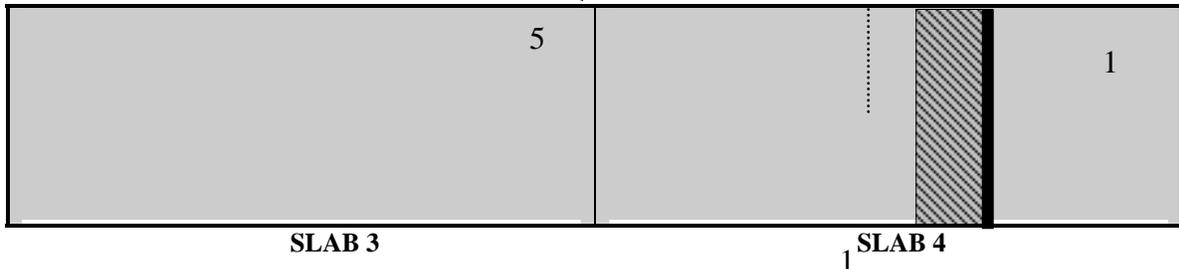
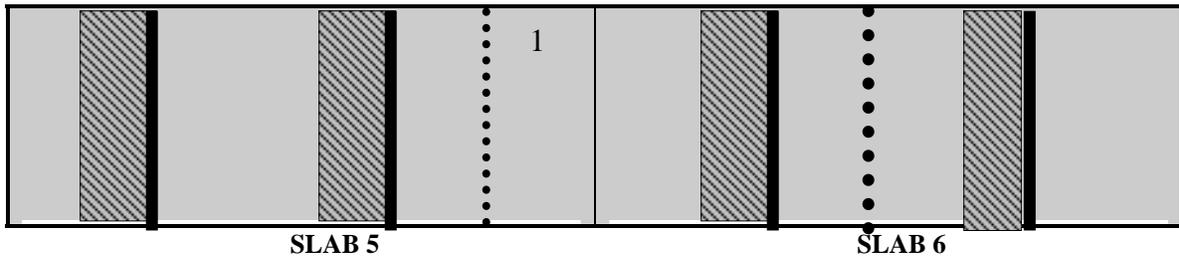
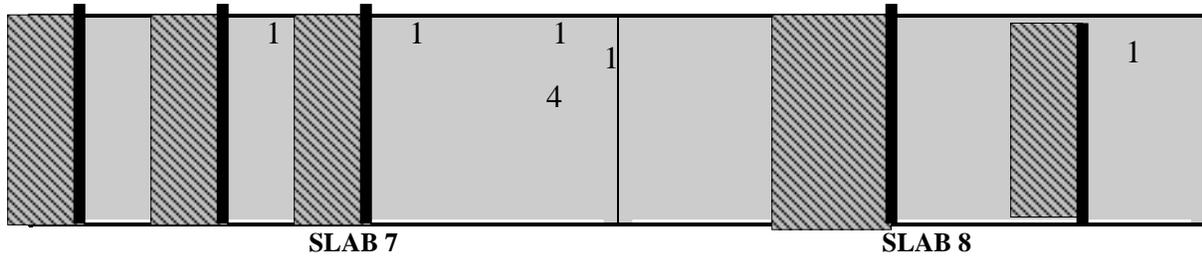
COMMENTS: Lane-shoulder dropoff; polished agg in wheelpath; popouts; lane-lane faulting; tar and chip repair throughout the entire site (especially near longitudinal joint); natural gravel pavement

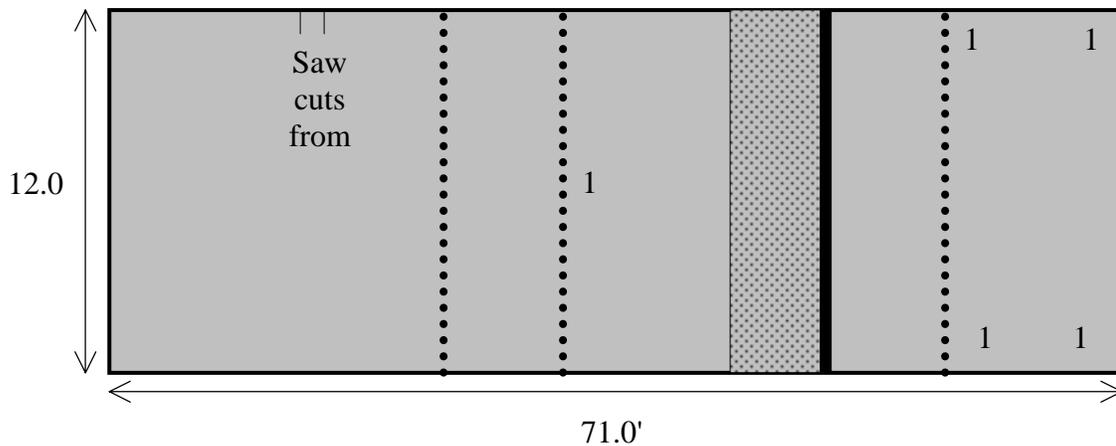
TYPICAL MRD SLAB: Slab 1

COMMENTS: General comments apply; Chip and seal repairs extensive along longitudinal joint; Polished agg (severe) in wheelpath; Popouts: ~ 2.5 per m²

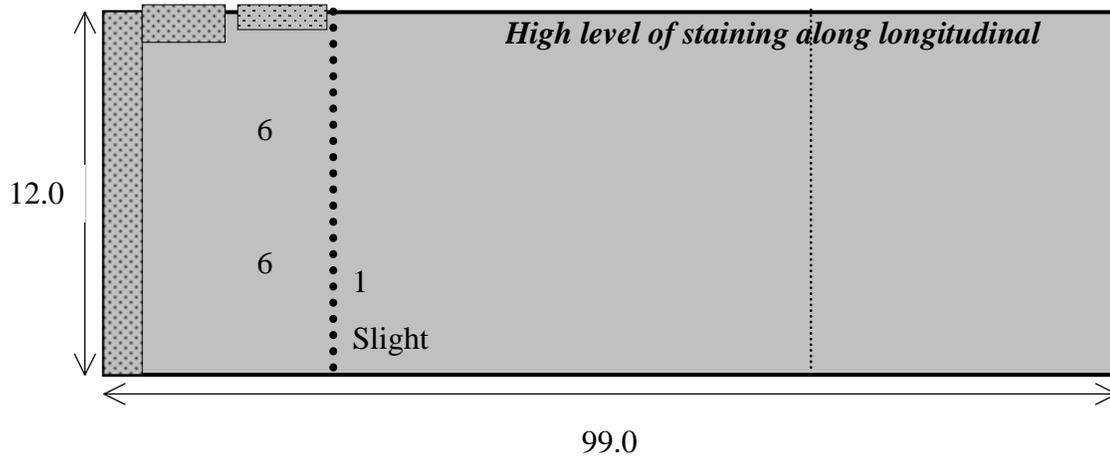
TYPICAL MRD SLAB: Slab 5

COMMENTS: Shrinkage-like cracking which is very tough to see, predominantly transverse; Polished agg (severe) in wheelpath; Popouts: ~ 2-3 per m²

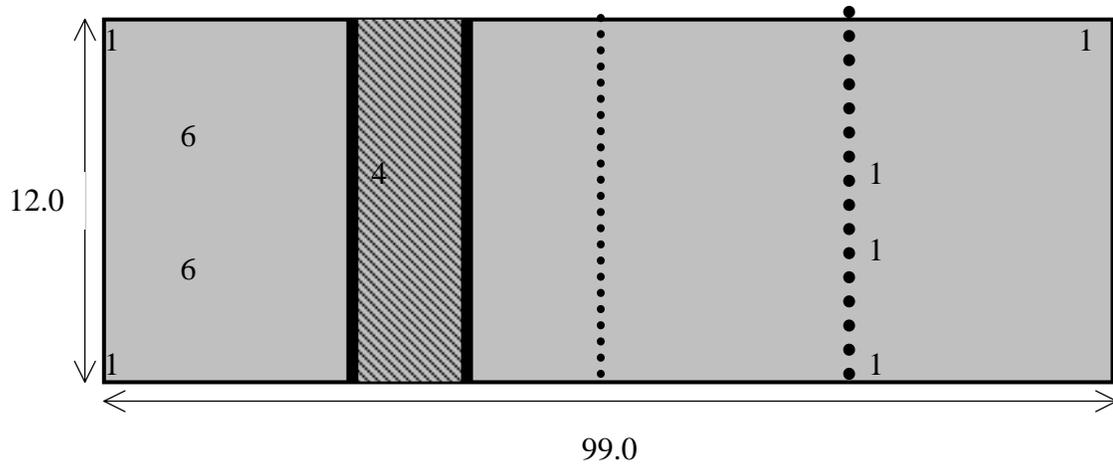
TYPICAL MRD SLAB: Slab 2

COMMENTS: Shrinkage-like cracking which is very tough to see, predominantly transverse; Popouts: ~ 3 per m²

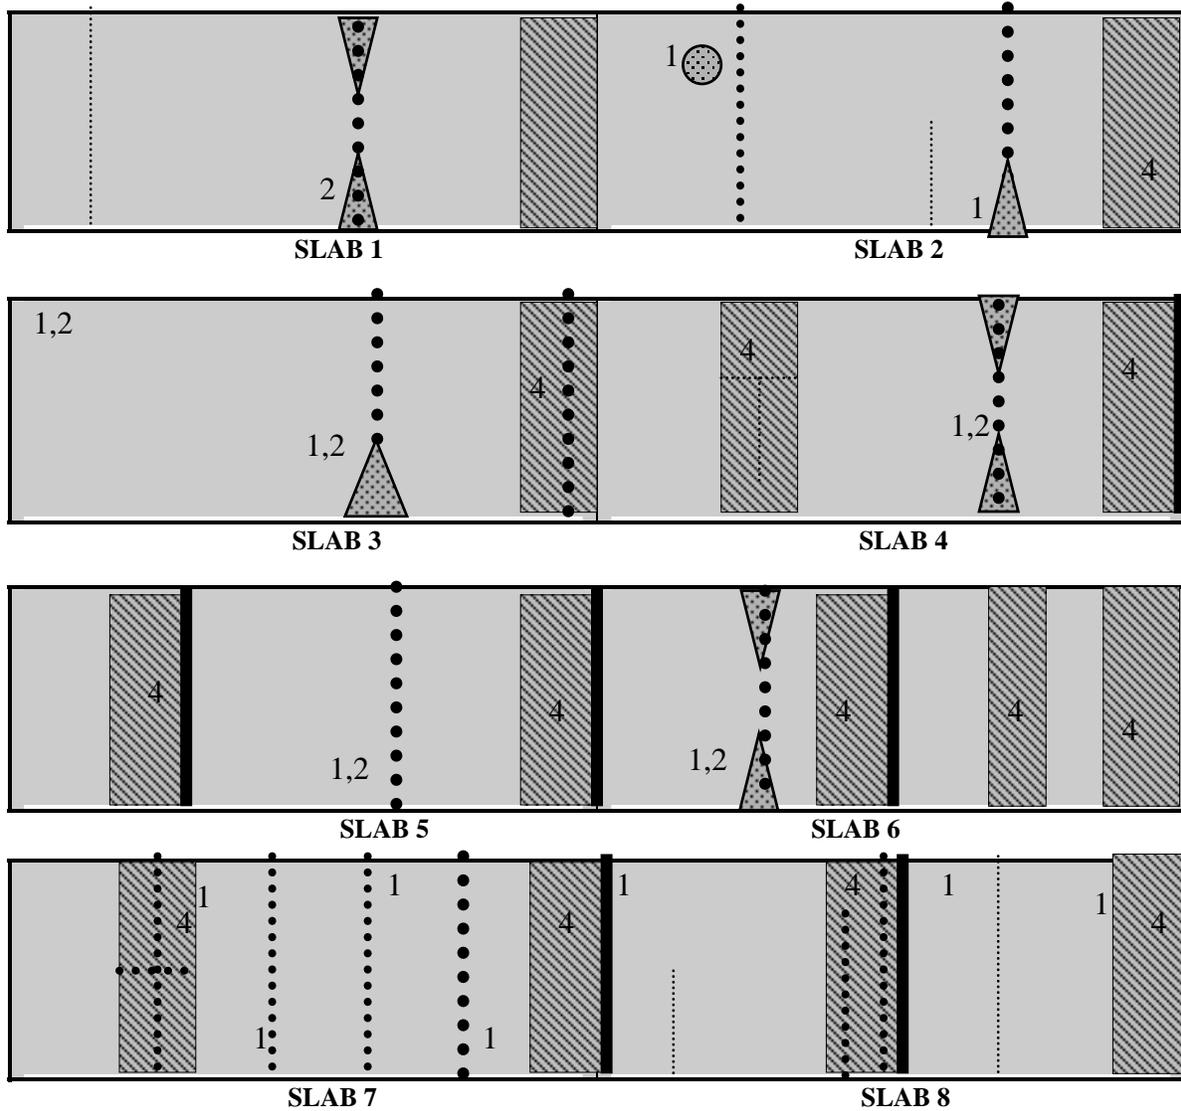
COMMENTS: All joints have been repaired by a full-depth patch, making joint spacing difficult to determine; ASR in most concrete patches; D-cracking on many severe cracks; Many popouts, high steel, and polished aggregate in the wheelpaths

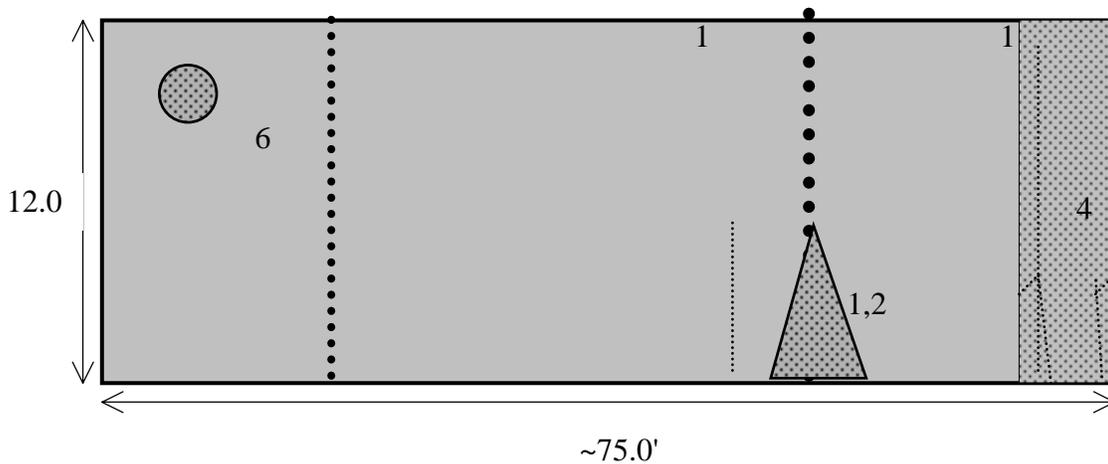
TYPICAL MRD SLAB: Slab 2

COMMENTS: ASR in patch; D-cracking near major crack; Polished agg (severe) in wheelpath; Popouts: ~ 3 per m²

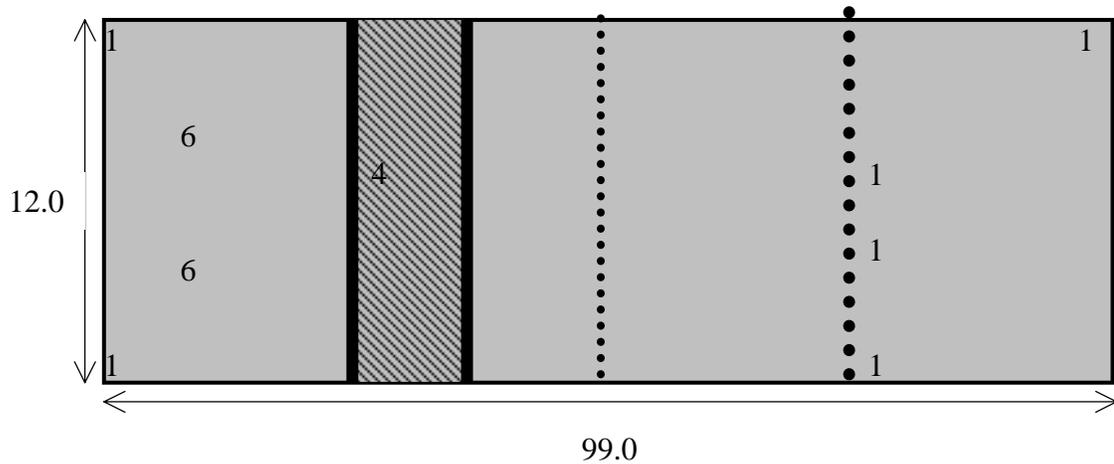
TYPICAL MRD SLAB: Slab 2

COMMENTS: Shrinkage-like cracking, which is very tough to see, predominantly transverse;
Popouts: ~ 3 per m²

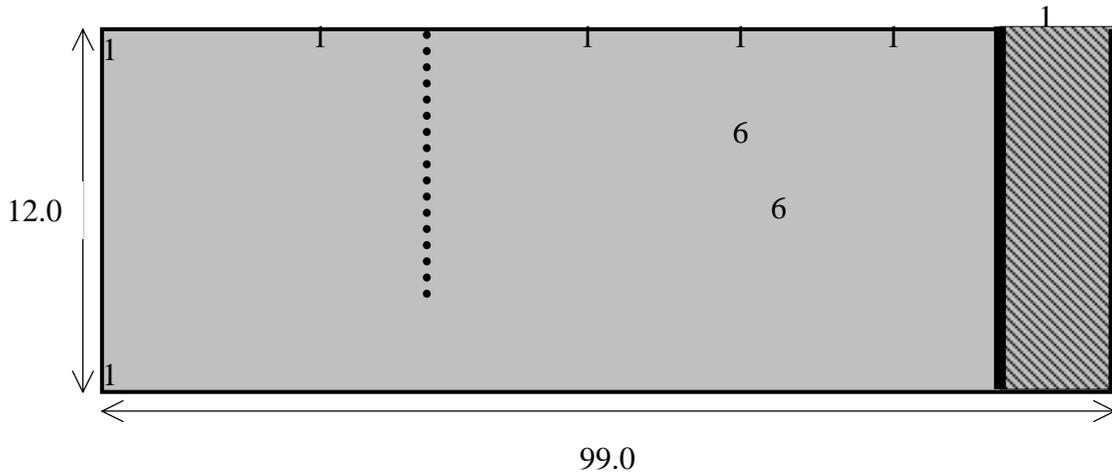
TYPICAL MRD SLAB: Slab 6

COMMENTS: Shrinkage-like cracking throughout slab; Popouts: ~ 1.5 per m² - could be due to diamond grinding; joint before patch is completely missing sealant.

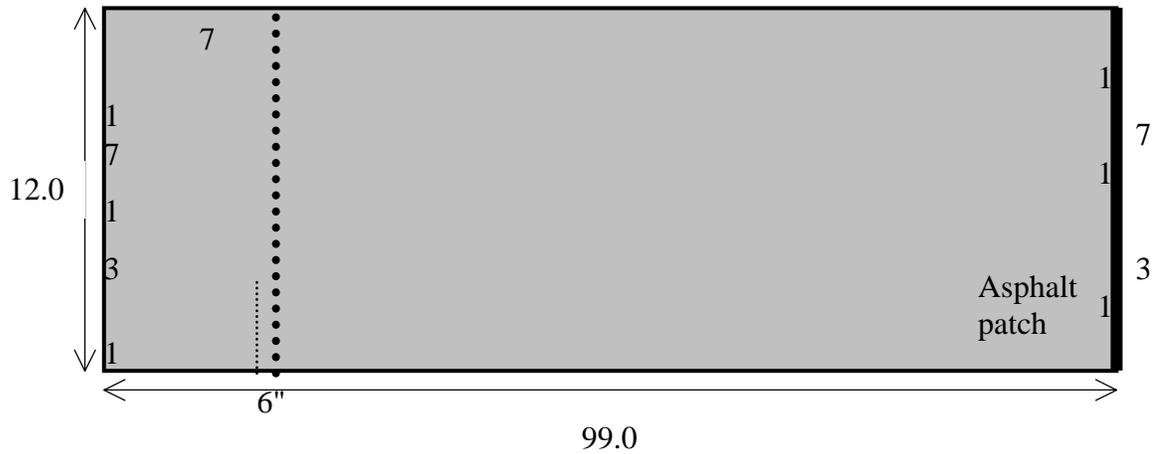
TYPICAL MRD SLAB: Slab 4

COMMENTS: Shrinkage-like cracking throughout slab; Popouts: ~ 0.5 per m²; Polished agg in wheelpath

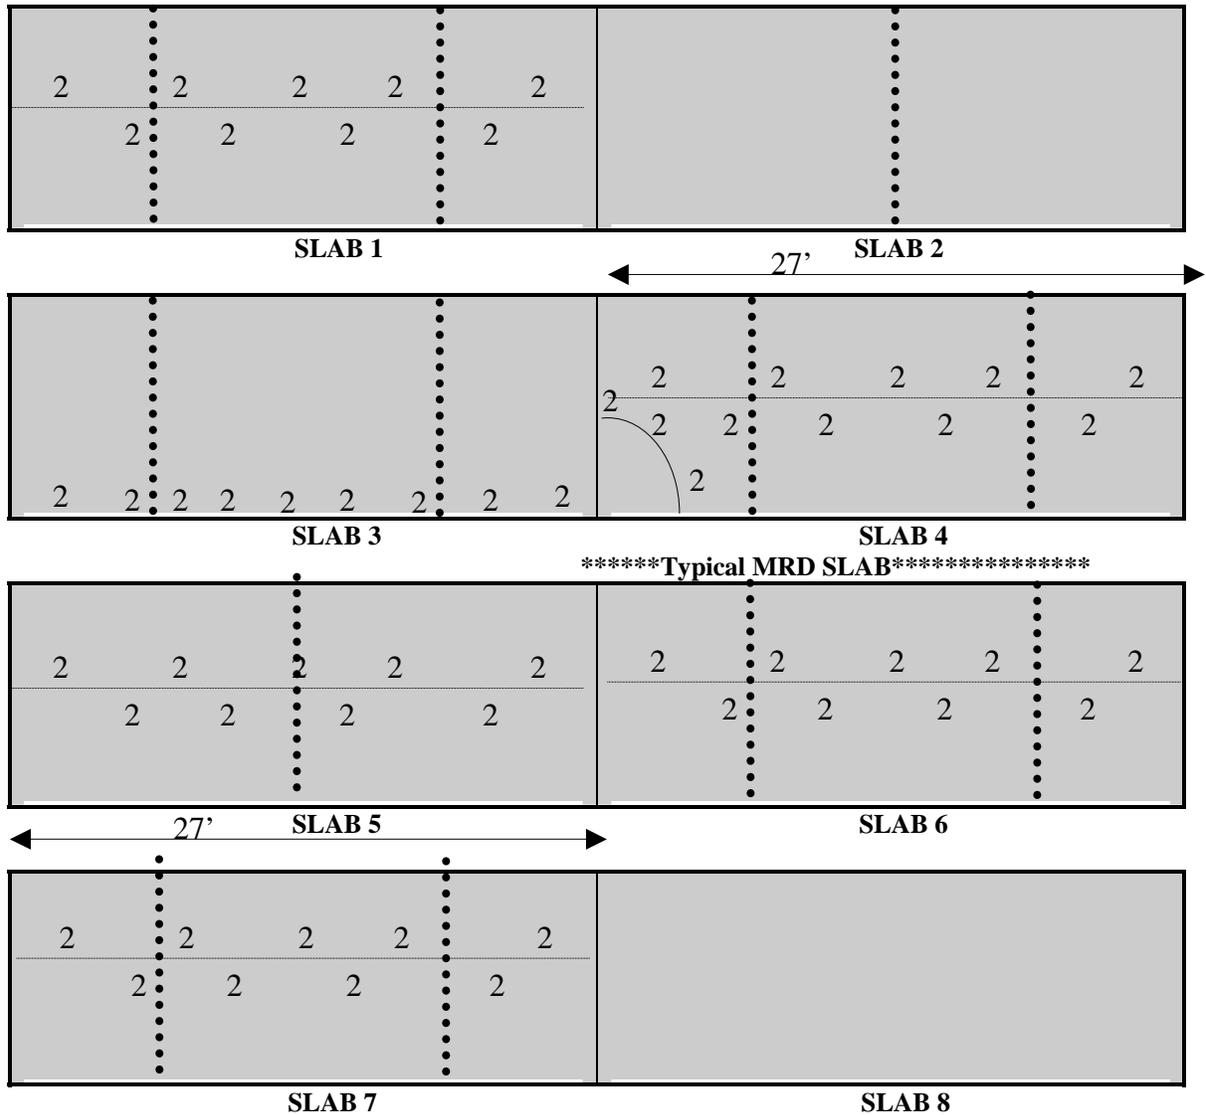
COMMENTS: Third point cracking in every slab; ASR kind of cracking is visible along the longitudinal crack and by the edge of the pavement.

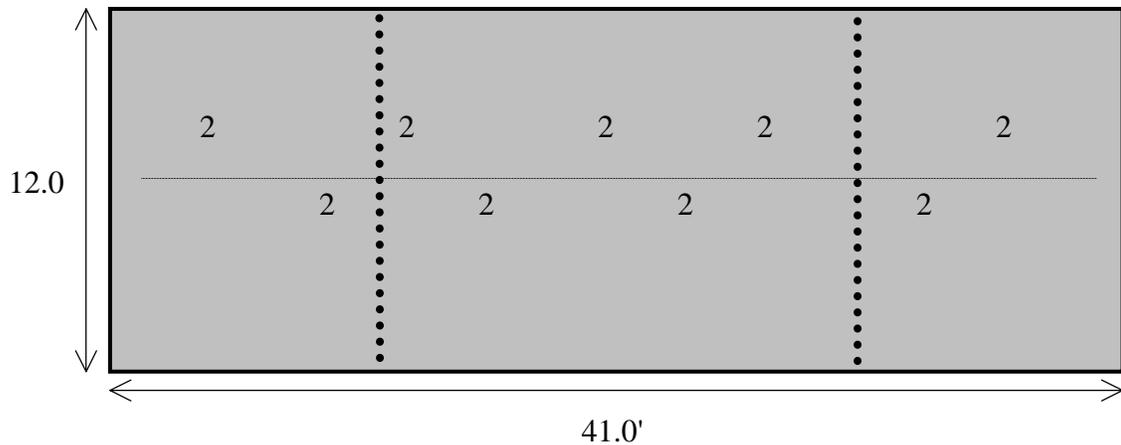
TYPICAL MRD SLAB: Slab 4

COMMENTS: General comments apply. Longitudinal crack at the middle of the slab and D-cracking is observed along the longitudinal crack.

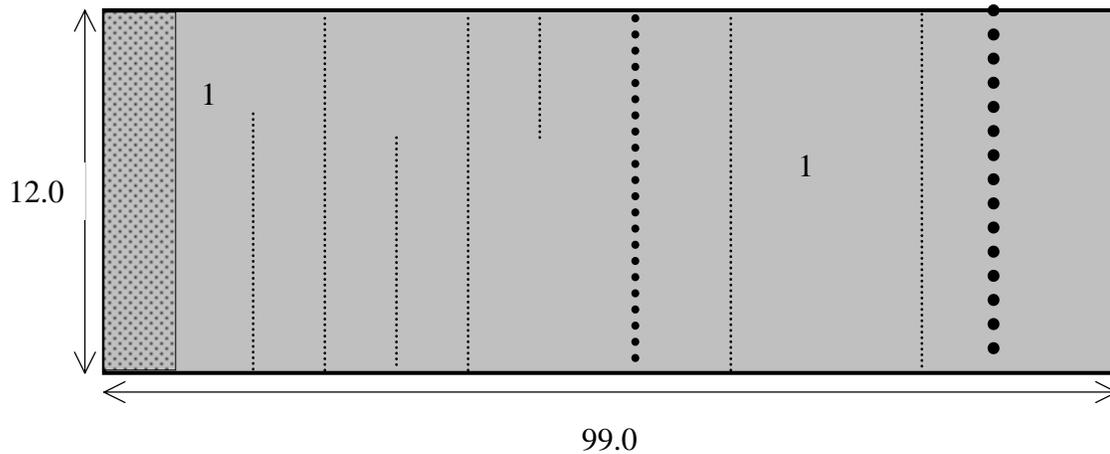
TYPICAL MRD SLAB: Slab 1

COMMENTS: Shrinkage-like cracking which is very tough to see, predominantly transverse; Polished agg (severe) in wheelpath; Popouts: ~ 1 per m²

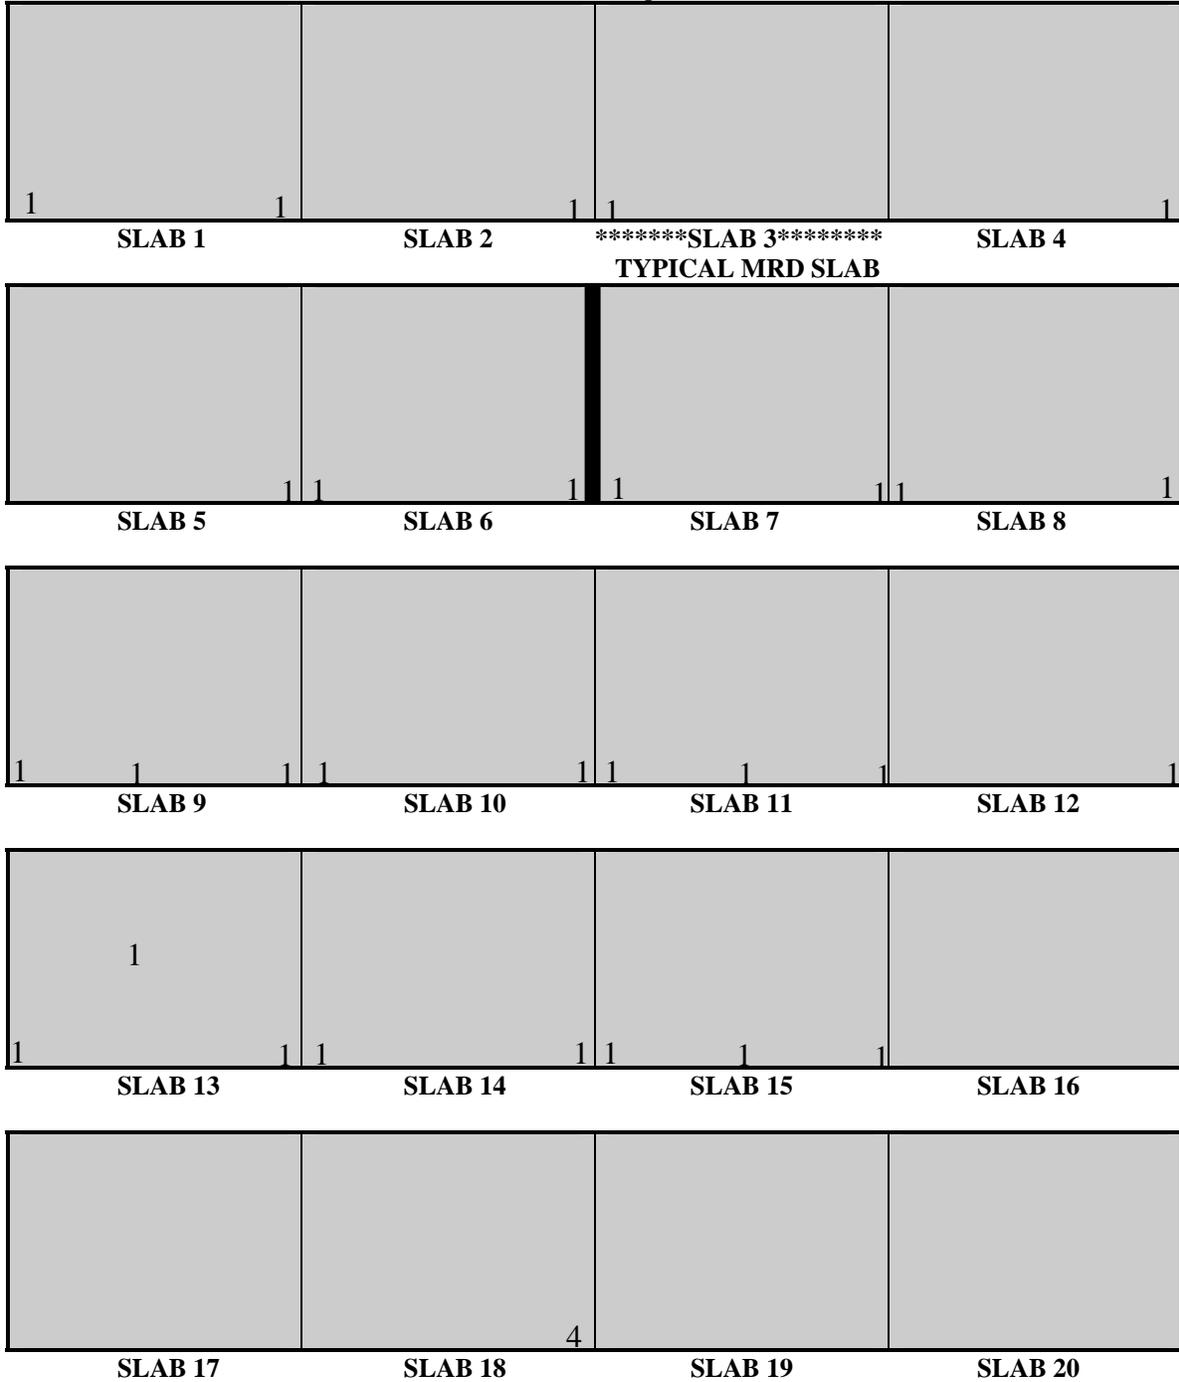
COMMENTS: Longitudinal joint completely spalled, Possible D-cracking at joints and cracks, Popouts: ~2 per m²

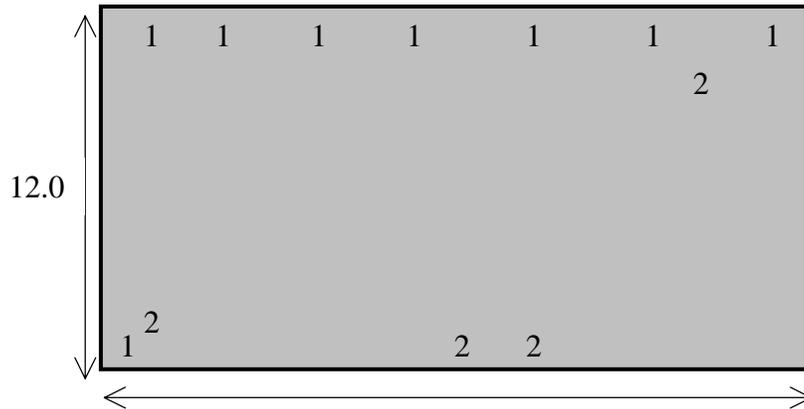
TYPICAL MRD SLAB: Slab 3

COMMENTS: Longitudinal joint completely spalled; Possible D-cracking at joints; Map cracking near joint and shoulder; Popouts: ~2 per m²
