APPENDIX B: TEST SITE INSPECTION DATA

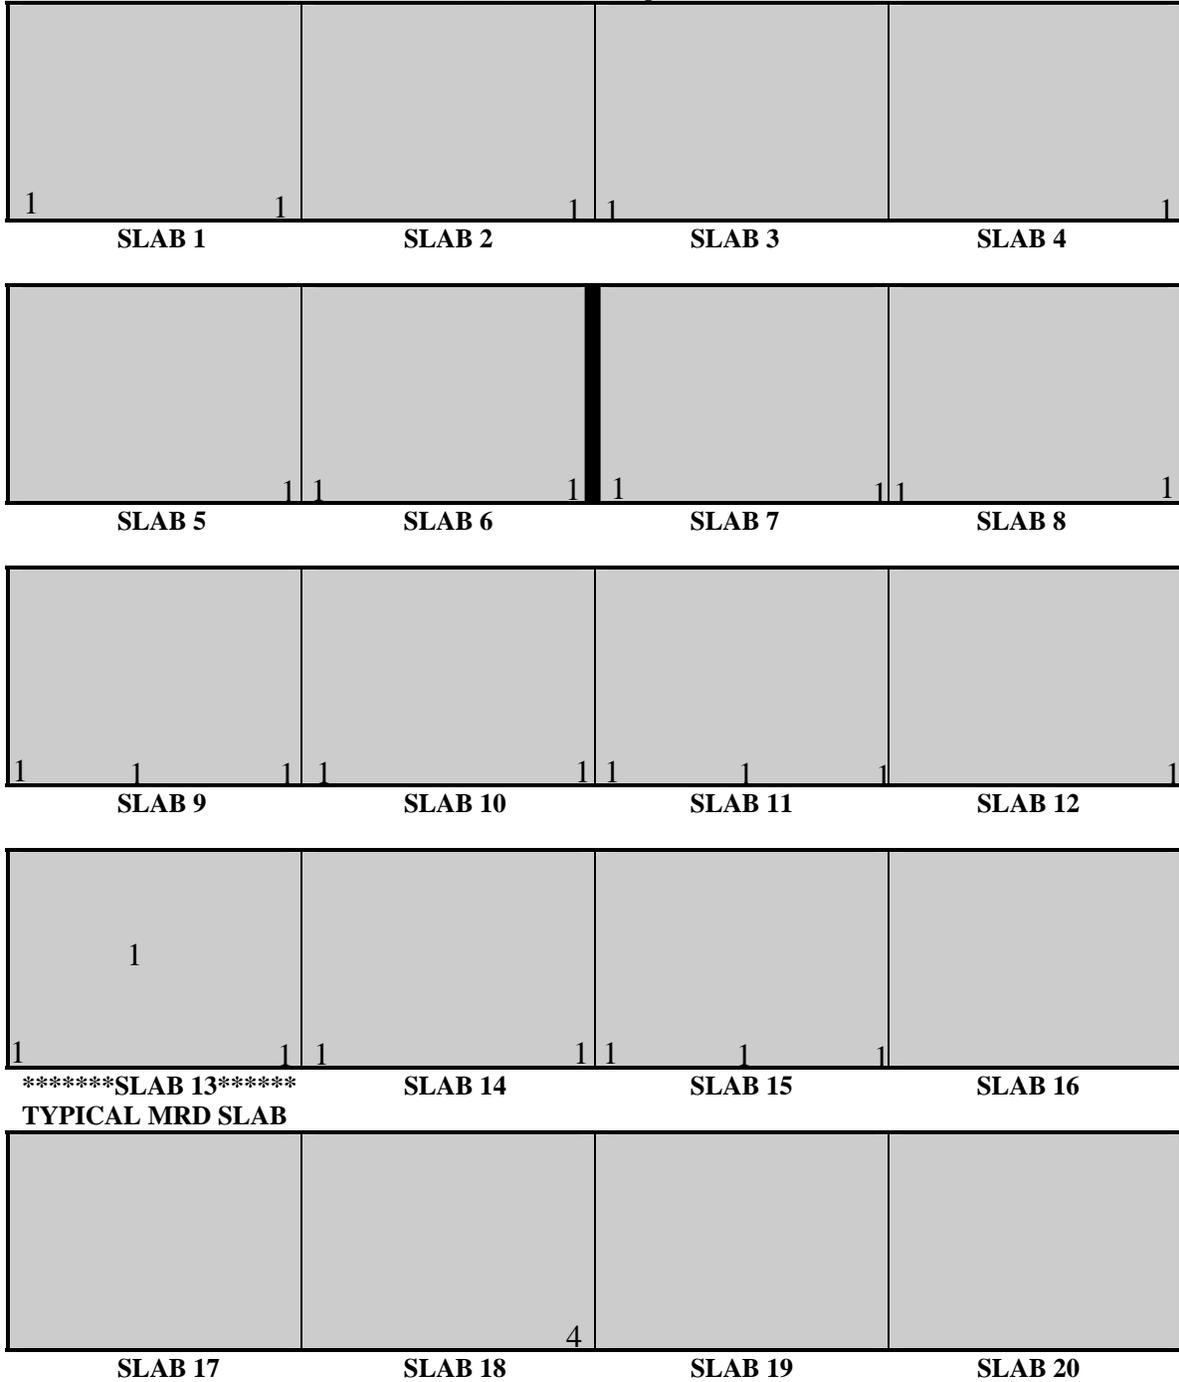
COMMENTS: Longitudinal joint completely spalled, Possible D-cracking at joints and cracks, Popouts: ~2 per m²

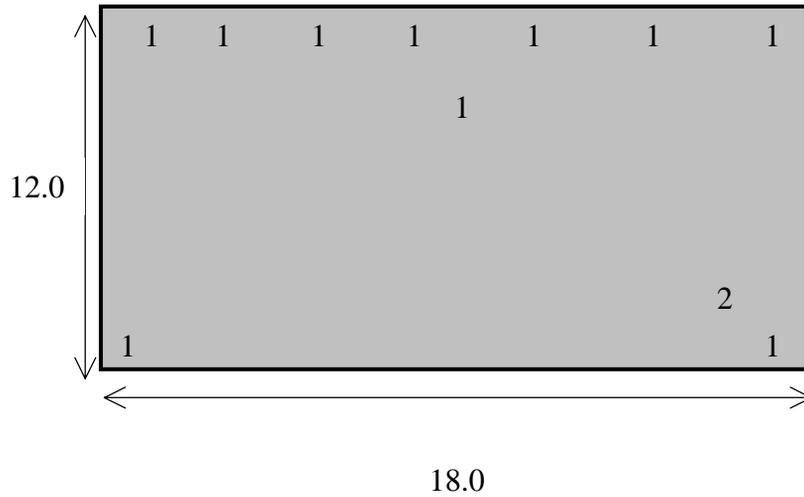
TYPICAL MRD SLAB: Slab 13

COMMENTS: Longitudinal joint completely spalled; Possible D-cracking at joints; Map cracking near joint and shoulder; Popouts: ~2 per m²

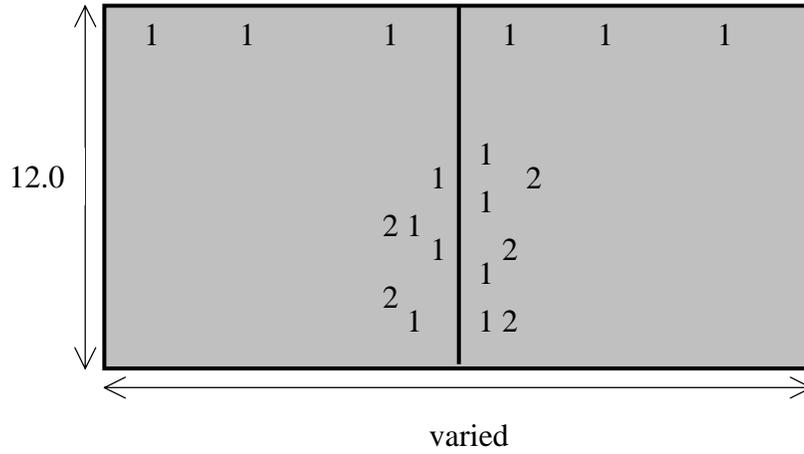
TYPICAL MRD SLAB: Slab 15/16

COMMENTS: Same as 26A and B although the spalling is more severe.

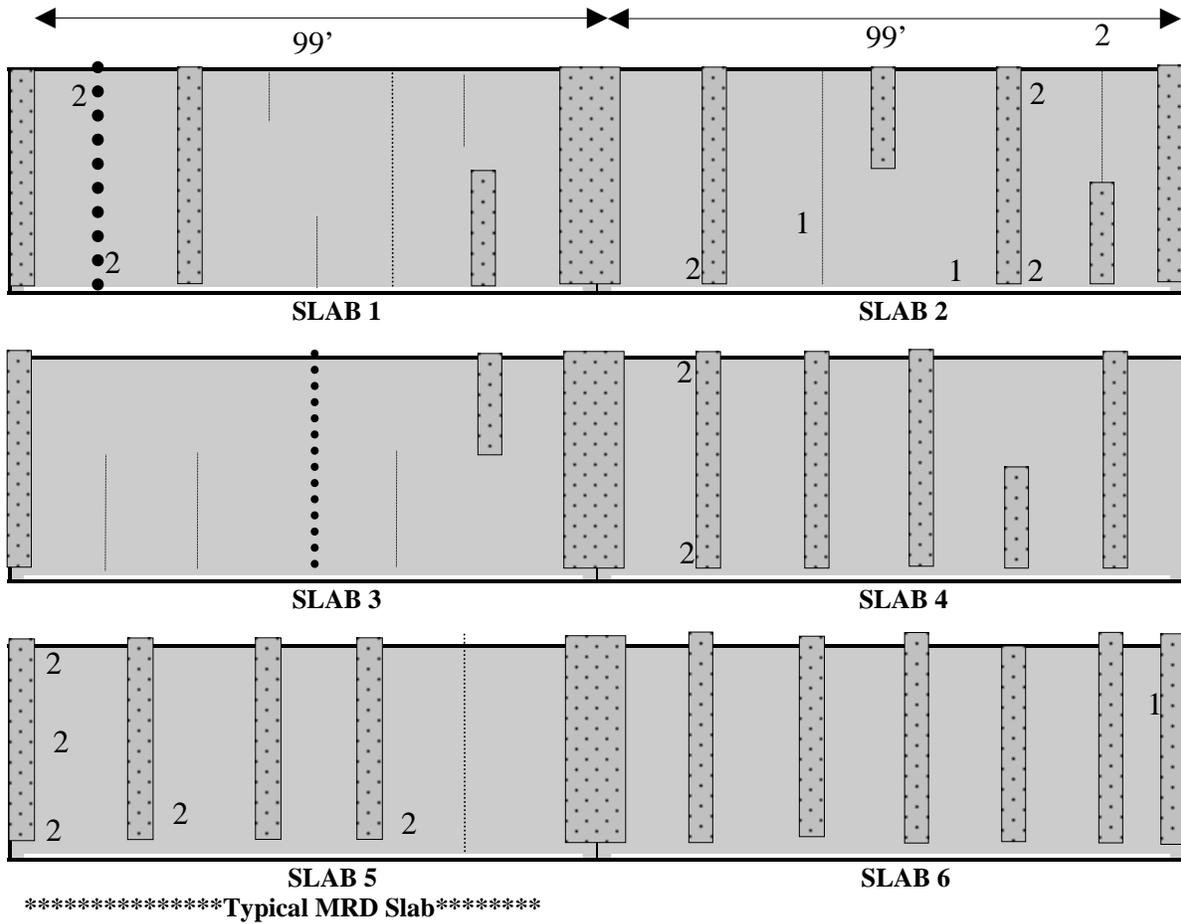
COMMENTS: Most of the Transverse Cracks are asphalt patched. Spalling on the Longitudinal joints (every 6 feet) but already been patched too. Popouts occurred here and there.

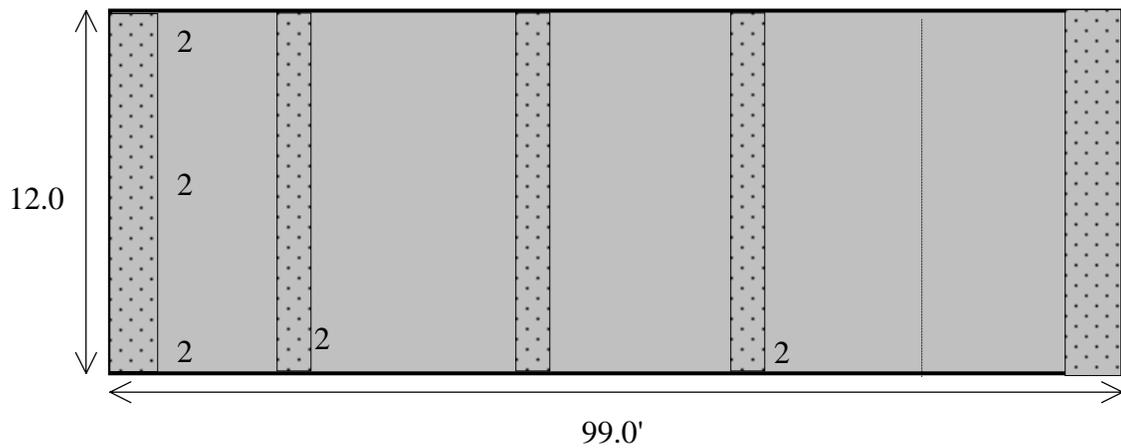
TYPICAL MRD SLAB: Slab 3

COMMENTS: General comments apply; Chip and seal repairs extensive along longitudinal joint; Polished agg (severe) in wheelpath; Popouts: ~ 1-2 per m²

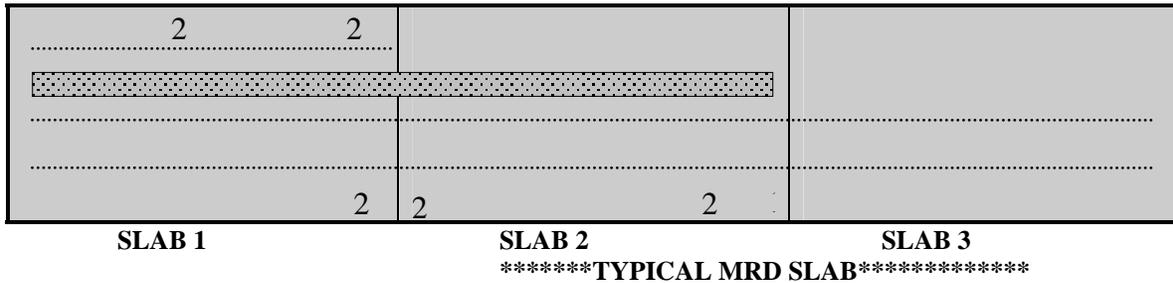
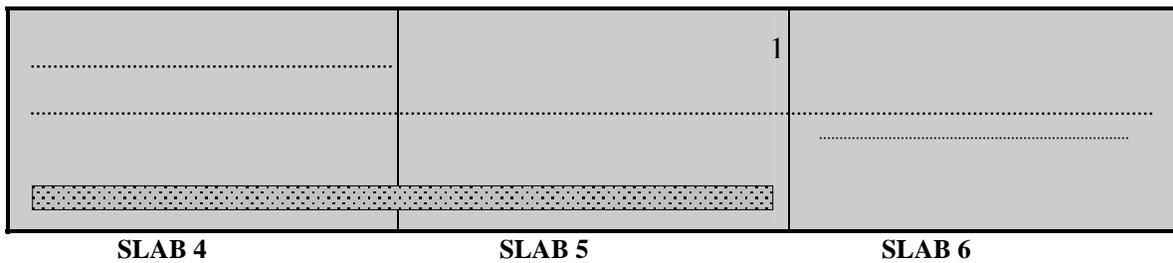
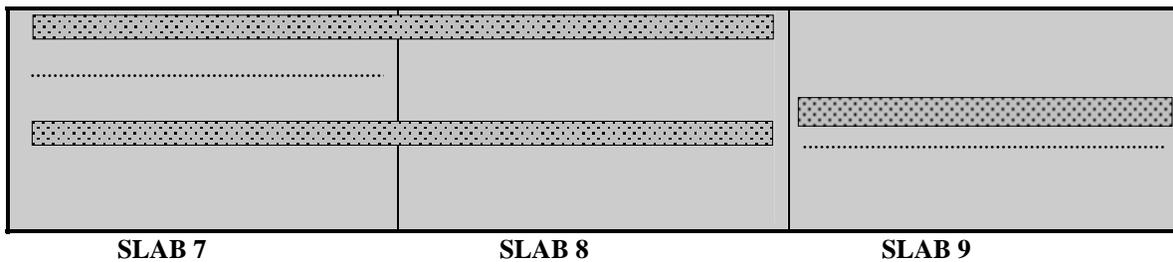
COMMENTS: Each of the longitudinal cracking exhibits D-Cracking. Most of the slab has D-Cracking at Longitudinal cracking and at longitudinal joints. Some of the cracks are asphalt patched.

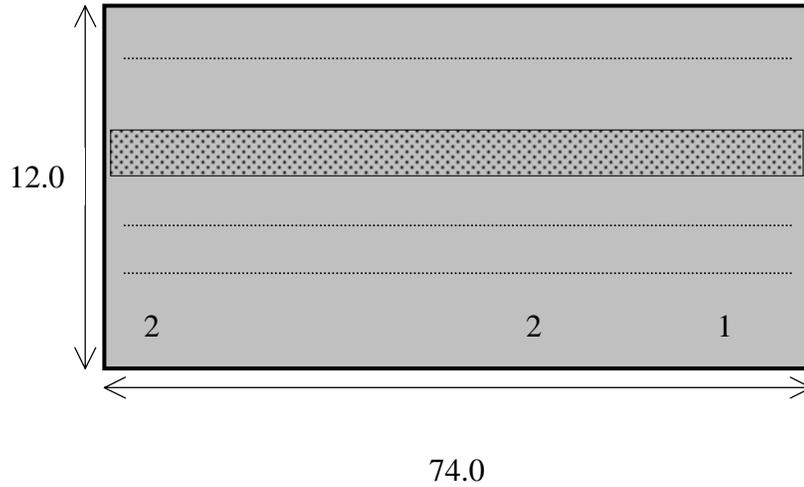
TYPICAL MRD SLAB: Slab 2/3

COMMENTS: Longitudinal cracking in slab due to connecting ASR-like cracks; Severe ASR-like cracking throughout entire slab; Popouts: 0.5 per m².
