# **APPENDIX A**

## **JACK PARKER'S INTERIM REPORT DECEMBER, 2002**

1. PURPOSE OF THIS REPORT: This is a response to a request by Michigan Dept of Transportation to evaluate the effects that an old gypsum mine beneath I-196 might have on the stability of that highway - in both near and long terms.

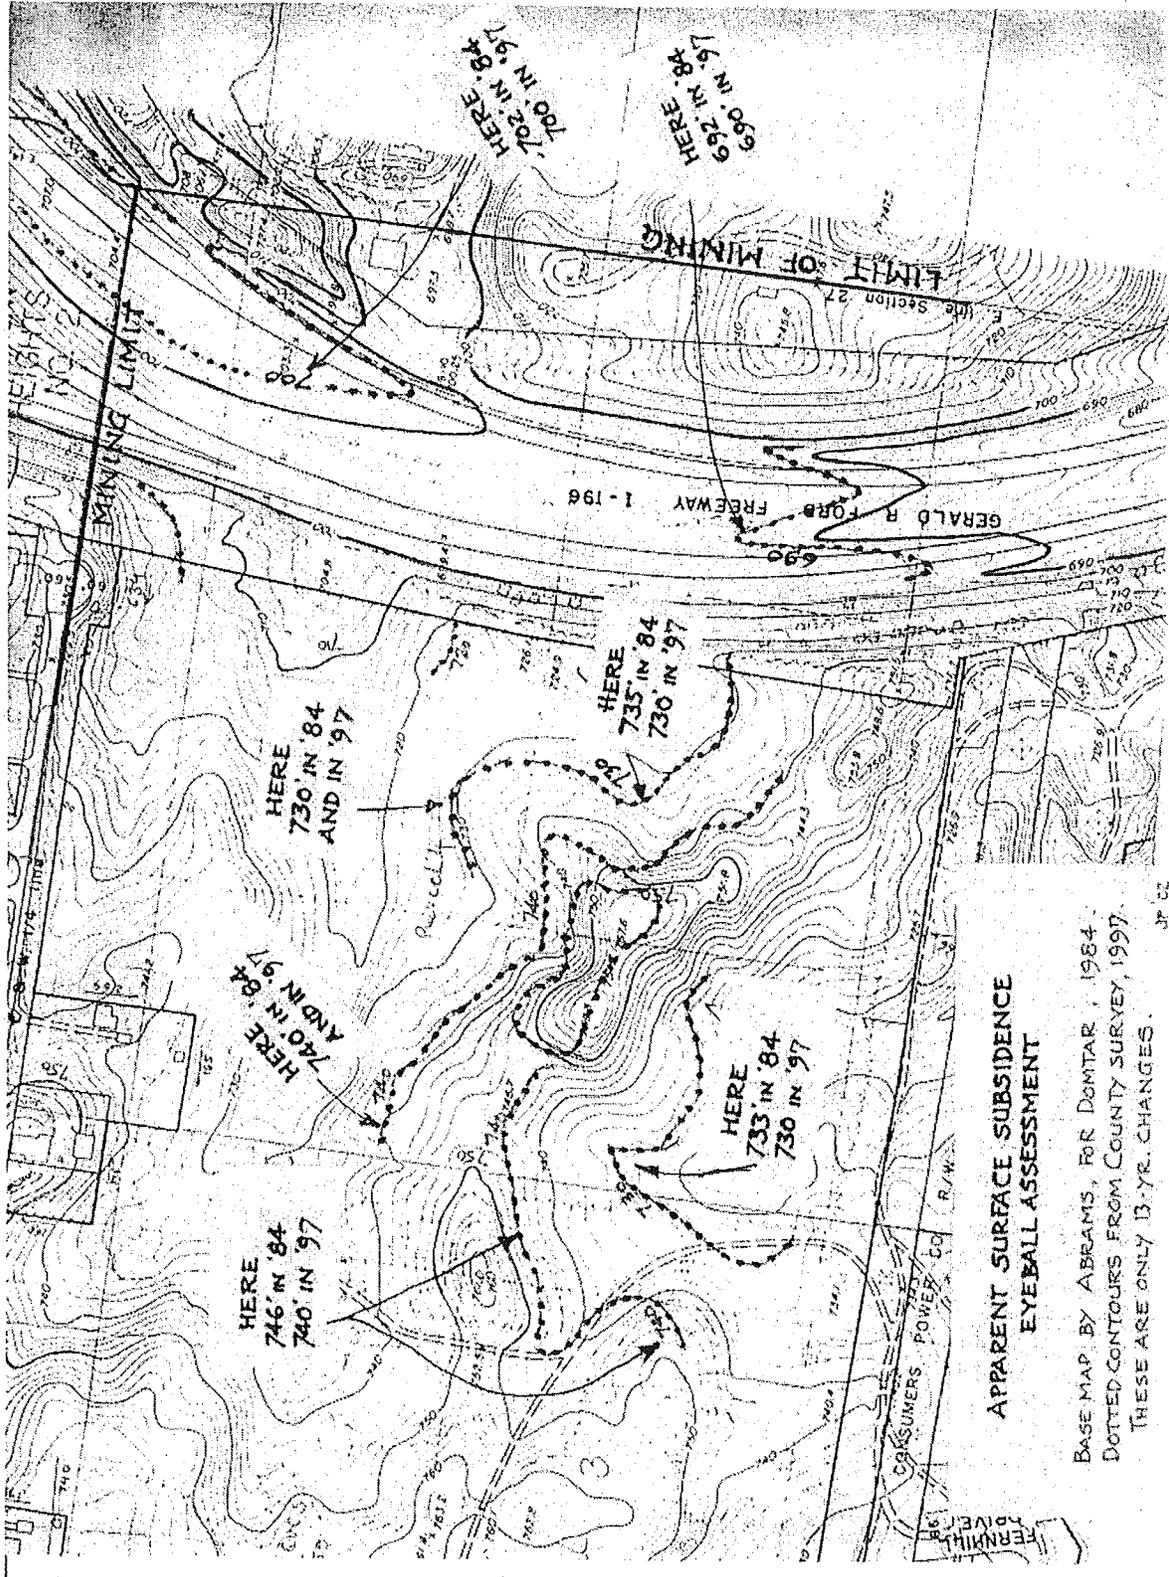
Figure 8.  
Comparison of  
elevations from  
1984 to 1997.

We have procured some topo maps, dated 1984 and 1997, and a very cursory comparison suggests that parts of the freeway, at the Fulton interchange, subsided a couple of feet during that interval, and the only indication we have heard of is that one concrete slab in that area "seems to be tilted . . ." To the west of the freeway the maps appear to show as much as 6 ft of subsidence in places during that 13-year period.

The mining layout in that area, the northeast corner of the mine, is unusual. To us it looks as if it was done with coal-mining equipment, using a coal-mining layout, with rather random formation of pillars followed by slicing up those pillars with diagonal tunnels ... It looks like - and probably was - the "last hurrah" for this part of the mine, gobbling up as much as possible as quickly as possible, to move into better ground further west. We think that this area would have started to fail not long after mining.

The geology here is also noteworthy. An exploration hole (1963-2) was drilled from surface about 150 ft west of the freeway (see map) and went through 100 feet of sand and gravel but only 7 feet of rock before entering seam #2 - so apparently there was an extremely thin roof beam above the rooms and pillars and a heavy dead load on that beam - two sufficient reasons for hasty mining and departure.

- a) That MDOT survey elevations along the freeway from Butterworth to Fulton to see how much change there has been since construction, and since the 1997 survey, and survey some E-W profiles if the changes are significant.
- b) That we procure several sets of topographic maps of different ages, all on the same scale, and superimpose them to arrive at contours of subsidence for the various time intervals, and contours of total subsidence, then relate them to the rooms and pillars on the mine maps.
