## **REPORT OF INVESTIGATION OF WATER PROBLEMS AT THE GRAND RAPIDS GYPSUM MINE, GRAND RAPIDS, MI**

**EDWARD M. BURT  
1965**

January 11, 1965

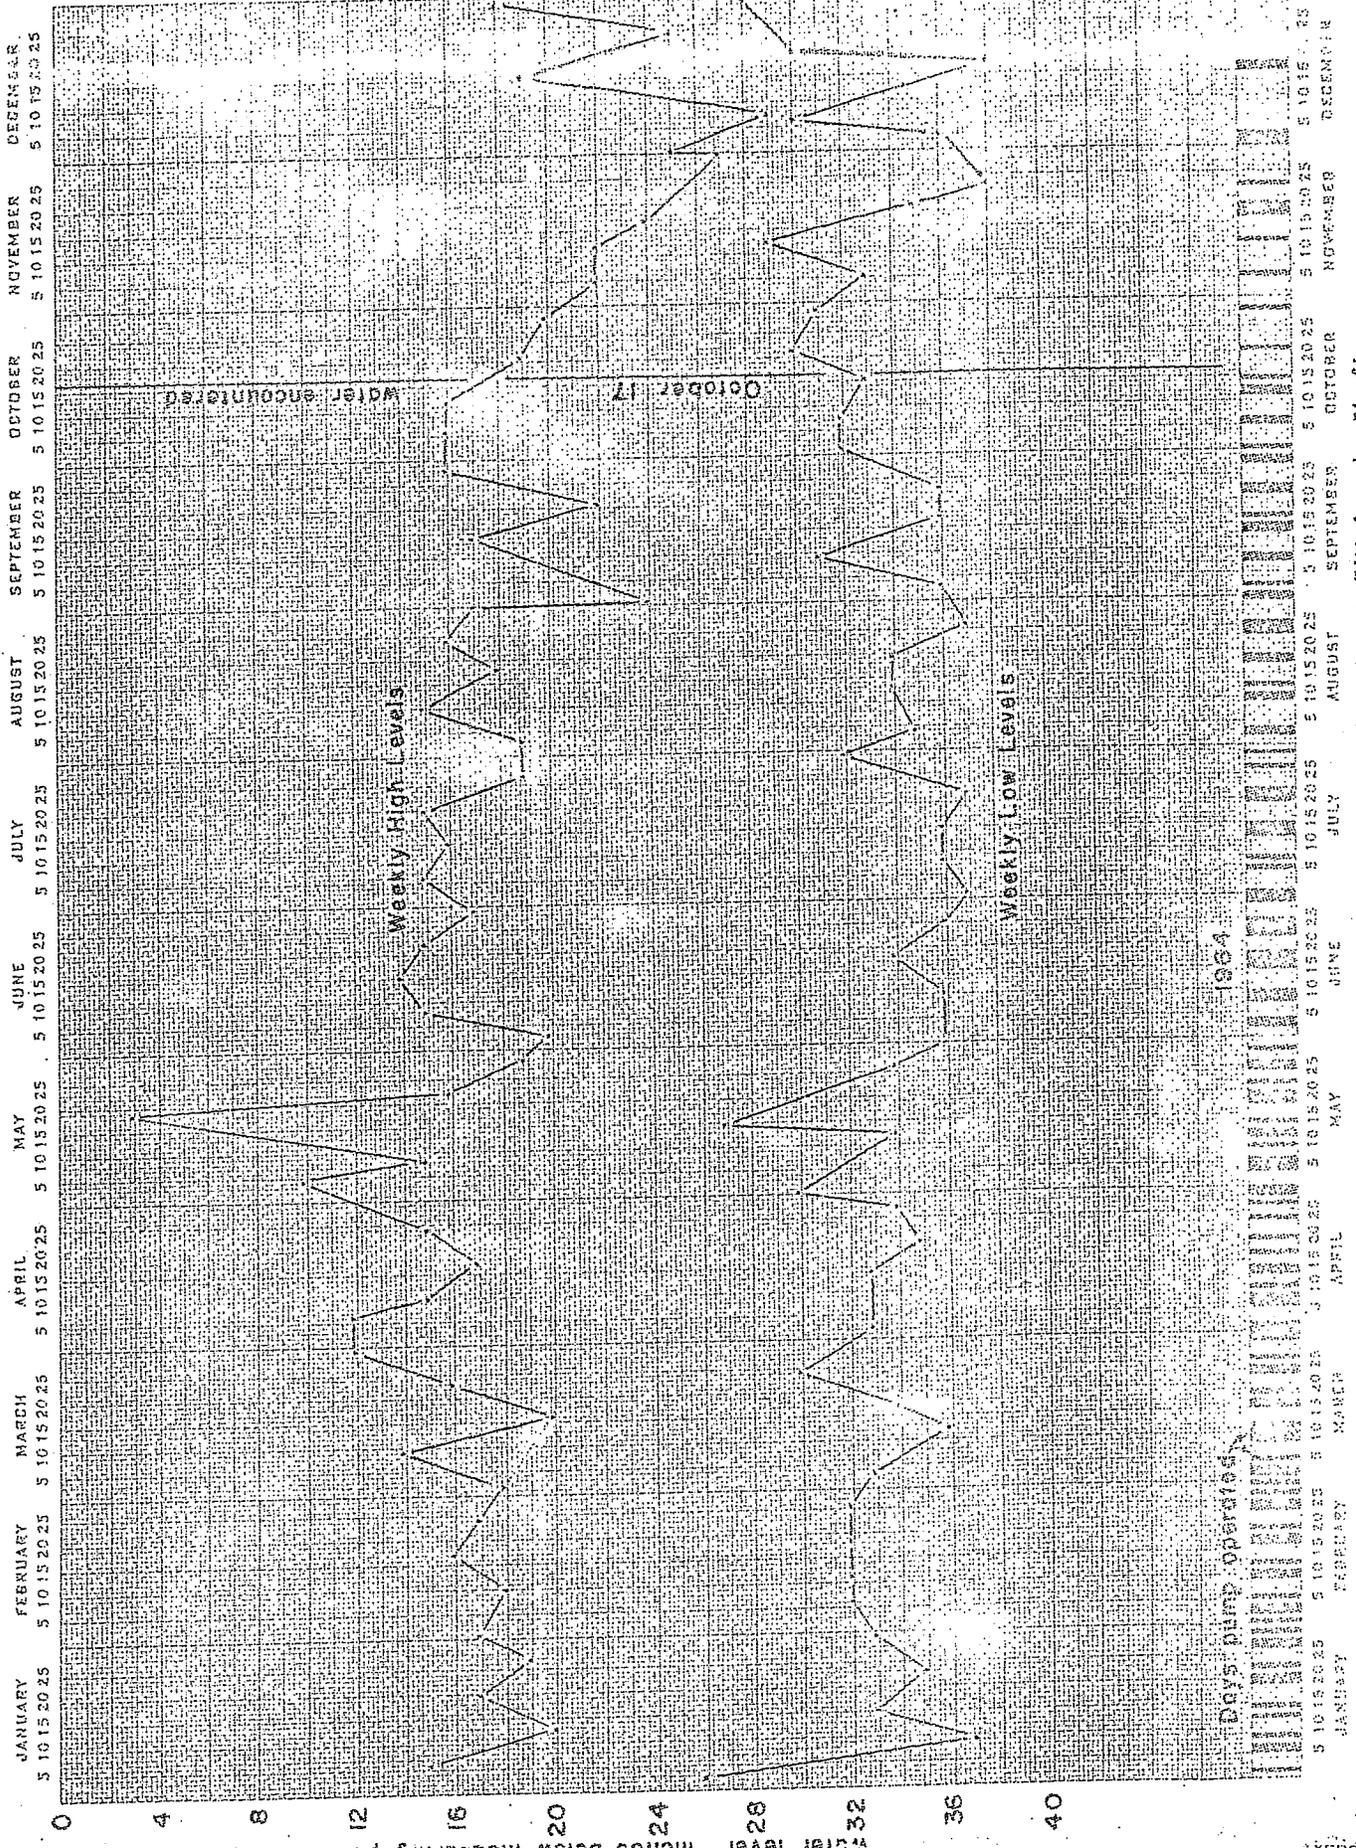
Figure 2 is a graph summarizing the weekly high and low water levels measured in the Pittsburgh shaft and the days the dewatering pump(s) were in operation. It is very apparent that the water encounter of October 17 represented an "interception" of water which previously found its way into the Pittsburgh shaft. The rapidity of the effect on the Pittsburgh shaft supports the theory that a solution channel was intercepted. Most recently, I understand the amount of water entering the mine has been decreasing, necessitating throttling of the pump in the mine. Though the exact cause of this cannot be identified, one or more of the following causes may be responsible for the diminishing flow.

The solution channel may be plugging up with sediments,

thus inhibiting the passage of water. If this is the cause, the flow may continue to diminish, but probably will not completely stop. Also, the pumpage at the Pittsburgh shaft should remain diminished.

The natural "winter decline" in the water table may be responsible for the decline in flow. If this is the cause, the pumpage at the Pittsburgh shaft should remain low and in the spring and summer of the year the flow should again increase.

The water may have eroded a new channel to a lower outlet. In this case the flow should stop in the mine and will probably find its way to the Pittsburgh shaft.

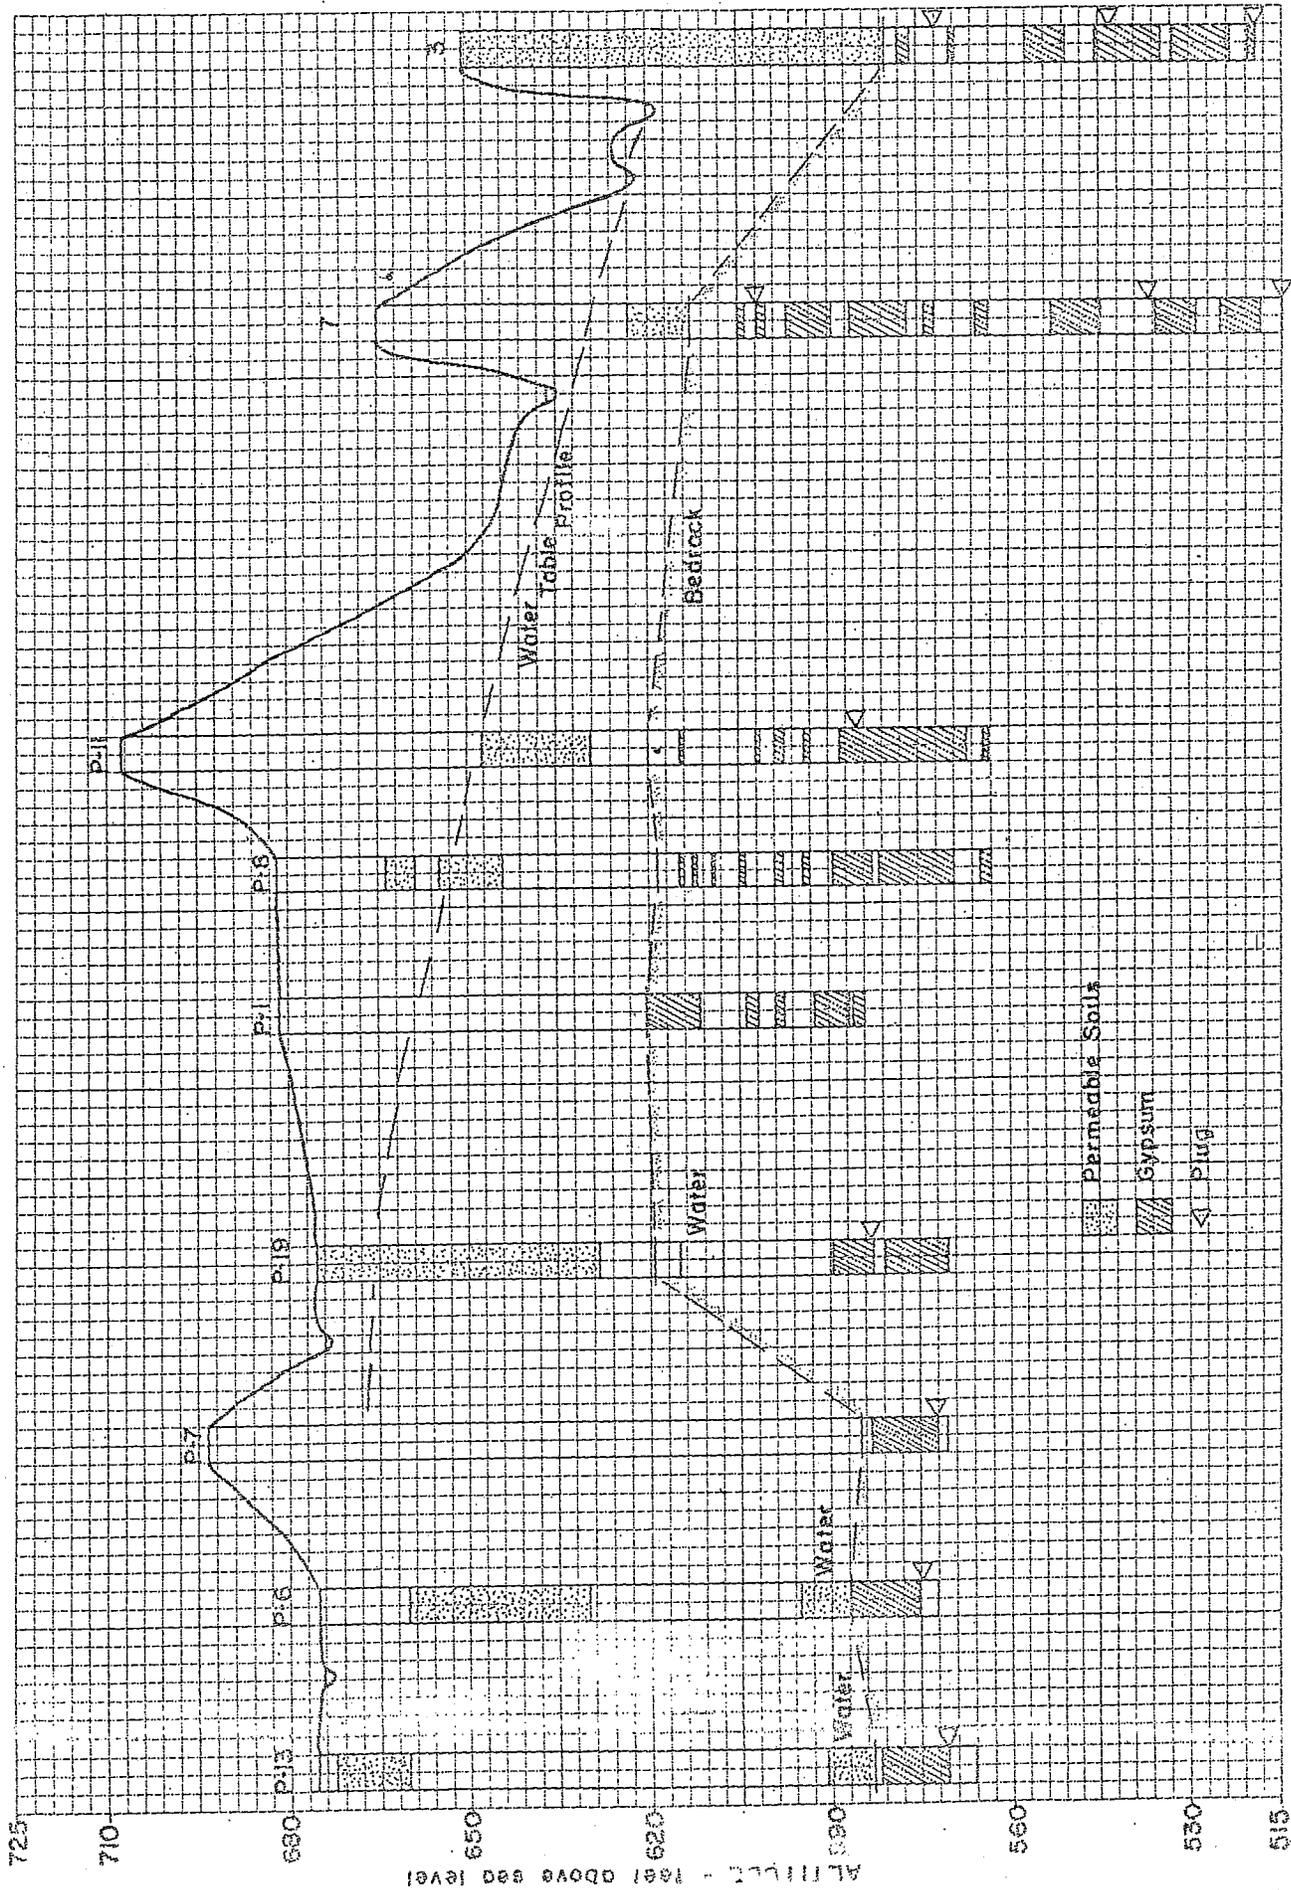
Fig. 3 - Section A-A' Paralleling Stream

will naturally move into the mine. For this reason, it is imperative that direct contact between the mine workings and the glacial soils be avoided if at all possible. The accompanying cross sections show such encounters would be possible by extending the mine openings too far to the west or south.

Figures 3 and 4 are cross sections portraying the distribution of permeable unconsolidated soils and their relationships to the underlying consolidated rocks. The vertical scales of the sections are exaggerated out of proportion with the horizontal scale. The horizontal well relationships are proportional to the distances between wells along the lines of the sections as shown on figure 1. Section A-A' (Fig. 3) also shows the estimated water table profile. The sections clearly show the soil and water head conditions are suitable for migration of ground waters from the glacial drift into the consolidated rocks. Analyses of the water quality at the flow site in the mine (Hardness 63-69 grains per gallon and Chlorides 91 to 114 parts per million) and at the Pittsburgh shaft (Hardness 93g/g and Chlorides 167 ppm) are also indicative of such migrating ground waters rather than native waters within the rocks.

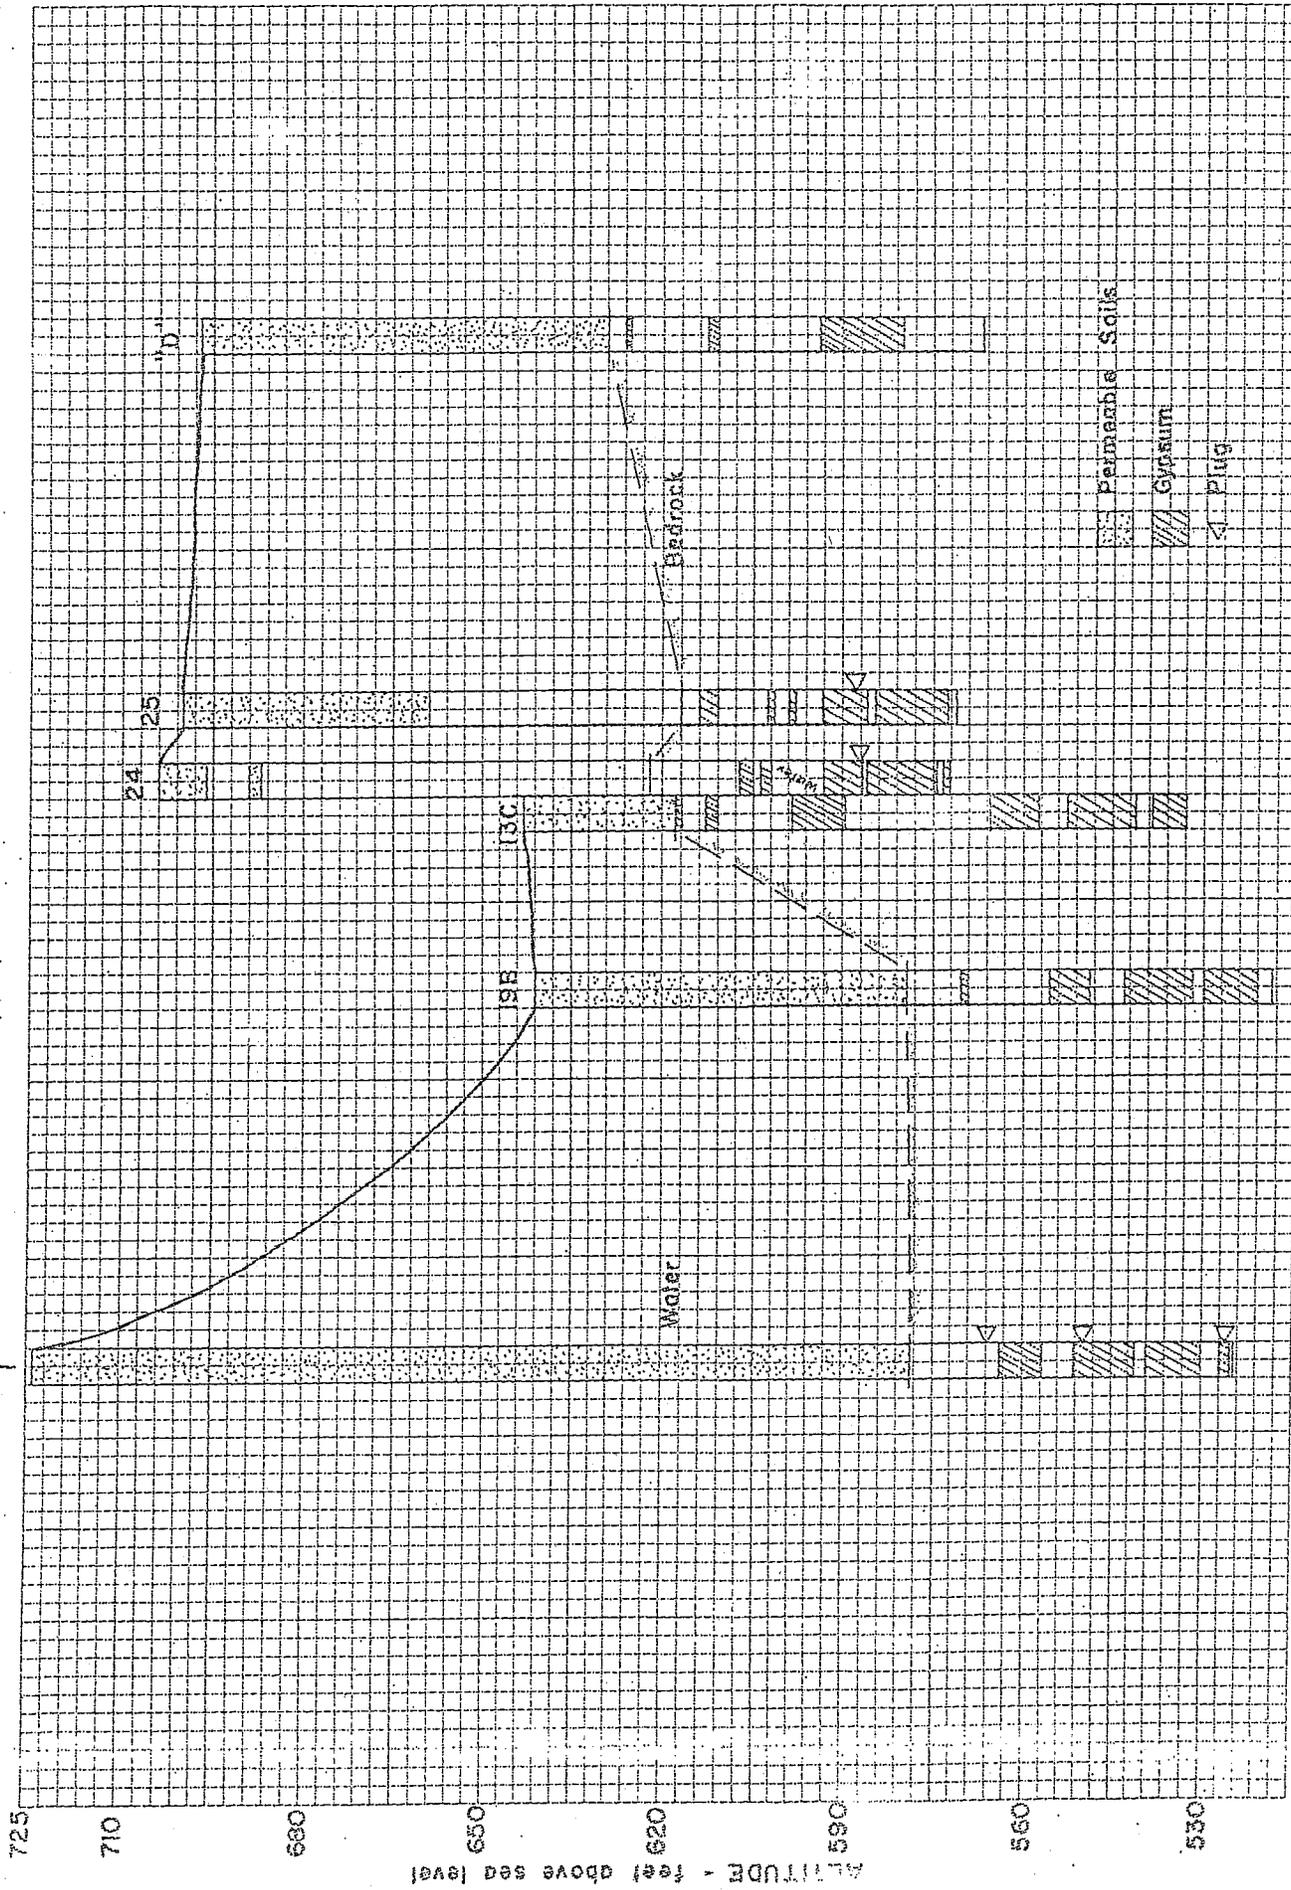
Fig. 4 - Section B - B' East - West thru Water Problem Area.

information, water quality information and water level information; it is my opinion that water flow represents a "tapping" of a solution channel receiving water from the glacial drift through a buried "sink hole" or similar feature.
