APPENDIX D

Selected Site Photos

It is recognized that a visual record of a pavement section's condition is invaluable. Thus, this appendix is included to provide a brief overview of each test section. The photos presented for each test section include a site overview, photos of typical distresses in the section, and highlights of notable features on the site, such as clogged edge drain outlets.

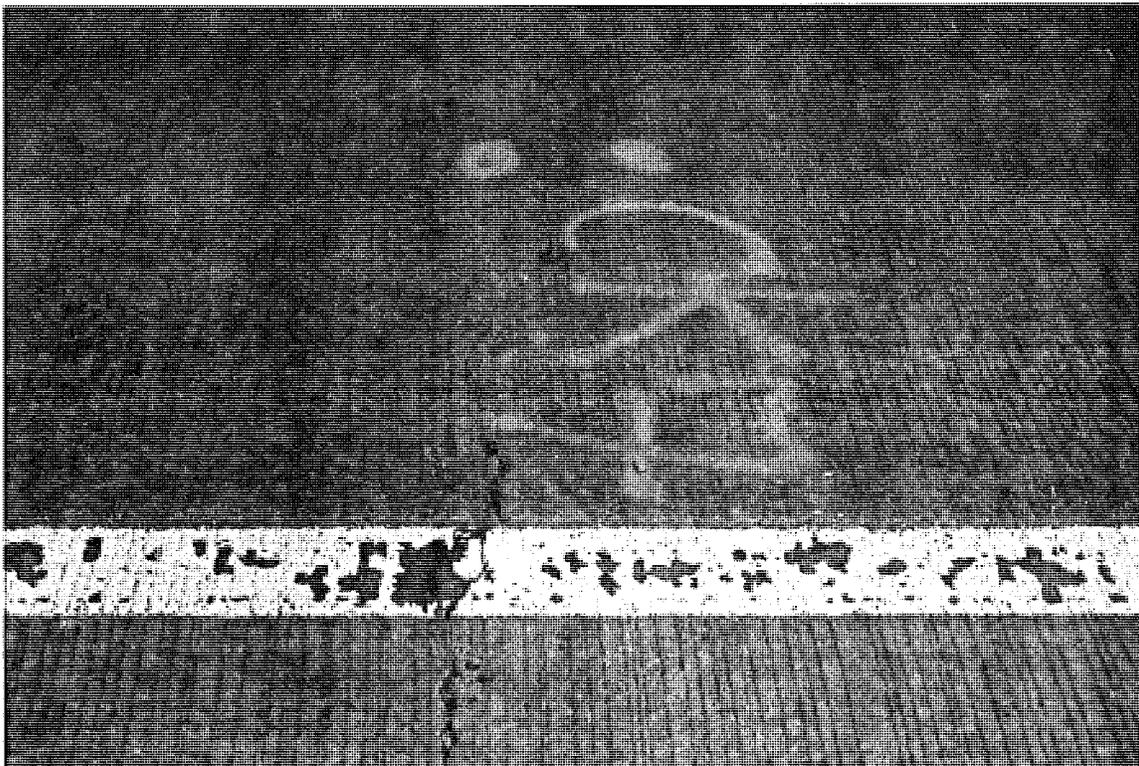
Photo C2. A typical midslab crack on CSN# 11017-32516A (Section A), EB. The beginning of some spalling can be seen at the bottom of the photo.

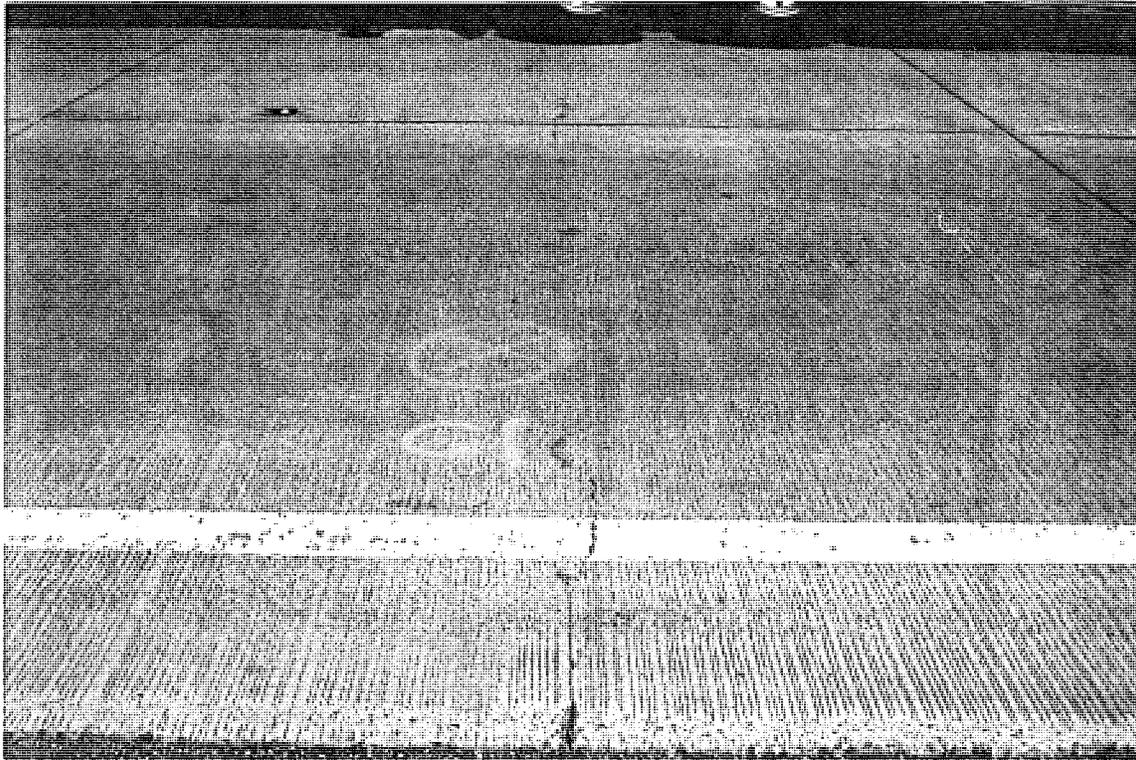
Photo C3. A midslab crack on CSN# 11017-32516A (Section A), EB. The location of core #C1 can also be seen. The crack extends through the passing lane. Transverse joints are spaced at 16 ft.

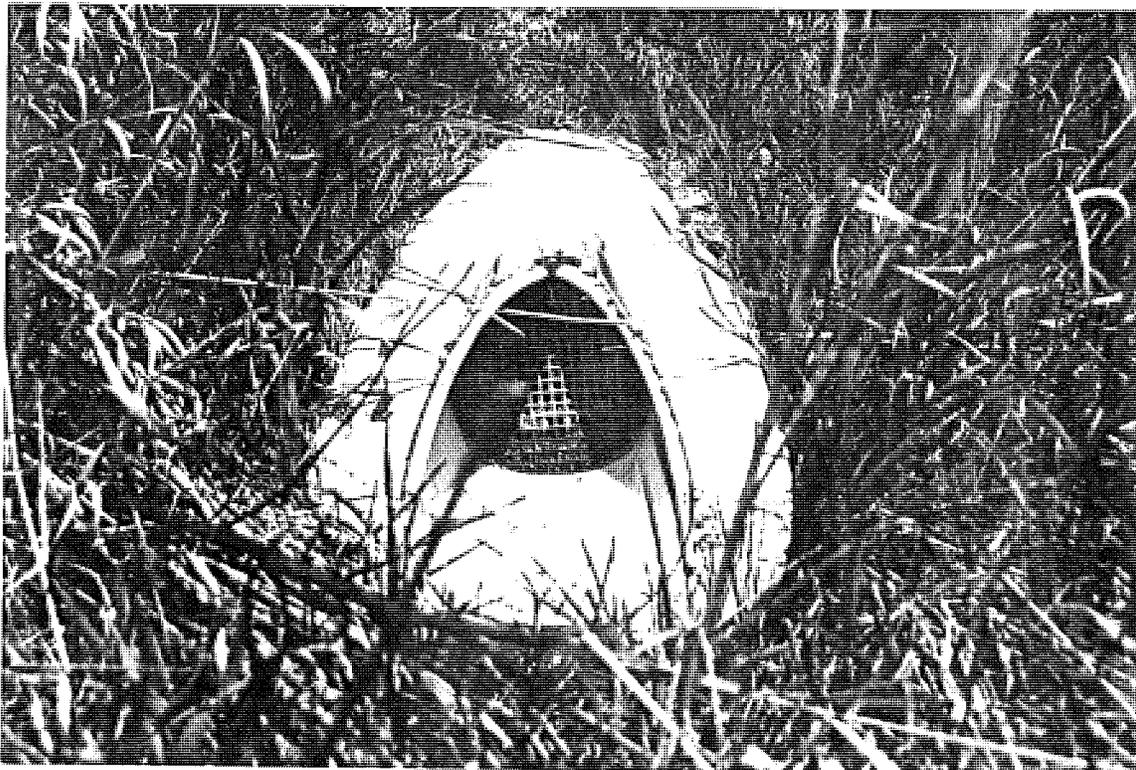
Photo C4. A typical drainage structure of CSN# 11017-32516A (Section A), EB. Water can be seen flowing freely from the drain after coring.

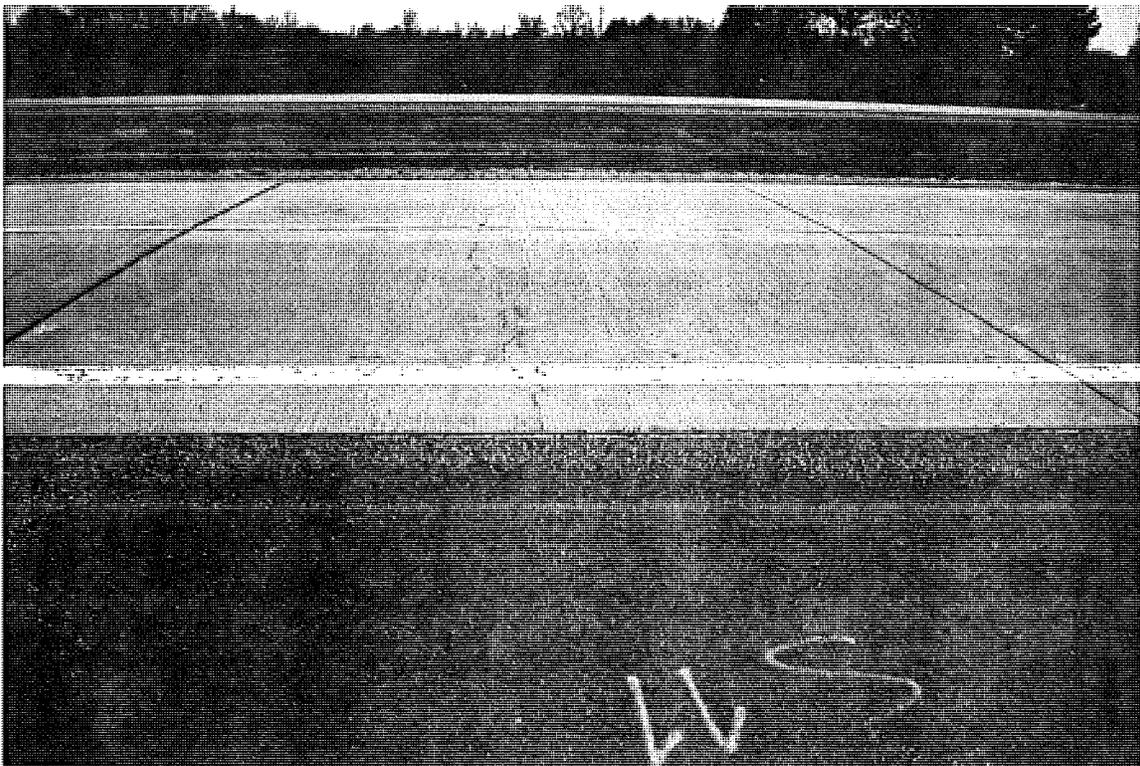
Photo C6. A full width transverse crack on CSN# 11017-32516A (Section C), EB. An expansion joint can be seen in the left side of the photo.

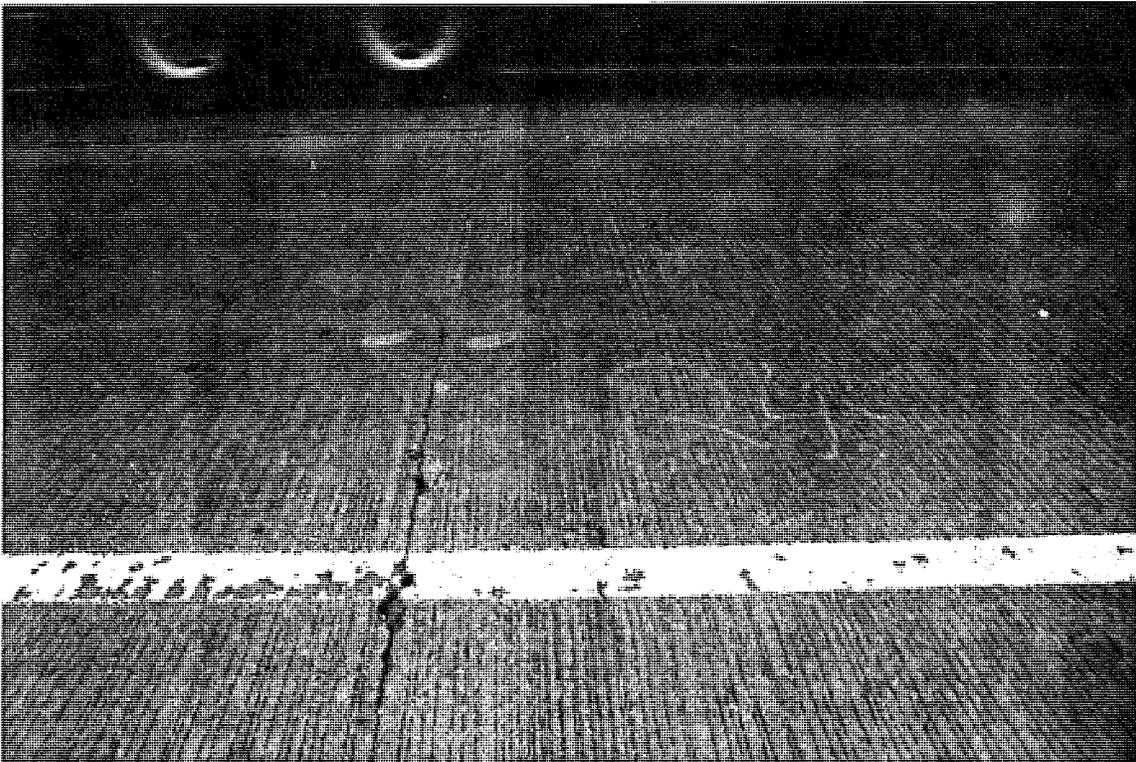
Photo C7. A close-up of a full width transverse crack in CSN# 11017-32516A (Section C), EB. The beginnings of spalling can be seen at the bottom of the photo.

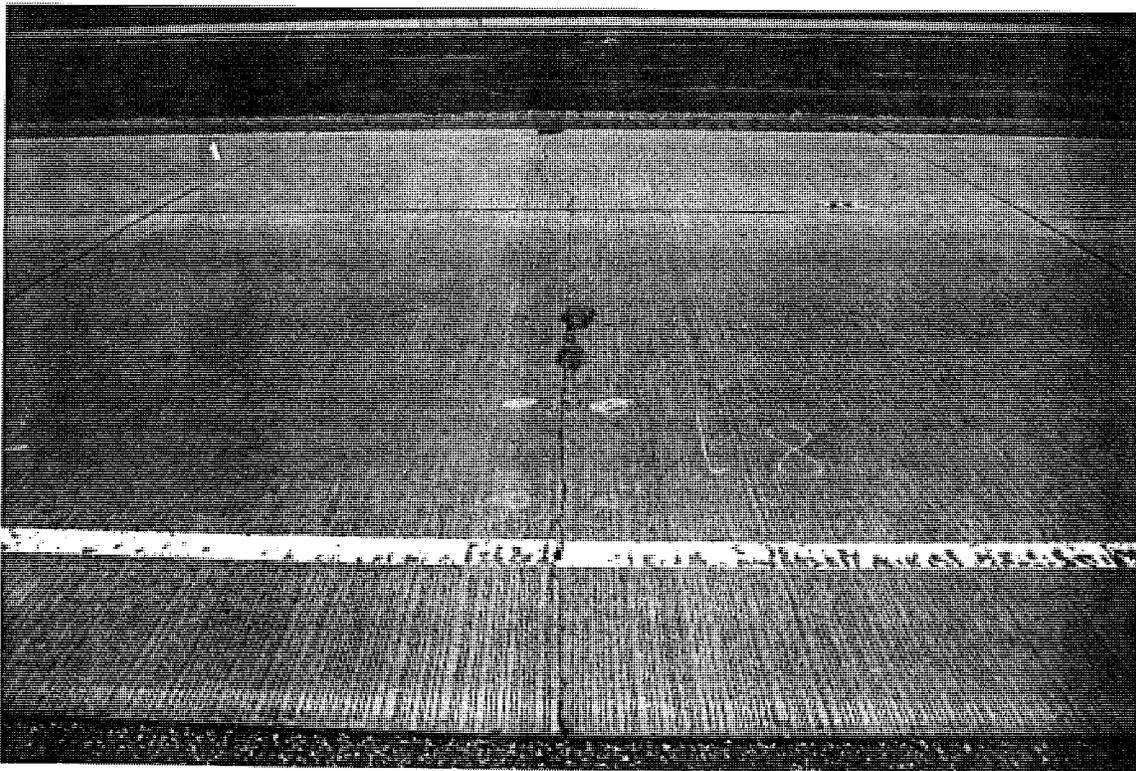
Photo C8. A transverse crack at midslab in CSN# 11017-32516A (Section C), EB. Moderate spalling is present.

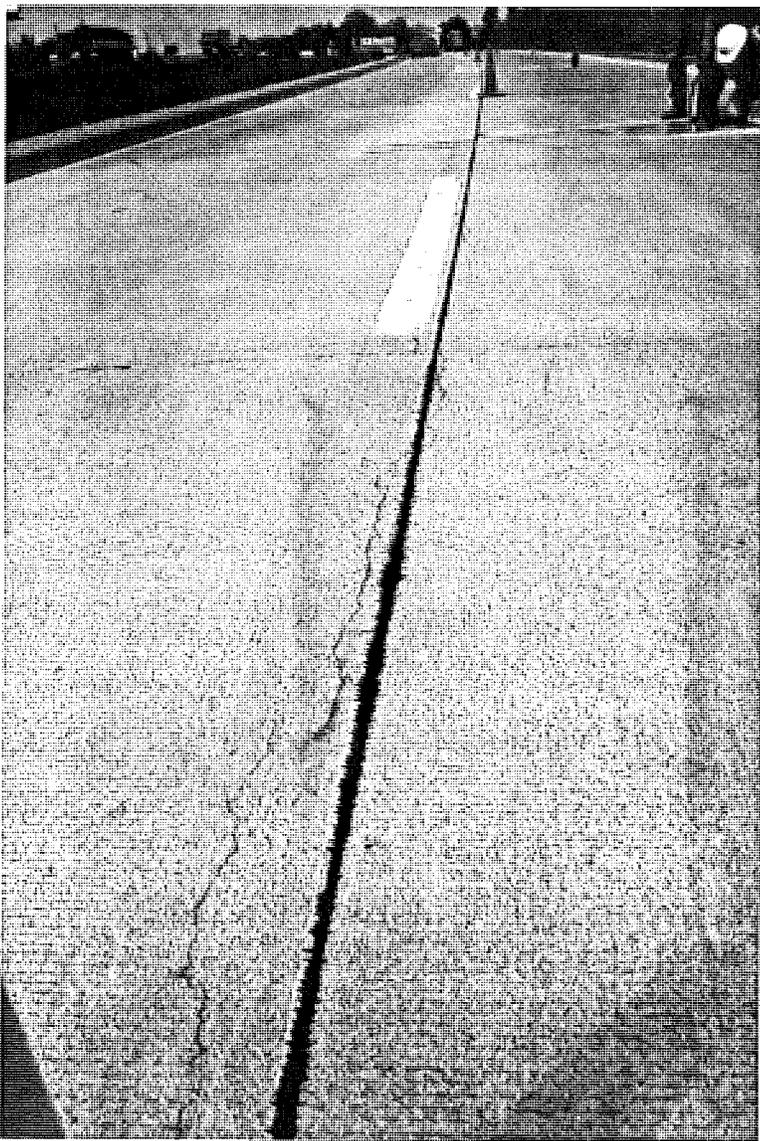
Photo C9. An overview looking west on CSN# 11017-32516A (Section D), WB. A tight longitudinal crack running parallel to the longitudinal joint can be seen.

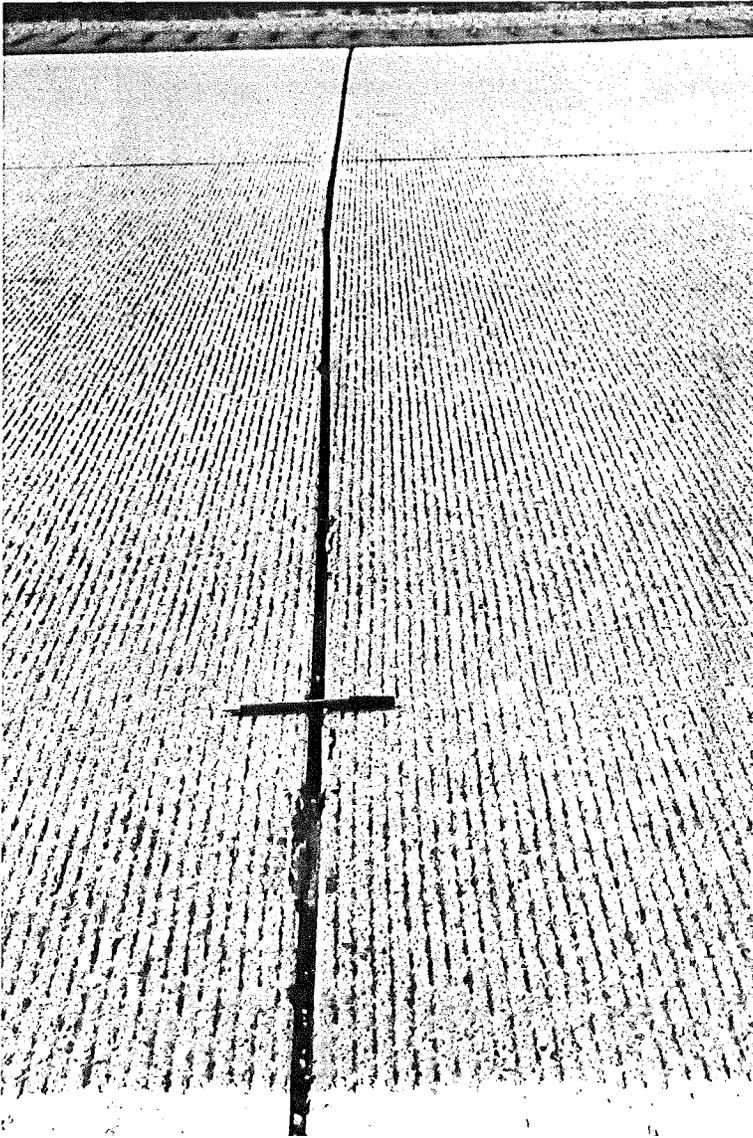
Photo C11. A typical contraction joint on CSN# 11017-32516A (Section D) WB, showing some spalling along the joint.

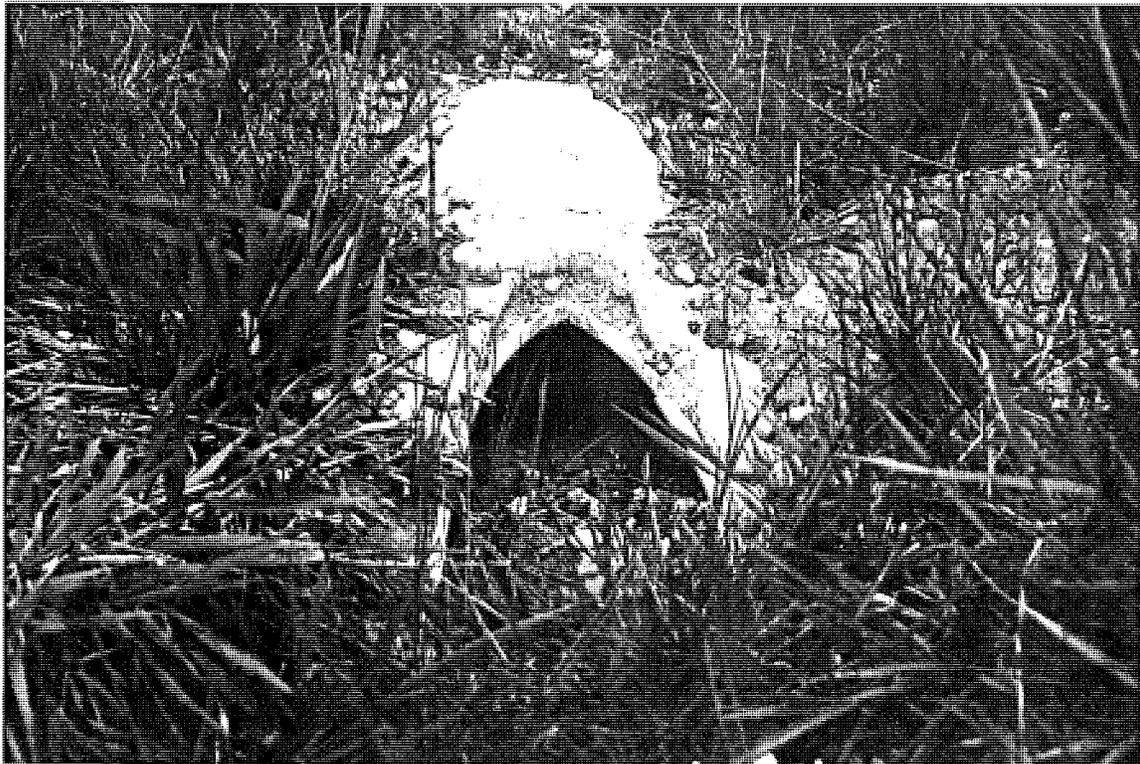
Photo C12. A partially clogged edge drain outlet on CSN# 11017-32516A (Section D) WB.

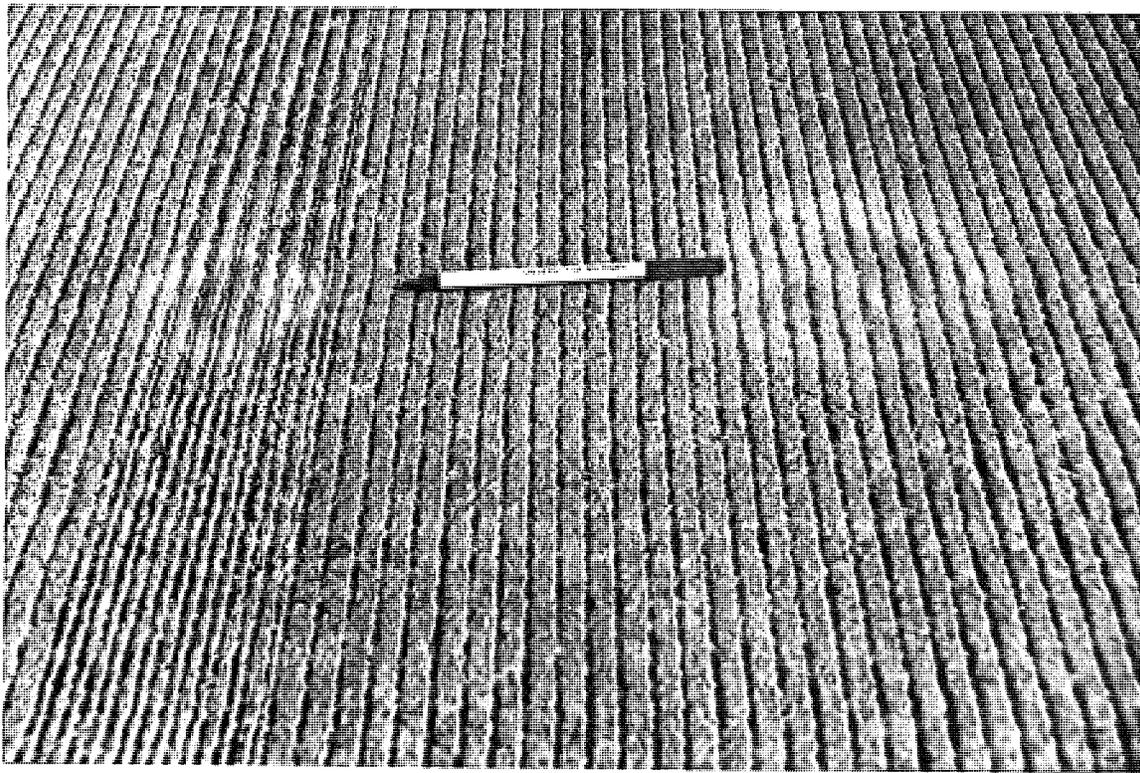
Photo C14. A tight transverse crack on CSN# 19042-24680A (Section B) EB, typical of those seen in the test section.

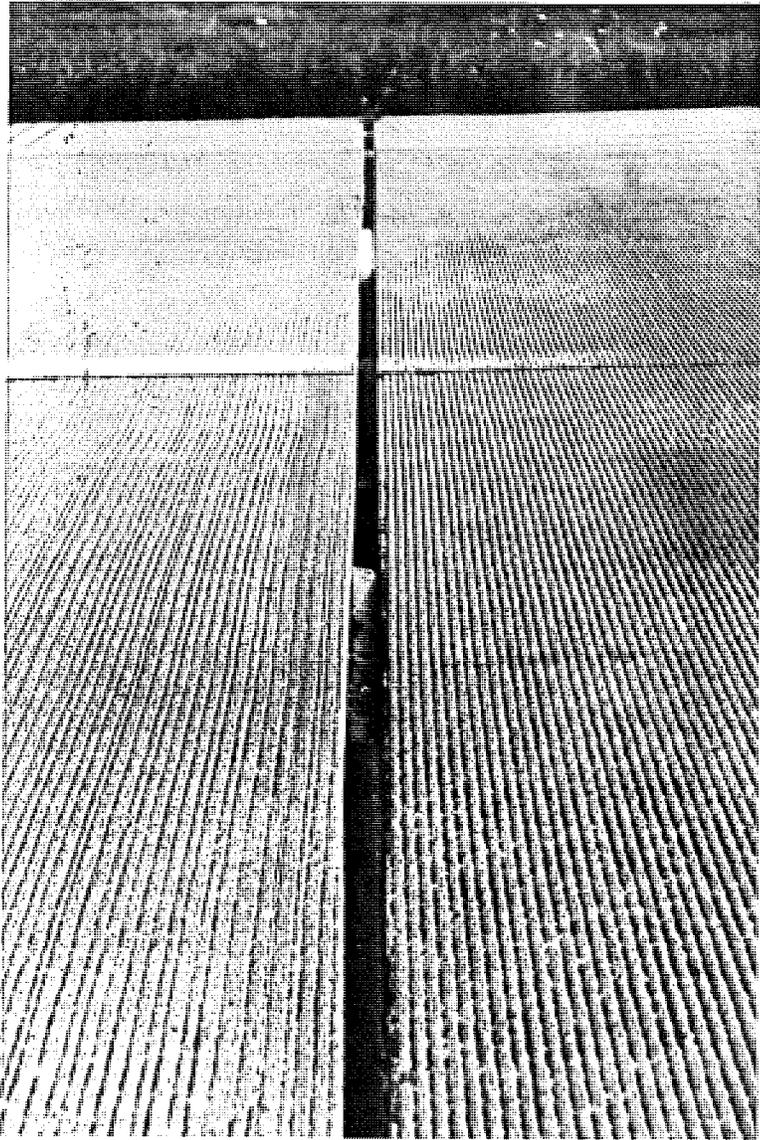
Photo C15. An expansion joint on CSN# 19042-24680A (Section B) EB showing some distress in the joint sealant. Sealant damage was present in several locations in the test section.

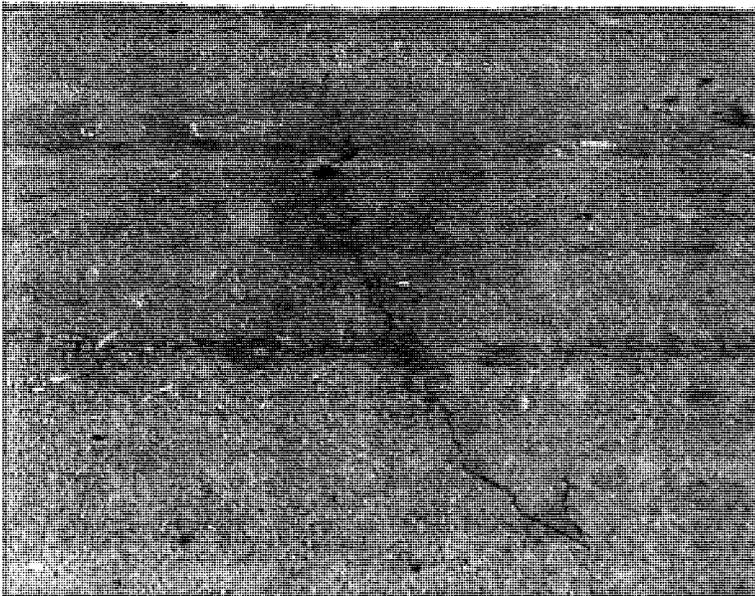
Photo C19. A tight crack on CSN# 19042-02233A (Section C) EB, joints are in good condition as can be noted here.

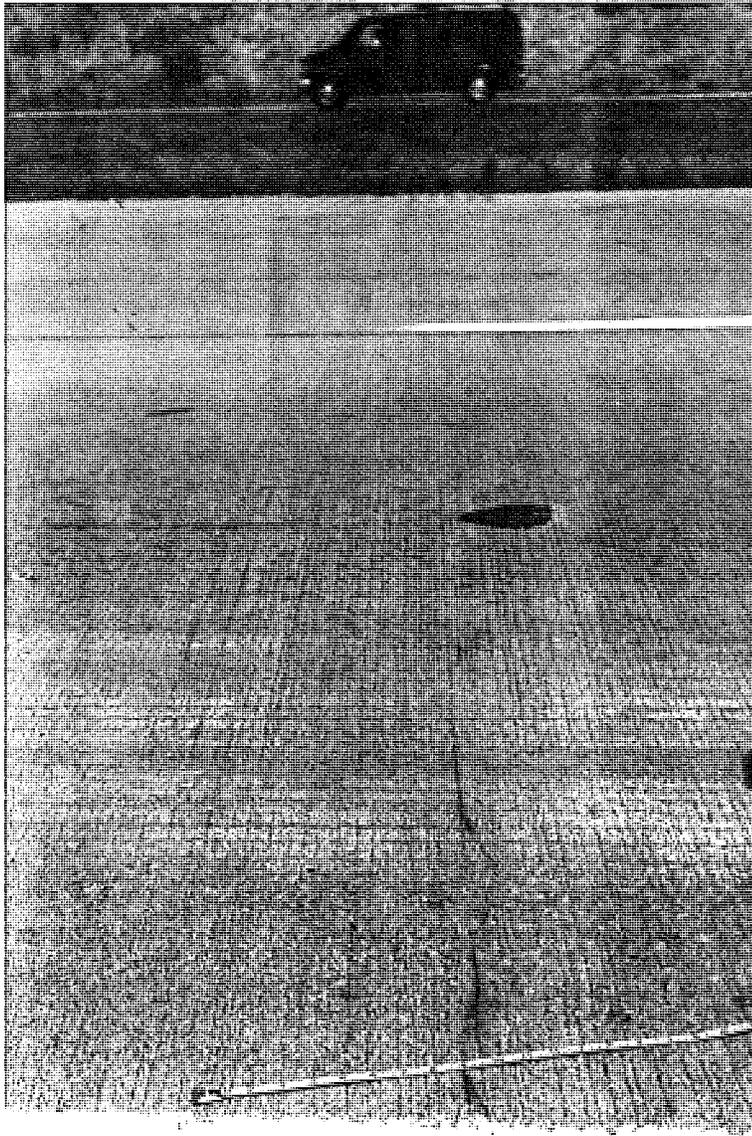
Photo C20. A tight midslab crack in the truck lane of CSN# 19042-02233A (Section C) EB, the crack extends into the shoulder, but is not visible in the passing lane.

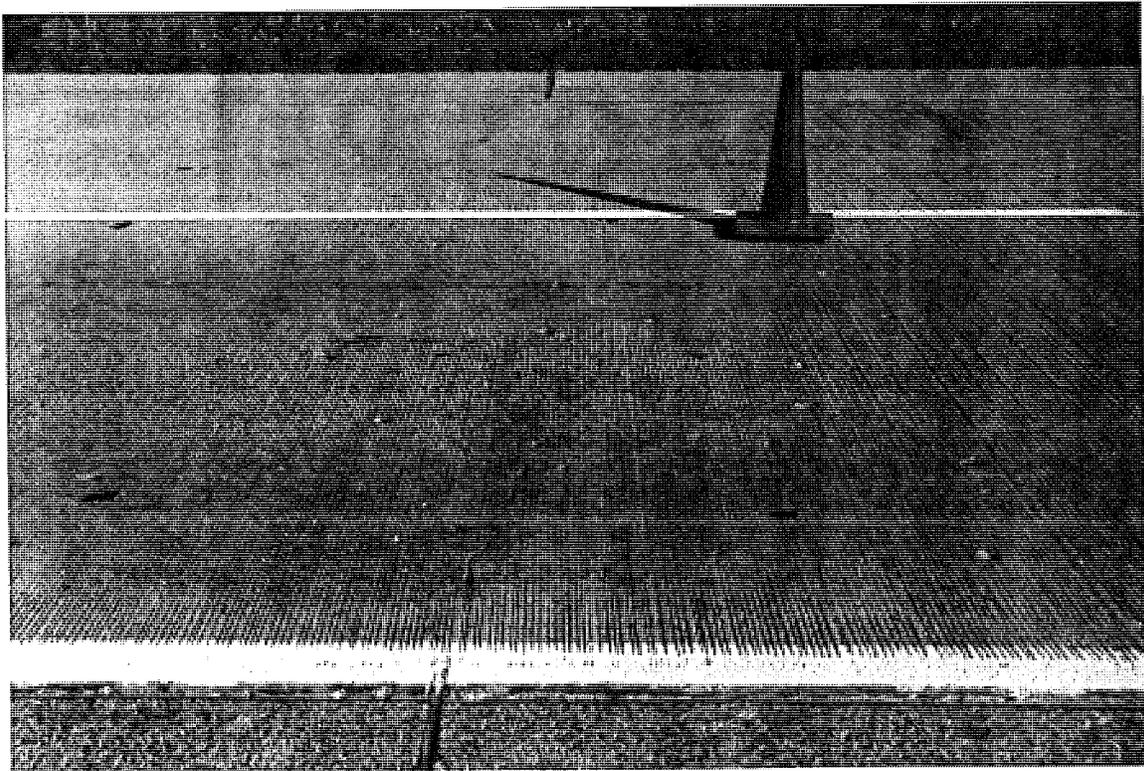
Photo C22. A typical midslab crack on CSN# 19043-02234A, EB, initiated by the third point intermediate shoulder joint.

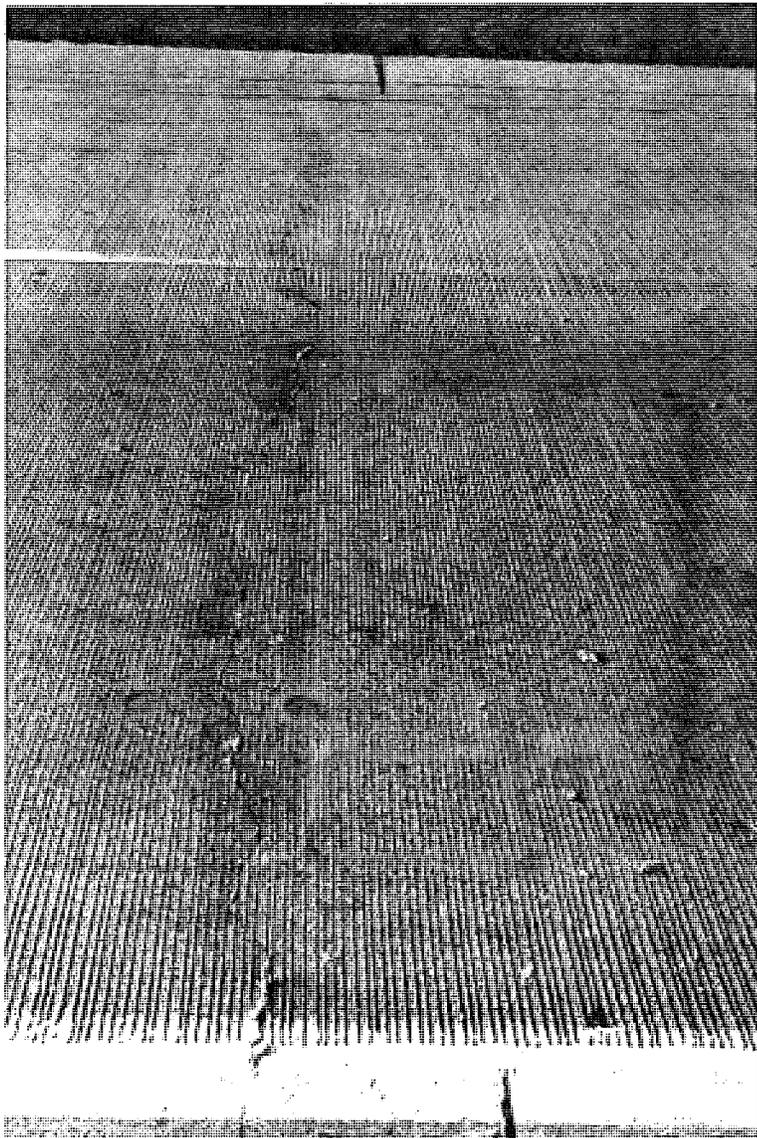
Photo C23. A full width transverse crack initiated by the third point intermediate shoulder joint along CSN# 19043-02234A EB.

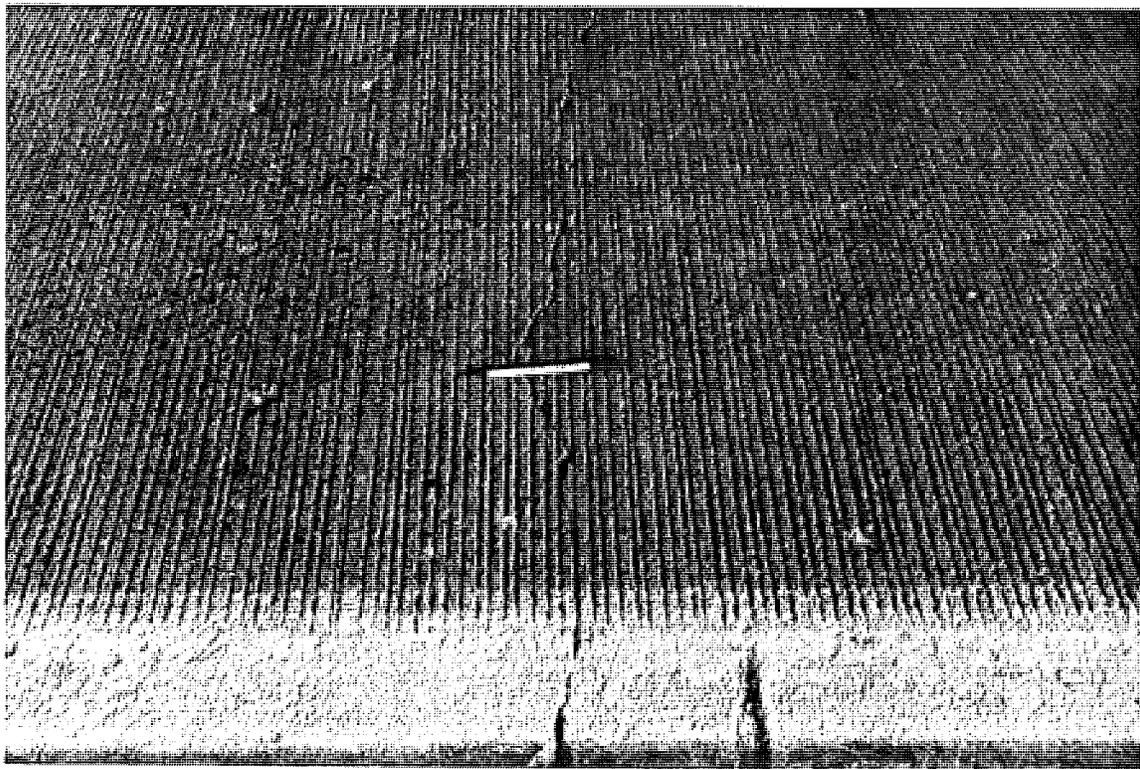
Photo C24. A close-up of a typical crack on CSN# 19043-02234A EB. The beginning of spalling can be seen.

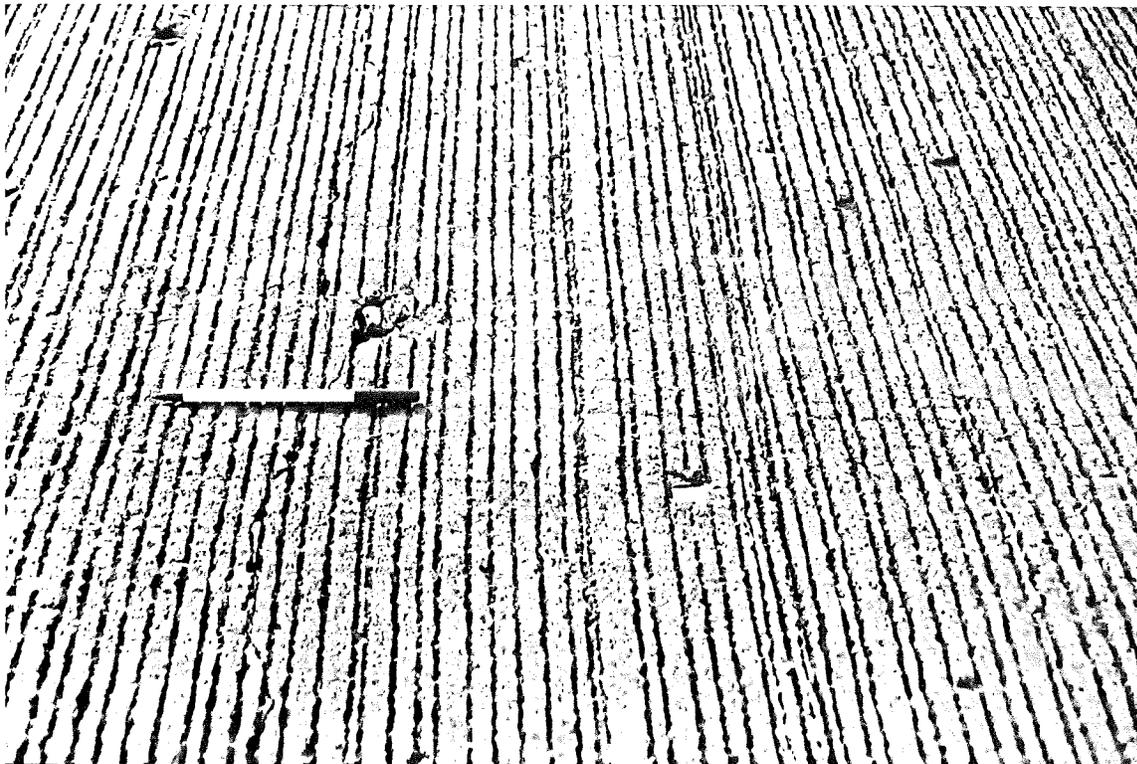
Photo C26. A closeup view of a tight crack on CSN# 19043-02234A, WB. The beginning of spalling can be seen in the center of the photo.

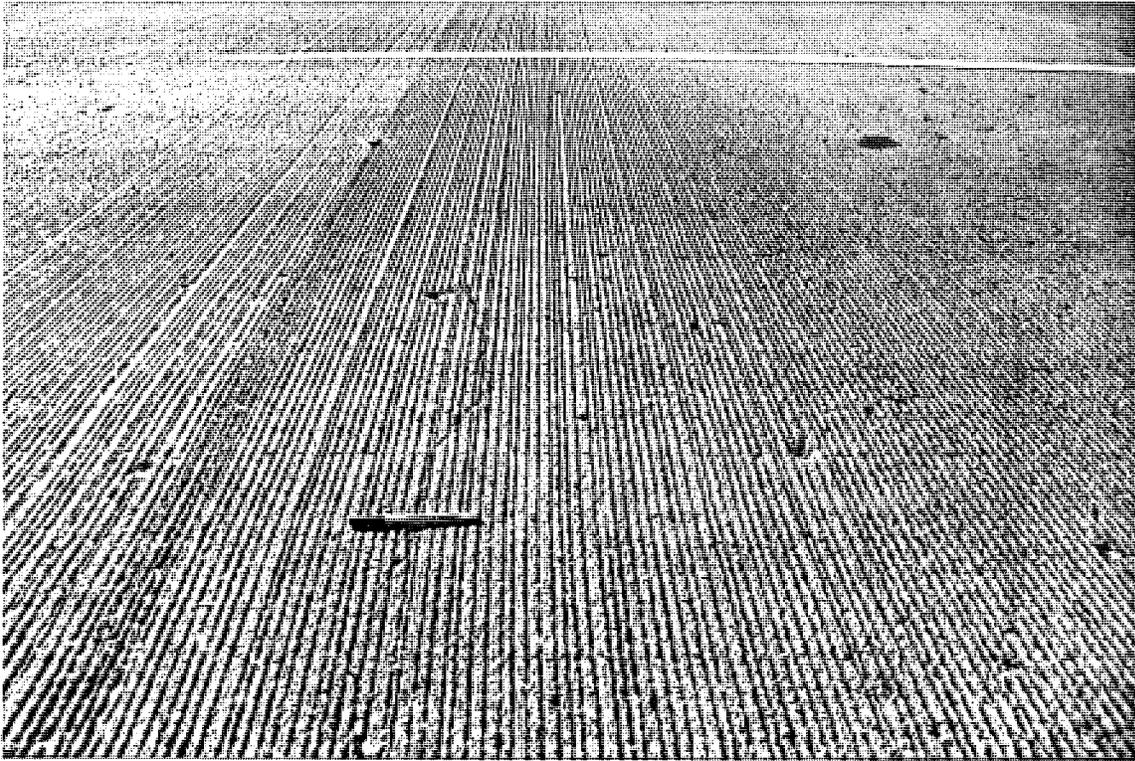
Photo C27. A midslab crack along CSN# 19043-02234A, WB. The crack propagates from the intermediate shoulder joint, which is typical for this section.

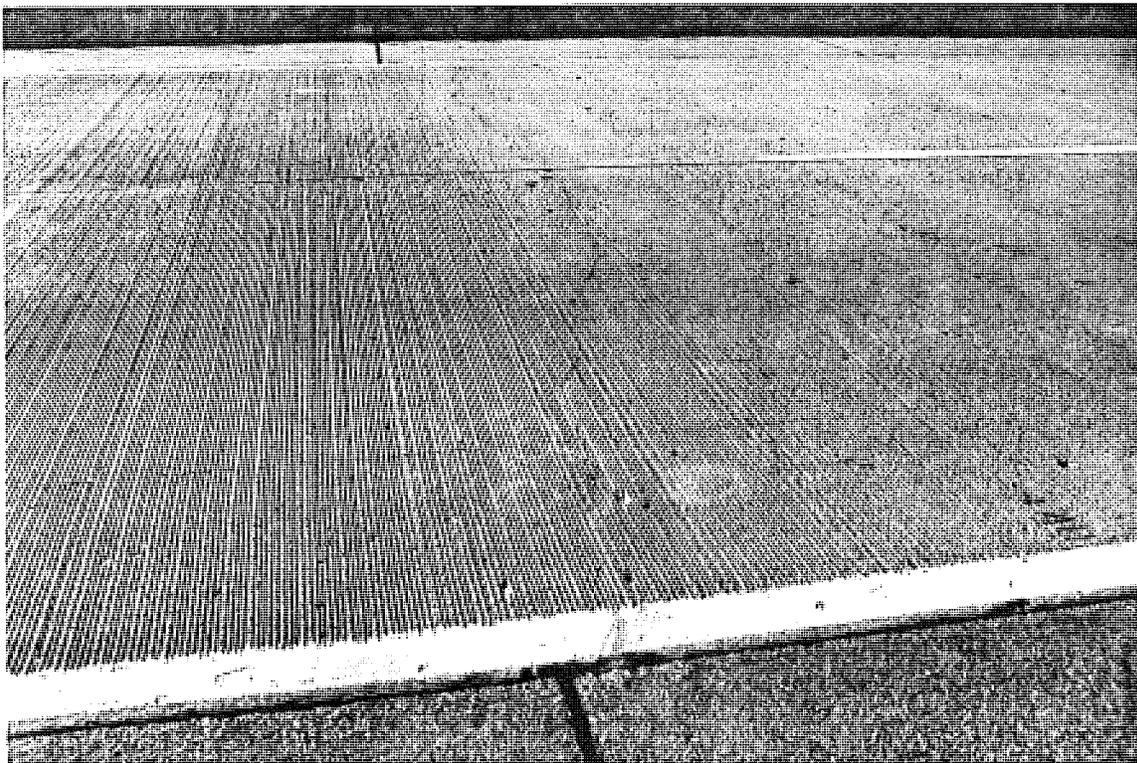
Photo C28. A typical full width mid slab crack on CSN# 19043-02234A, WB. This crack was initiated by the third point intermediate shoulder joint seen at the bottom of the photo.

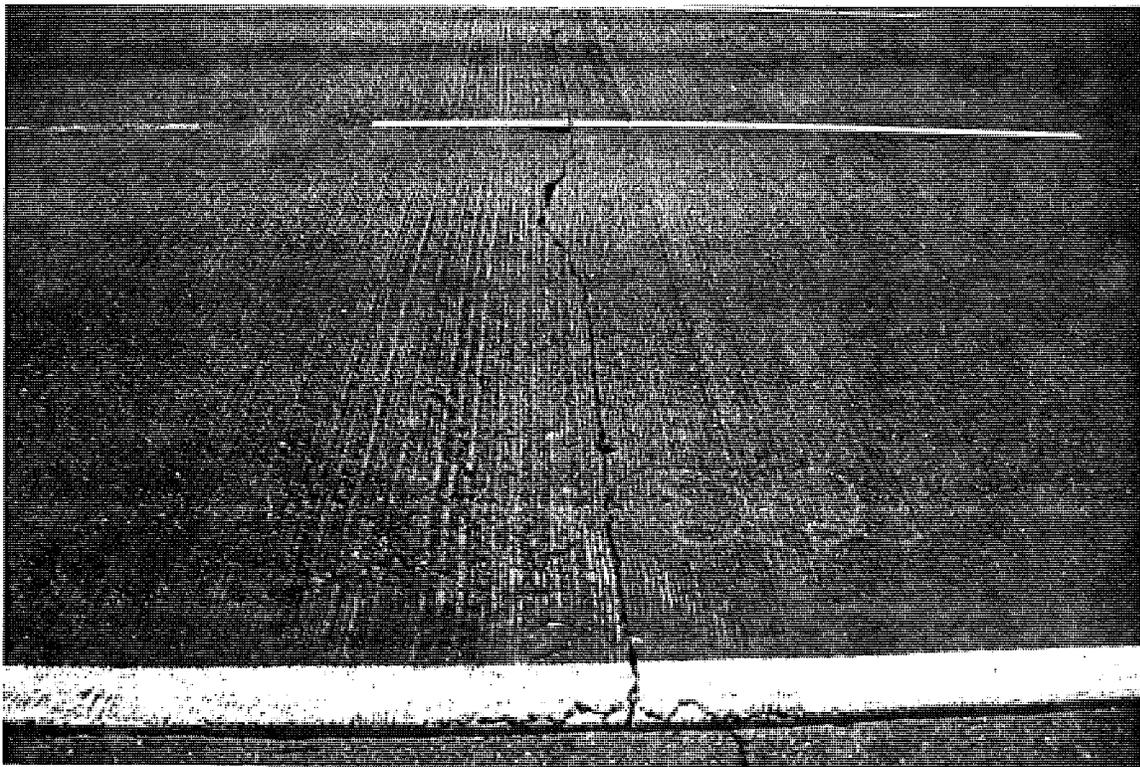
Photo C30. A typical third point full width crack showing the beginnings of spalling on CSN# 25132-06582A SB.

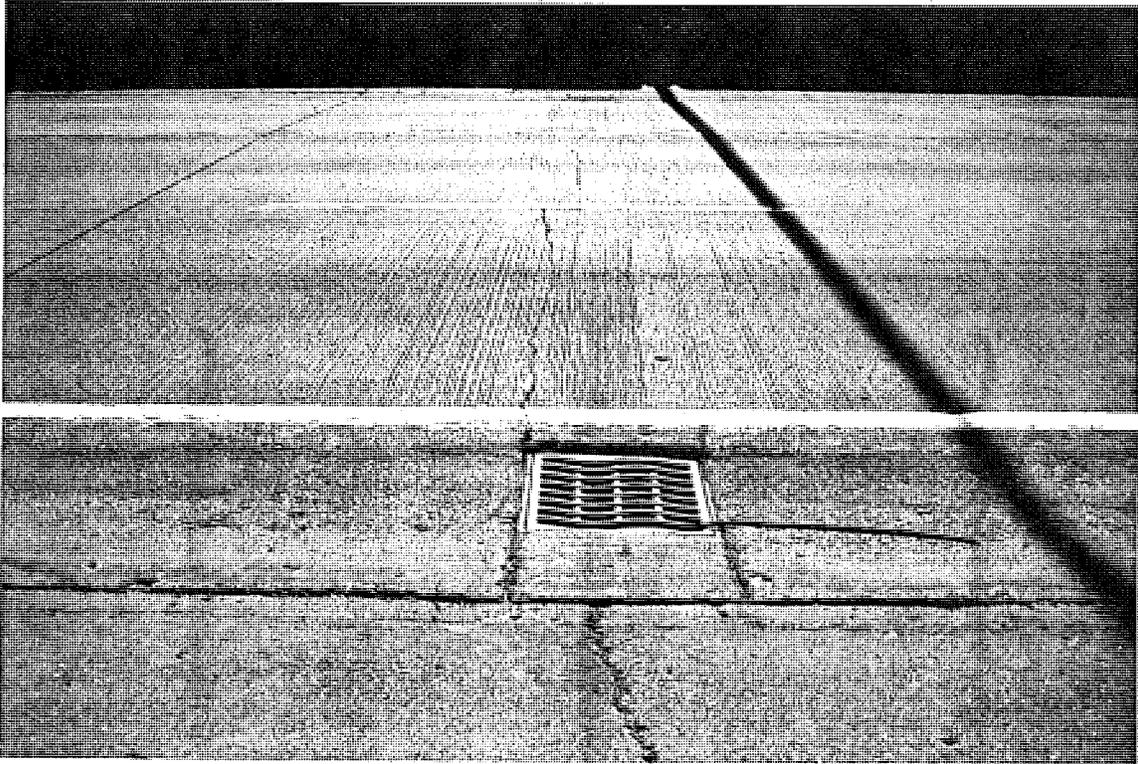
Photo C31. A drainage structure that has induced a full width transverse crack on CSN# 25132-06582A SB.

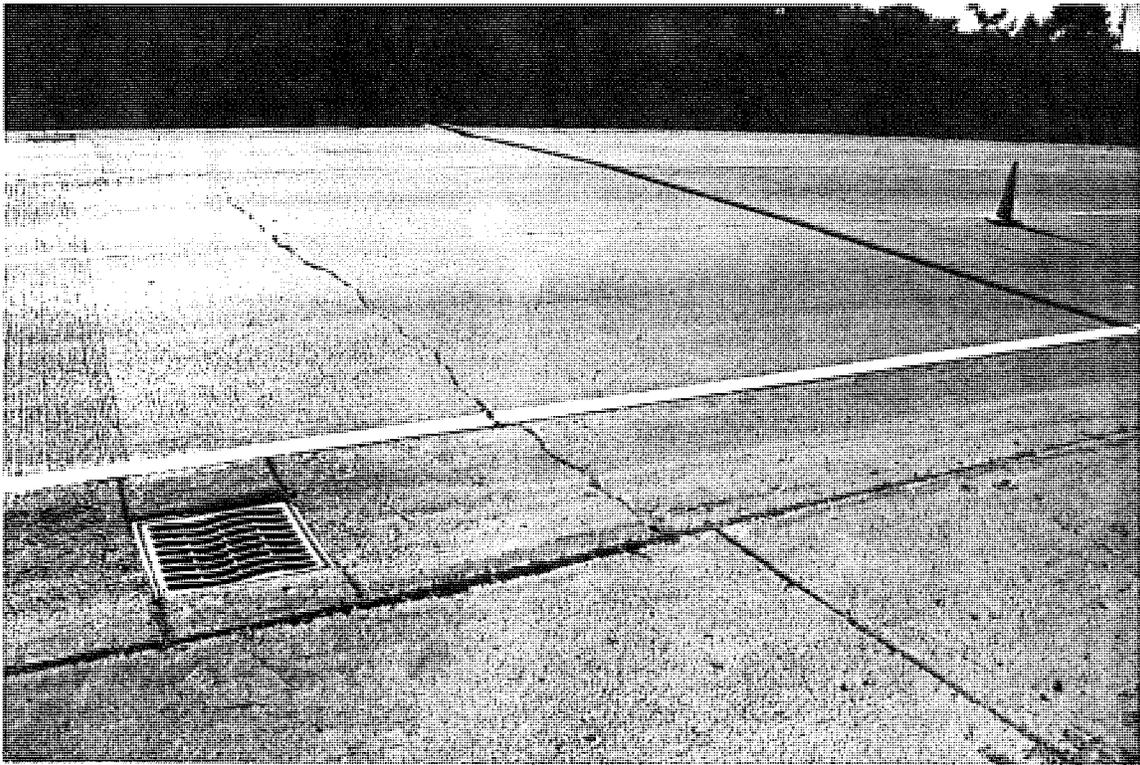
Photo C32. A full width transverse crack induced by the third point intermediate shoulder joints on CSN# 25132-06582A SB.

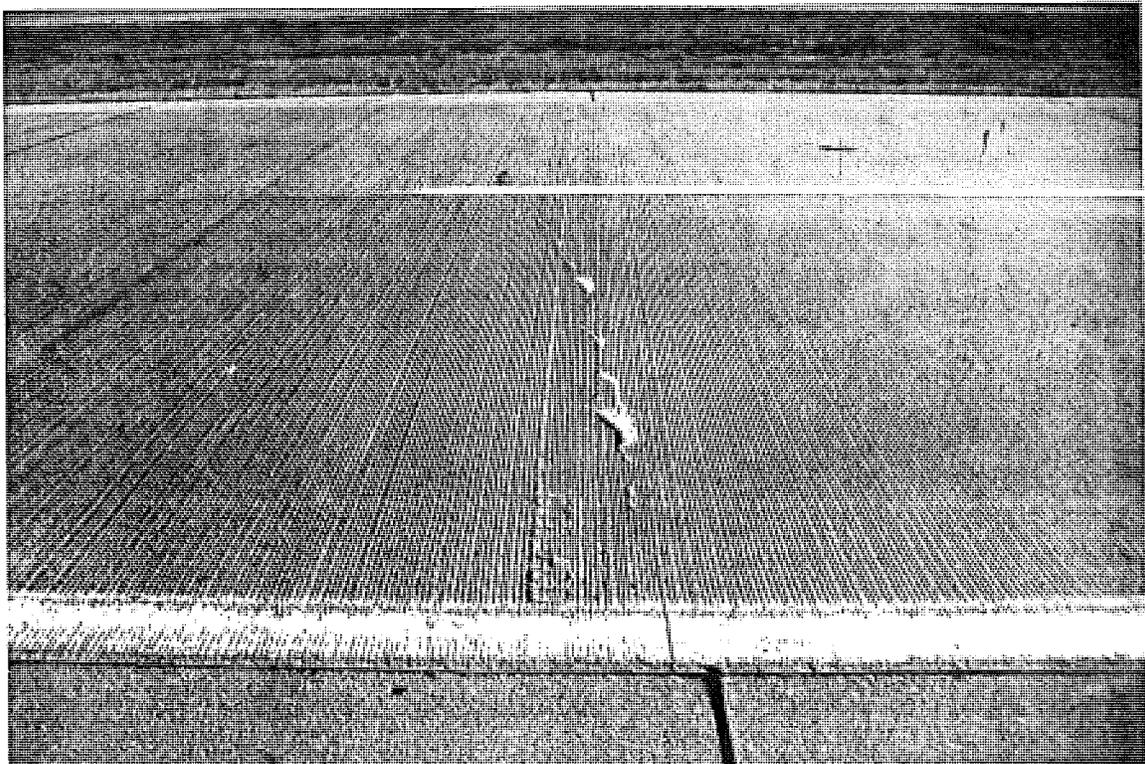
Photo C34. A third point crack that is spalling on CSN# 44044-18804A WB.

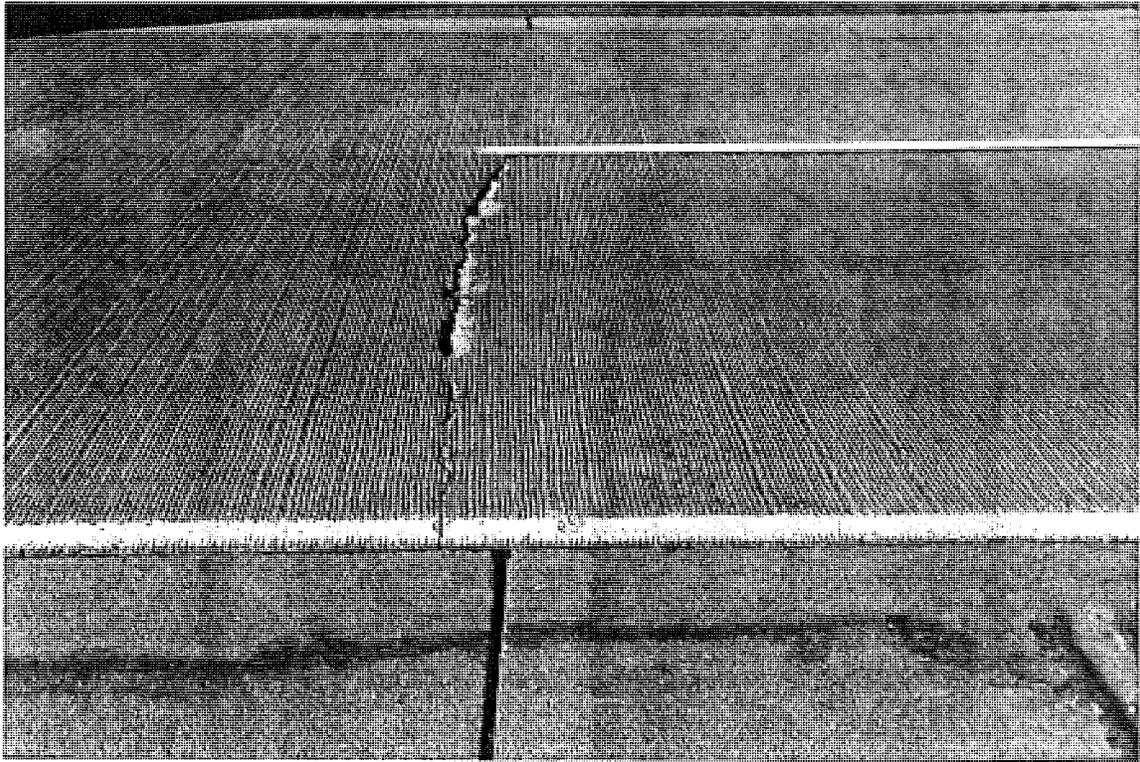
Photo C35. A full width transverse crack on CSN# 44044-18804A WB. The crack is tight in the passing lane and is spalling in the truck lane. This crack, was induced by the intermediate shoulder joint.

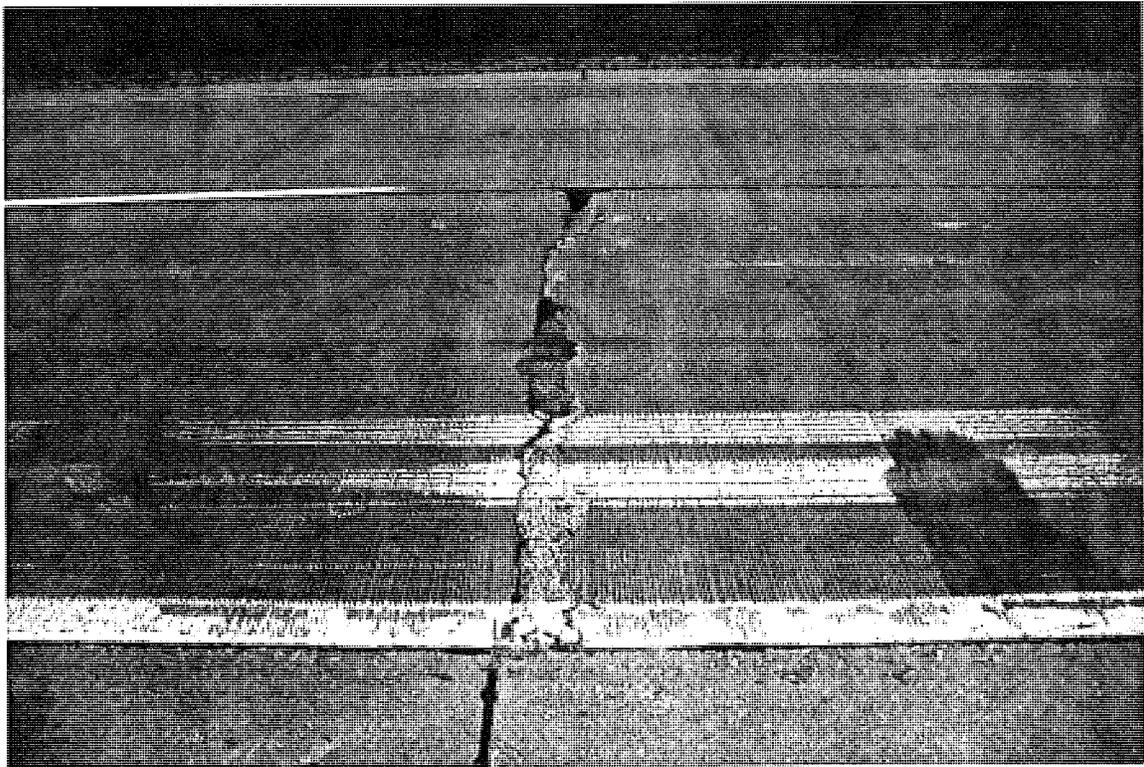
Photo C42. A transverse crack at a third point intermediate shoulder joint on CSN# 77023-21586 EB. Severe spalling is present in the truck lane and has been cold patched.

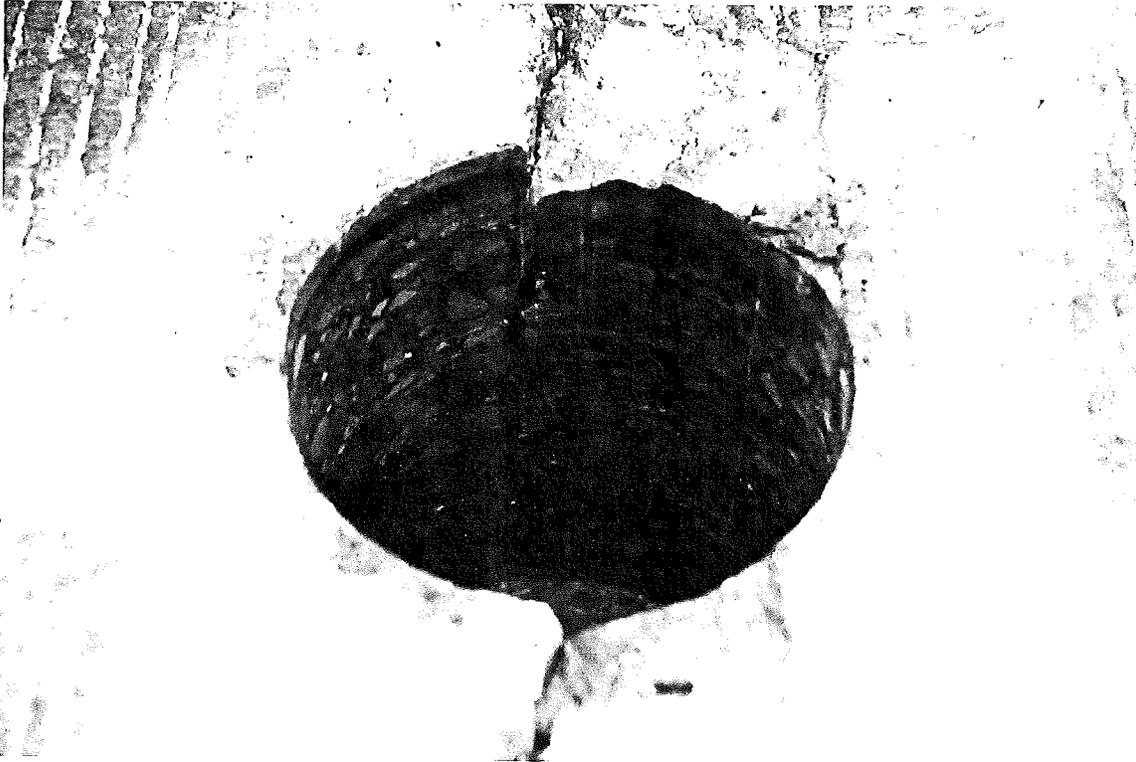
Photo C43. A core hole showing the effects of severe faulting and spalling on the crack faces of a transverse crack on CSN# 77023-21586A EB.
