APPENDIX D

Selected Site Photos

It is recognized that a visual record of a pavement section's condition is invaluable. Thus, this appendix is included to provide a brief overview of each test section. The photos presented for each test section include a site overview, photos of typical distresses in the section, and highlights of notable features on the site, such as clogged edge drain outlets.

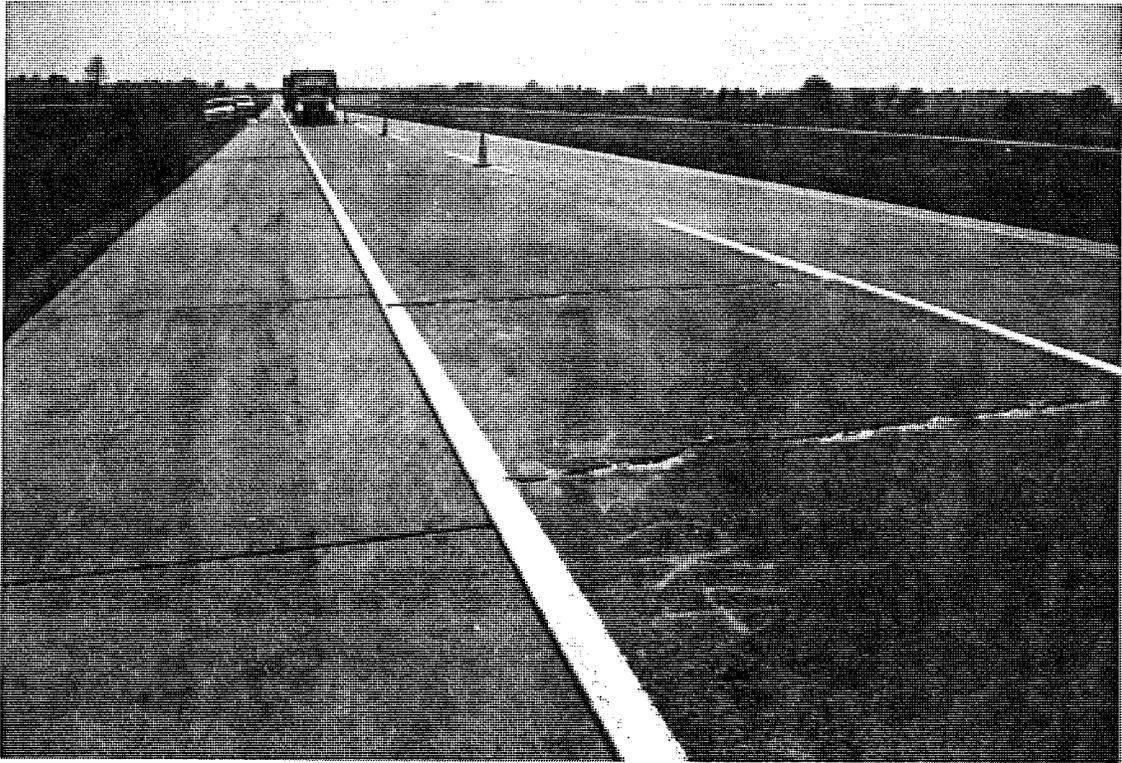
Photo C45. An overview of CSN# 77024-20821A (Section A), EB, showing severely spalled and faulted cracks at third point shoulder joints. The joint spacing in the driving lanes is 41 ft.

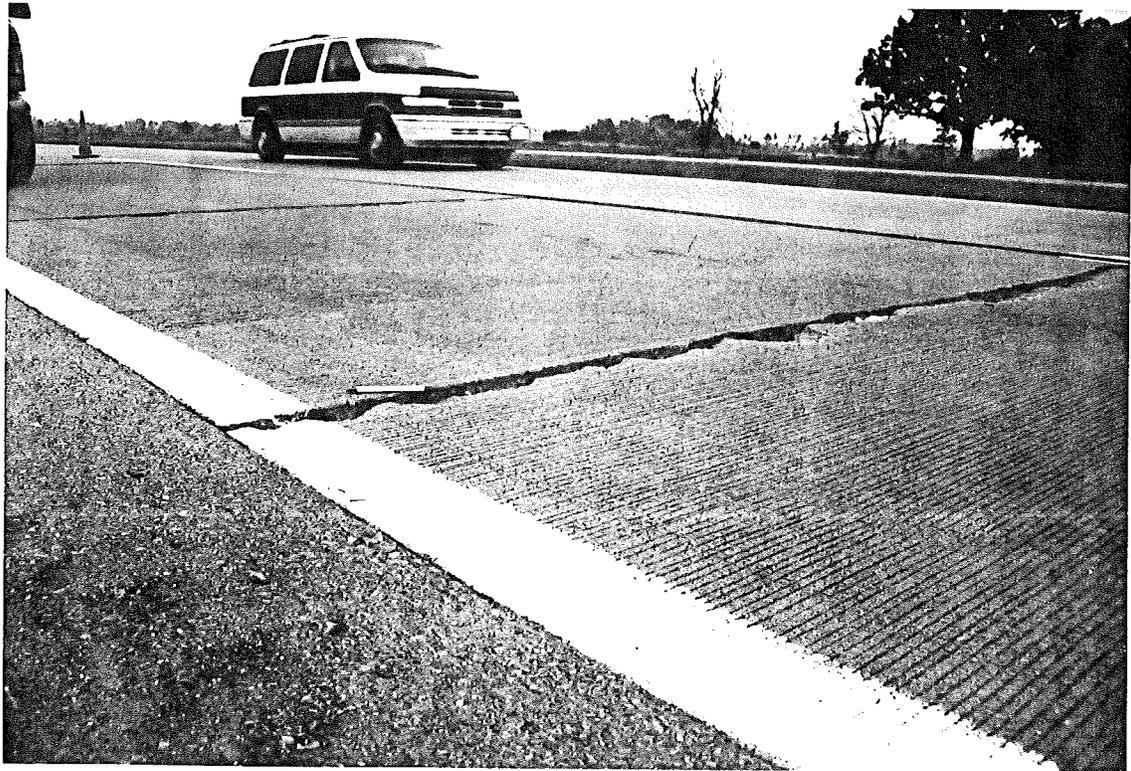
Photo C46. A severely spalled and faulted transverse crack in CSN# 77024-20821A (Section A), EB.

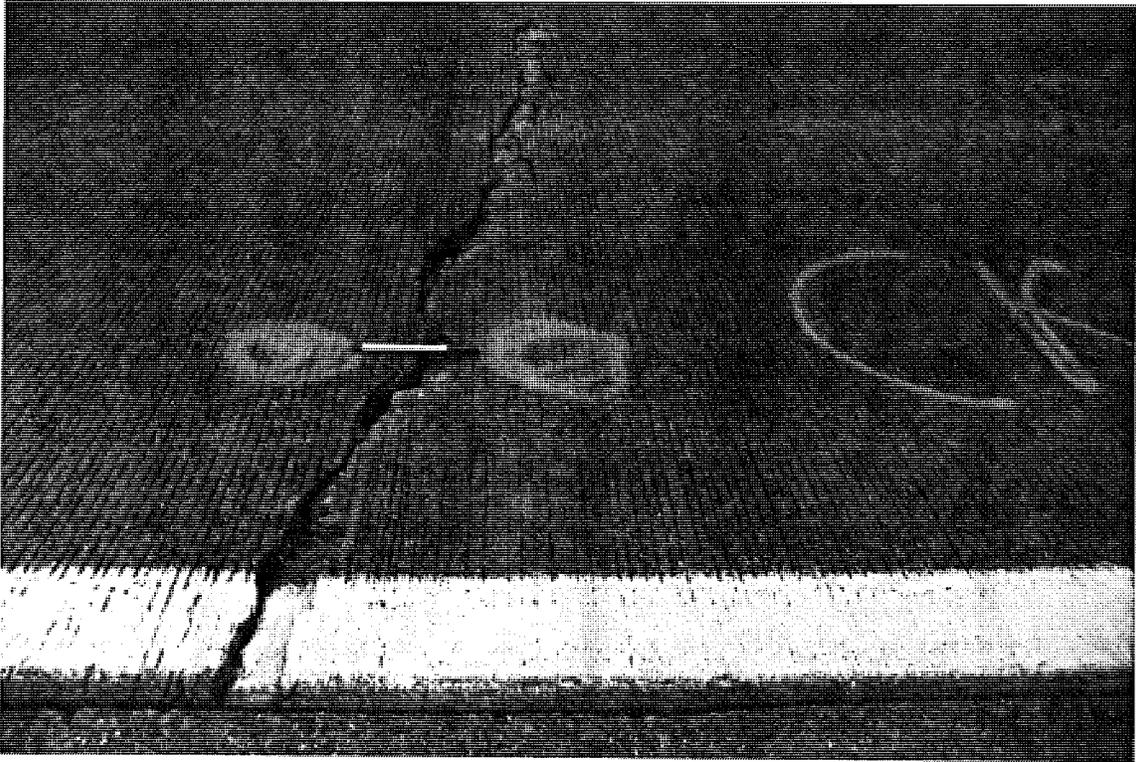
Photo C47. A typical transverse crack on CSN# 77024-20821A (Section A), EB, showing severe spalling and faulting.

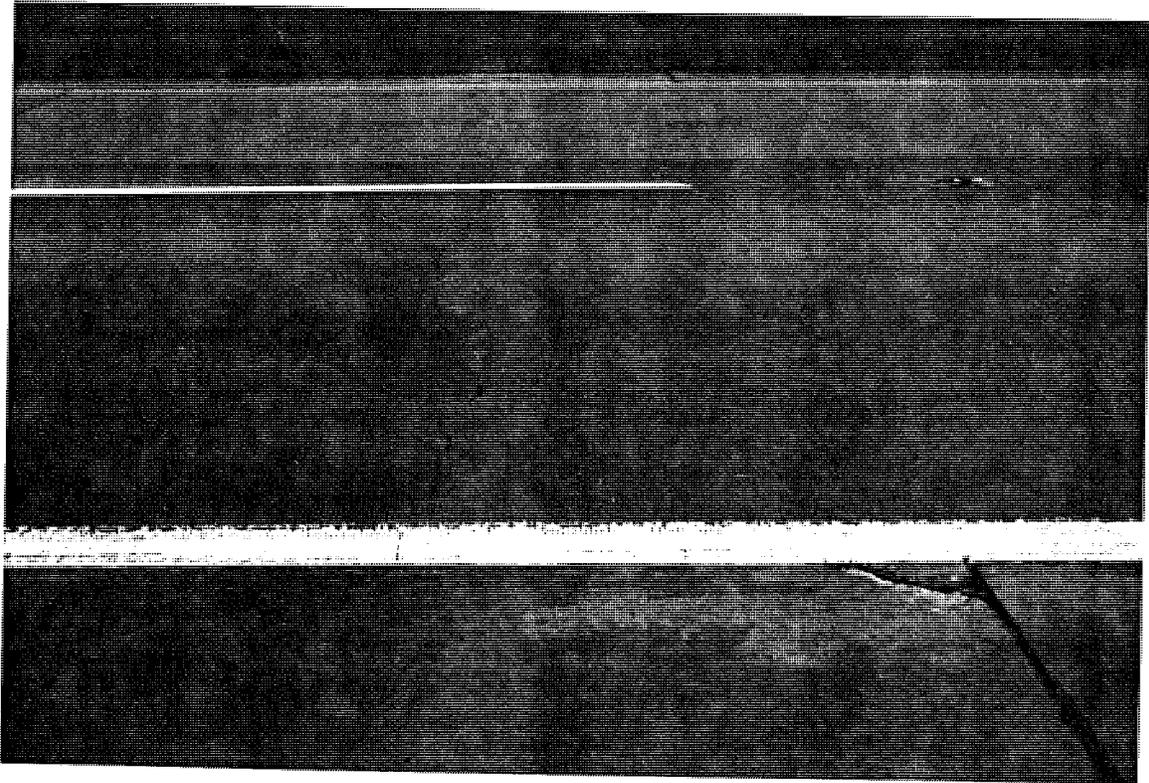
Photo C50. A typical third point transverse crack on CSN# 77024-17988A, (Section B), EB. The beginnings of spalling are visible here.

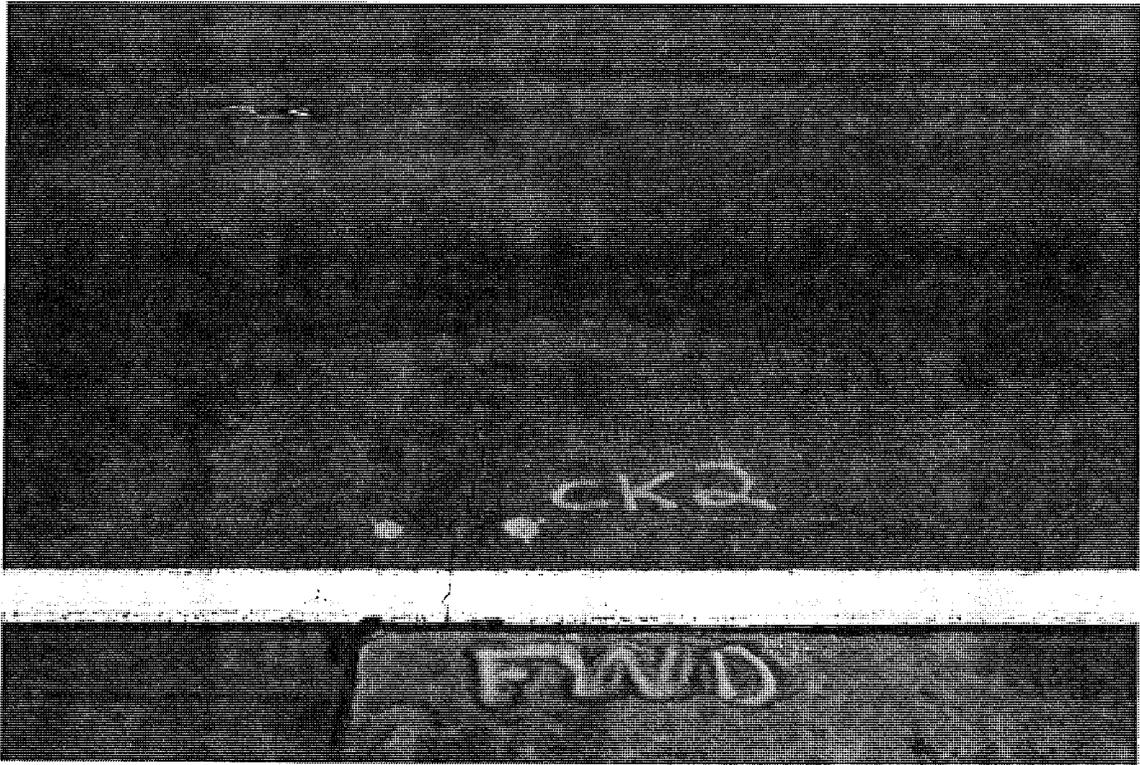
Photo C51. A tight transverse crack induced by the intermediate shoulder joint on CSN# 77024-17988A, (Section B), EB.

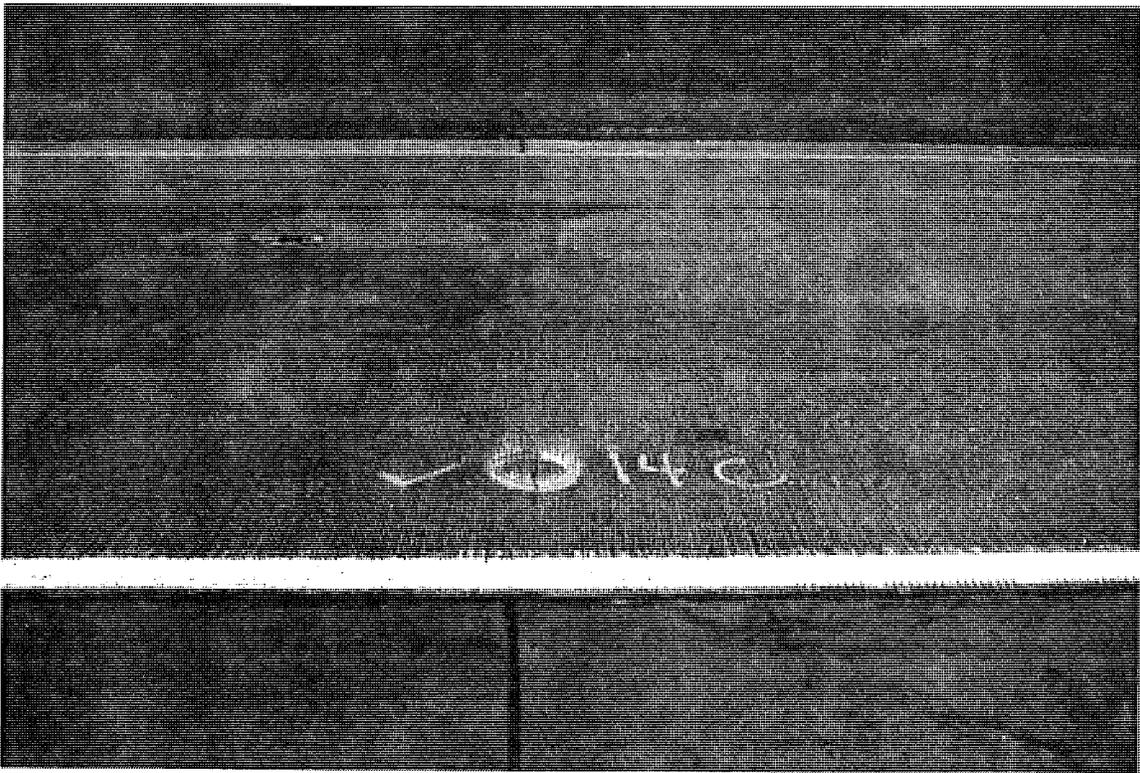
Photo C52. A typical transverse crack on CSN# 77024-17988A, (Section B), EB. Showing the location of core 14.
