1. Report No. RC-1605	2. Government Accession No.	3. MDOT Project Manager	
4. Title and Subtitle Twenty Year Performance Review of Michigan's European Concrete Pavement		5. Report Date October 7, 2013

**Twenty Year Performance Review of Michigan's European
Concrete Pavement**

John F. Staton

**Construction Field Services Division
Research Report**

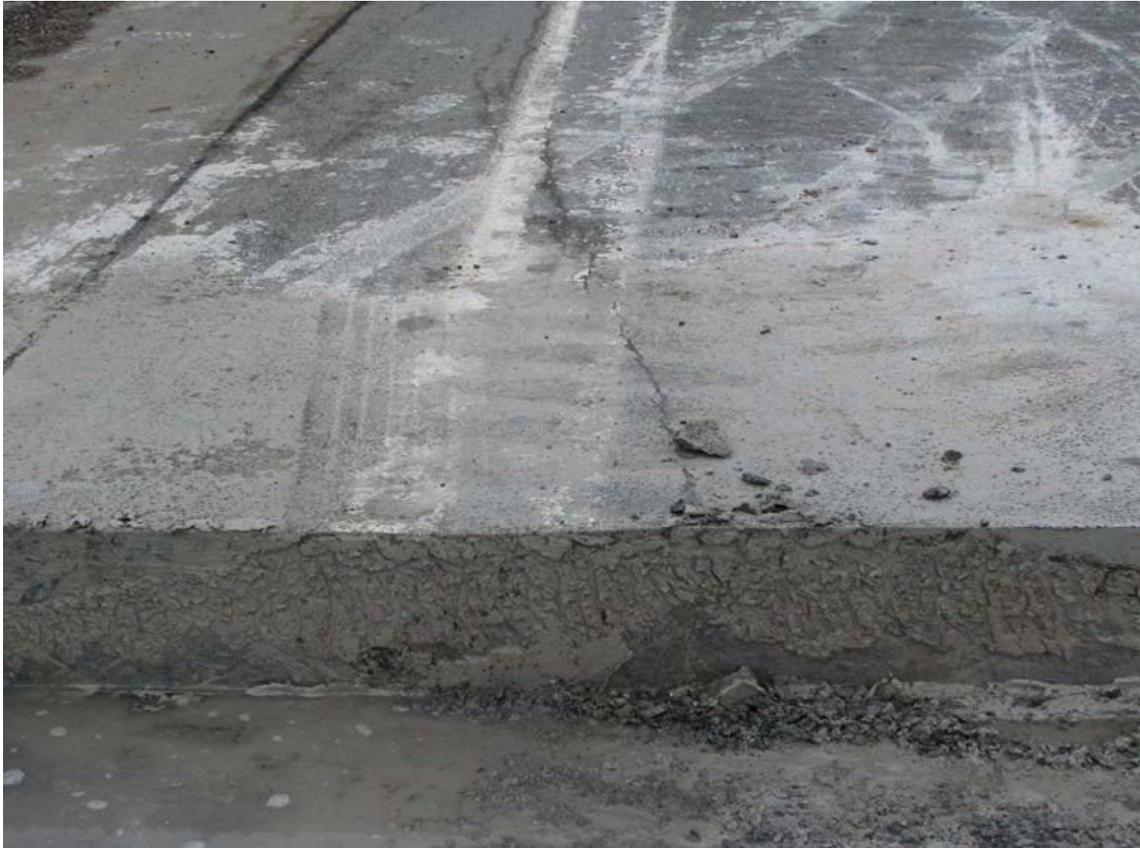
FIGURE 5. Typical Longitudinal Crack (LC) with Euro-pavement

The LC is intermittent over the project length, but it occurs mostly amongst groups of two and three contiguous slabs. The LC has slight wander and occurs in the right third of the slab width (13.5'), shoulder side of the right wheel-path. It may skip to the next slab with a slight offset at a transverse joint. A picture of a slab with a typical LC is shown in figure 5, when it was replaced. Most LC is occurring in the outside right lane.

The February 2007 coring found the LC to be full-depth through the 10" two-layer, surface pavement. There was no indication that reflective cracking was occurring, as no cracking was found below in the lean concrete base. Where cracks existed, the cores found no bond between these pavement layers, as well as, no indication of scour or erosion at their interface. The crack width was noticeably wider through the carbonate portion of the 10" layer, which would indicate the cracks are occurring bottom-up. Figure 6 is a core which depicts the contrast in crack width between the layers. Where multiple cores were taken in the same panel, the lower crack width was wider near mid-panel, than near a transverse joint.

- Water upon entering the interface between the 10” surface slab and LCB, begins to degrade any bond. During winter it freezes, then acting as a fulcrum lifts the outside edge of the 10” surface slab. The lifting action (ice formation) forms a gap (void space) adjacent to the ice formation, leaving that portion of the slab unsupported during truck loading. A tensile stress forms in the area of this gap at the bottom of the slab. From normal fatigue, especially during melting¹⁵, the crack initiates. Over time, the process continues and the crack propagates to the surface and free edge (joint). This postulate is supported by the fact that the LC is wider with depth (bottom-up initiated).

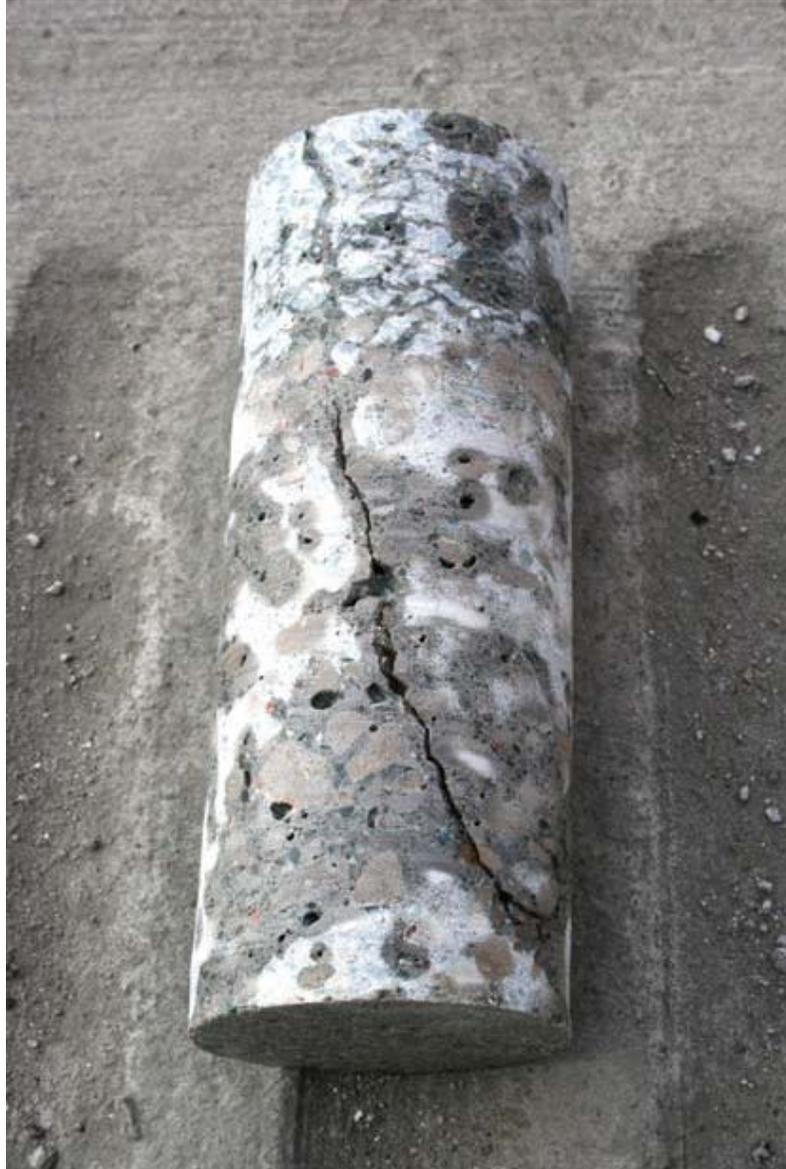
Figure 6. Contrast in Crack Width per Depth of Euro-Pavement Longitudinal Crack

As at the north end, the LC was found to be full-depth. Although the crack width was very tight at the surface, it was remarkably wide through the carbonate concrete layer. The crack width contrast was dramatic at the layer interface, much unexpected. Again, there was no indication of bond at the interface with the lean concrete base which showed no scour or cracking. The cores also found (surprisingly) the sub-crack width wider away from the TJ, nearer mid-panel.

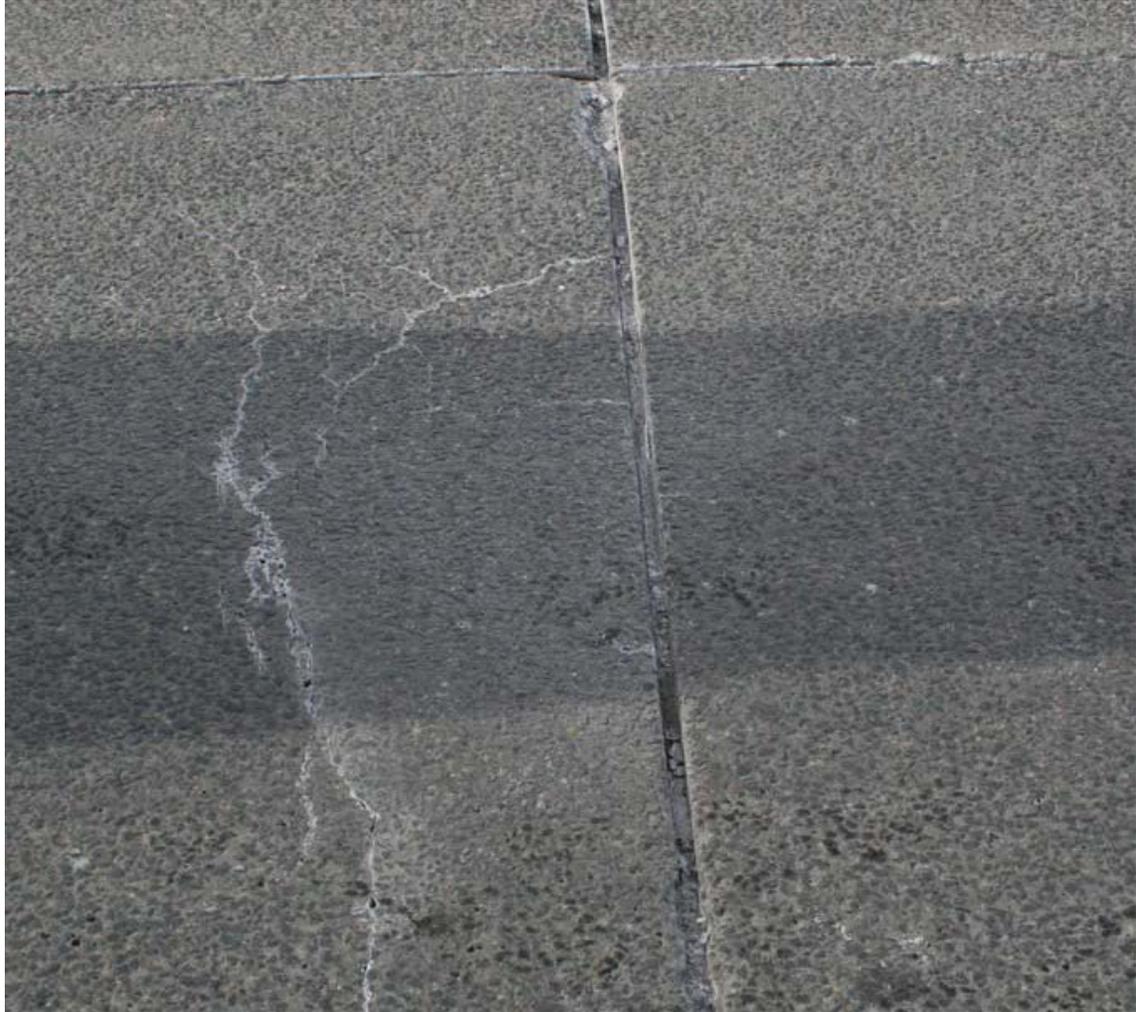
Areas of surface spalling were also cored. Visually, the spalling is not confined to any particular lane or location within the project limits, but does occur mostly adjacent to joints and cracks. The cores showed the spalling to more resemble a delamination action of the top-course. It appears to be initiating within the depth limits of the top-layer and not at the interface with the carbonate layer. Sounding with a heavy metal rod or hammer produced a classic hollow-thud, indicating internal layer separation. Site inspection of the cores showed the exposed layer depth was poorly consolidated with indication of possible freeze-thaw deterioration. Figure 7 through 9 show a series of picture examples of the severity levels of the surface spalling from a starting condition without breakup to where patching with cold-patch becomes necessary.

FIGURE 7. Beginning Spall of Euro-Pavement
Note: White substance in crack is salt (de-icing) residue.

As stated, the surface delamination of the exposed aggregate surface layer is easier to explain. The delamination appears to be solely material-moisture related. The joint cavities are retaining water and de-icer (chloride) materials, providing a source for freeze-thaw action and/or degradation of the concrete’s air-void system from infilling. MDOT conducted a petrographic examination and hardened air determination of core samples. The report with results is included in the appendix. The air-void system exhibited post-construction deposits, most likely a carbonate formation that is compromising freeze-thaw resistance. Measured entrained air properties are marginal per PCA guidelines. Although no permeability testing was performed, microscopic examination of the cores and broken pavement fragments indicates the concrete is highly susceptible (permeable) to water entry. The concrete breakup is occurring under traffic loading after internal expansion cracking from freezing action.

No coring was done at surface spall/delamination areas as no additional confirmation of their condition was believed warranted. The FHWA recommendation was the delaminated areas should be repaired with traditional partial depth patching methods.

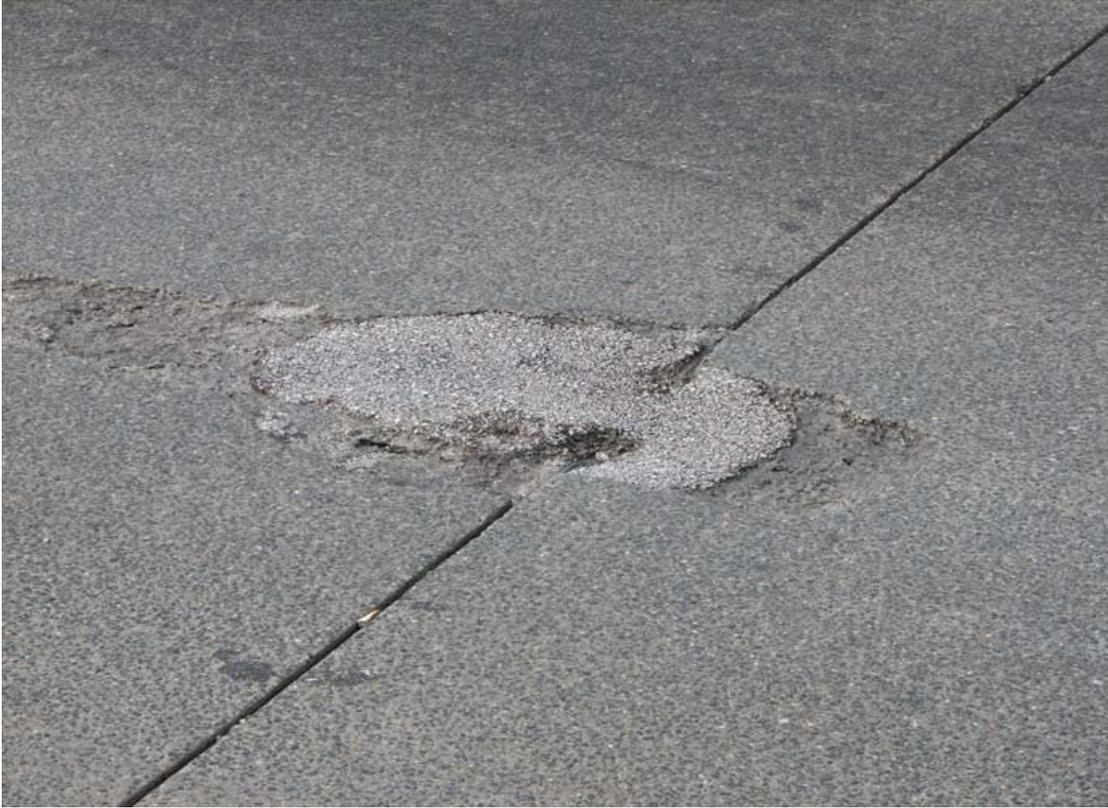
FIGURE 8. Spall on Both Sides of Transverse Joint of Euro-Pavement

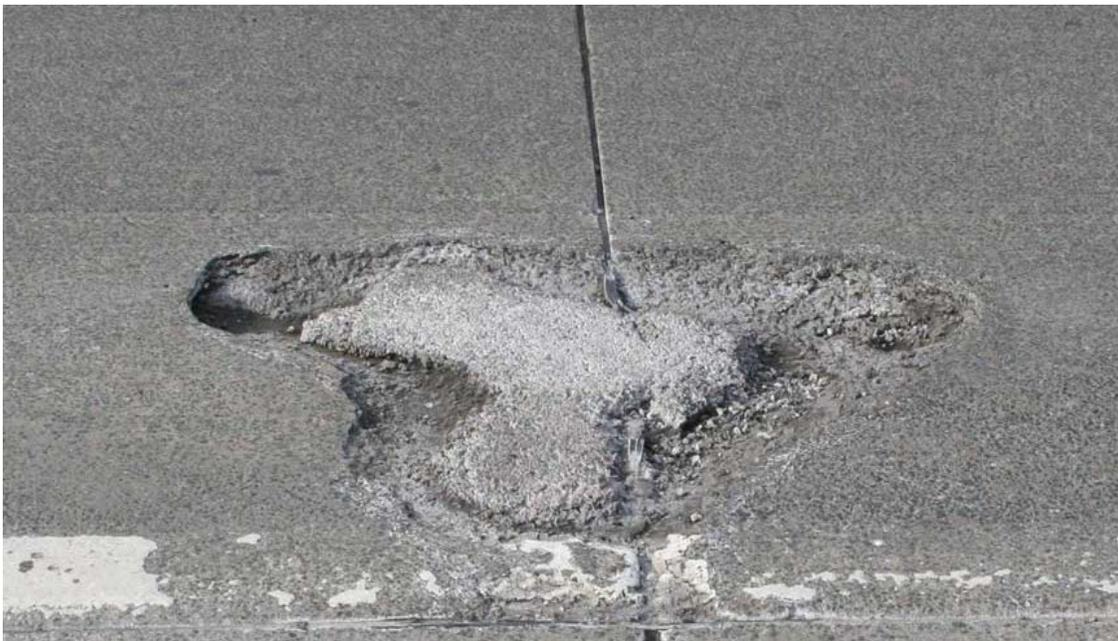
FIGURE 9. High Severity Spall/Delamination of Euro-Pavement

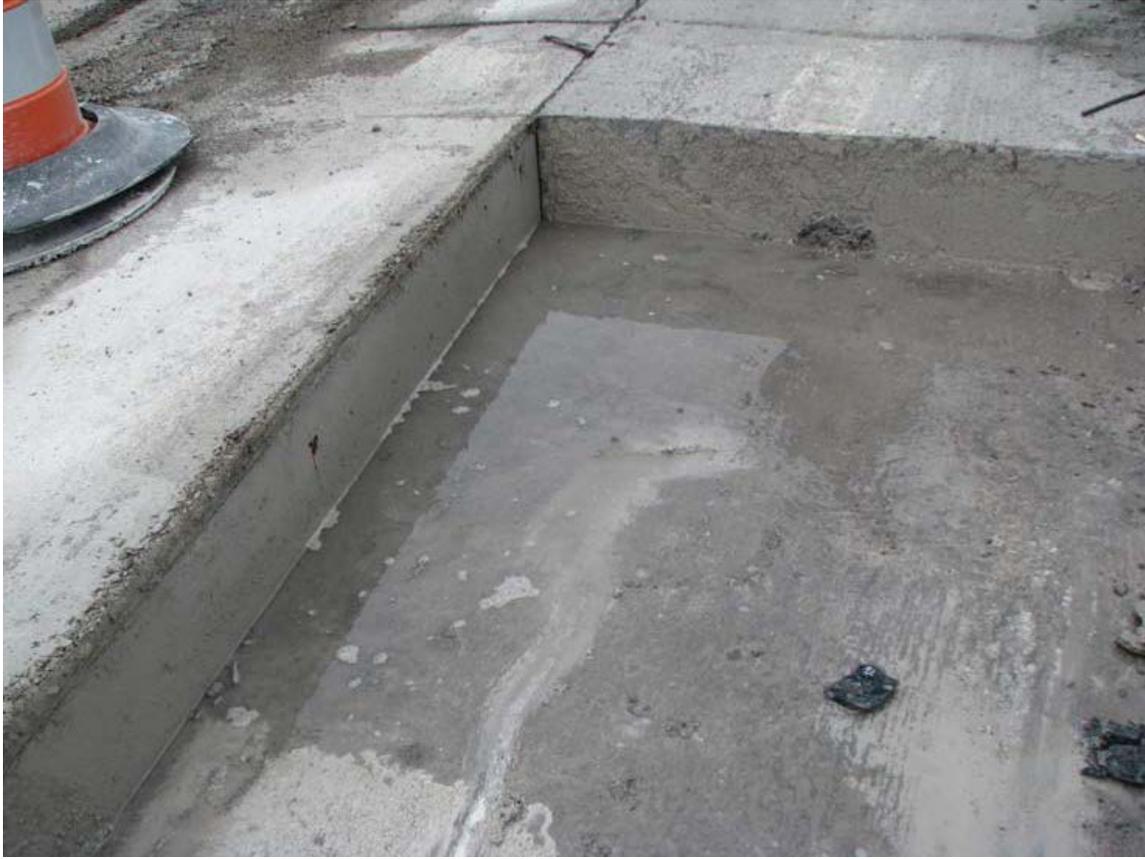
Figure10 is a revealing picture of the lean concrete base after pavement removal showing standing water. The water is apparently unable to gravity drain through the shoulder interface to the underdrain trench. Whether this standing water is evidence of a non-existent drainage path or a clogged interface (pathway) is subject to conjecture. But, the condition is still relevant as it may provide confirmation of why designs emphasizing structural performance need to account for the eventual onset of non-structural causes for deterioration.

**FIGURE 10. Exposed Lean Concrete Base of Euro-Pavement
(Note standing water)**

Euro-pavement full-depth pavement repairs for longitudinal cracking were made in only two areas¹⁸ in the outside lane. The repair area included the entire slab width. The SP included a schematic of the repair detail, which is included in the appendix. The lane ties were replaced with larger No. 9 epoxy-coated, deformed bars. The lean concrete base was not disturbed during the repair of the 10" surface pavement. As with the partial-depth repairs, the surface received a broom finish and was coated with curing compound. No deterioration of the polyethylene dowel bar coating after 15 years of service was reported during slab removal.

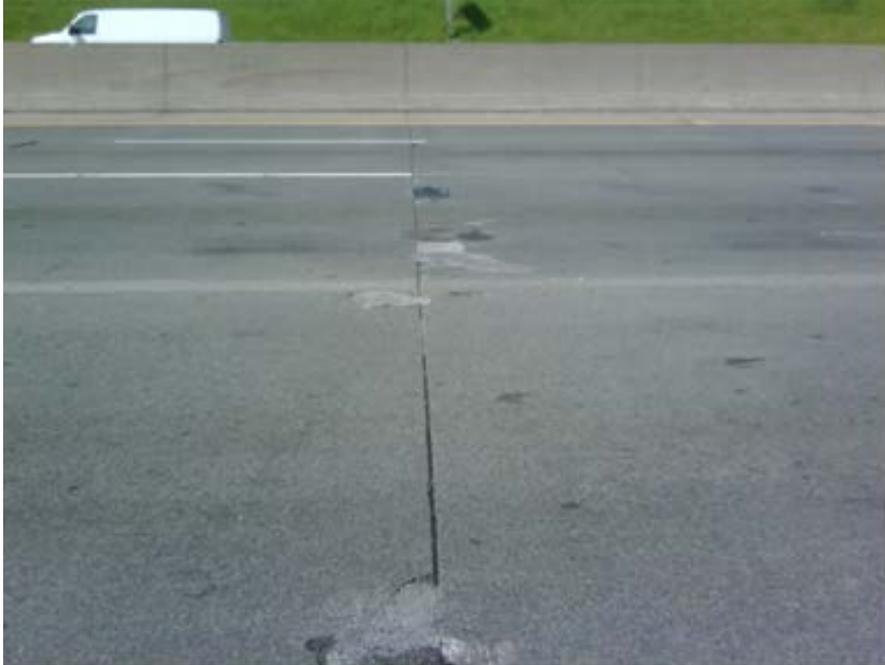
Some of the partial depth repairs performed during the 2008 preventive maintenance project have already failed. However, the full depth repairs installed at the same time are performing in good condition. Some joint seals have already failed, and based on micro-cracking at the transverse joints, a majority of these joints are likely to exhibit spalls.

FIGURE 11. 2012 Pavement Condition - Spalls at Transverse Joints

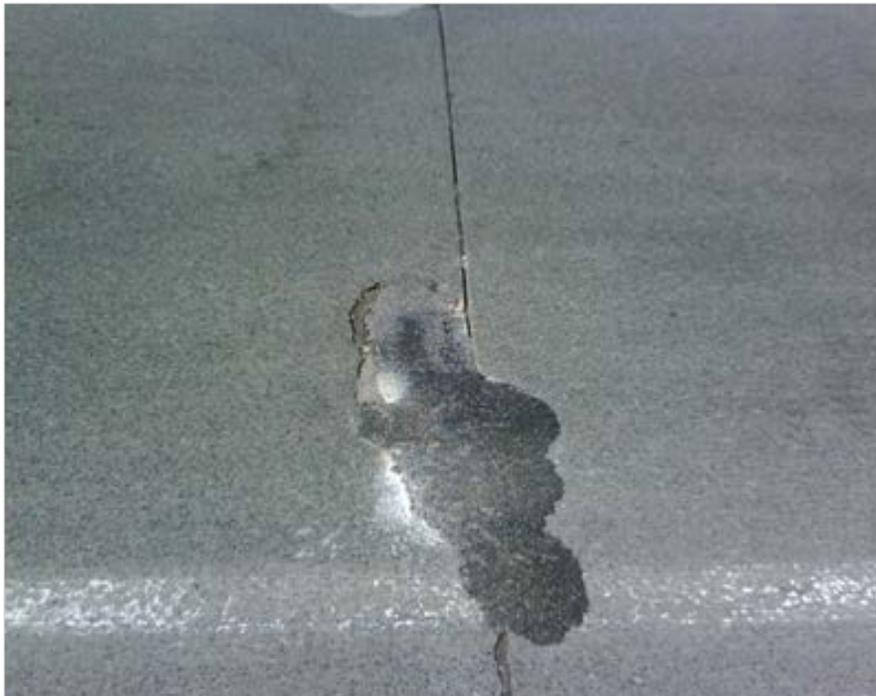
FIGURE 12. 2012 Pavement Condition - High Severity Spall at a Transverse Joint
