DEPARTMENT OF STATE HIGHWAYS

July 11, 1973

Subject: Joint Failures on I 75 North of Flint.
Research Project 68 F-102. Research Report No. R-869.

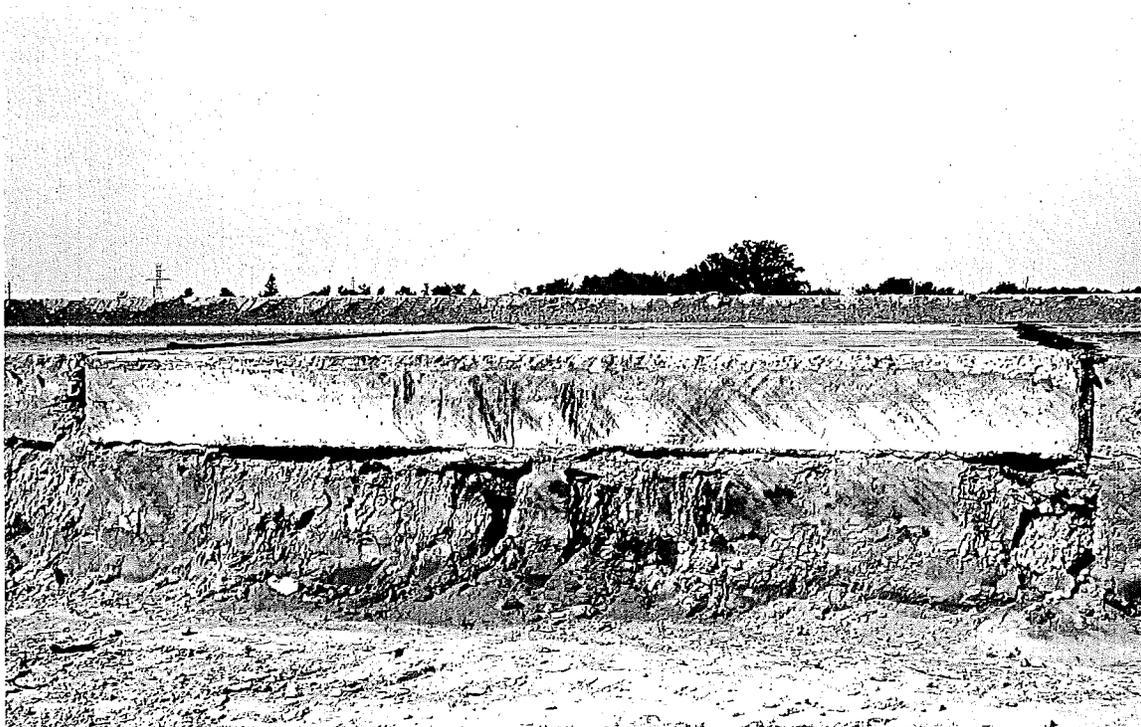
Figure 1. Typical precast slab repair in an area where shoulder and base materials have been removed.

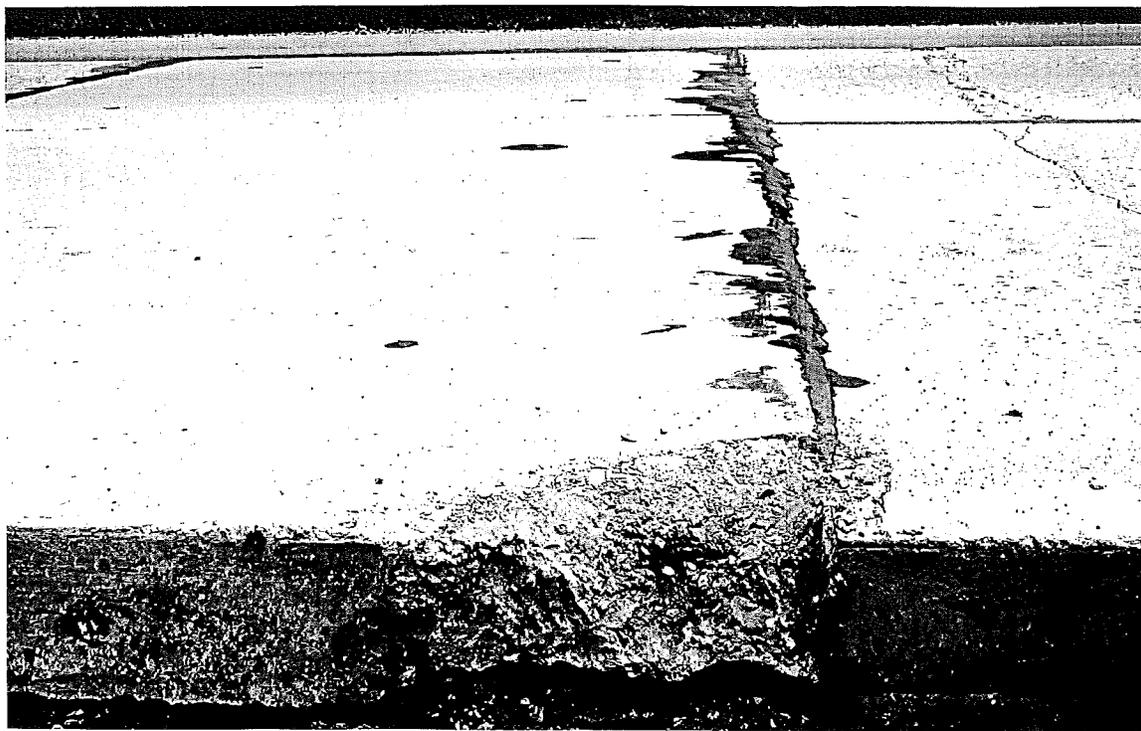
The slab at Sta. 1436+20 (northbound) was found to be about 1-in. high along the south edge. A corner spall, measuring about 12 by 18 in. at the surface, had occurred in the precast slab as can be seen in Figure 2. The slab was about 2 in. wider than the existing pavement lane and the spall appeared to have resulted from the slab being hit by equipment used to remove the existing shoulder. It is believed that the severity of the collision was sufficient to cause a vertical misalignment of the slab. The problem may have been aggravated by the increase in compressive forces resulting from the hot weather in early June. During that period a blowup occurred in the passing lane 1,400 ft south of the precast slab repair. The traffic lane had been repaired with a precast slab earlier, but no relief was provided in the adjacent passing lane.

Figure 2. General view of precast slab repair at Sta. 1436+20 (northbound) showing high side and damaged corner.

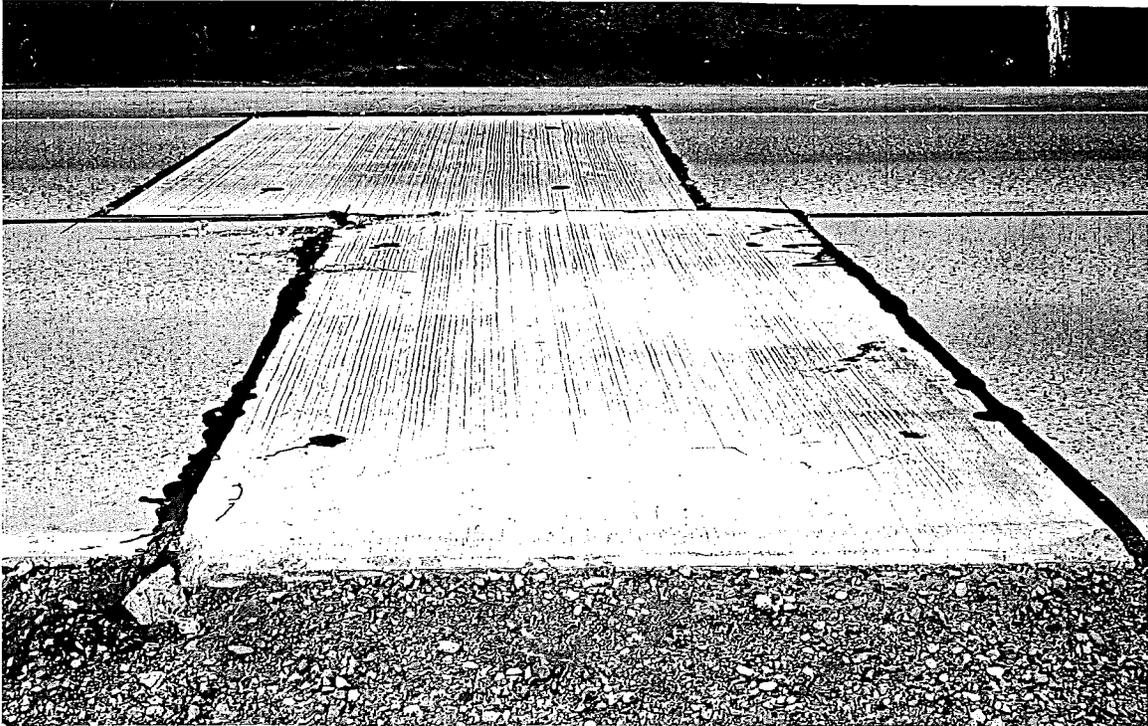
The condition of the repair of Sta. 1369+90 (southbound) is shown in Figure 3. The slab had raised up about 1 in. along the south edge. The precast slab extended about 2 in. beyond the existing slab edge and had been hit during removal of the shoulder and base materials. The filler was completely compressed and a surface corner spall had occurred (Fig. 4). A surface spall along the offset between the traffic and passing lane slab extended a-

Figure 3. Condition of repair at Sta. 1369+90 (southbound). High side of slab and spalling are on the left side of repair.

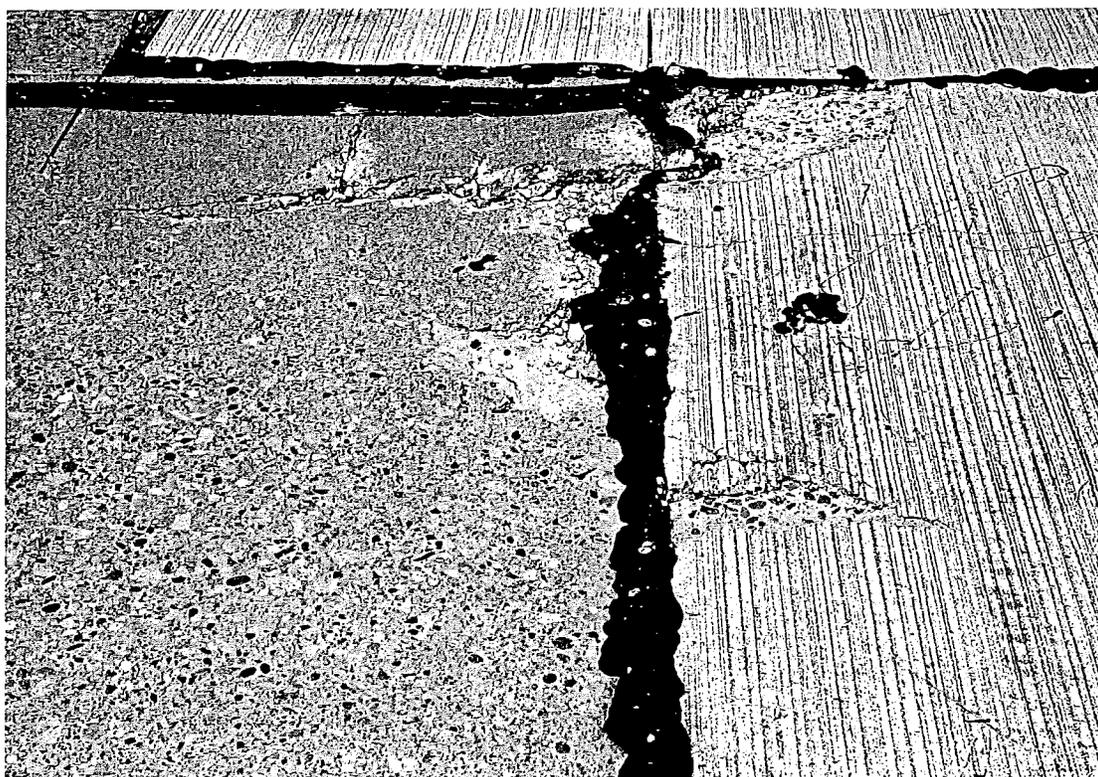
bout 3 ft out from the centerline (Fig. 5). This spall appeared to be about 1-1/2 to 2 in. deep. The precast slab had also spalled along the joint in this area. As in the case of the slab on the northbound roadway the vertical misalignment could have occurred initially during removal of the shoulder. The spalling has been caused by expansion of the pavement which possibly could have increased the amount of vertical alignment offset. The reason for the compression failure is that only the passing lane was available to resist the pavement expansion because a repair had been made at the adjacent joint in the traffic lane without providing relief in the passing lane. Thus, twice as much expansion can be accommodated in the traffic lane as compared to the passing lane.

Figure 5. Condition of repair along the centerline showing spalled area.
