STEEL-FIBER-REINFORCED CONCRETE OVERLAY

Progress Report

Research Laboratory Section
Testing and Research Division
Research Project 72 F-127
Research Report No. R-878

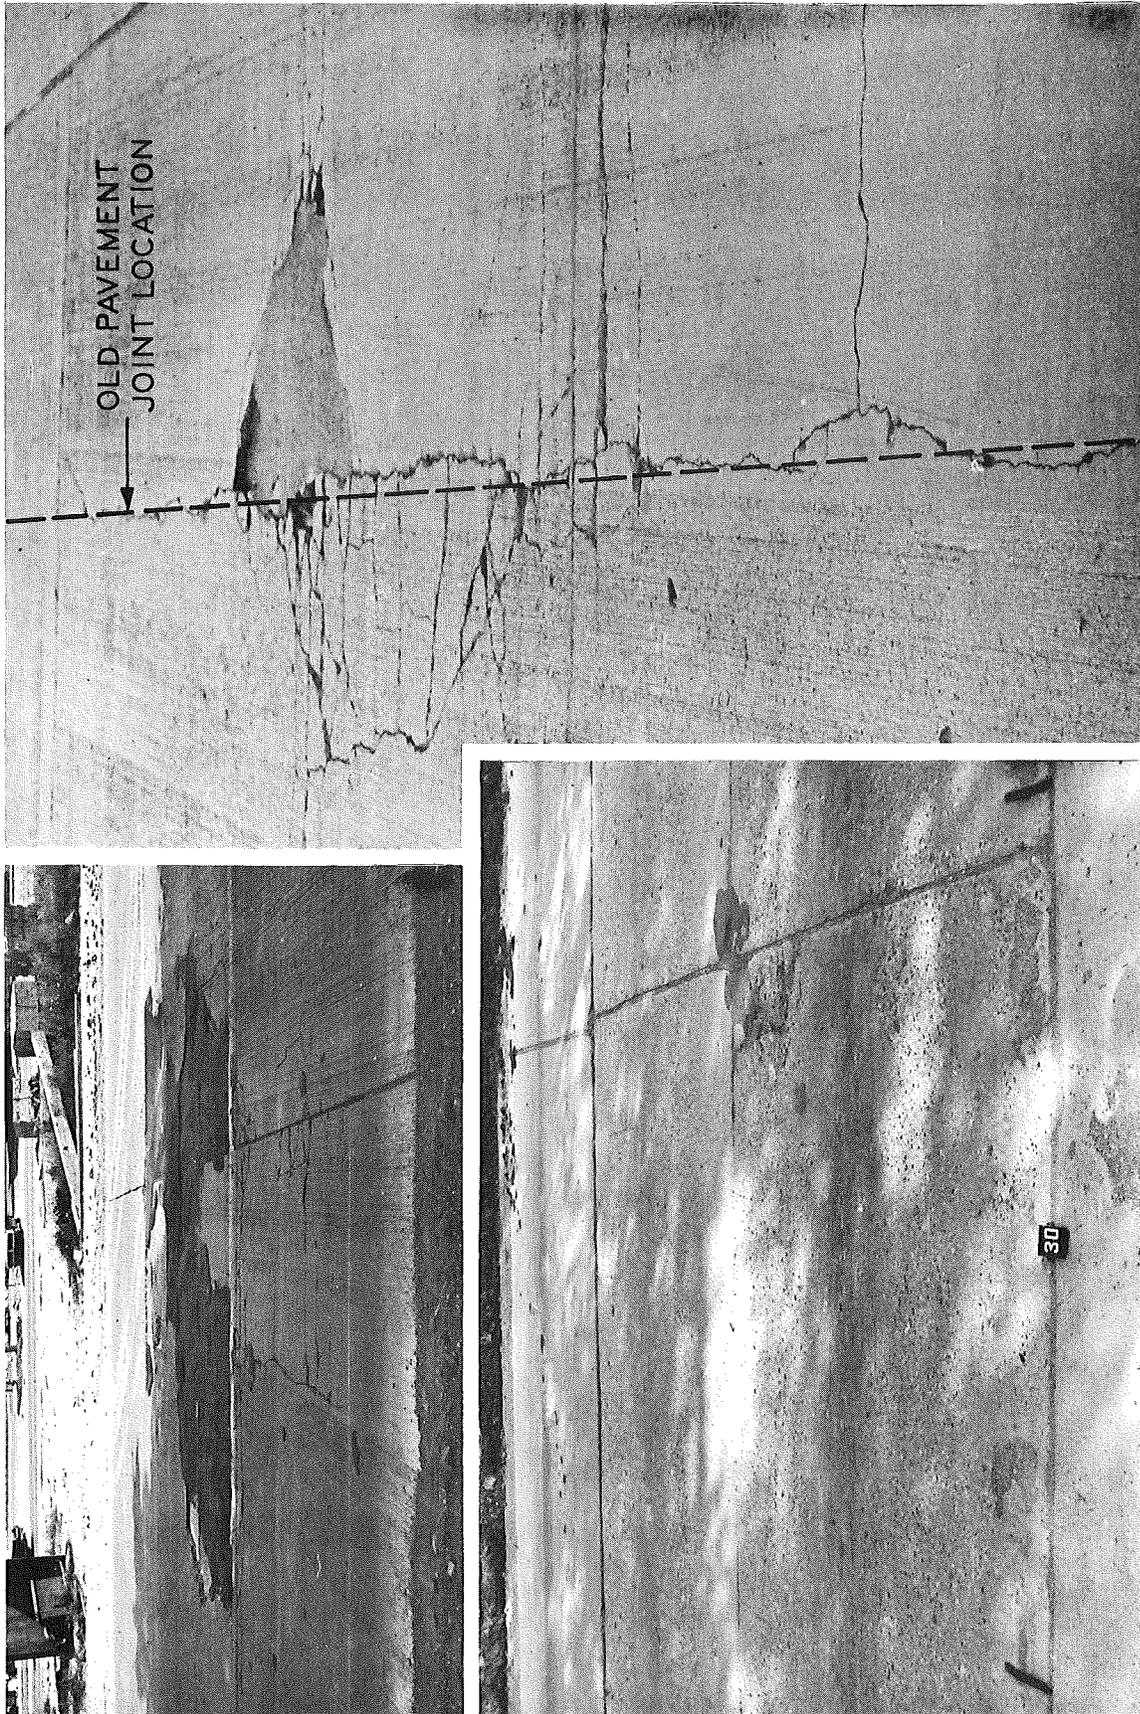
After nine months, the largest deteriorated area is the area where the first failure occurred. Figure 1 shows the extent to which the failure has spread at that location. It is obvious that the extent of the failure is not related to pavement condition underneath the overlay, since much of the area has a sound concrete slab underneath. Fragments at this location show the thickness of the overlay to be only slightly more than 1 in. Figure 2 shows conditions at several other locations. The worst conditions were found in the western, or 120 lb/cu yd, section of the overlay. Similar failures in earlier stages of development were found in the outside lanes of the 200-lb/cu yd section as well.

Figure 1. Extent of failure at the location where initial failure occurred. Photo at lower left shows original pavement; overlay at age 3 months (right); and, overlay at age 9 months (upper left).

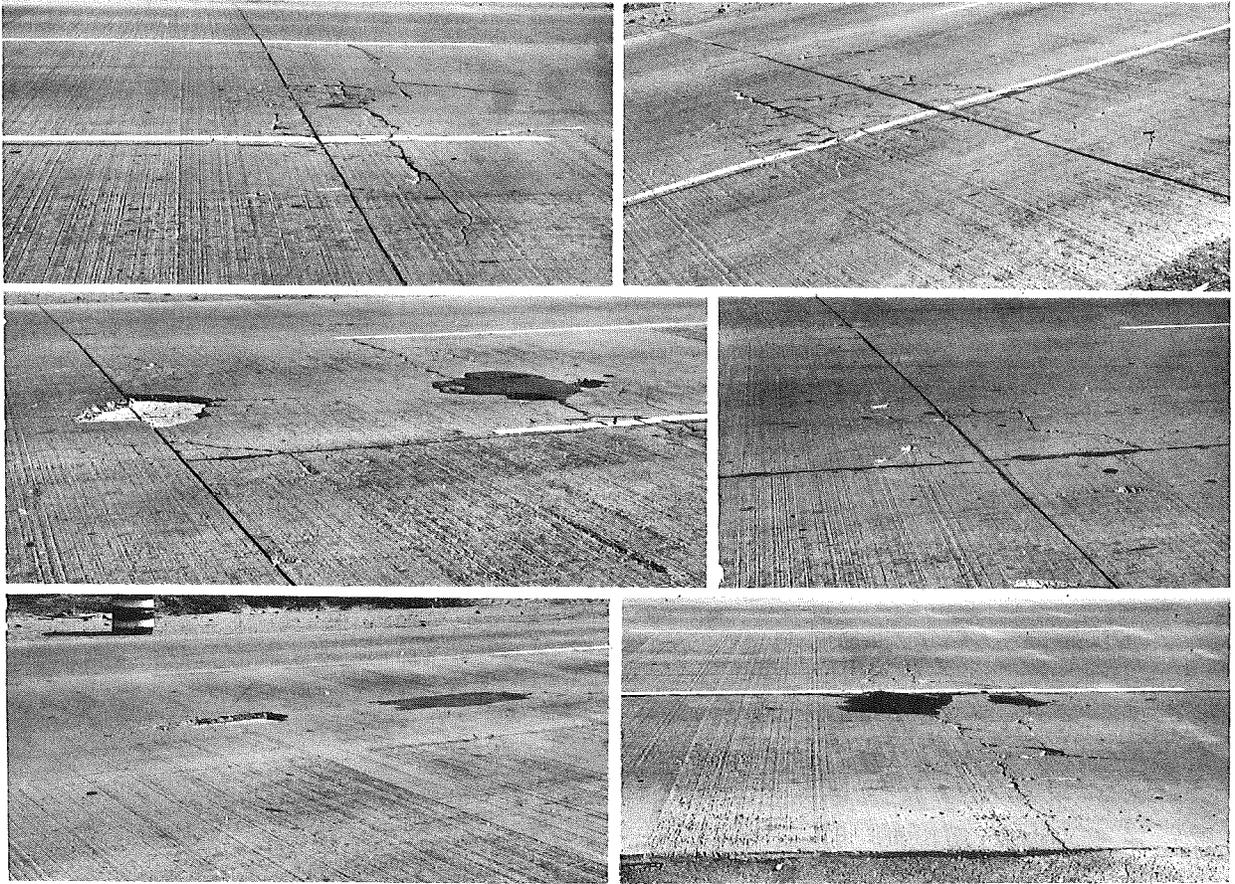
Figure 2. Examples of overlay failures, mainly within the western or 120 lb/cu yd section. However, similar failures in earlier stages of development, were noted in the outside two lanes of the 200 lb/cu yd section.

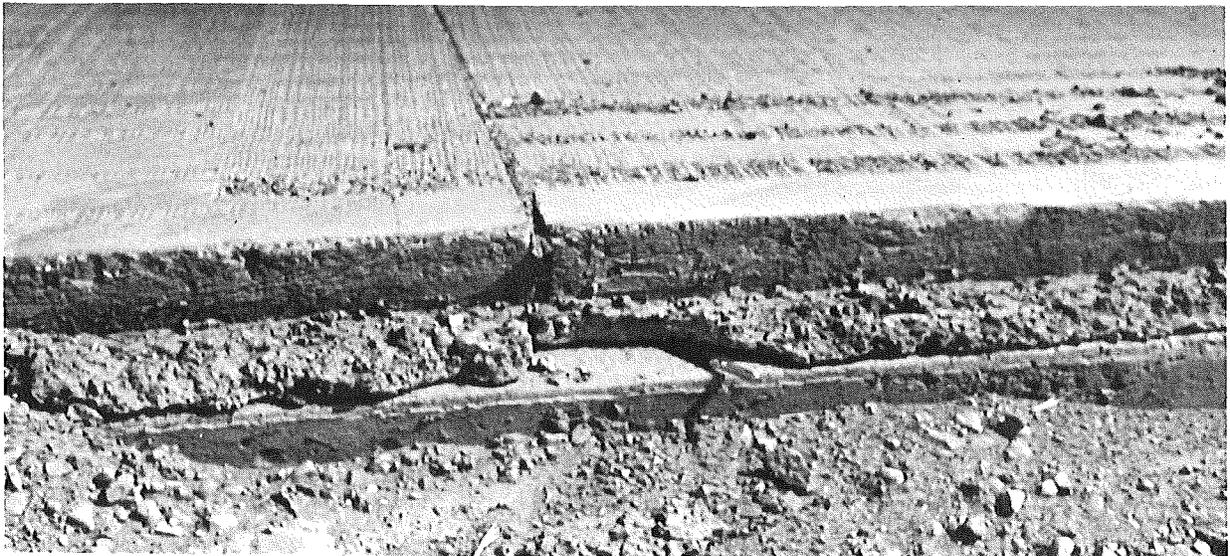
Soundings with a hammer indicate that the overlay has lost its bond over nearly the entire area. Since no elaborate procedures to obtain bond were used at the time of construction, this probably could be anticipated; however, it was expected that a greater portion of the overlay would remain bonded for a longer period of time. Bond loss seems to be aided by extensive warping of the overlay. In many places the joint edges appear to be raised almost 1/8 in., and more at the corners (Fig. 3). Traffic over these joints causes pounding of the overlay against the underlying slab. The amount of warping is variable throughout the installation, and on July 18,

ranged from near zero, to an isolated maximum in excess of 1/4 in. at a slab corner on the north side where there is no traffic. This was on a hot day, when thermal stresses should have tended to warp the surface in the opposite direction.

Figure 3. Warping lifts overlay away from underlying slab.

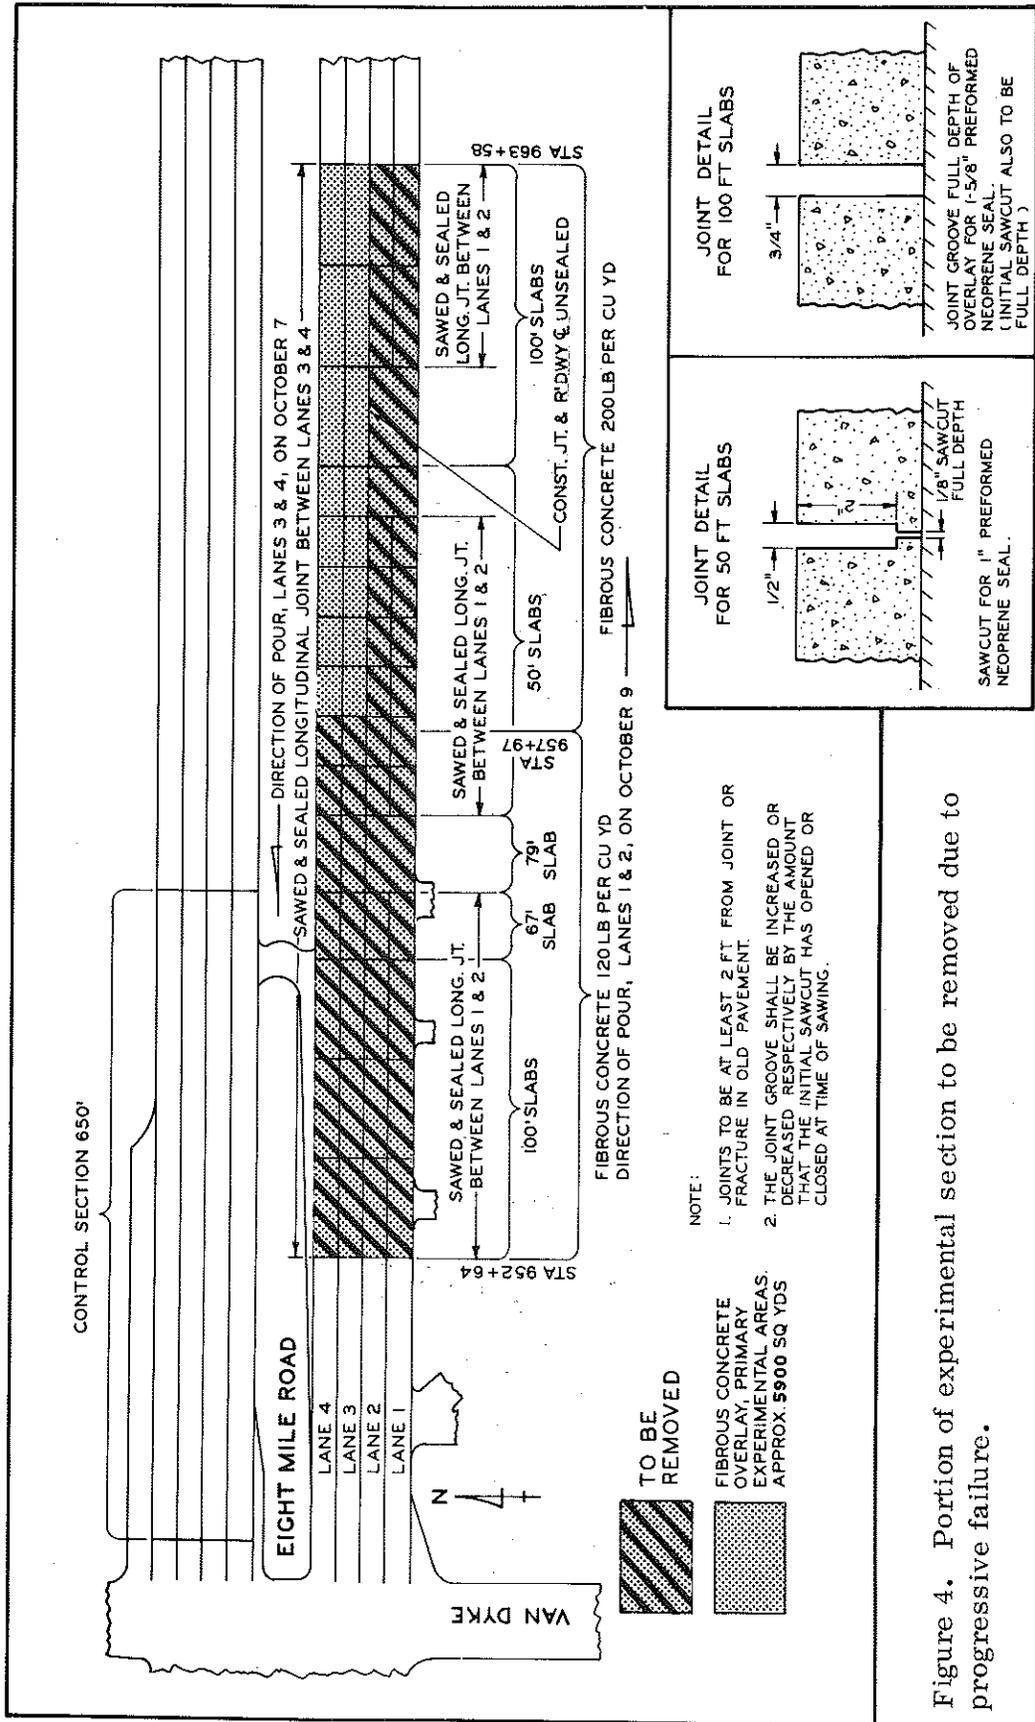
Figure 4. Portion of experimental section to be removed due to progressive failure.

Our extensive system of concrete highways will need surface repairs and overlays at some future point in time. If rigid overlays are to be used in any case, they will require workable designs. Bonded overlays are not suitable for use over broken slabs and joints, so the remaining options are unbonded (or semi-bonded) jointed overlays, and continuously reinforced overlays. The former presents some problems with joints. The latter would require a considerable amount of steel, would have to be quite thick to provide adequate protection for the reinforcement, and also would present some construction problems. For these reasons, it was considered to be useful to keep a portion of the overlay in service for a longer period of time, to gain additional experience with performance of the joints in the overlay. The two inside lanes of the 200 lb/cu yd section were in far better condition than the remainder of the installation. Therefore, it was agreed that those two lanes of the 200 lb/cu yd section should be left in place for further observation. The remainder of the overlay is to be removed and replaced with a bituminous cap. This will be done in conjunction with scheduled paving operations on the adjacent roadway, probably during August or September of 1973. The sections to be removed are shown in Figure 4.
