INVESTIGATION OF TRAFFIC-INDUCED  
VIBRATIONS AT 3018 WOODRUFF ST., LANSING

Research Laboratory Section  
Testing and Research Division  
Research Project 74 TI-257  
Research Report No. R-955

Michigan State Highway Commission  
E. V. Erickson, Chairman; Charles H. Hewitt,  
Vice-Chairman, Carl V. Pellonpaa, Peter B. Fletcher  
John P. Woodford, Director  
Lansing, January 1975

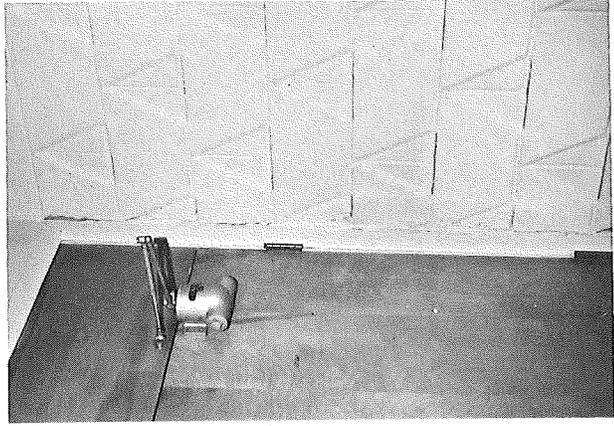
North Entrance, East Corner

Reported damage consists of cracks in the lobby where light-weight walls join the two main block walls of the building (Fig. 2). The cracks are slightly wider at the top, and indicate in some cases that the light-weight walls have moved downward about 1/8 in. relative to the block walls.

▲ Figure 2. Cracks in building at 3018 Woodruff St.

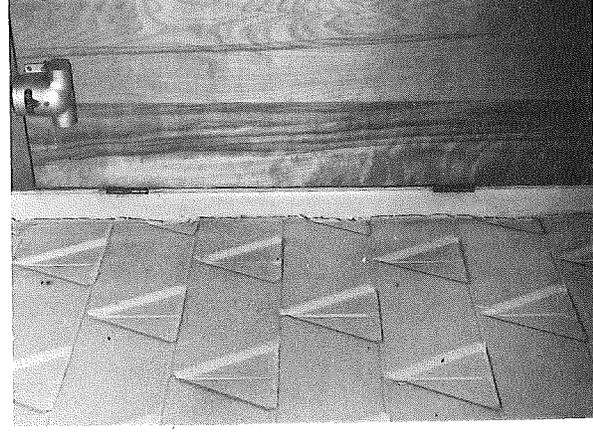
South Entrance, East Corner

Therefore, we must conclude that the structural damage in this apartment building was not because of ground vibrations. The appearance of the fractures indicates the probability that the light-weight walls at either end of the entrance hallway, were simply laid up against the block walls of the main sections of the building without adequate ties and without provision for expansion and contraction of the structure. There is no evidence of major settlements or cracking of the foundation.
