OFFICE MEMORANDUM

SUBJECT: Investigation of Straw Fire Damage to CRCP, I 96 Near Novi
(I 63191-03586A).
Research Project 75 TI-294. Research Report No. R-997.

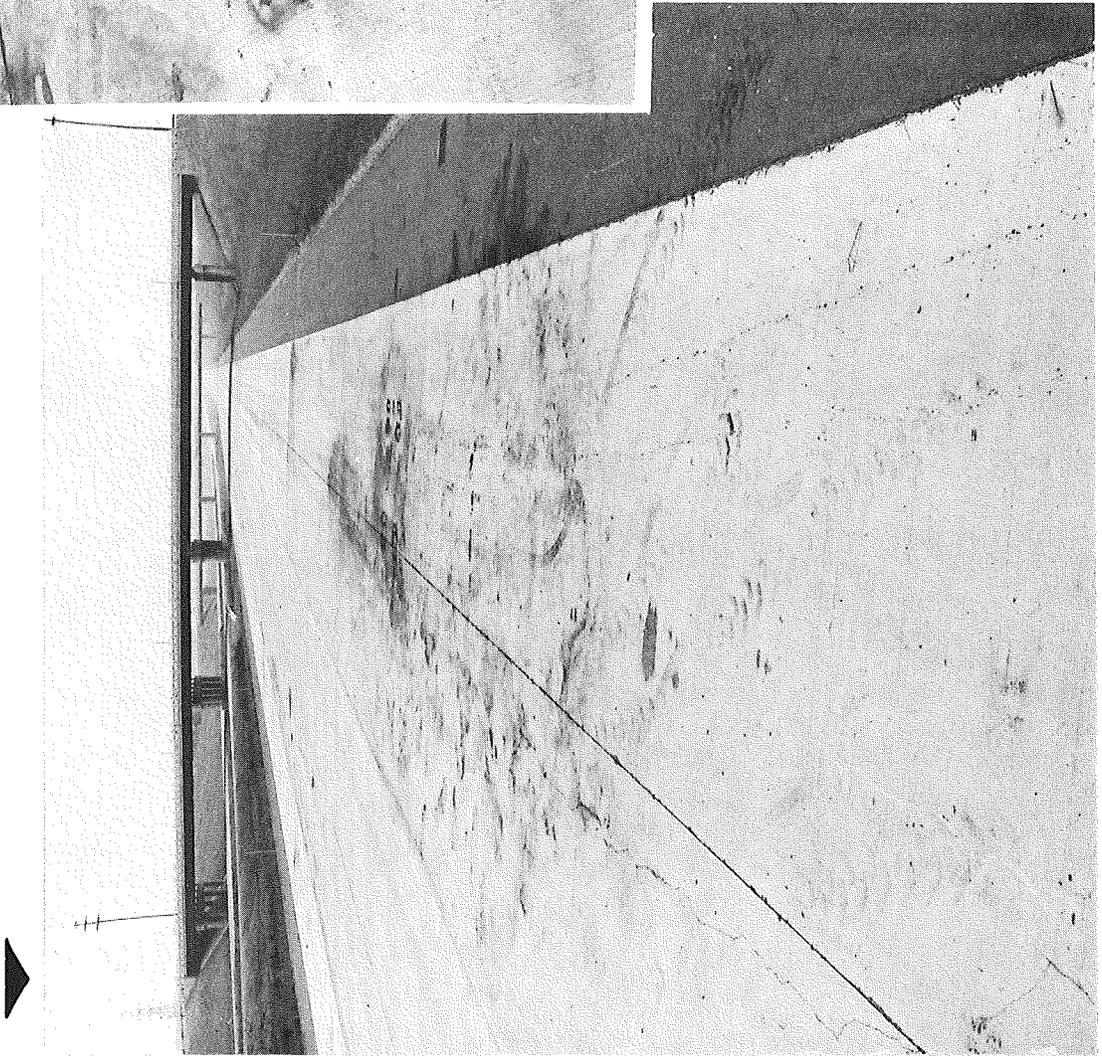
The damage was located on the two eastbound outer lanes of I 96, approximately 1-1/2 miles south of the junction of I 96 and I 696 near Novi. The pavement showed no spalling, but distinct craze cracking was apparent in the outside lane where the trailer had been parked; isolated areas of craze cracking were also present in the second lane. Surface condition features are shown in Figures 1 and 2.

Figure 1. General area view looking south along eastbound I 96 where straw-laden semi-trailer burned.

Since examination of the fire site revealed no spalling, Swiss Hammer tests indicated no strength loss, and the cores showed no disintegration in freeze-thaw, it is believed that the fire damage was slight; thus, no repair procedures are recommended.

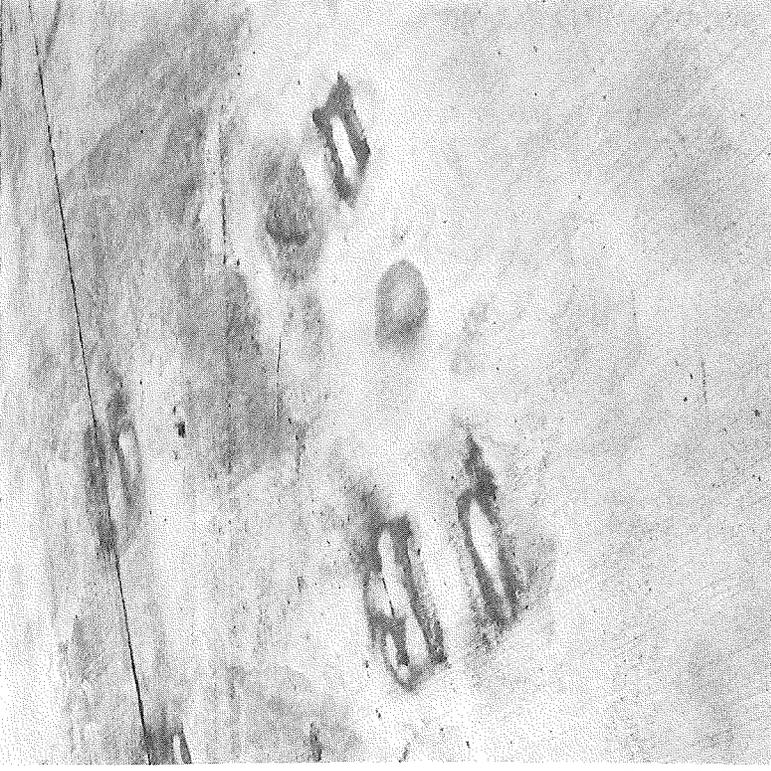
The Swiss Hammer readings taken in the fire area generally produced higher values than the readings taken in the control area; this fact resulted because the fire dried and hardened the concrete surfaces. In addition, the rapid loss of moisture in the surface concrete produced shrinkage and caused the craze cracking in the fire area.

Figure 2. Close-up of Swiss Hammer test areas Nos. 1 and 6 and core C. Burned tire marks of trailer.

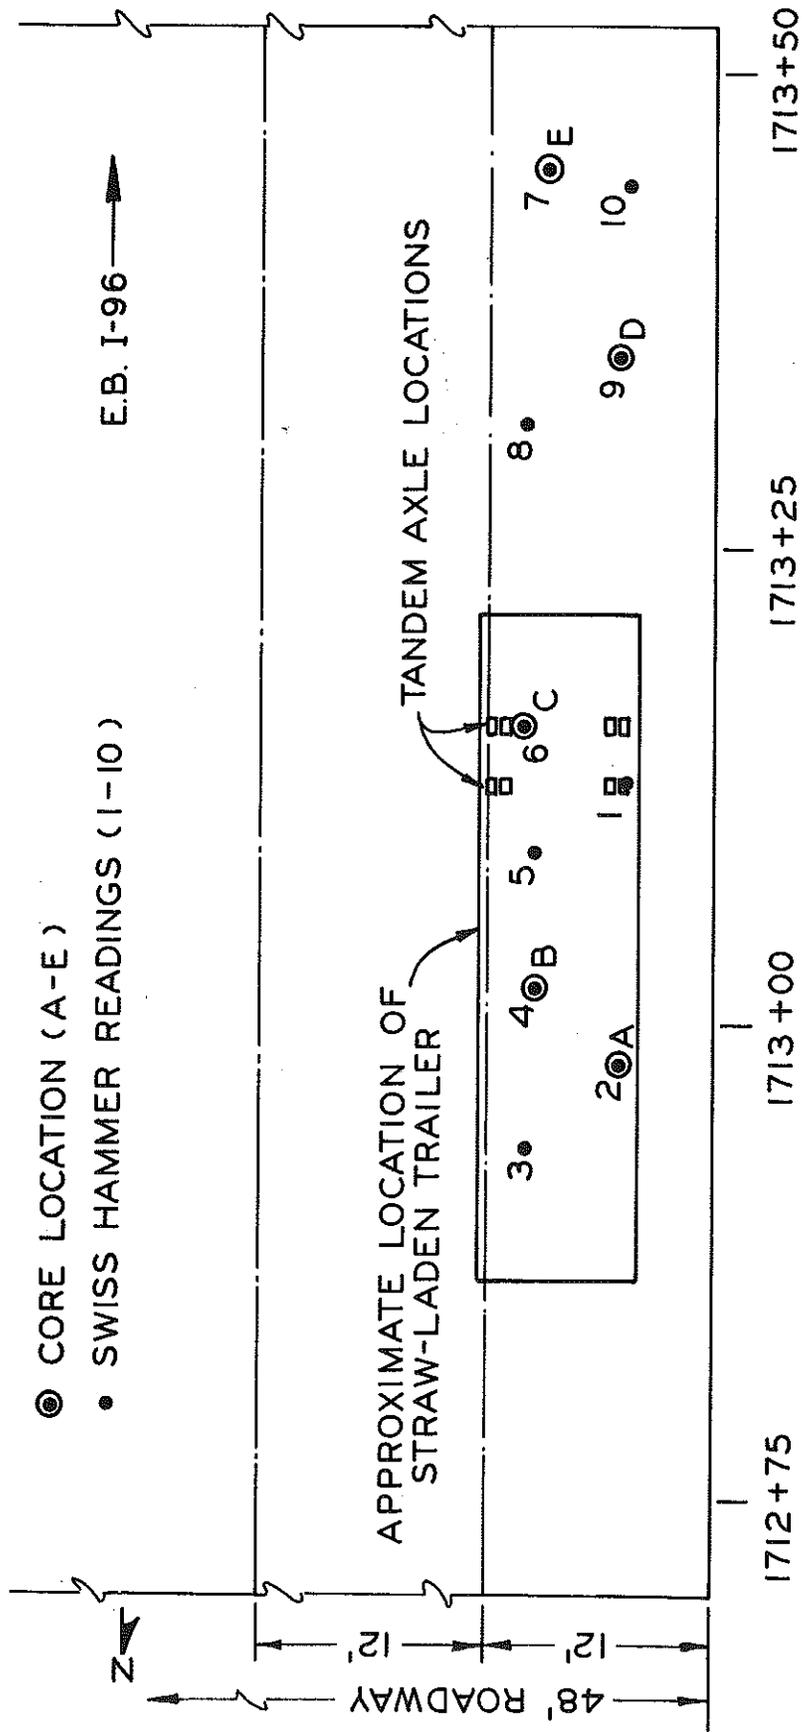
A scale drawing of the fire area is shown in Figure 3. Ten spots were selected for Swiss Hammer readings; six were in the fire area, and four were in an undamaged area. Seven individual readings were taken at each spot and averaged, as shown in Table 1. Three spots, having an intermediate value average, were selected for coring in the fire area, and two in the control area.

Figure 3. Location of fire damage, Swiss Hammer readings and coring sites on eastbound I 96.
