Maintenance Advisory

MA 2009-09

High-Tension Cable Barrier Systems

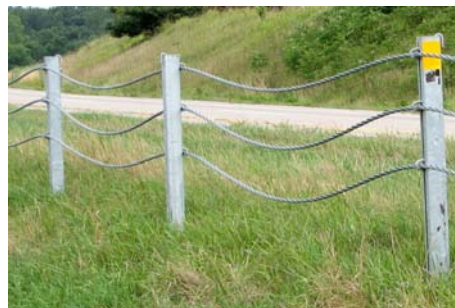
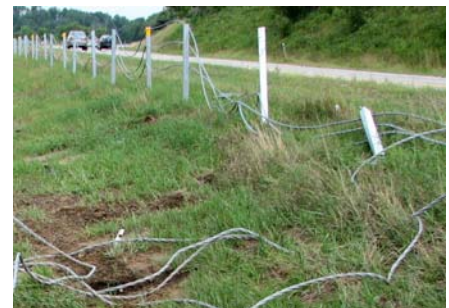
Drive-by inspections for the purpose of discovering damage of HTCB should be performed while doing your routine road patrol. Look for damage such as slack or down cables, and damaged posts.

After an impact, the system will require some repair. Under most impacts, the HTCB will still maintain its original cable height and may be able to withstand additional hits. Even with this capability, it is recommended that the system be repaired as soon as possible. Because of the ease of repair, repairs can usually be done in a short period of time.

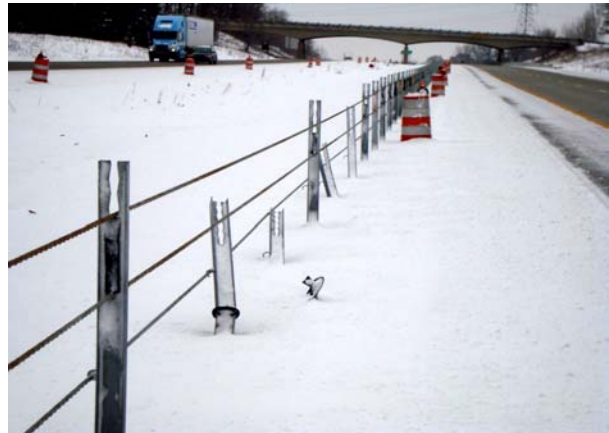
The height of the cable above the ground is very important to the proper function of these systems. It needs to be monitored, particularly after a crash. Although cable height even after a hit appears to have been maintained, rutting due to a collision or erosion may alter the relative cable height. Restoration of the grade to its original condition may be required.

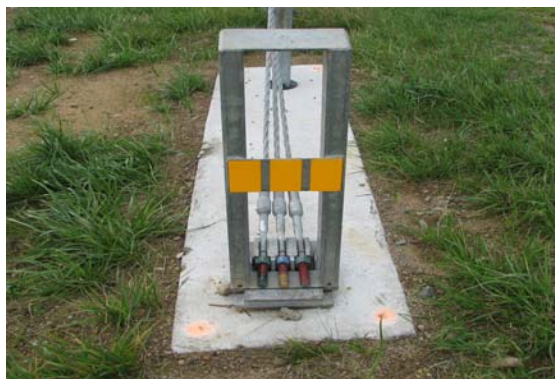
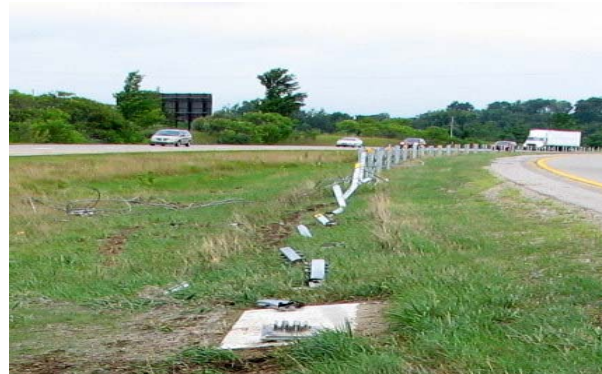
During the road patrol, pay particular attention to the end terminal post and the connection between the cable(s) and the cable terminal foundation. It is imperative that each cable be properly attached to the cable terminal foundation. Disconnected cables, improperly connected cables, and damaged end terminal may seriously compromise the functional ability of the system. These types of repairs may take additional time and may require re-tensioning of the entire run of cable.

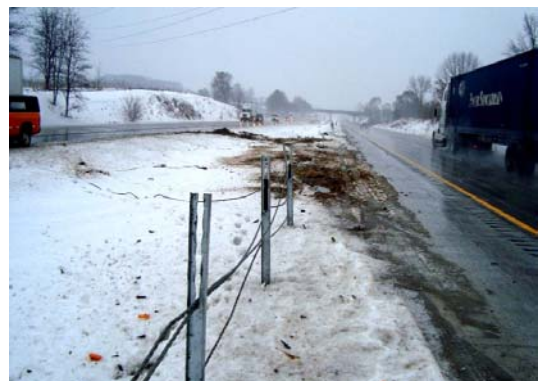
Concrete line post foundations, which are typically 12" to 14" in diameter and 48" deep, are intended to be reusable after a typical impact. Nevertheless, it is possible for line post foundations to crack. Therefore, maintenance personnel should inspect concrete foundations, especially line post foundations, for cracks after an impact. In most cases, cracked line post foundations can be repaired with epoxy or other concrete patching/repair material. As a general rule, line post foundations are repairable if the foundation is structurally intact and if the steel socket embedded in the foundation has not been damaged. Otherwise, it may be necessary to remove the damaged line post foundation and replace it with a new one. Keep in mind that foundation cracking will vary from one foundation to the other, so each damaged foundation must be evaluated to determine if it is repairable. Therefore, a certain degree of judgment must be exercised during this process. Maintenance staff should contact MDOT's Crash Barrier Engineer for assistance in the evaluation of damaged line post foundations.
