# Incident History

**Michigan Public Service Commission**

**2016** Pipeline  
Safety  
September 26-28 **Conference**

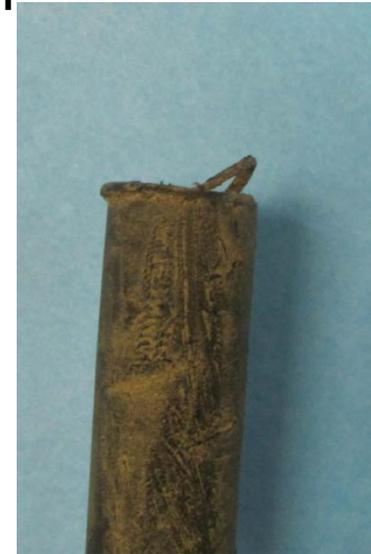
- Explosion at residence.
- Third party damage – Homeowner excavating with backhoe snagged gas service.
- Heat fusion joint at a 1” to ½” service line reducer failed and separated.
- Homeowner called the operator to report the damage.
- Operator employee was onsite investigating the leak when the explosion occurred.
- 2 fatalities and 1 injury.
- Homeowner called MISS DIG. Staking accurate. No evidence of hand exposure.
- \$361,435 damages.

- Recommendations:
- Recommend that operator evaluate the need for first responders to carry squeeze-off tools with a capacity larger than  $\frac{5}{8}$  inch.
- Recommend that operator accurately document perceptibility tests on the work order for tests related to incidents.
- Recommend that operator utilize a form/drawing to document leak investigations in response to a fire or explosion. Form/drawing should include enough details to clearly identify the scope and findings of the leak investigation.
- Recommend that operator's leak test of service lines involved in an incident are completed at operating pressure.

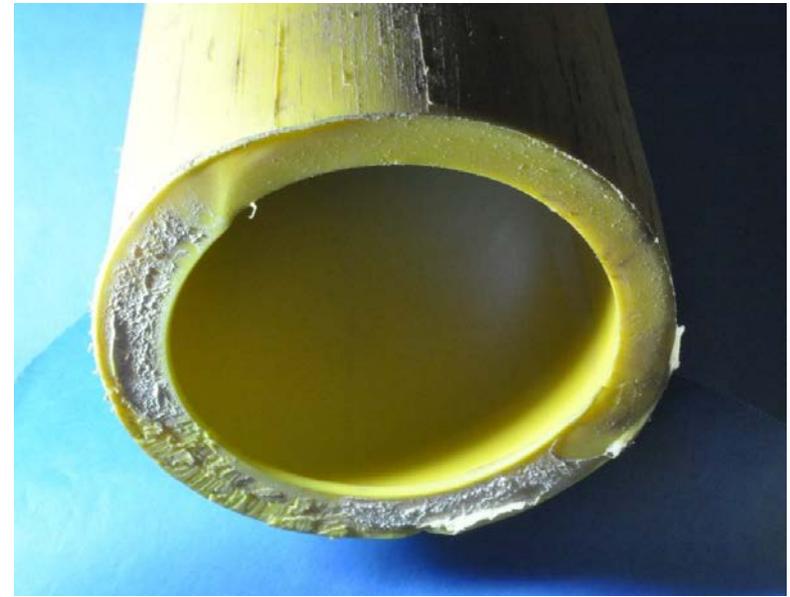
- 6" plastic main that failed at a fused joint.
- Main was installed by directional drill two months prior by a contractor.
- Main extraction discovered a 6" plastic cold fuse.
- Pipe was cut on an angle and was not completely faced. Due to the improper facing, the heating element lacked contact.
- Fusers OQ suspended.
- \$85,000 damages.
- 0.7056 Mmcf gas released.

- Compliance Actions:
- 192.13(c) - Not pressure testing a distribution main for the durations required by operator's O&M.
- 192.13(c) - Not checking alignment of the pipe as required by operator's O&M. Pipe ends involved in the failure were improperly faced.
- 192.13(c) - Not observing the proper melt bead size while the heater plate is in place as required by operator's O&M. Lack of melt bead on the interior and exterior circumference on one side of the failed joint.

- Recommendations:
- Recommend operator analyze its distribution system for the adequacy of system valves and consider using valves to shut the gas off in emergency situations. Gas blew for 5 hours.
- Recommend that operator develop an action plan to ensure integrity of other projects that this joiner was involved in. Joiner allowed to fuse other mains while incident was under investigation.
- Recommend that operator's procedure require actual surface temperature of the heater plate to be periodically checked with a pyrometer.
- Recommend operator provide increased oversight of contractors to ensure projects are constructed in accordance with the 49 CFR Part 192 and company procedures.

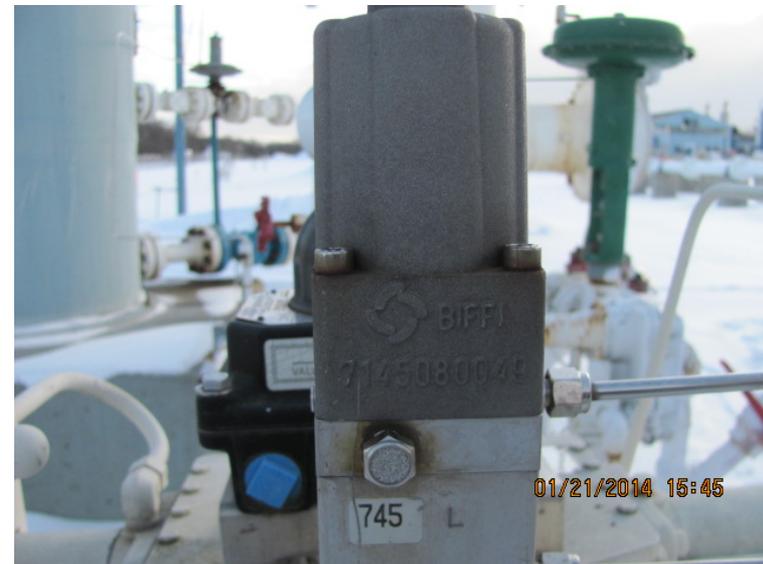
- Leaking shaft seal on Biffi pilot assembly at regulator station caused a blowdown valve to open at a compressor station.
- Vent above shaft seal was plugged with ice after severe ice storm, preventing the gas leaking through the shaft seal from venting.
- This caused an increase in pressure above the seal, simulating a drop in pressure below the seal.
- Signaled blowdown valve to open.

- Recommendations:
- Recommend that operator orient the newly installed pilots in a manner to reduce or eliminate the potential for ice and debris to accumulate on the pilot body vent.
- Recommend that operator develop a reoccurring preventative maintenance work order that meets or exceeds the manufacturer's recommendations for maintenance and testing of all newly installed pilots.
- Recommend that operator ensure that employees are knowledgeable with the operation, maintenance, and testing requirements associated with the newly installed pilots.
- Recommend that operator conduct a system-wide study to identify pilot assemblies that may have issues with vent orientation and internal seals and take any necessary remedial action.

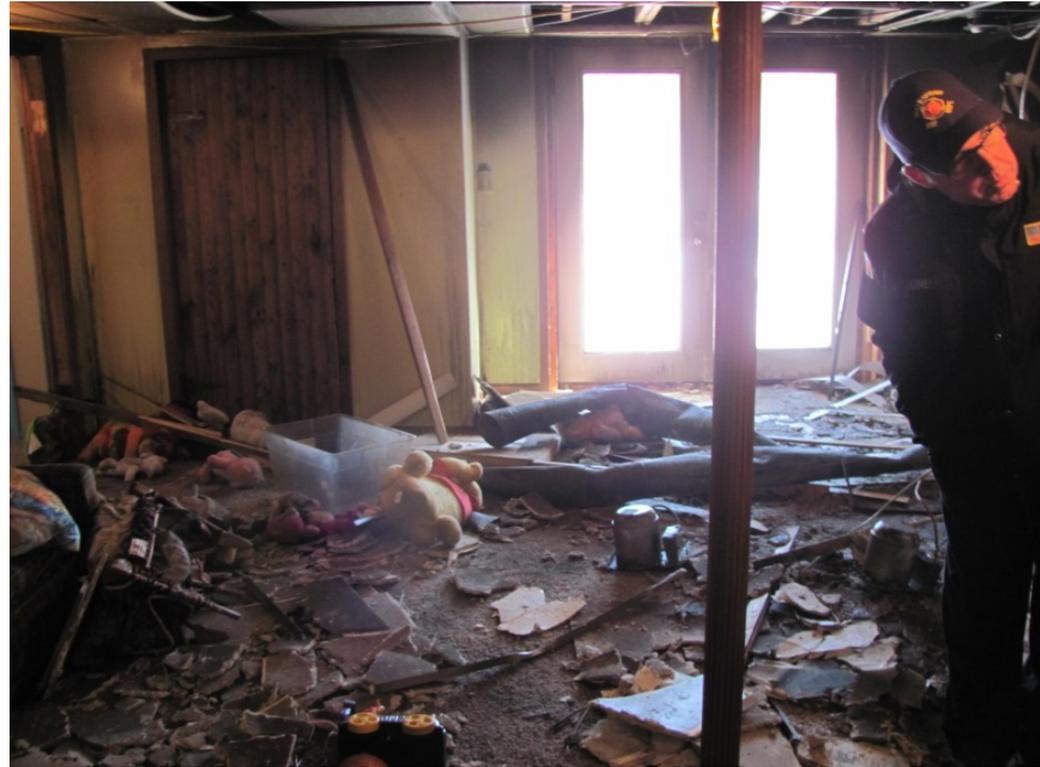
- House fire caused by gas migration from an outside main leak. Fire started in downstairs utility room.
- After the incident, gas was detected at an exterior building wall and inside the basement.

- Recommendations:
- Staff requests that an incident be reported to NRC if the cause of the incident is unknown and damages are expected to exceed \$50,000.
- Recommend that operator reexamine all evidence and details in this investigation and submit a revised supplemental incident report to PHMSA. Staff recommends that operator ensure future incident investigations are thorough enough to determine the cause of the failure.
- Recommend operators leak testing records are consistent.
- Recommend that operator utilize a form/drawing to document leak investigations in response to a fire or explosion. Form/drawing should include enough details to clearly identify the scope and findings of the leak investigation.

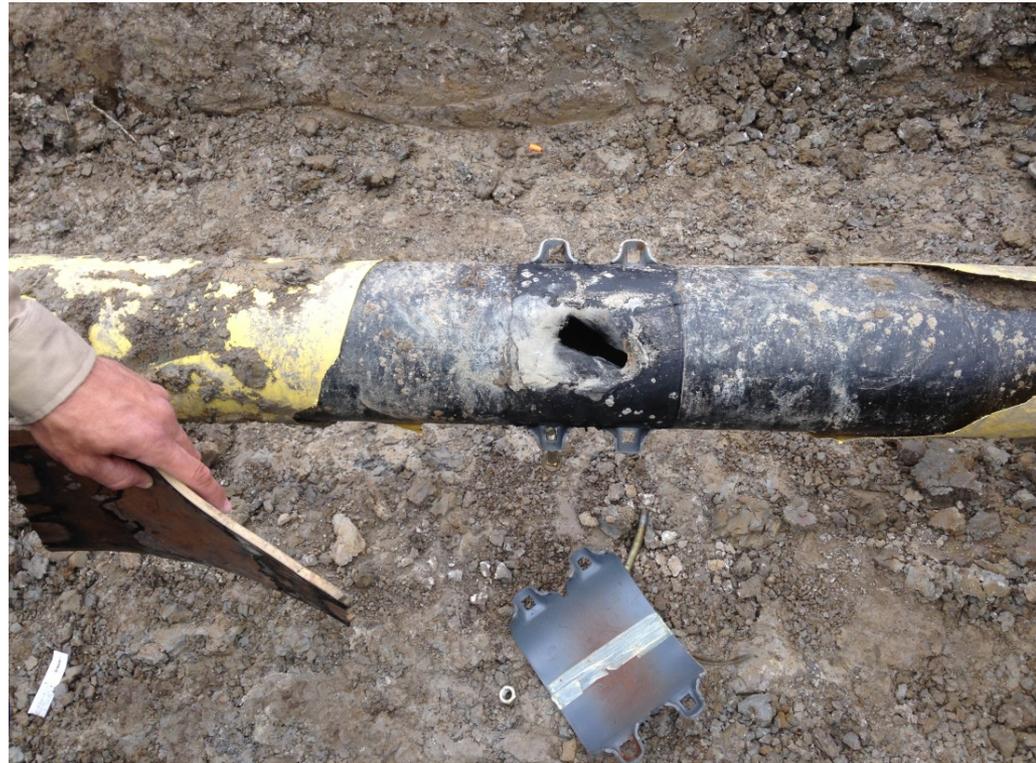
- Third party damage.
- 300 psi 8" main.
- Farmer was removing stumps with loader bucket.
- Emergency valve failed to close completely.
- Gas was blowing for approximately 18 hours.

- Compliance Actions:
- 192.605(a) – Not monitoring for combustible gas before and during work. Combustible gas indicator was located approximately 15 feet away from the work area and the atmosphere near the employees was not checked prior to excavating.
- 192.605(a) – Not tightening bolts on a repair clamp to the specification listed in operator's field manual.
- 192.629(a) - Not purging a pipeline of air by releasing gas into one end in a moderately rapid and continuous flow.
- Rule 460.20501(2)(b) - Not maintaining an up-to-date schematic drawing of station piping at each aboveground pressure-regulating station containing buried station components.

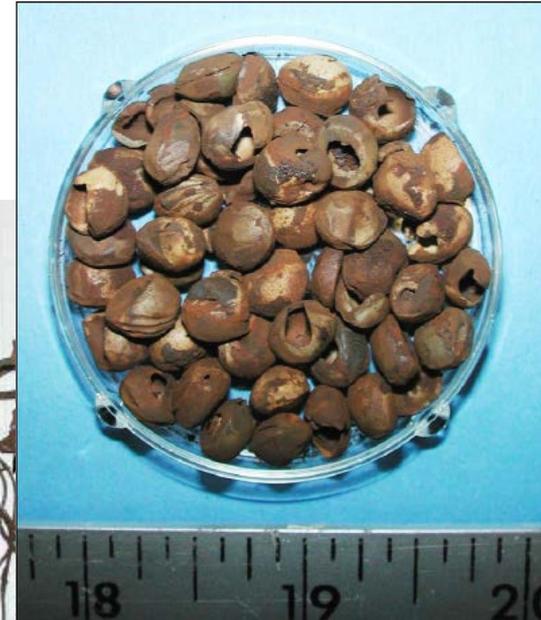
- Debris moving through distribution system caused double regulator failure.
- Working-monitor regulator station.
- Caused 139 psig pressure on a 60 psig system.
- 120 miles of distribution main and 7,010 gas services overpressured.

Cherry pits

- Recommendations:
- Recommend operator conduct a study to determine:
  - The need to install filters upstream of regulator stations where regulator boot wear from debris is periodically observed.
  - The need for additional safety measures to enable earlier detection of overpressure situations and mitigate the possible consequences.
  - The need for weekly regulator station pressure-recording chart inspections and replacements on stations that do not have relief valves or SCADA transducers located after each pressure cut.

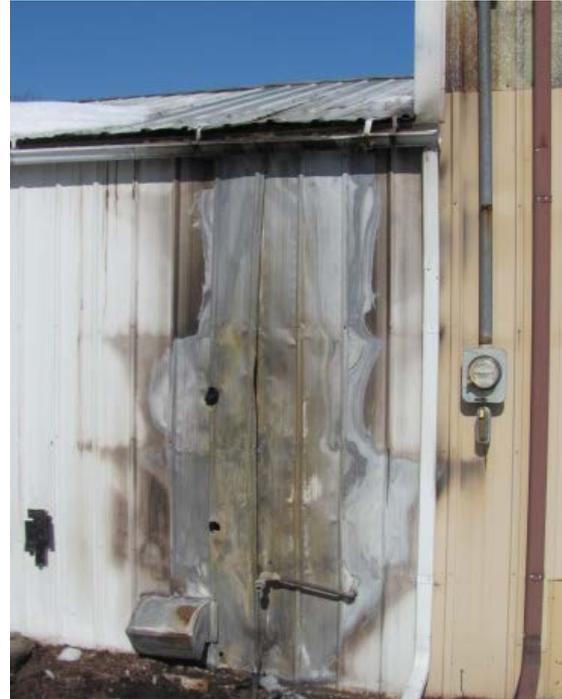
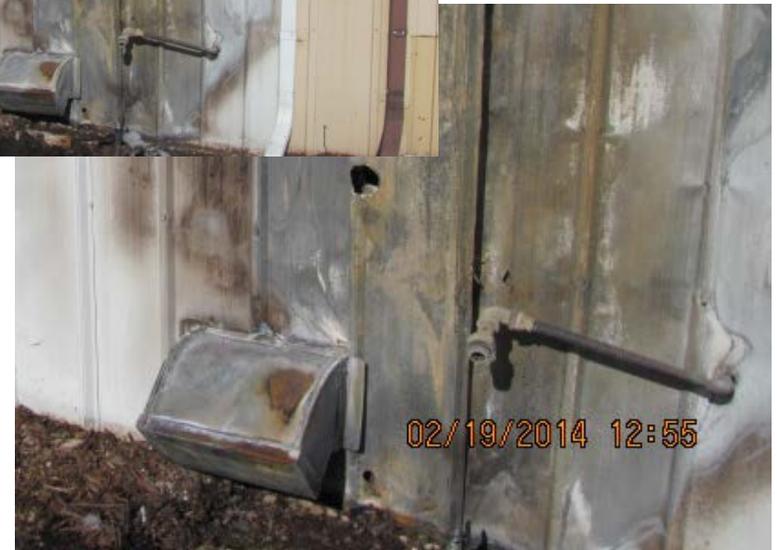
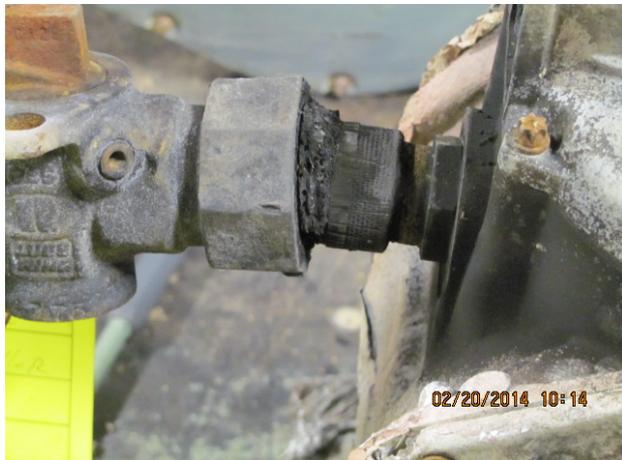
- Snow/ice buildup on roof fell onto gas meter, causing a leak which led to ignition.
- Furnace located right inside wall from gas meter.

- Recommendations:
- Recommend operator consider revising first responders' geographic area of responsibility to enable a 30-minute response time to be possible.
- Recommend additional precautions be taken when locating meters underneath steel roofs due to the greater possibility of snow and ice runoff.
- The meter assembly was located within three feet of the air intake for the furnace. It is not known whether the intake was installed before or after the meter assembly; however, the operator conducts meter readings and atmospheric corrosion and leak surveys at gas meters. As part of Rule 192.613 entitled "Continuing Surveillance," it is expected that details that could pose a hazard to the public would be reported and remediated.

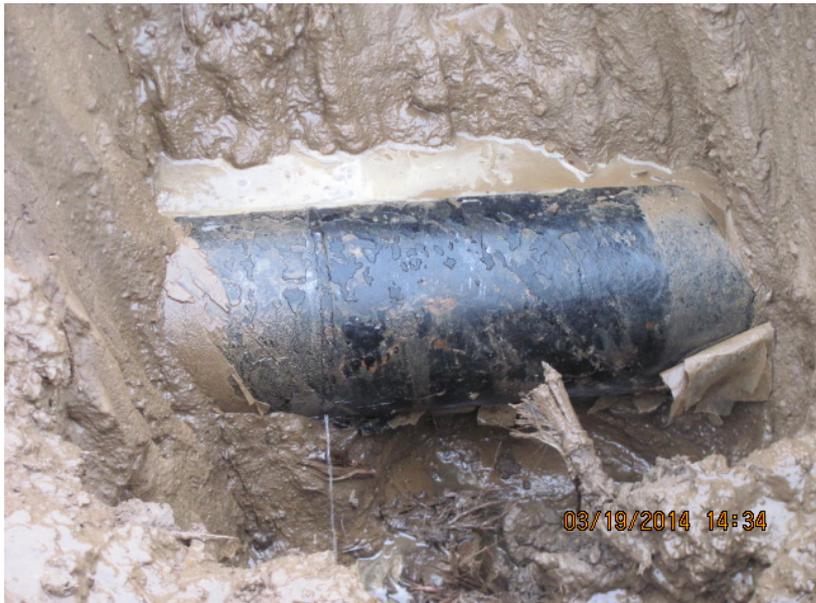
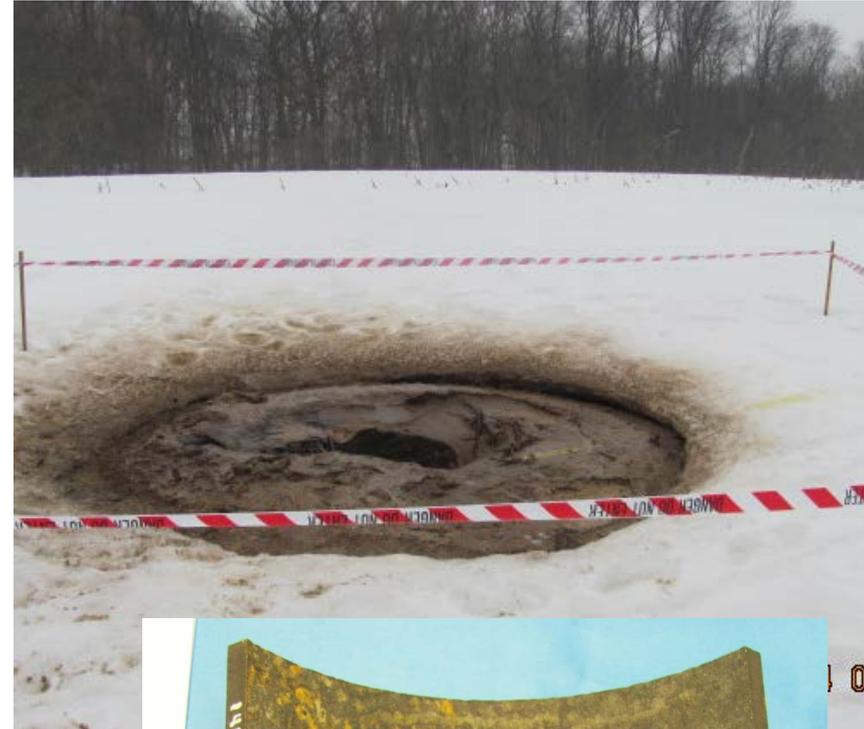
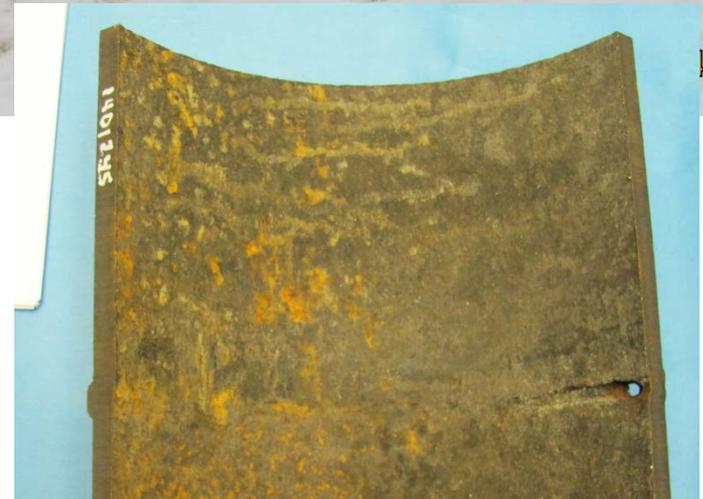
- Internal corrosion caused a leak on a storage field girth weld.
- Operating at 417 psig; was operating at 1350 psig 3½ months earlier.

- Recommendations:
- Recommend operator reevaluate the cleaning and corrosion inhibitor program at the Storage Field. This program should include a comprehensive review of corrosion history, in-line inspections, gas quality, operations and maintenance history, etc. This incident occurred when the Lateral was at a significantly lower pressure than what it had experienced earlier in the season; indicating accelerated corrosion growth from the beginning of the season until the failure.
- Operator must conduct a thorough cause analysis to prevent recurrence of similar internal corrosion incidents in accordance with 49 CFR 192.617. The laboratory analysis received by Staff did not determine a cause of the failure.

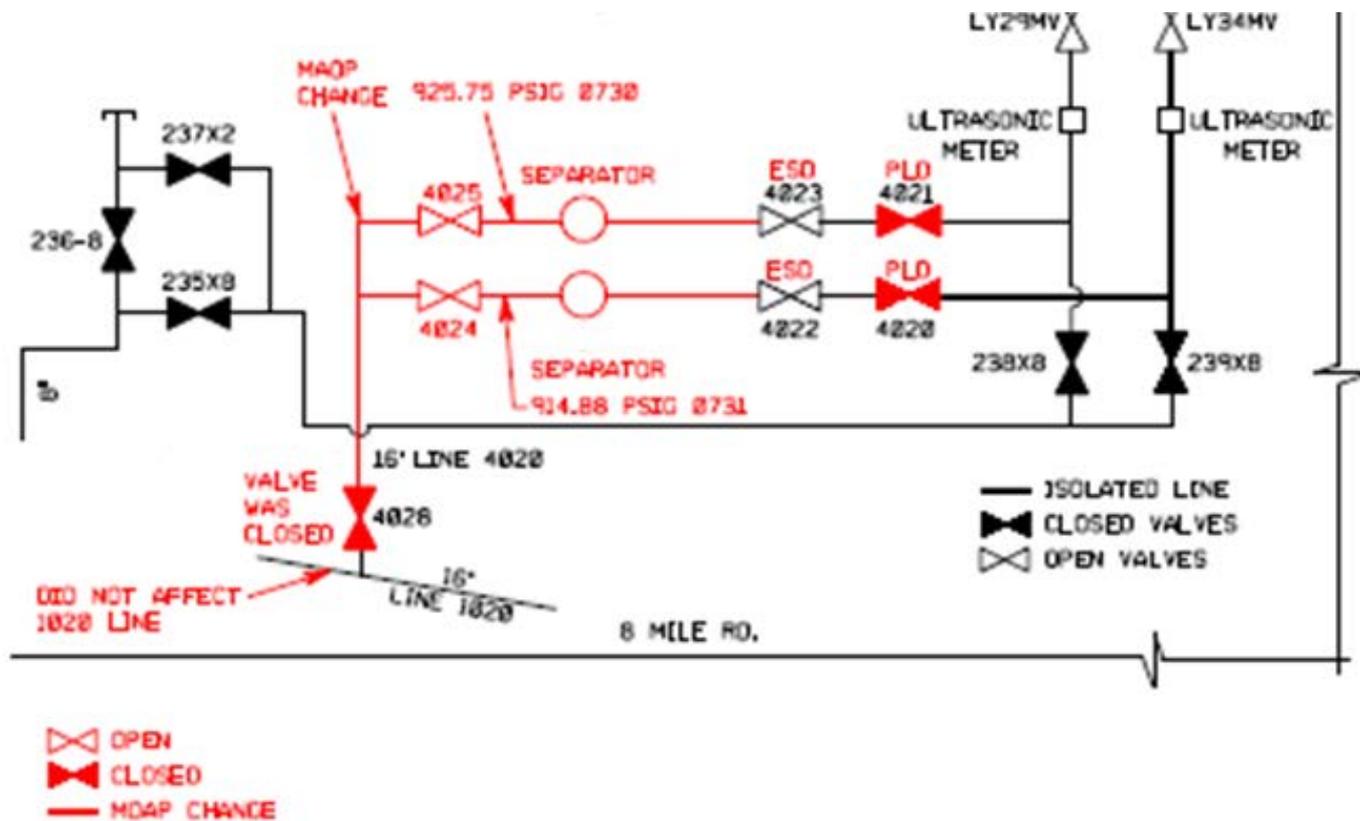
- SRC. Overpressure within storage field due to equipment failure.
- Gas Control was gradually opening control valve to withdraw from storage.
- Downstream blockage – Manual valve closed.
- Gas Control interpreted pressure stabilization as line-packing and continued to open control valve.
- Gas Control's 4th command to gradually open the control valve
  - Control valve quickly jerked open and pressures increased near 800 psig MAOP.
- Gas Control recognized the downstream blockage.
  - Sent a command to close the control valve; took 20 minutes to close.
- ESD valve failed to provide OPP due to faulty solenoid.
- 802 feet of storage piping encountered an overpressure for 20 minutes in duration, reaching 925.75 psig.

- Compliance Action:
- 192.709(c): Not retaining a record of each patrol, survey, inspection, and test required by subparts L and M of this part for at least 5 years or until the next patrol, survey, inspection, or test is completed, whichever is longer. Operator was unable to produce inspection records that included set points for pressure control valves.
- Recommendations:
- Recommend field personnel report all critical pipeline valve statuses (open/close) to Gas Control. Recommend valve status be documented by both operations and gas control.
- Recommend field personnel are adequately trained when a new withdrawal or injection procedure is developed.

- Recommendations:
- Recommend storage field withdrawal procedure include the requirement for Gas Control to verify valve functionality prior to withdrawal operations.
- Recommend Gas Control's storage field withdrawal procedure require Gas Control to monitor the gas flow rate and valve position while opening valve. Recommends gas controller training focus on the gas controllers' ability to recognize and evaluate AOC's.
- Recommend that adequate notification be provided to verify valve statuses or to reconfigure valve positions in the event that the field needs to be utilized.
- Recommend Gas Control utilize technicians in the field to assist diagnosing abnormal operating conditions or in an emergency situation.
- Recommend operator conduct a study on storage fields to verify that all sectionalizing block valves are protected from tampering and damage.

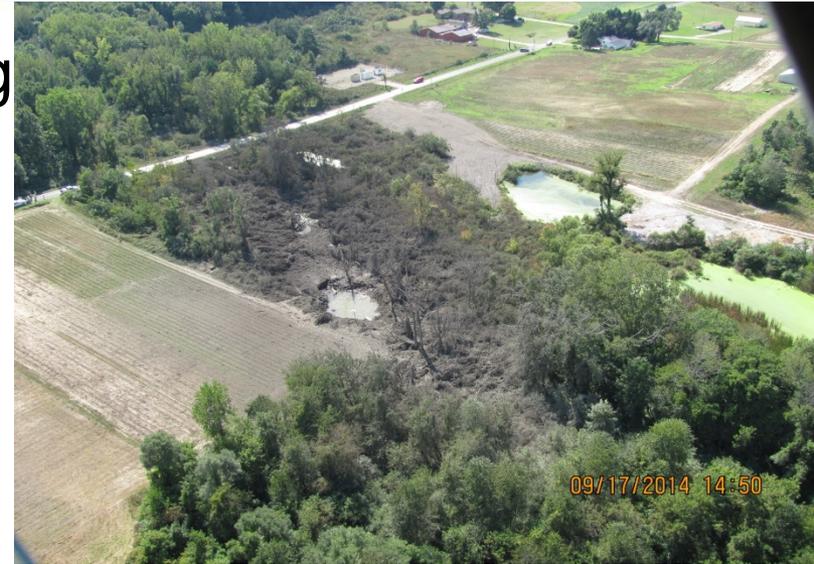
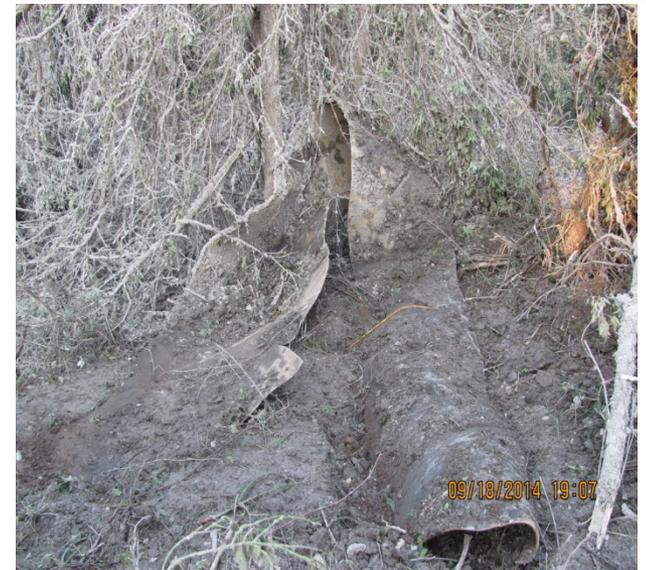
- Pipeline rupture following operating pressure increase from approximately 720 to 805 psig.
- 200 evacuated homes
- Pipe characteristics:
  - 22” pipe
  - Coal tar enamel coating
- Failure origin:
  - 21 feet segment of pipe installed in 1960 (pipeline constructed in 1949)
  - Body of pipe
  - Saturated wet environment
- Cause: High-pH SCC.

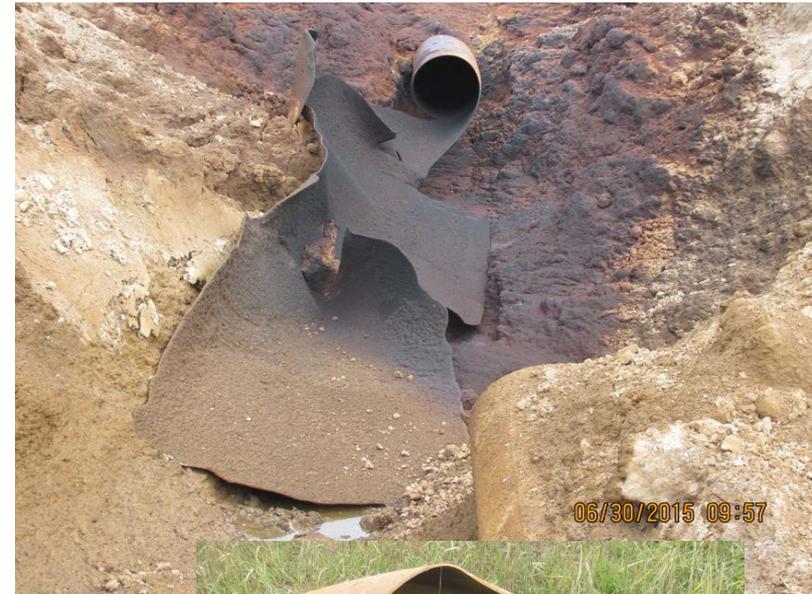
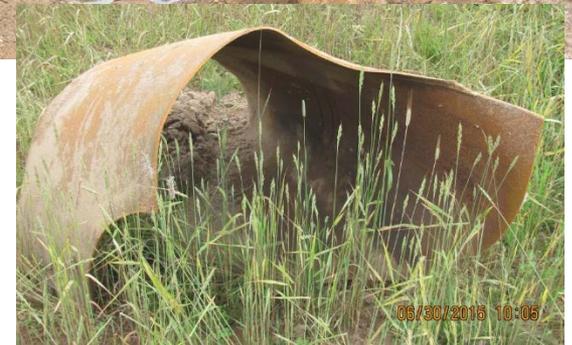
- Pipeline rupture while line was static at 634 psig (~58% SMYS at time of failure). MAOP is 650 psig.
- Between two compressor stations with bi-directional flow.
  - 3.8 miles from northerly
  - 17.8 miles from southerly
- Pipe characteristics:
  - 24-inch, 0.250 wall, X-52
  - A.O. Smith with EFW seam
  - Wax coating
  - Installed in 1950
- Cause: Near-neutral pH SCC.

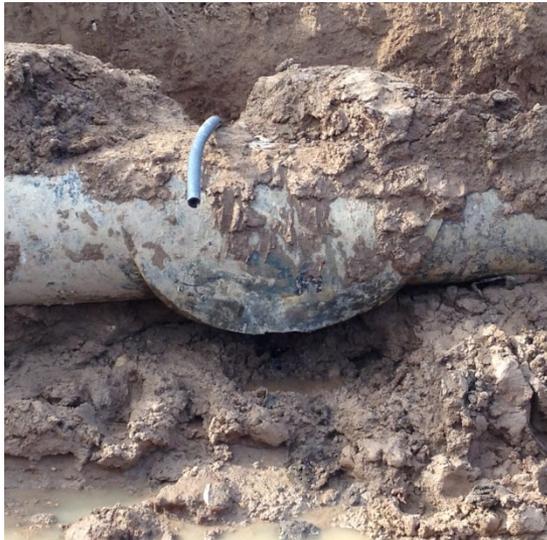
Hydrostatic testing of ~22.3 miles of pipe

- 2 test sections.
- 1 hour spike and 7 hour leak.

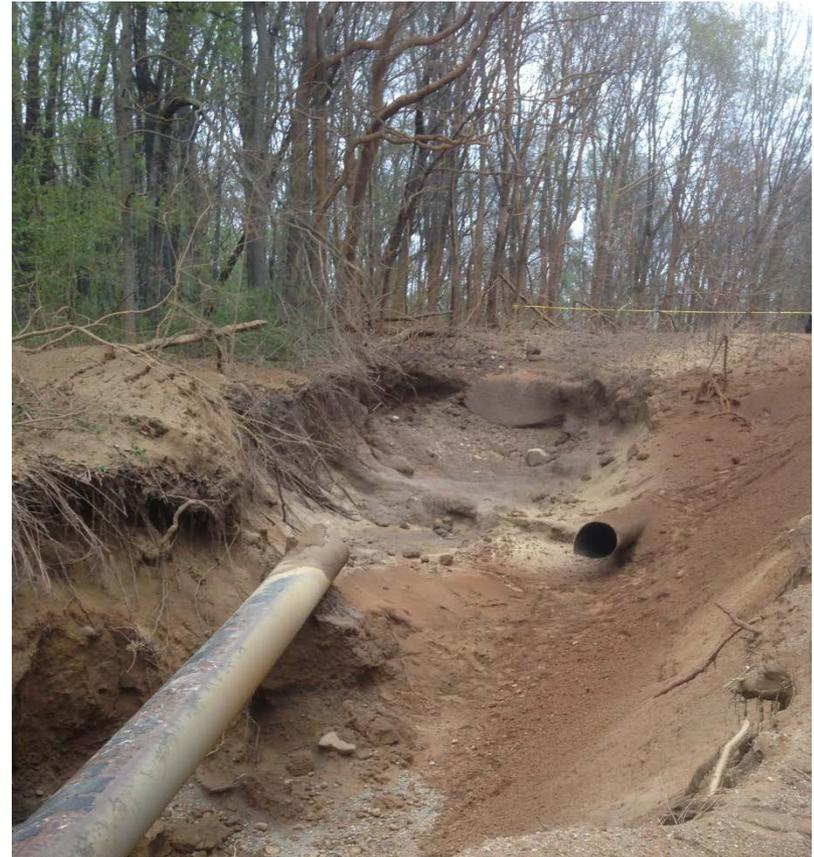
- Pipeline Rupture.
- 20-inch.
- 1949 AO Smith EFW.
- Wax coating with wrapper.
- Cause: near-neutral pH SCC.
- MAOP of 780 psig (60% SMYS).
- Operating at 650 psig (50% SMYS) when rupture occurred.

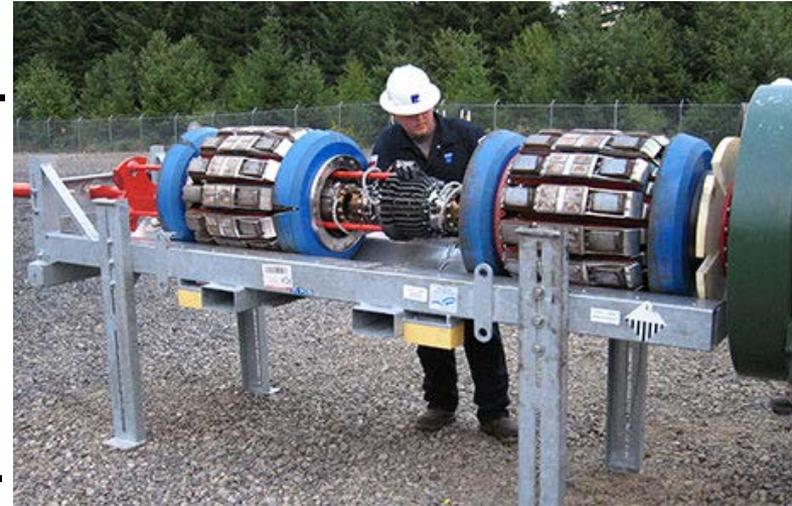
- 60.6 miles of EMAT ILI.
- 37 Digs (54 crack-like anomalies).
- 2,700 feet new pipe at rupture.
- 545 feet replaced at 8 digs due to SCC similar to rupture.
- 2,893 feet replaced due to less severe SCC and other anomalies.
- 6.25 miles replaced immediately downstream of compressor station.
- ASME B31.8S, A3 “Spike Test” 54.35 miles, 6 segments, 1 failure.
- Total of 8.8 miles of the 60.6 miles replaced.

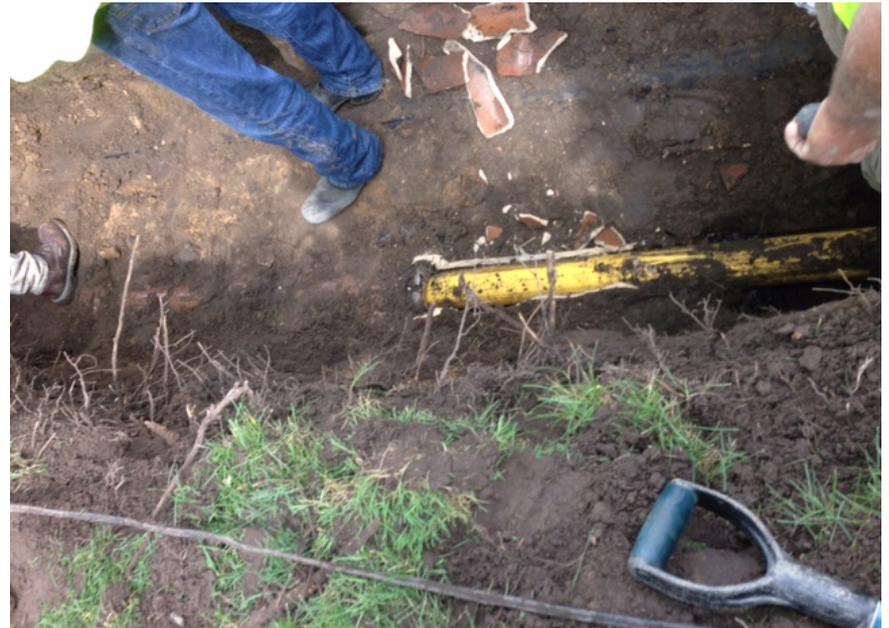
- Cross-bore.
- Property owner was performing routine sewer cleaning when their equipment would not pass through the sewer.
- Property owner then used root-cutting equipment and tore open a 4” gas service, causing a release of gas.
- The gas service had been longitudinally laying inside the sewer for several feet.
- Gas service was installed via directional drill by the Operator’s contractor 2 months prior to damage.
- Contractor failed to hand expose the sewer prior to installing gas service.

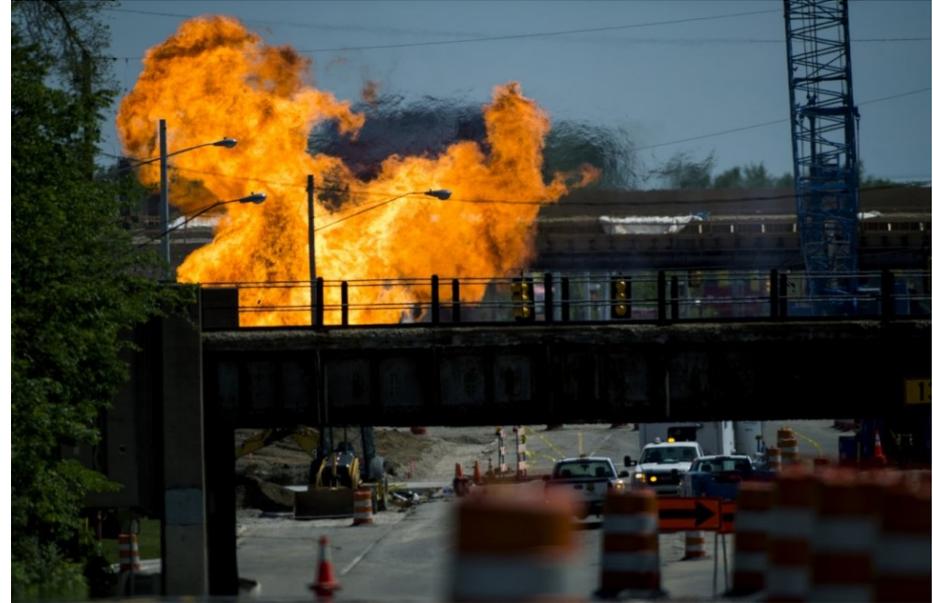
- Third-party damage.
- 5 hours, 6MMcf
- Contractor did not request re-stake; did not hand expose.
- Traffic was allowed to pass blowing gas.
- Unknown responsibility for road closure between fire department and the operator.
- Operator did not immediately dispatch a construction crew. Gas blew 1.5 hours before ignition.
- Two motorists injured.

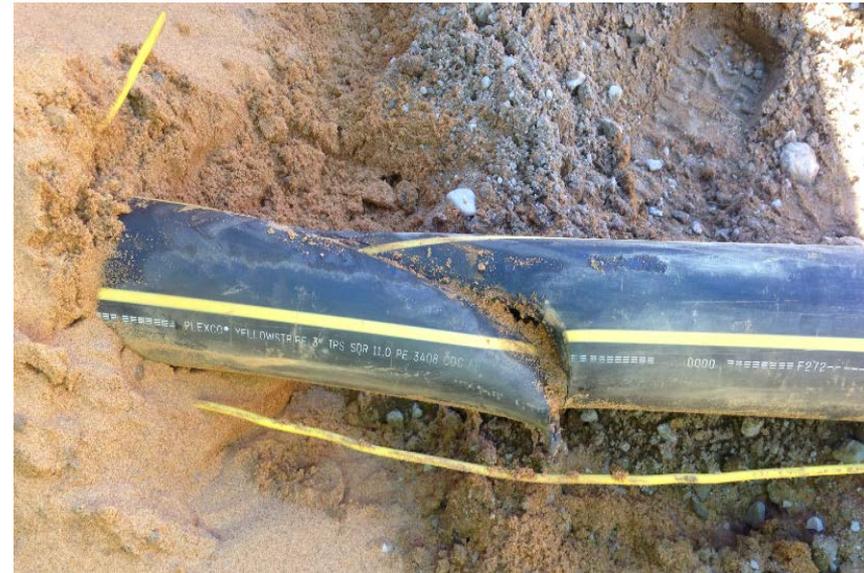
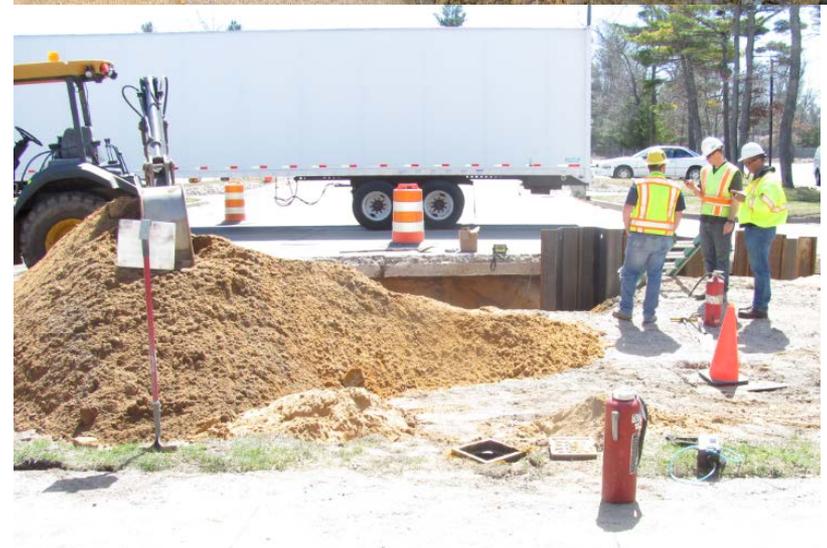
- Third Party Damage. Highway road construction.
- Occurred on a 5-lane highway that was already restricted to two lanes (one in each direction).
- Detour was several miles out of the way. Additional traffic delays and significant media attention.

- Compliance Action:
- 192.605(a) – Not following operators O&M regarding staking. Markings did not indicate a change in direction. Spacing between markings exceeded 50 feet.
- Recommendations:
- Recommend operator provide additional training to their field technicians that perform locating and marking.
- Recommend operator consider utilizing photos to document the results of field marking.

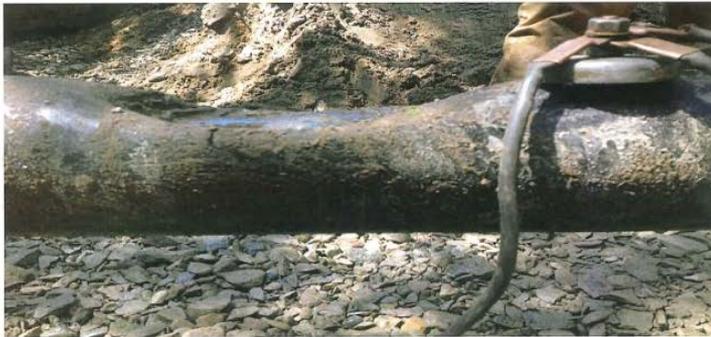
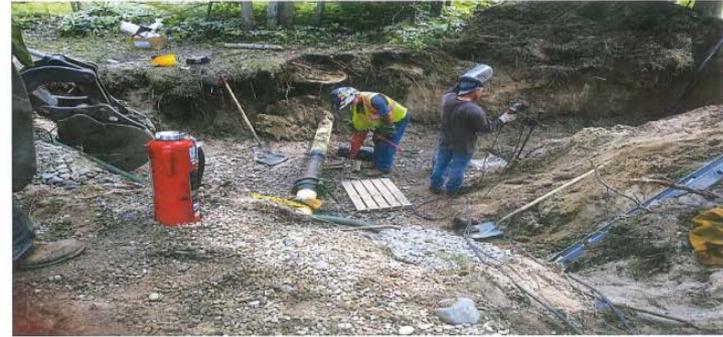
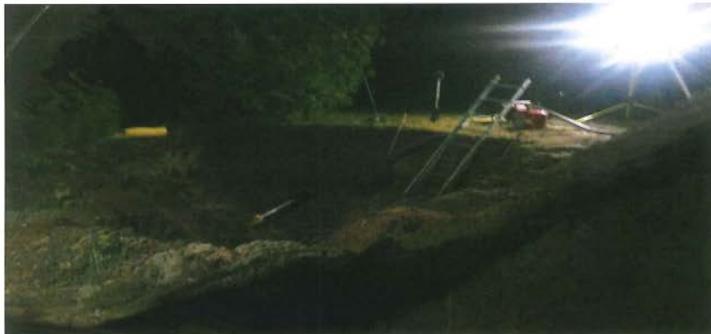
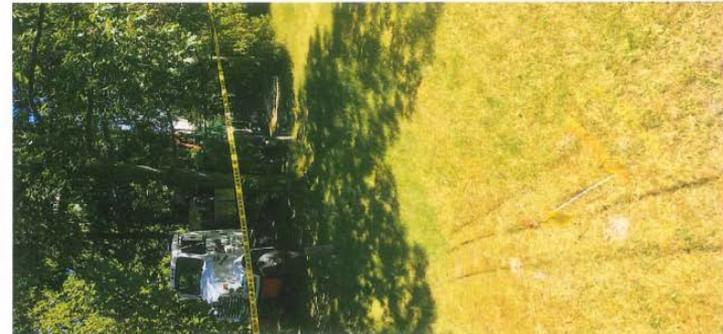
- Compliance Action:
- MCL 460.727(1): Excavator damaged a 6" steel gas main while drilling a well. The utility location was mismarked by approximately 41'. The staker located and marked a phone line (photo provided by operator).

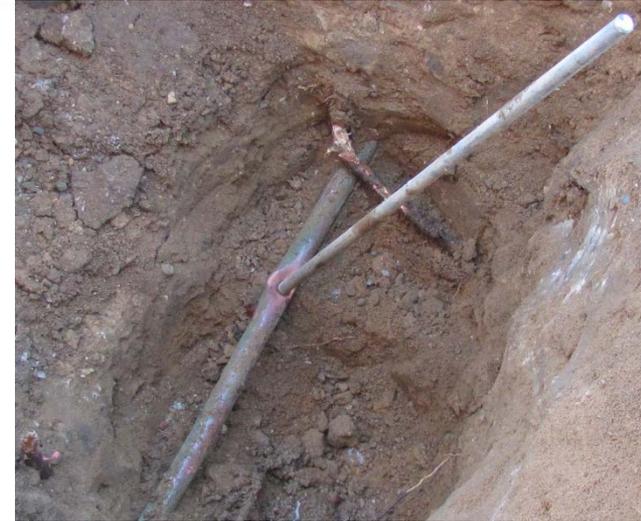
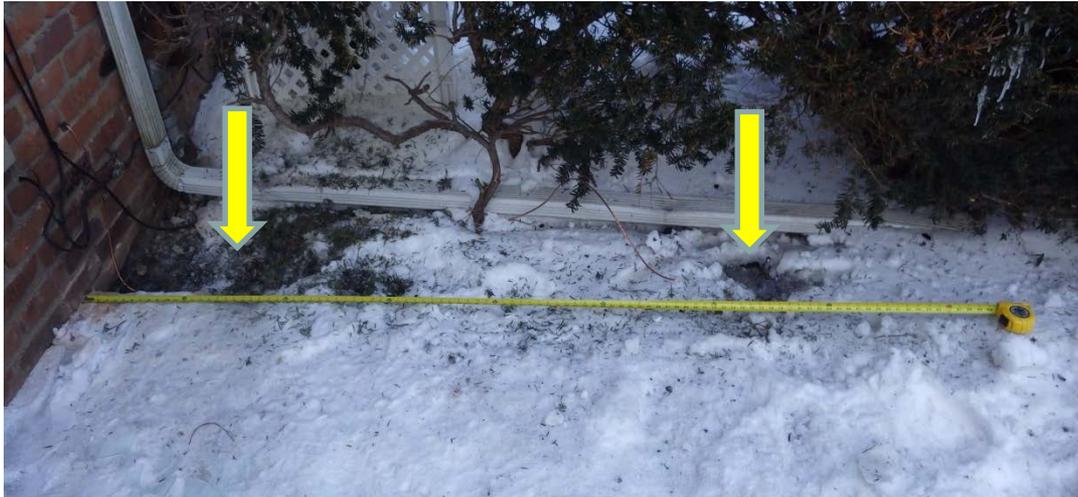
- Third-party damage causing multi-unit condo fire.
- Electrician hit 1-1/8" copper service line with a grounding rod 6.5' from bldg wall. 60 psig MAOP.
- Electrician waited 2 hours before notifying operator.

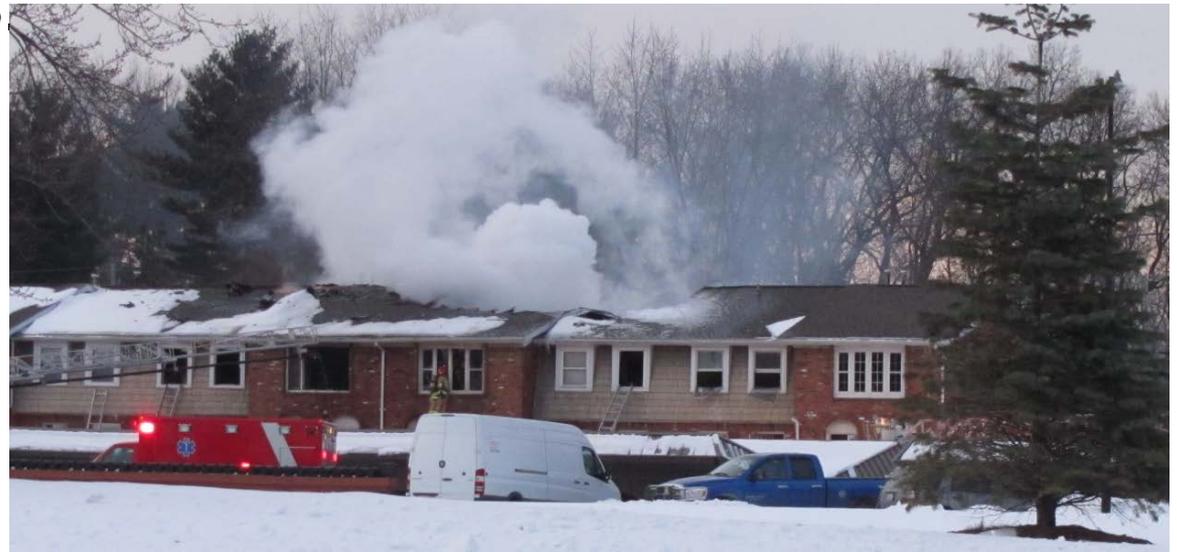
- Technician detected gas inside building and was evacuating when fire started.
- Witness observed flames exiting floor drain near furnace.
- Supervisor told technician not to shut gas off at the master meter.
- Technician had poor communication with fire department.
- Damages \$304,423

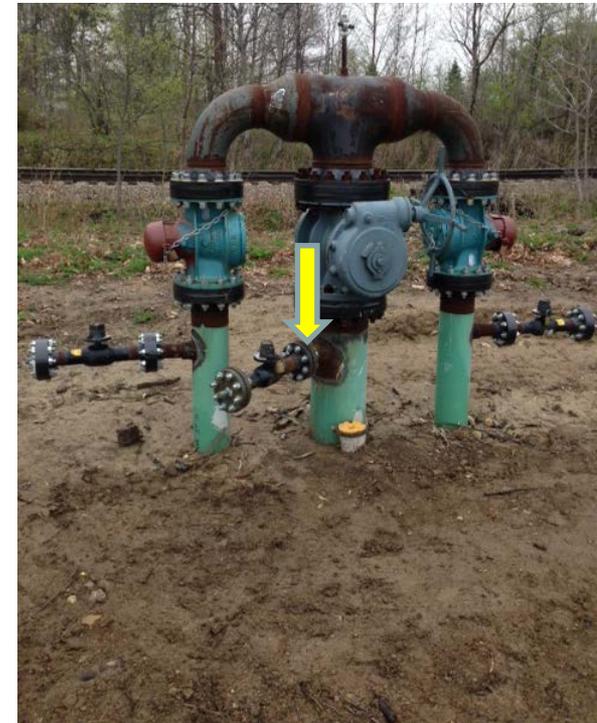
- Farmer hits 2" threaded nipple on above grade valve cluster.
- Leak on 10" steel distribution main. Operating at 315 psig.
- Gradual pressure reductions prevented interruptions.
- 22 hours to shut off gas and make repair.
- 12.525 MMcf gas lost.
- Valve cluster installed in December 2013.
  - Not protected from damage.
  - Girth welds were not coated.

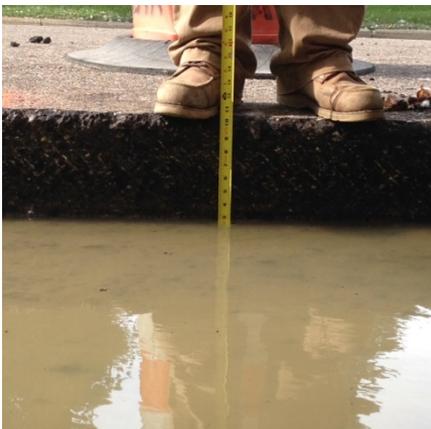
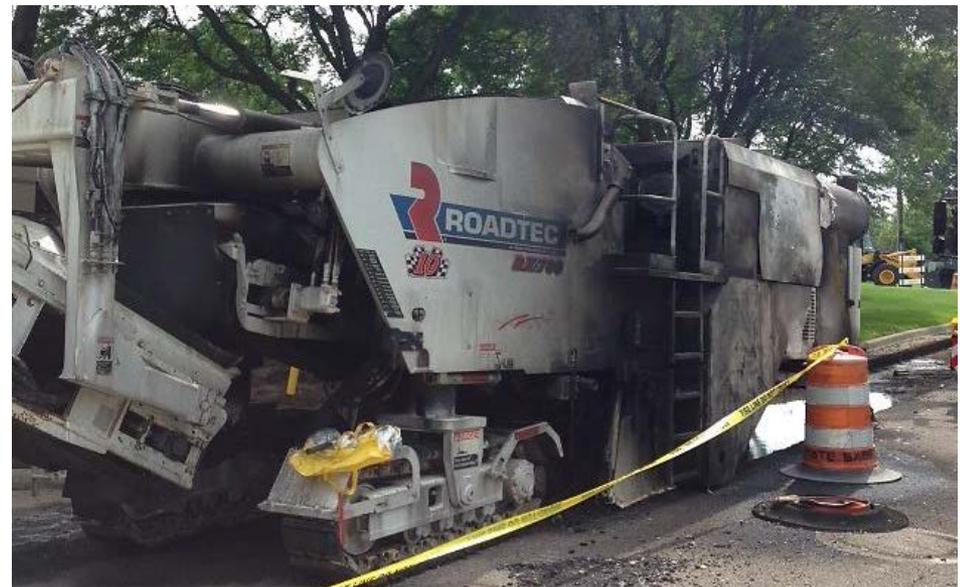
- Third-party damage causes ignition.
- Milling the road 10-inches deep. Hit a plastic service line. 60 psig MAOP.
- MISS DIG ticket called by general contractor. Facilities were staked.
- No injuries.
- \$304,923 damages.

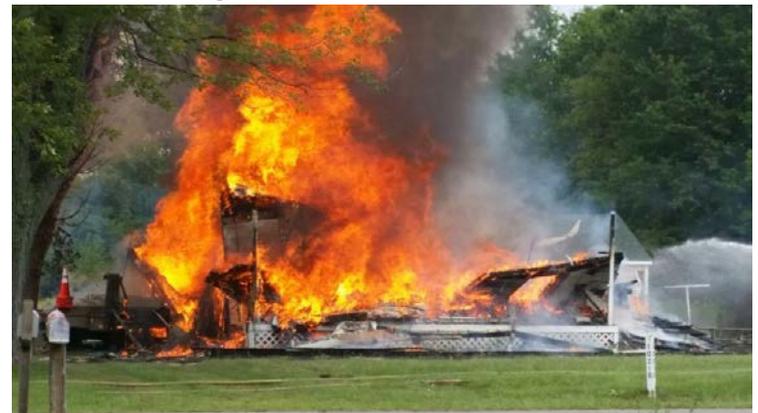
- Lighting strike causes damage to gas service line.
- Resident reported an outside gas leak.
- Service Worker detects 100% gas under roadway prior to explosion.
- Distribution crew arrives to excavate service line tee.
- Explosion occurs.
- No injuries.
- Positive gas reads detected above the gas main and extending through the front yard following explosion.
- \$102,840 damages.

- 192.603(b) – Not keeping records to administer the procedures established under 192.605. Records were not adequate to demonstrate the scope and extent of the leak investigation before and after the explosion.
- 192.605(a) – 4 counts of not following the operator’s leak investigation procedures before and after the explosion. Specifically regarding bar testing over the pipelines, mains, and services in the area. \$40,000 fine.

- Recommend Service Workers notify their appropriate Field Leader that a leak survey is needed if they identify evidence of a lightning strike.

- Recommendations:
- Recommend that service workers continue to monitor the area of an immediate action leak until gas is shut off or conditions are deemed safe. Service workers should continuously perform bar hole testing to confirm that gas is not migrating.
- Recommend Service Workers avoid making assumptions that a resident is not home. Service Workers should make a conscious effort to gain access into a building to check for gas infiltration, such as knocking on doors.
- Recommend operator perform a road closure if there is an unsafe amount of gas escaping near a roadway, which could cause ignition from a passing vehicle.
- Recommend operator reexamine all evidence and details in this investigation and submit a revised supplemental incident report to PHMSA. Recommend operator ensure future incident investigations are thorough enough to determine the cause of the failure.

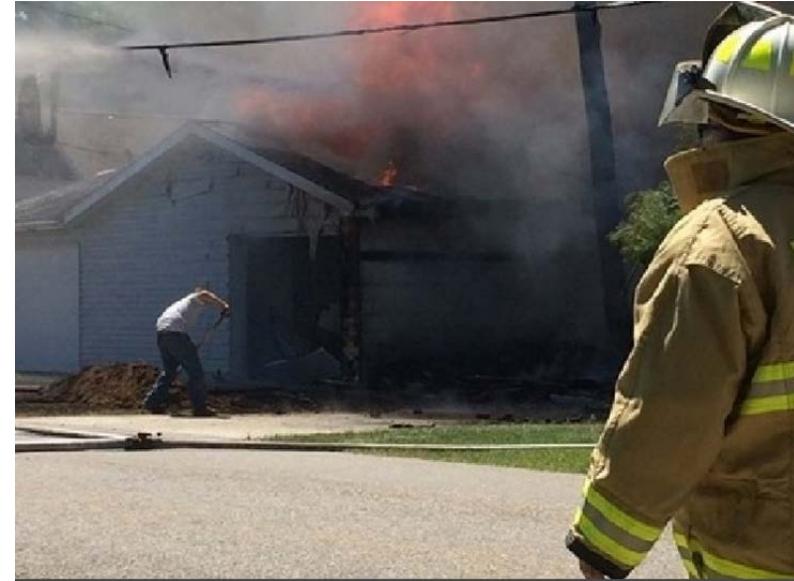
- Outside force damage. Resulting in a house fire.
- Homeowner struck meter with lawn mower.
- House fire spread to garage and to the neighboring structure. 2 homes were destroyed.
- No injuries.
- Damages exceeded \$50,000.
- Operator failed to notify the MPSC. Resulting in late reporting to PHMSA.

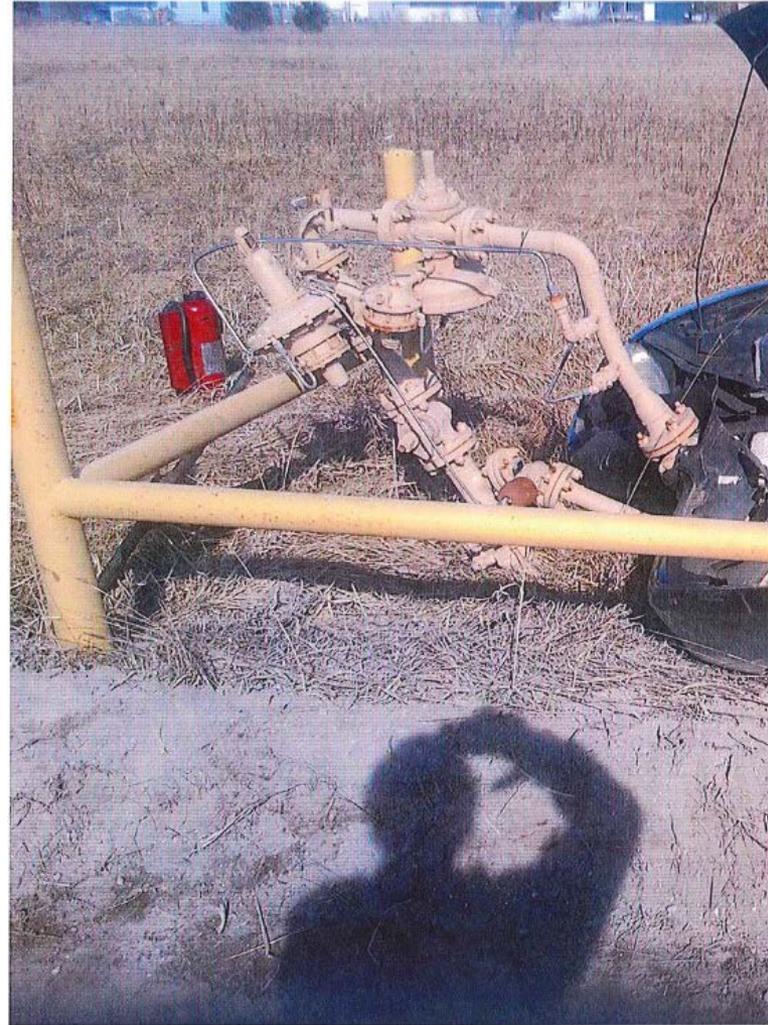
- Outside Force Damage. Regulator Station.
- Car damage to Regulator Station.
- Resulted in school closure for two days following the event.
- According to media, the 2nd closure resulted in the School district exceeding their number of closures for the year.
- Damages exceeded \$10,000.

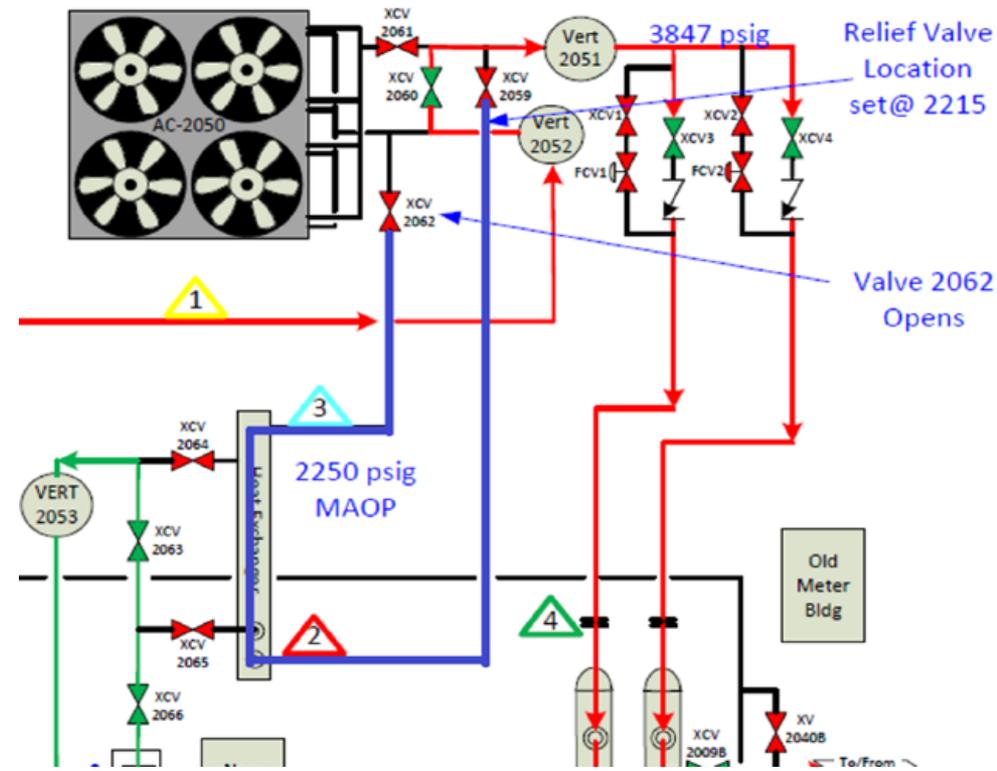
- Overpressure – SRC. Within a Compressor Station that is tied to storage.
- Station was in injection mode.
- PLC commanded a normally closed valve to open. 3847 psig gas entered 2250 psig MAOP piping. Relief valve activated but was unable to prevent the pressure surge.
- Cause still being determined.
