# Incident History

**Michigan Public Service Commission**

**2016** Pipeline  
Safety  
September 26-28 **Conference**

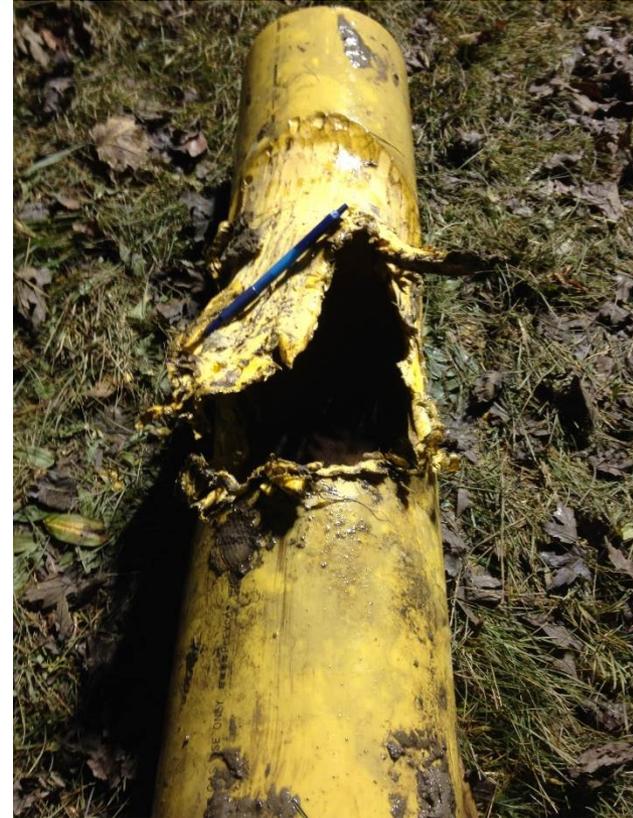
- Third-party damage.
- Contractor installing watermain hit 6" plastic gas main during directional bore pull back of a reaming tool.
- 7.99 Mmcf gas released. Gas blew for 13 hours.
- \$85,416 damages.

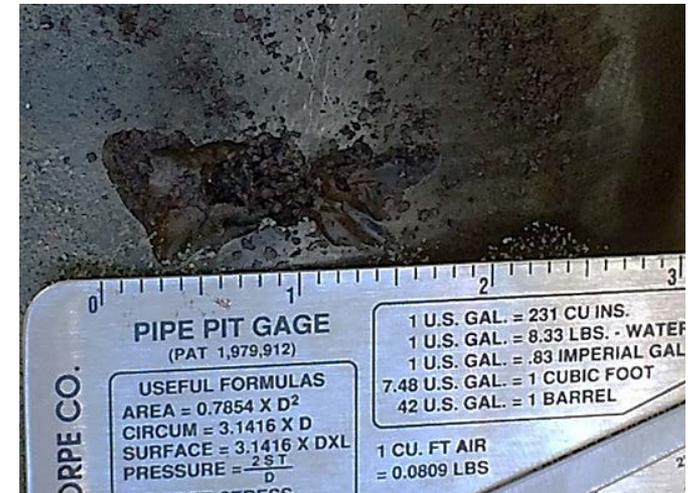
- First event:
  - Pipeline Leak. Storage Field Lateral. 3.6 MMcf gas loss.
  - Lab analysis determined cause to be internal corrosion.
  - The lateral was shut down, repaired, and returned to service.

- Second event (5 months later):
  - Pipeline Leak. Storage Field Lateral. 3.7 MMcf gas loss.
  - Lab analysis determined cause to be internal corrosion.
  - Lateral remains shut-in and scheduled for replacement.

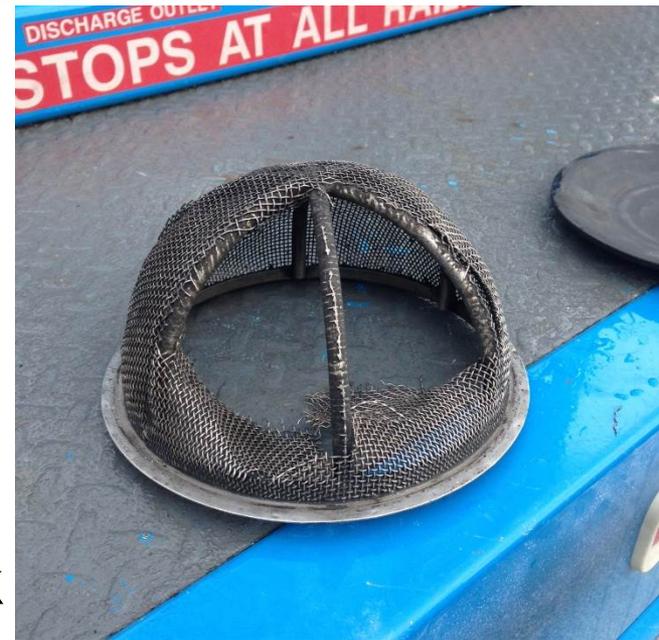
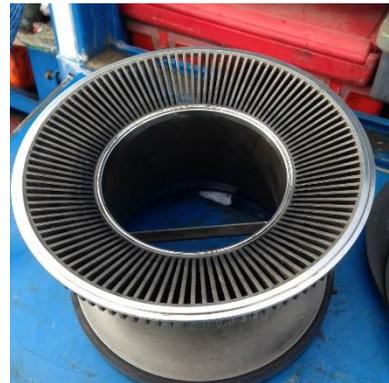
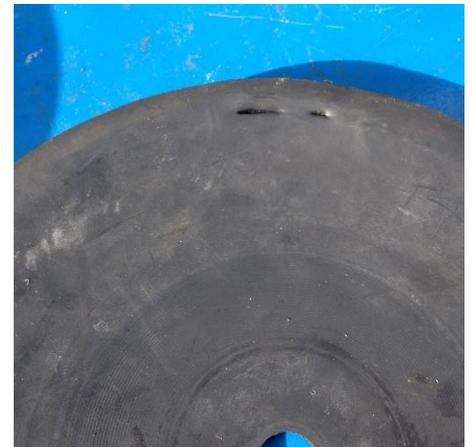
- First event:
- Regulator failure causing 4.2 Mmcf gas to vent from relief.
- Fisher EZR regulator had a damaged filter screen and diaphragm.
- Regulator overhauled and placed back into service.
- Regulator was also overhauled one week prior because of a defect identified in the cage during an inspection.

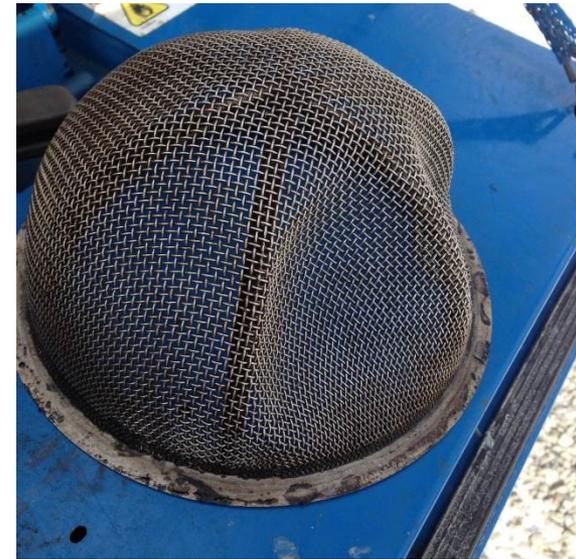
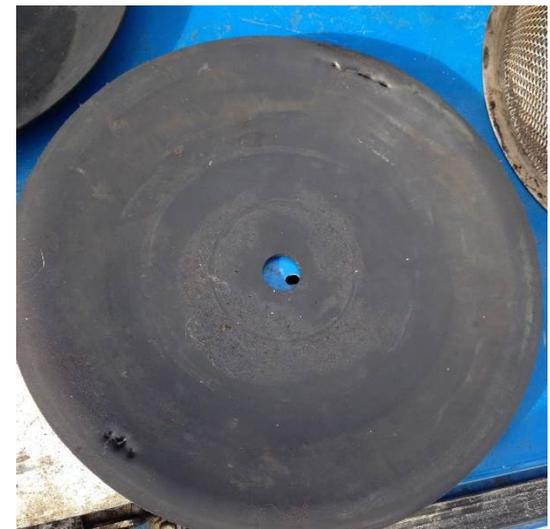
- Second event (following day):
- Regulator and relief failure caused 1 mile of transmission line to experience 113% MAOP exceedance.
- SRC indicates hydrates entrained in the gas stream were found to have precipitated out and froze in the relief valve's pilot control loop resulting in delayed activation.
- Fisher EZR regulator filter screen deformed and diaphragm damaged again (1 day in service).
- Regulator taken out of service.

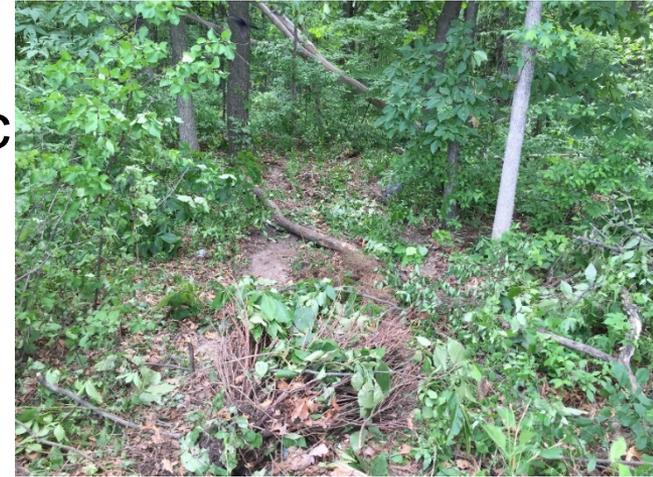
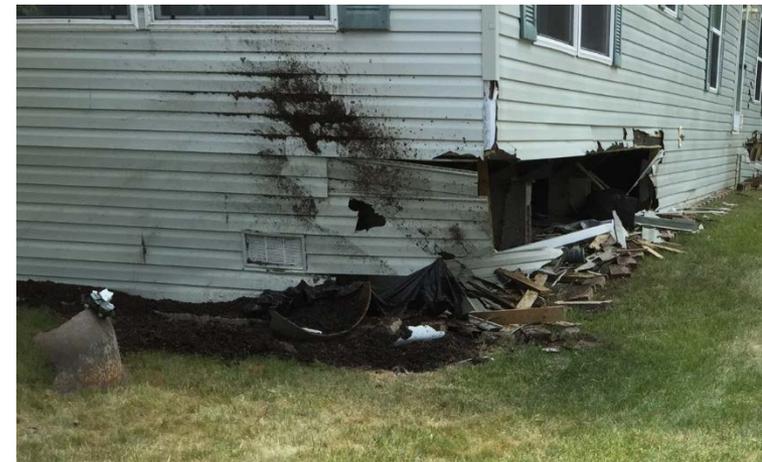
- Vehicle exits the road and strikes a pedestal containing both gas and electric meters.
- Escaping gas ignited causing damage to a home.
- One injury.
- Drug/alcohol suspected to be involved.
- Driver did not apply brakes before or after meter was hit and the vehicle proceeded past the house and into woods.
- \$19,301 damages.

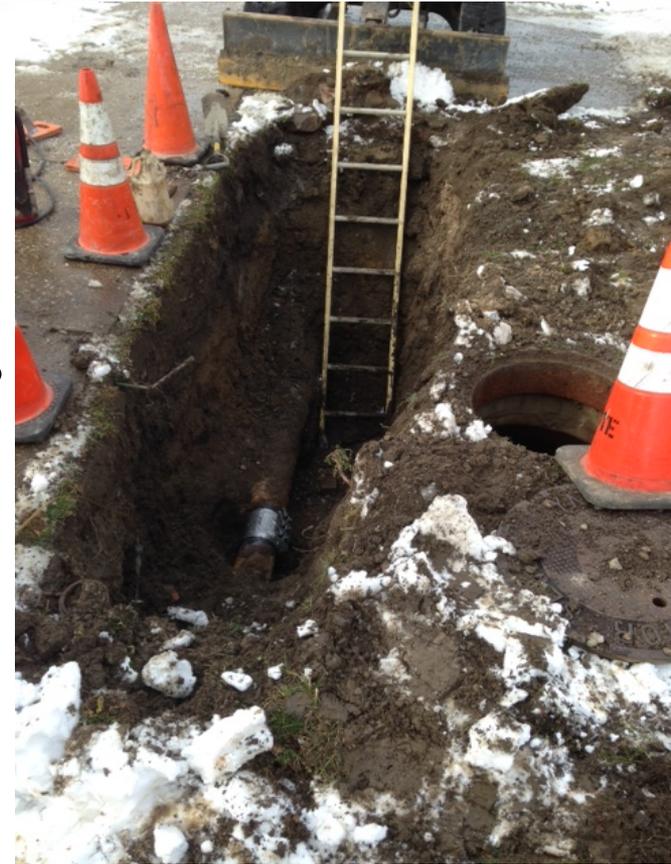
- Restroom building explodes in a public park.
- Prior to explosion, operator investigated leak call and found no gas.
- After explosion, operator discovers a gas leak on a 6" cast iron main several blocks away from the explosion.
- Gas migrated through the nearby sanitary sewer to the location of the explosion.
- Leak repaired with a repair clamp.
- \$233,398 damages.

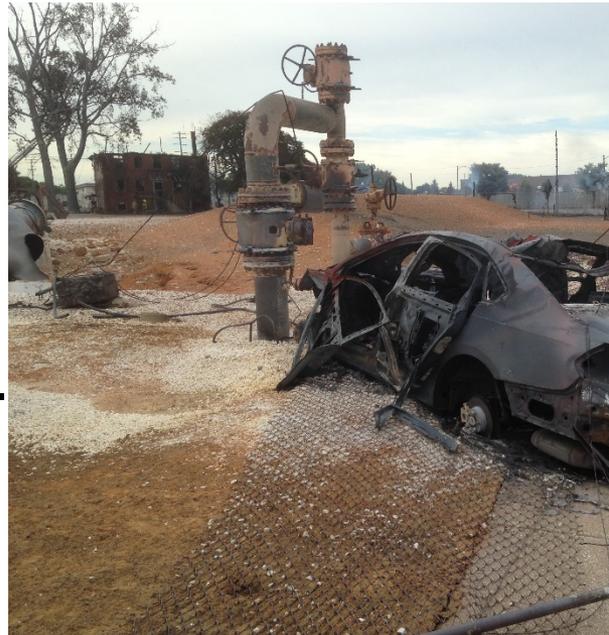
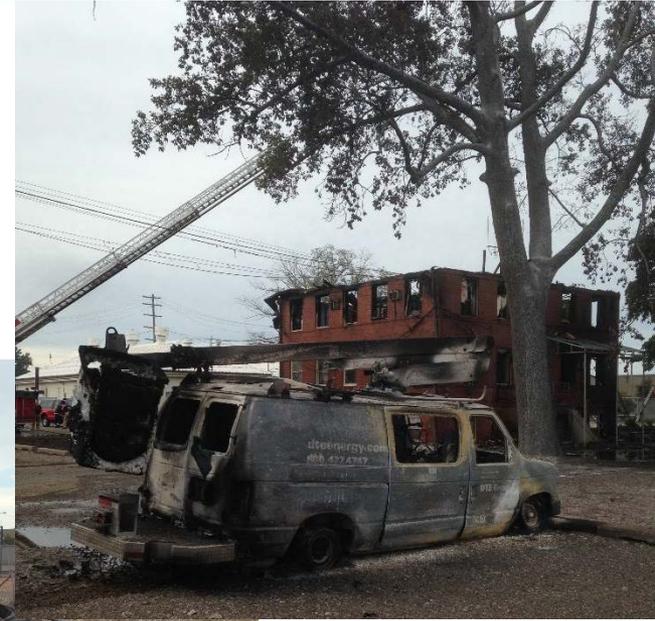
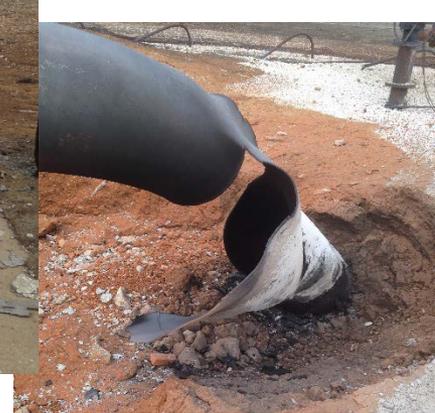
- Vehicle exits the road and strikes an above grade transmission pipeline.
- Escaping gas ignited causing damage to vehicles, gas facilities, and operator's buildings.
- Two injuries.
- 540 psig MAOP.
- 1,000 evacuated.
- 24 Mmcf gas lost.
- Extensive damages.
