# I-94 PILEUP

KALAMAZOO COUNTY

January 9<sup>th</sup>, 2015

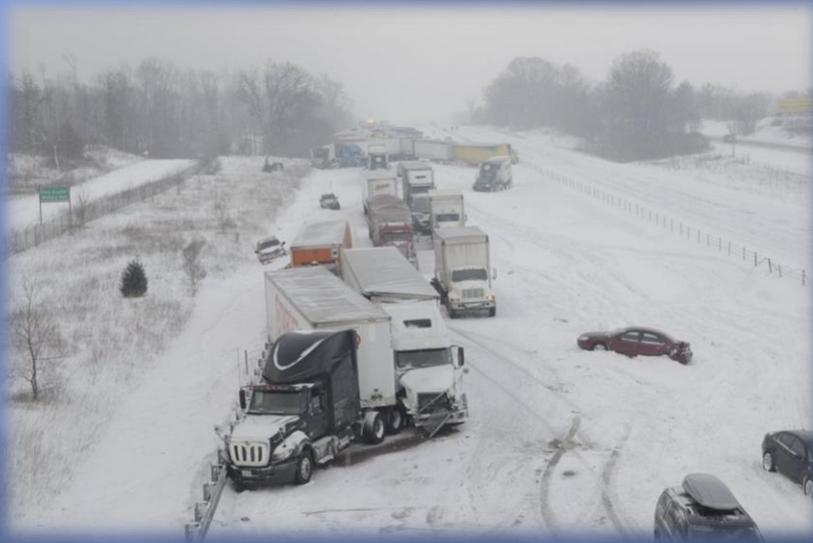
WESTBOUND I-94

12 injuries

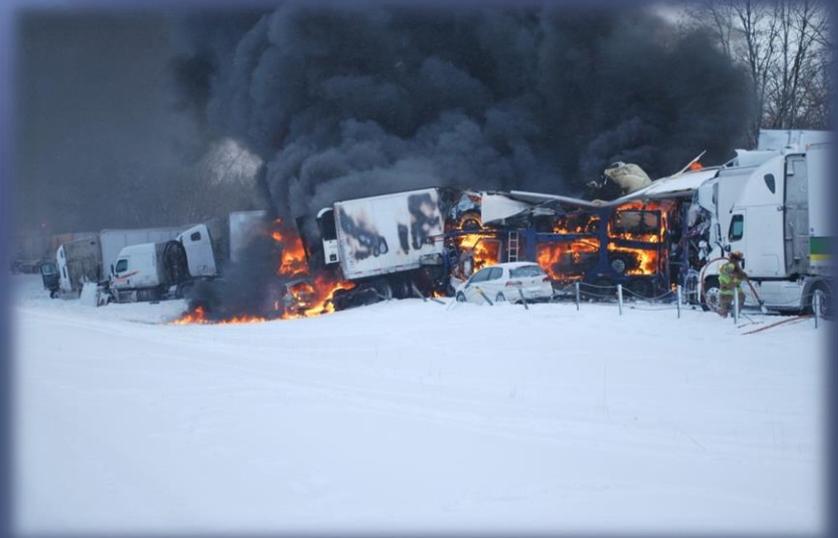
EASTBOUND I-94

10 injuries  
1 fatal

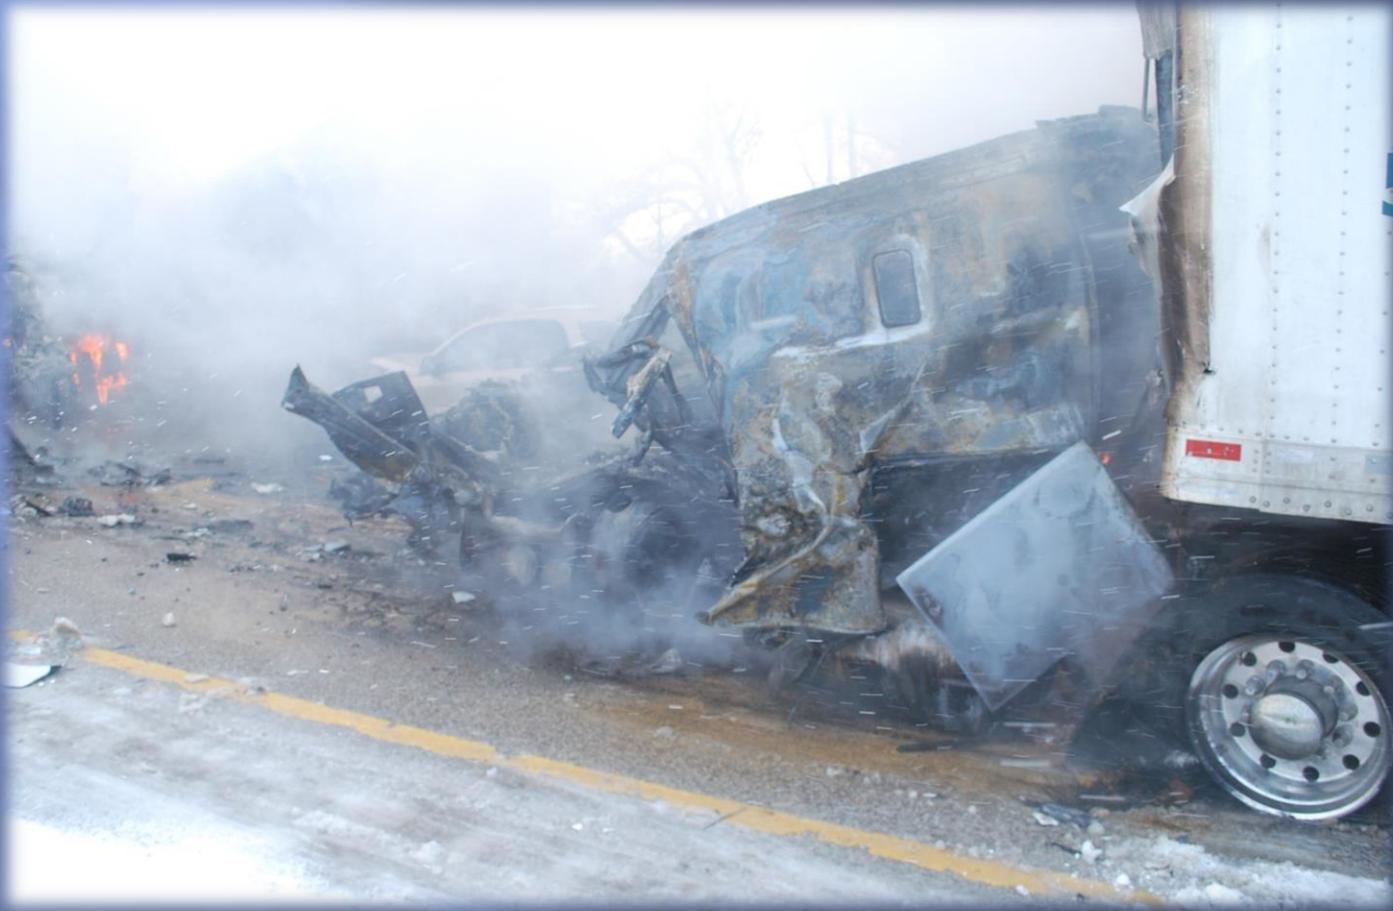
# Fatal Investigation

e/b I-94

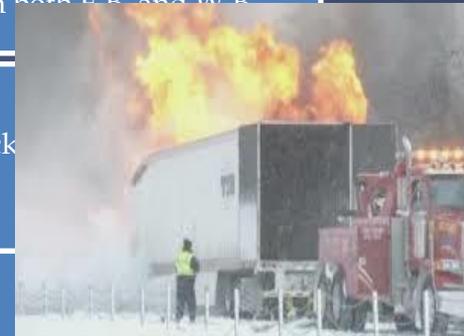
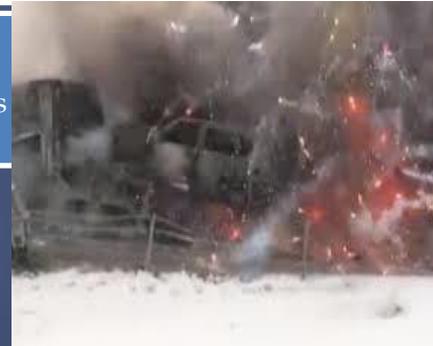
## Fire Works Trailer

- While trying get the vehicles moved the fireworks
- 1 employee injured and taken to the hospital
