FROM: Jim Pawloski P.E., Hydrologic Studies and Dam Safety Unit
Water Resources Division

DATE: October 8, 2018

SUBJECT: Edenville Dam – Dam ID 549, Gladwin County

**Edenville Dam – Dam ID No. 549
Gladwin County**

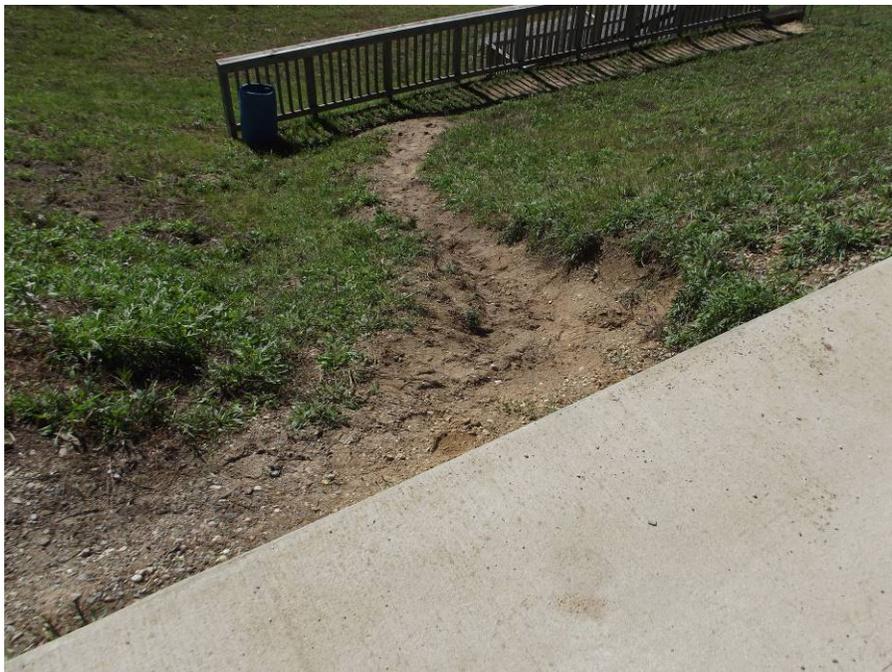
Photograph 4 – Foot traffic erosion at left Tobacco embankment.

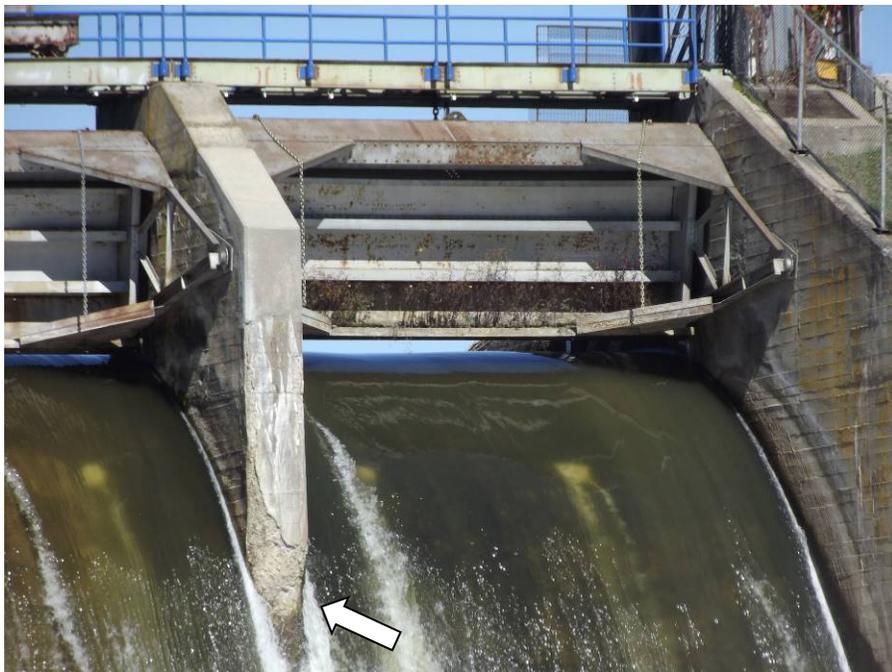
**Photograph 10 – Left gate of Tobacco spillway.
Note the moderate appalling of pier nose.**

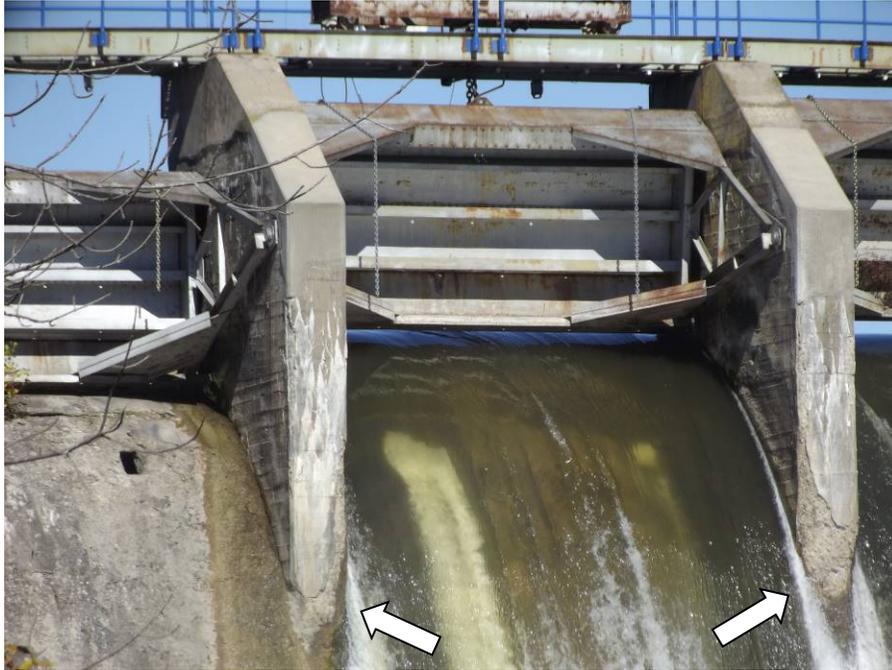
**Photograph 11 – Center gate of Tobacco spillway.
Note the moderate spalling of pier noses.**

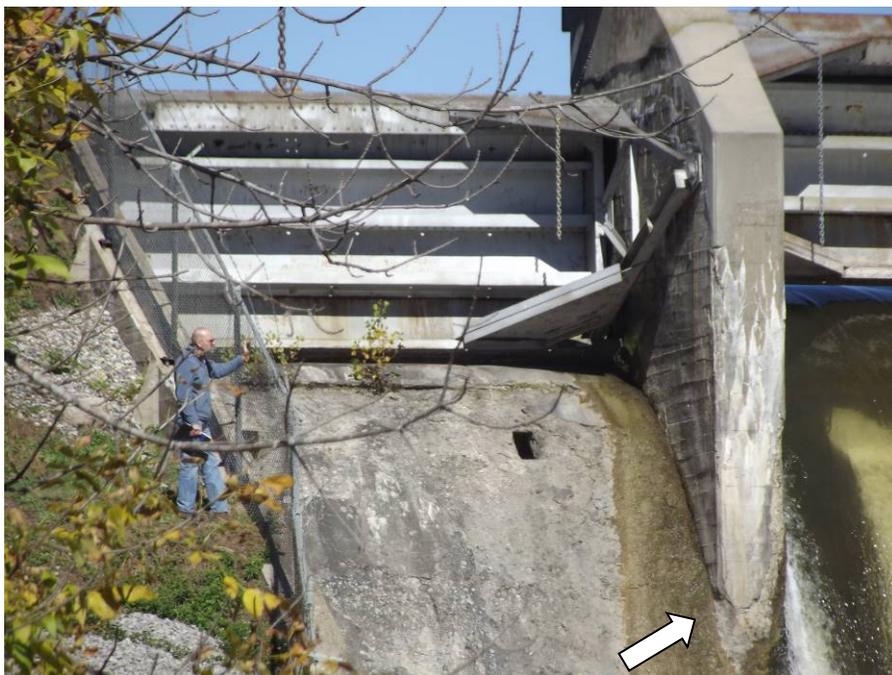
**Photograph 12 – Right gate of Tobacco spillway.
Note the moderate spalling of pier nose and spillway face.**

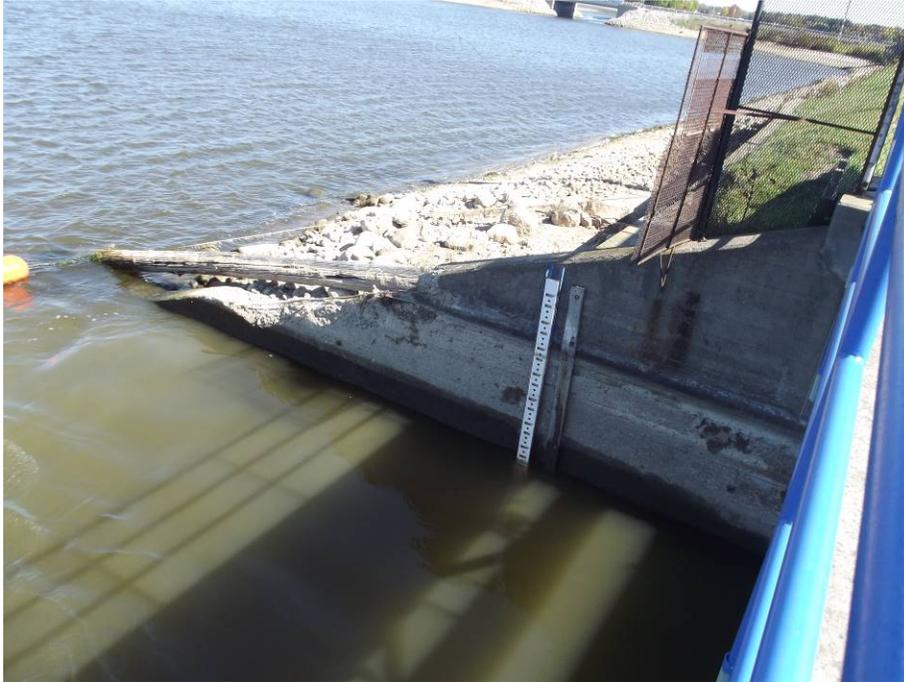
**Photograph 13 – Left upstream abutment wall of Tobacco spillway.
Note the significant spalling and exposed reinforcing steel at top of wall.**

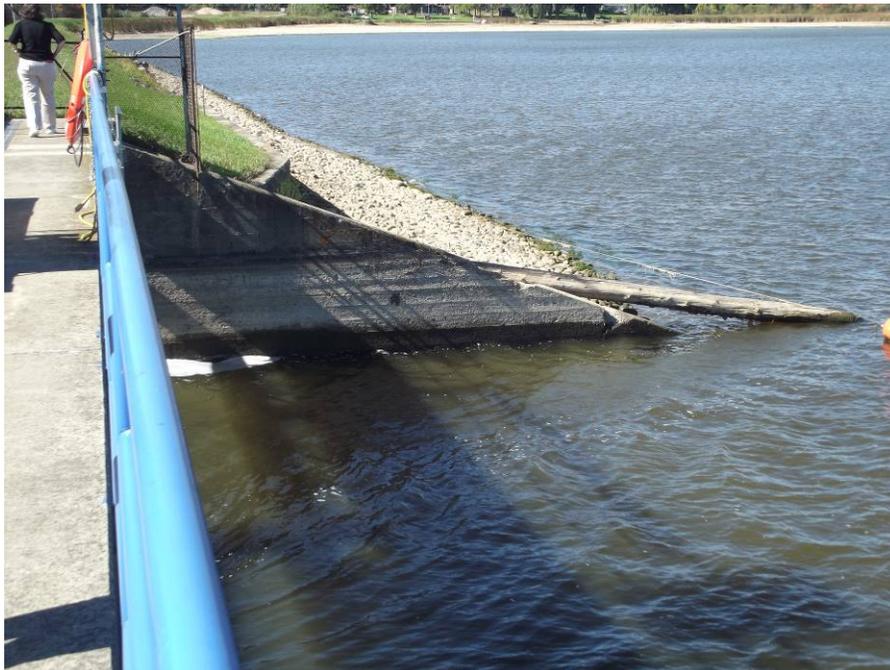
**Photograph 14 – Right upstream abutment wall of Tobacco spillway.
Note the moderate spalling at the top of wall.**

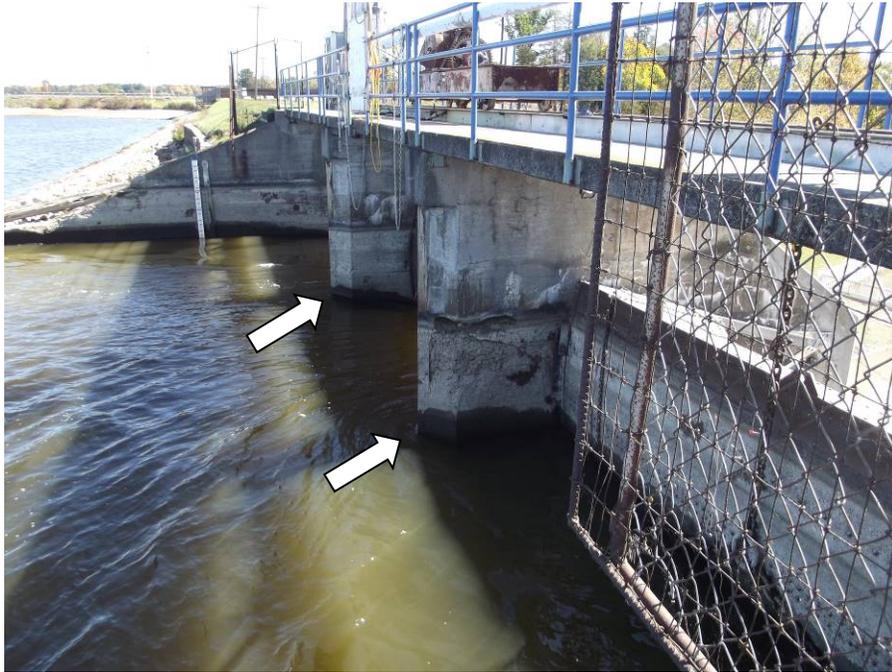
**Photograph 15 – Upstream face of Tobacco spillway.
Note the moderate spalling of pier noses.**

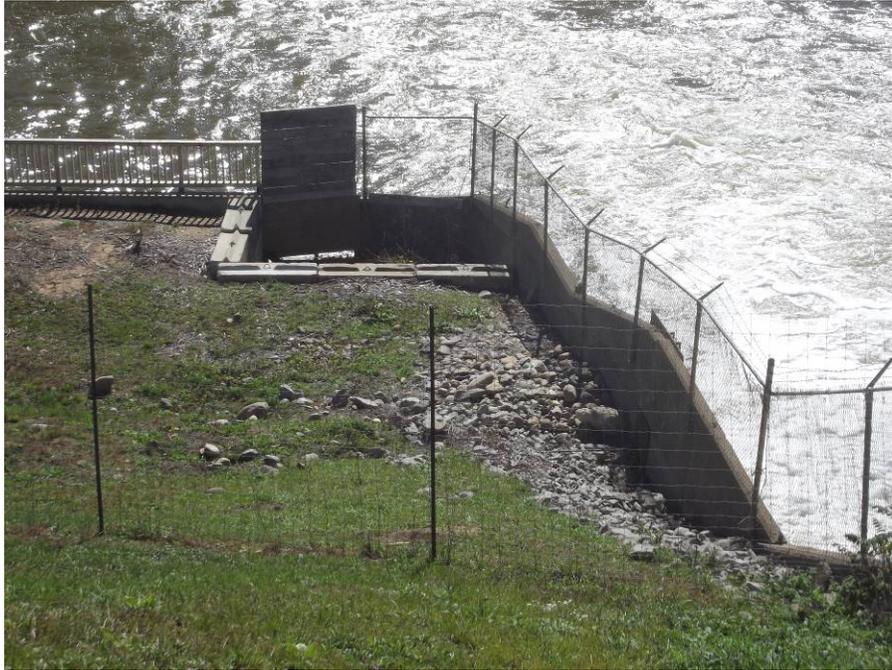
Photograph 17 – Erosion behind left abutment wall.

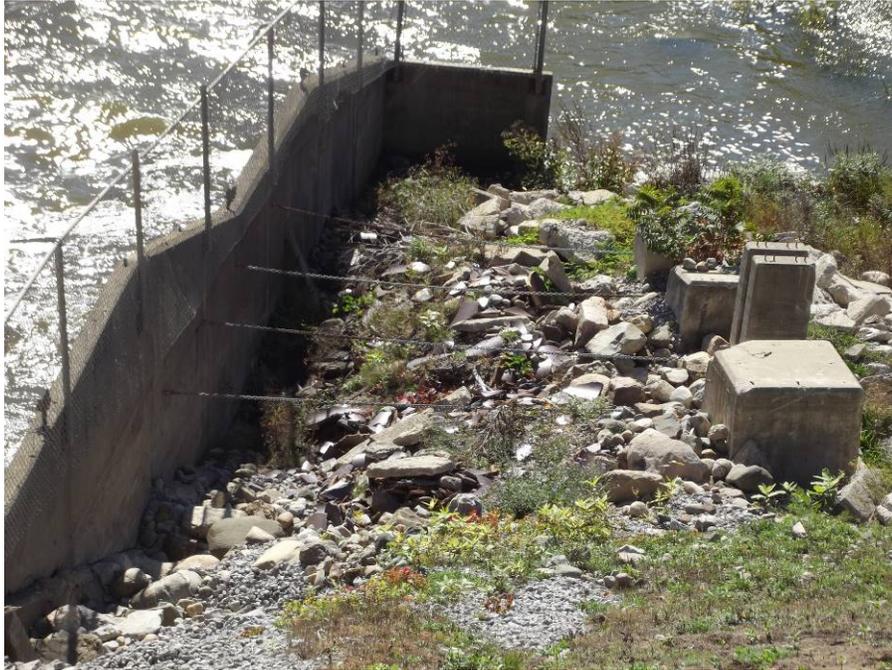
**Photograph 19 – Erosion behind right abutment wall.
Note the dead men and tie-backs and rotation of lower wall.**

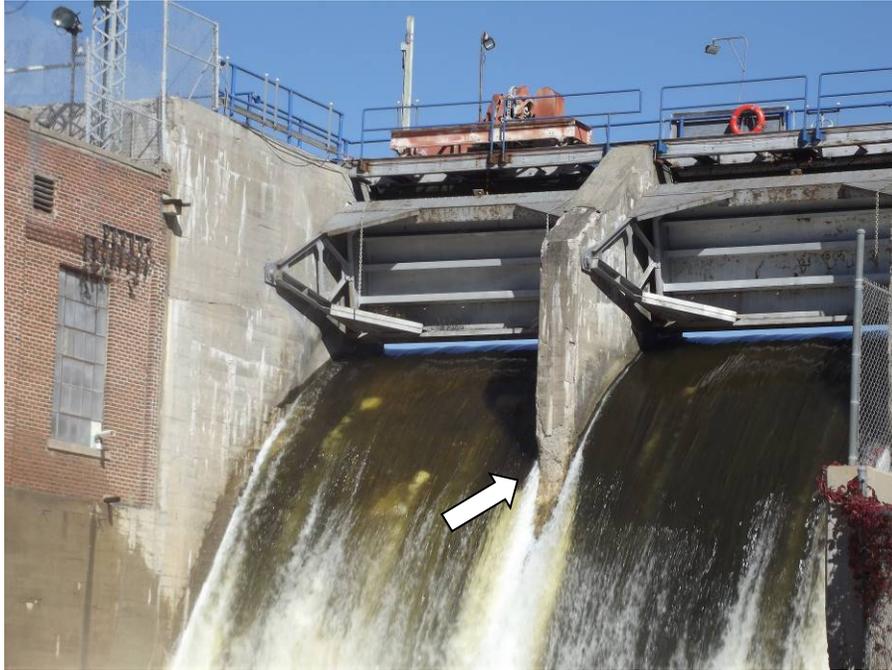
**Photograph 27 – Right gate of Tittabawassee spillway.
Note the moderate spalling of pier nose.**

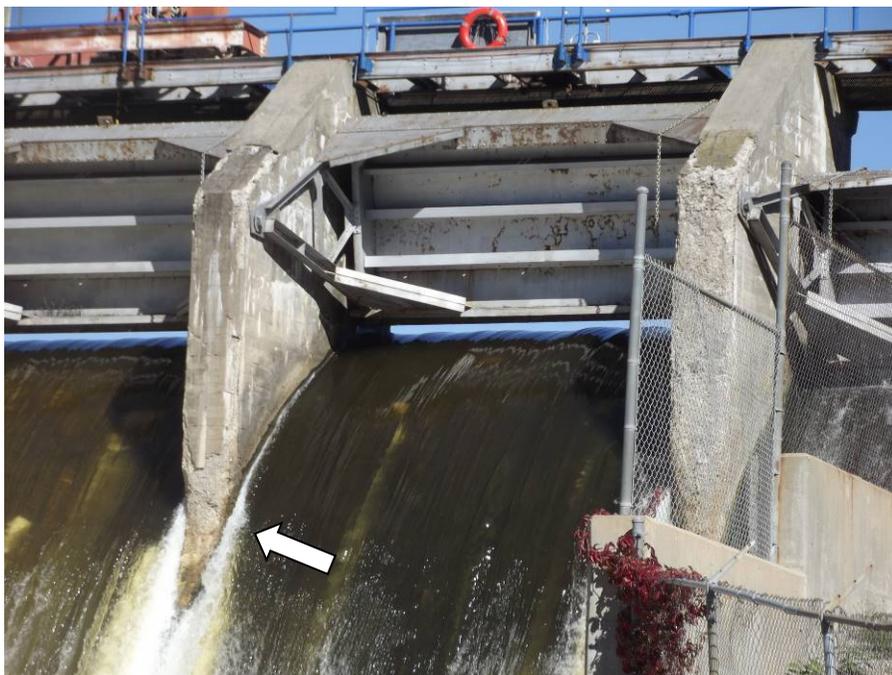
**Photograph 28 – Center gate of Tittabawassee spillway.
Note the moderate spalling of pier nose.**

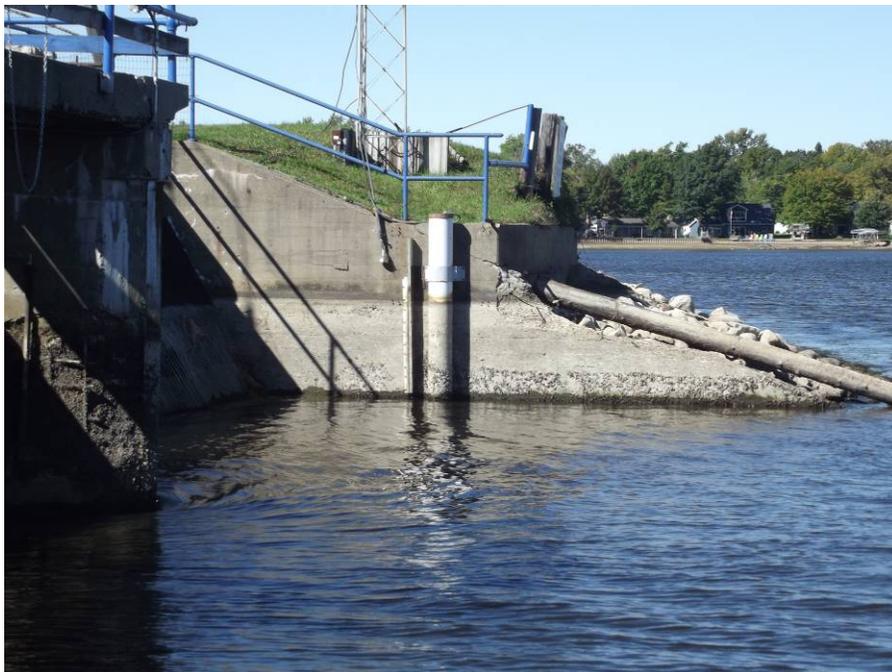
**Photograph 30 – Upstream right abutment wall of Tittabawassee spillway.
Note the significant spalling and exposed reinforcing steel at top of wall.**

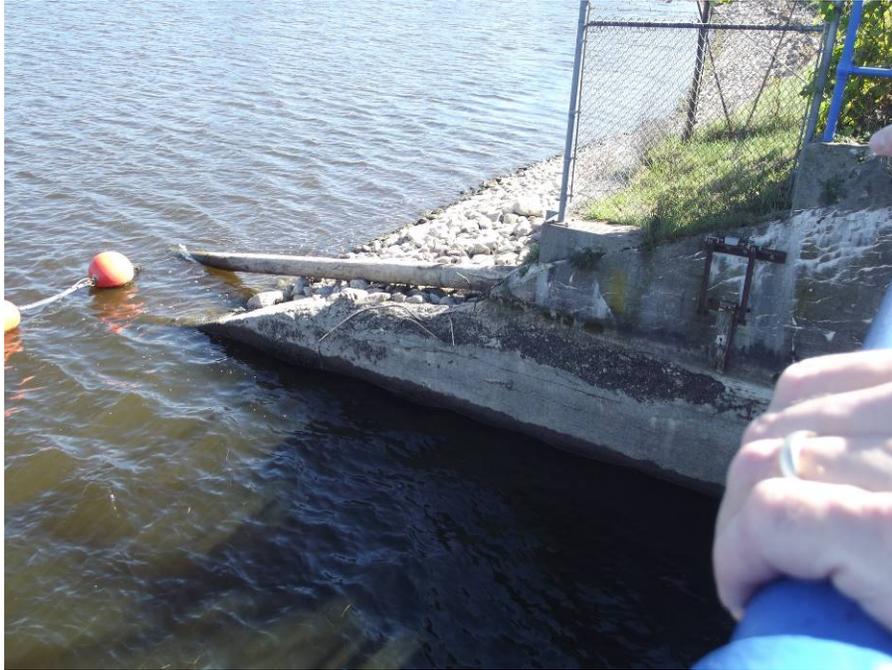
**Photograph 31 – Upstream left abutment wall of Tittabawassee spillway.
Note the significant spalling and exposed reinforcing steel at top of wall.**

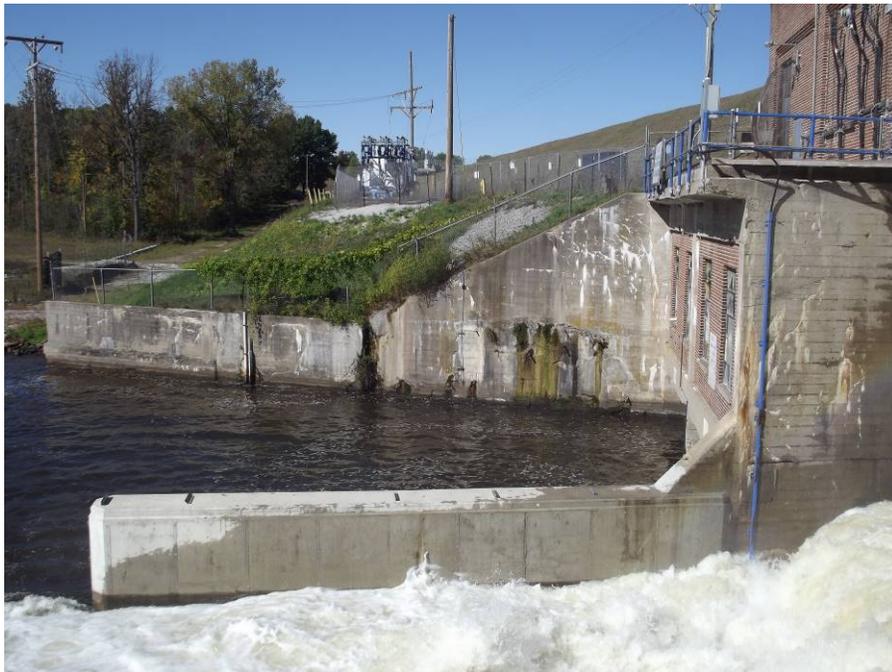
**Photograph 32 – Downstream right abutment wall of Tittabawassee spillway.
Note the significant spalling, cracking and efflorescence throughout.**

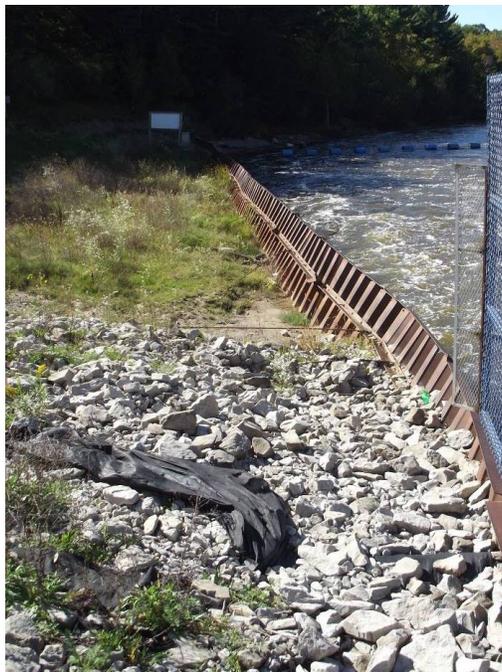
Photograph 34 – Failing retaining wall downstream of left abutment.

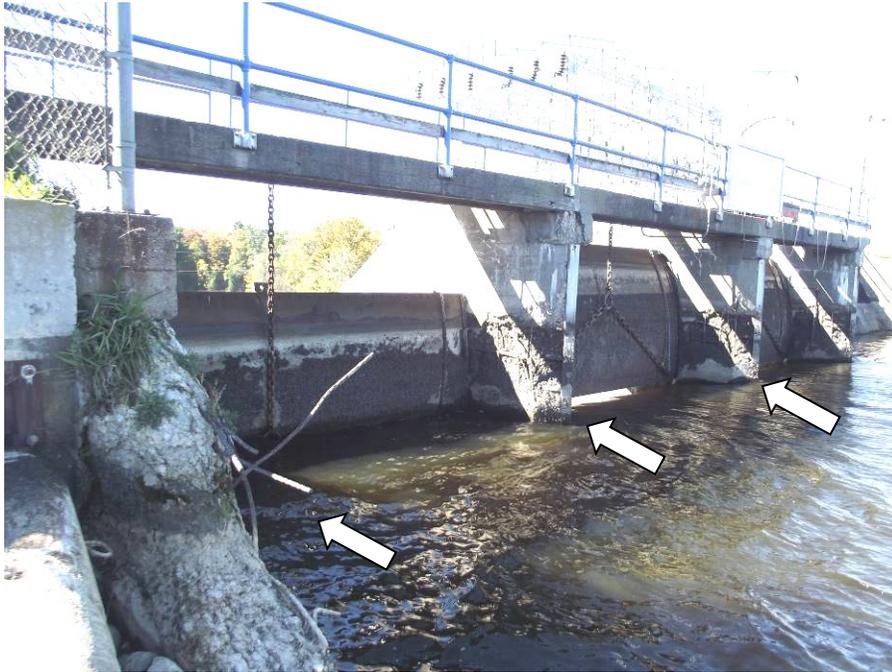
**Photograph 35 – Upstream face of Tittabawassee spillway.
Note the significant spalling and exposed reinforcing steel throughout.**
