February 29, 2020

Progress Update - February 2020 Activities
Former Revere Copper and Brass
5851 West Jefferson, Detroit, Wayne County, Michigan 48209
EGLE Site ID No. 82000136

**RE: Bank Failure Area Aggregate Material Removal and Visual Stability Evaluation Summary (December 2019 and January 2020)
5851 West Jefferson Avenue, Detroit Michigan
Former Revere Copper and Brass
EGLE Site ID No. 82000136
PM Environmental Project No. 01-5303-3-0001**

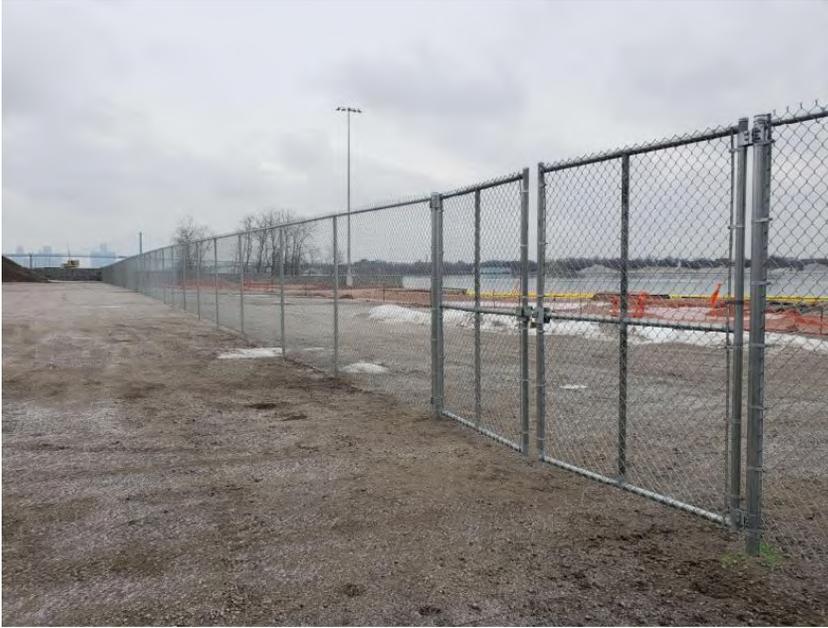
Photograph 1 (January 31, 2020)

- **Security Fencing:** A 6-foot tall chain link fence was constructed across the entire north/south width of the subject property on January 31, 2020, which is equipped with a locked security gate (Appendix A). This fence prevents access to the bank failure area by unauthorized persons. This fencing is inspected on a weekly basis with records maintained by Revere Dock.

View of chain link security fence – facing northeast.

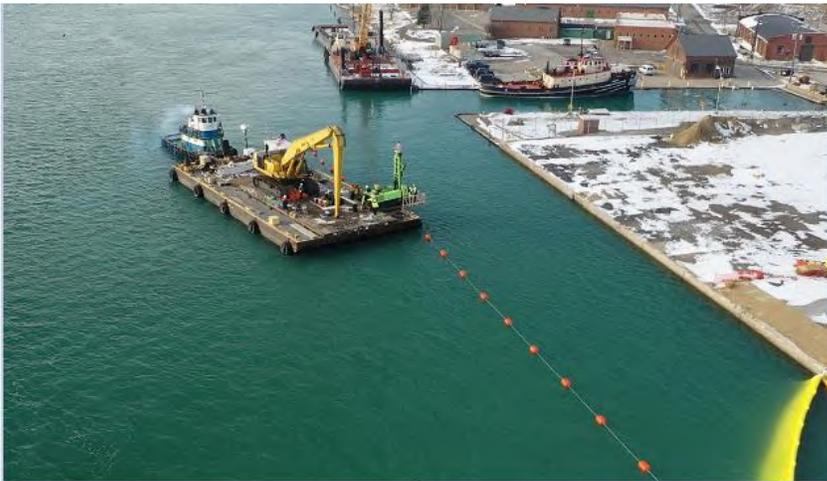
Photograph 2 (February 11, 2020)

View of bank failure and sediment sampling activities – facing south.

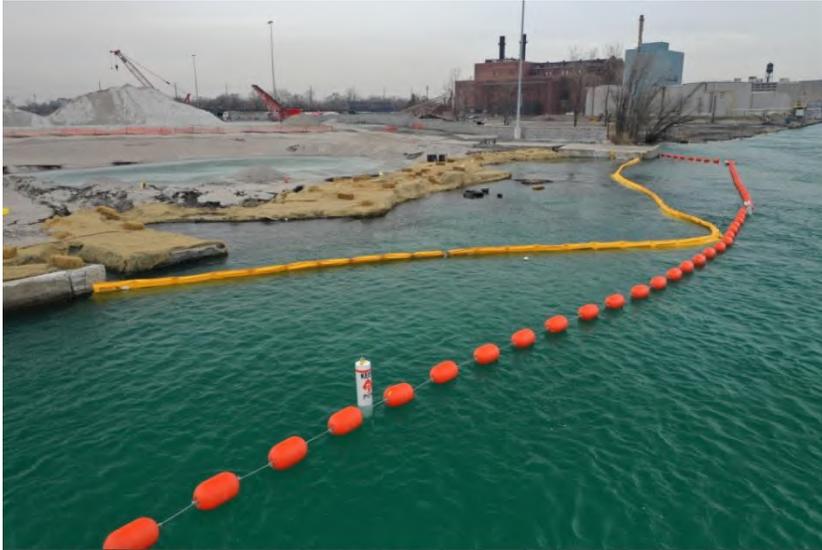
Photograph 3 (February 25, 2020)

Ice-related damage was identified during turbidity curtain inspection activities. Therefore, the 5-foot turbidity curtains were replaced during the week of February 20, 2020, as depicted in the photographs included in Appendix A. Consistent with the February 7, 2020 Response to January 31, 2020 Compliance Communication, the curtains are inspected on a daily basis with records maintained by Revere Dock.

Cable buoys, erosion control blankets, and 5-foot turbidity curtains – facing north/northwest.

Note: Drums of drilling spoils from geotechnical investigation have been removed.

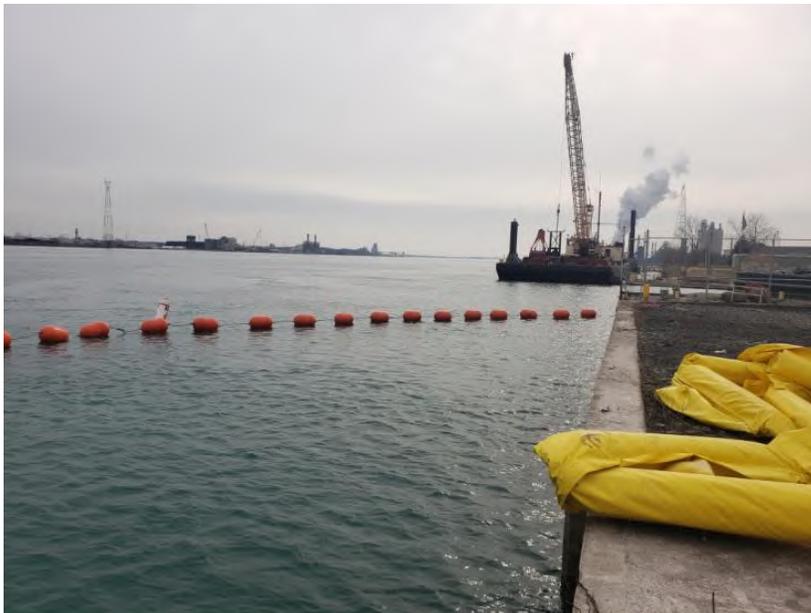
Photograph 4 (February 25, 2020)

The cable buoys are inspected on a weekly basis, with records maintained by Revere Dock. Refer to Appendix A for photos of the cable buoys.

View of cable buoys, facing south.

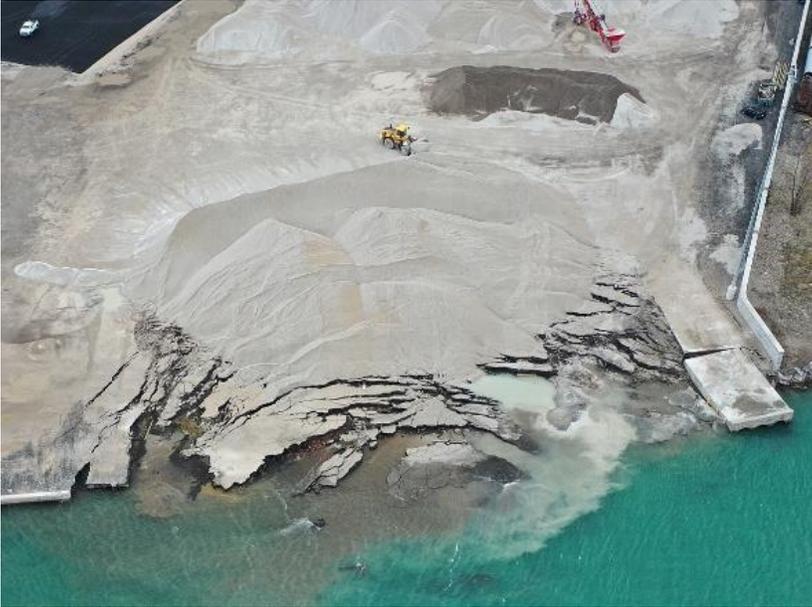
Photograph 1 – Taken by Revere Dock, LLC (November 27, 2019)

A failure of approximately 200-feet of shoreline along the bank of the Detroit River occurred at the subject property on November 26, 2019. A large aggregate stockpile owned by DBS was present in the area at the time of the incident. The presence of the aggregate stockpile resulted in an apparent rotational slope failure that displaced soils downward within and outward from the subject property to an area of the Detroit River immediately east of the former shoreline boundary. Photo #1 in Appendix A depicts the aggregate stockpile on November 27, 2019, the day after the bank failure incident occurred.

View of river bank failure area, facing west.

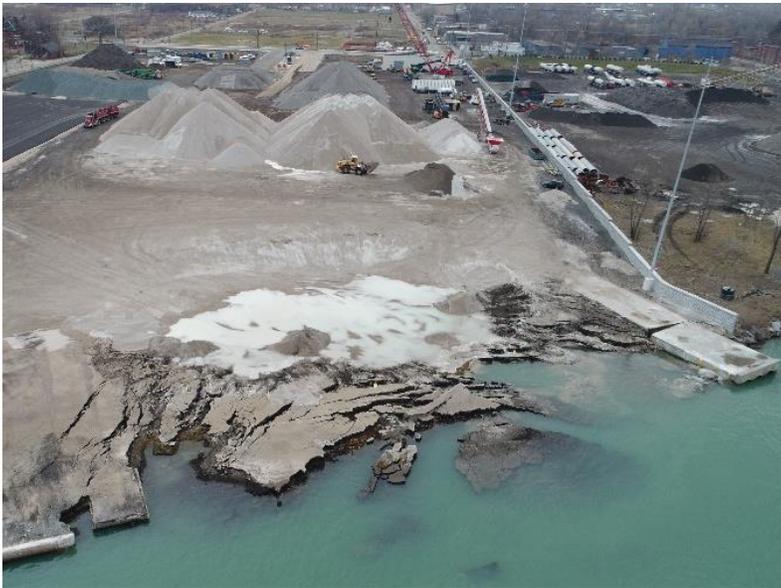
Photograph 2 – Taken by EGLE (December 6, 2019)

Photo #2 in Appendix A depicts the area of the bank failure on December 6, 2019, when EGLE, the United States Environmental Protection Agency (USEPA), and others toured the subject property.

View of river bank failure area, facing west.

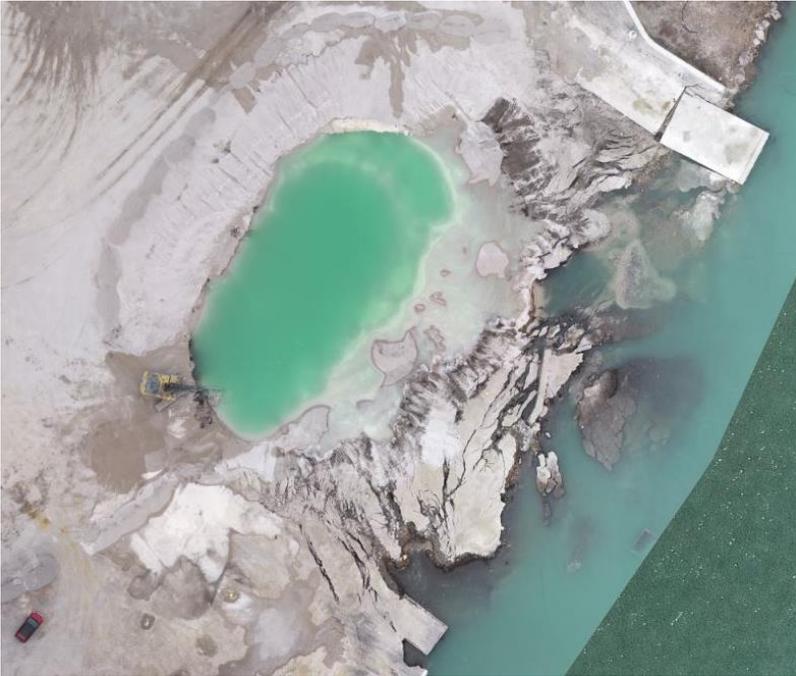
Photograph 3 – Taken by G2 Consulting Group (December 13, 2019)

Photo #3 in Appendix A depicts the area of the bank failure on December 13, 2019, during the latter stages of aggregate excavation from the pond area.

View of river bank failure area, facing west/northwest.

Note in-progress excavation activities within the southern portion of the pond area.

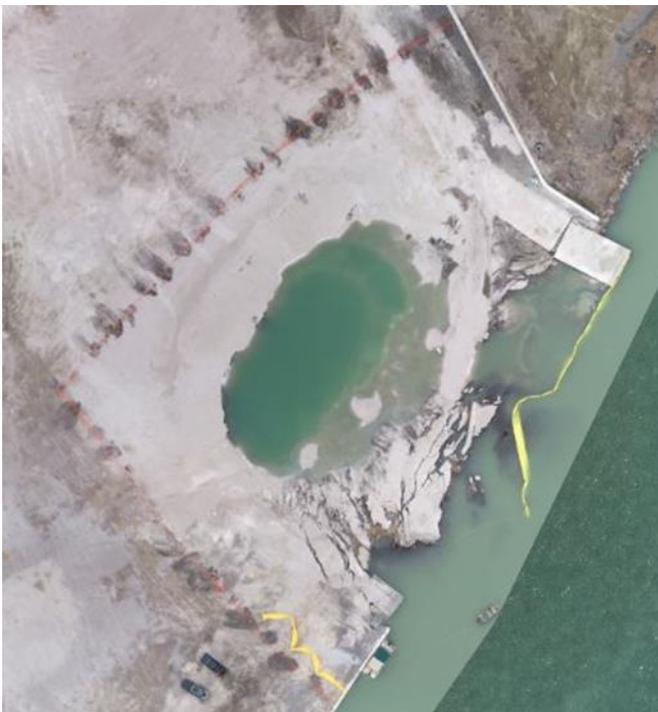
Photograph 4 – Taken by G2 Consulting Group (January 17, 2020)

Aerial drone photos of the bank failure area collected by G2 on December 13, 2019 and January 17 and 21, 2020 are included in Appendix A as Photos # 4 and #5, respectively.

View of river bank failure area, facing west/northwest.

Note in-progress turbidity curtain installation activities and presence of gravel erosion control berm installed along the eastern boundary of the pond area.

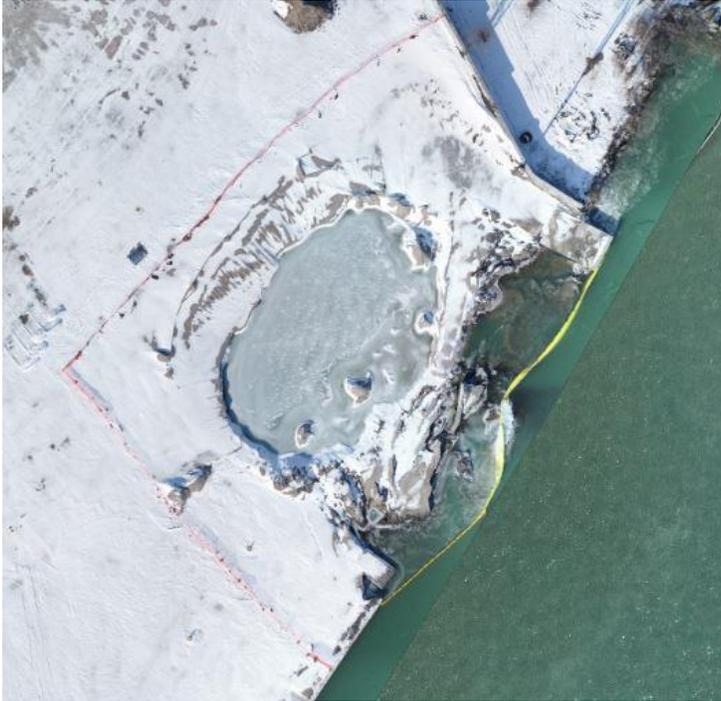
Photograph 5 – Taken by G2 Consulting Group (January 21, 2020)

View of river bank failure area, facing west/northwest.

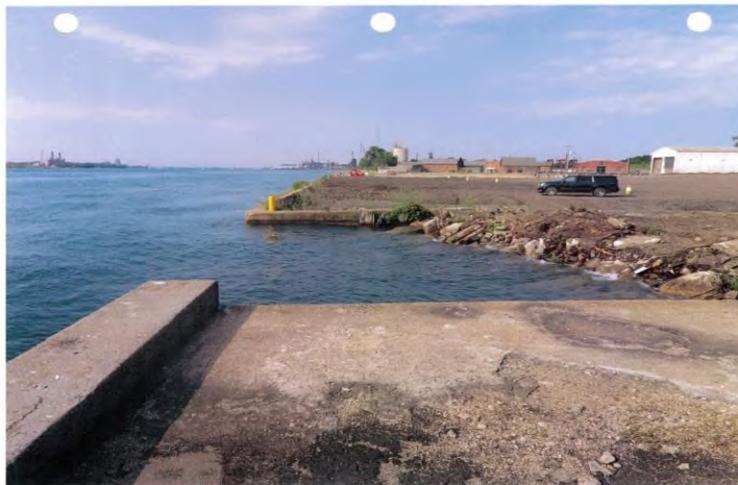
Photo 1 – Site Conditions Before Failure October 17, 2019

Photo 1 shows the subject property site along the existing shoreline, at the upstream (north) property line, looking downstream (south). The concrete box structure in the foreground is the GLWA outfall box structure. Downstream, the photograph shows the intact Pile Supported Concrete Cap structure that we investigated in 2016. Between the two aforementioned structures is a slope shoreline into the Detroit River.

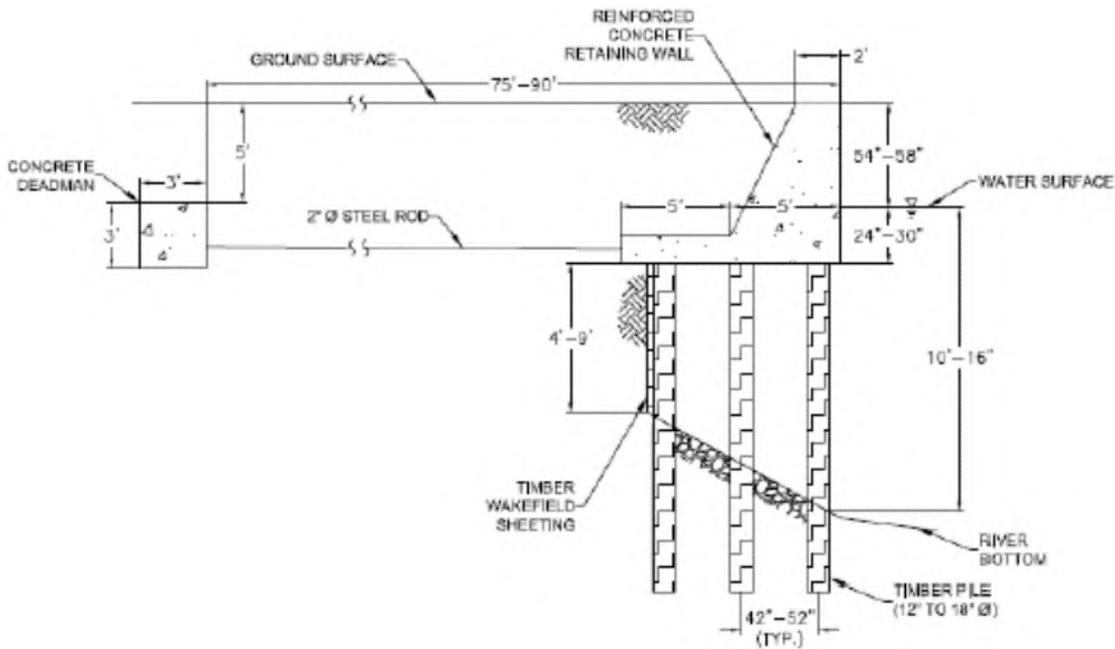
Figure 1 - Cross Section Along Pile Support Concrete Cap

Figure 1 presents a cross section of the Pile Supported Concrete Cap structure. This cross section is looking upstream (north). It should be noted that the existing shoreline structure is not a vertical wall, but rather, a pile support concrete slab and cap over natural shoreline.

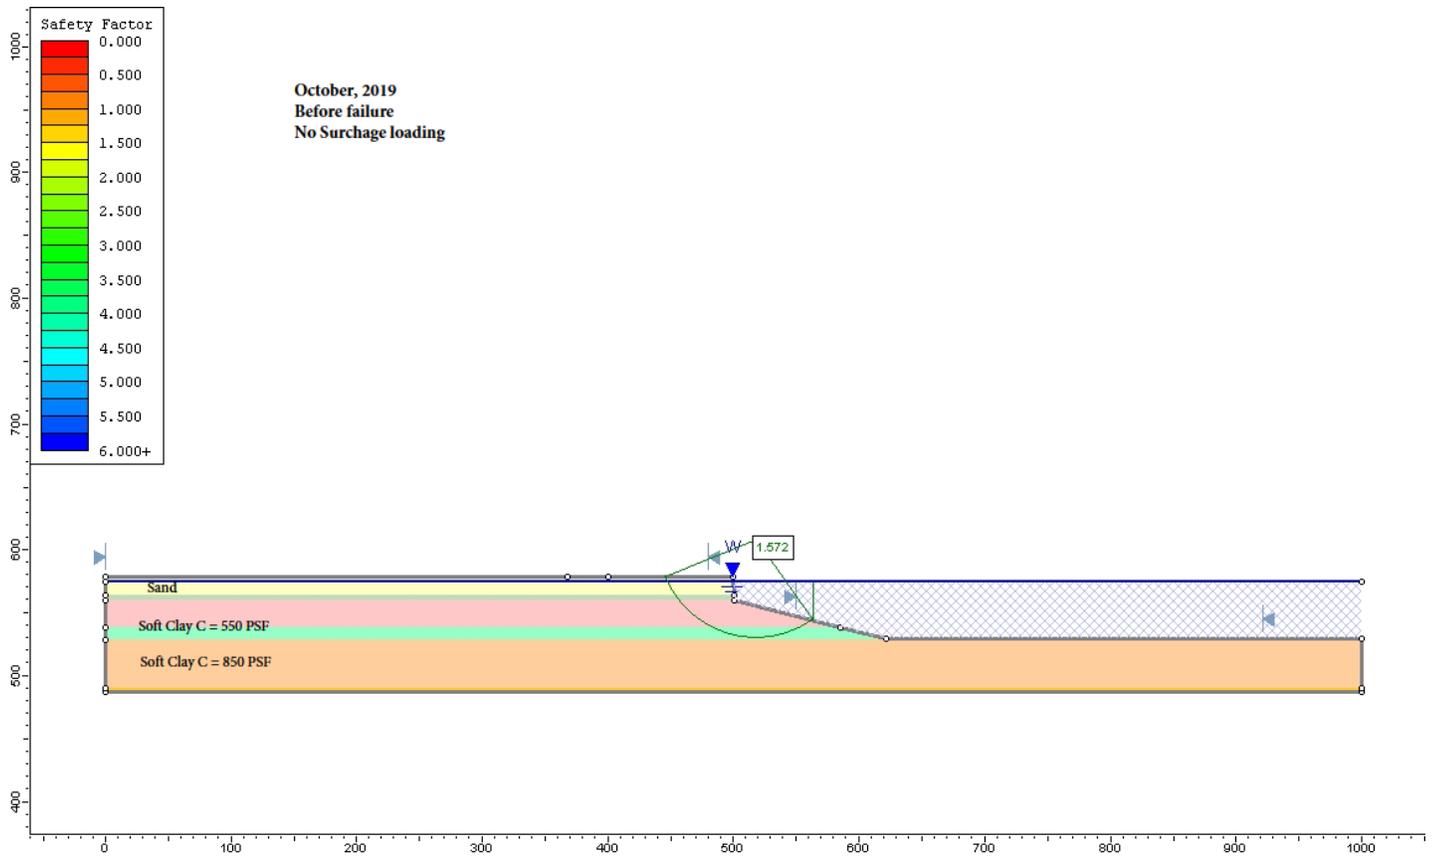
Figure 2 - October 17, 2019 Slope Stability Condition

For the purpose of this study, we performed slope stability analyses using the compute program SLIDE using the Simplified Bishop Method option. Slope stability is the potential of soil slopes to withstand movement. Stability is determined by the balance of shear stress caused by loadings and the shear strength of the underlying soils. The above figure indicates the conditions as of October 17, 2019 with no surface loadings had a Factor of Safety against movement (slope failure) of 1.57. That is, the resisting forces of the soil are 57% greater than the driving forces. The circular arc indicated in Figure 2 shows the potential failure path.

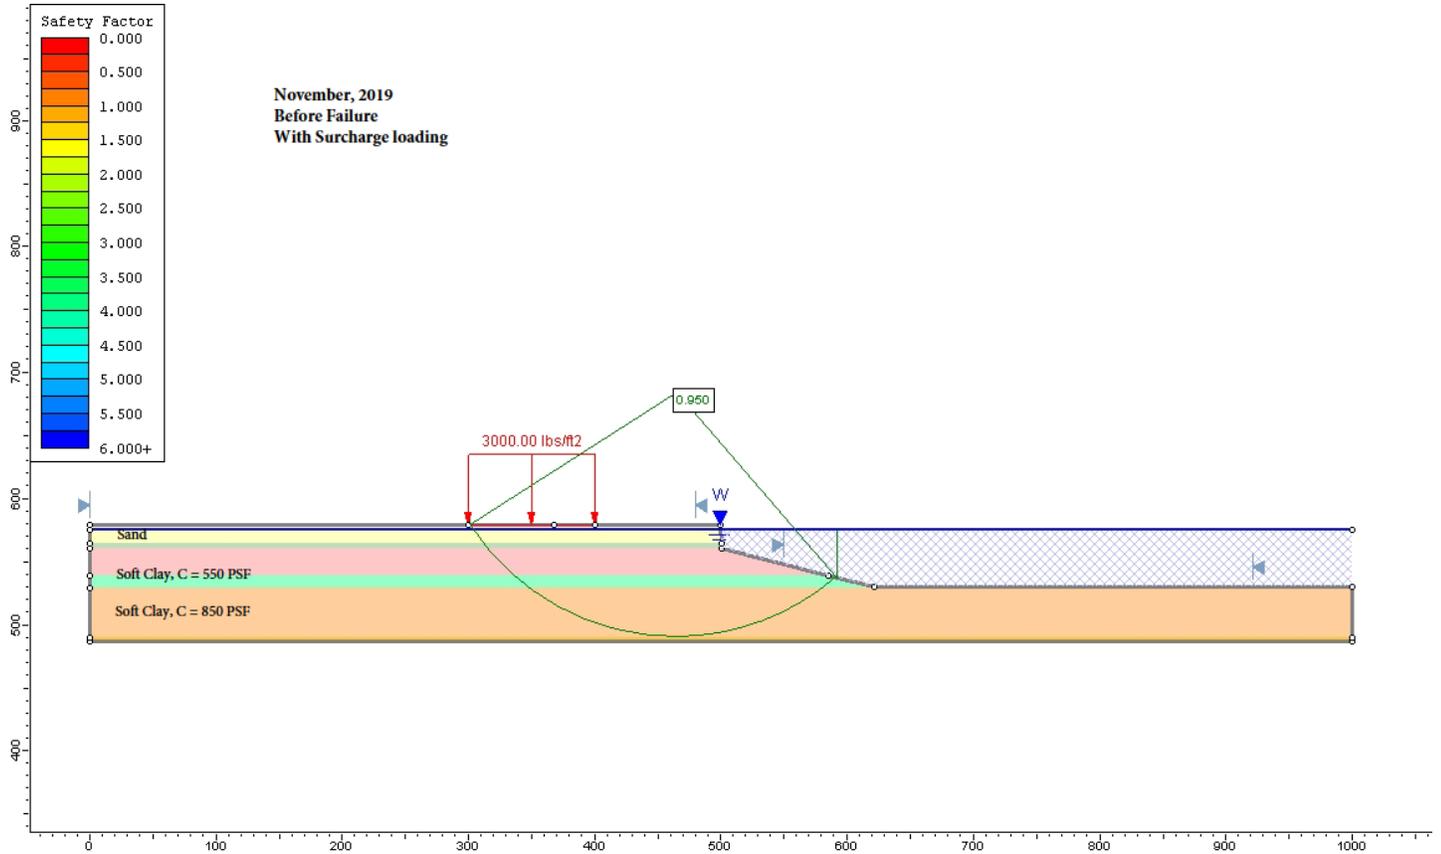
Figure 3 – Slope Stability with Stockpiling Operations

The above figure indicates the conditions under stockpiling conditions. Our analysis shows a Factor of Safety against movement (slope failure) of less than 1 meaning large scale deep rotational slope movements are imminent.

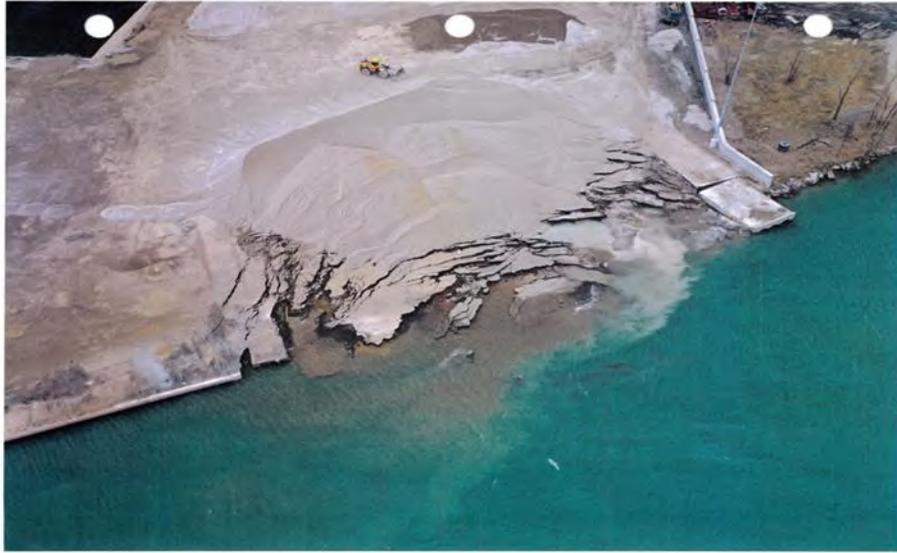
Photo 2 - Site Conditions November 27, 2019

The above Photo 2 is an aerial photograph taken on November 27, 2019. Large scale movements between the stockpile areas and the shoreline are apparent. These movements cause a reduction of soil strength from peak conditions to remolded conditions. The result is a large circular mass slide toward the Detroit river bottom. The result of soil mass moving into the Detroit River is a flattening of slope into the Detroit River.

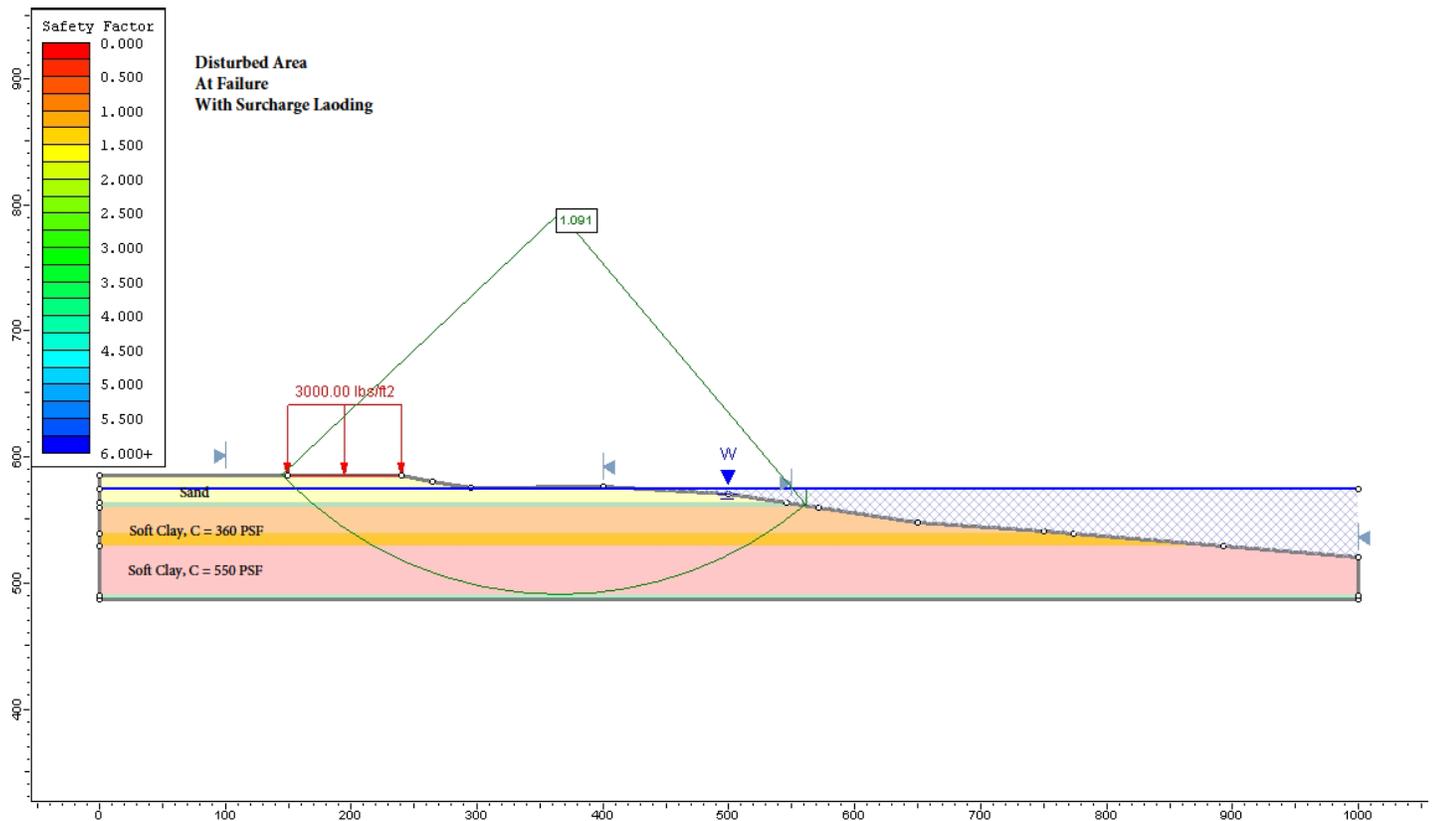
Figure 4 – Slope Stability with Stockpiling Operations Immediately After Failure

The above figure indicates the condition immediately after failure. Remolded soil strengths were used in the analysis along with the milder soil slope into the Detroit River as was reported to us. Our analysis indicates a Factor of Safety against failure for this condition is slightly above 1, indicating the slope movements should stop even with stockpile surcharge loadings.

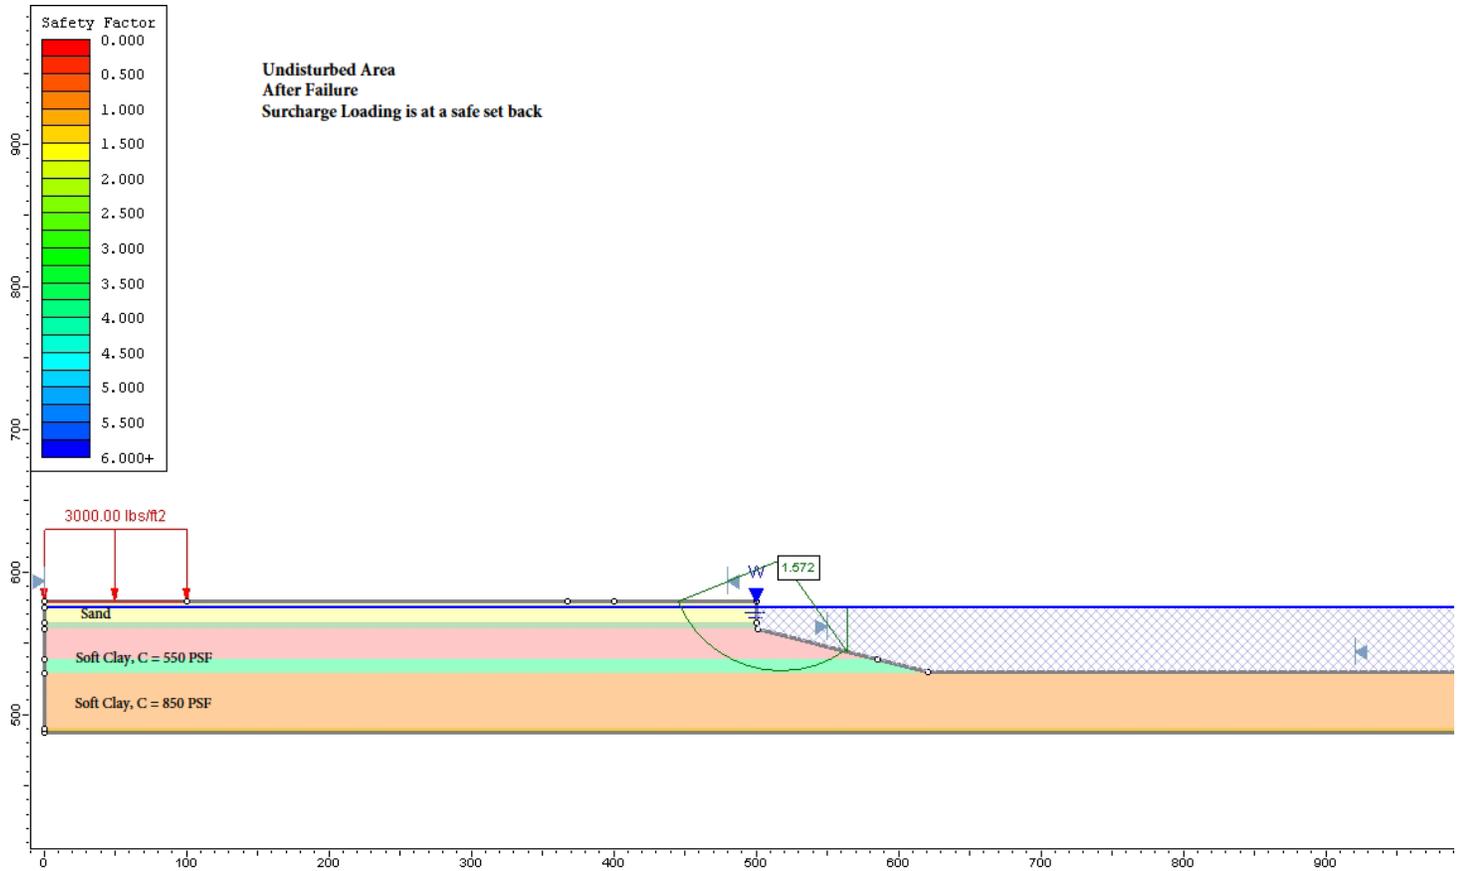
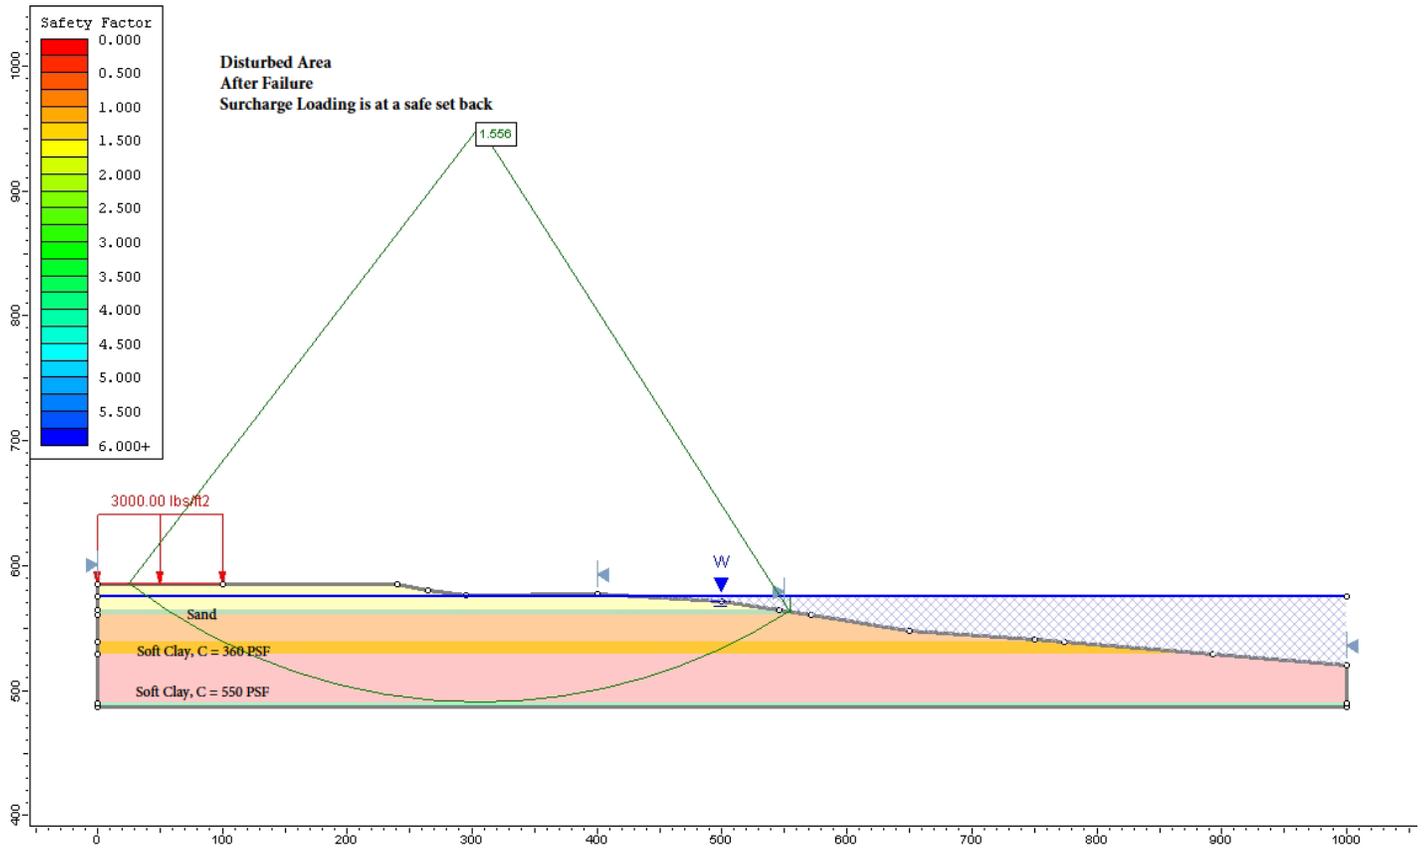
Figure 5 - Undisturbed Zone Stockpiling Operations 400 Feet from Shoreline

The above Figures show that Factors of Safety should be acceptable with stockpiling operations greater than 400 feet from the existing shoreline.

G2 issued a February 18, 2020 Site Stability Evaluations report (Appendix D), which concludes that the site is stable in its present condition so long as aggregate stockpiling activities are conducted at a distance greater than 400 feet of the river shoreline.
