MICHIGAN DEPARTMENT OF  
ENVIRONMENT, GREAT LAKES, AND ENERGY

Holloo Farms-CAFO  
20849 F Drive S.  
Marshall, Michigan 49068

**Concentrated Animal Feeding Operation Full Facility Inspection**  
**November 5, 2021**

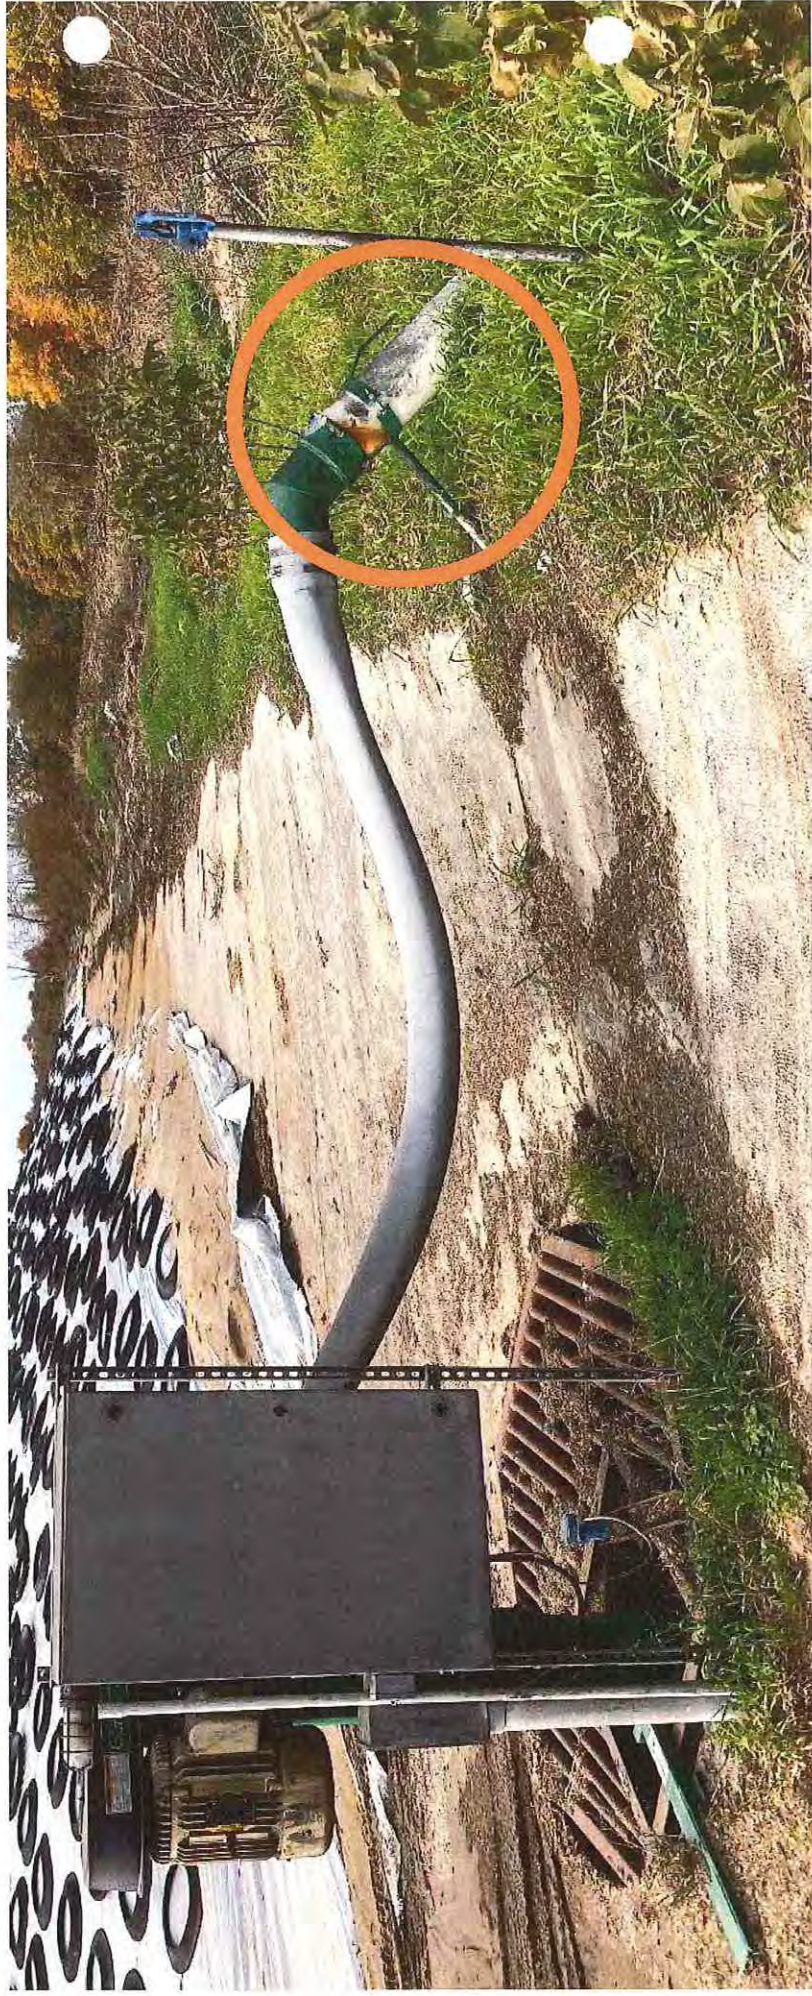
Silage collection basin, water is pumped to a WSS through the circled pipe.

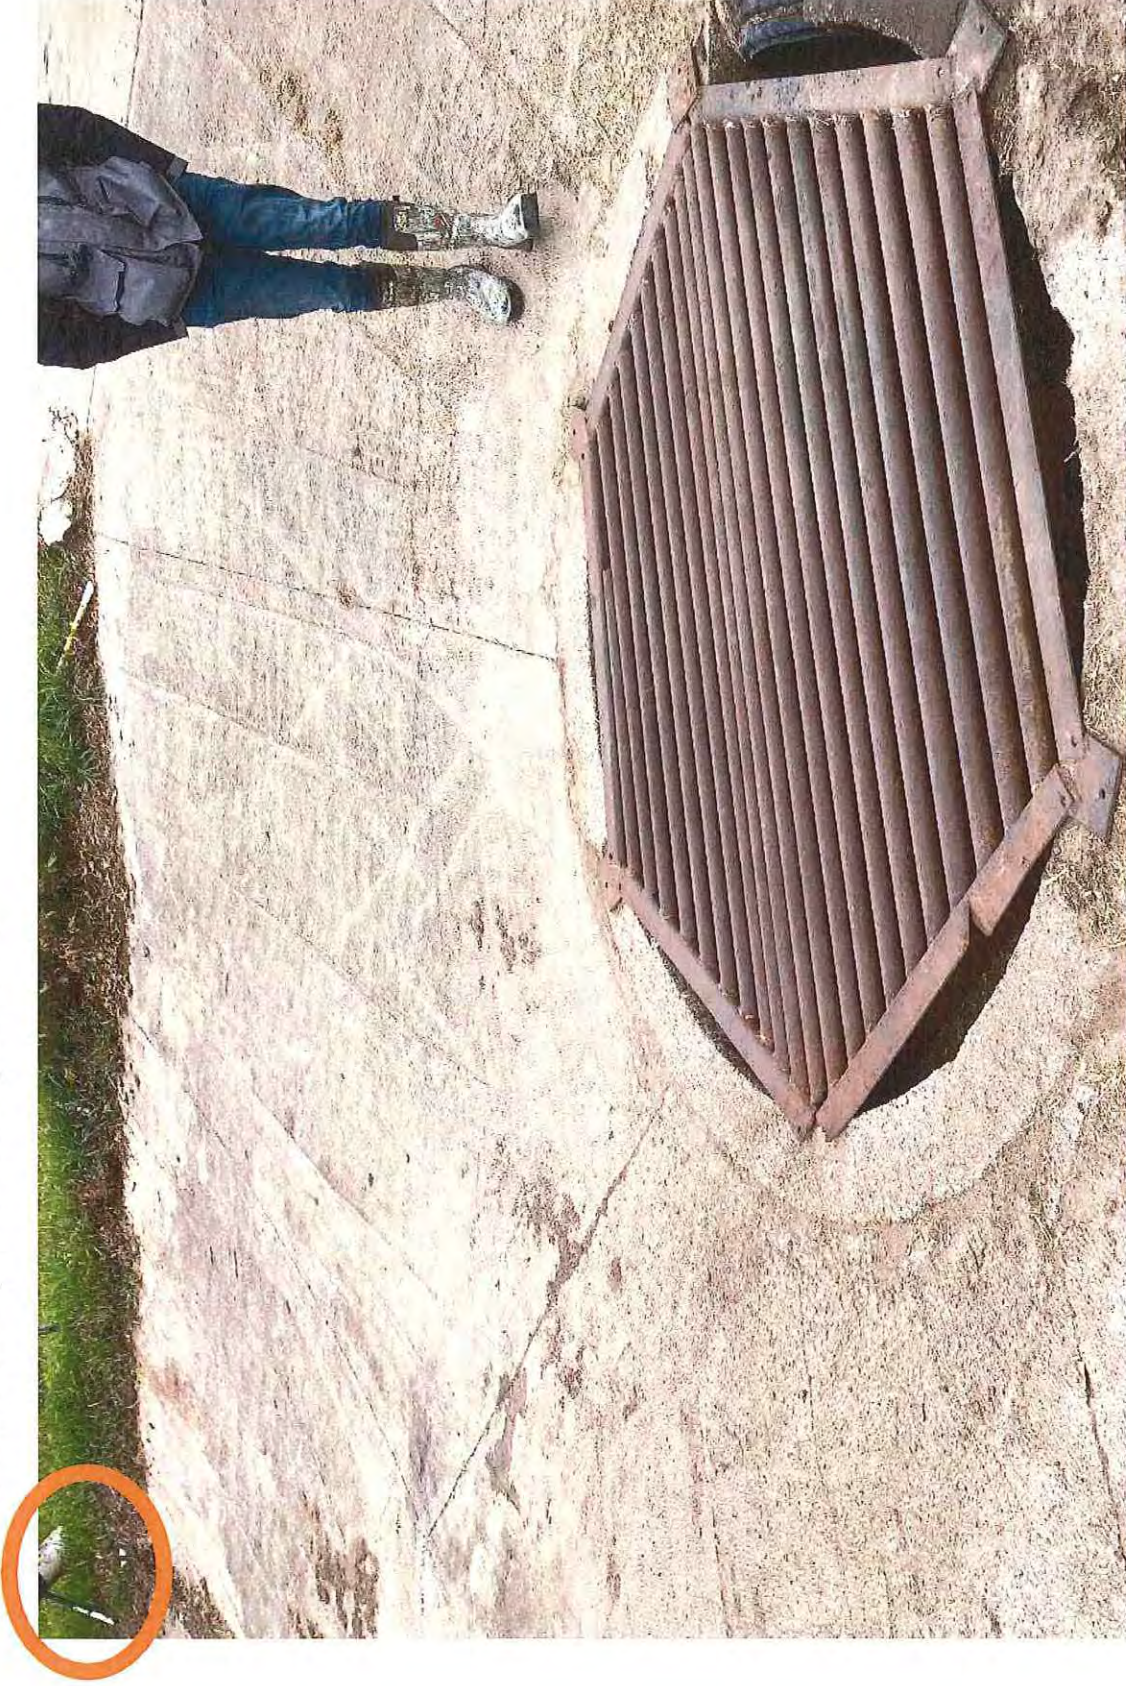
This is the clean water collection basin, note the circle is the same pipe from the previous photo..

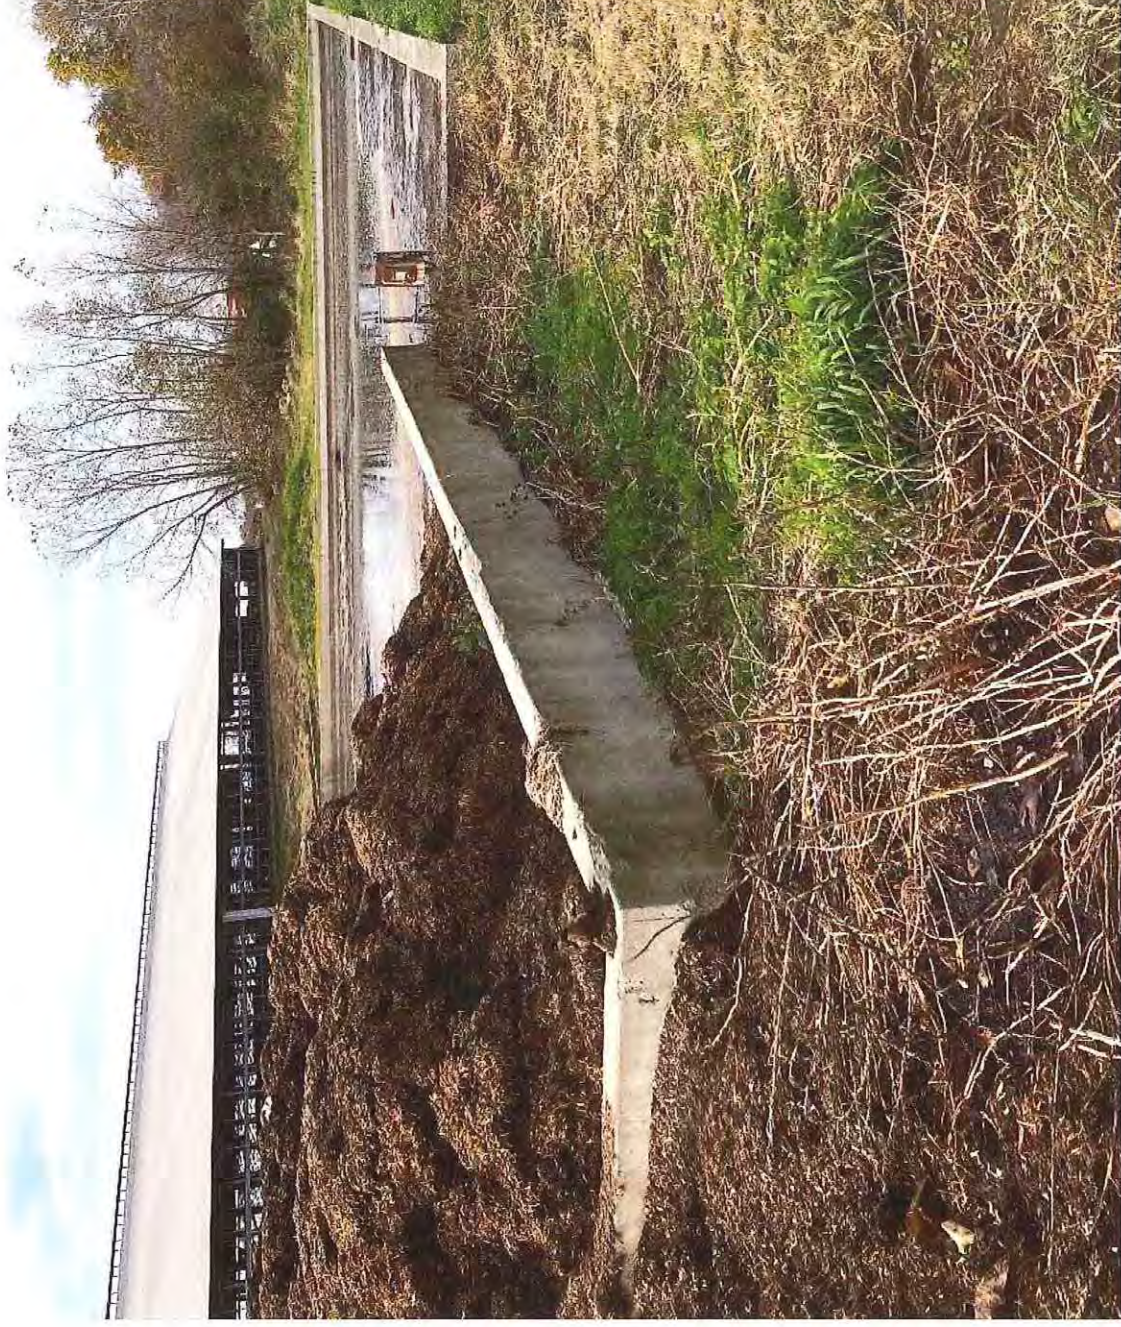
Compost pit has evidence of going over concrete wall.

- Spillage of Compost Pad material over the structure's sidewall onto the ground. This is a violation of Rule 2205 and Part I.A.3 and Part I.B.1.a of the Permit.

- e. The composting material spillage removed from the North end and composting materials contained on the concrete Compost Pad.
9. An explanation for the ponding and rutting observed on the recent land applied fields, 97, 98 and 7W.

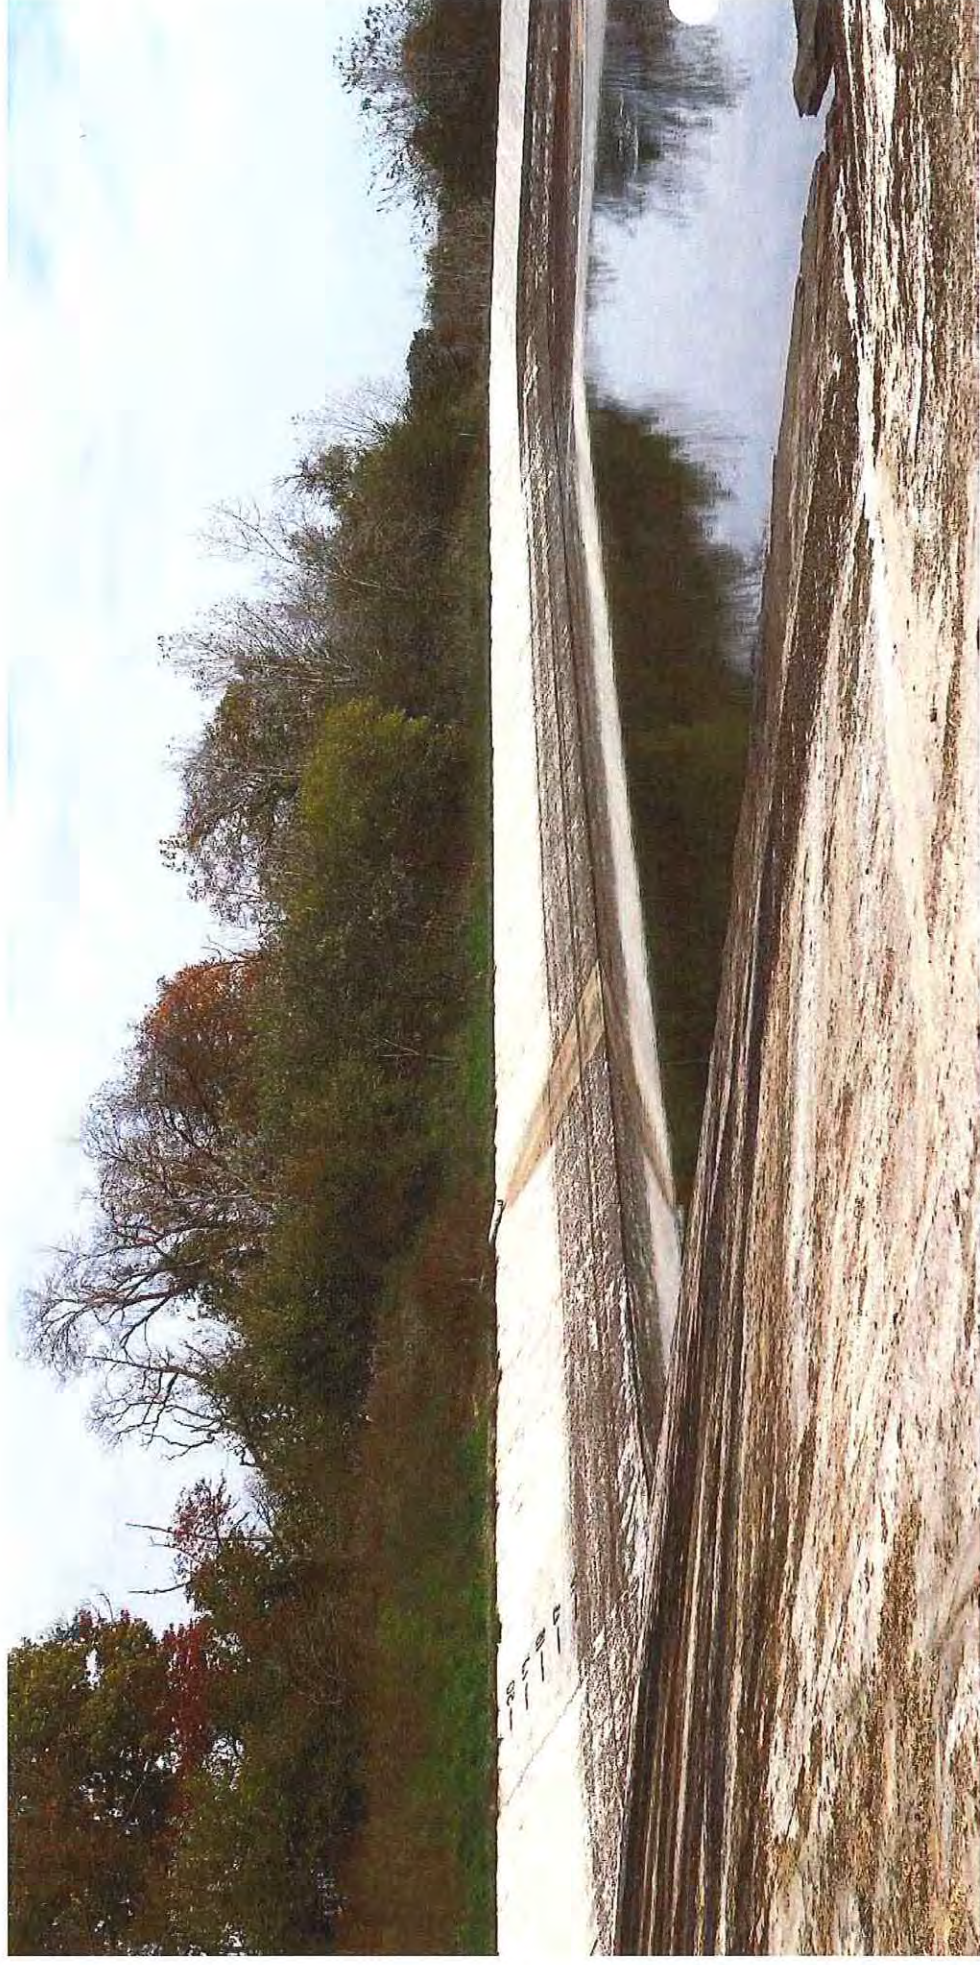
Height numbers painted on are not accurate representations of pit levels based off CNMP listings.

- b. On Page 5 of the CNMP, the Earthen Storage structure is listed with a total depth of 21 feet. Based on observations during the inspection, the depth measurements on the North wall stopped at 20 feet and no emergency or freeboard volumes were delineated. The CNMP also states that the areas collected include the Settling Pit. Based on discussions and observation on site, the runoff from the Feed Bunker and Solid Stacking areas are directed into Earthen Storage pit. The CNMP does not reflect this in the areas collected description, nor is this reflected in the required emergency volume.

It appears there is a discrepancy in accuracy in either the CNMP or the observed visual depth markings on both the Earthen Storage and Concrete Lagoon structures. If the markings observed during the inspection were not representative of the storage structure volumes, they must be corrected to properly delineate the operational, emergency, and freeboard volumes as required by the Permit. If the markings observed during the inspection are accurate, then based on EGLE staff calculations, the Facility may not have the minimum six (6) months storage as required by the Permit.

- b. An explanation for the discrepancy between the depths listed in the CNMP and the observed markings on the structures during the inspection.
  - c. Please provide updated calculations of the Facility's current total waste storage capacity including the solid waste areas.

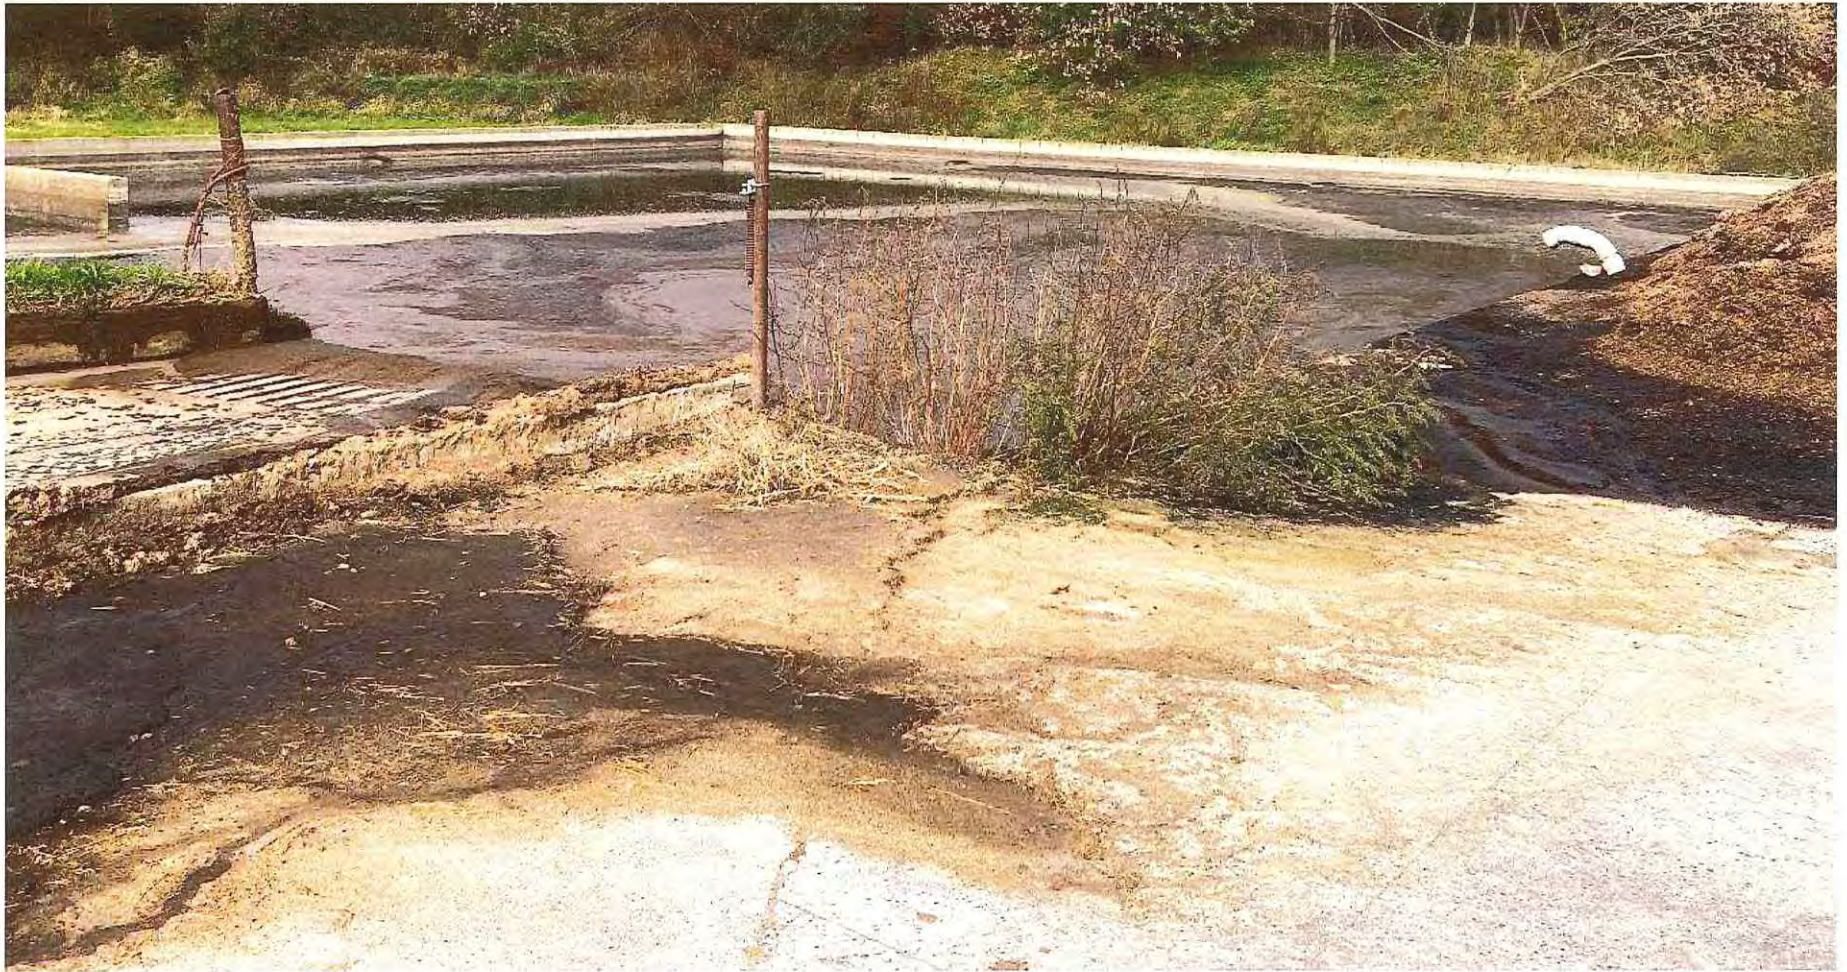
Vegetation is growing round settling pit and there are no visible measurements for freeboard and emergency volume.

- a. Historically and prior to waste storage structure upgrades, the Settling Pit and Earthen Storage Structure had an automatic overflow/equalization pipe hydraulically connecting the two structures. As such, no depth gauge was previously required on the Settling Pit because of the automatic overflow into the Earthen Storage Structure. Based on discussions with Mrs. Brink regarding upgrades to the Earthen Storage structure in 2020, and observations of both structures during the inspection, the automatic overflow/equalization pipe has been removed and material from the settling pit must now be mechanically pumped to the Earthen Storage Structure. Page 4 of the most recent CNMP describes the Settling Pit depth gauge information as "N/A – hydraulically connected to Earthen Storage." Because there is no longer an automatic overflow/equalization pipe between the two structures, there is the potential for the settling pit to overflow. As such, a depth gauge must be installed that properly delineates operational, freeboard and emergency volumes and the CNMP must be updated to show this information as well. Furthermore, the Settling Pit is listed as collecting waste only from the "Milk cow barns." Based on discussions and observation on-site, the Settling Pit is also collecting runoff from the Commodity Shed area and Compost Pad. The CNMP does not reflect this in the areas collected description, nor is this reflected in the required emergency volume.

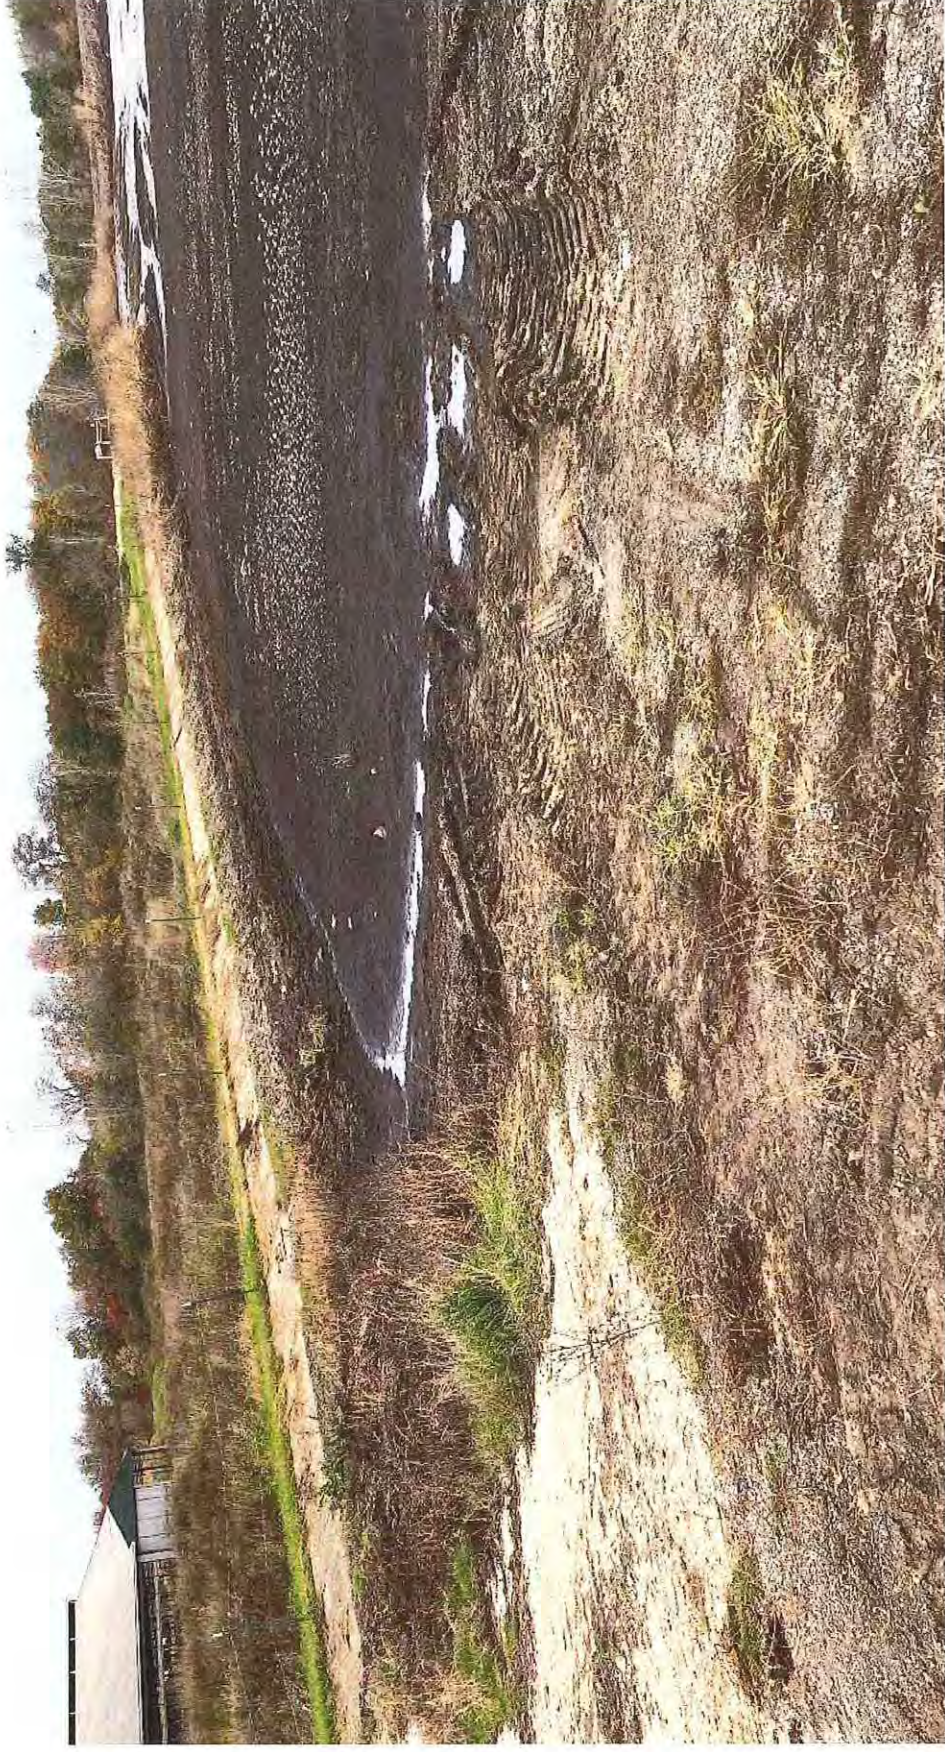
Height numbers sprayed on pits are not representative of levels listed on CNMP.

- c. On Page 6 of the CNMP, the Concrete Lagoon structure is listed with a total depth of 24.5 feet and the CNMP lists the type and location of the depth gauge as a staff gauge, located in the Southwest corner. Based on observations during the inspection, the depth measurements were indicated by spray-paint values instead of a staff gauge on the Southwest corner. The measurements stopped at 20 feet instead of the max depth stated in the CNMP of 24.5 feet, and no emergency or freeboard volumes were delineated.

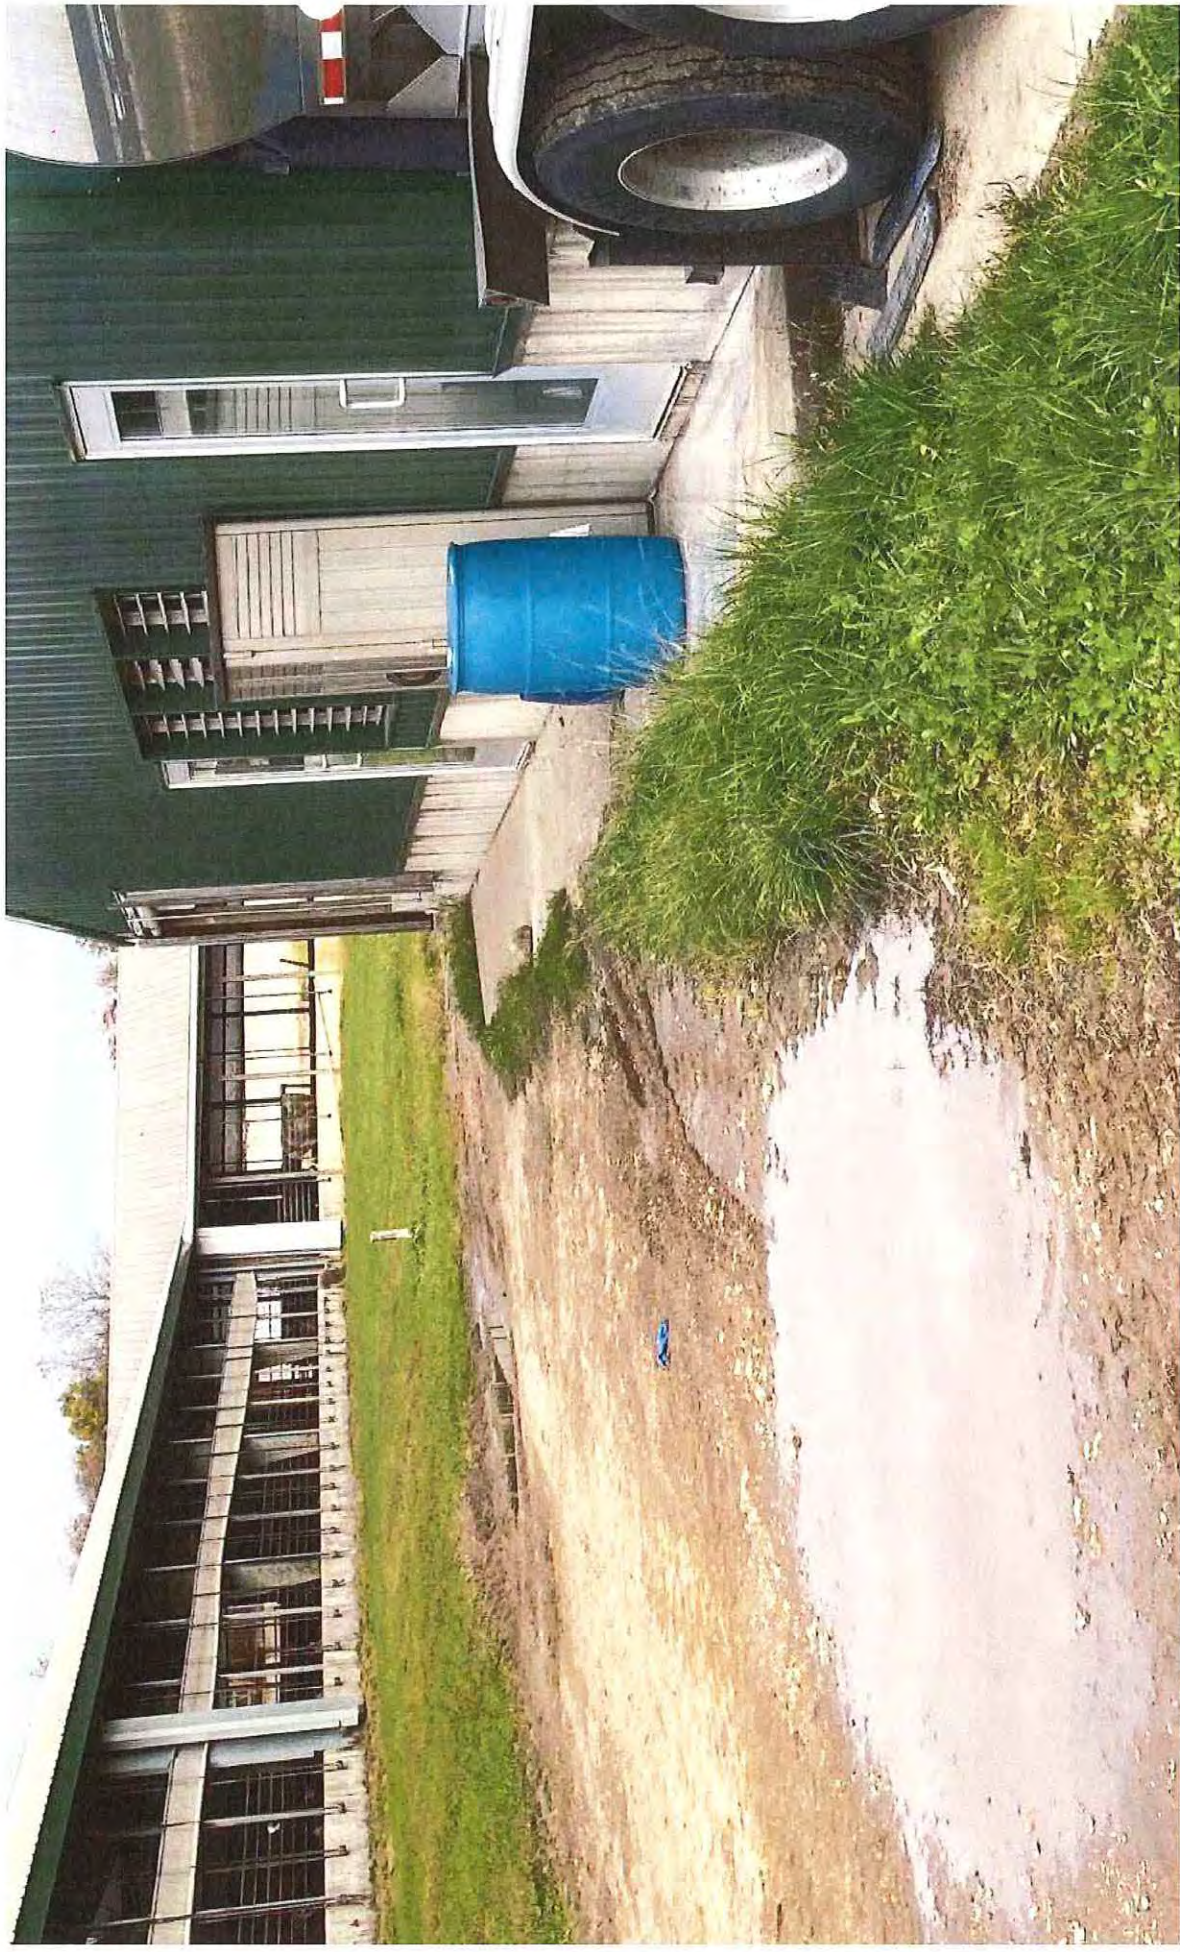
Parlor waste is leaking out of the door. All production area waste must be collected.

There was also waste from the Parlor and Fresh Cows barns observed to be exposed to storm water. At the Parlor, spilled milk waste was observed on the sidewalk outside the Southeast side entry door, not being properly collected by the drainage system currently in place. At the Fresh Cow barn, there was maternity/birthing materials hanging over the sidewalls of the barn and on the ground that were exposed to storm water.

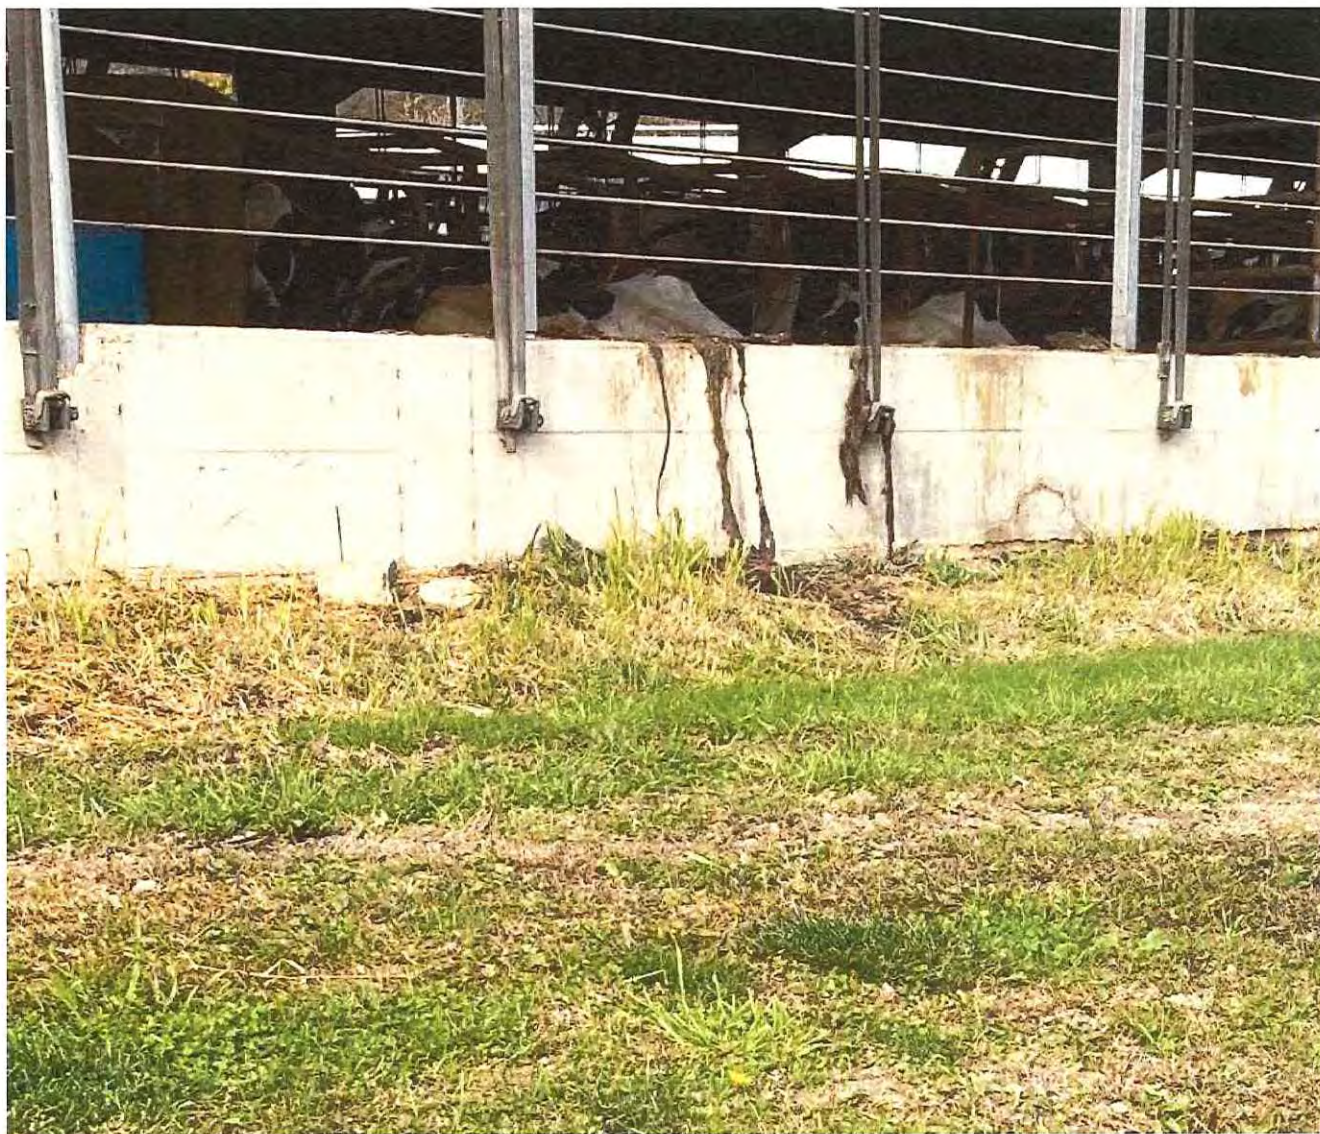
Maternity waste hanging over the side wall of the Fresh Cows barn into a clean water diversion area.

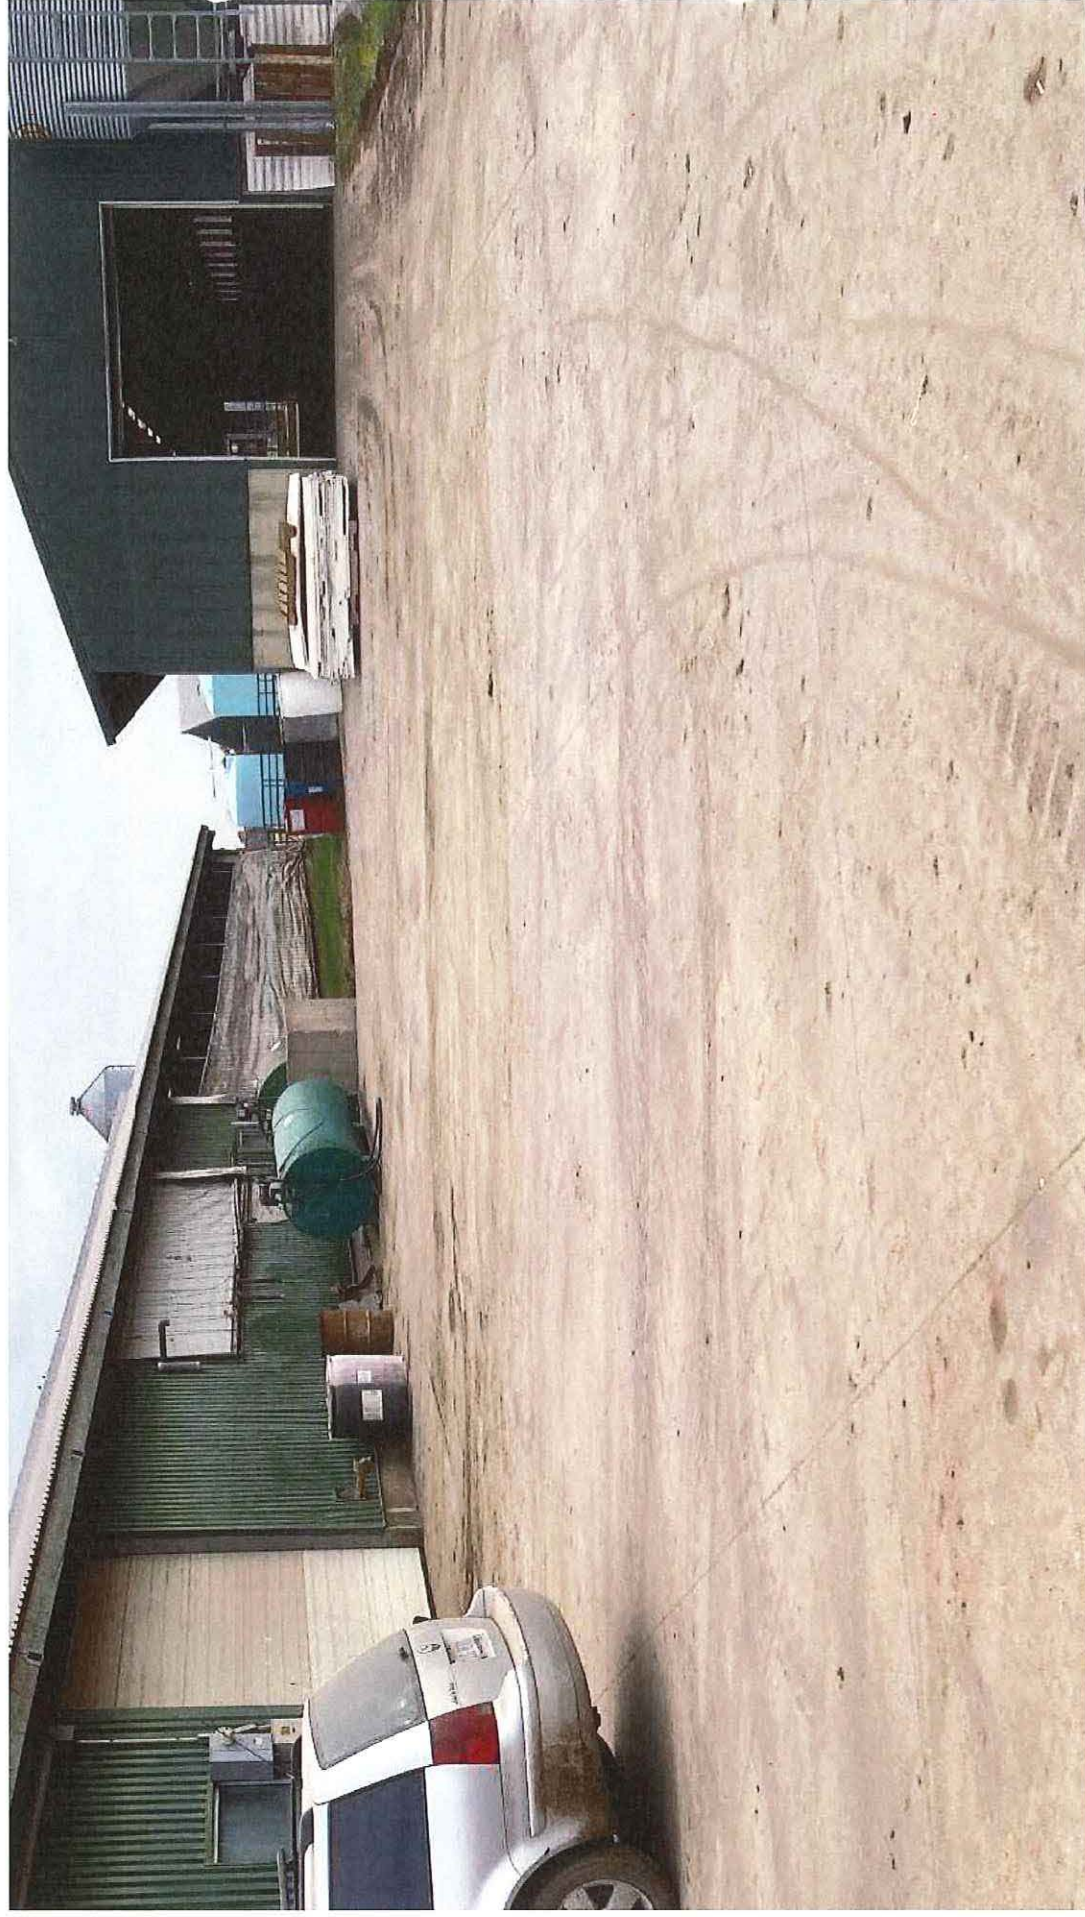
Chemicals are being stored outside exposed to storm water.

- Multiple barrels of various chemicals and petroleum products, including a side punctured barrel of SAE 30 oil, were observed exposed to storm water. The Permit requires the permittee to implement practices including preventative maintenance, good housekeeping, and periodic inspections to minimize and control pollutants in storm water discharges for non-production areas. Failure to ensure minimization and control of pollutants to storm water in these non-production areas is a violation of Part I.B.3.h of the Permit.

- c. Vegetation has been cleaned out of the Concrete Lagoon.
  - d. The areas with 55-gallon drums exposed to storm water cleared or covered to prevent storm water contamination.

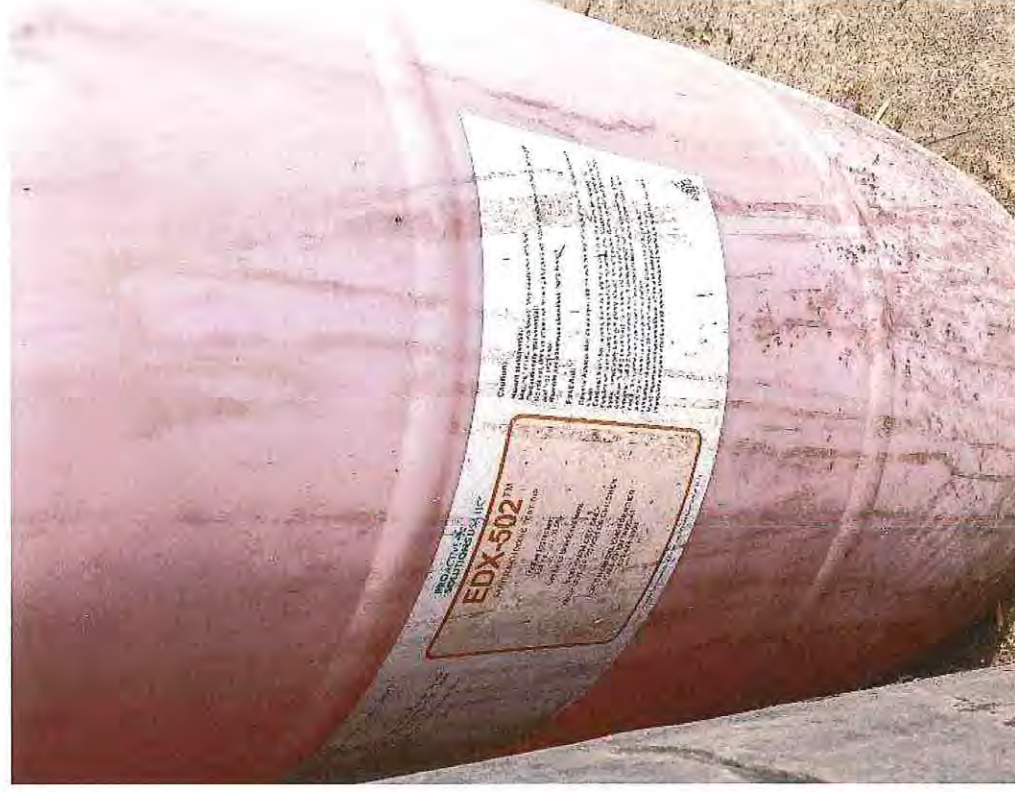
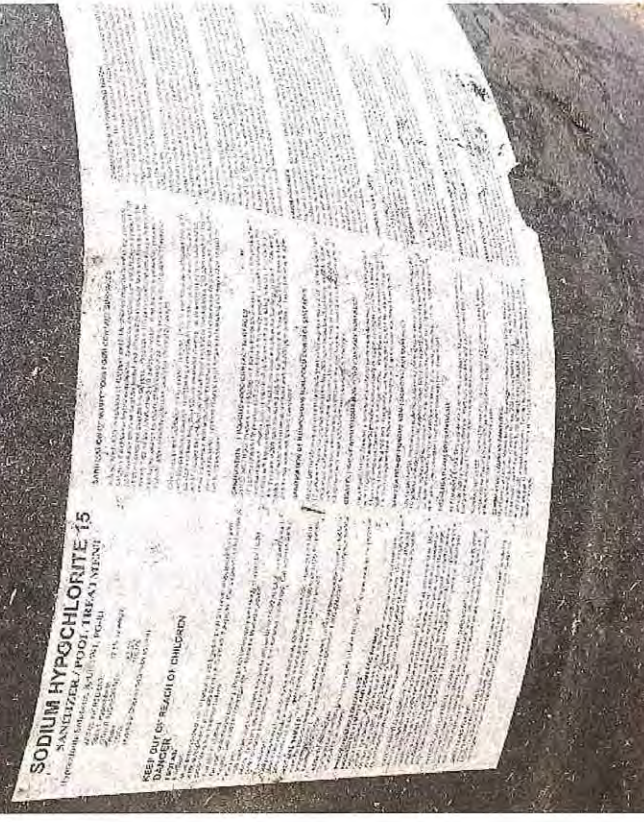
Chemicals stored near the green diesel tank.

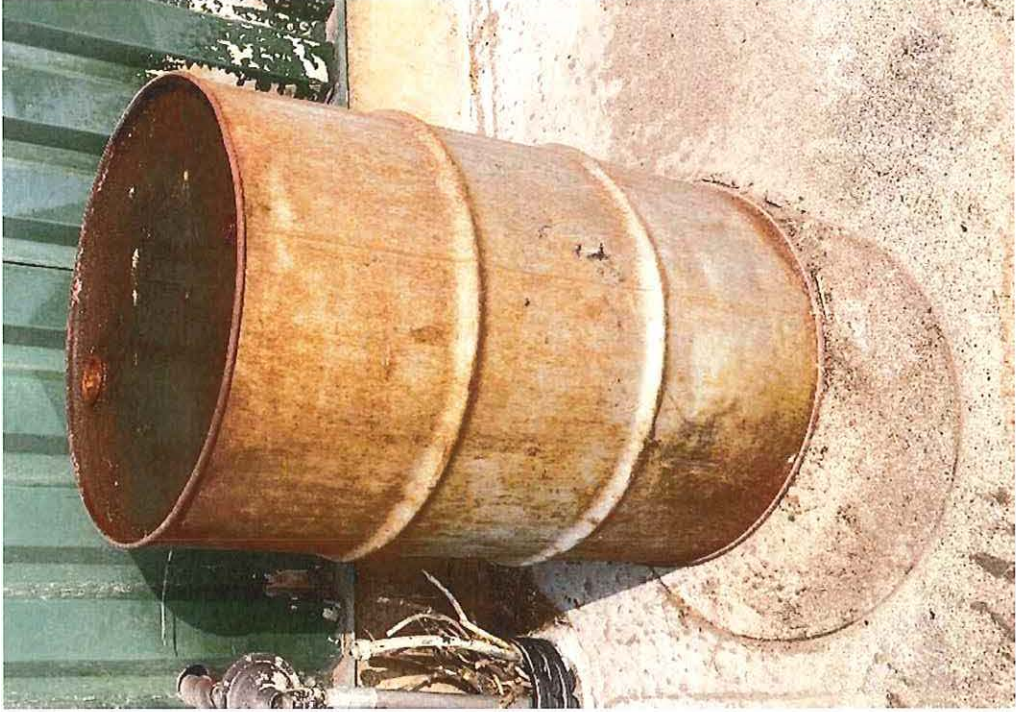
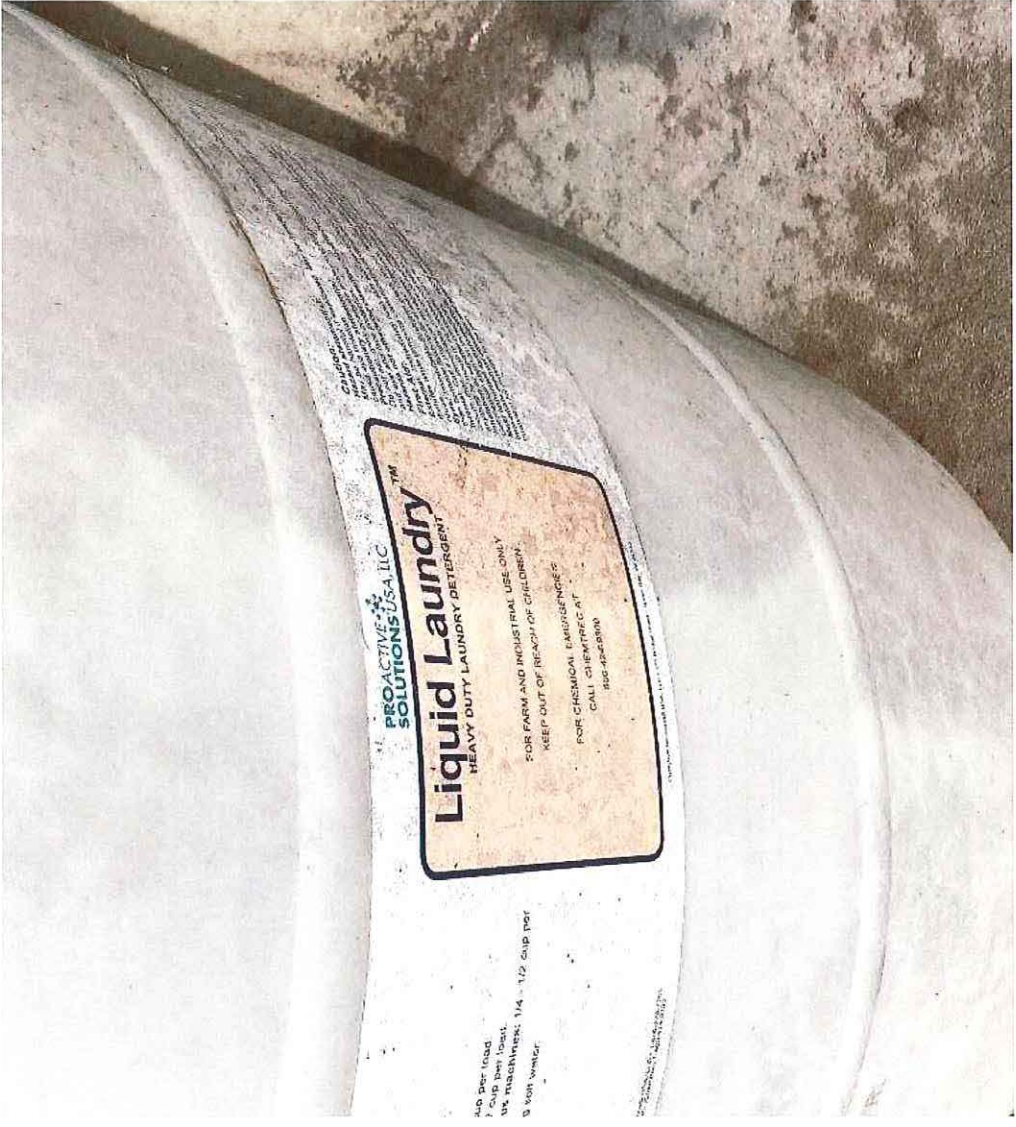
Barrels exposed to storm water continued; including an unlabeled barrel that is degraded.

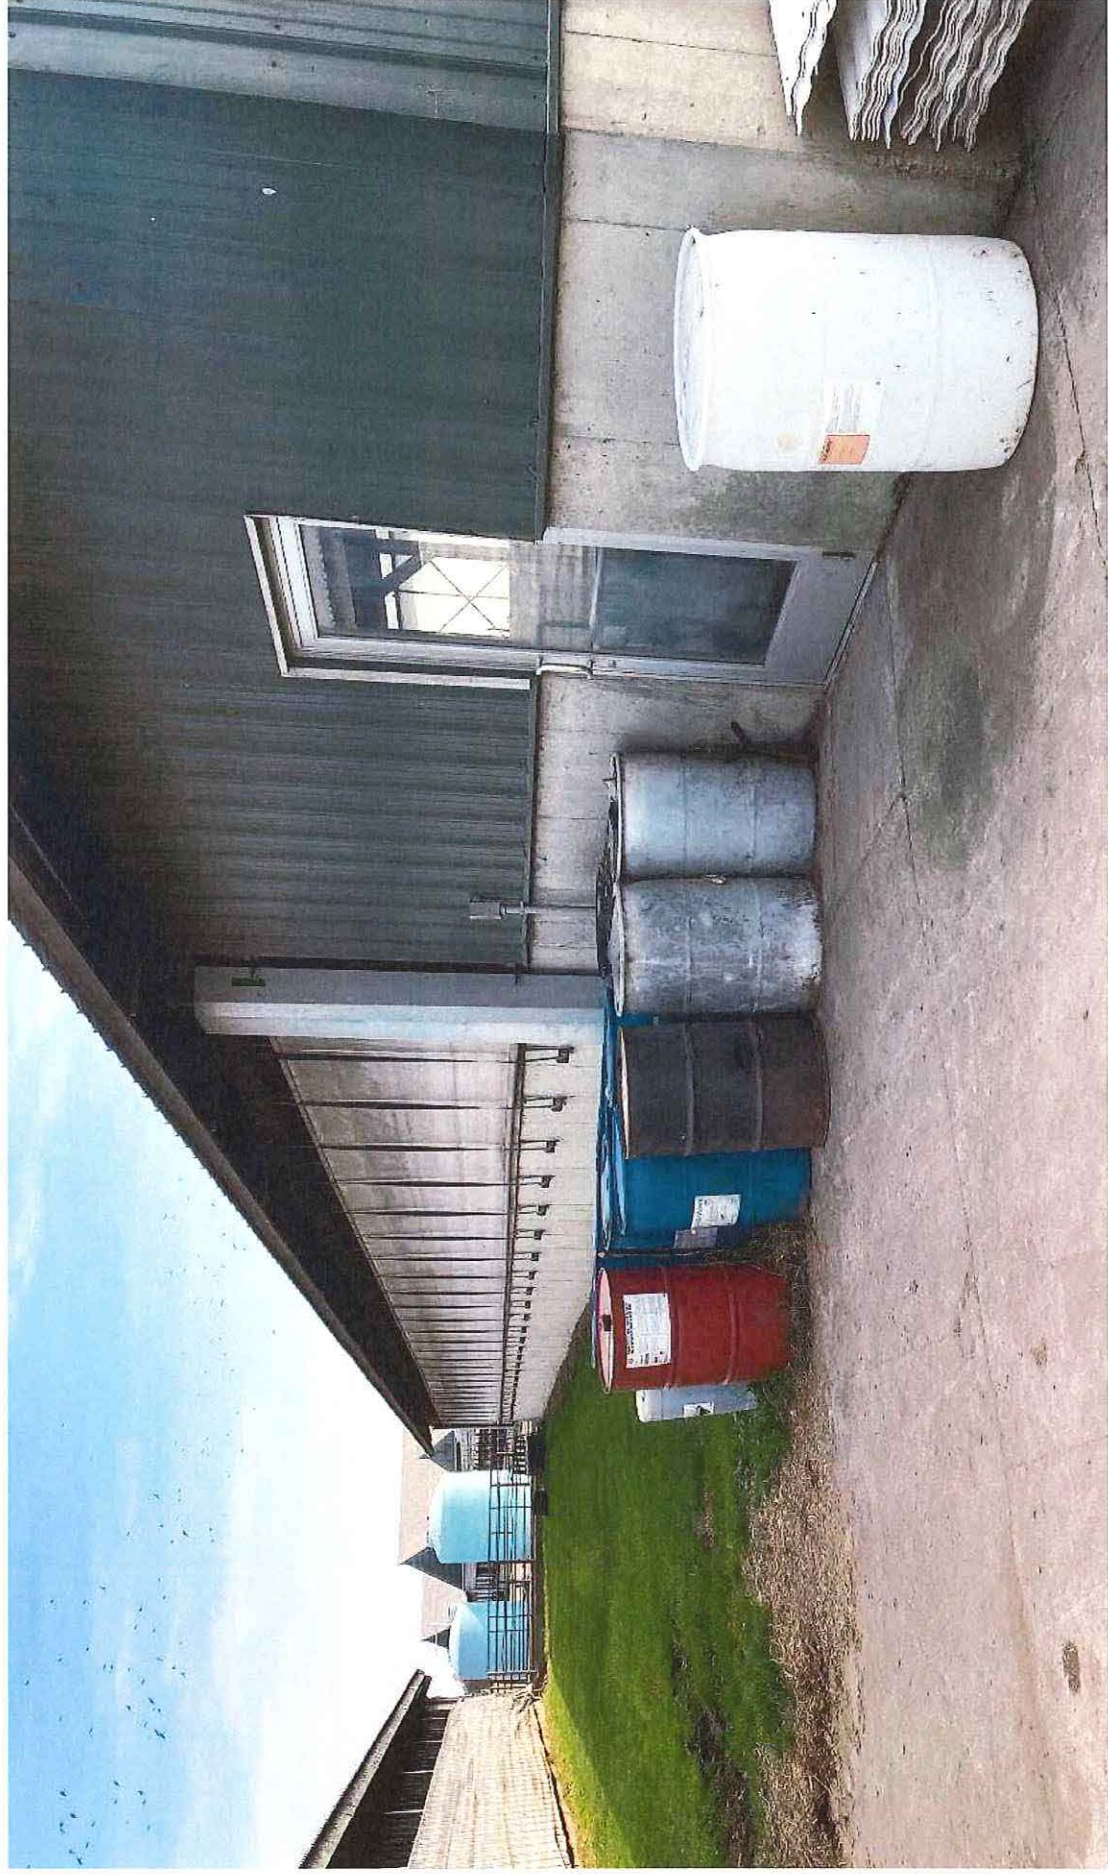
Area of storm water exposure continued.
