MICHIGAN DEPARTMENT OF  
ENVIRONMENT, GREAT LAKES, AND ENERGY

Holloo Farms-CAFO  
20849 F Drive S.  
Marshall, Michigan 49068

**Concentrated Animal Feeding Operation Full Facility Inspection**  
**November 5, 2021**

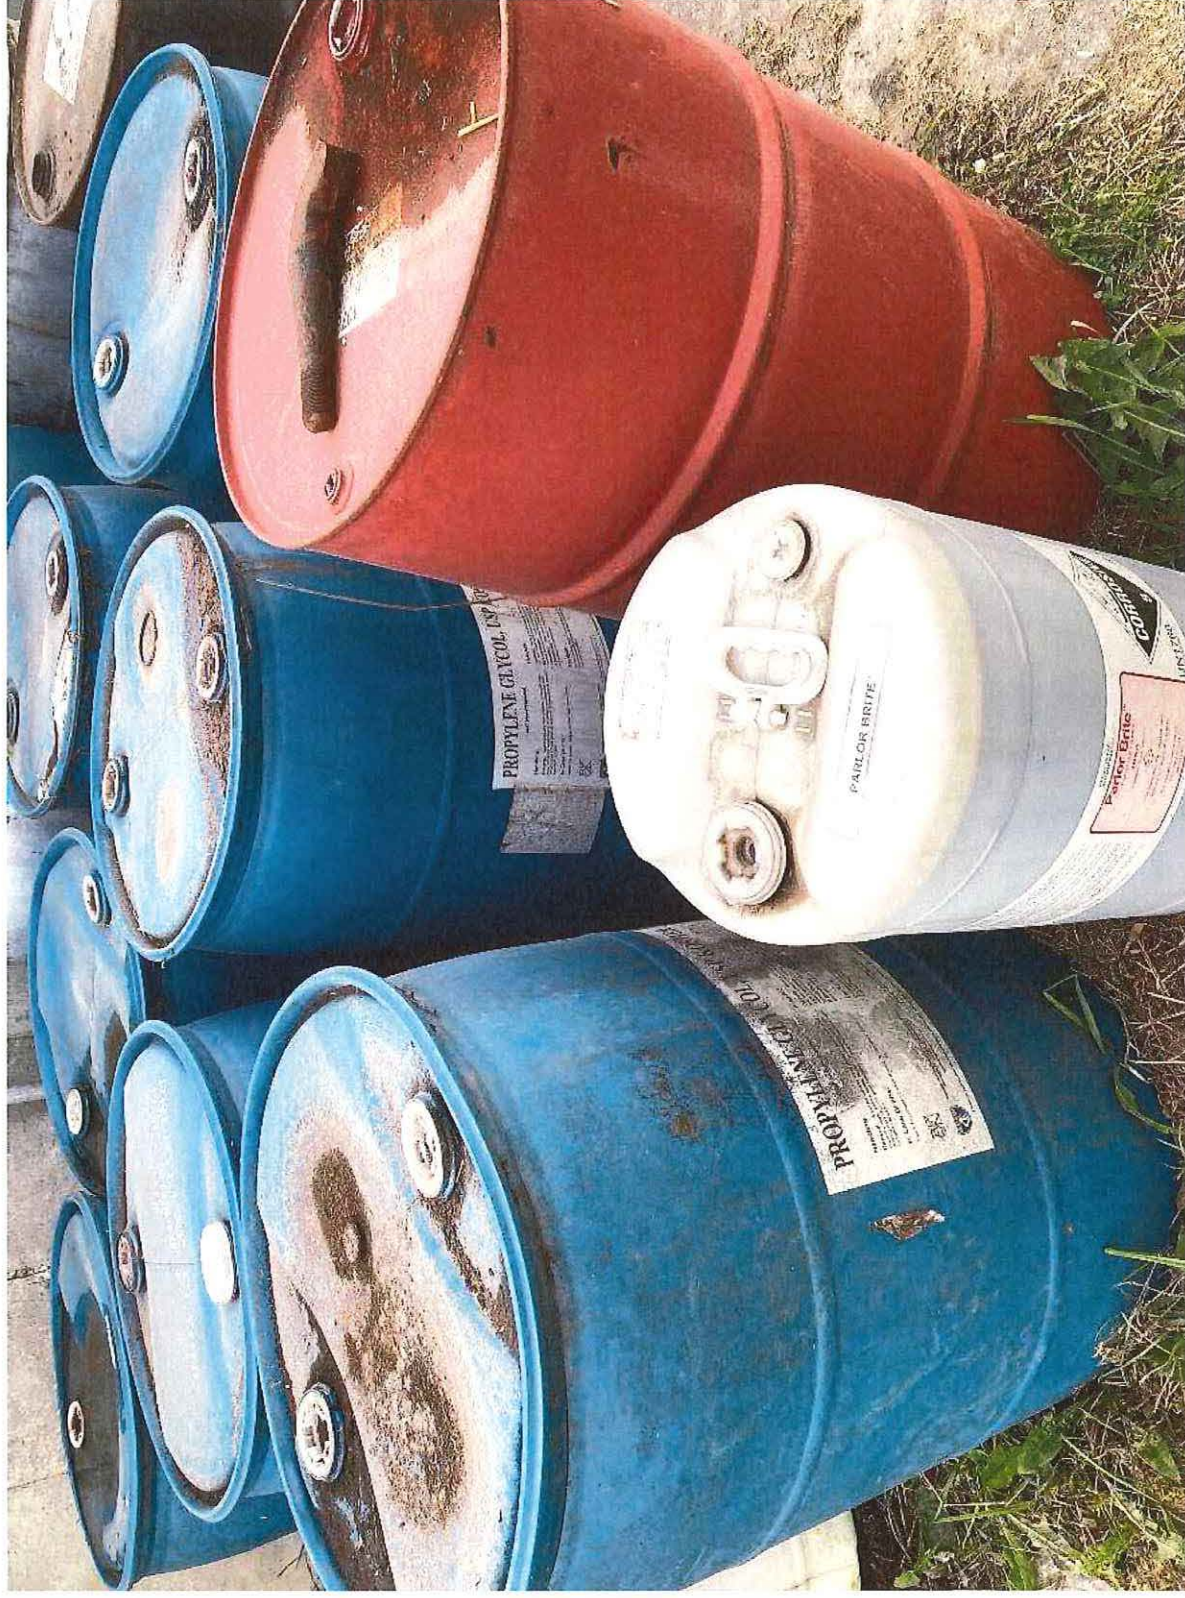
Overview of chemicals barrels exposed to storm water.

- c. Vegetation has been cleaned out of the Concrete Lagoon.
  - d. The areas with 55-gallon drums exposed to storm water cleared or covered to prevent storm water contamination.

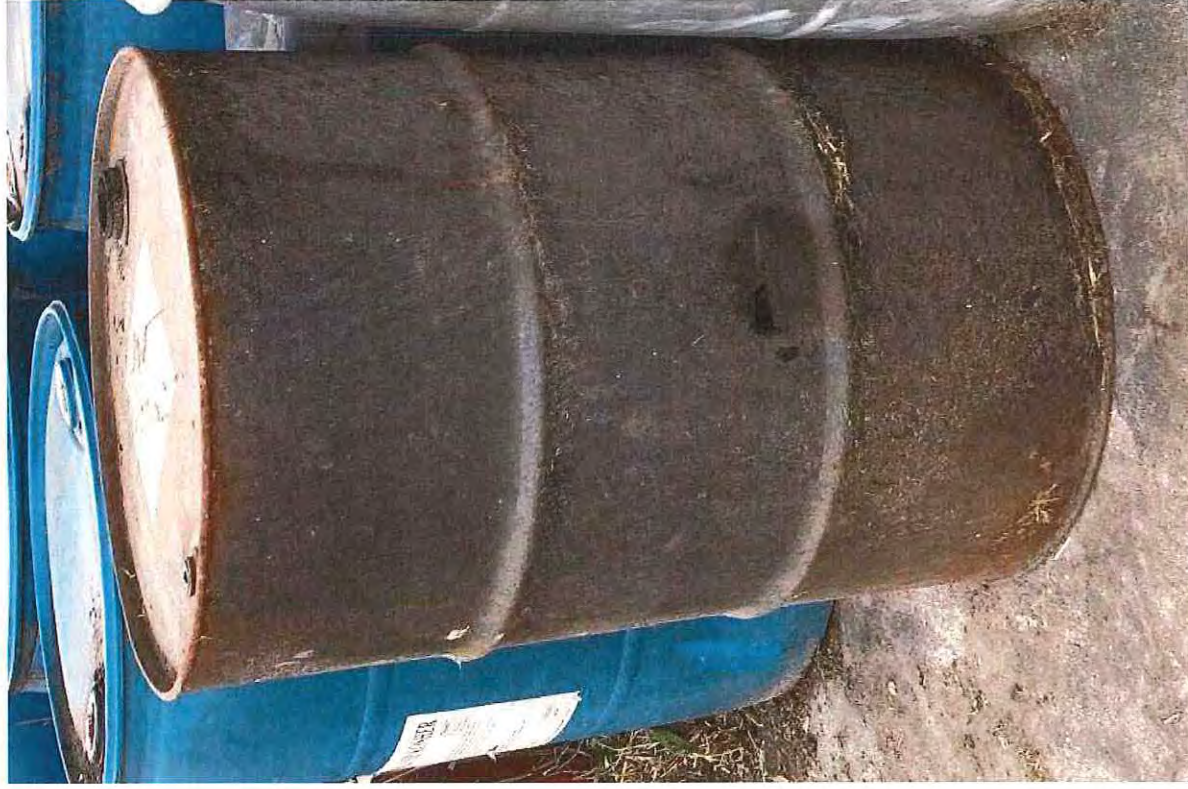
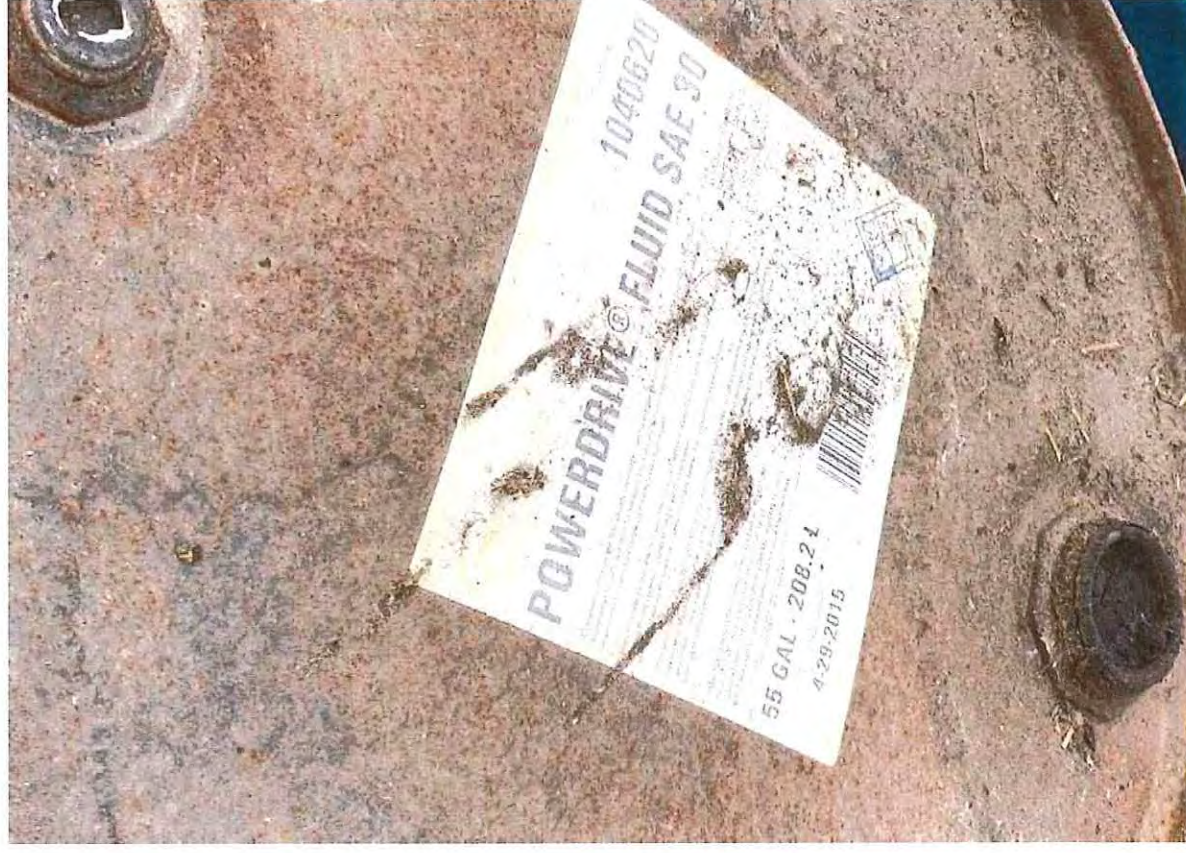
Drum of SAE 30 oil pierced,exposed to storm water.

- Multiple barrels of various chemicals and petroleum products, including a side punctured barrel of SAE 30 oil, were observed exposed to storm water. The Permit requires the permittee to implement practices including preventative maintenance, good housekeeping, and periodic inspections to minimize and control pollutants in storm water discharges for non-production areas. Failure to ensure minimization and control of pollutants to storm water in these non-production areas is a violation of Part I.B.3.h of the Permit.

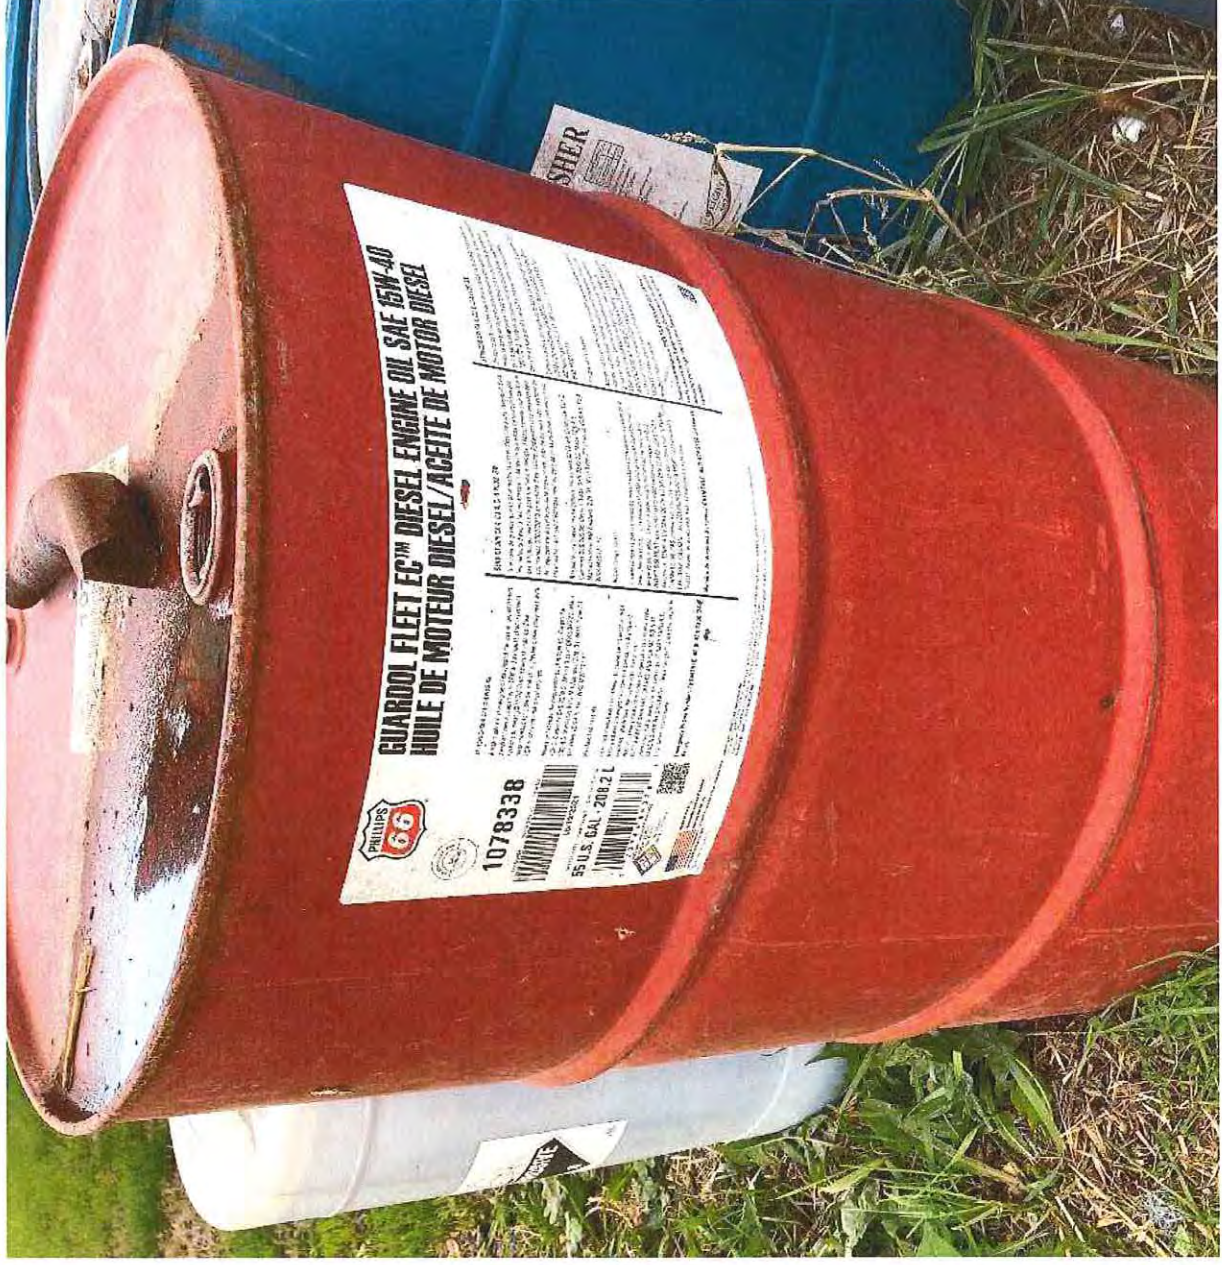
Drum of oil exposed to storm water continued.

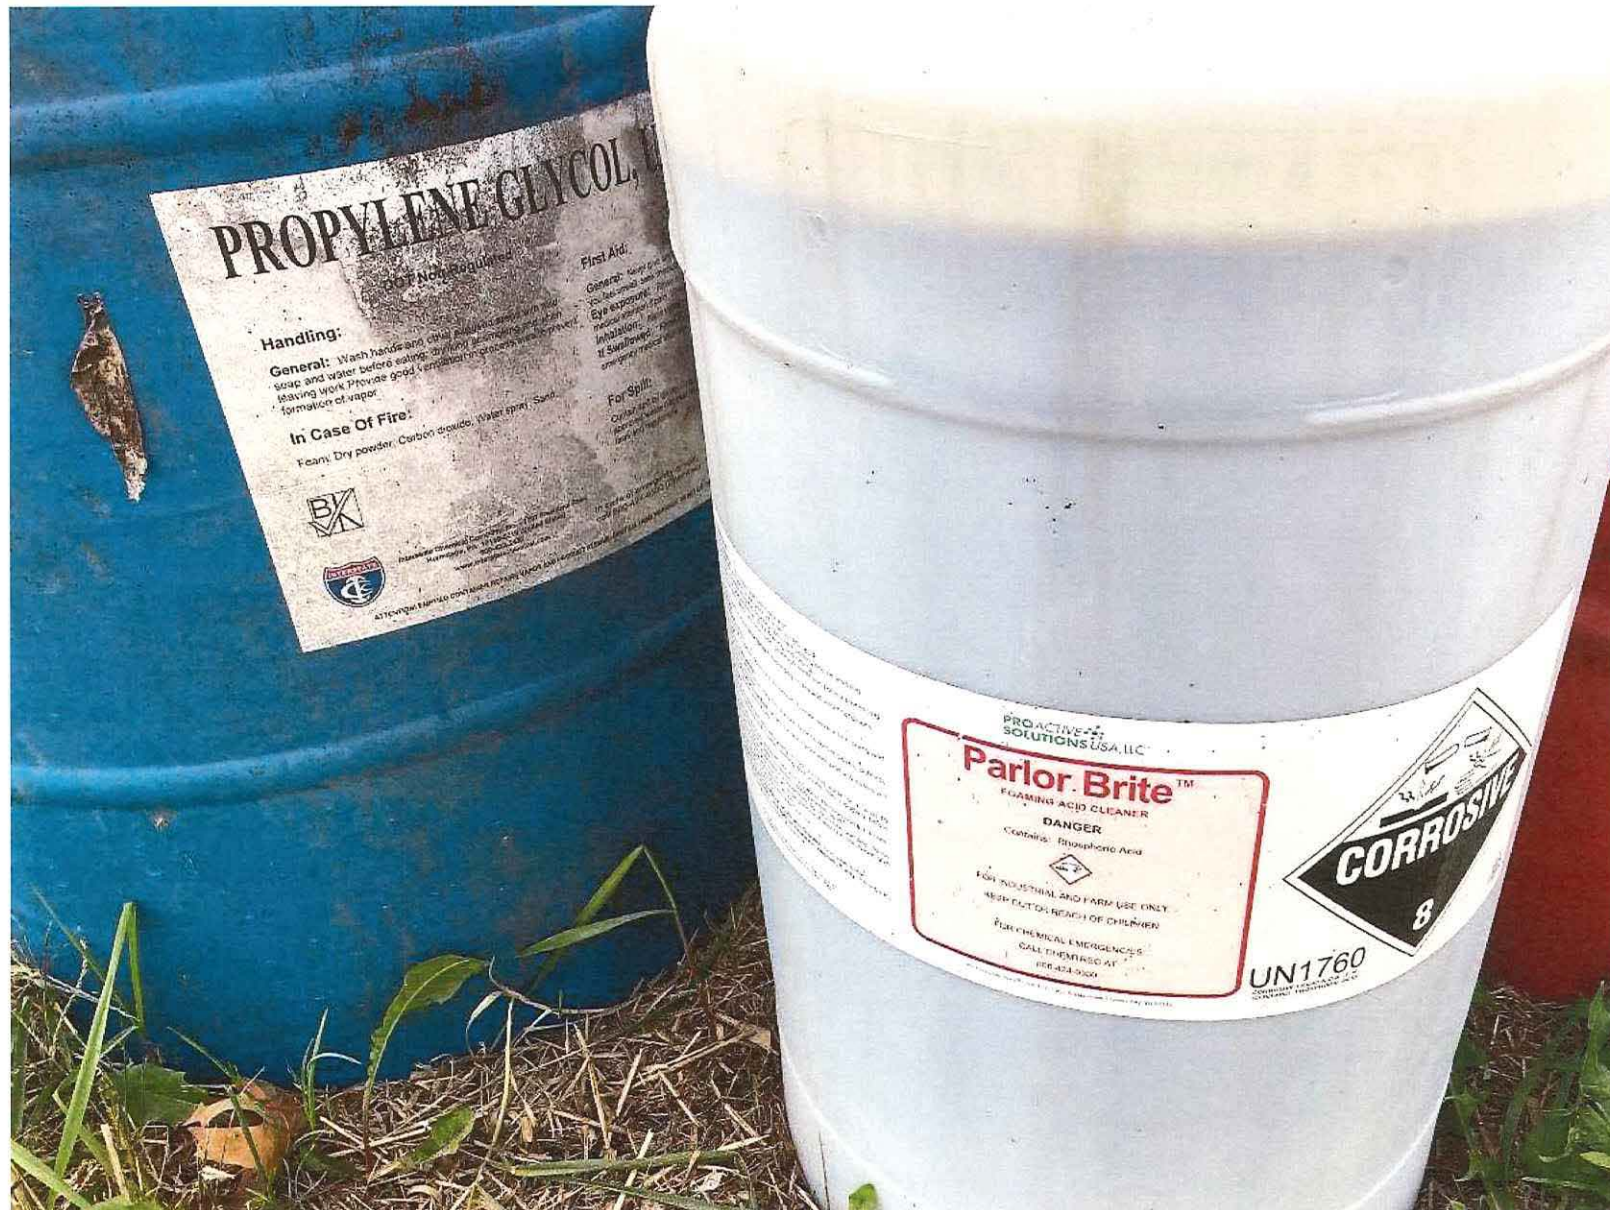
Chemicals exposed to storm water continued.

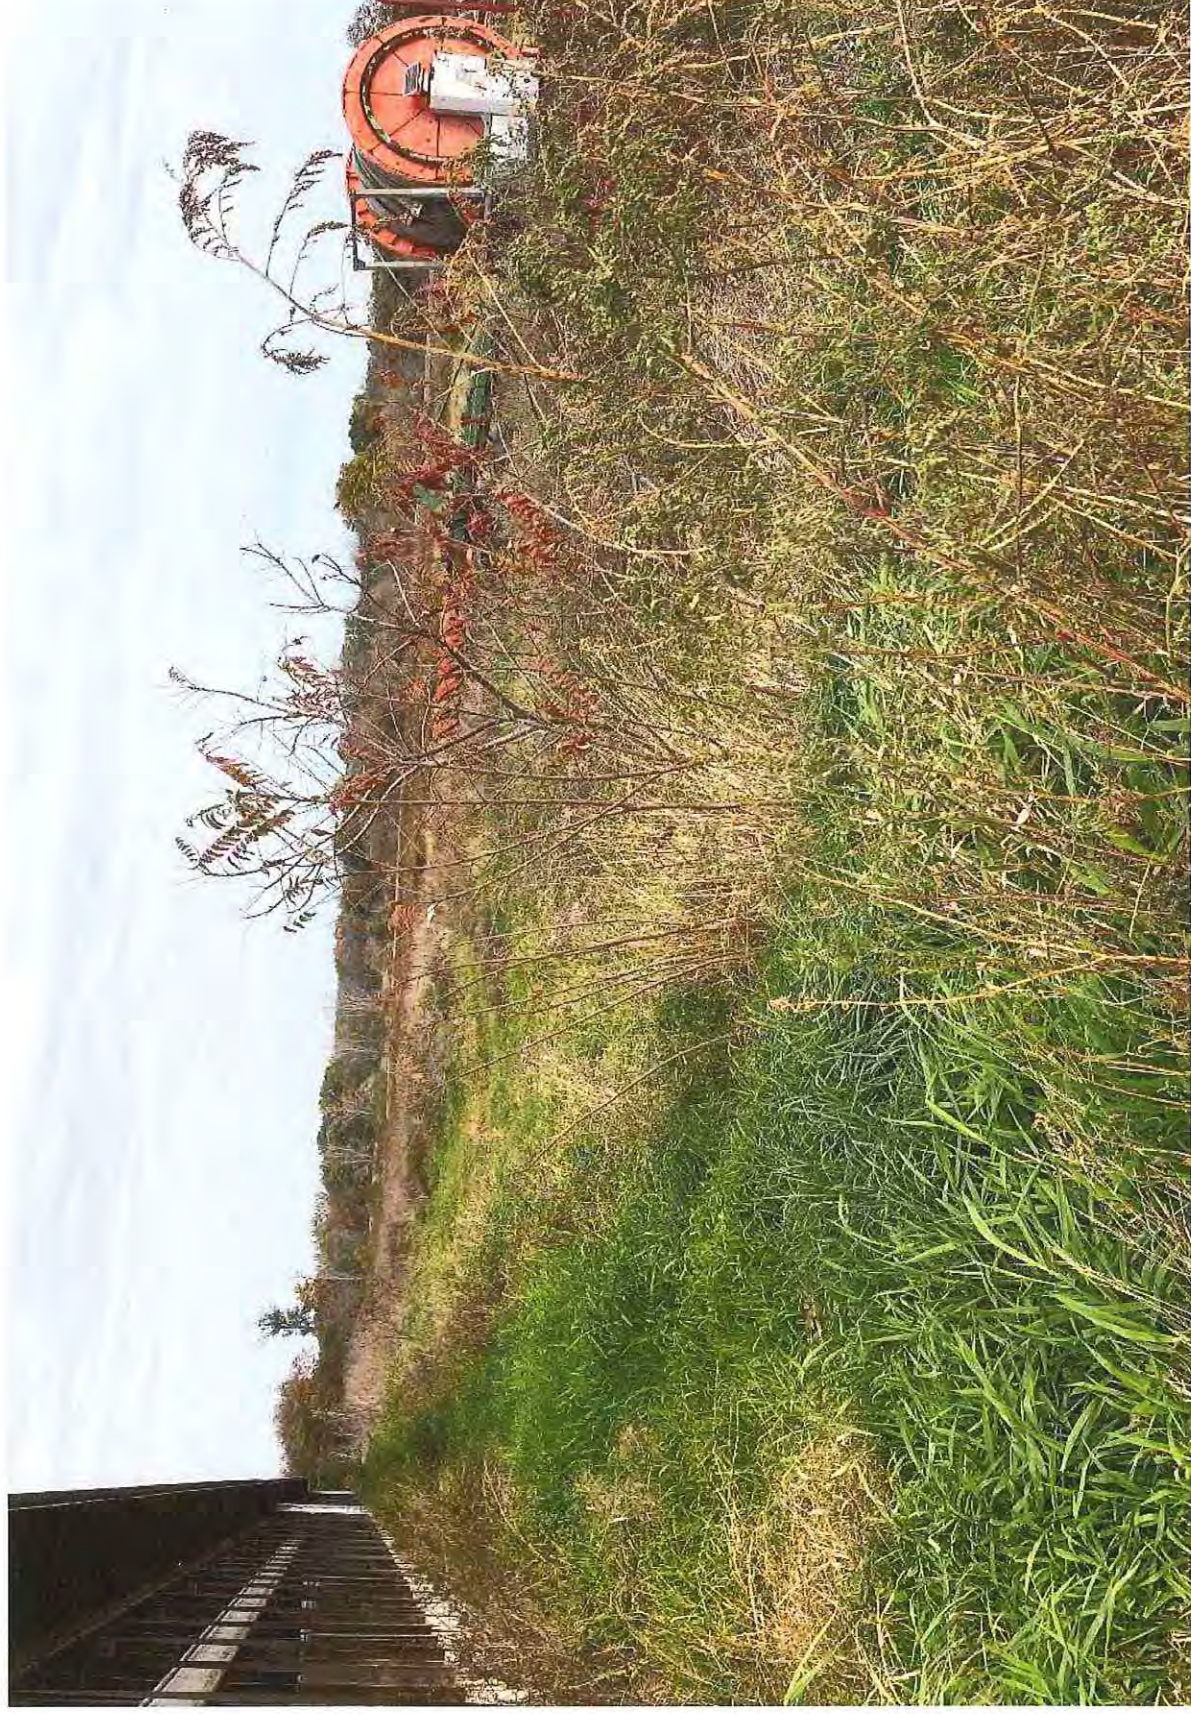
Vegetation along Group 3, 4 barn must be maintained for proper visual inspection.

- The Group 3,4 Barn had vegetation overgrown along the East side of the barn. Failure to ensure all waste management devices and production areas are available for required visual inspections is a violation of Part I.B.2.f.3 of the Permit.

8. Photos showing the following:
  - a. Areas around the Group 3,4 barn have been cleared of vegetation.
  - b. The depth gauge for each of the following structures: Settling Pit, Earthen Storage and Concrete Lagoon, delineating clear, major divisions of operational, emergency and freeboard volumes.

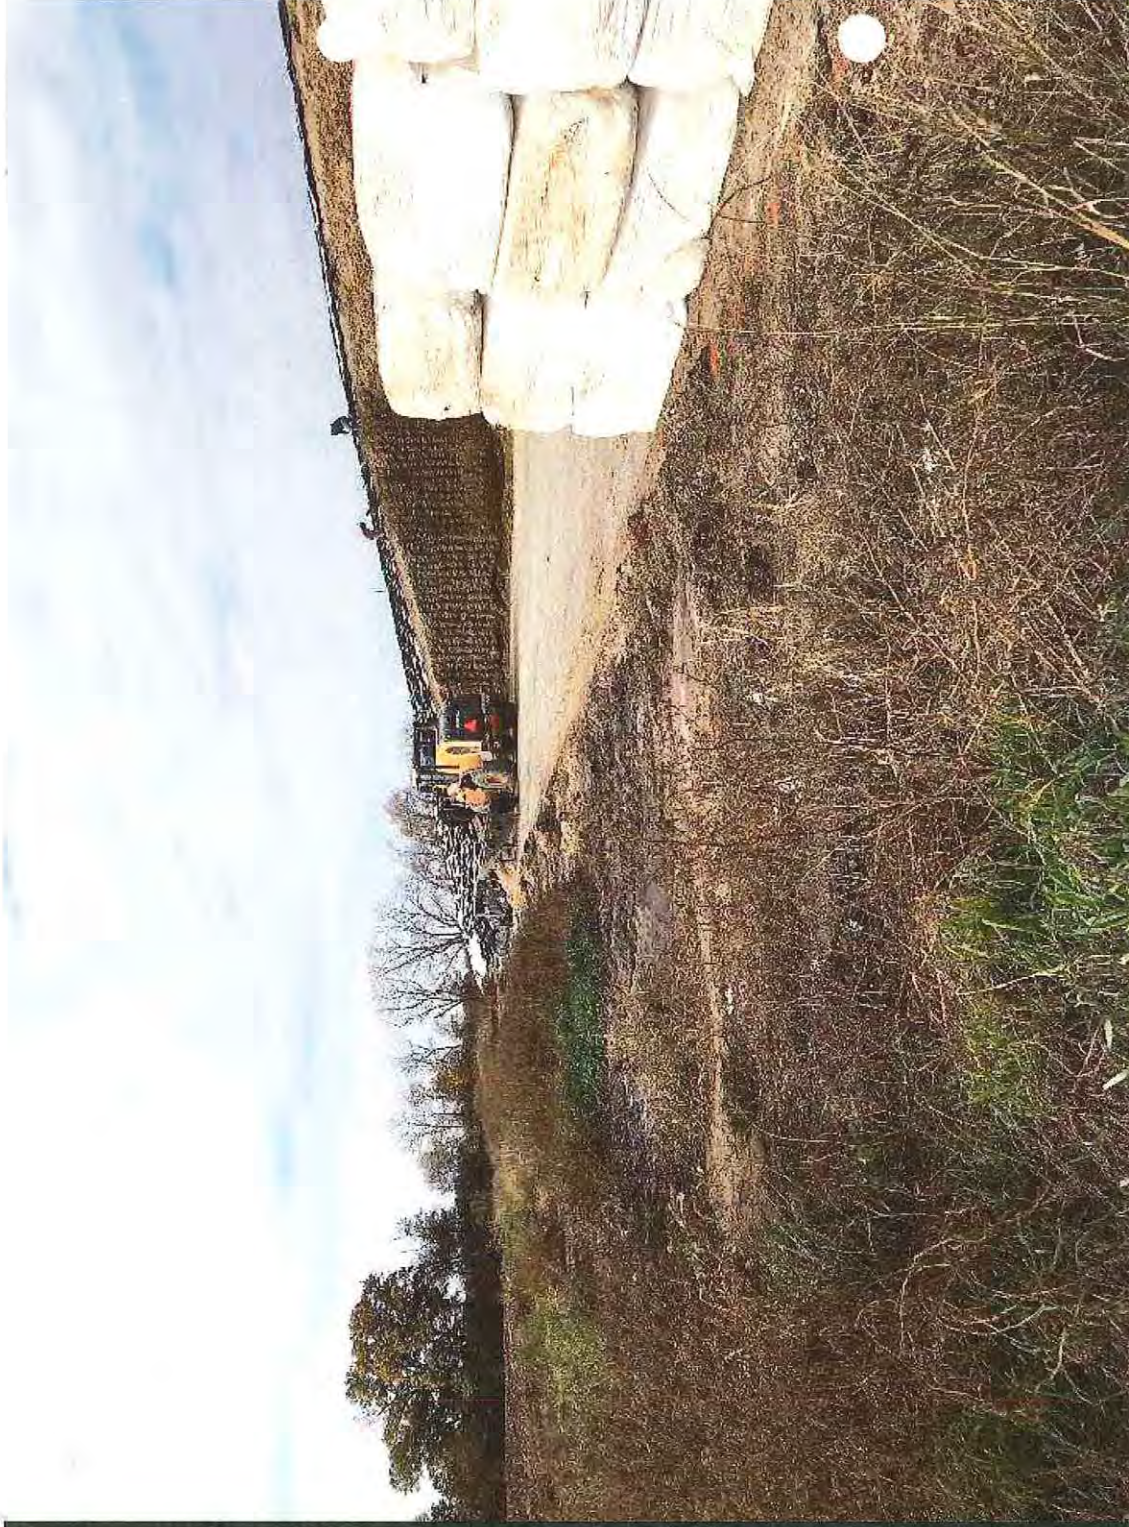
Southeast corner of  
silage pad looking west  
along south edge.  
Production area waste  
(silage and runoff) not  
being collected. Burnt  
vegetation,  
discoloration, lack of  
vegetation.

1. **Unpermitted Discharge from Silage Pad:** Evidence of a discharge of silage leachate to an adjacent field, Field 7W, including nutrient/chemical burned vegetation, was observed on the south side of the silage pad. All silage leachate must be properly collected as production area waste. The unpermitted discharge of silage leachate and failure to properly collect and contain all production area waste are violations of Rule 2205 of the Part 22 Groundwater Quality Rules, Michigan Administrative Code, R 323.2205 (Rule 2205) and Part I.A.3 and Part I.B.1.a of the Permit.

1. An explanation as to why the Facility allowed the silage leachate to discharge, an immediate plan to stop it from continuing and a plan to prevent it from occurring in the future.

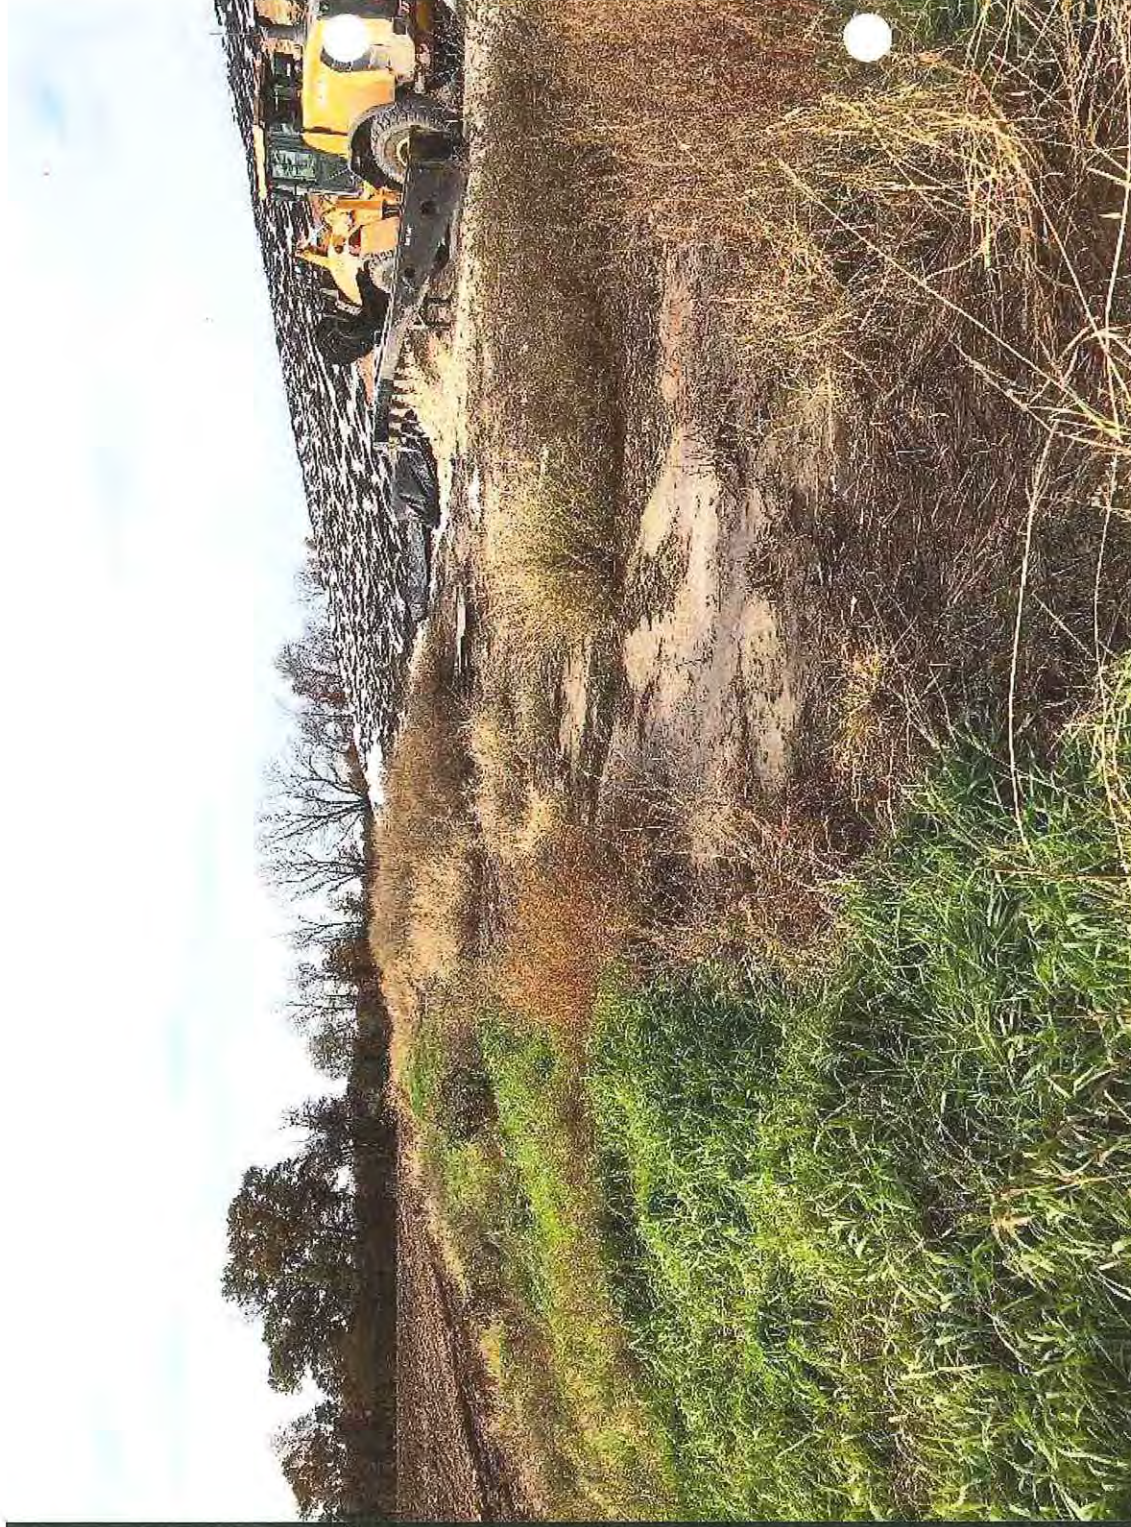
South side of silage pad  
looking west. Burnt  
vegetation, sediment,  
silage, and solids on  
bare soil.

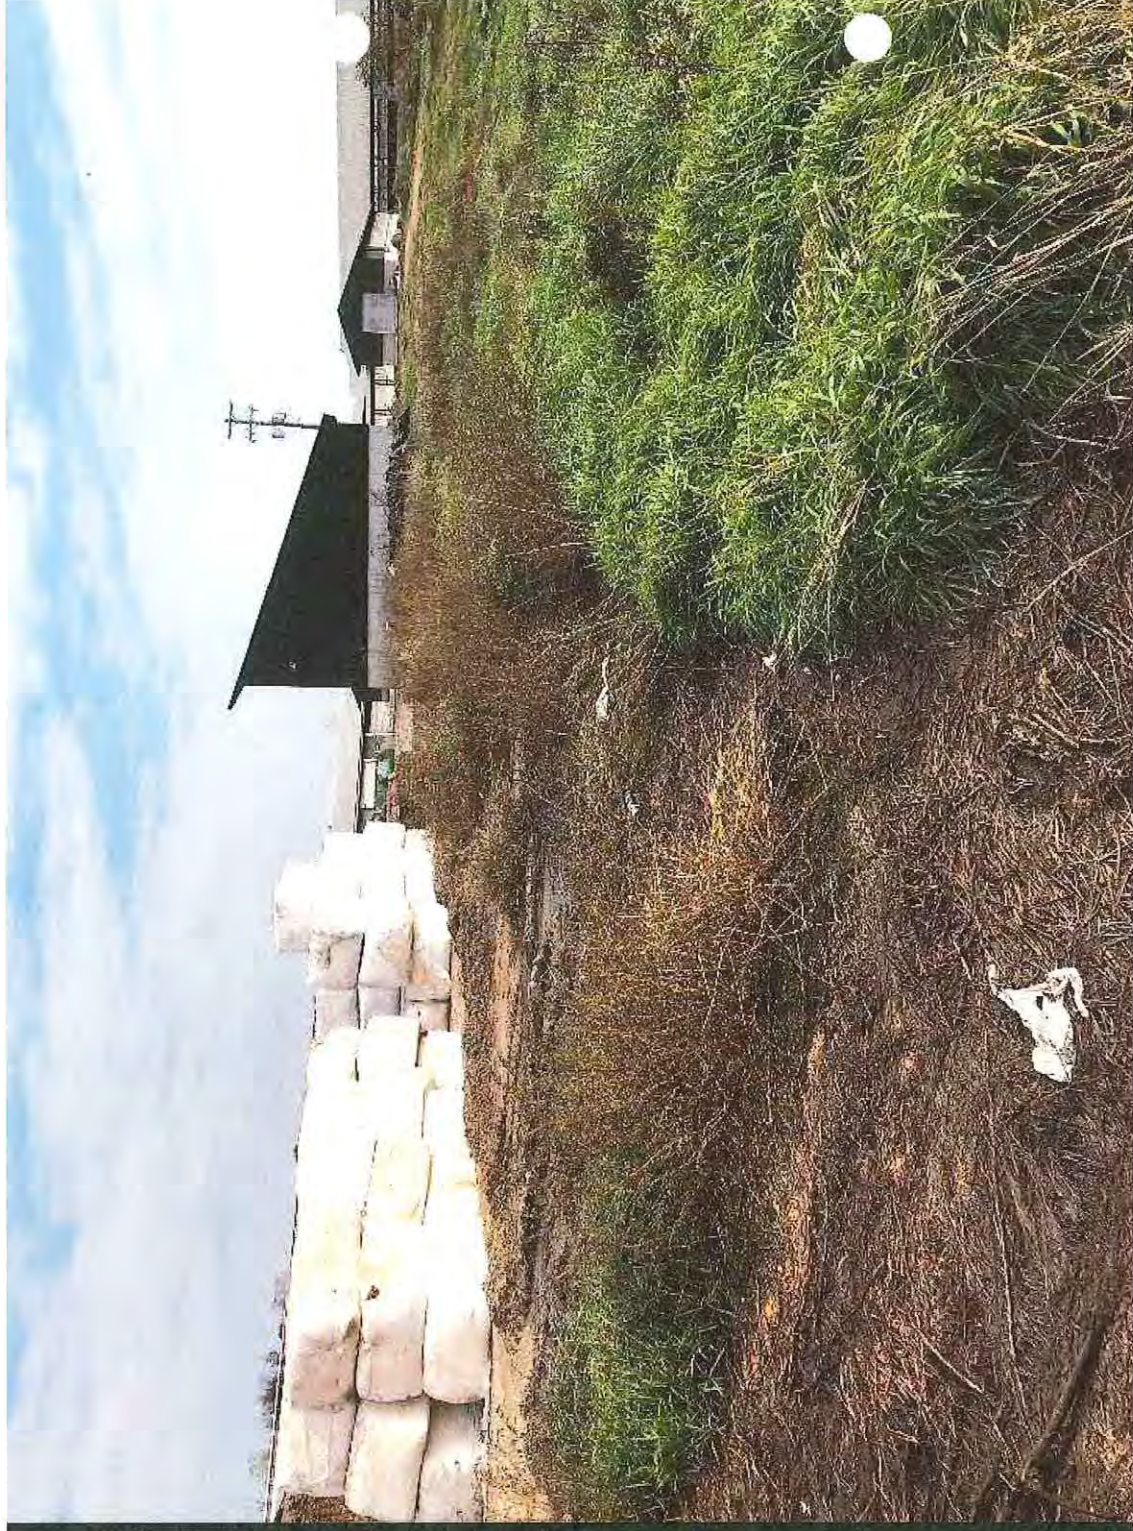
South side of silage pad  
looking east. Burnt  
vegetation, feed,  
staining on bare ground.  
Flow is toward the  
camera to the west.

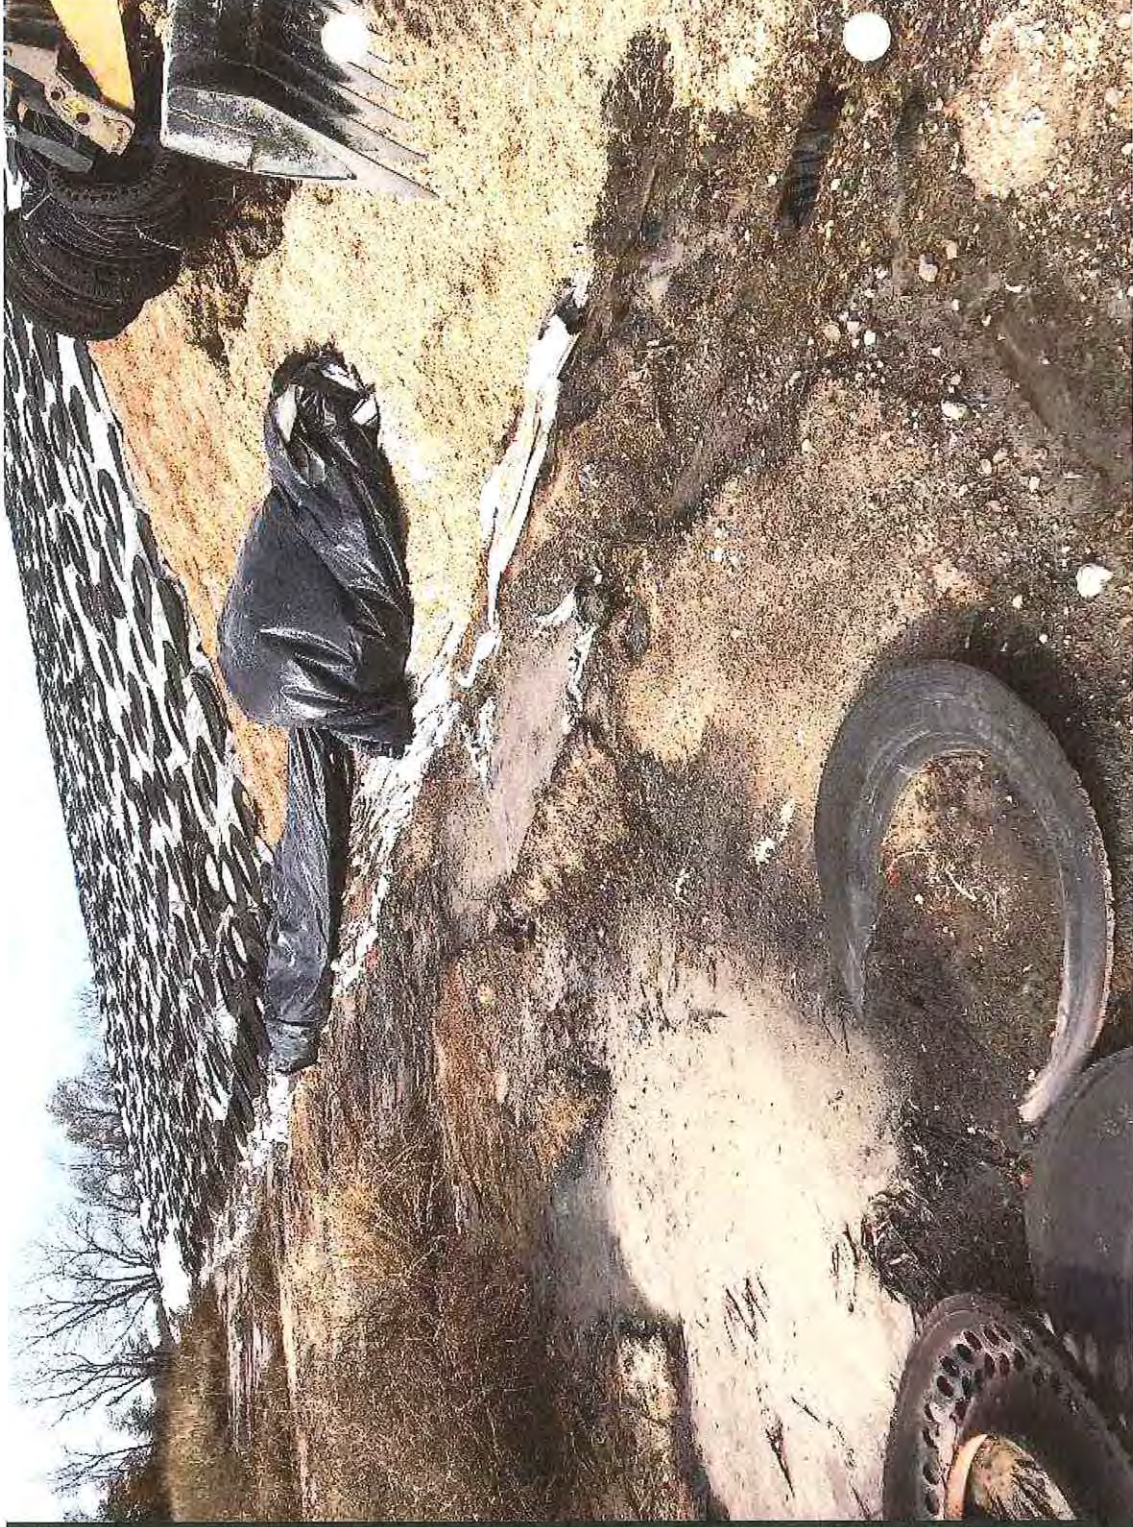
South side of silage pad,  
looking west-northwest.  
Silage is not properly  
contained, burnt  
vegetation,  
discoloration, and  
solids.

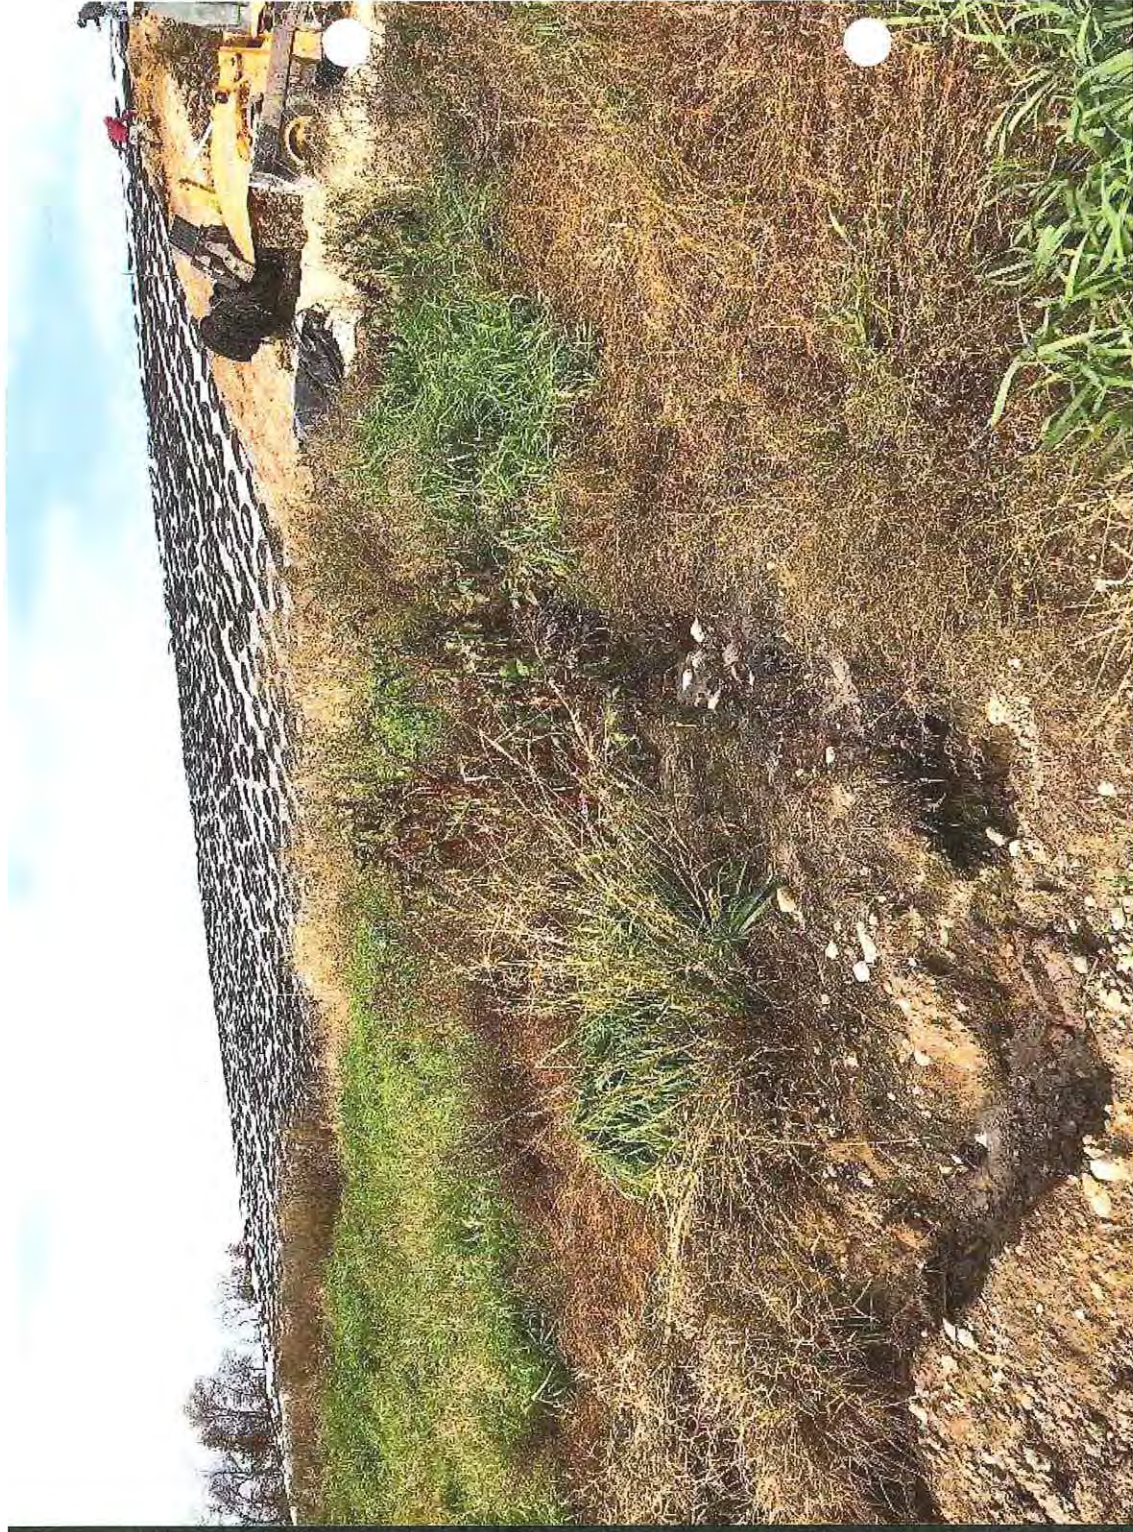
South side of silage pad,  
midway between east  
and west ends, looking  
north-northwest at the  
silage pile. Burnt  
vegetation, erosion from  
flow coming off of the  
silage area.

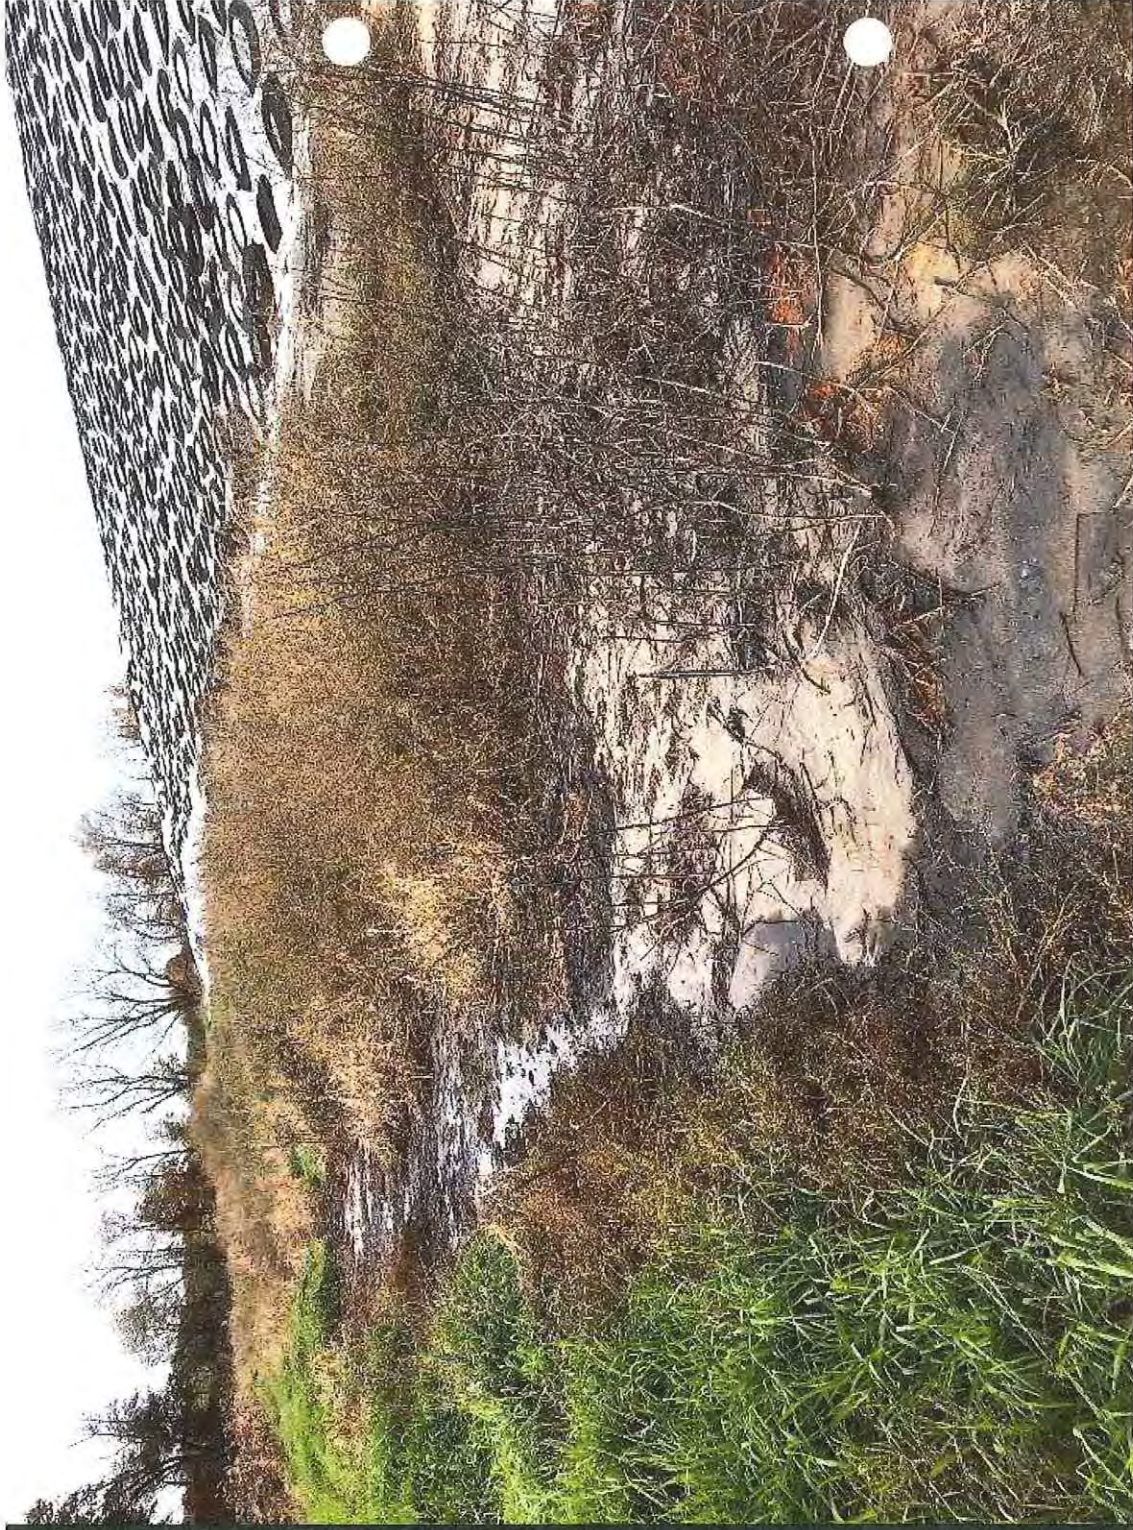
South side of silage pad,  
looking west. Burnt and  
killed vegetation,  
discoloration, standing  
water with discoloration.

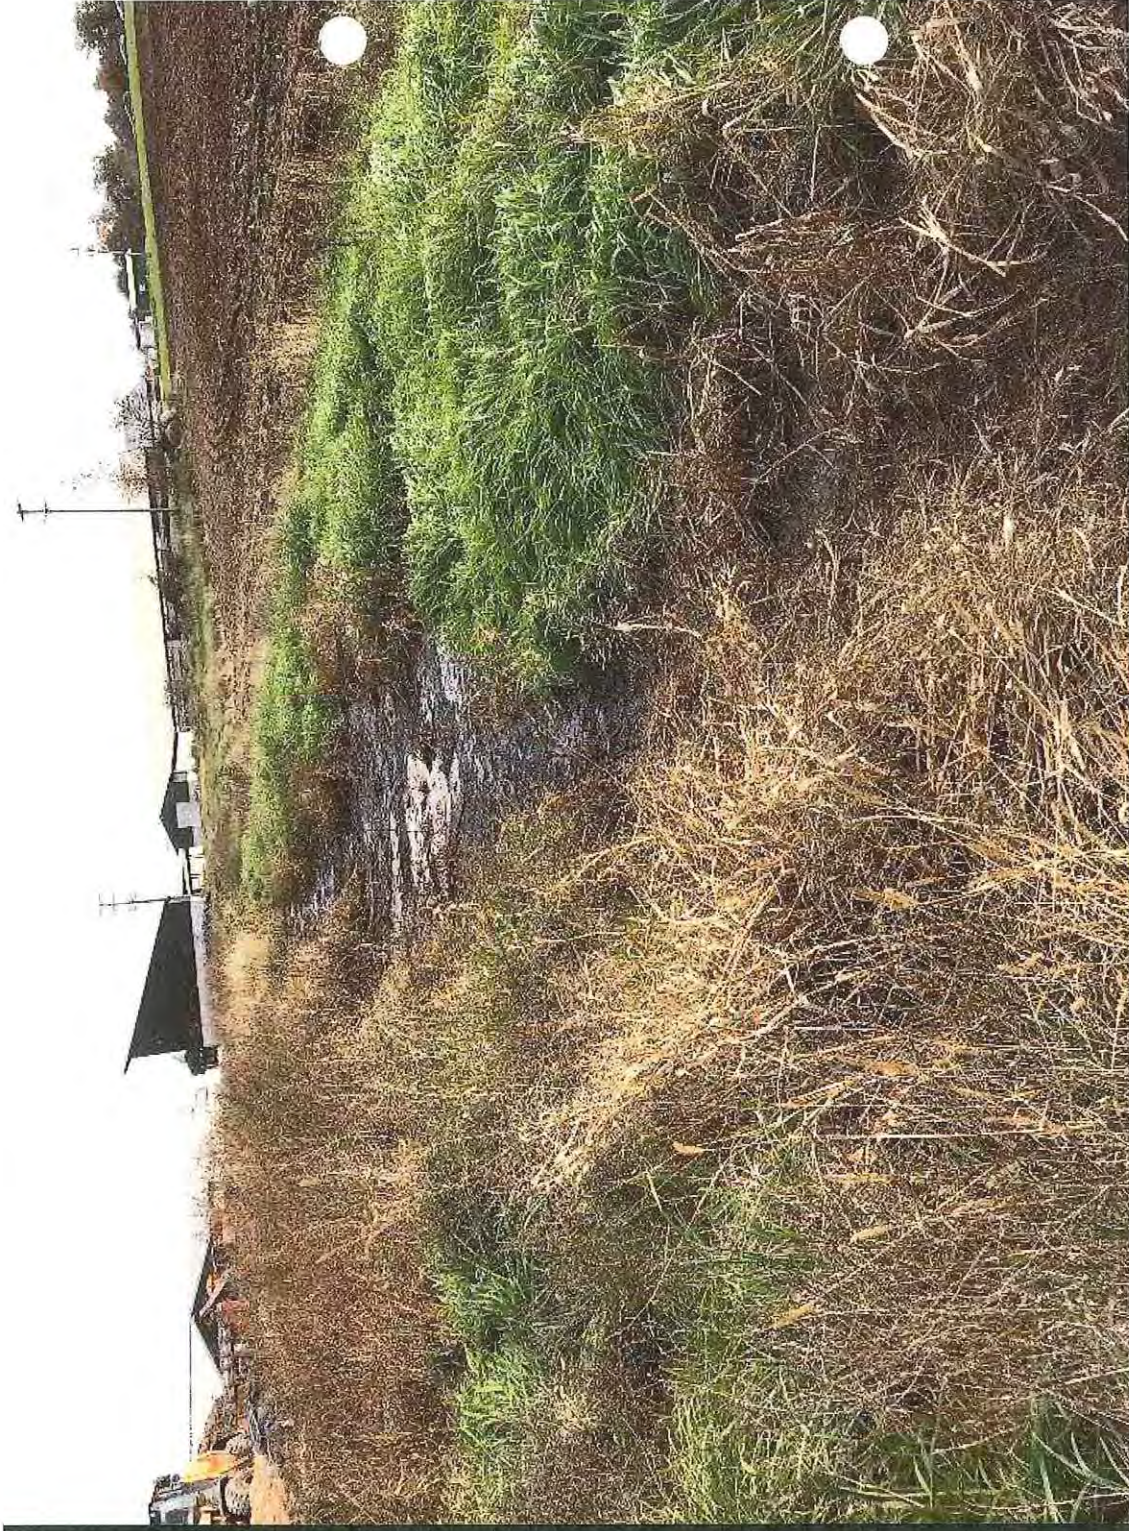
South side of silage pad,  
looking east. Burnt  
vegetation, standing  
water. Water is  
discolored.
