MICHIGAN DEPARTMENT OF  
ENVIRONMENT, GREAT LAKES, AND ENERGY

Holloo Farms-CAFO  
20849 F Drive S.  
Marshall, Michigan 49068

**Concentrated Animal Feeding Operation Full Facility Inspection**  
**November 5, 2021**

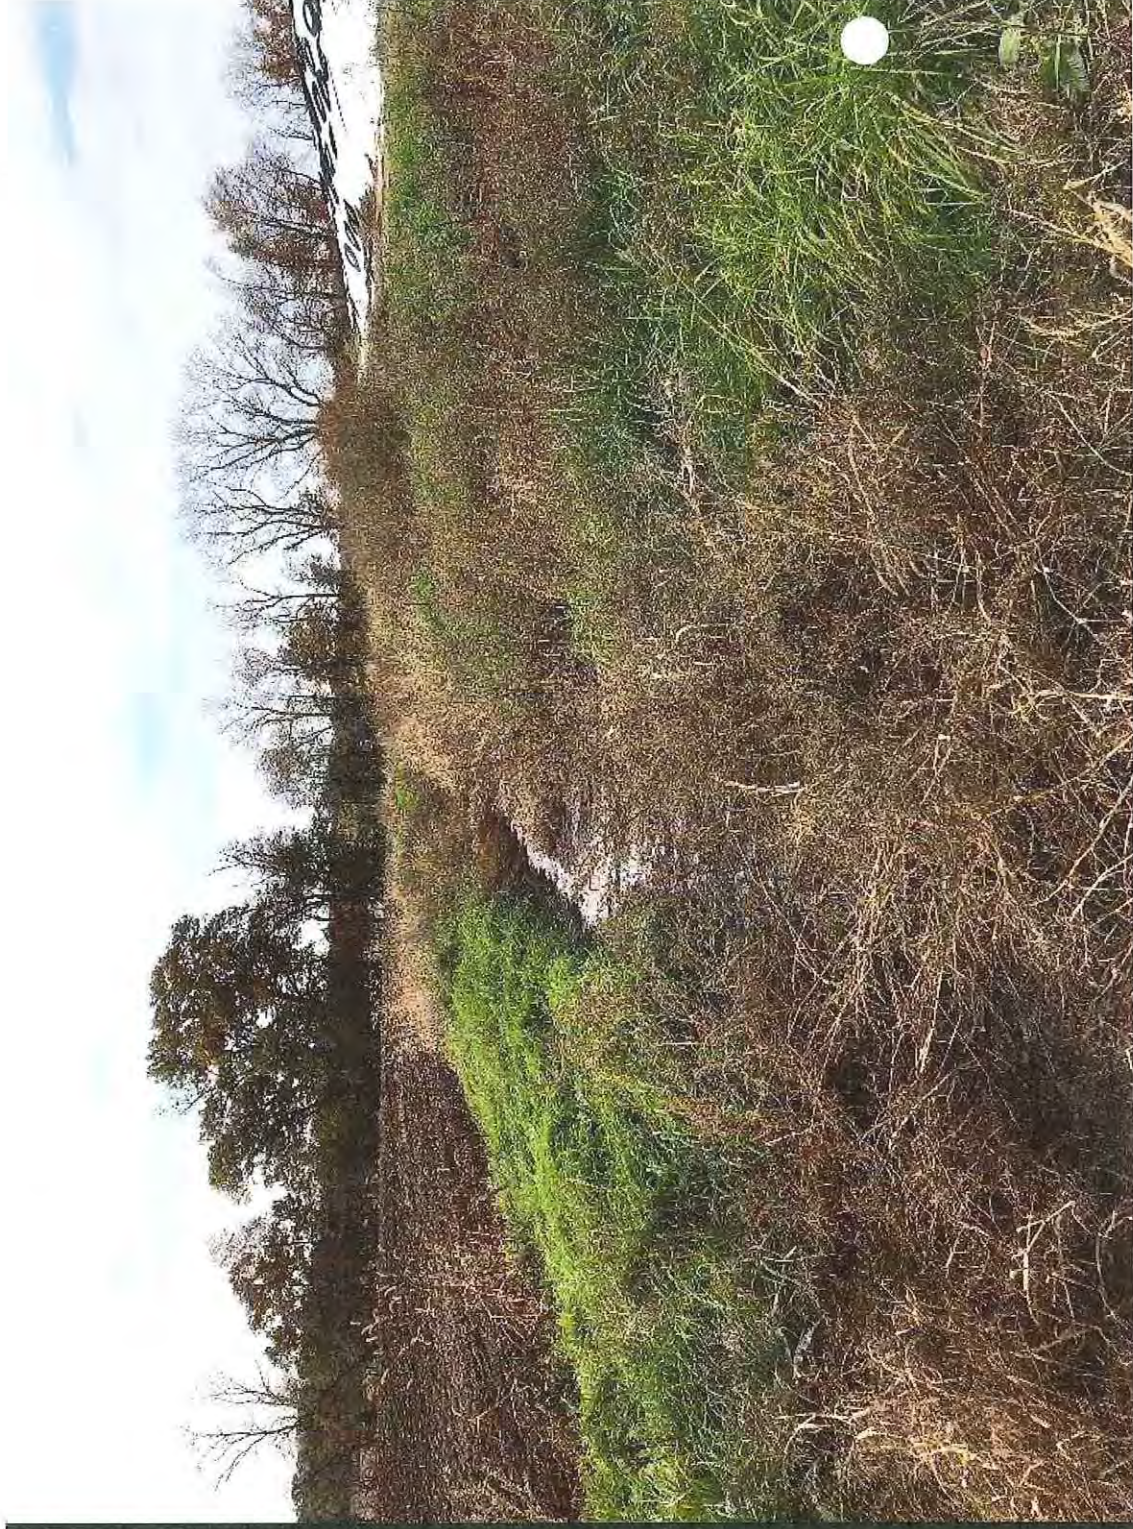
South side of silage pad,  
looking west. Burnt  
vegetation, standing  
discolored water.

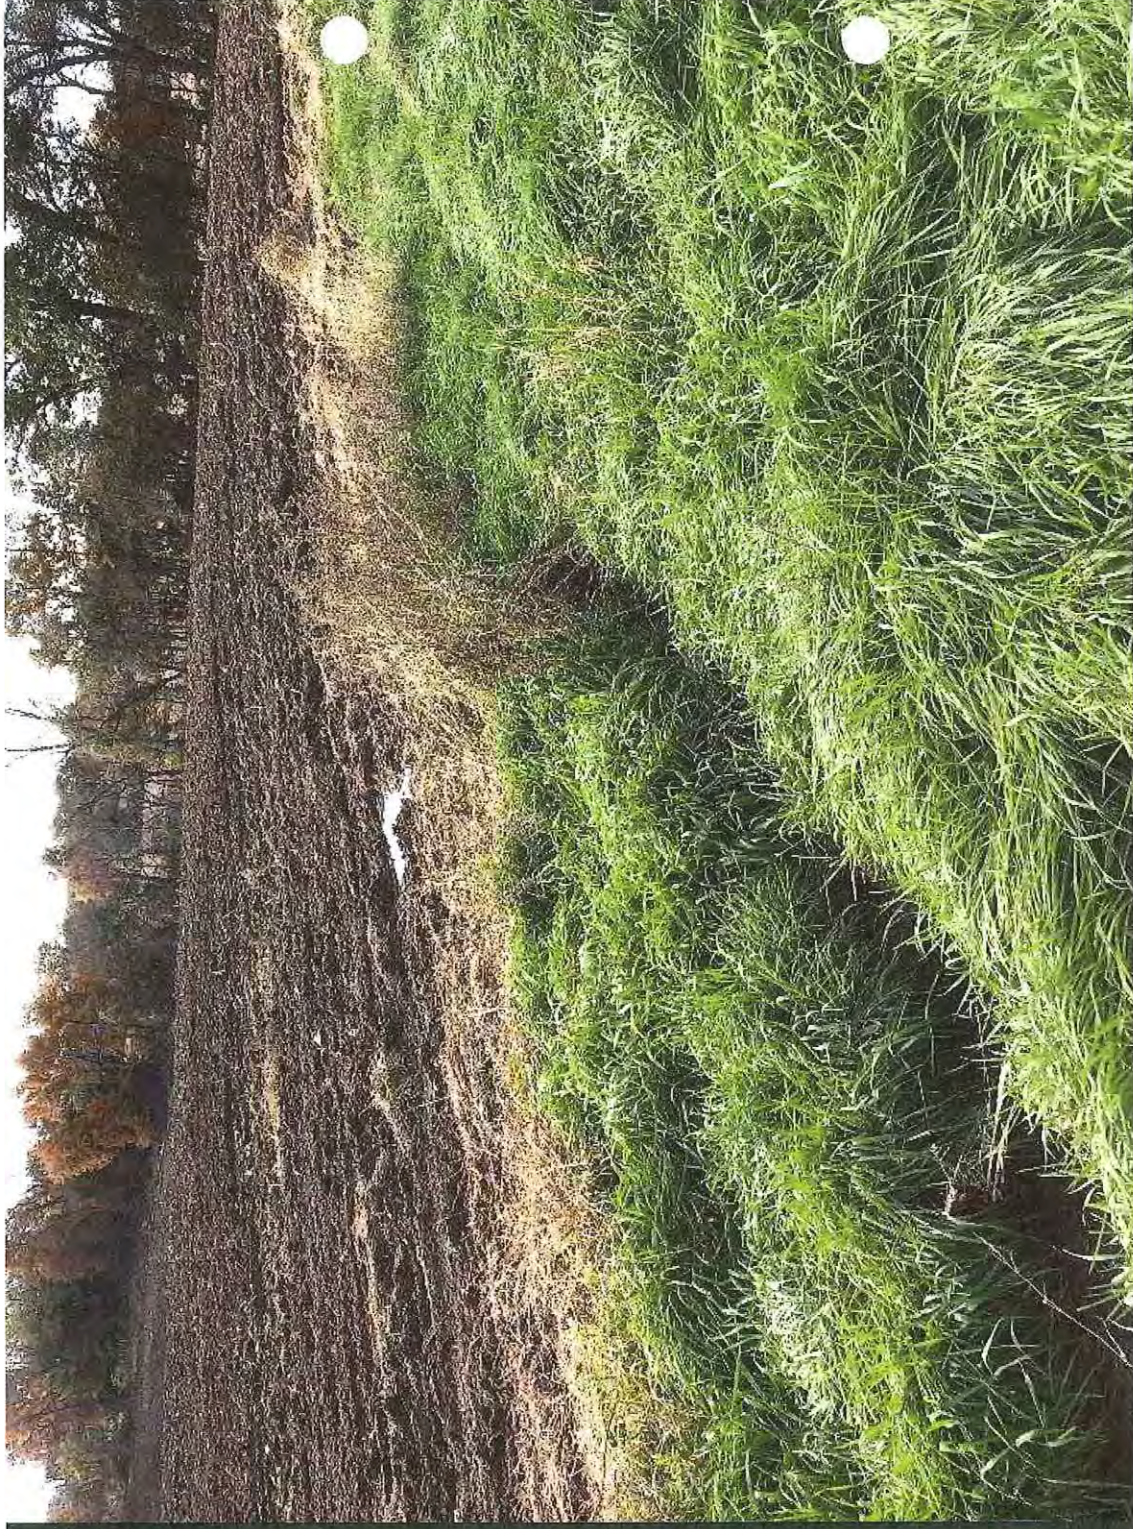
South side of silage pad,  
looking southwest  
toward adjacent field.  
Flow path from silage  
pad to field with  
standing water in the  
field. Low spot in the  
field to the south had  
ponding water.

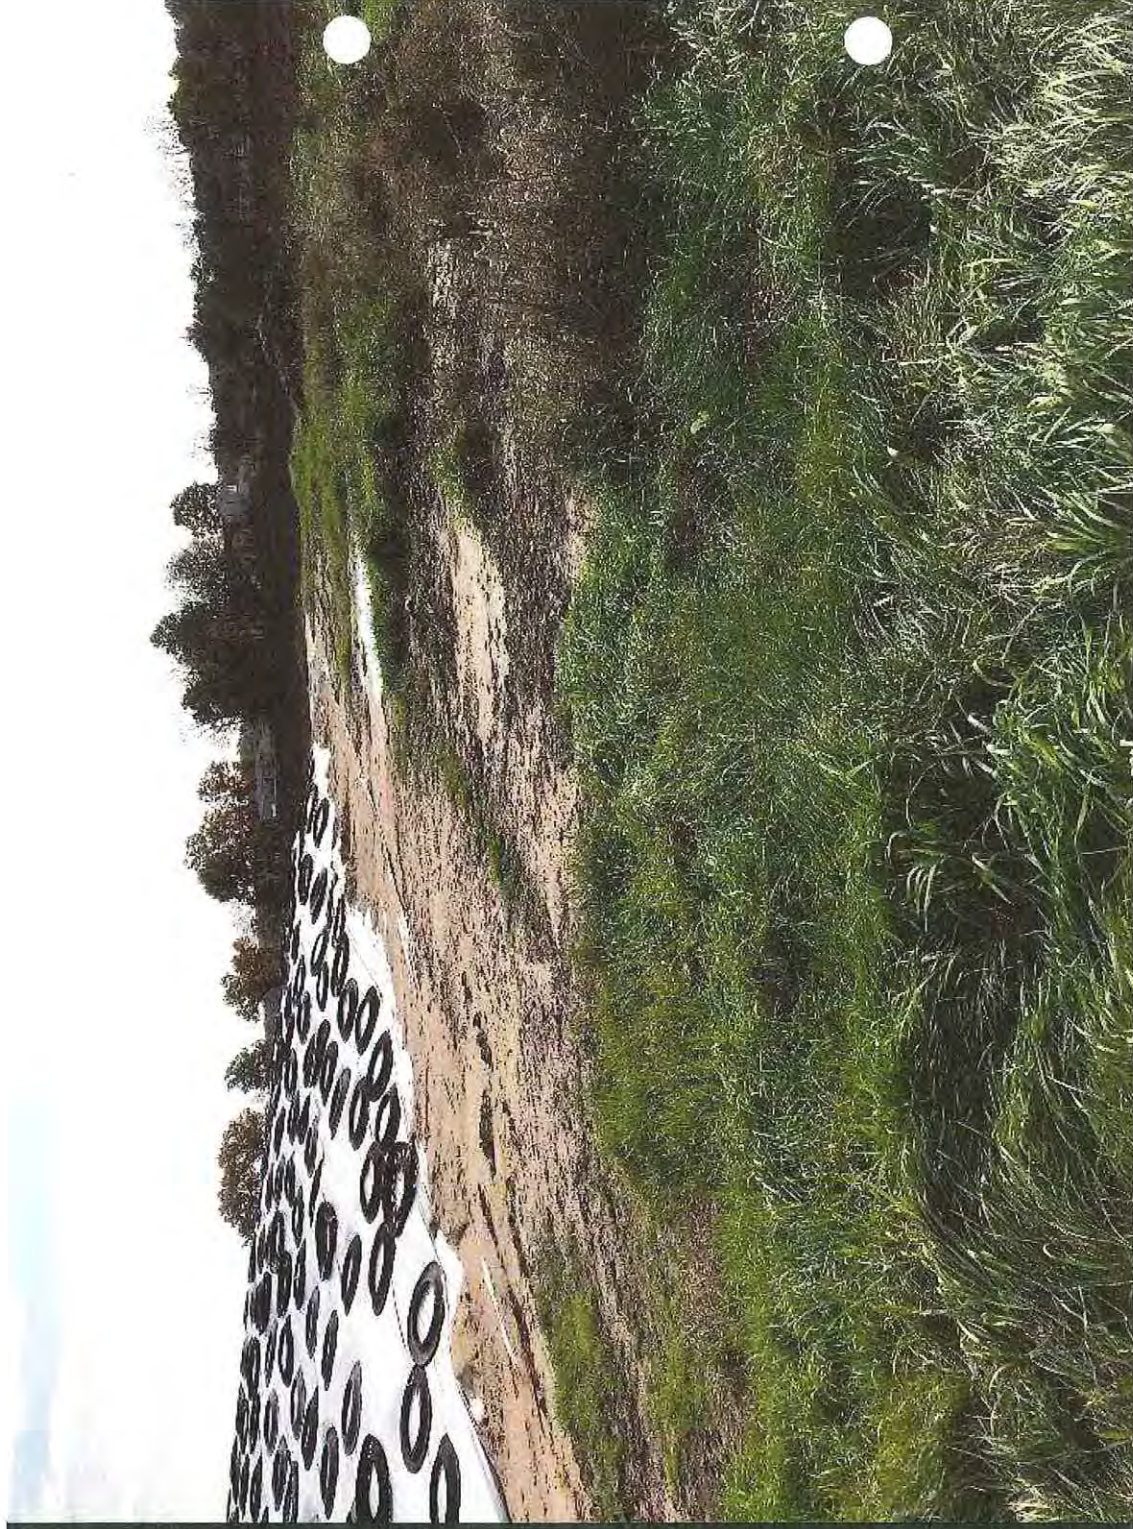
West side of the silage pad, looking toward the southwest corner of the pad. Burnt vegetation, standing water, sediment off of the silage pad. All silage appeared to be on the concrete in this location.

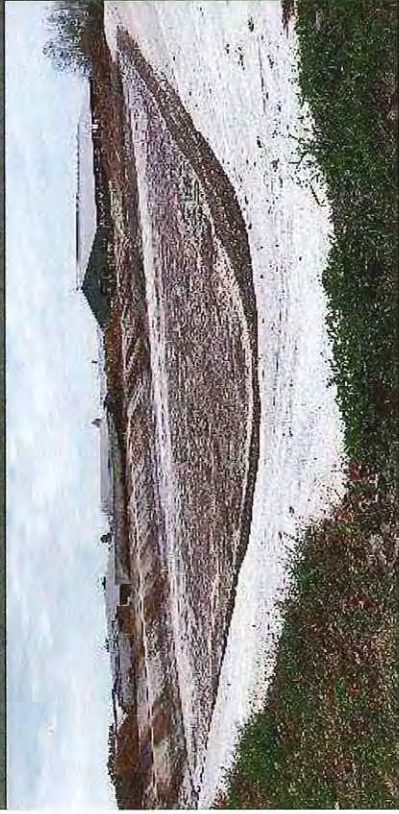
Earthen Storage with new  
concrete liner

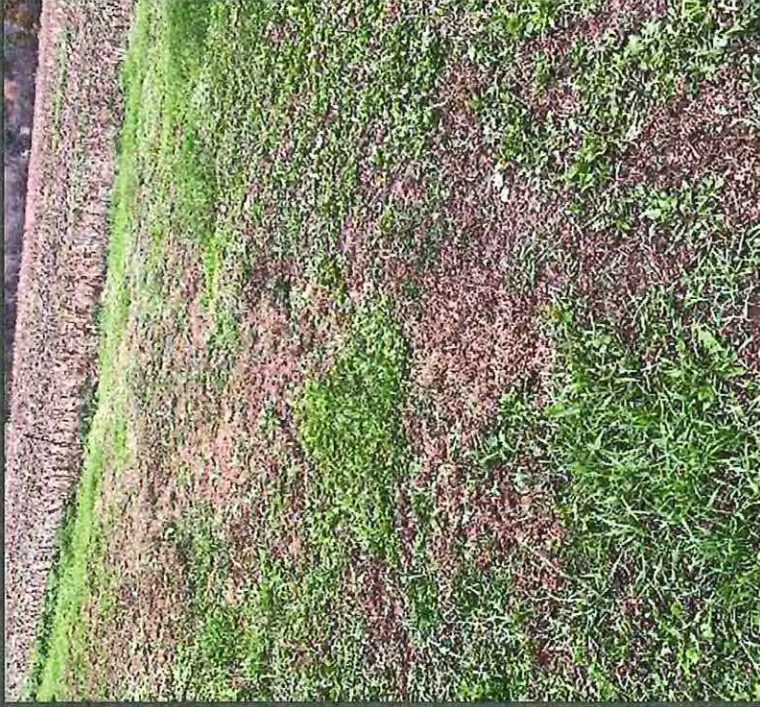
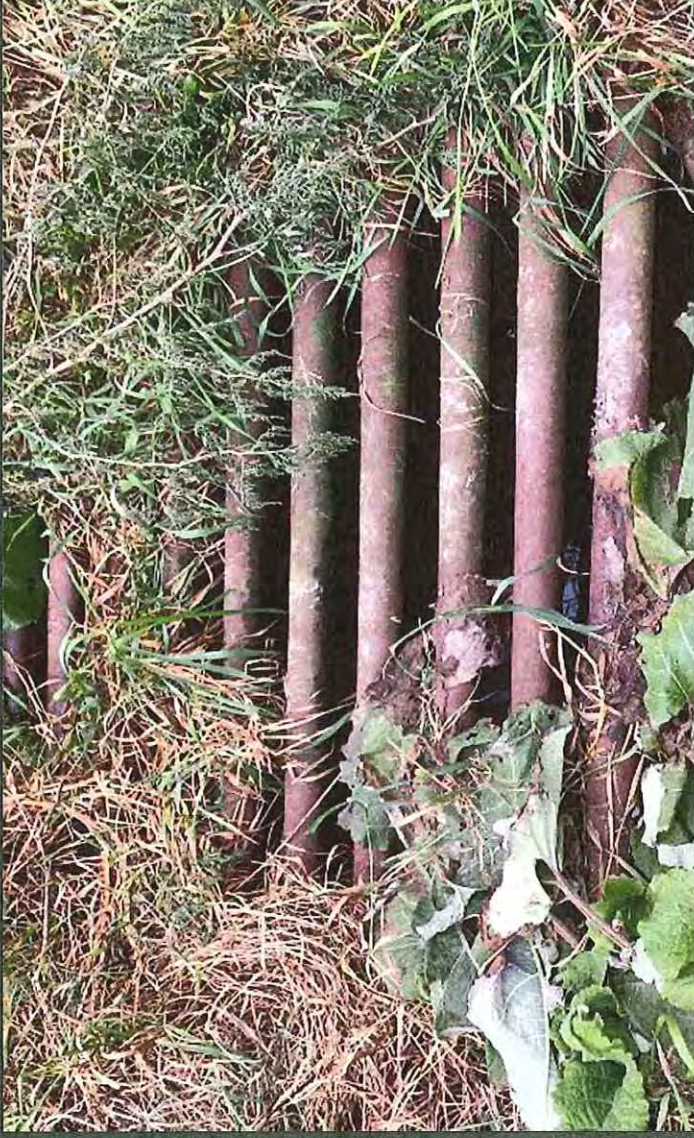
Storm run-off sewer covered  
with vegetation (closest to  
discharge point)

3. Photos showing the clean water catch basins cleared of vegetation and the plan as to how the Facility is going to prevent overgrown vegetation from occurring in the future.

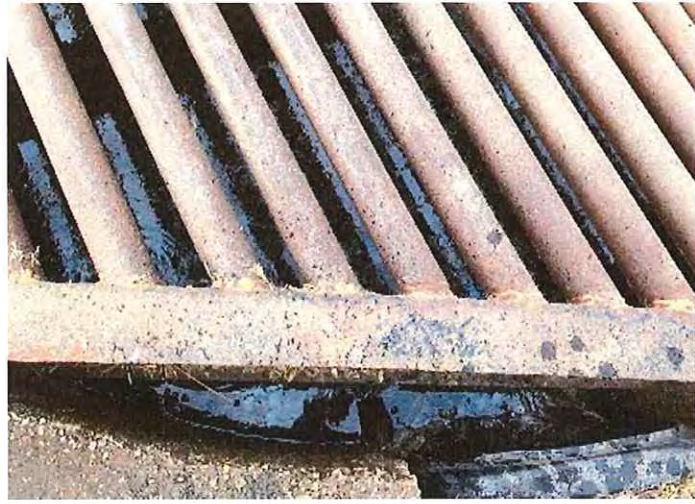
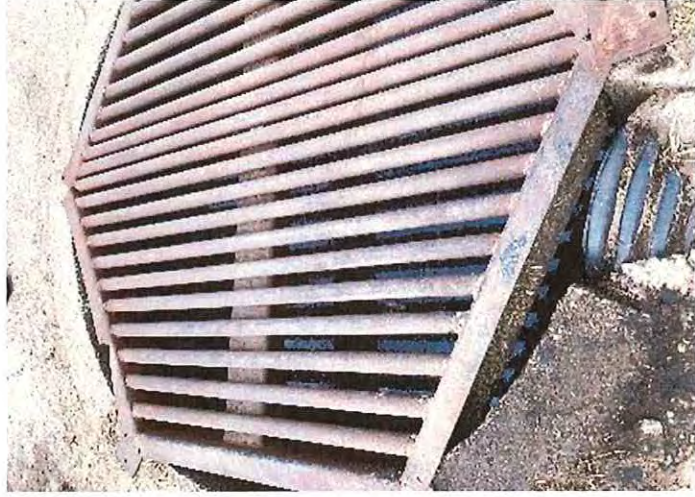
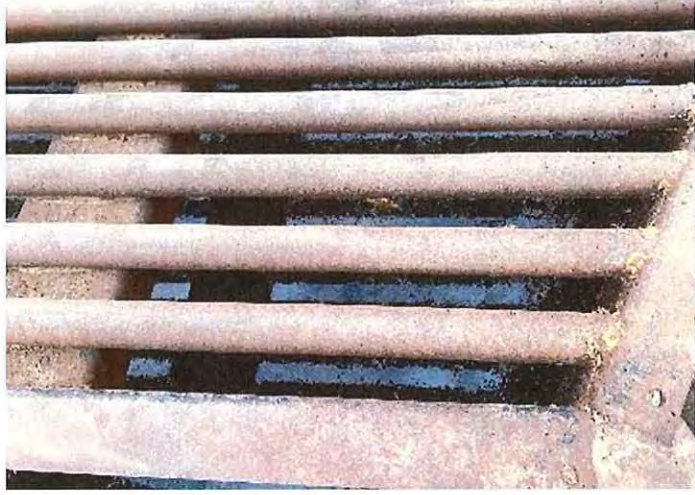
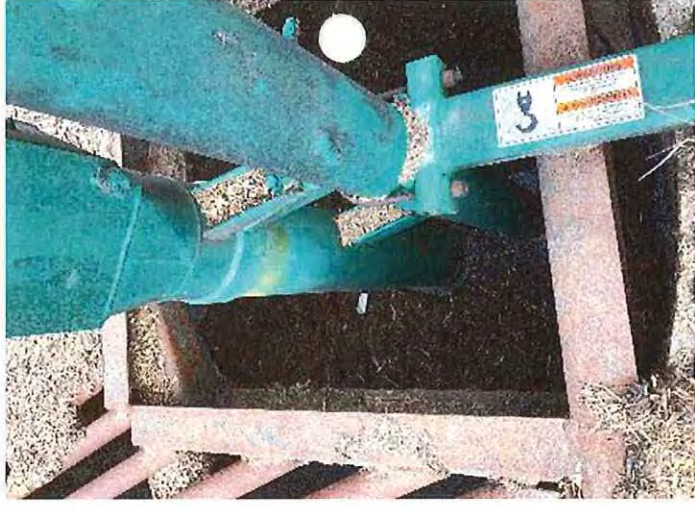
Second Storm sewer with possible  
overflow swale and vegetation  
cover (near freestall barns)

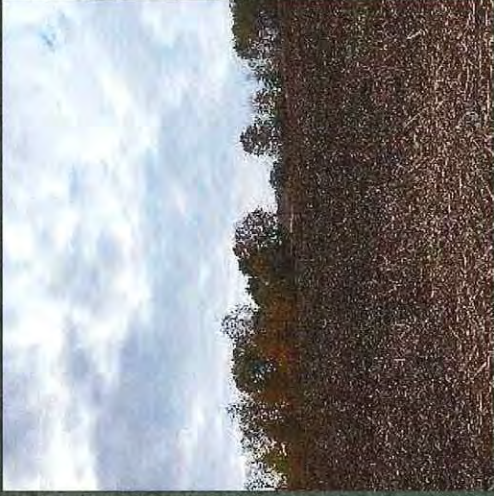
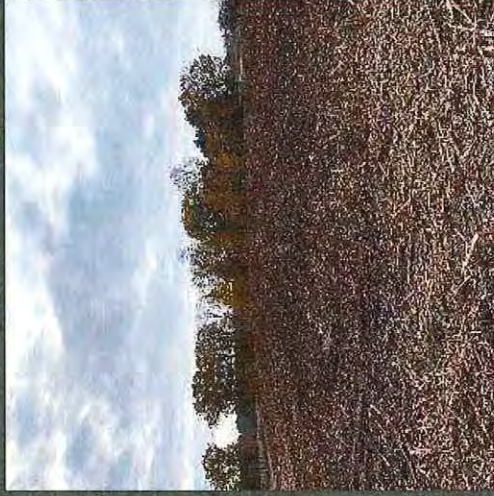
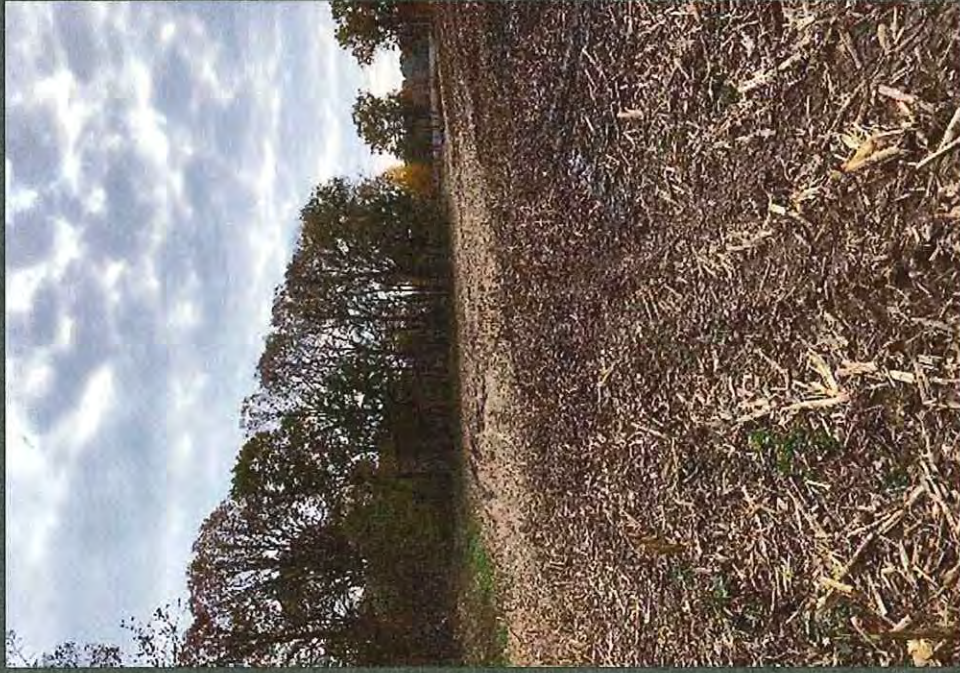
Production area clean stormwater  
collection with oily sheen

Recently  
applied field  
appears to be  
oversaturated

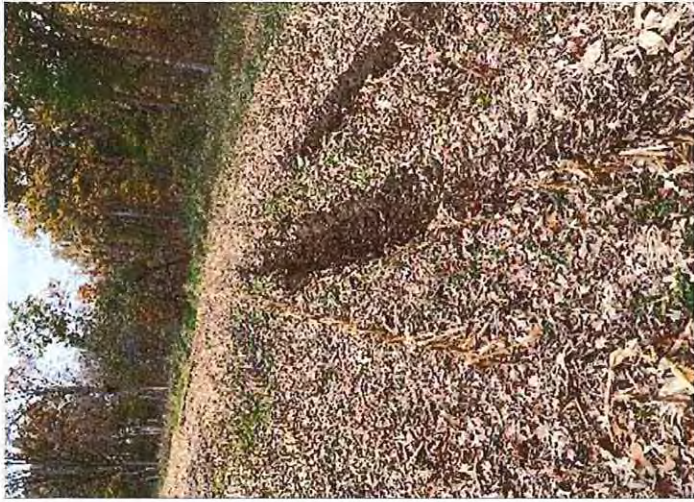
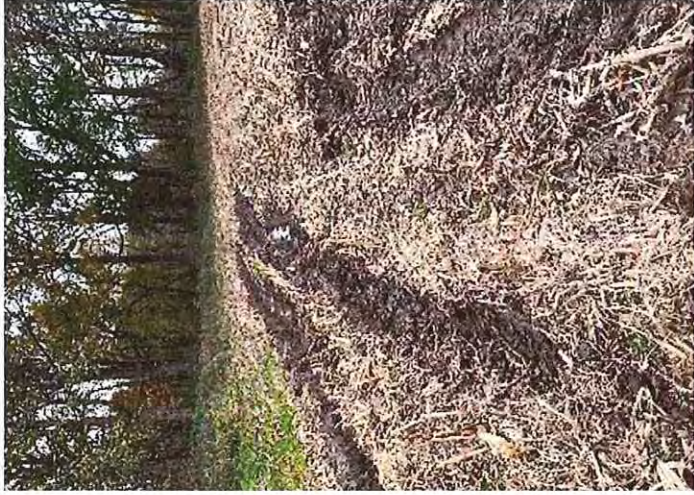
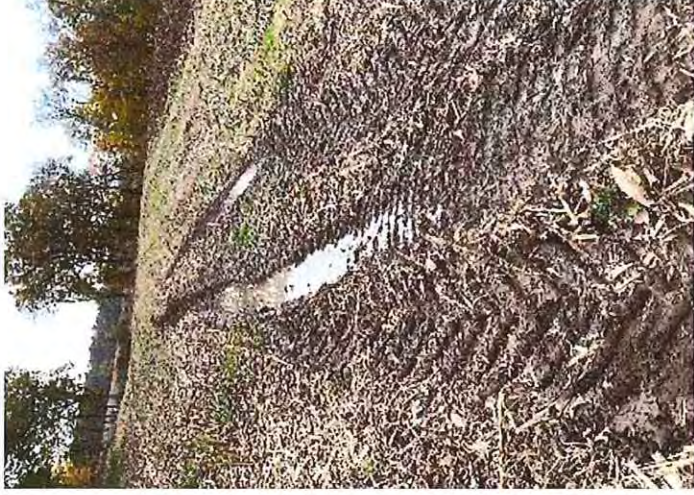
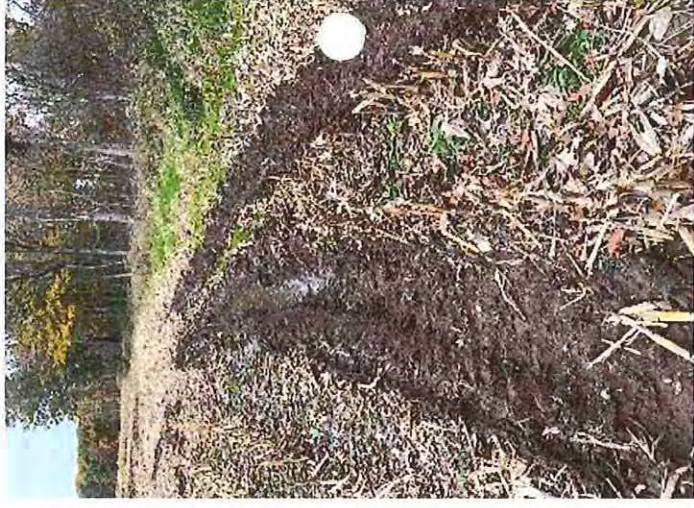
Tire tracks in over-saturated field

5. **Land application:** During the inspection EGLE staff inspected recently land applied fields including fields 97, 98 and 7W. For all fields, ponding, tire rutting and blocky soil chunks were observed indicating the soils were over saturated and proper land application procedures were not followed. This is a violation of Part I.B.3.a.1 of the Permit.

- e. The composting material spillage removed from the North end and composting materials contained on the concrete Compost Pad.
9. An explanation for the ponding and rutting observed on the recent land applied fields, 97, 98 and 7W.

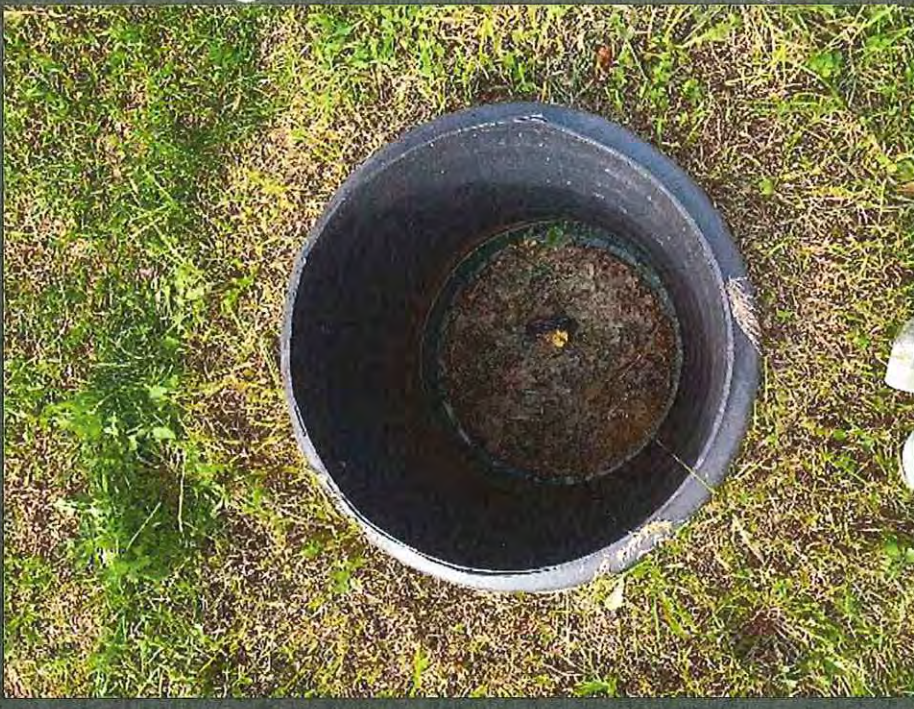
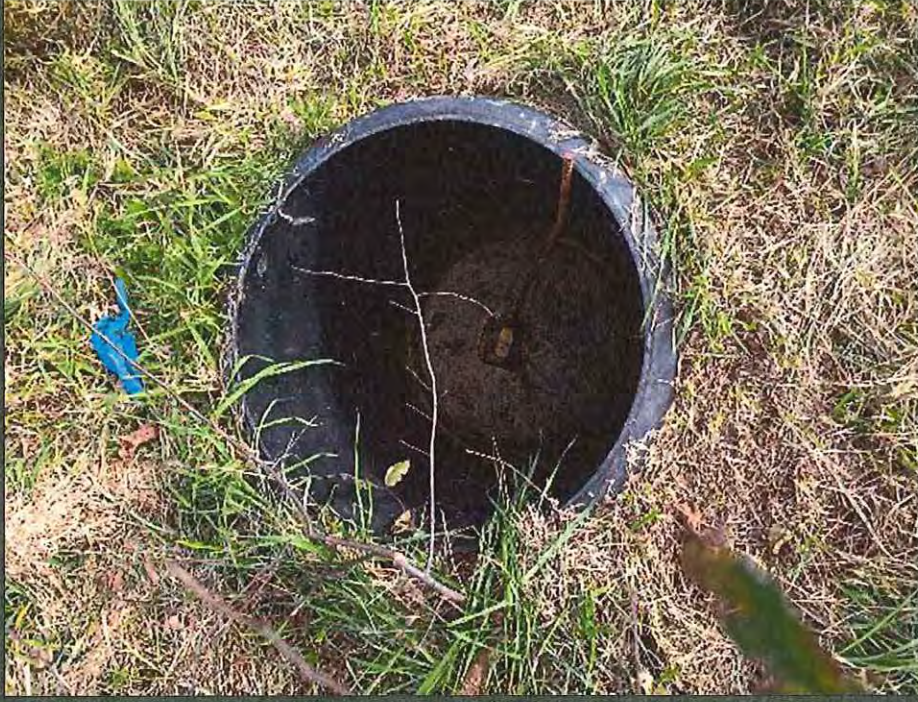
Tank  
access  
for  
laundry  
room  
waste
