# DETROIT BOAT CLUB

## PHYSICAL NEEDS ASSESSMENT REPORT

<b>Classification:</b>	Recreational Facility
<b>Cluster:</b>	
<b>Location:</b>	Riverbank road, Belle Isle
<b>Total Area:</b>	45,000 square feet
<b>No. of Stories</b>	Three Story Facility
<b>Acreage Owned:</b>	
<b>Acquired:</b>	1902
<b>Most Recent Improvements:</b>	Boiler recently installed and new plaster and paint in a few areas.

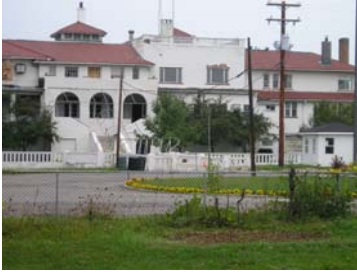
Picture left shows the approach elevation of the Detroit Boat Club. Parts of the masonry are falling off the walls.

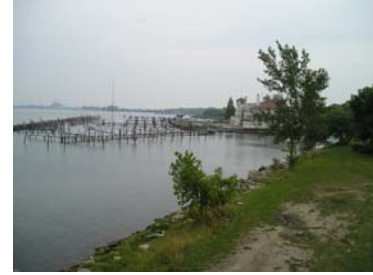
Picture right shows the wood docks on the North and West sides of the building. These are all in varying degrees of deterioration.

The wooden dock platforms and floating docks are all in various stages of deterioration and need to all be reconstructed to meet current code requirements.

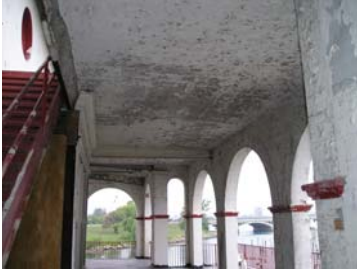
Picture left shows the colonnade on the north-west side of the building. The brick walls and plaster ceiling soffits are badly deteriorated.

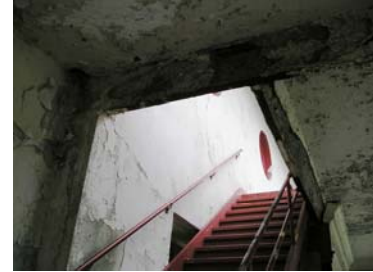
Picture right shows a steel staircase leading from the second floor to the third floor. Note the deteriorating walls and ceiling around the stairwell.

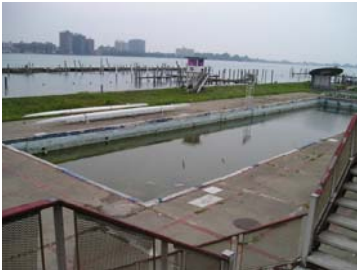
Picture left shows the Olympic size swimming pool which is now full of stagnant water and has water from the river seeping into it.

The Detroit Boat Club has two external swimming pools. One of them is Olympic size in length while the other one is about ¼ the length of the larger one. Both of the pools are in deplorable condition. Both of them contain stagnant water and receive water seepage from the surrounding Detroit River. For these two pools to be made functional again, they would have to be completely re-constructed (along with ladders, steps, diving boards etc.) to ensure that they are impenetrable and highly structurally stable and meet current code requirements. The external paving around the pools also has to be repaired to match the newly constructed swimming pools.

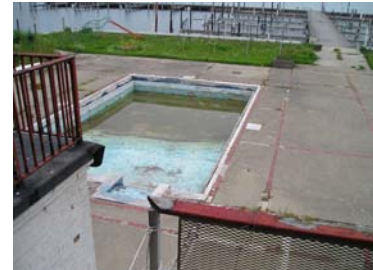
Picture right shows the smaller pool also in very poor condition.

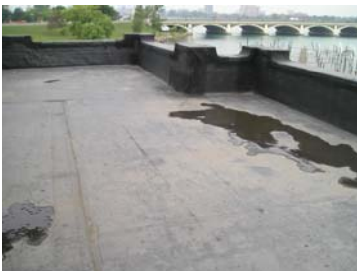
Picture left shows the terrace deck at the third floor level recently covered with rubber coating to stop some of the roof leakage.

A portion of the terrace at the third floor level has been covered with a rubber finish but this is a temporary solution to a very serious problem.

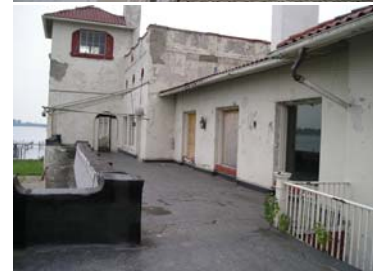
Picture right shows the third floor level with wall surfaces badly deteriorated. Several windows are missing or broken or missing.

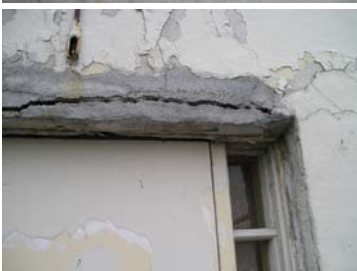
Picture left shows the lintel and wall over a door at the second floor level and this is cracked right through.

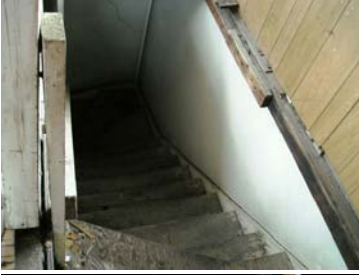
Picture left shows the wooden staircase leading up to the roof. The staircase and surrounding walls are in poor condition.

There are several wooden staircases in the building some of which have been covered with carpeting which would have to be removed for closer examination. The wood staircase leading to the roof level is in very poor condition and needs to be replaced.

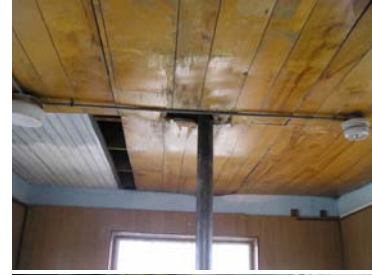
Picture right shows the ceiling at the highest level of the building supported with a steel prop.

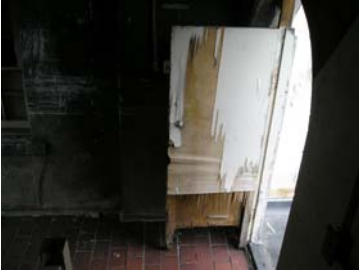
Picture left shows a deteriorated door from the second floor terrace.

Several of the doors in the building are French doors with divided lights. They are wood-framed and are in fair to poor condition. The wooden flush doors on the exterior walls of the building all have to be replaced, preferably with steel storm doors designed to withstand that type of exposure.

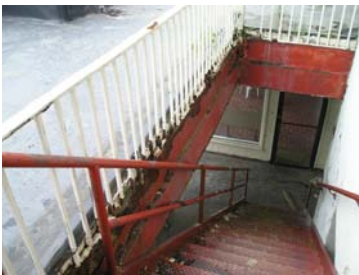
Picture left shows metal railing at the third floor level deteriorating from rust due to exposure.

There are steel handrails at the terraces and most of these are rusting badly and need to be replaced.

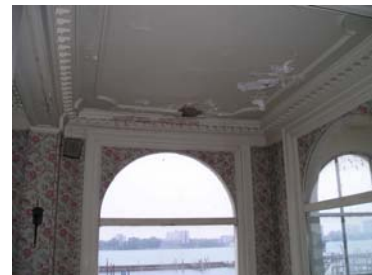
Picture right shows water damaged ceiling in a lounge facing the river.

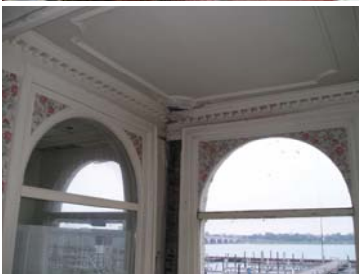
Picture left shows water damaged ceiling in a lounge facing the river.

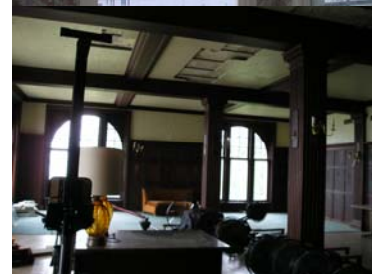
Picture right shows damaged ceiling with several ceiling tiles missing.

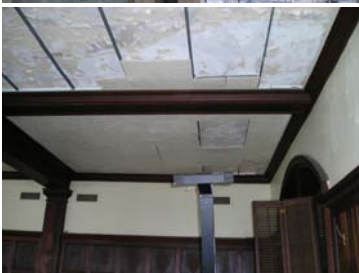
Picture left shows damaged ceiling.

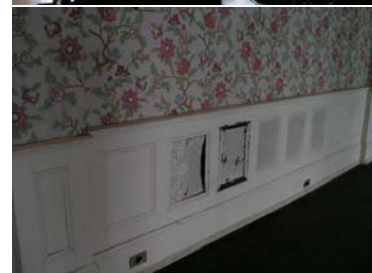
Picture right shows damaged vents in the lounge area.

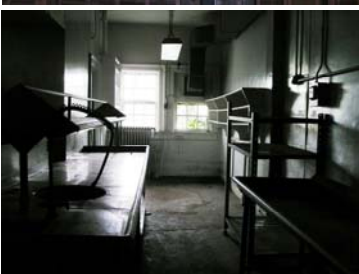
Picture left shows stainless steel kitchen equipment. The kitchen floor is in very poor condition.

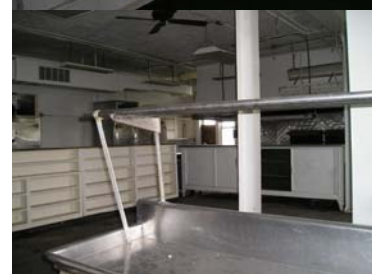
Picture right shows stainless steel kitchen equipment. Some of this equipment is still serviceable and was used up to about 3 years ago.

The kitchen is equipped with modern stainless steel equipment which appears to have been in use up to about 3 years ago. Some of this equipment is still serviceable once power has been restored to that part of the building. The cooking range and some other equipment however needs to be replaced.

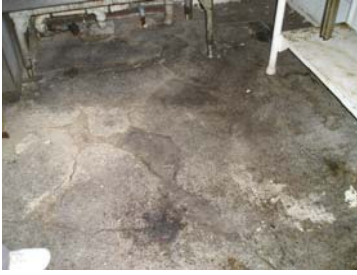
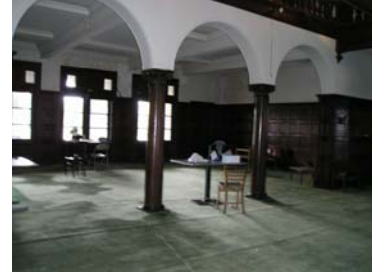
Picture left shows the floor in a part of the kitchen. There are several cracks on the concrete floor slab and any finishing has been peeled off it. Picture right shows a lounge with carpeting. A broken pipe recently leaked water all over this carpet.

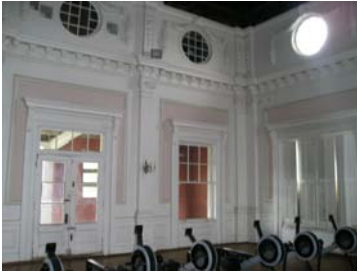
Picture left shows the ballroom. This area has been kept in fair condition. However there is a lot of peeling paint from moldings, balusters, door and window frames. Picture right shows the wooden ceiling over the ballroom.

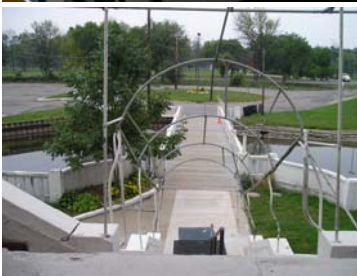
Picture left shows the steel entrance canopy frame. The canopy itself has deteriorated and been removed over time.

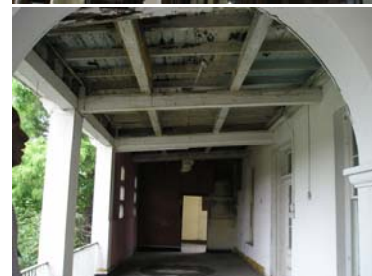
Picture right shows the entrance level terrace. The ceiling joists and soffits are in very poor condition.

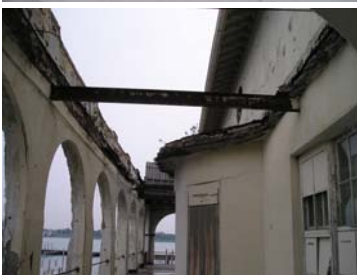
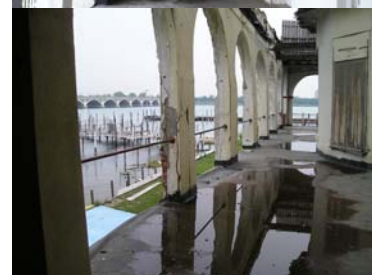
Picture left show the terrace on the west side of the second floor level of the building. The concrete slab over is has been falling off and is now all gone. Picture right shows the west side second floor terrace with water puddles partly because there is no covering overhead and slope is inadequate to drain water.

The concrete roof deck at the second floor level has now completely collapsed and continues to lose bits of masonry periodically.

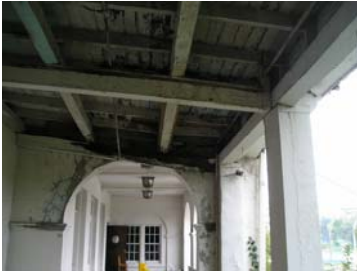
Picture left shows the entrance level terrace. The ceiling joists and soffits are in very poor condition.

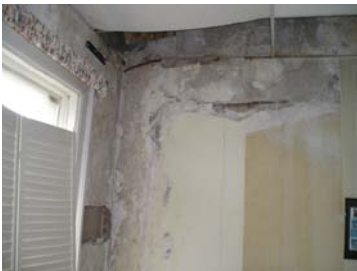
Picture left shows severe water damage to walls and ceiling in a lounge area at the second floor level.

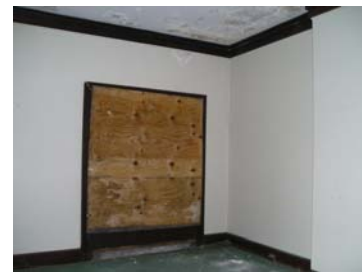
Picture right shows a boarded up window at the third floor window. The glazing is missing.

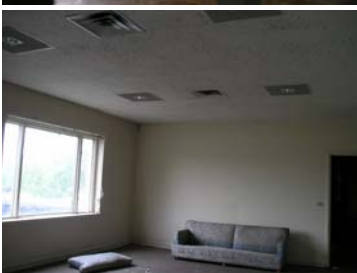
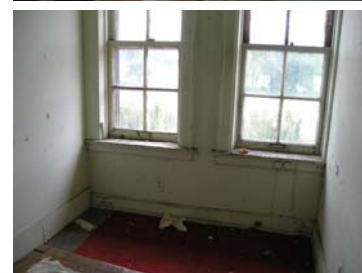
Picture left shows the River room extension which has been recently refurbished. The acoustic ceiling tiles, walls and carpeting are in fair condition. Picture shows a window with wooden window frames in poor condition.

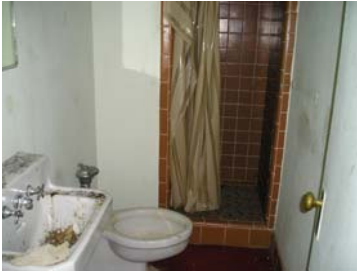
Picture left shows a shower room at the third floor level. The fixtures are in poor condition because of lack of use and maintenance.

The plumbing piping system of the building has to be overhauled. Some of the wash hand basins and water closets in the restrooms and locker rooms are no longer useable and need to be replaced. The toilets do not meet ADA requirements.

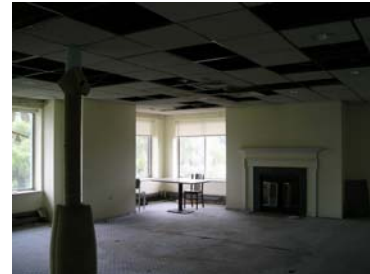
Picture right shows a lounge at the third floor level. The carpeting has been severely water damaged and several ceiling tiles are missing.

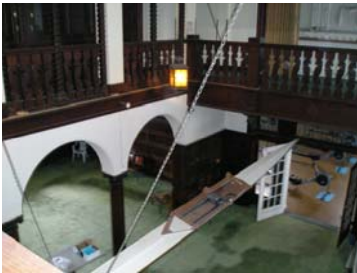
Picture left shows view from the mezzanine over the entrance foyer area. The carpeting in this area has been water damaged.

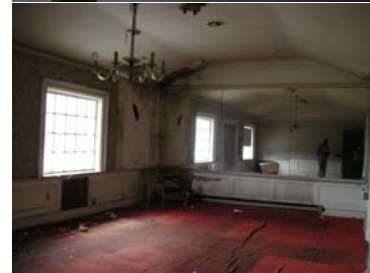
Picture right shows a lounge which is in very poor condition. Walls, ceilings and floors have been severely water damaged.

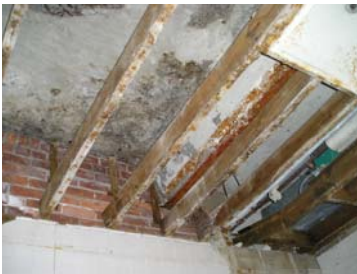
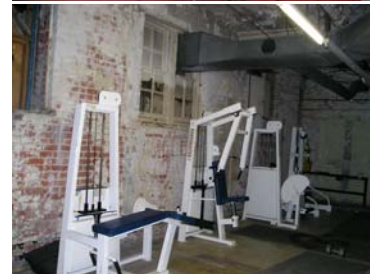
Left shows ceiling over female locker room at first floor level. Ceiling joists and slab are in very poor condition. VCT floor (not shown) is also badly damaged. Picture right shows a weight equipment room at the first floor level. The walls have been severely damaged and are in poor condition.

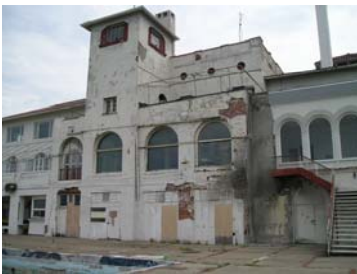
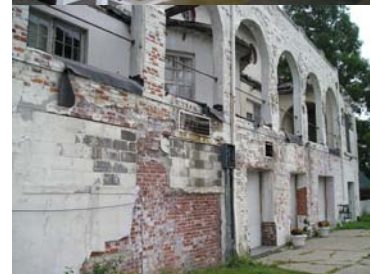
Picture left shows the North side elevation of the building. Note the repairs to the façade to the right of the picture. The building's walls are in very poor condition. Picture right shows part of the West side of the building where a lot of the wall plaster has fallen off.
