Belle Isle Boathouse Building and Site Assessment

E Picnic Way, Belle Isle, Detroit, MI 48207

SMITHGROUP

December 2019

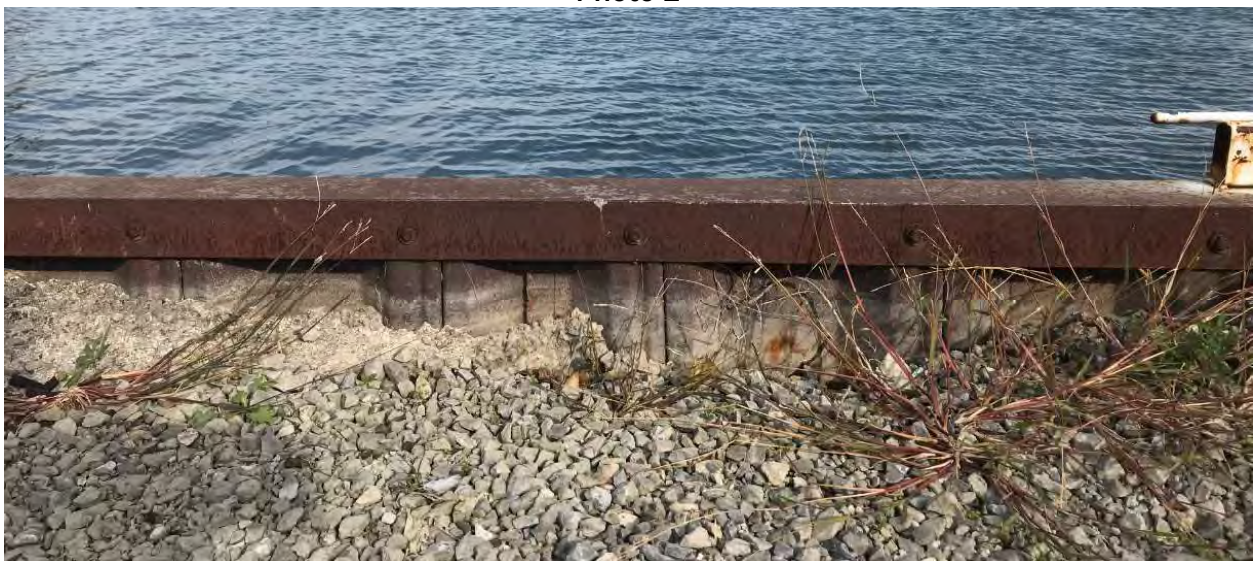
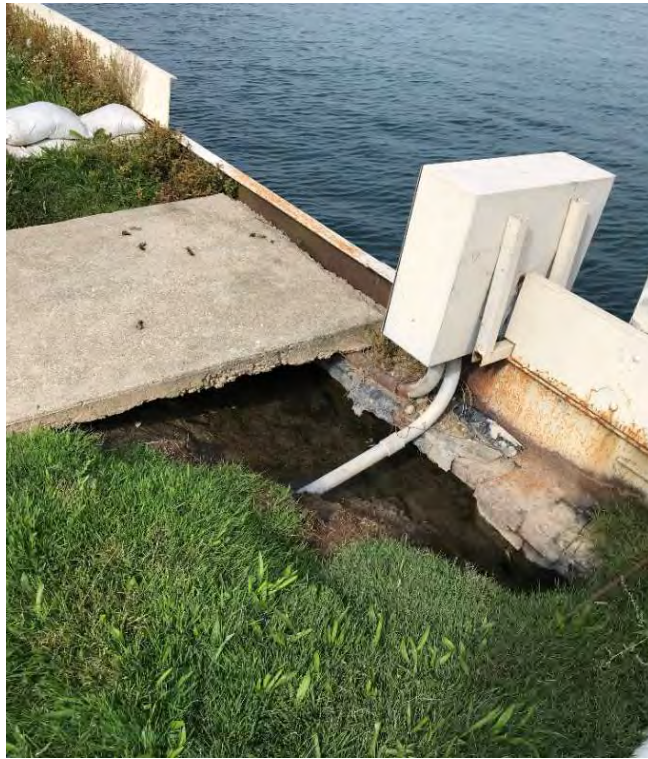
The sheet pile walls are in **FAIR** condition. The areas immediately behind the sheet pile wall are in **POOR** condition. The additional shoreline is in **FAIR** condition.

- Typical condition behind sheet pile wall **[Photo #1, #2, #3]**.
- Non-structured shoreline, rubble present **[Photo #4, #5]**.

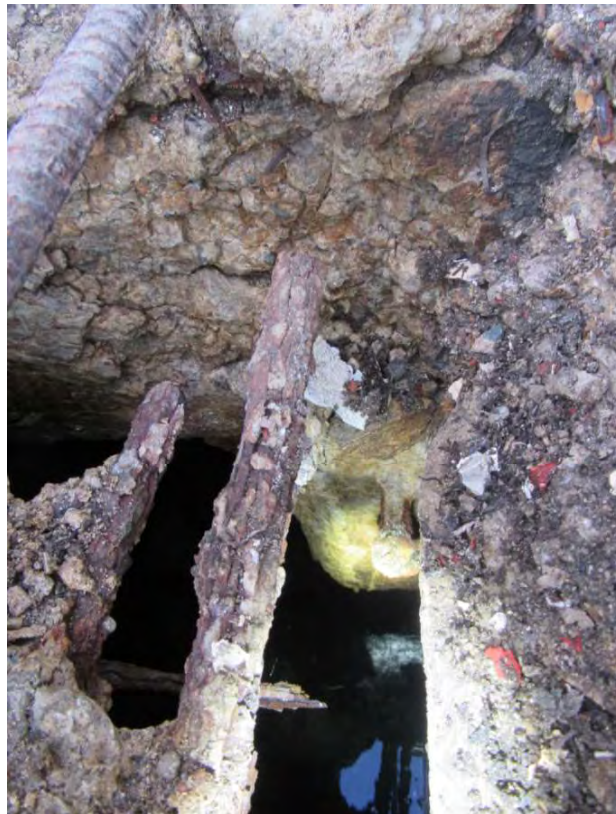
The pools and surrounding decking are in **POOR** condition overall.

- Representative condition of pool decking **[Photo #6, #7]**.
- View of pool condition **[Photo #8]**.
- Close up of pool wall deterioration **[Photo #9]**.
- Spalling, tile breakage in smaller pool **[Photo #10]**.

The swimming pools have failed beyond repair and require removal to eliminate the current life safety hazards. Given the structural design of the pool and their proximity to the boathouse removal is a prerequisite to renovation/remediation of the boathouse. Additionally, the pools are currently serving as a makeshift pumping system for the building and an alternative method for pumping will be required.

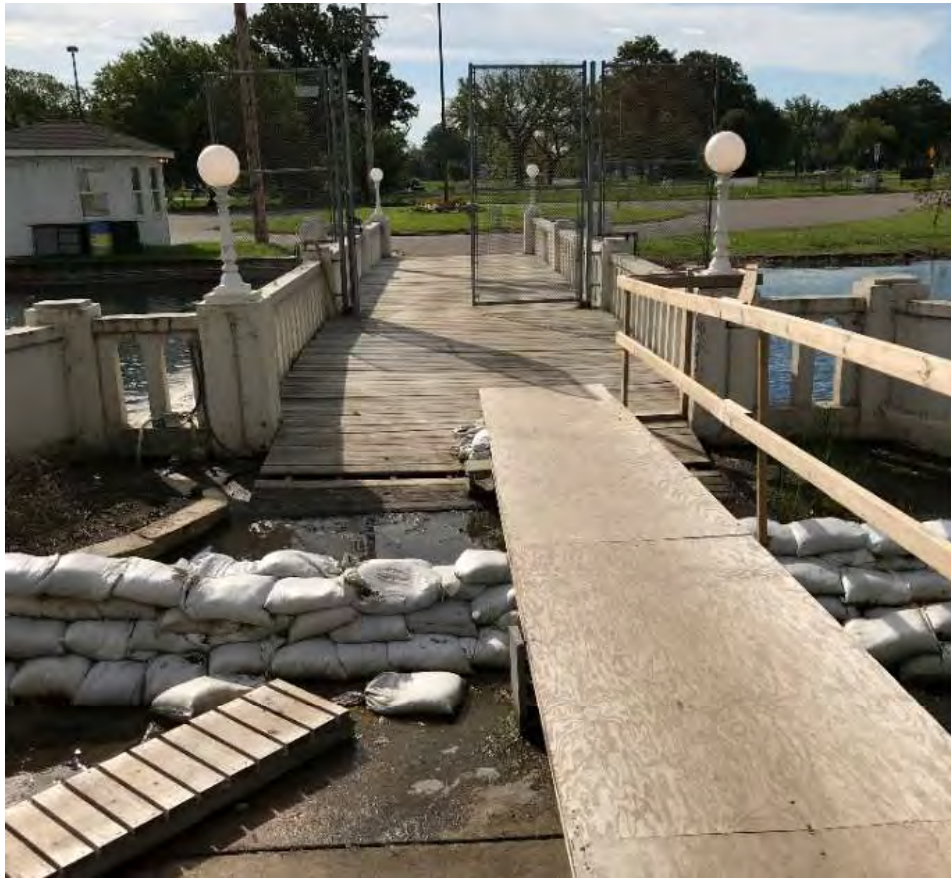
Photo 11

- Main bridge, makeshift access during high water **[Photo #11]**.
- Main Bridge structure compromised by water levels **[Photo #12]**.
- Secondary access bridge **[Photo #13]**.

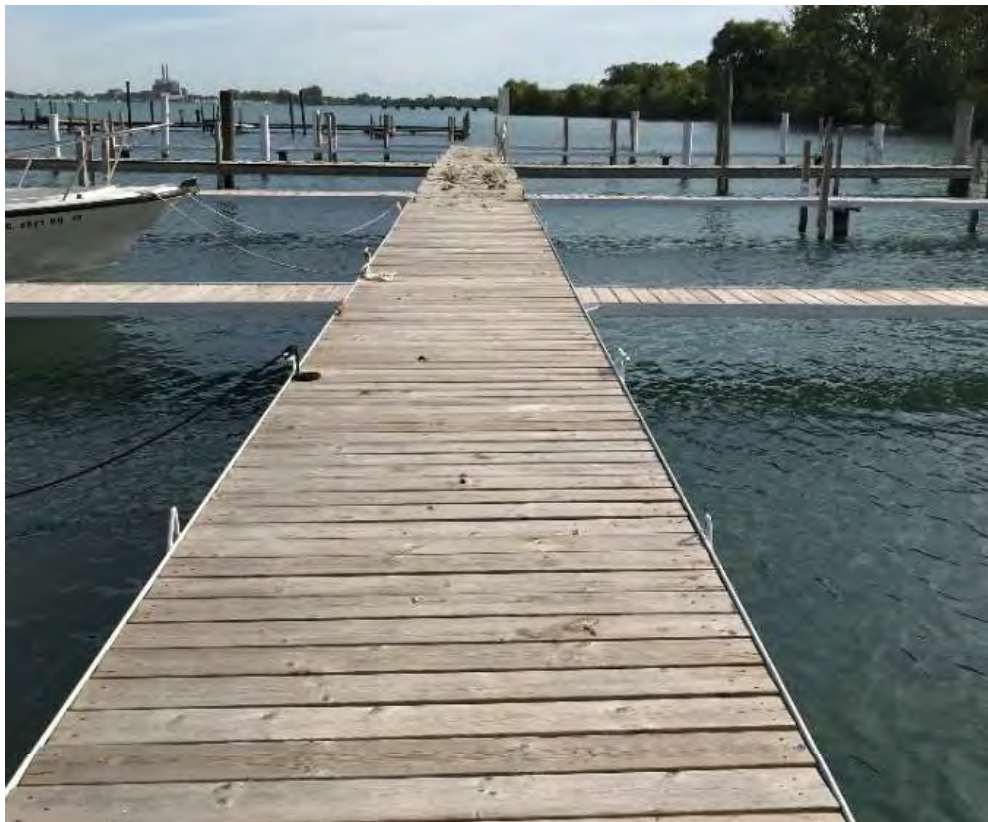
Photo 14

- Dock system on east side, some decking recently replaced **[Photo #14]**.
- Representative condition of docks on north side of island. These docks are not safe for use **[Photo #15]**.
- West side docks are a combination of formats. Newer metal portions may be salvageable **[Photo #16]**.

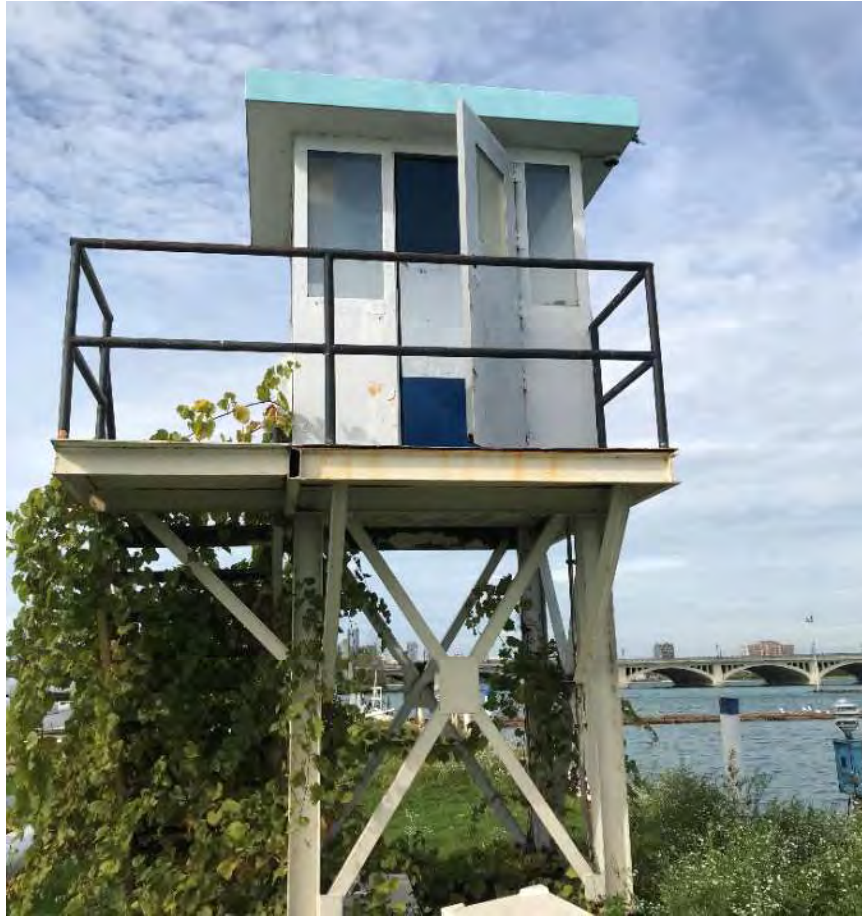
Photo 17

- Lifeguard Structure and Stand have surface rust and deterioration. Removal of both is recommended, though the main structure could be repurposed depending on future programming needs **[Photos #17]**.
- Band Shelter Structure. Overall the structure is in fair shape and appears to have been maintained. However, its removal is necessary to facilitate stabilization of island. It is

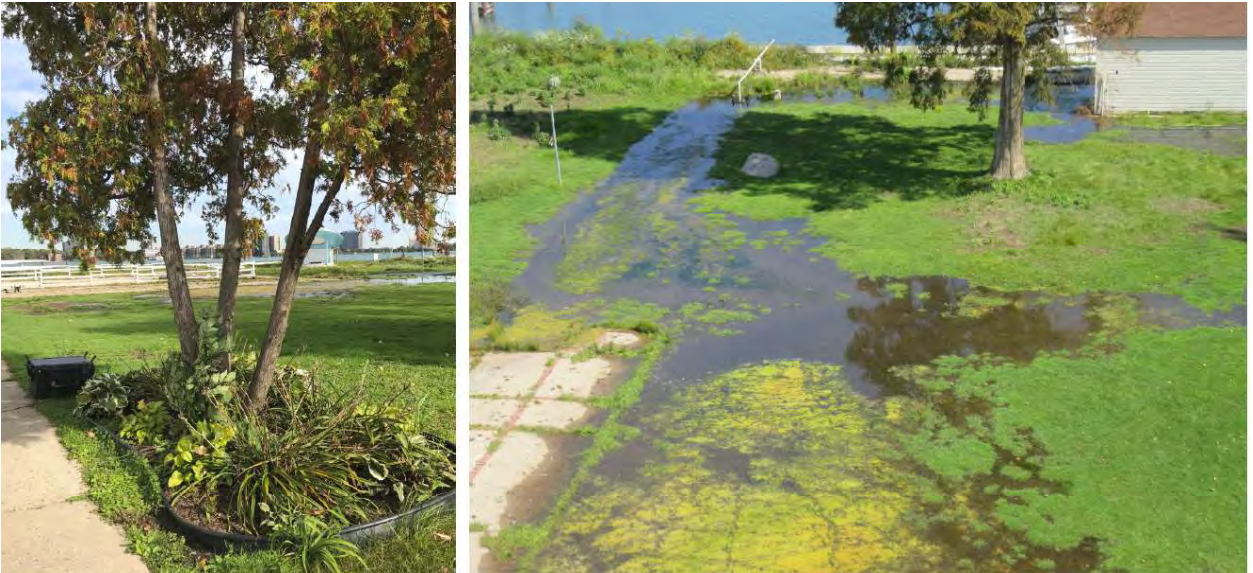
Photo 24

The ornamental landscape on the site has suffered from deferred maintenance and environmental impacts (i.e. flooding). Lawn areas are in poor shape due to standing water. Dead and dying trees and shrubs are present and should be removed for safety reasons. It is not recommended that any landscape planting be re-installed until all site and structure stability issues have been resolved.

- Representative landscape [Photo #24].
