Belle Isle Boathouse Building and Site Assessment

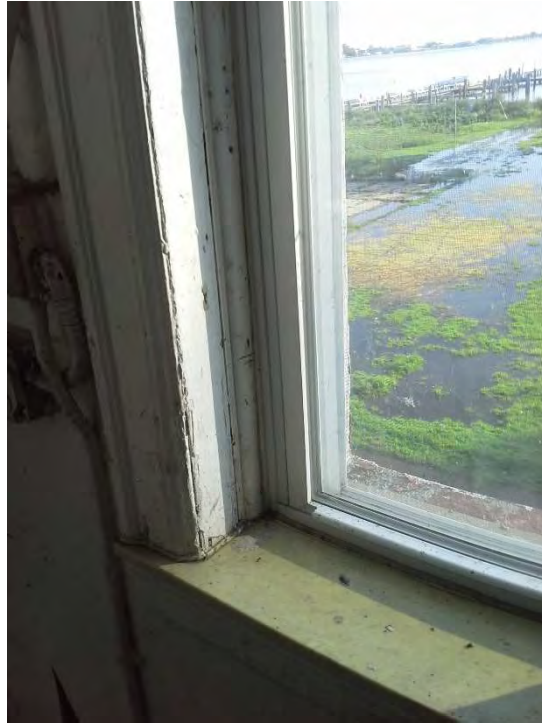
Photo 43 Modern Window in Original Frame

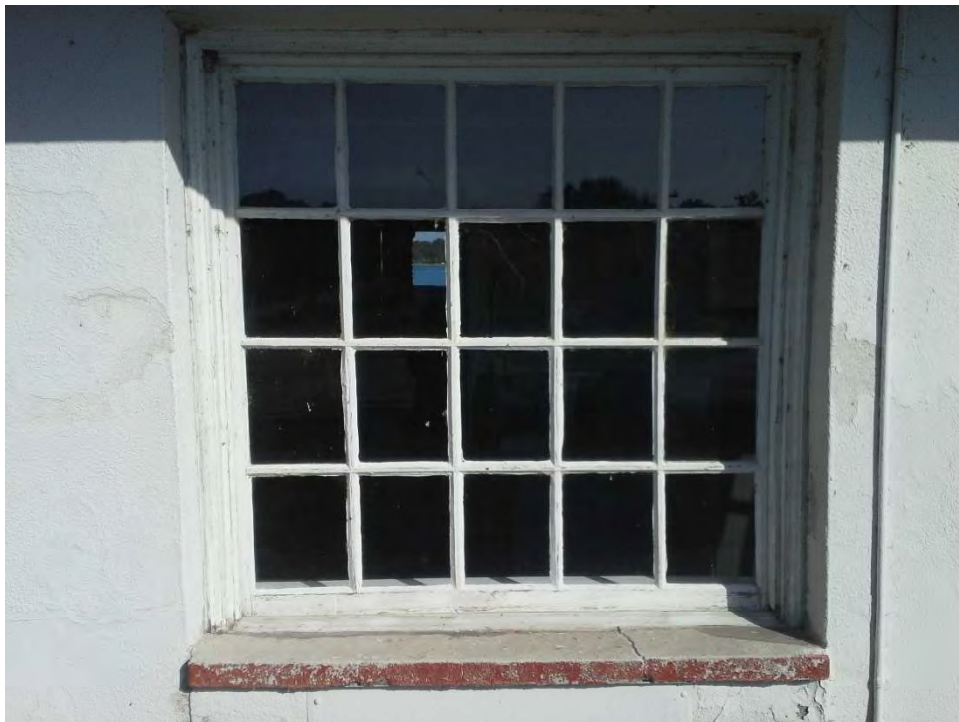
Photo 44 Single Pane Windows

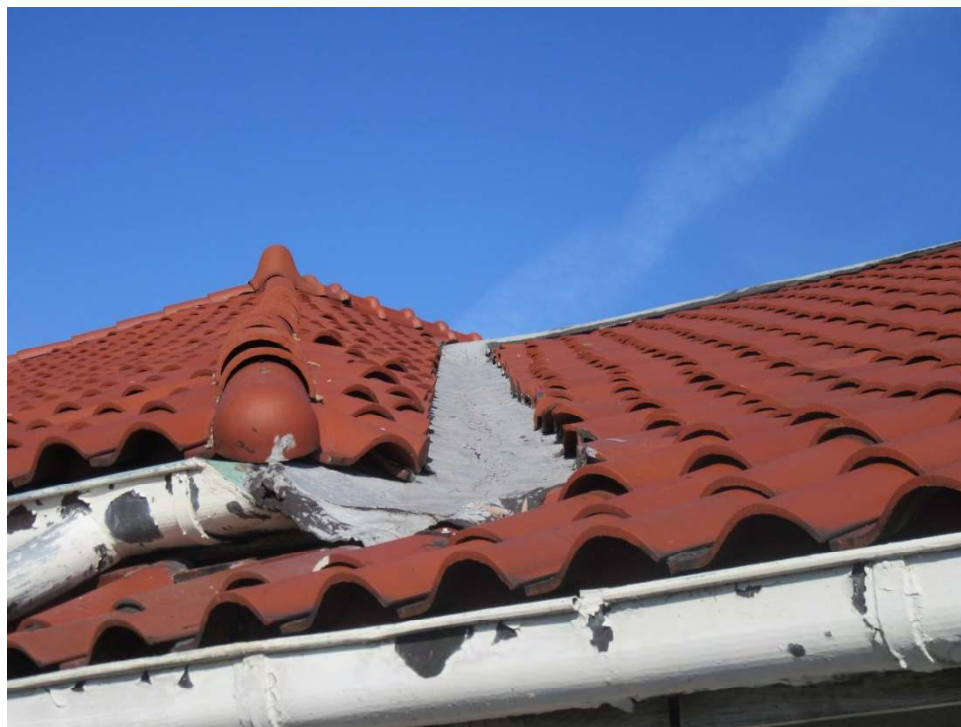
Photo 48 Mastic Over Valley Flashing

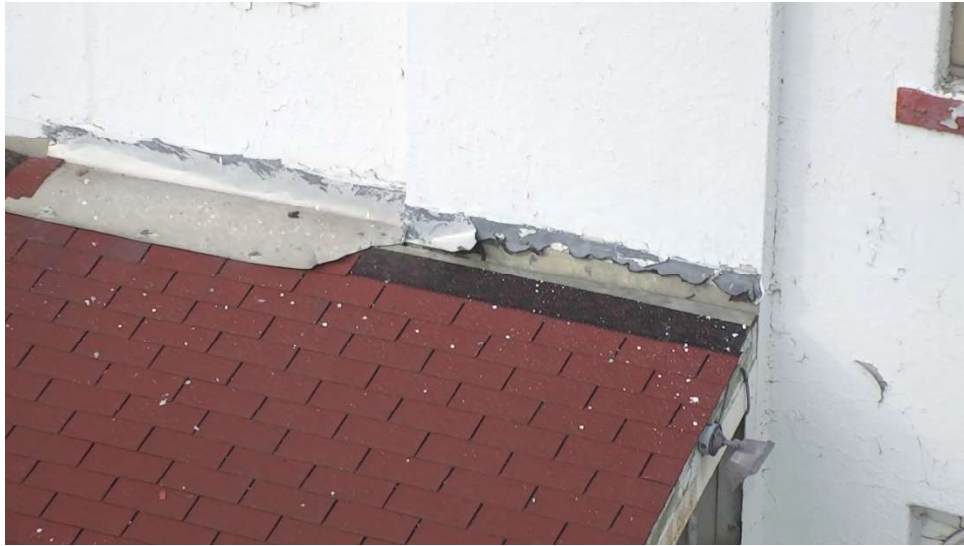
Photo 49 Shingle Roof

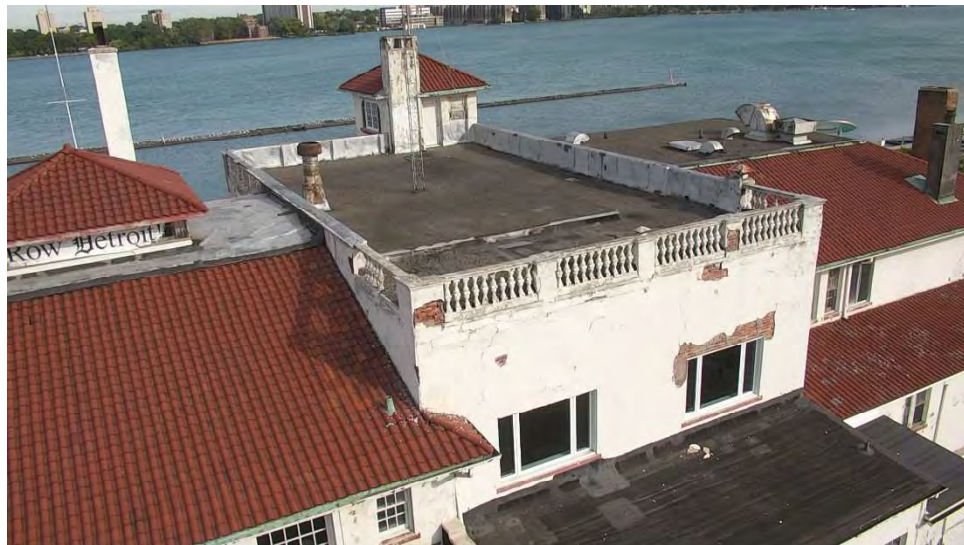
Photo 50 Upper Low Slope Roofs

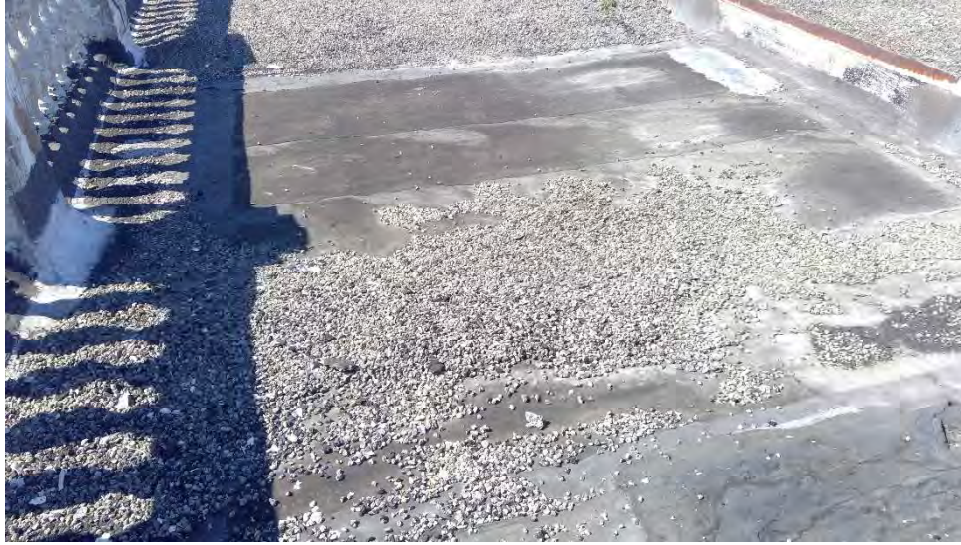
Photo 51 Multiple Roof Patches

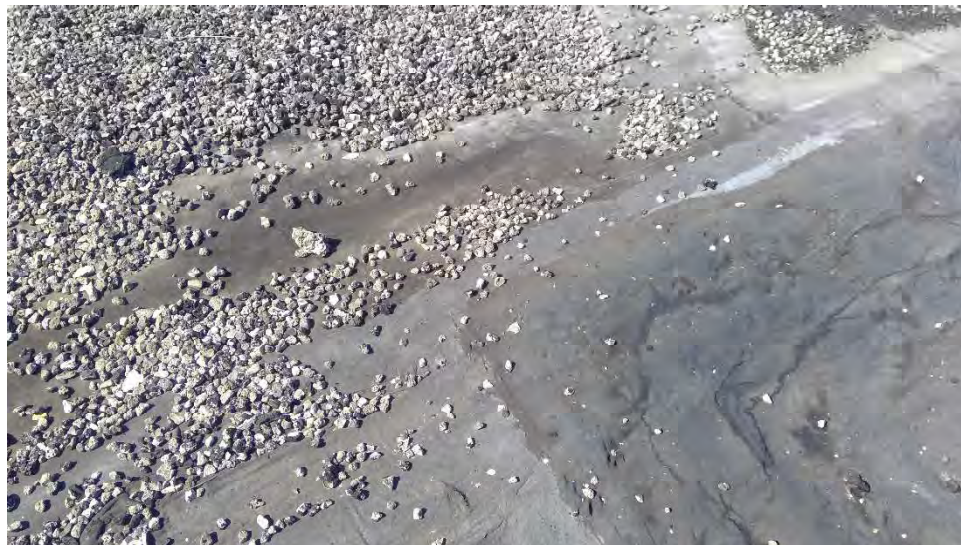
Photo 52 Scoured Roof Surface

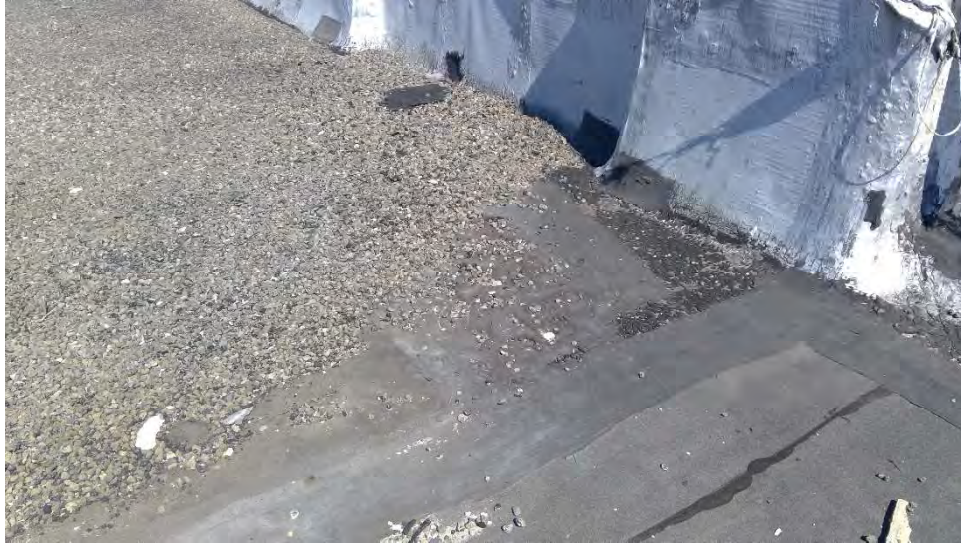
Photo 53 Exposed Reinforcing Fabric

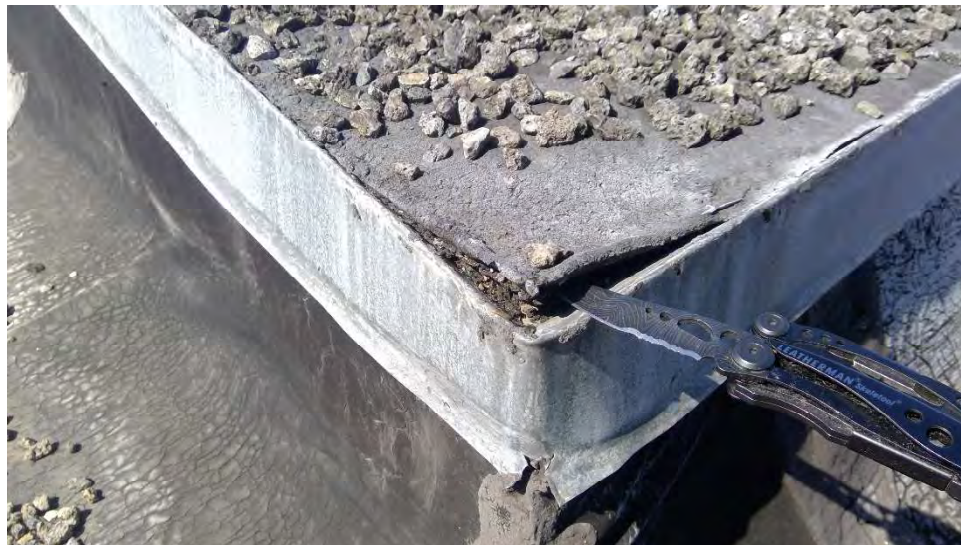
Photo 54 Alligating and Disbonded Roofing

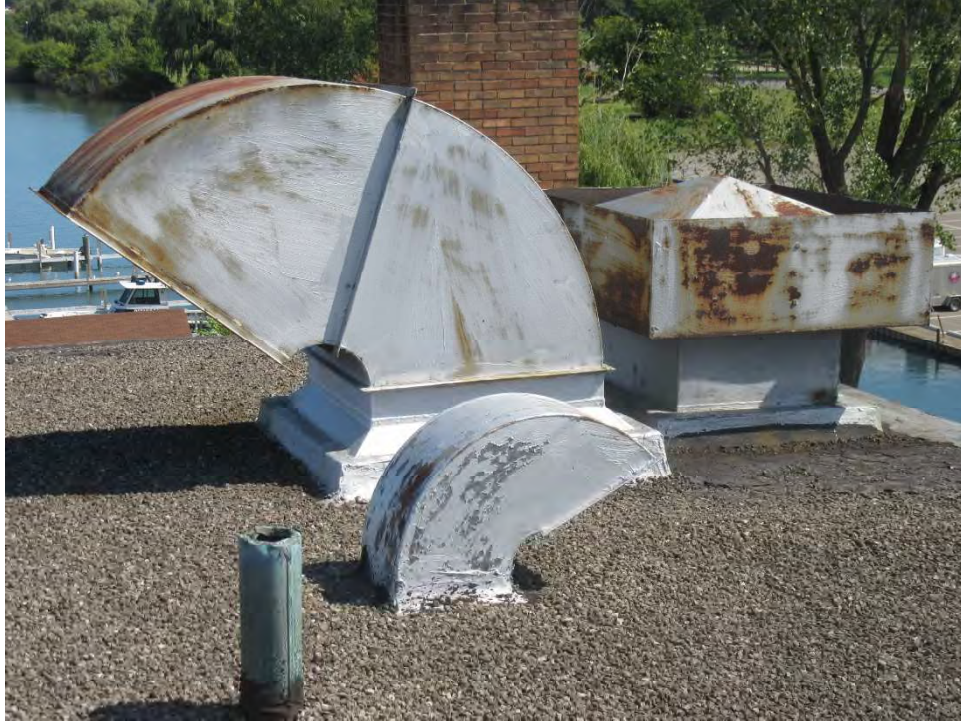
Photo 55 Roof Penetrations

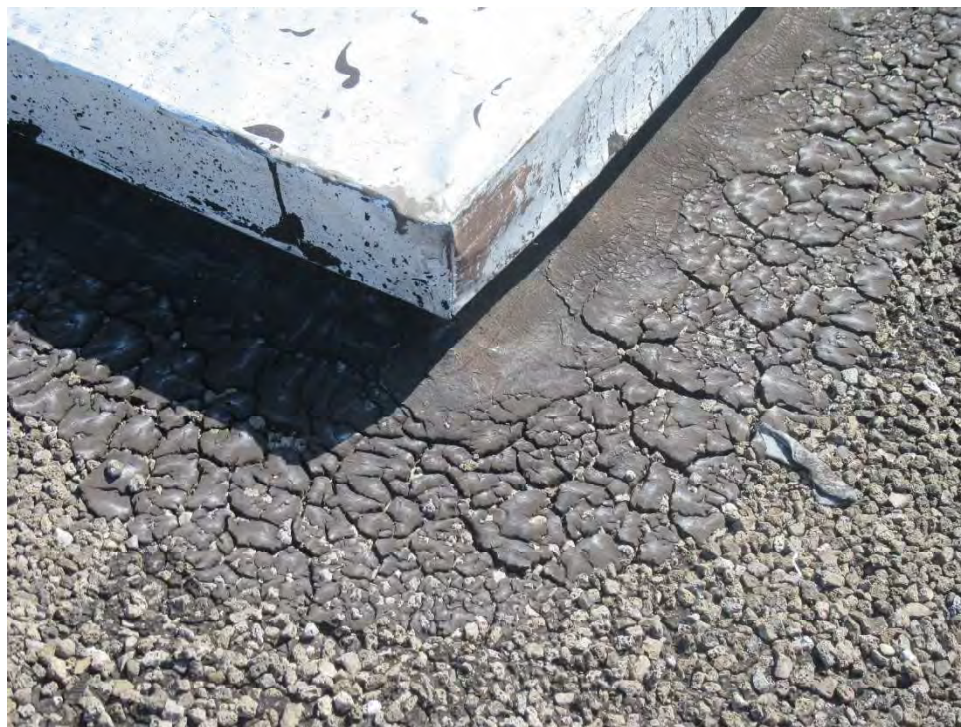
Photo 56 Damaged Flashing

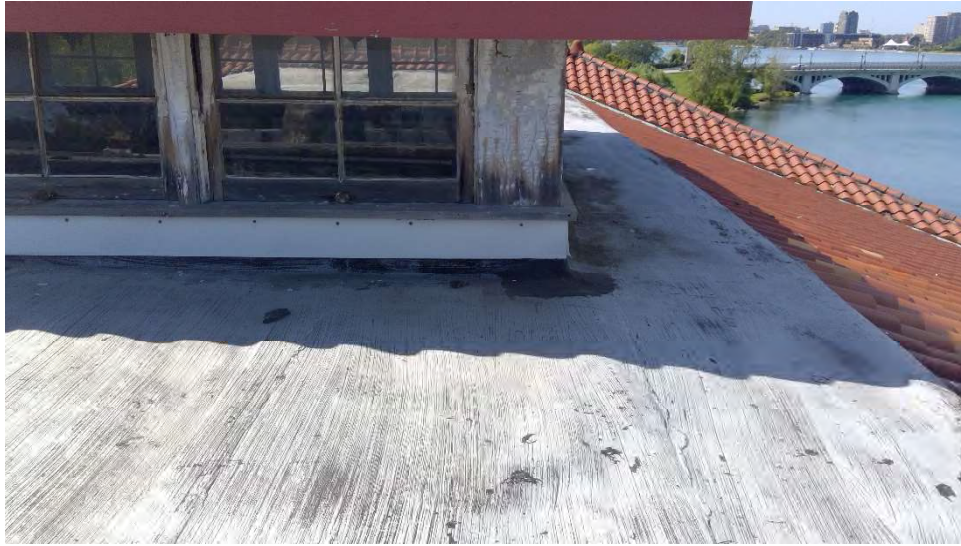
Photo 57 Aluminized Topcoat

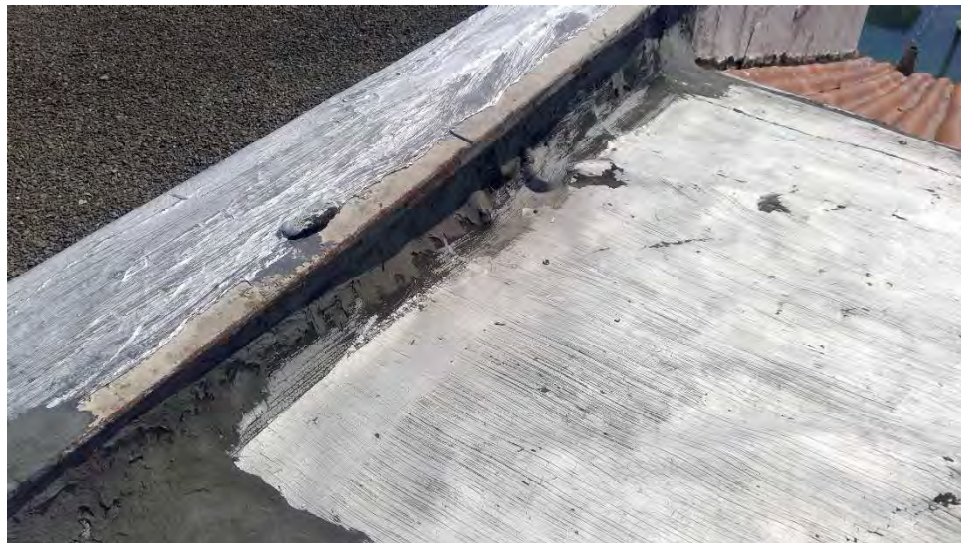
Photo 58 Poorly Flashed Parapet

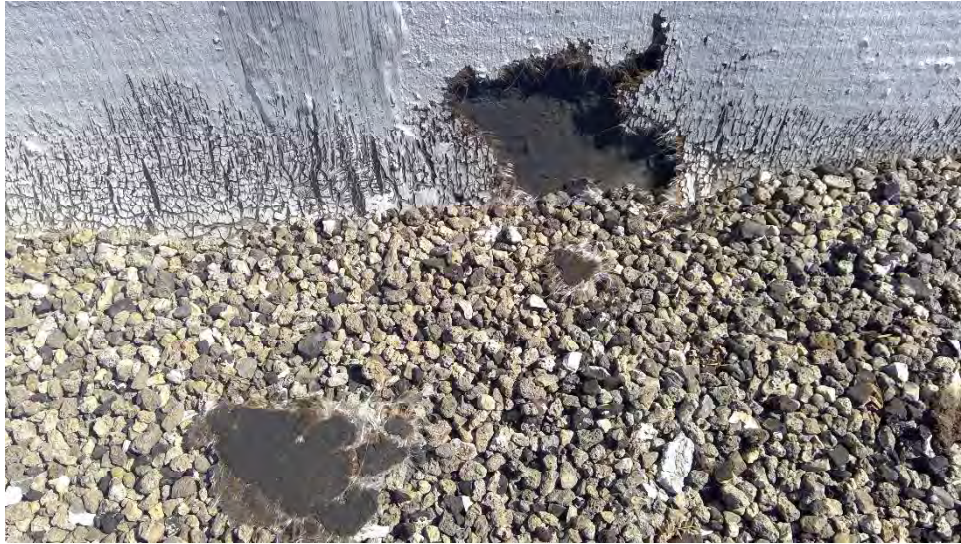
Photo 59 Hole in Flashing

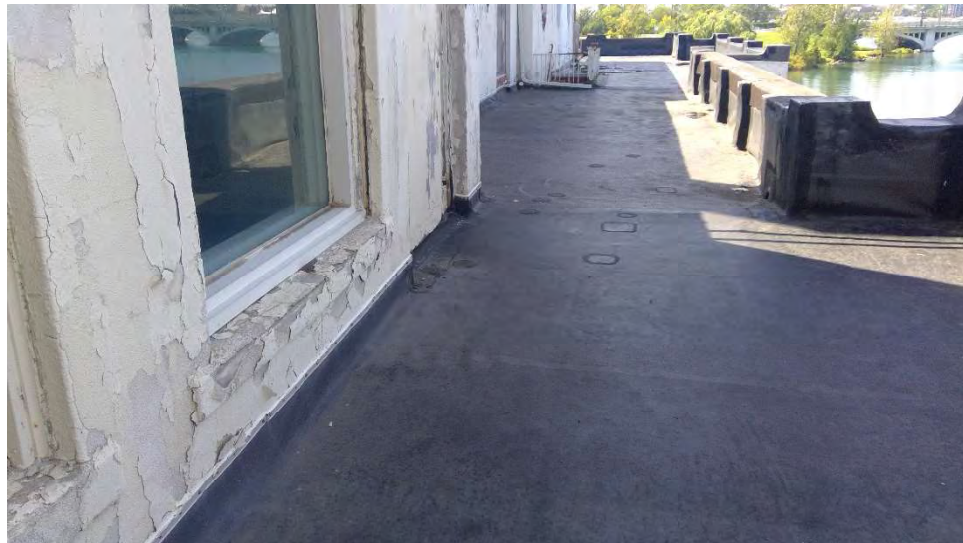
Photo 62 Third Floor Terrace with EPDM

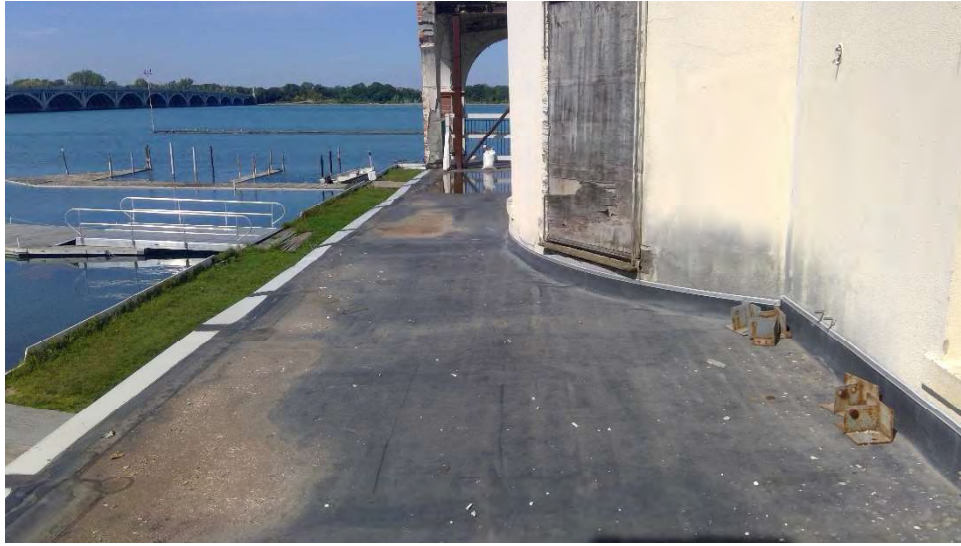
Photo 67 Detailing is More Akin to a Temporary Roof

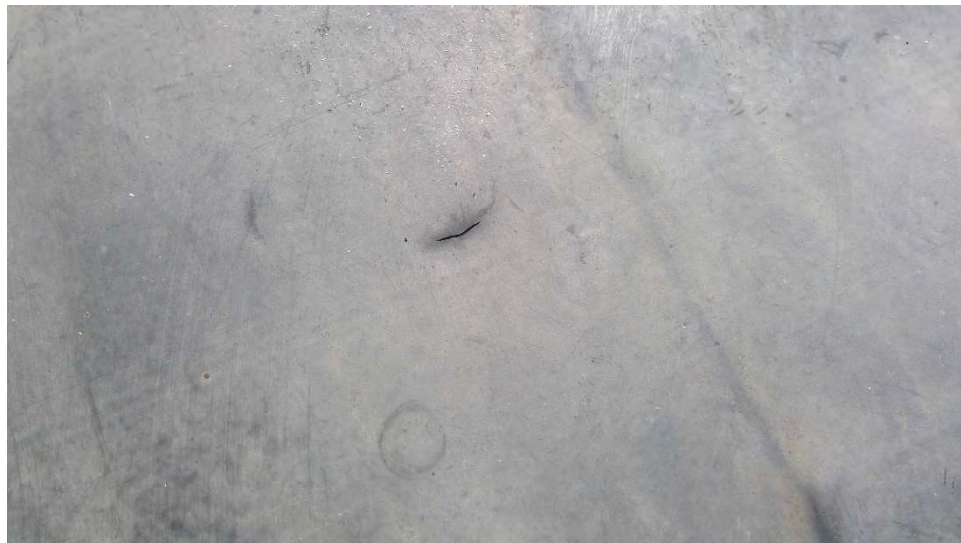
Photo 68 Hole in Membrane

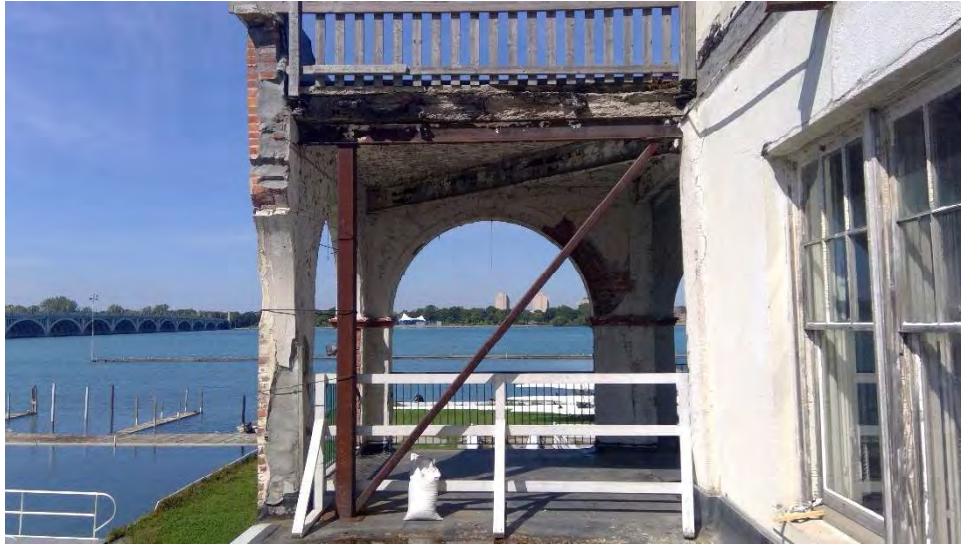
Photo 69 Shoring at End of Demolition

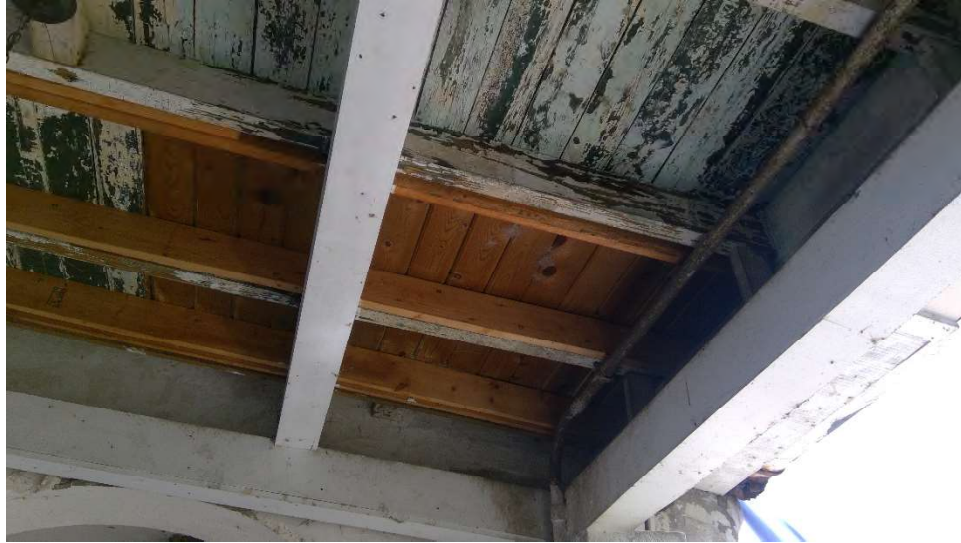
Photo 71 Roof Deck Repair

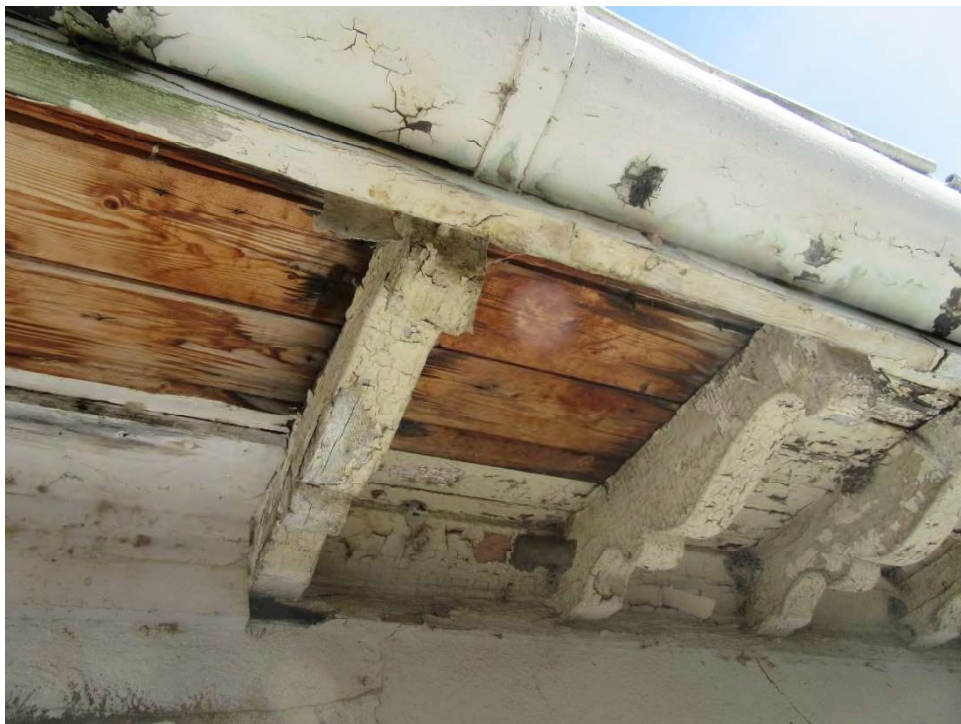
Photo 72 Roof Deck Repair with Staining

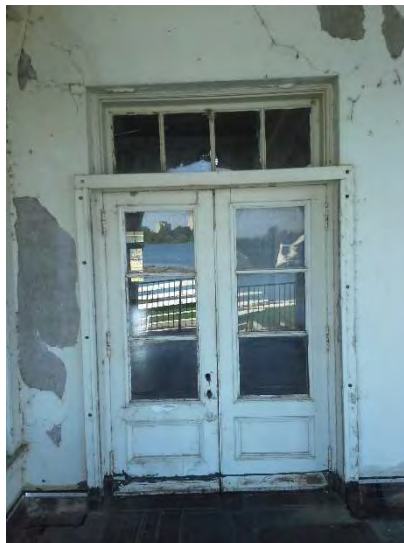
Photo 74 Wood Doors at Ballroom (North)

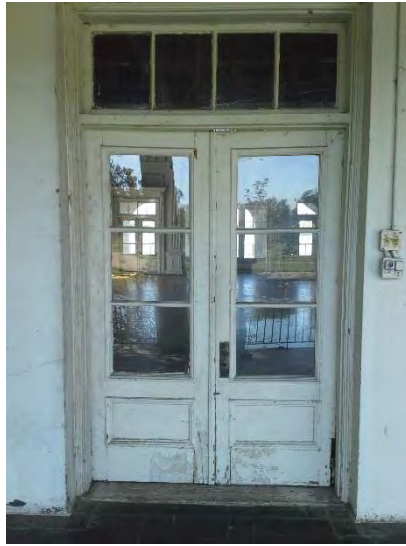
Photo 75 Wood Doors at Ballroom (South)

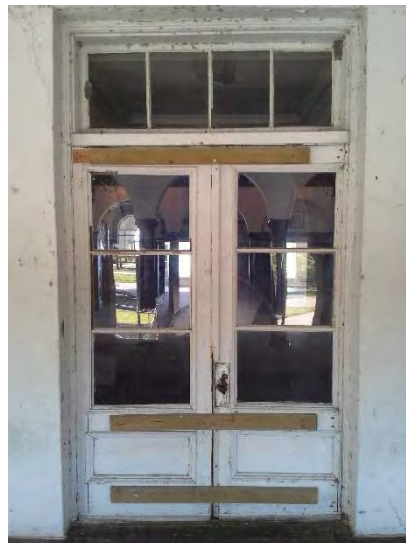
Photo 76 Boarded Up Doors at Entry Hall

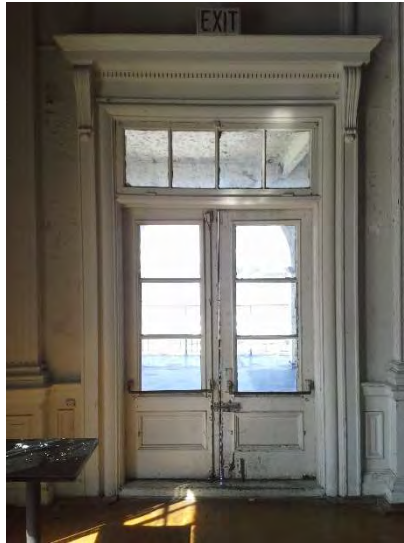
Photo 77 Door from Ballroom

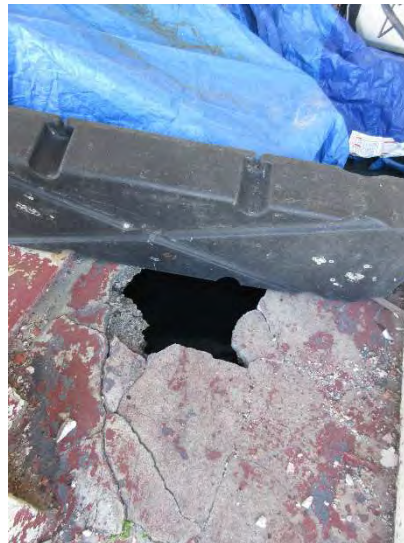
Photo 78 Hole in Pool Deck Below Northeast Terrace 2016

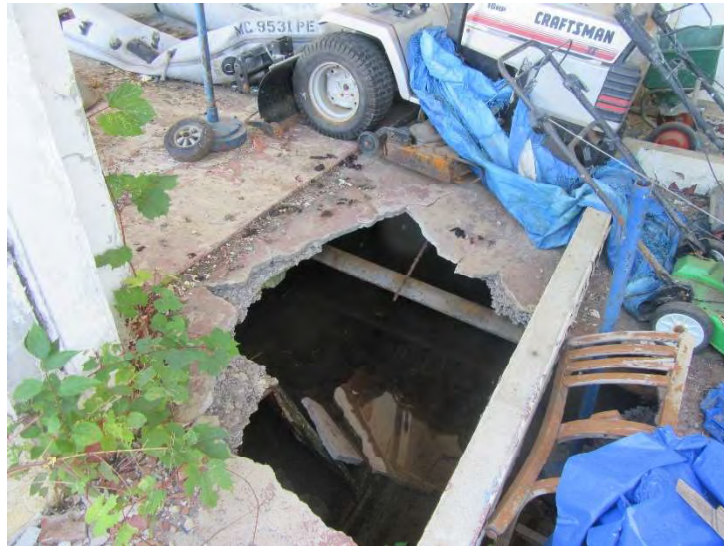
Photo 79 Hole in Pool Deck Below Northeast Terrace 2019

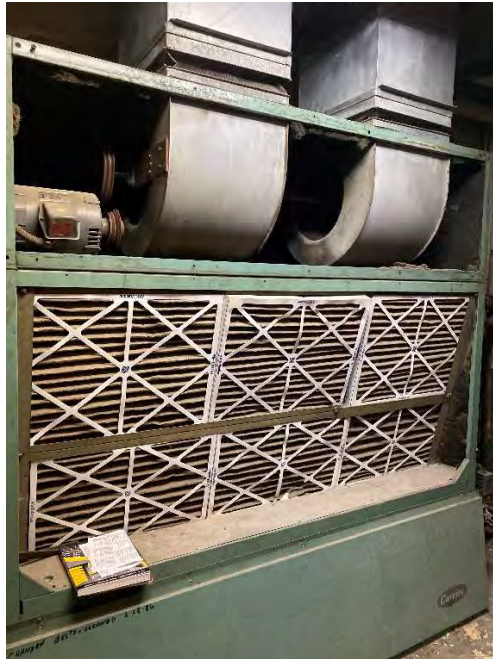
Photo 1

A portion of the second floor has a ducted air distribution from an existing AHU. This unit is located in a closet on the second floor. It serves the dining areas and other various rooms on the second floor. This unit does not have ventilation air and is not in operation.

- Air Handling Unit serving second floor [Photo 1].
- Air Handling Units in attic space [Photos 2,3].
- Exhaust Fans in Ballroom [Photo 4]

It is recommended to remove all existing Air Handling systems and replace with new central Air Handling Units for all spaces. The new units would be variable volume, chilled water cooling and hot water heating. Zoning and quantity of units to be determined. These units would bring ventilation air into each space in accordance with code/occupancy requirements.

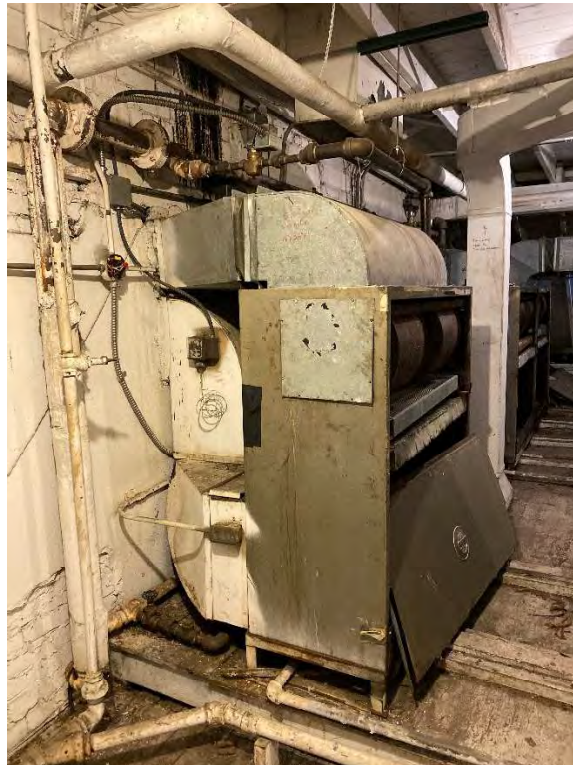
Photo 2

There are 3 sets of dual fan AHUs located in the attic space. These units serve various rooms on the third floor. These units do not have ventilation air and are not in operation.
