Phase 100 – Phase 1 and Phase 2
Exterior Structural Conditions and Cost Assessment

Belle Isle Boathouse Detroit, Michigan

File No. 751/22346.SMD
WTA Project No. 2022039
September 29, 2022

Phase I Structural Report

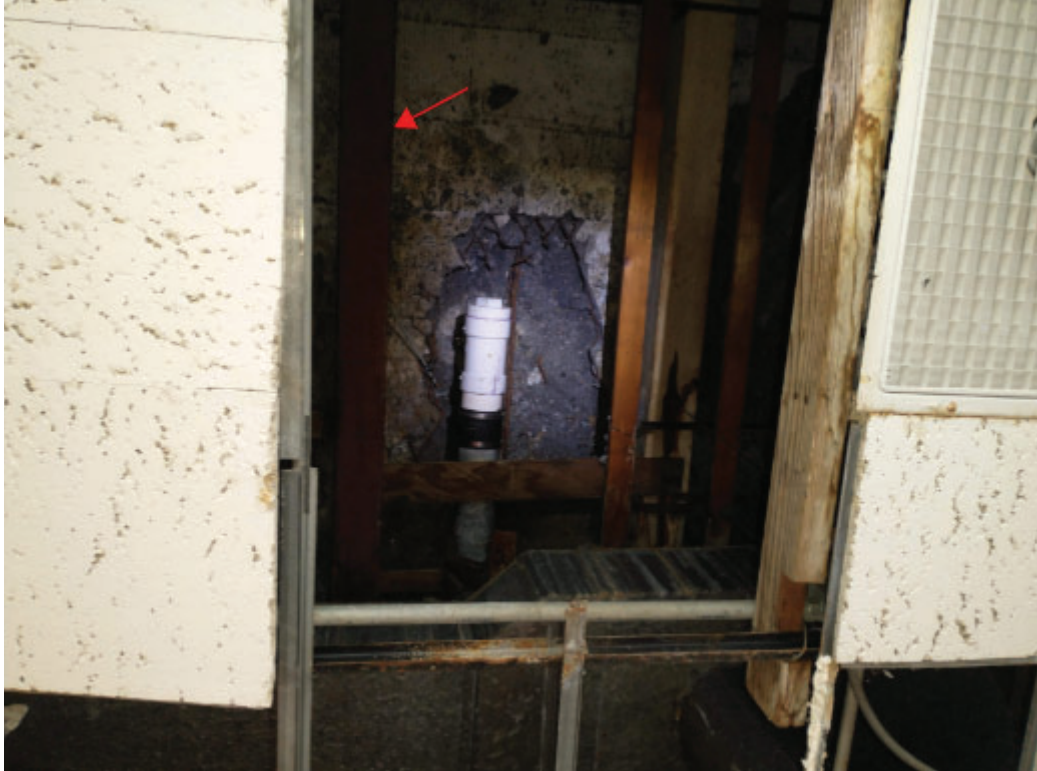
The flat concrete roof slab over Lounge 319 exhibits rusting rebar and mesh along with spalled concrete. It appears that newer beams were added sometime after original construction in order to reinforce this slab. The rusting reinforcing mesh was not repaired. Long term leaking of the roofing in this area is likely the cause for the damage. See Photo No. 1

Photo No. 1 – Roof slab above Lounge 319. Rusted reinforcing and spalled concrete. Note newer red steel.

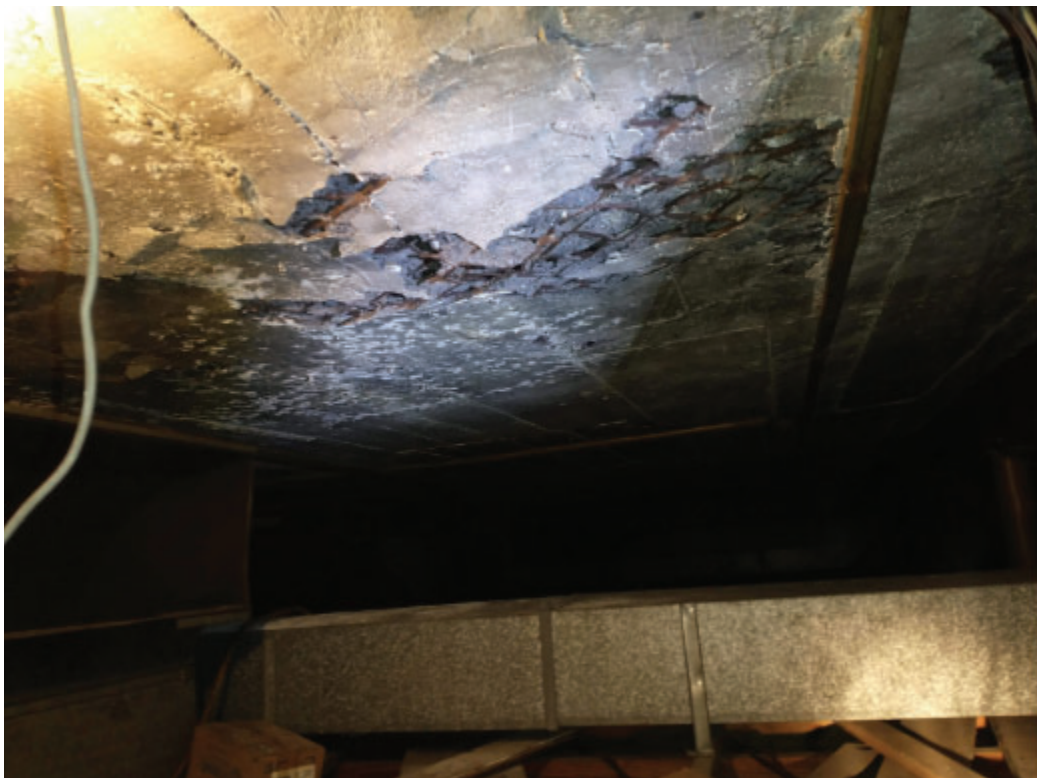
The flat concrete roof slab over the Bar 318, exhibits rusting rebar and mesh, along with spalled concrete. This is visible through a wall hatch at the top of the stairs to the attic. See Photo No. 2.

Photo No. 2 – Roof slab over Bar 318.

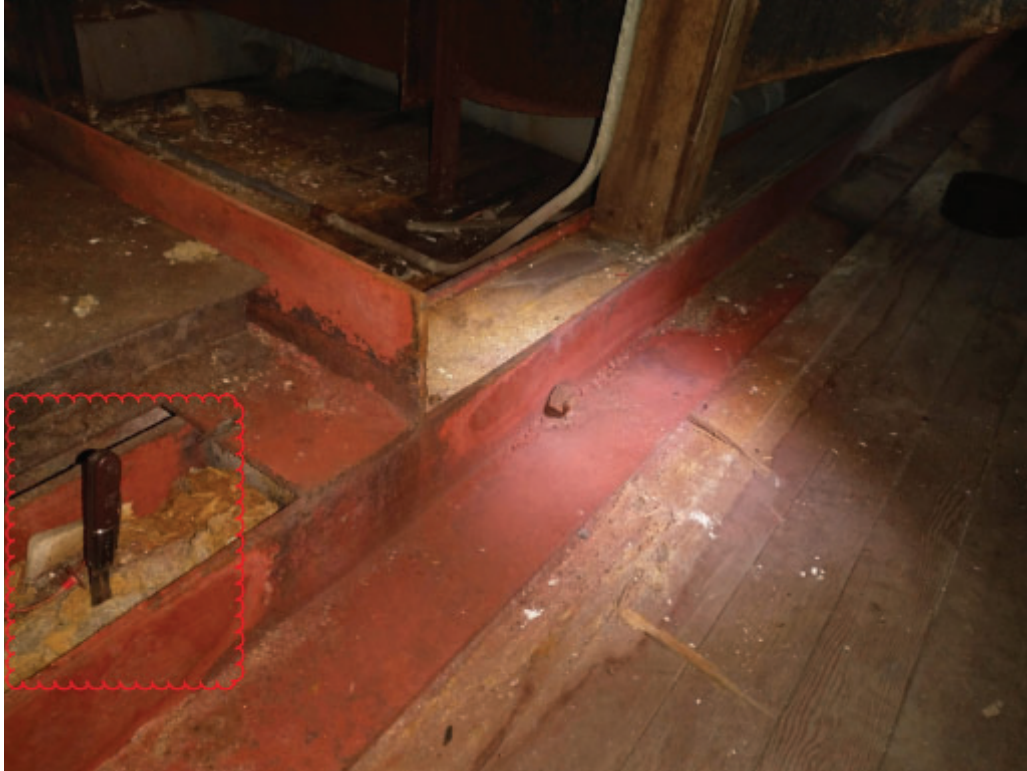
There is rotted wood noted at the bottom chord of a truss located in the attic over Conference Room 309. Steel angles have apparently been added in order to reinforce the rotted member. The ceiling in the Conference room appears flat, with no indications of continuing excessive deflection. See Photo No. 3.

Photo No. 3 – Bottom chord wood truss over Conference Room 309. Red steel reinforcement. Note knife in rotted wood.

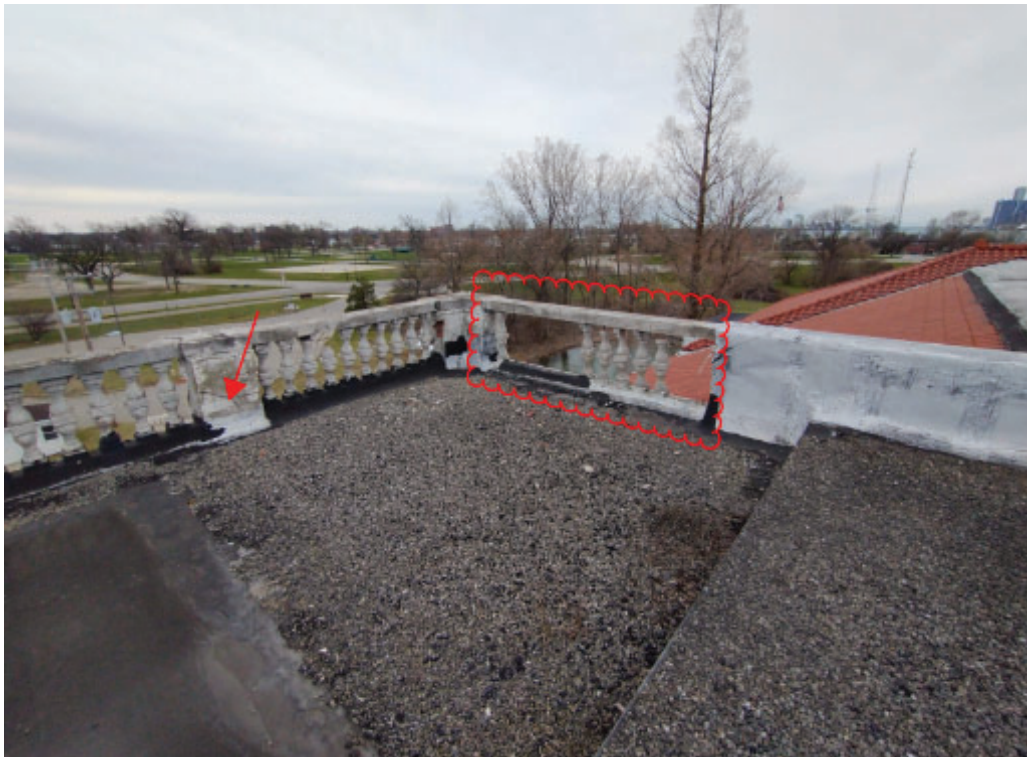
The concrete railing at the flat concrete roof over Room 319 is severely deteriorated. There are also several large holes in the roofing in this area. See Photo No. 4.

Photo No. 4 – Roof over Lounge 319. Deteriorated railing and posts.

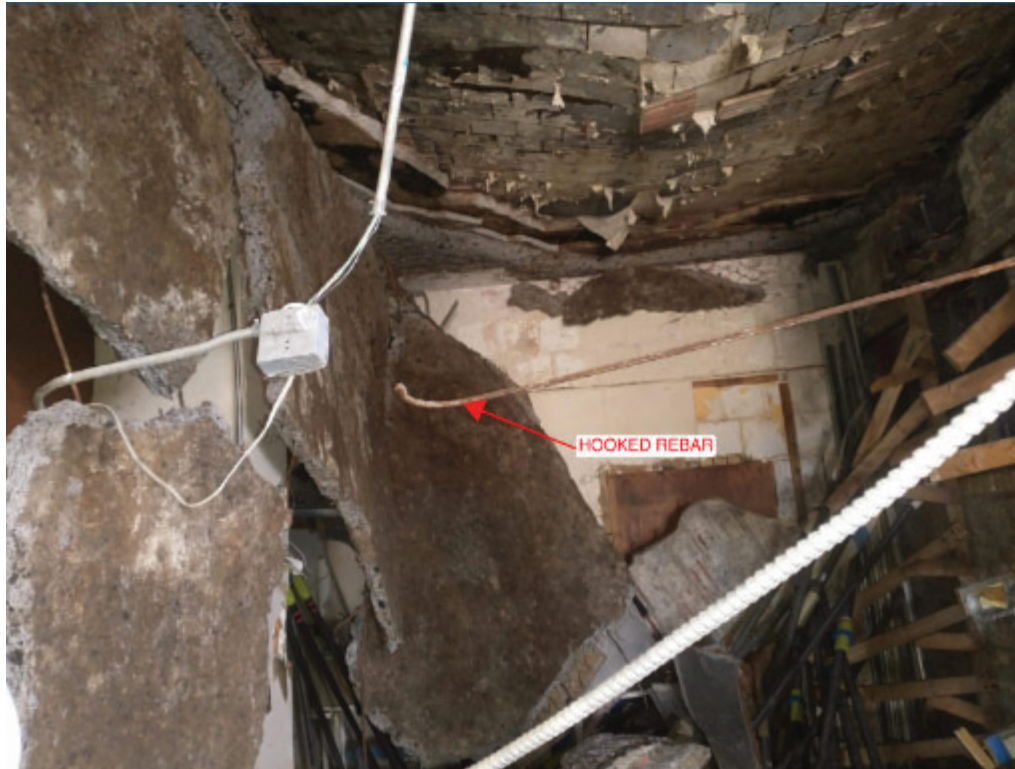
A portion of the west terrace slab collapsed recently. The slab appears to have failed at the exterior end and rotated against the main building wall. The slab remains hung there by the hooked reinforcing bars. The terrace slab just to the north of this collapse was reportedly replaced in the 1950s. See Photo No. 9. The exterior wall at the west terraces was removed in 2015 due to excessive deterioration and leaning of the arched brick wall. See Photo No. 5 – 8.

Photo No. 5 – Failed west side terrace slab.

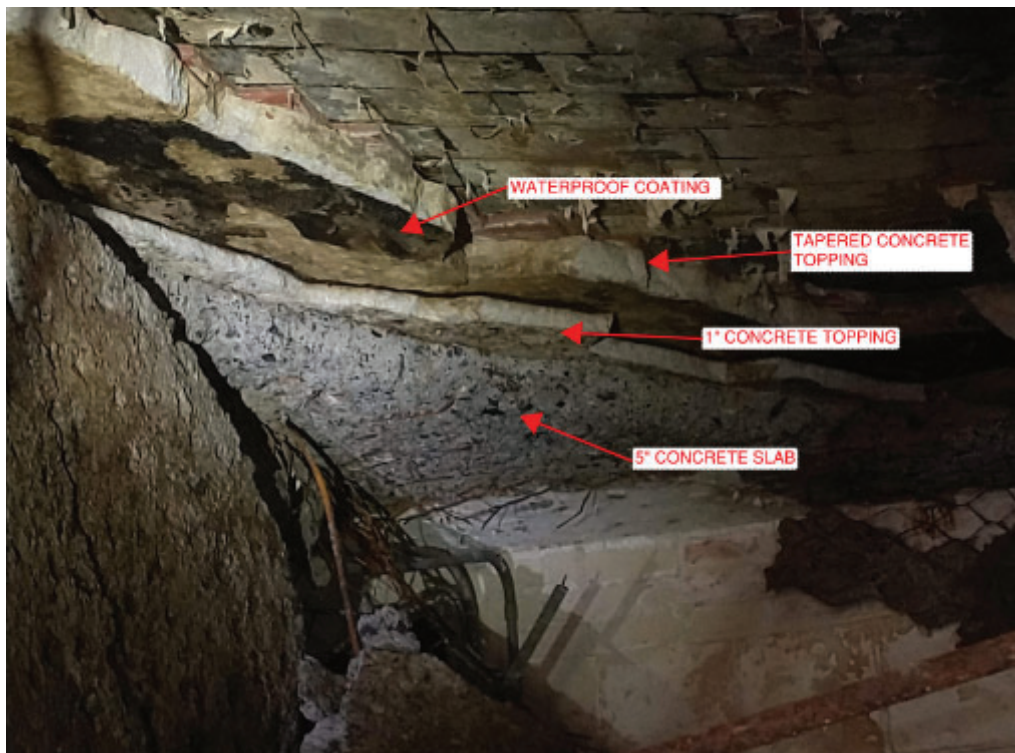
Photo No. 6 – Terrace slab layers.

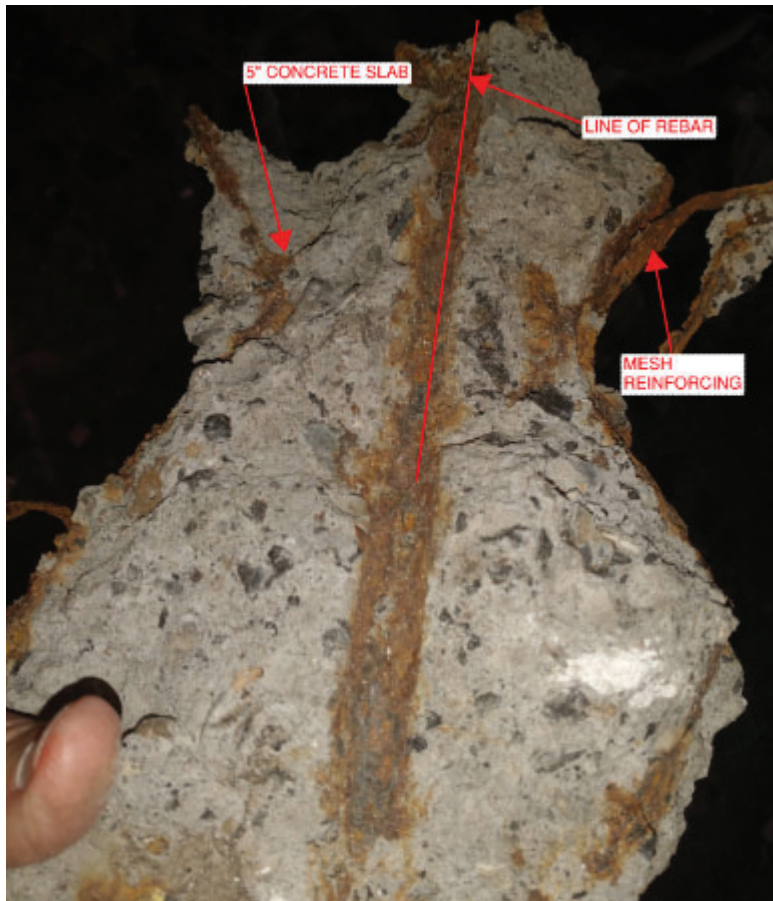
Photo No. 7 – Piece of terrace slab showing rust stain from a rebar and rusted steel mesh.

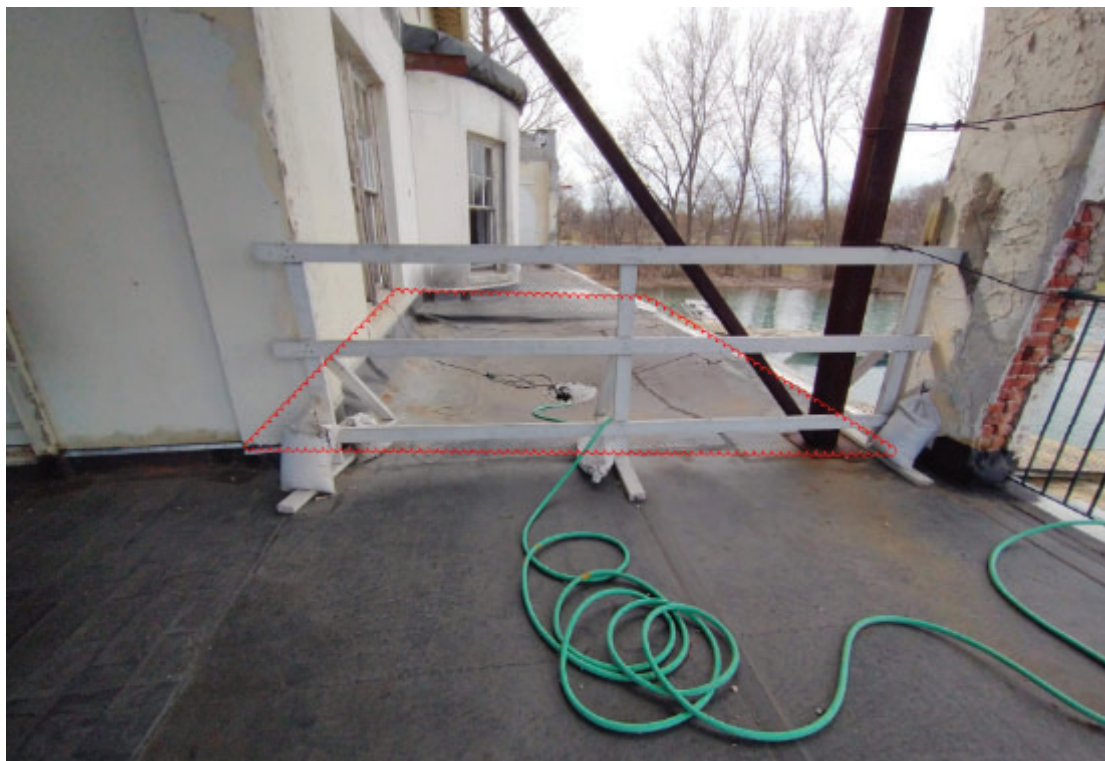
Photo No. 8 – Failed terrace slab viewed from topside.

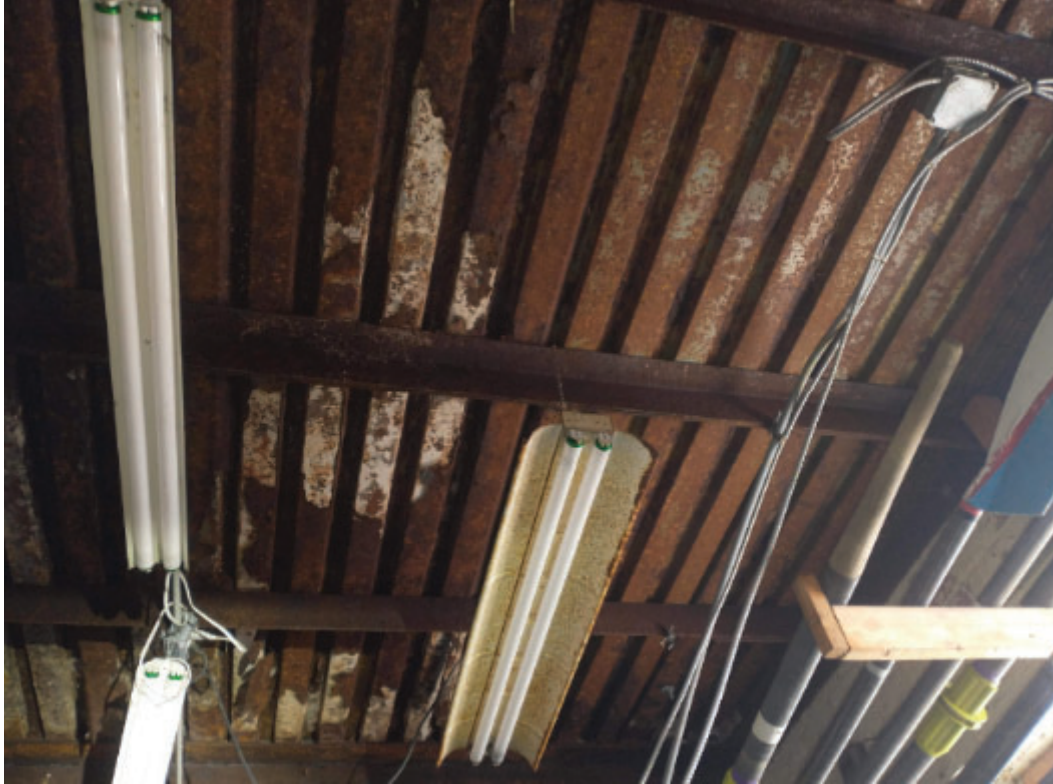
Photo No. 9 – Underside of 1950s replacement slab.

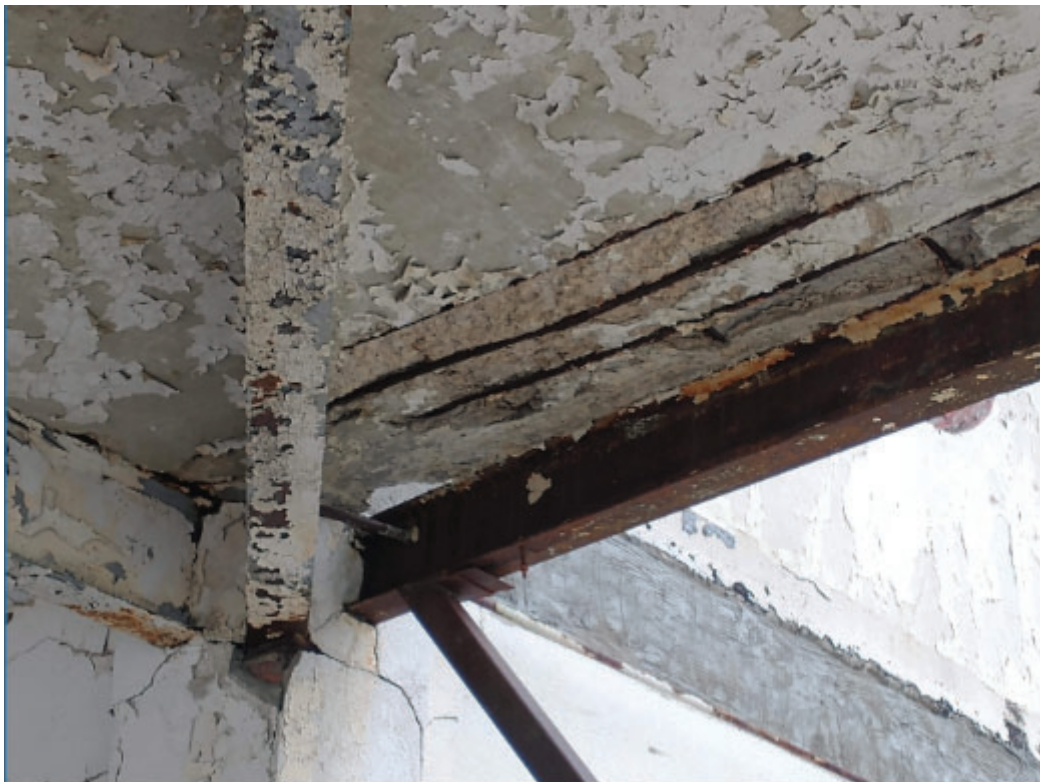
There is rusted rebar and spalled concrete at the terrace roof just north of the area of the recent deck collapse. See Photo No. 10.

Photo No. 10 – Terrace roof slab with rusted rebar, spalled concrete.

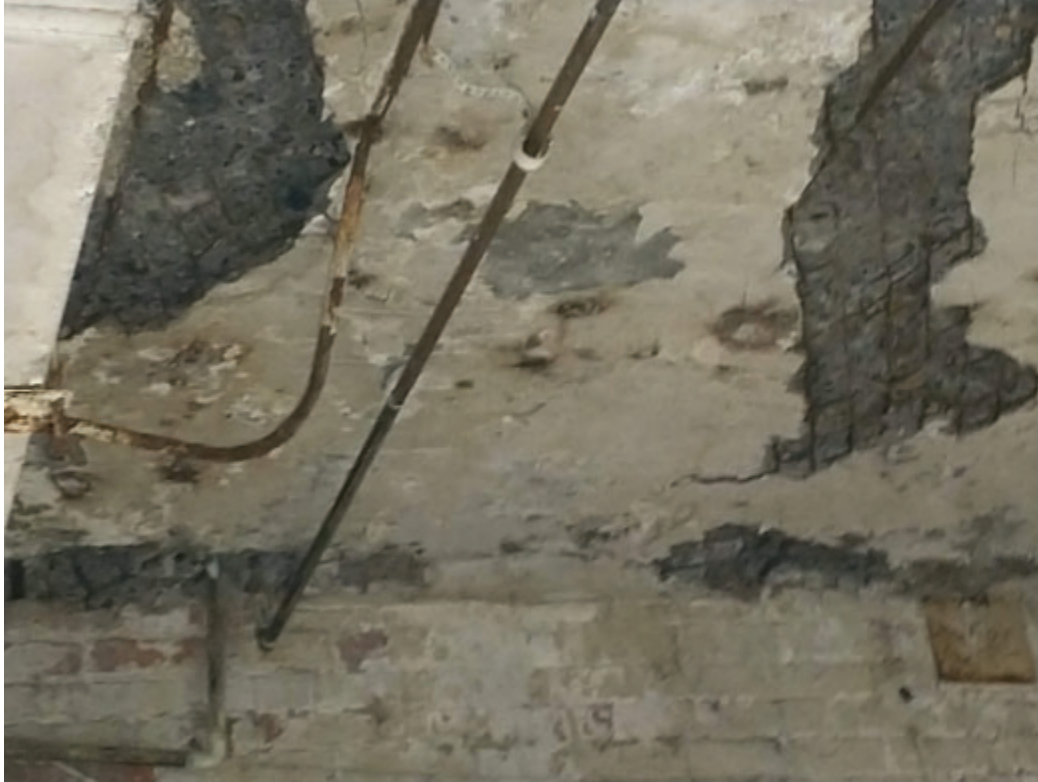
There is extensive rusting of the underside of the terrace slabs along with spalled concrete at the south, west, and north elevations of the building. The extent of deterioration appears to be most extensive at the west elevation above Boat Storage Room 109, but does exist at the underside of most terrace areas. See Photo No. 11 – 12.

Photo No. 11 – Underside of terrace slab.

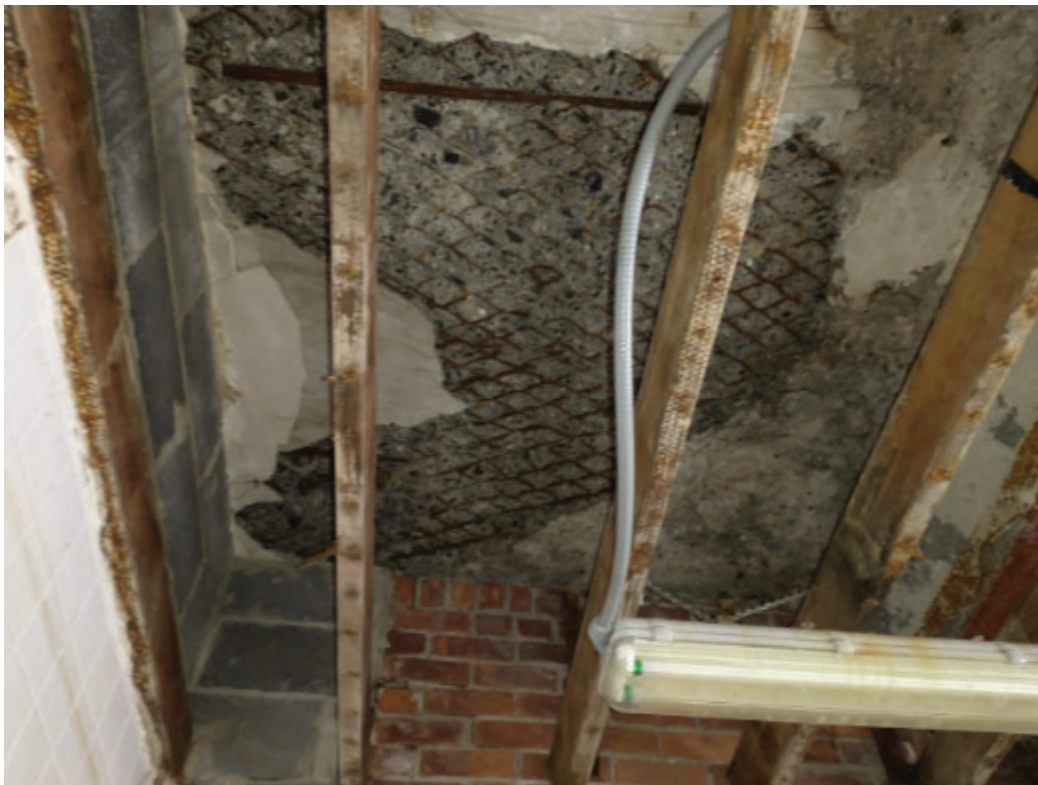
Photo No. 12 – Underside of terrace slab.

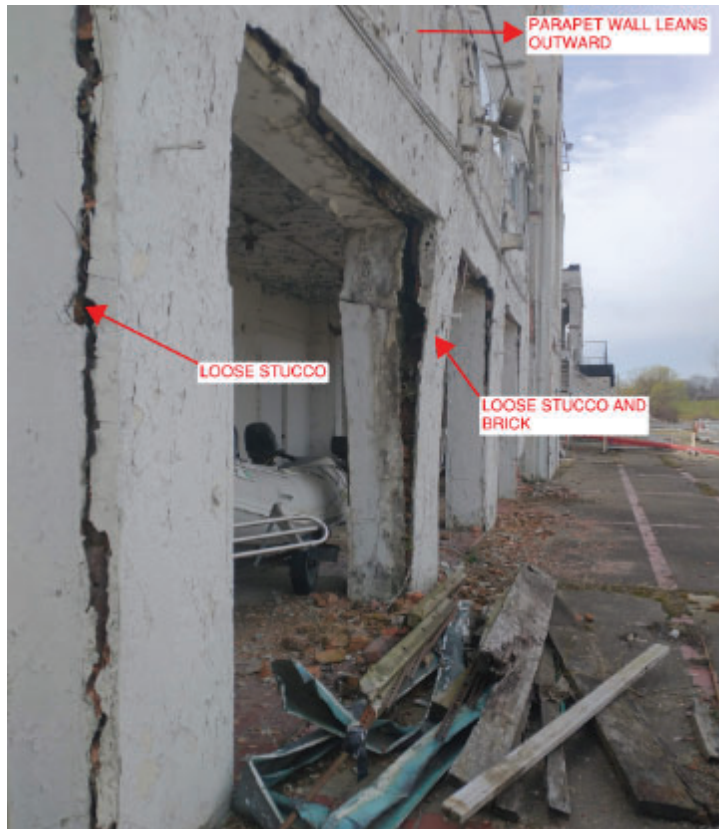
The exterior wall of the north terrace, east end is severely deteriorated and leaning outward. The stucco cover over the brick is loose. Much of the brick support columns are severely deteriorated, cracked and spalled. The parapet wall leans outward above the deck level. If this wall were to collapse, it would likely cause severe damage and possibly collapse of the adjacent main building wall. See Photo No. 13. The deck topping slab is severely cracked. The aluminum window and roof canopy framing are in very poor condition. See Photo No. 14. There is a large unprotected hole in the first floor below this terrace. See Photo No. 15.

Photo No. 13 – North terrace, east end, exterior wall

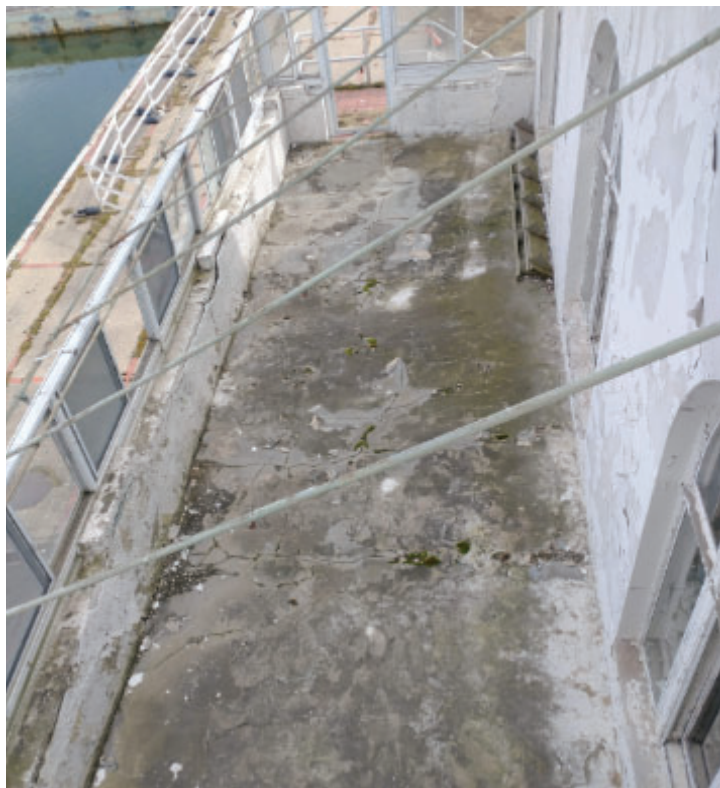
Photo No. 14 – North terrace, east end. Deteriorated concrete topping, loose canopy and screen wall framing.

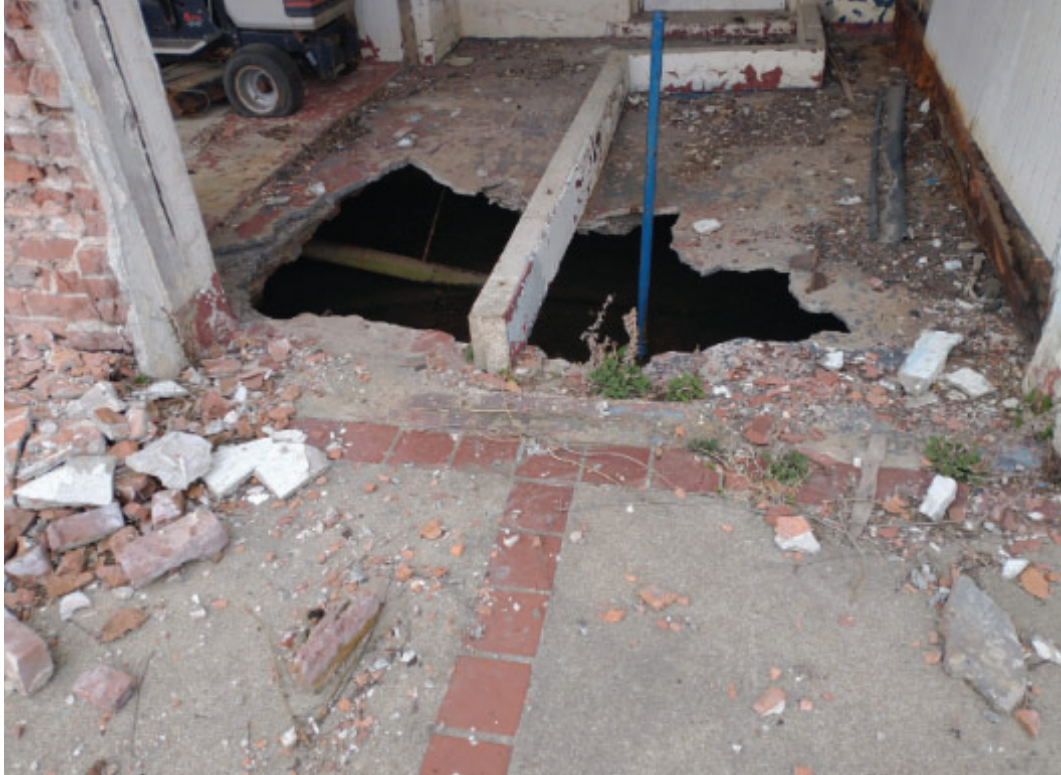
Photo No. 15 – Hole in first floor slab under the north terrace, east end.

5. Close 6 openings at eave/soffit area.				\$22,000
6. Repair roof structure damage at the center flat roof area.	\$50,000	\$10,000	\$8,000	\$68,000
9. Cover hole in 1st floor slab Under North Terrace, East End.	\$15,000	\$4,000		\$19,000

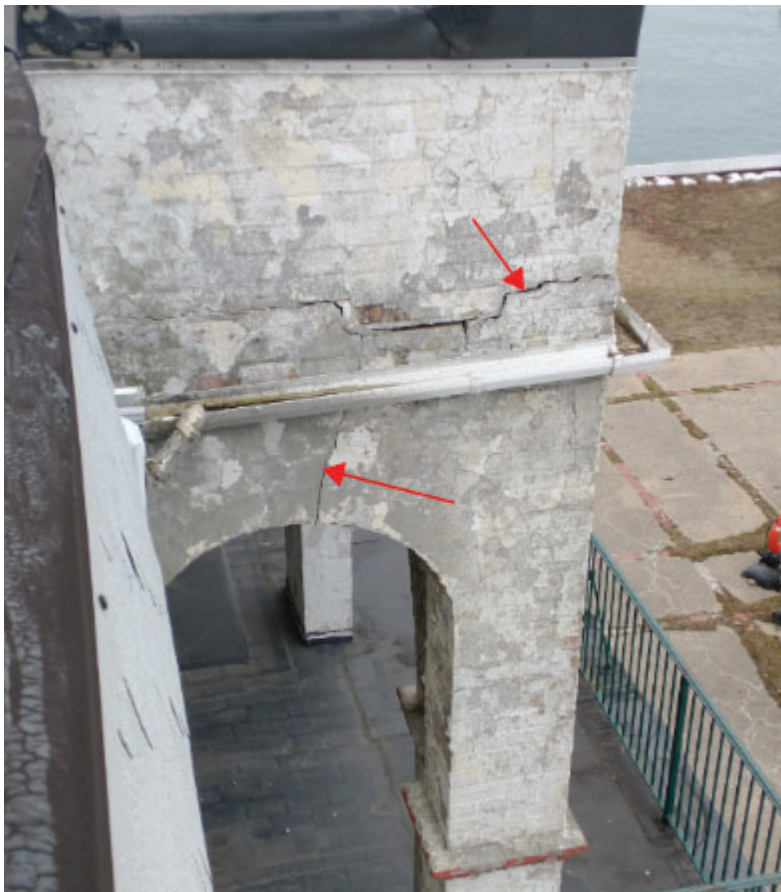
There is a horizontal crack at the terrace roof level at the north elevation, west end. This may be an indication of problems with the parapet wall in this area. See Photo No. 16.

Photo No. 16 – Cracked brick masonry.

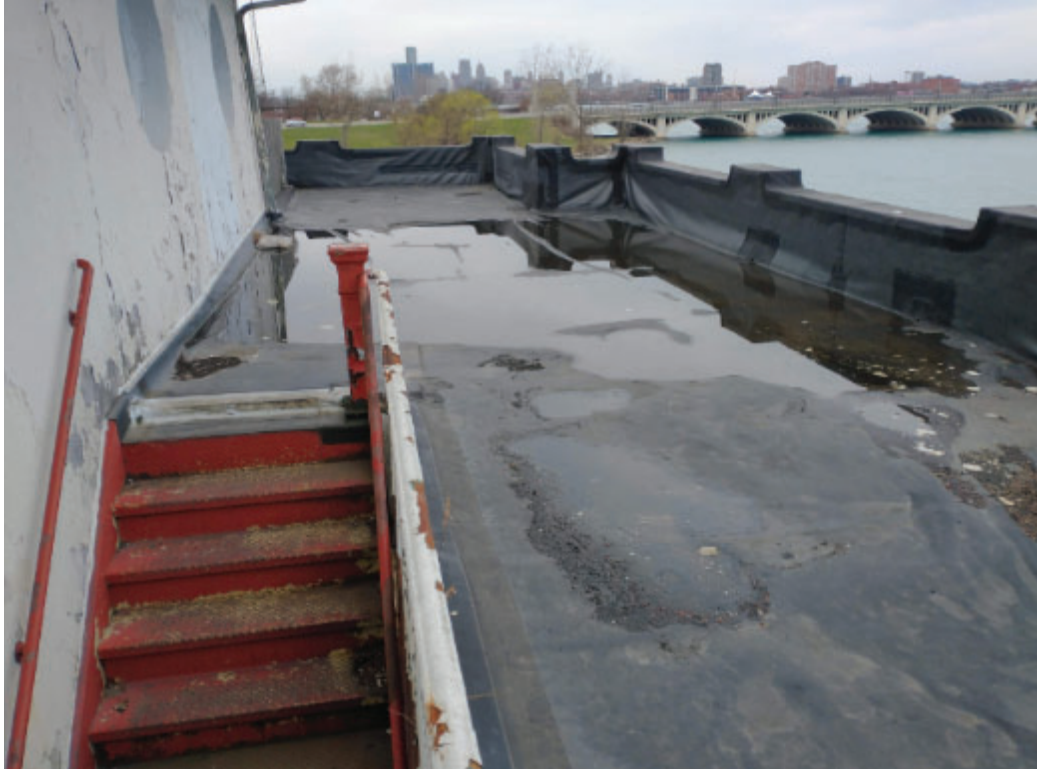
There are several inches of ponded water at the roofs of the terraces at the north elevation. These could be indications of excessive deflection and distress of these roofs. See Photo No. 17.

Photo No. 17 – Ponded water at the north terrace, west end.

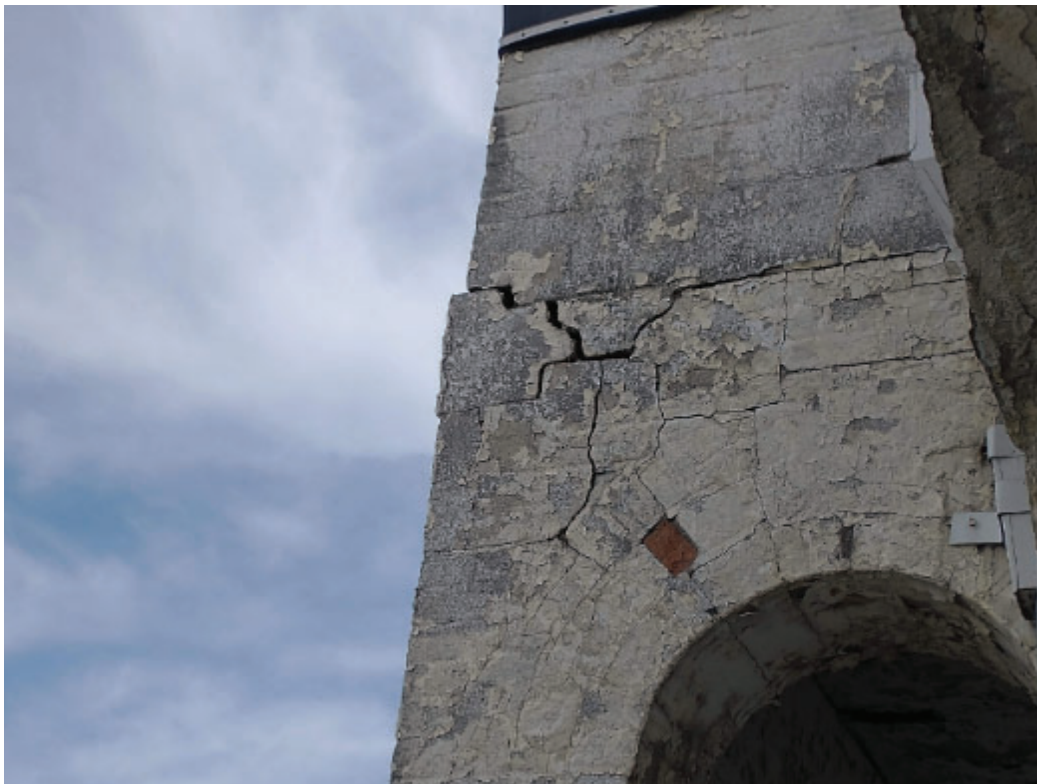
There are a number areas of the building where the exterior stucco and brick are severely deteriorated. Several brick arches have vertical cracks at the top of the arch opening. The end of several steel lintels bear on masonry where much of the brick has spalled off leaving a reduced support area. Many of these steel lintels are severely rusted. See Photo No. 18 – 22.

Photo No. 18 – Distressed masonry.

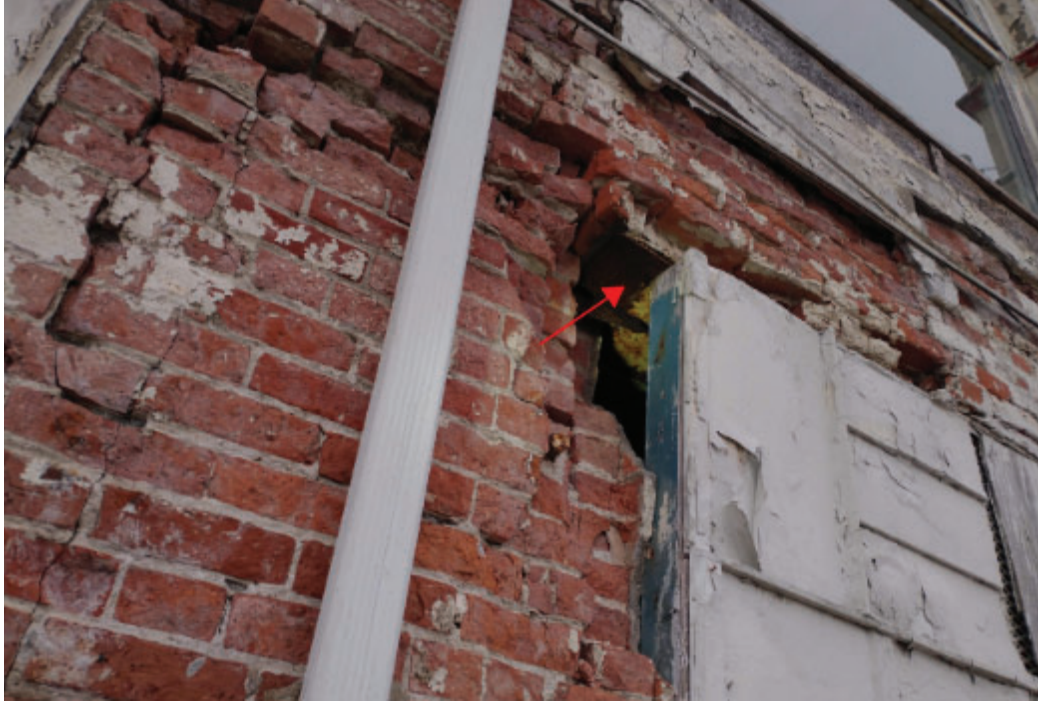
Photo No. 19 – Deteriorated masonry, brick missing at steel bearing.

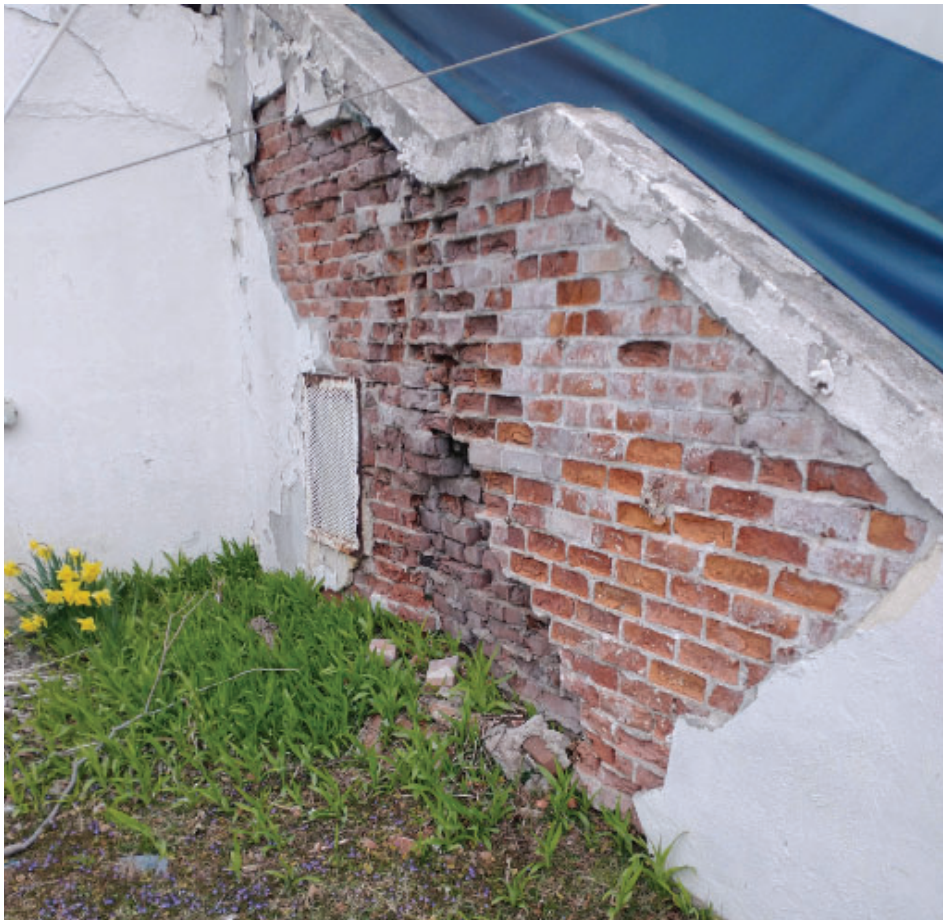
Photo No. 20 – Deteriorated masonry at south main entrance.

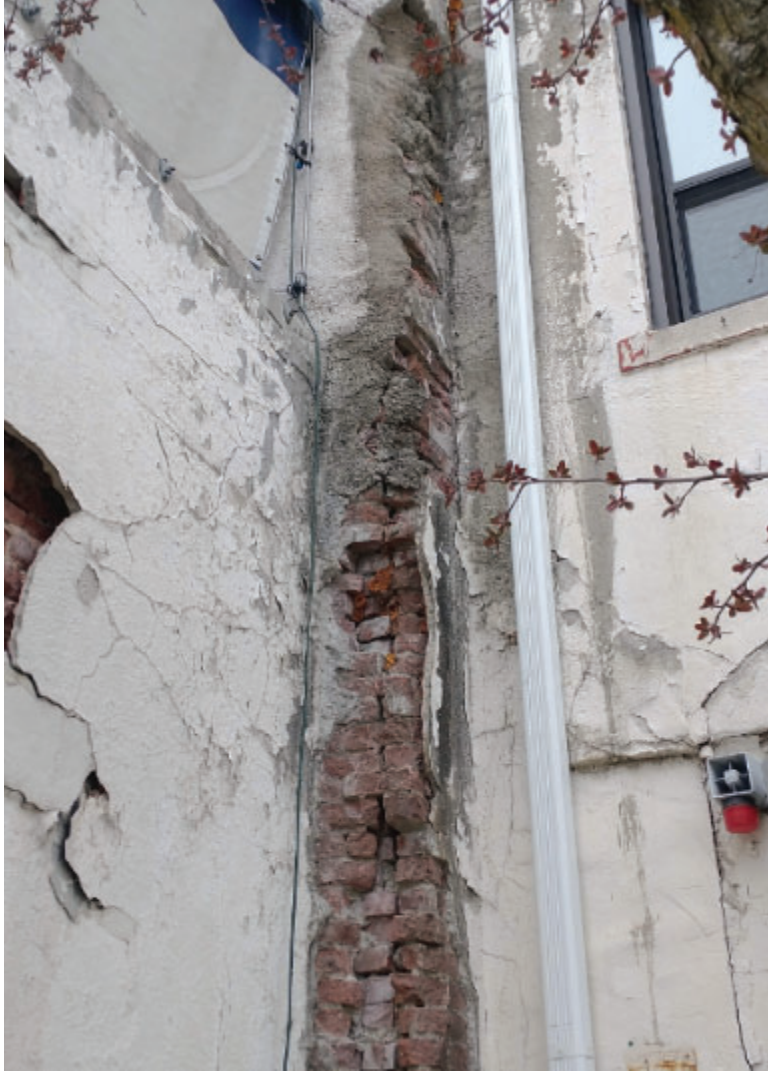
Photo No. 21 – Deteriorated brick masonry near south main entrance.

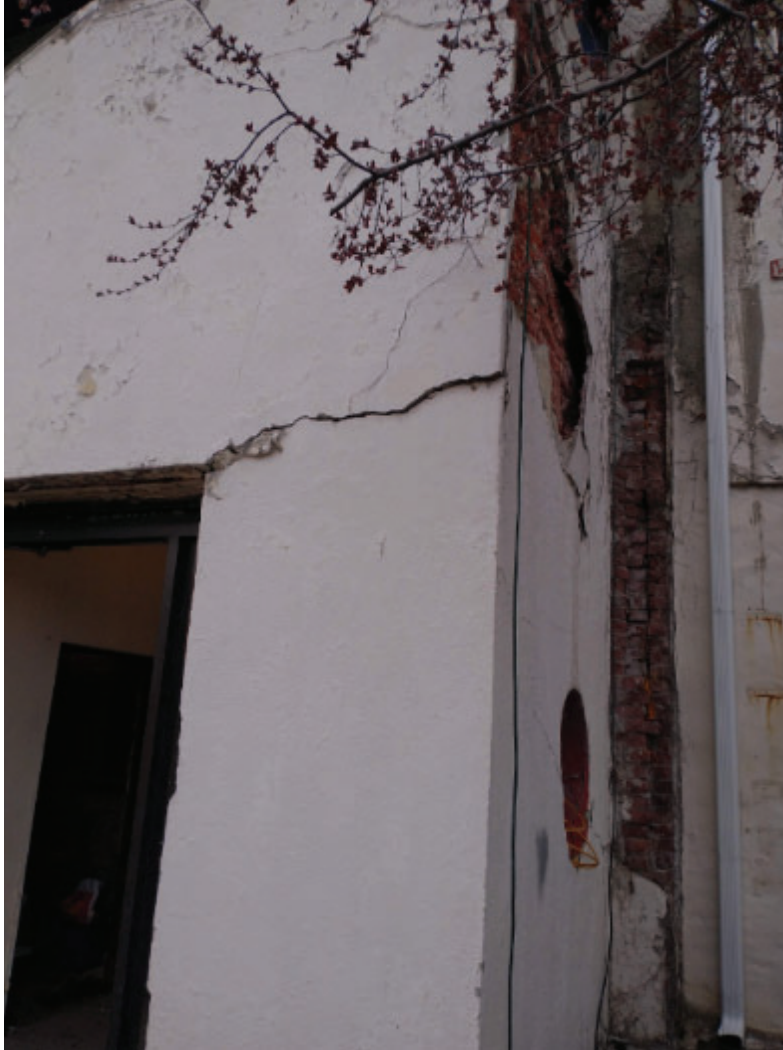
Photo No. 22 – Cracked stucco.

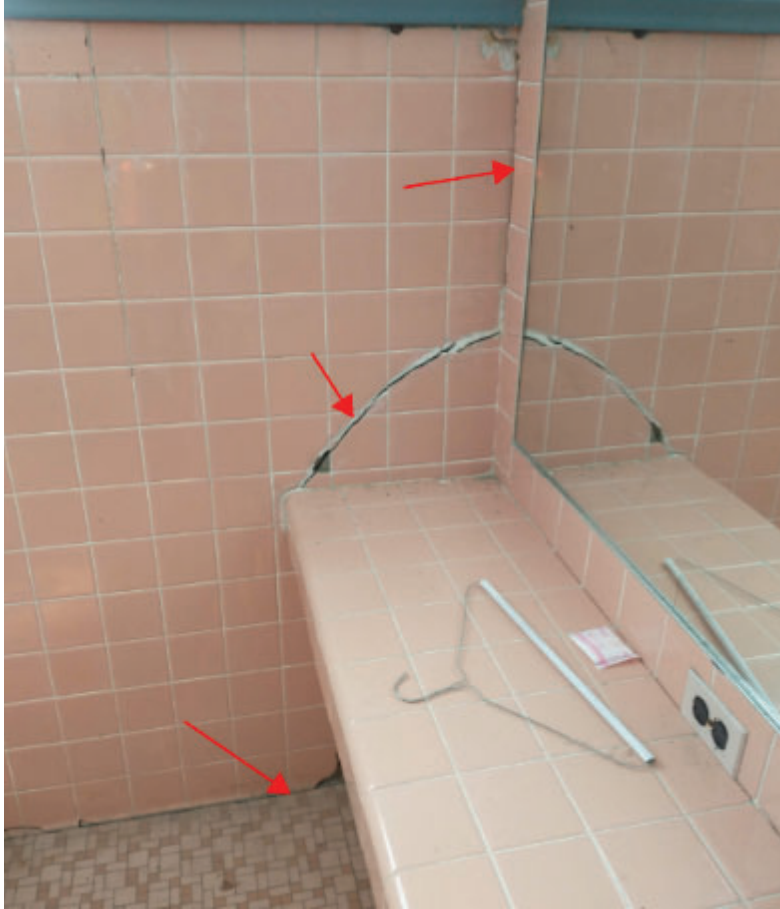
The north wall of the Women's Locker Rooms 111, 112, and 113 shows signs of foundation settlement. These rooms were reportedly constructed after the time of the building construction. The exterior walls in this area are likely not founded on piles as the majority of the building is. See Photo No. 23.

Photo No. 23 – Cracked exterior wall at Women's Locker Room.

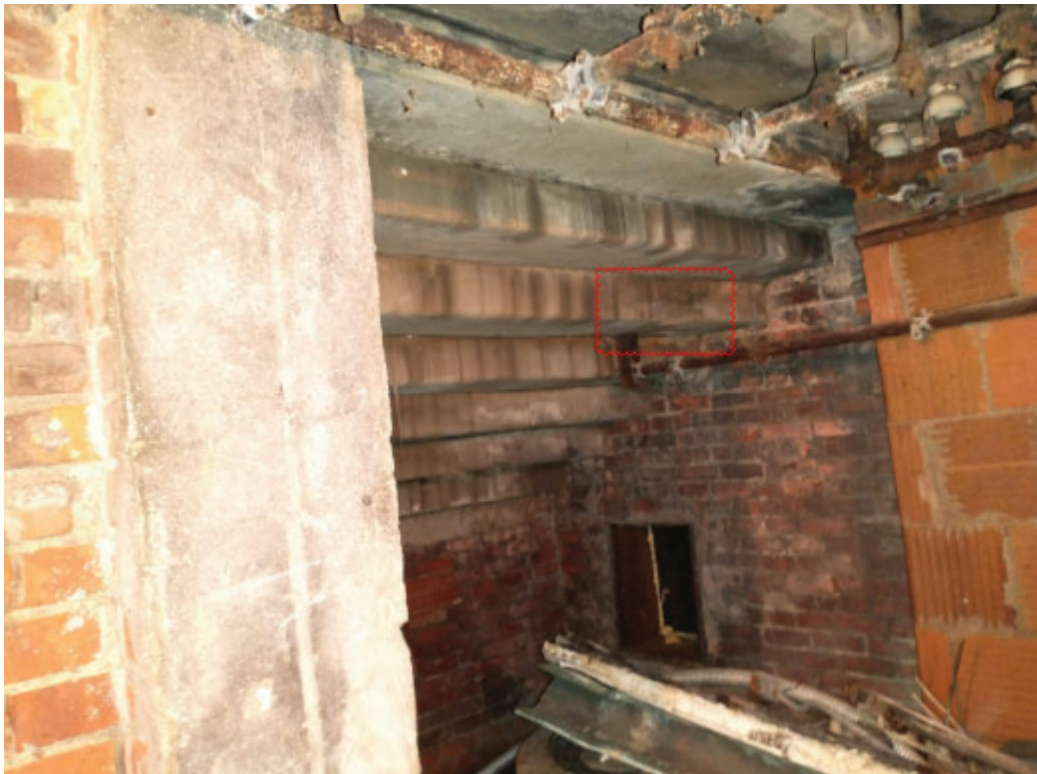
One stone stair riser at the south main entrance has a large spall near mid span. See Photo No. 24. Another riser has a large crack. These risers appear to be spanning a relatively long distance.

Photo No. 24 – Spalled stone stair riser.

10. Replace deteriorated concrete floor slabs.	\$483,870	\$90,322	\$70,968	\$645,160
11. Repair the South Entry Stairs. Additional support beneath limestone step.	\$40,000	\$2,500		\$42,500
	\$10,000	\$1,500		\$11,500

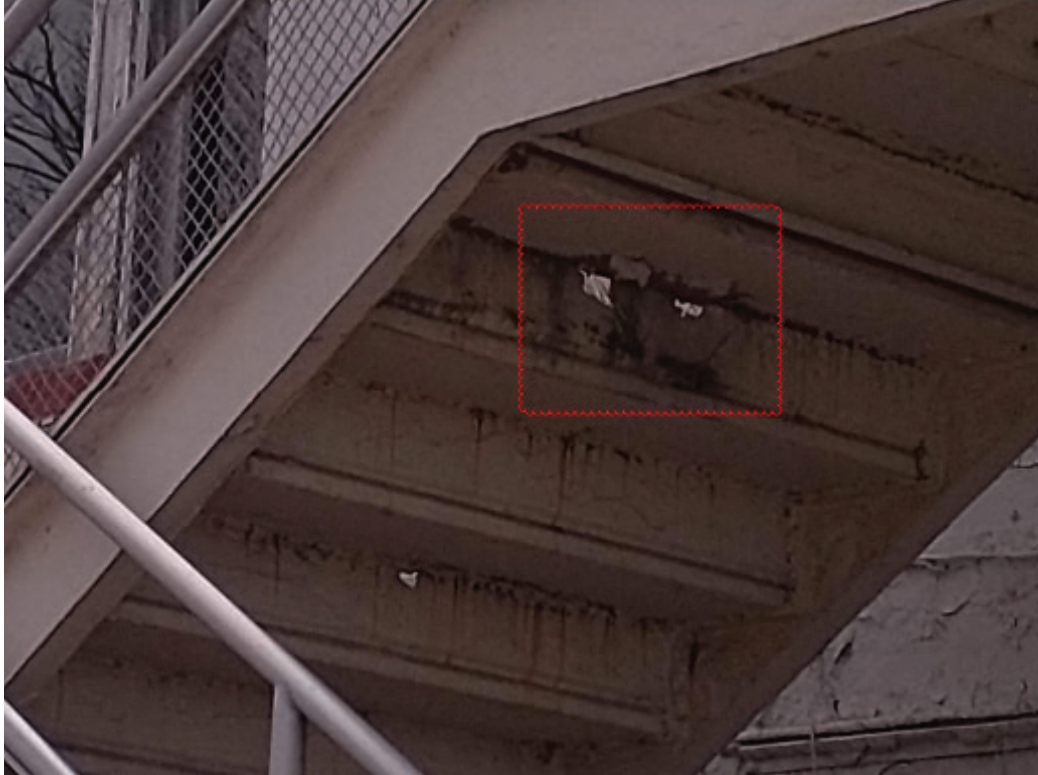
The steel stairs at the north elevation of the building are deteriorated, rusted and in a state of partial collapse. The stairs do not meet the Building Code for railings. These stairs should not be used for egress of the building. See Photo No. 25 – 27.

Photo No. 25 – Rusted stair riser.

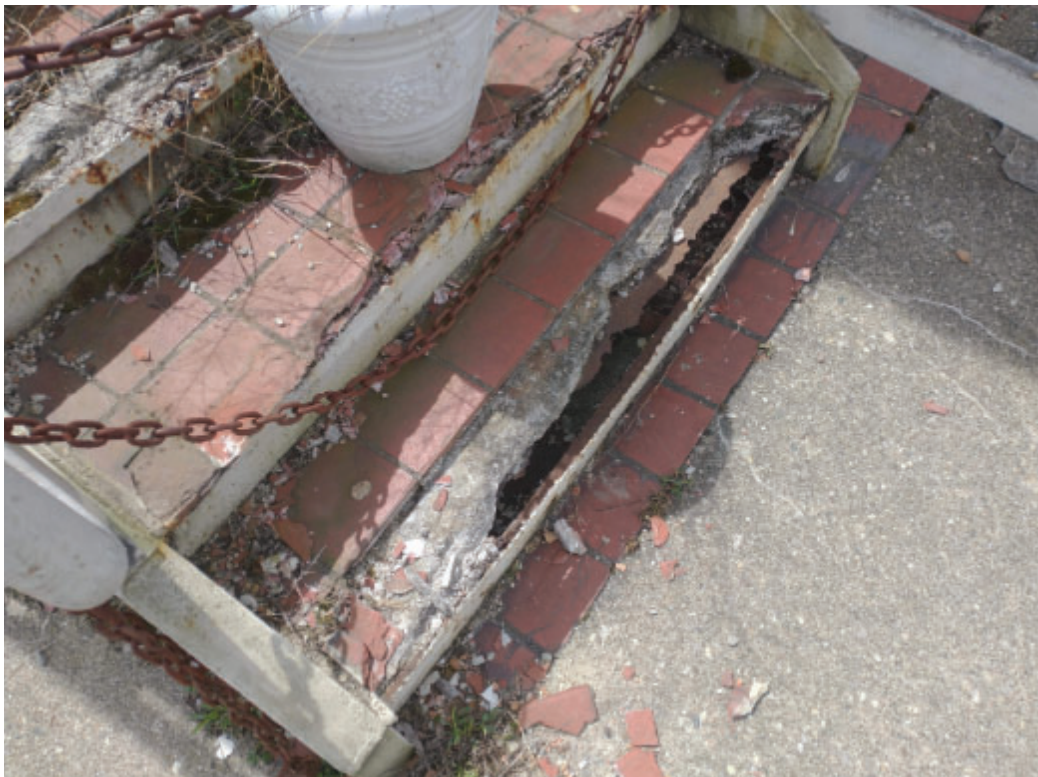
Photo No. 26 – Deteriorated stair riser.

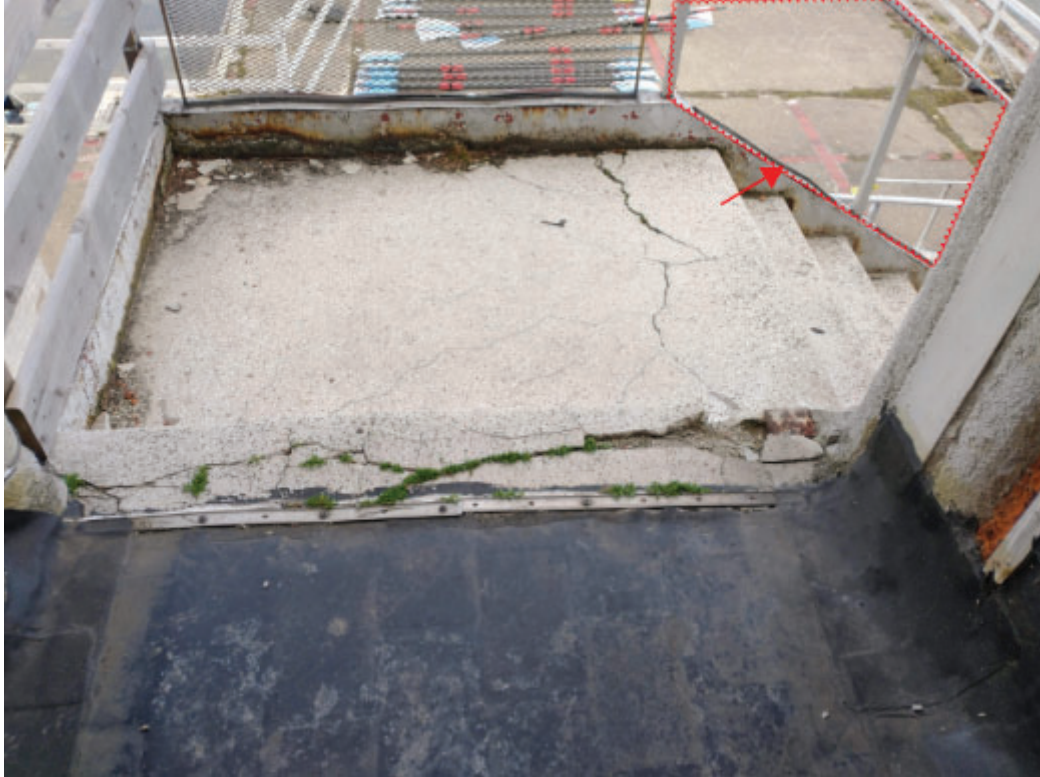
Photo No. 27 – Deteriorated stair landing. Missing rail screen.
