Phase 100 – Phase 1 and Phase 2
Exterior Structural Conditions and Cost Assessment

Belle Isle Boathouse Detroit, Michigan

File No. 751/22346.SMD
WTA Project No. 2022039
September 29, 2022

Phase I Structural Report

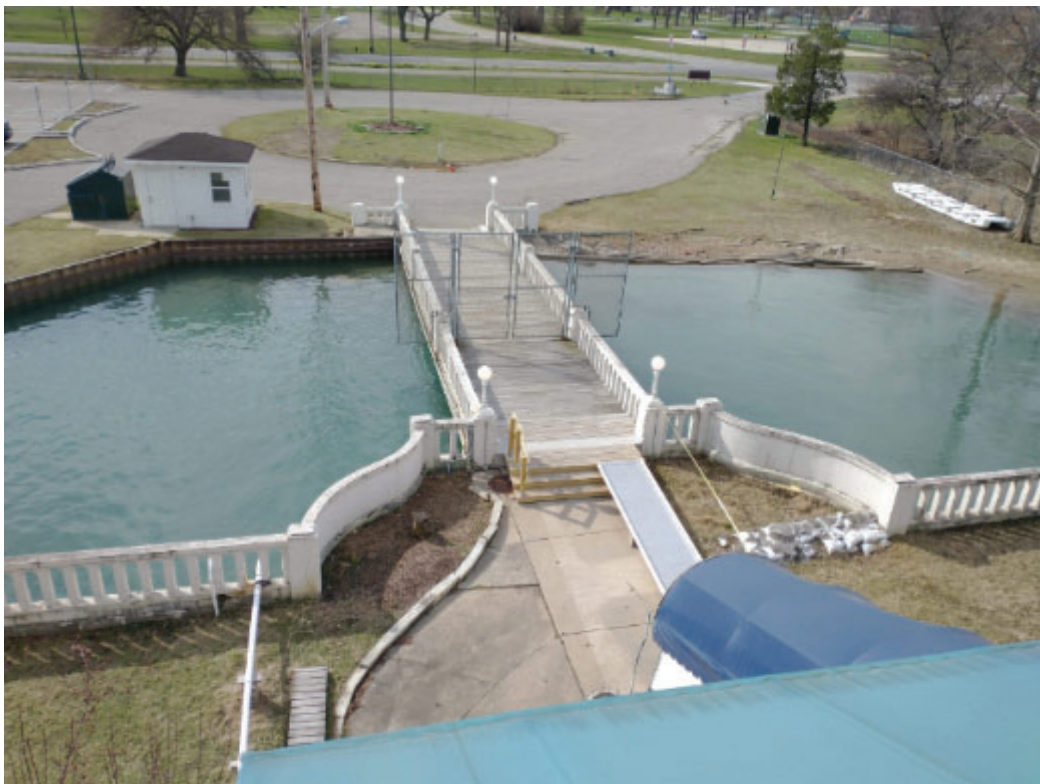
There are two bridges that serve the building site. The west bridge has reportedly been repaired but may be in need of additional repairs. The east bridge appears to be a relatively shallow structure for the span. The bridges should be evaluated for their load capacity prior to using for any construction equipment. See Photo No. 28 – 29.

Photo No. 28 – Access bridge at main entrance.

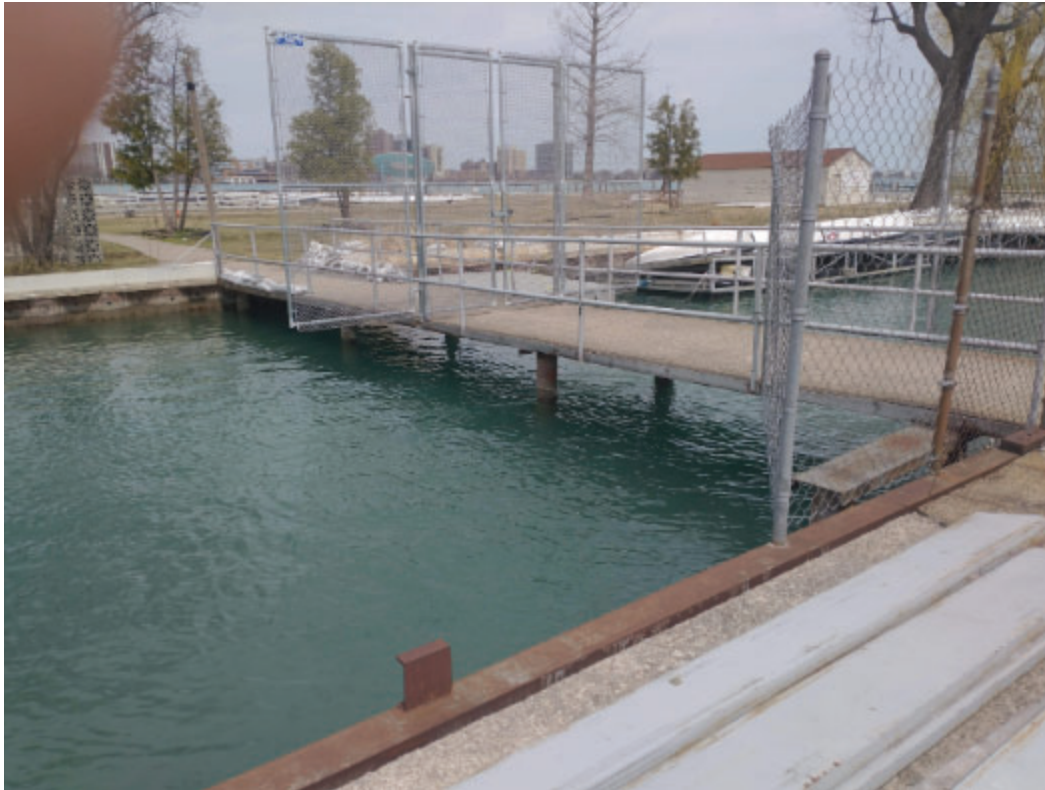
Photo No. 29 – Access bridge southeast of the building.

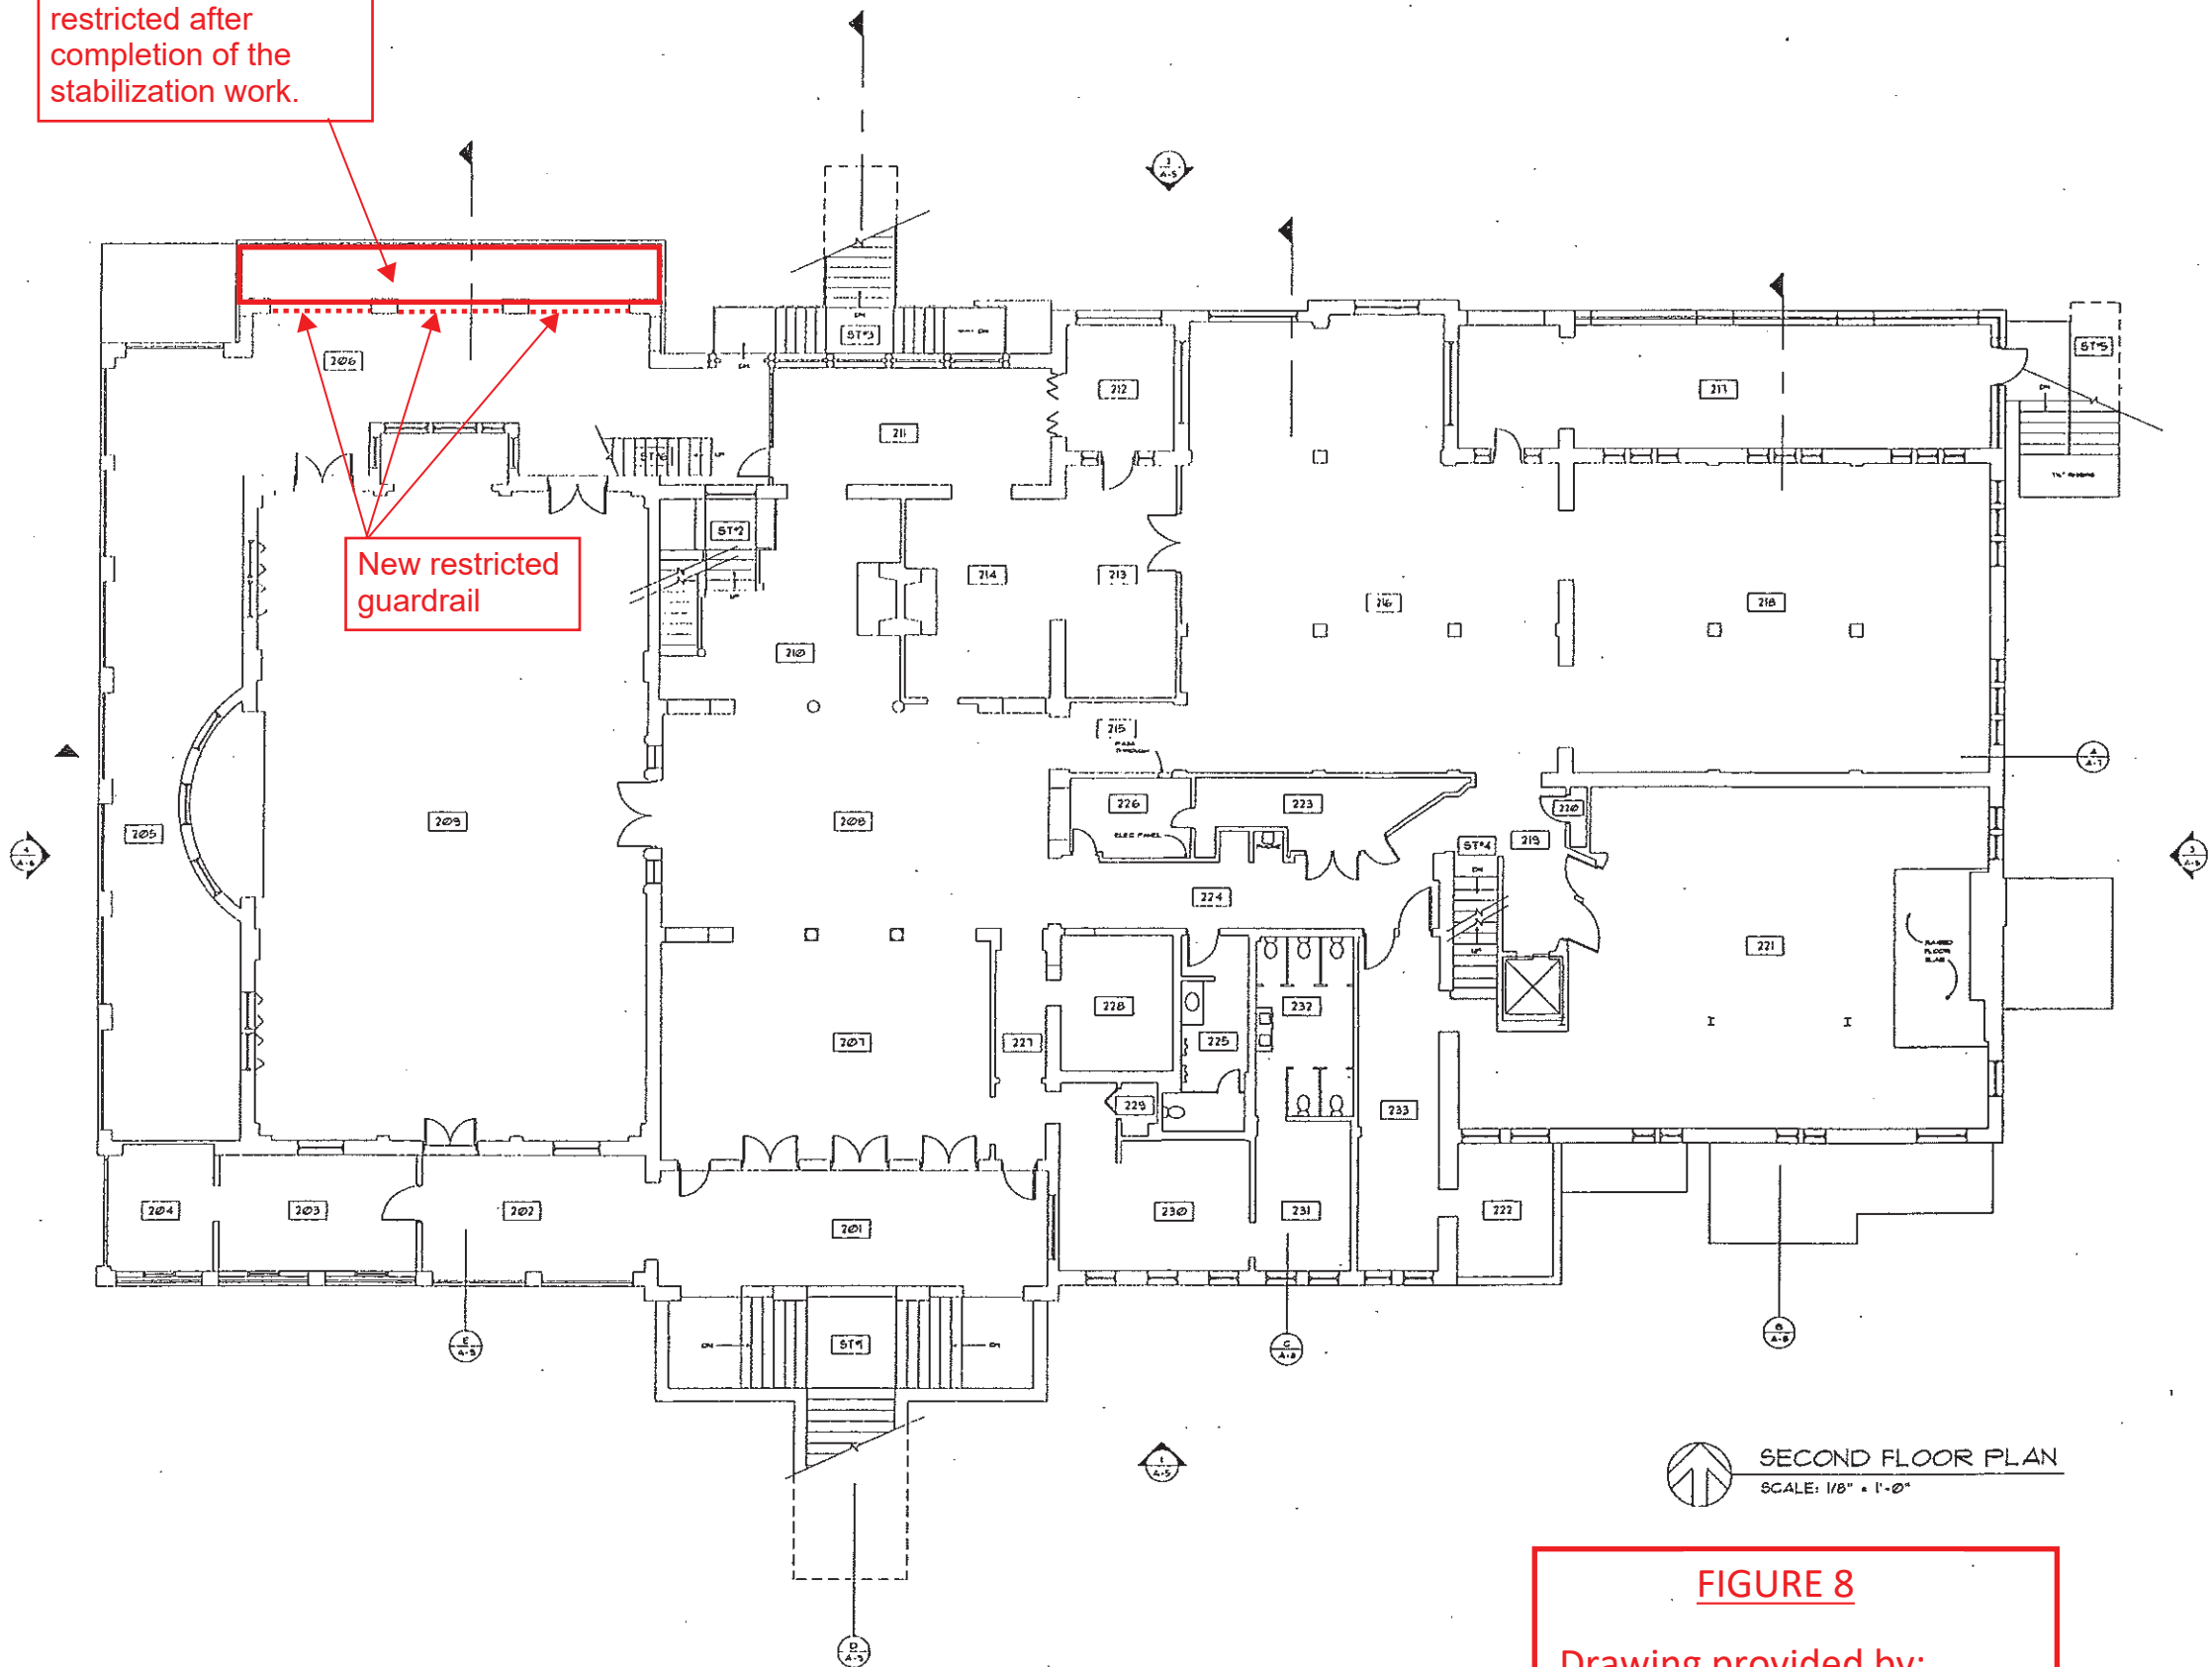
FIGURE 8
Drawing provided by:
Friends of Detroit Rowing

Along with stabilization requirements to the mothball option, the Appendix “C” option addresses restricted occupancy. Areas that would remain restricted after the stabilization work are indicated by Figure 7 and Figure 8. At these areas there are signs of slight displacement of the exterior wall from a lack of proper foundation support. This condition should be continually monitored for any further movement. The total
