EXISTING MAIN ACCESS BRIDGE**Existing Construction**

Belle Isle – Access Fishing Location
File No.: 751/15224.MNB
Index No.: 59715

Bridge Safety Inspection Report

Facility	Federal Structure ID	Insp. Agency	Insp. Name	Insp. Date	Insp. Freq.
Main Access Bridge at Detroit Boat Club Building		NDG, LLC	J. Rintala	9/8/2016

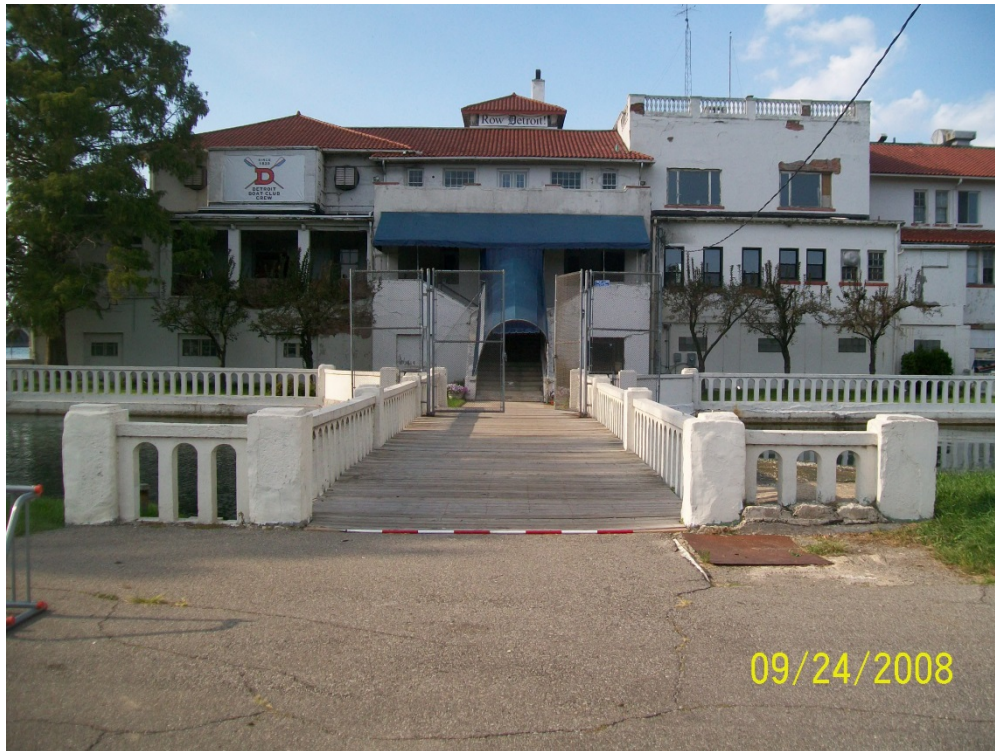
Main Access Bridge South Approach (Looking North)

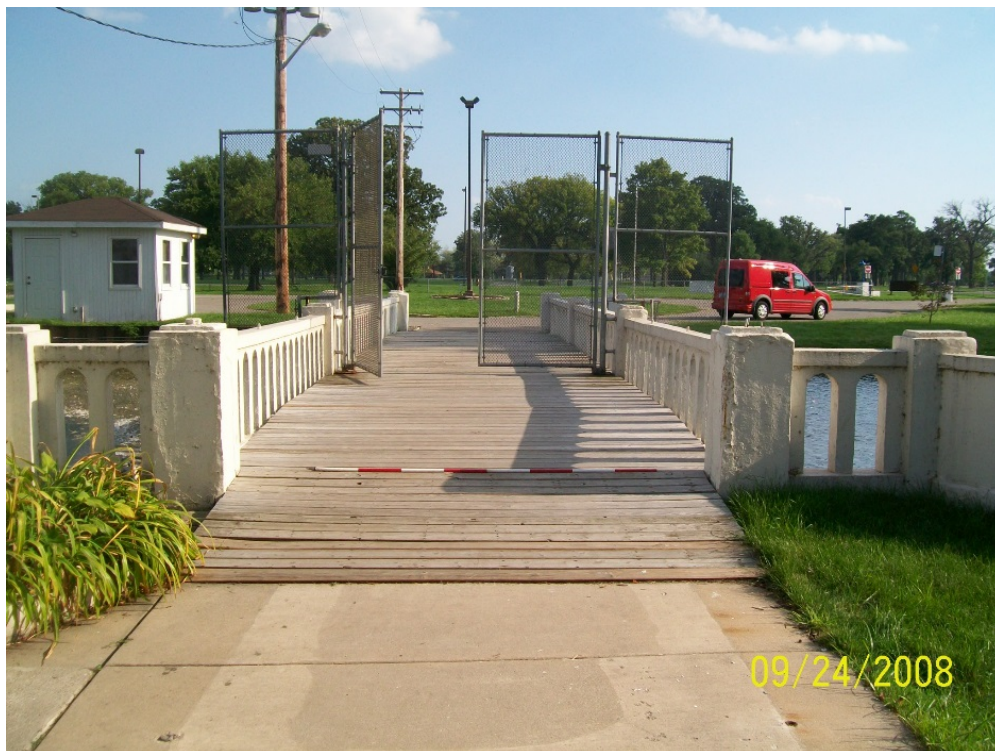
Main Access Bridge North Approach (Looking South)

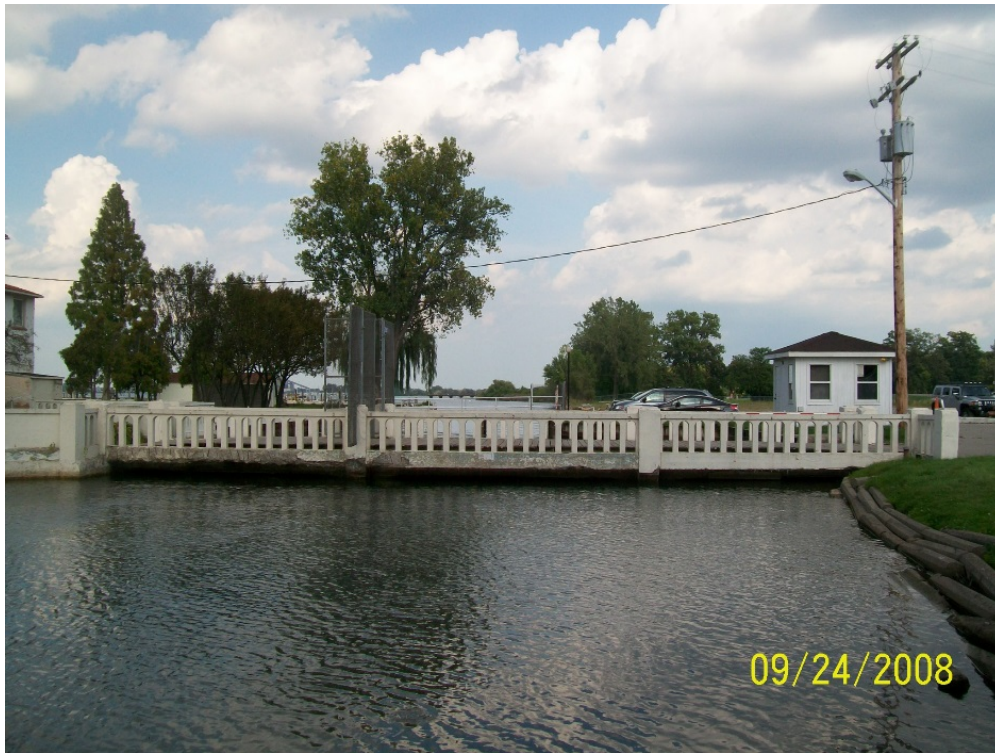
Main Access Bridge West Elevation (Looking East)

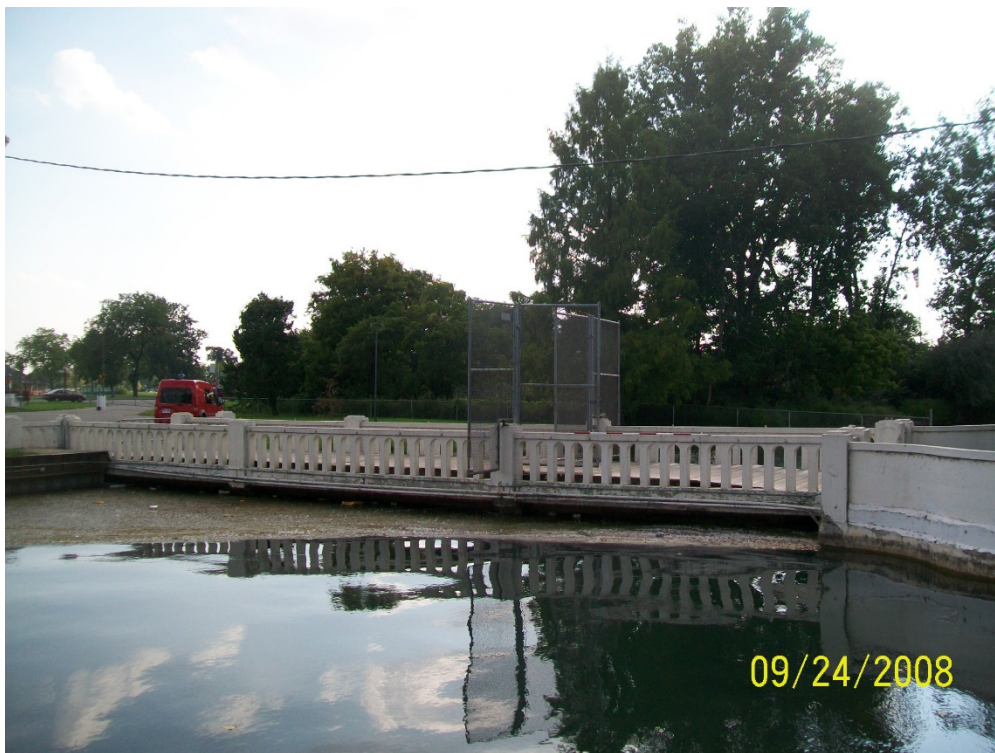
Main Access Bridge East Elevation (Looking West)
