## **EXISTING BUILDING AND PLAZA FOUNDATION INSPECTION**

BELLE ISLE BOAT CLUB

Prepared for: DNR/DTMB

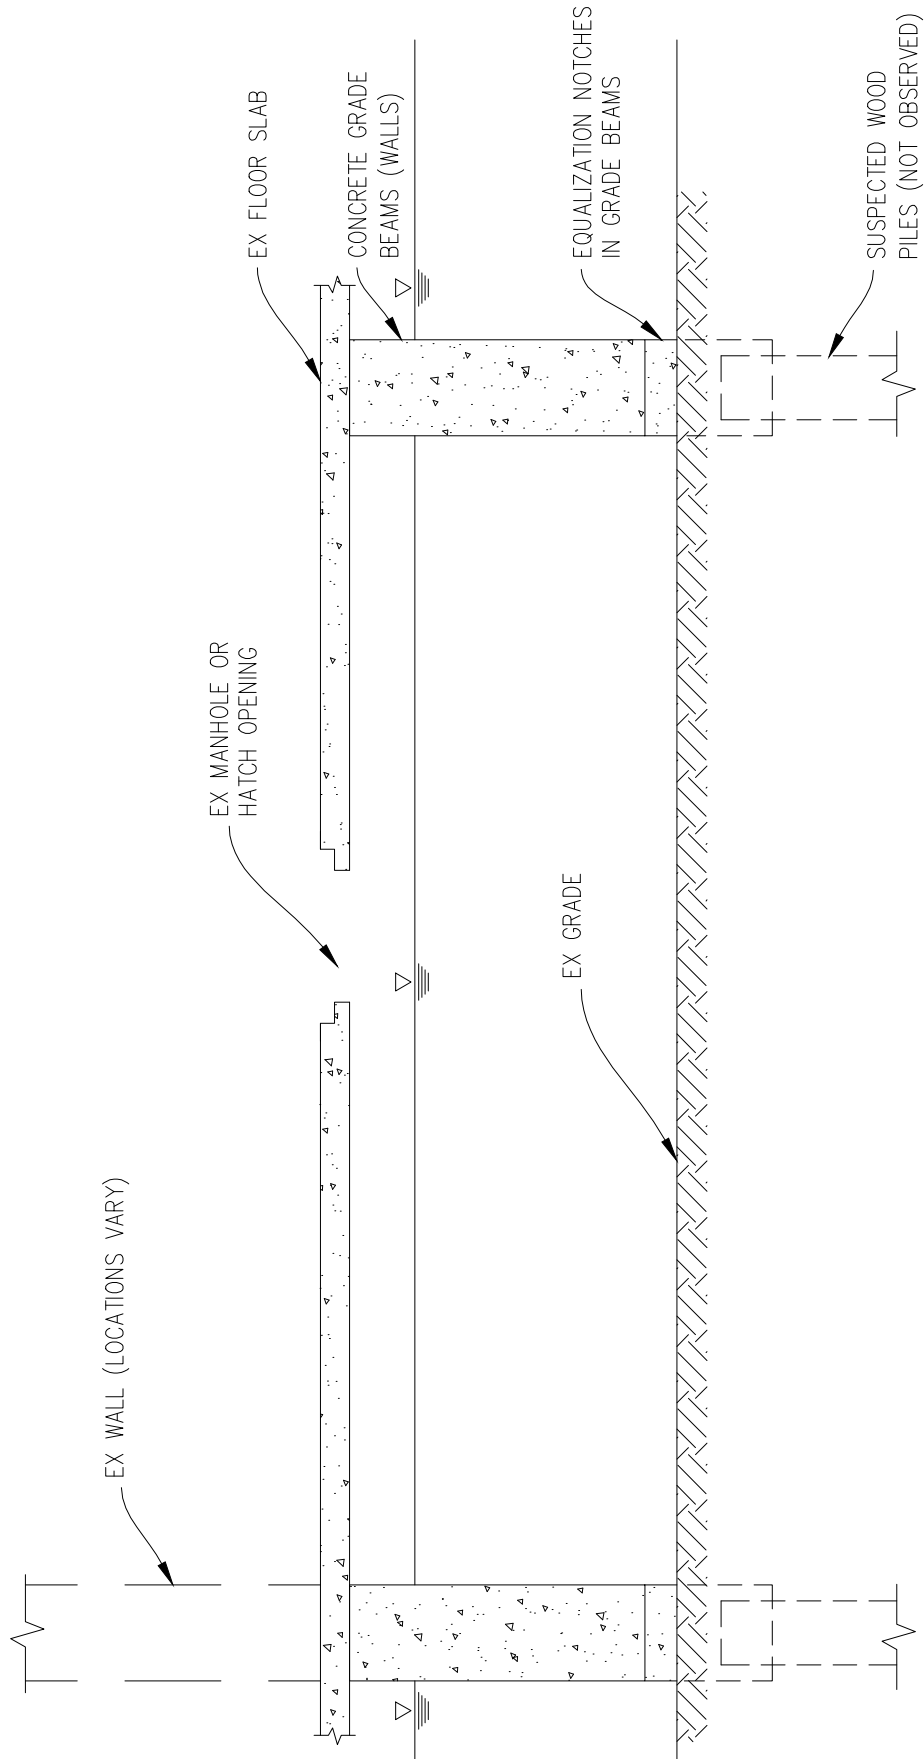
## SECTION – TYPICAL BOAT CLUB BUILDING FOUNDATION

In general, the existing concrete grade beams and supported floor slab appeared to be in good condition. In some locations, usually around the perimeter of a floor hatch, the floor slab was spalled which appeared to have possibly been due to the installation of the hatch after the placement of the floor slab. The piles that are suspected to be supporting the grade beams were not observed since the ground surface was above the bottom of the grade beams.

1. Continue to periodically observe/monitor the existing building for potential signs of settlement.
