# **PRE-RENOVATION HAZARDOUS MATERIALS SURVEY**

**BELLE ISLE PARK- BOATHOUSE**

**E PICNIC WAY, DETROIT, MI 48207**

188BS22746

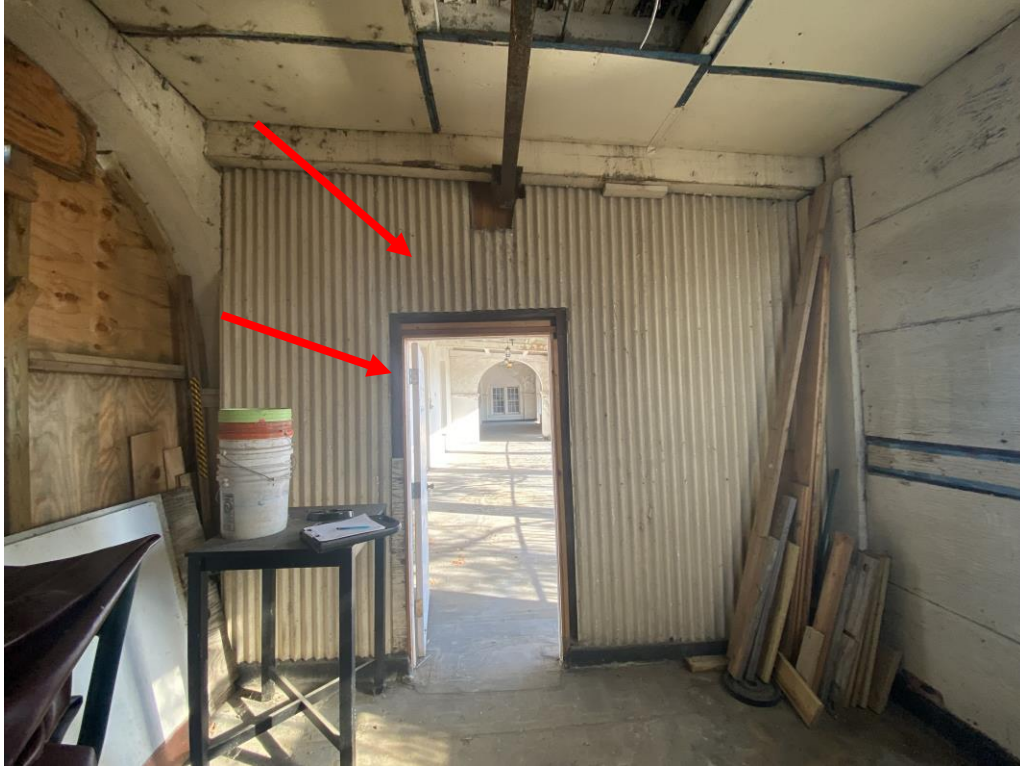
| Sample ID/Material | Location of Materials | Material | Condition | Friable Yes/No | Estimated Quantity | Recommendation |
|---|---|---|---|---|---|--|
| 104-TP-A,B,C | Exterior Room in Front, on Entry Porch and Possibly Docks | Transite Corrugated Panels | Good | No | 96 SF | Abate during current planned renovation |
| 112-IC-A,B,C | Exterior Room in Front on Entry Porch | Interior Caulk on Corrugated Transite Panels | Good | No | 40 LF | Abate during current planned renovation |

Transite Panels and Interior Caulk (HA 104 & H A112)

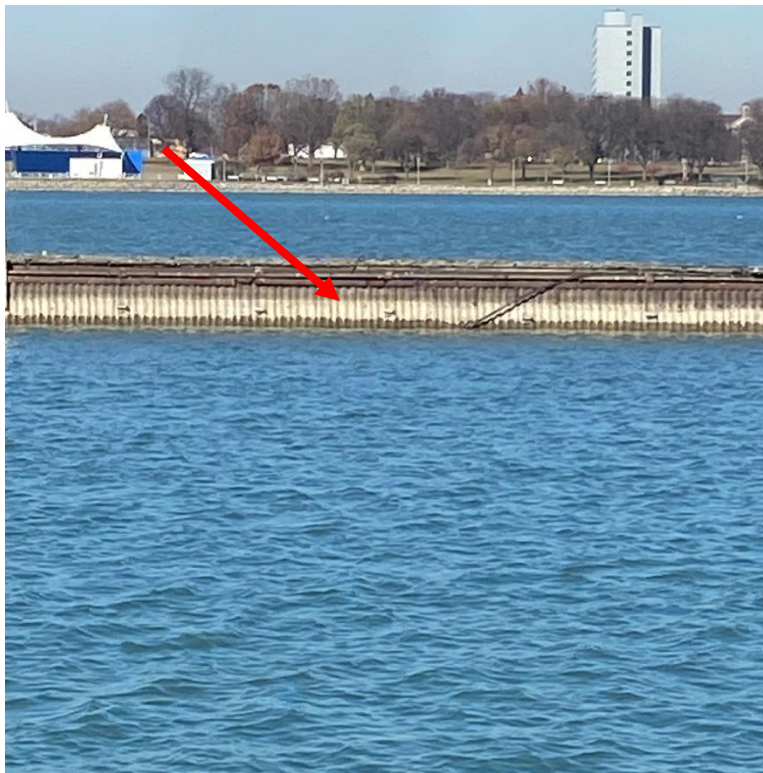
Transite Panels on Docks (HA 104)

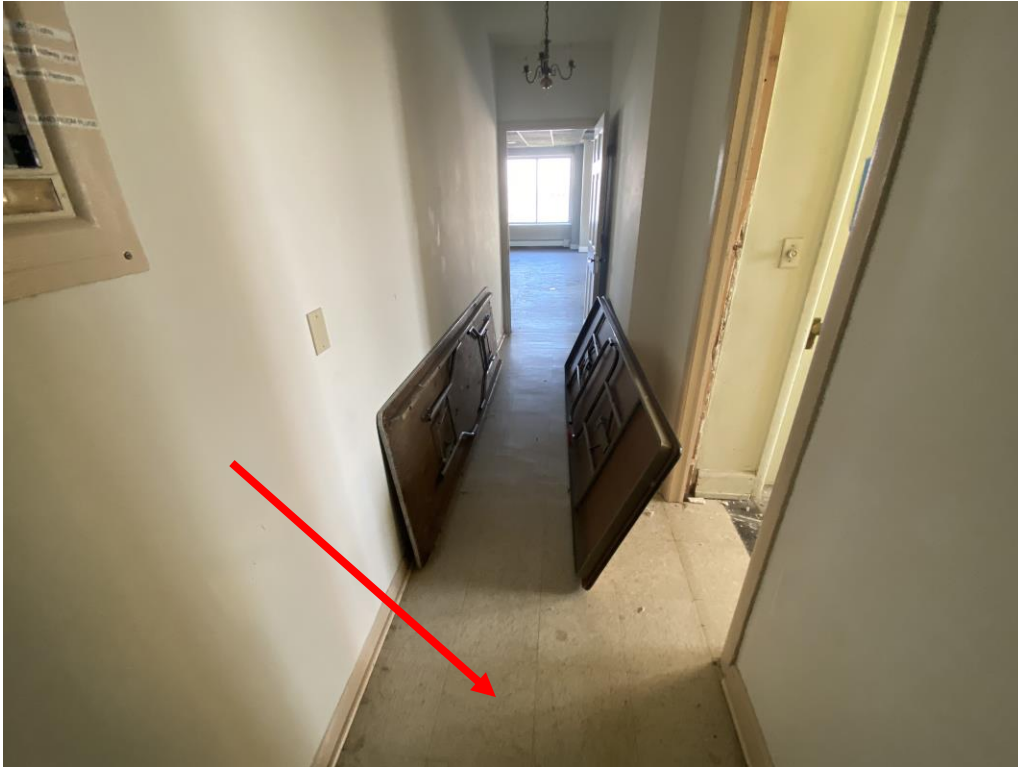
Positive Floor Tile Under New Tile

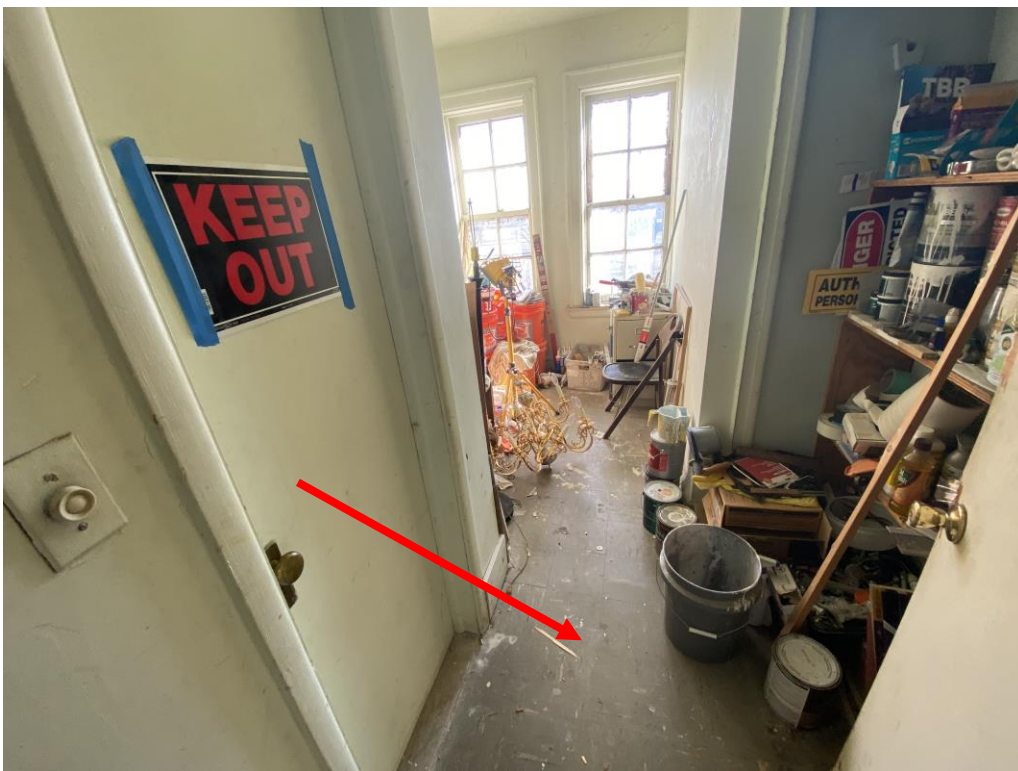
| Belle Isle State Park Boathouse<br>E Picnic Way, Detroit, MI 48207 | | | | | | |
|--|---|---|---|---|---|--|
| 58-FT-A,B,C | FS 7 | Floor Tile 9x9 Gray with Black and White Streaks | Good | No | 100 SF | Abate if impacted during future renovation |

9"x9" Floor Tile; Grey (HA 58)

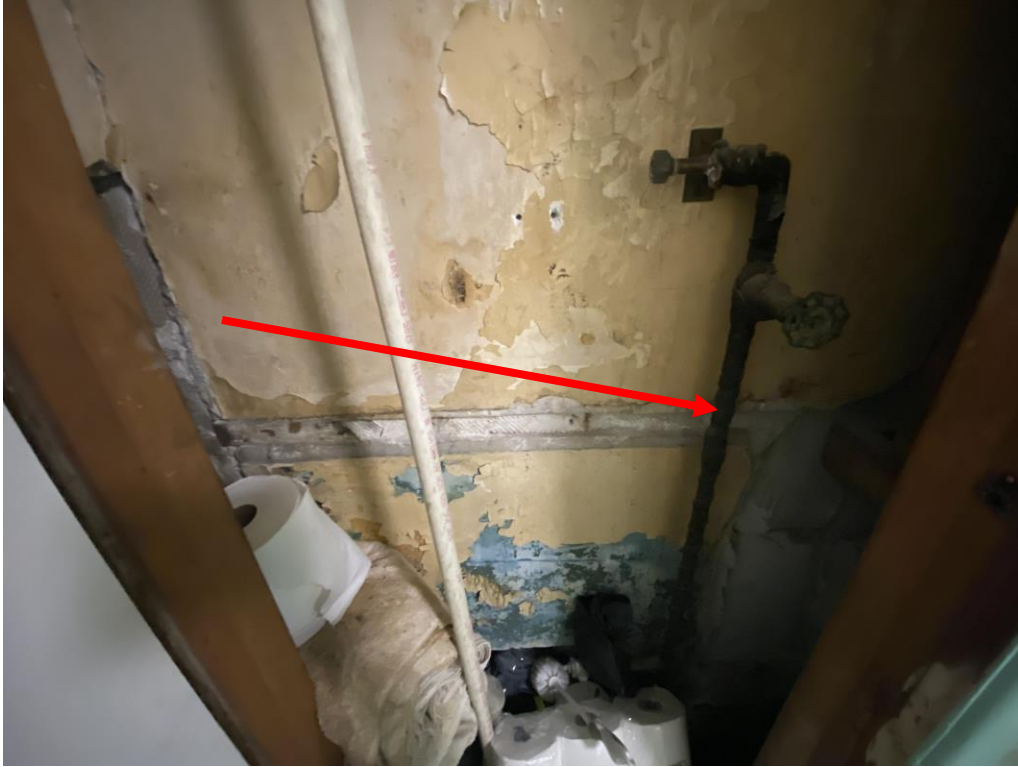
| Belle Isle State Park Boathouse<br>E Picnic Way, Detroit, MI 48207 | | | | | | |
|--|---|---|---|---|---|--|
| 67-PI-A,B,C | FS 11,25 | Pipe Insulation;<br>Mastic Tape; Black | Good | Yes | 70 LF | Abate during current planned renovation |

Black Pipe Wrap (HA 67)

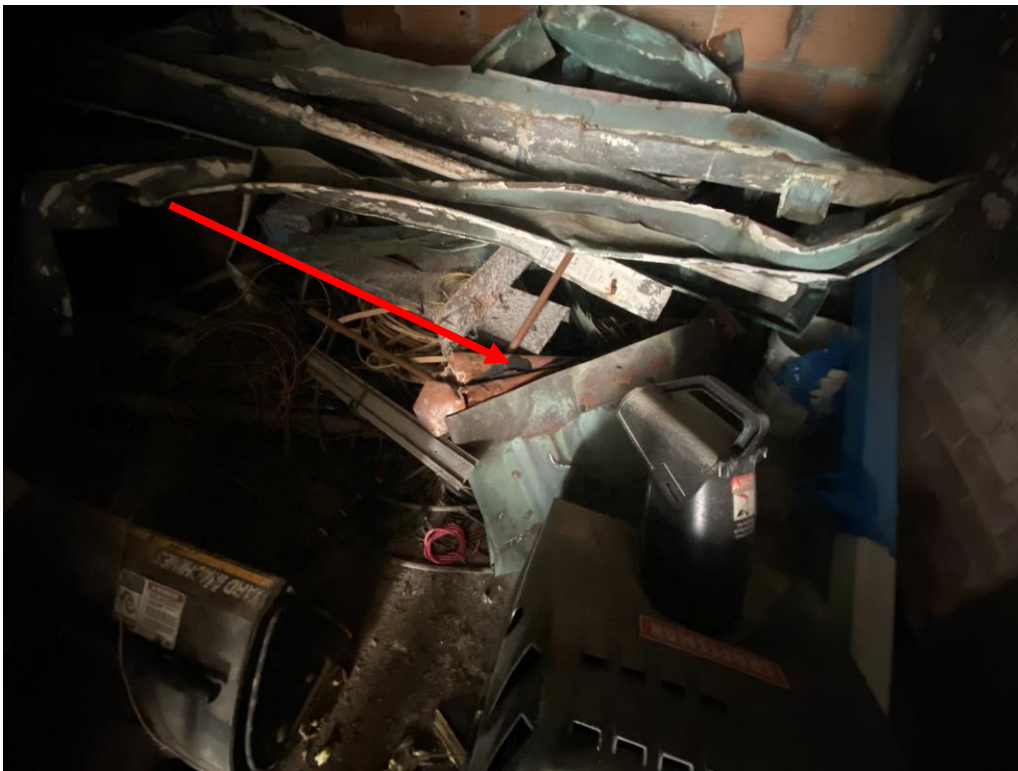
| Sample ID/Material | Location of Materials | Material | Condition | Friable Yes/No | Estimated Quantity | Recommendation |
|---|---|---|---|---|---|--|
| 101-BM-A,B,C | FS 35<br>UNDER STAIRS | Black Mastic Debris<br>Under the Stairs | Good | No | 6 CY | Abate during current planned renovation |

Black Mastic in Debris (HA 101)

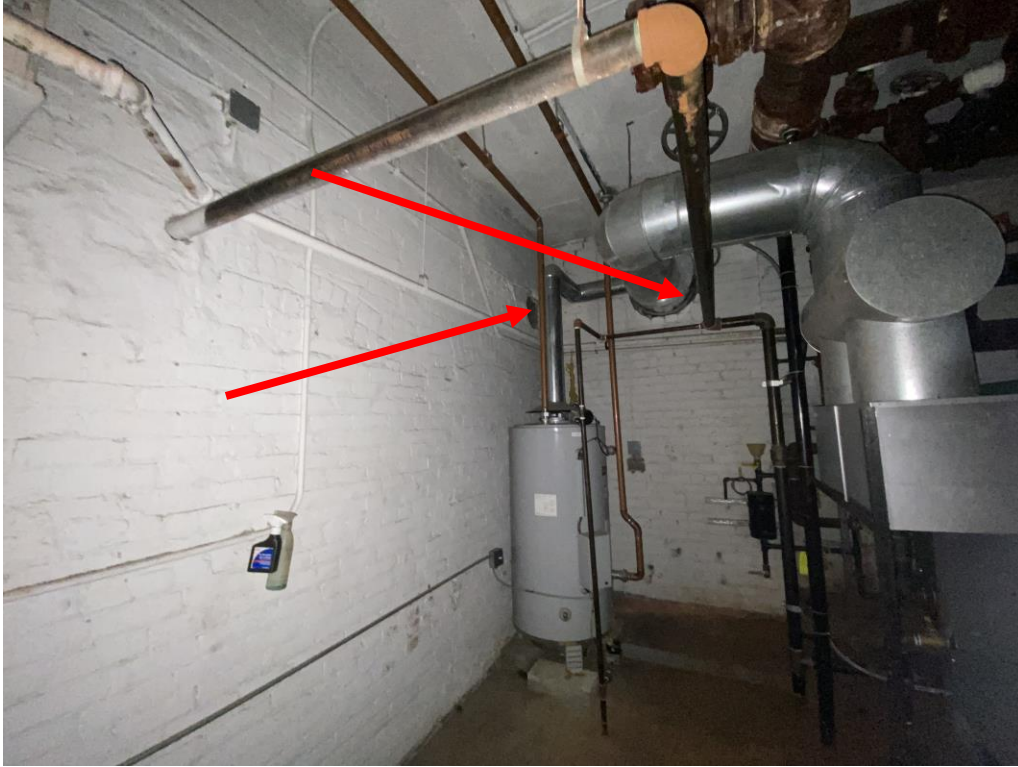
| Sample ID/Material | Location of Materials | Material | Condition | Friable Yes/No | Estimated Quantity | Recommendation |
|---|---|---|---|---|---|--|
| 91-SC-A,B,C | BOILER ROOM | Stack Cement | Good | No | 10 SF | Abate during current planned renovation |

Stack Cement and Penetration Mudding (HA 91 & HA 146)

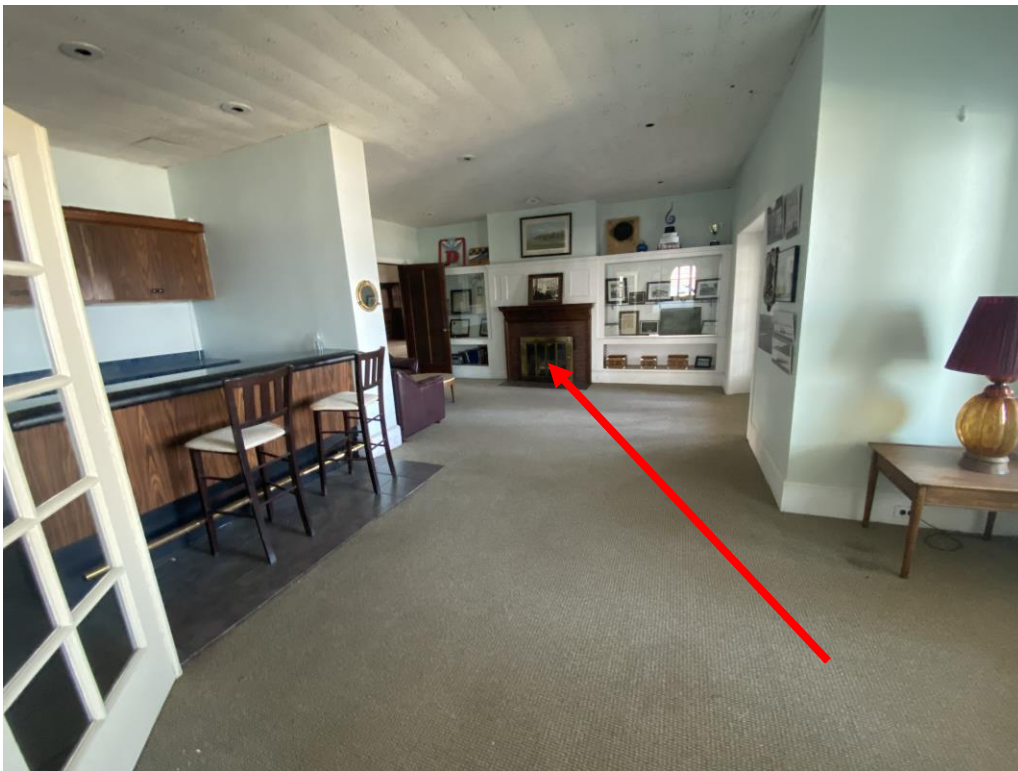
| Belle Isle State Park Boathouse<br>E Picnic Way, Detroit, MI 48207 | | | | | | |
|--|---|---|---|---|---|--|
| 24-FB-A,B,C | FS 8,24,28 | Fire Brick & Mortar;<br>3 Fire Places | Good | No | 90 SF | Abate if impacted during future renovation |

Fire Brick and Mortar (HA 24)

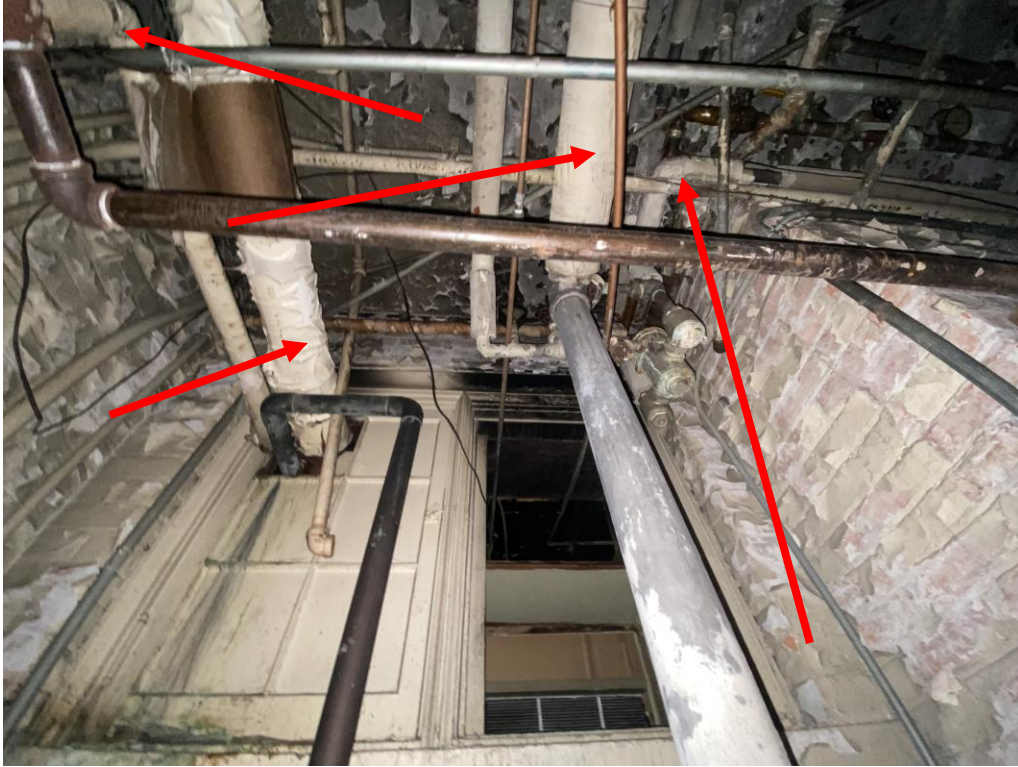
| Belle Isle State Park Boathouse<br>E Picnic Way, Detroit, MI 48207 | | | | | | |
|--|---|---|---|---|---|--|
| 69-PI-A,B,C,D | FS 1-45 | Pipe Insulation;<br>Straight-Line Layered Brown Paper | Good | Yes | 500 LF | Abate during current planned renovation |
| 70-PF-A,B,C,D | FS 1-45 | Pipe Fitting Associated w/<br>Layered Brown Paper | Good | Yes | 50 FITTINGS | Abate during current planned renovation |

| Sample ID/Material | Location of Materials | Material | Condition | Friable Yes/No | Estimated Quantity | Recommendation |
|---|---|---|---|---|---|--|
| 71-PI-A,B,C | FS 1-45 | Pipe Insulation; Straight-Line; Corrugated Paper | Good | Yes | 500 LF | Abate during current planned renovation |
| 72-PF-A,B,C,D,E | FS 1-45 | Pipe Fitting Associated W/ Layered Corrugated Paper | Good | Yes | 50 FITTINGS | Abate during current planned renovation |

Pipe Insulations and Pipe Fittings (HA 69, 70, 71 & 72)

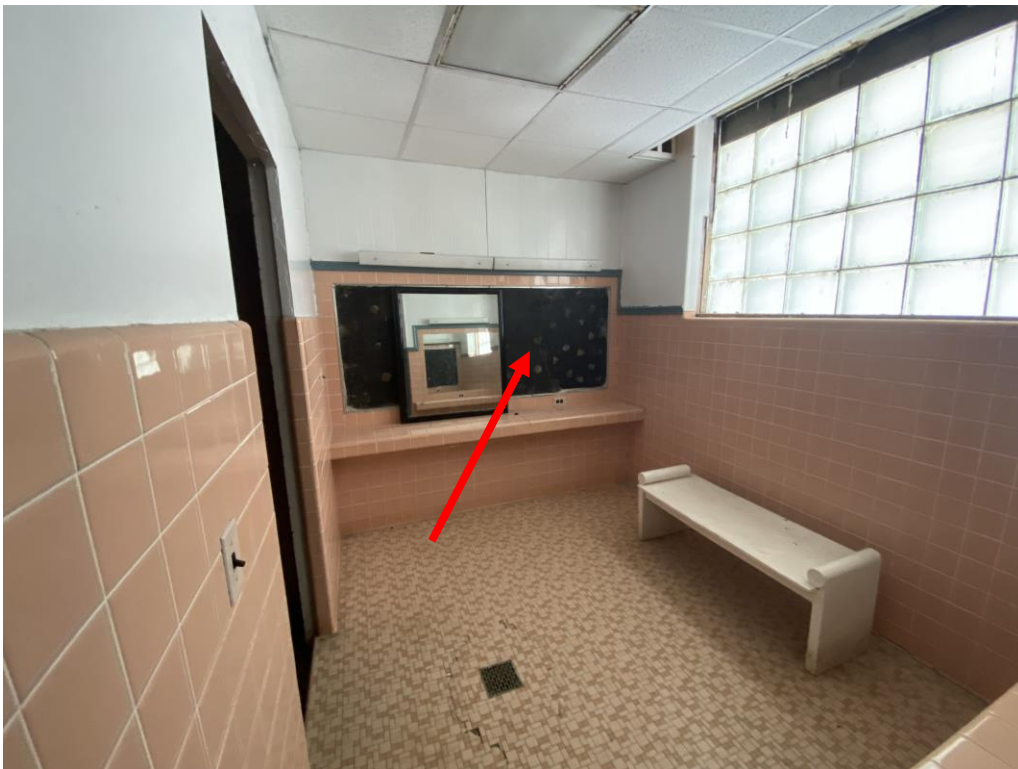
| Sample ID/Material | Location of Materials | Material | Condition | Friable Yes/No | Estimated Quantity | Recommendation |
|---|---|---|---|---|---|--|
| 86-MA-A,B,C | FS 32 | Mirror Adhesive | Good | No | 60 SF | Abate during current planned renovation |

Mirror Adhesive (HA 86)

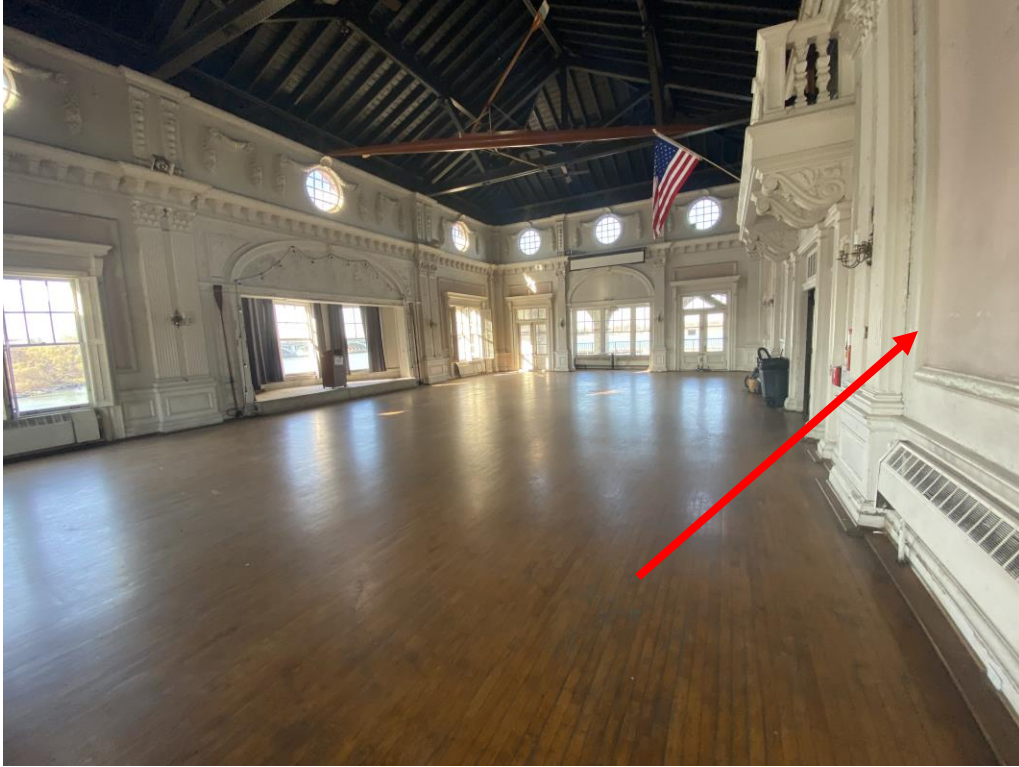
| Sample ID/Material | Location of Materials | Material | Condition | Friable Yes/No | Estimated Quantity | Recommendation |
|---|---|---|---|---|---|--|
| 109-IC-A,B,C | FS 1-45 | Interior caulk on Plaster; AT DECORATIVE PLASTER | Good | No | 700 LF | Abate during current planned renovation |

Interior Caulk on Plaster (HA 109)

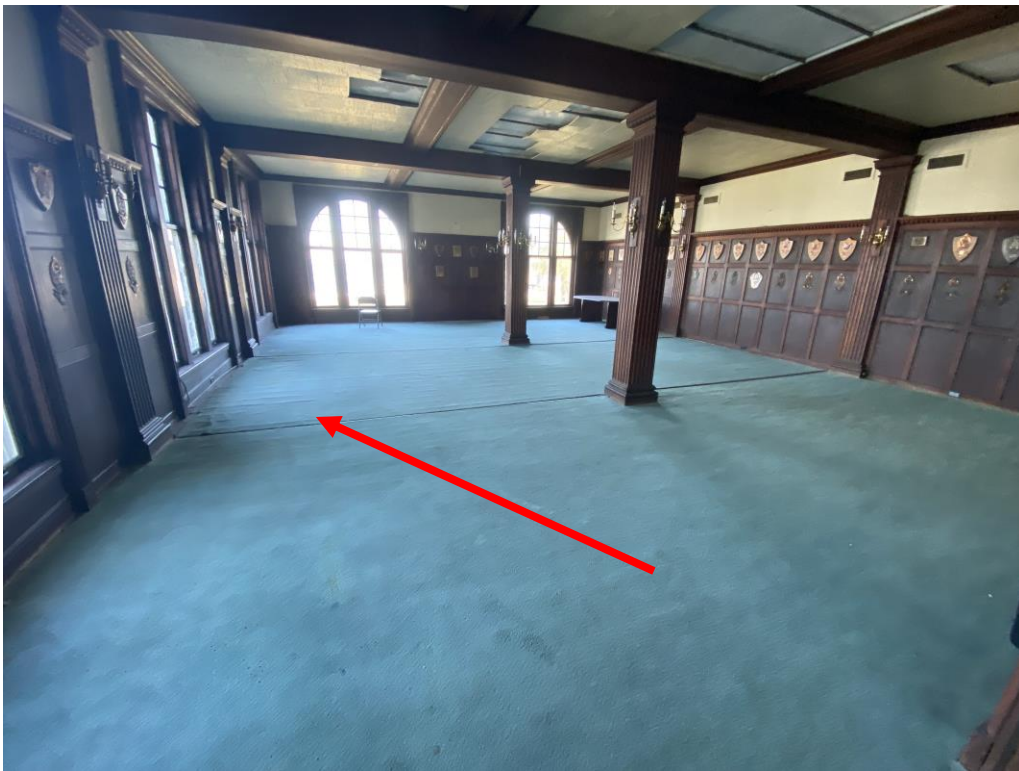
| Belle Isle State Park Boathouse<br>E Picnic Way, Detroit, MI 48207 | | | | | | |
|--|---|---|---|---|---|--|
| 40-FT-A,B,C | FS 26,27 | Floor tile 9x9 Maroon, White & Black Streaks | Good | No | 2,000 SF | Abate if impacted during future renovation |

Floor Tile 9x9 Maroon Under Carpet (HA 40)

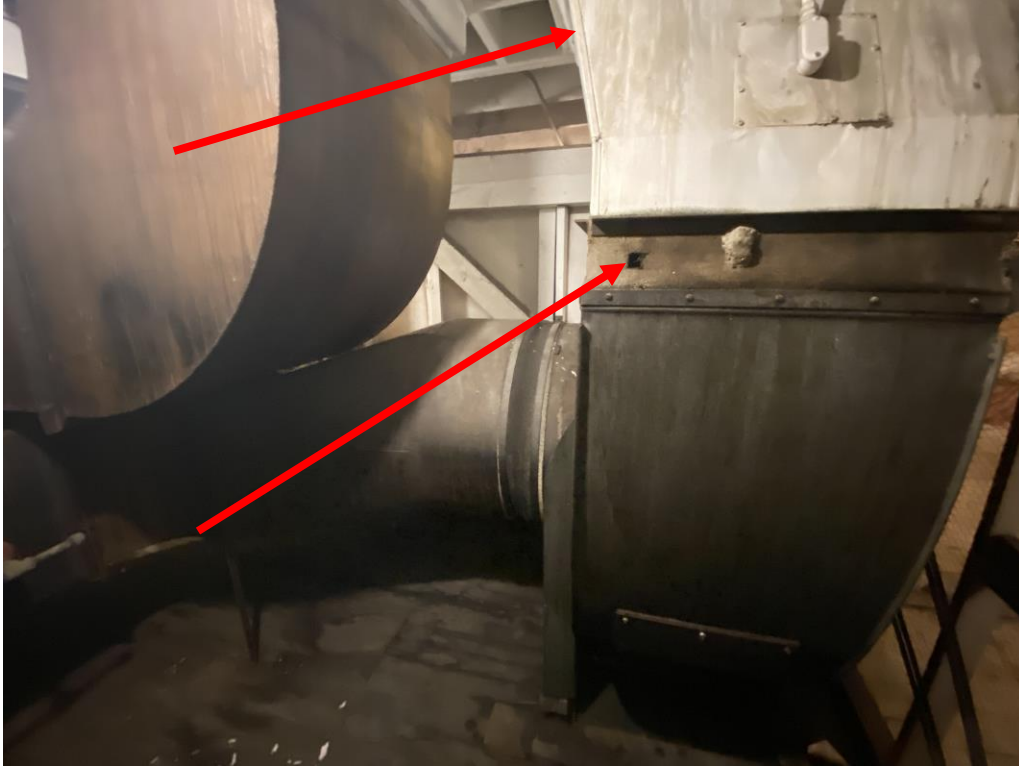
| Sample ID/Material | Location of Materials | Material | Condition | Friable Yes/No | Estimated Quantity | Recommendation |
|---|---|---|---|---|---|--|
| 74-VD-A,B,C | ATTIC | Vibration Dampener; Gray | Good | Yes | 20 SF | Abate if impacted during future renovation |
| 113-DW-A,B,C | ATTIC | Duct Wrap | Good | Yes | 20 SF | Abate if impacted during future renovation |

Vibration Dampener and Duct Wrap (HA 74 & HA 113)

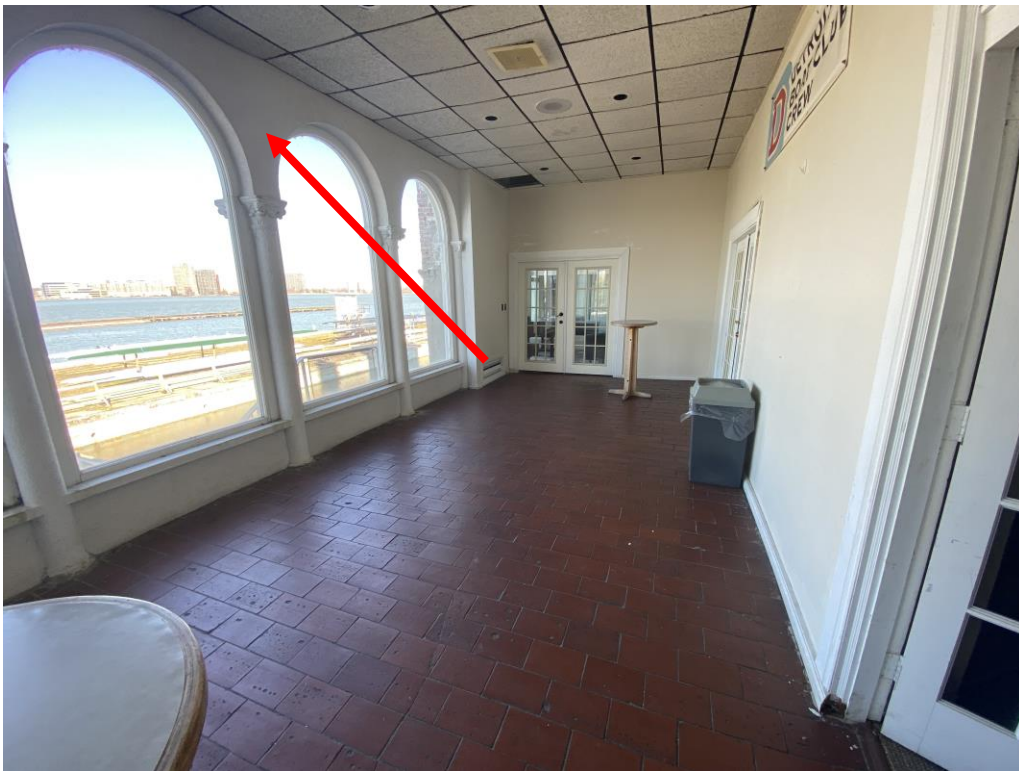
| Belle Isle State Park Boathouse<br>E Picnic Way, Detroit, MI 48207 | | | | | | |
|--|---|---|---|---|---|--|
| 27-TPL-A,B,C,D,E,F,G | FS 1-45<br>EXTERIOR WALLS | Textured Plaster Bumpy | Good | Yes | 5,000 SF | Abate during current planned renovation |

Textured Plaster; Bumpy (HA 27)

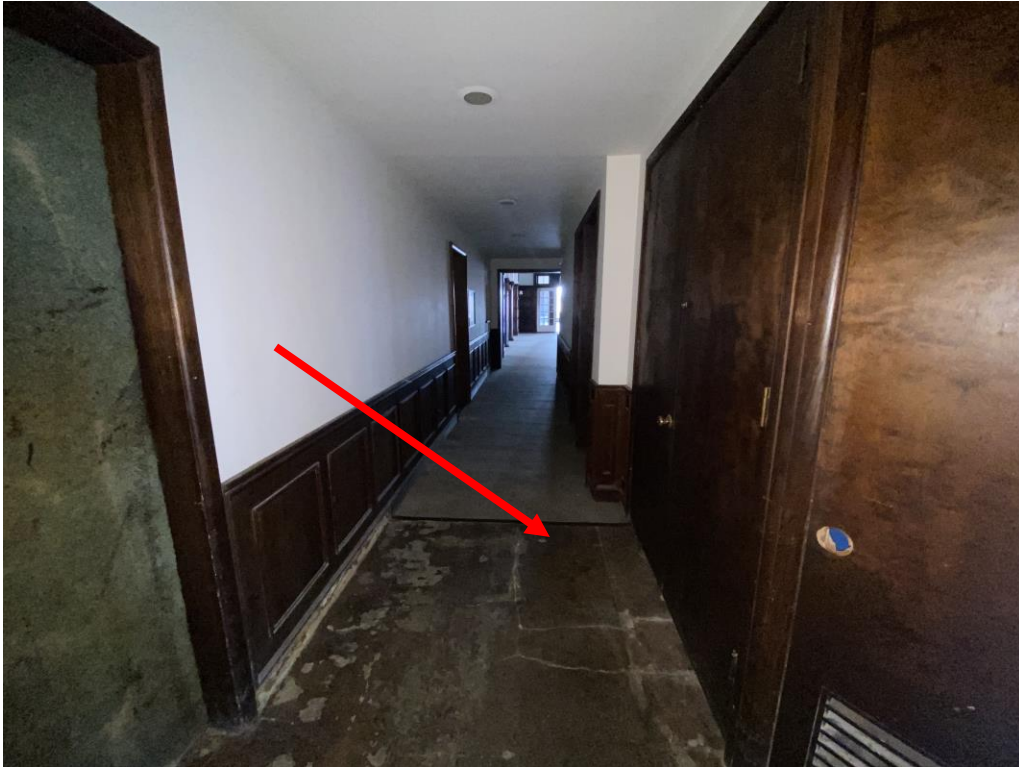
| Sample ID/Material | Location of Materials | Material | Condition | Friable Yes/No | Estimated Quantity | Recommendation |
|---|---|---|---|---|---|--|
| 84-FT-A,B,C | FS 25,37,42 | Floor Tile<br>12x12 Brown; Remnants | Good | No | 60 SF | Abate during current planned renovation |

Floor Tile Brown Remnants (HA 84)

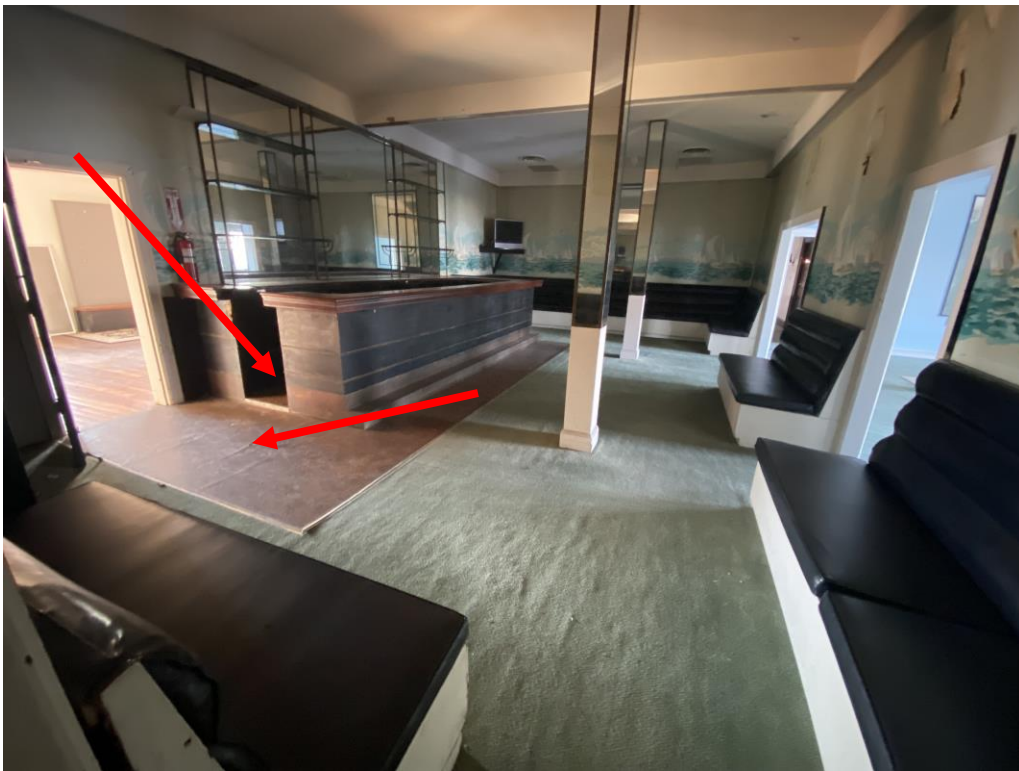
| Belle Isle State Park Boathouse<br>E Picnic Way, Detroit, MI 48207 | | | | | | |
|--|---|---|---|---|---|--|
| 51-MLF-A,B,C | FS 4 | Multi Layered Flooring<br>Bar area 2nd Floor Parquet on Top | Good | No | 100 SF | Abate if impacted during future renovation |

| Sample ID/Material | Location of Materials | Material | Condition | Friable Yes/No | Estimated Quantity | Recommendation |
|---|---|---|---|---|---|--|
| 114-MLF-A,B,C | FS 4 | Multi Layered Flooring Behind Bar 2nd Floor Parque on Top | Good | No | 80 SF | Abate if impacted during future renovation |

Multi layered flooring (HA 51 & 114)

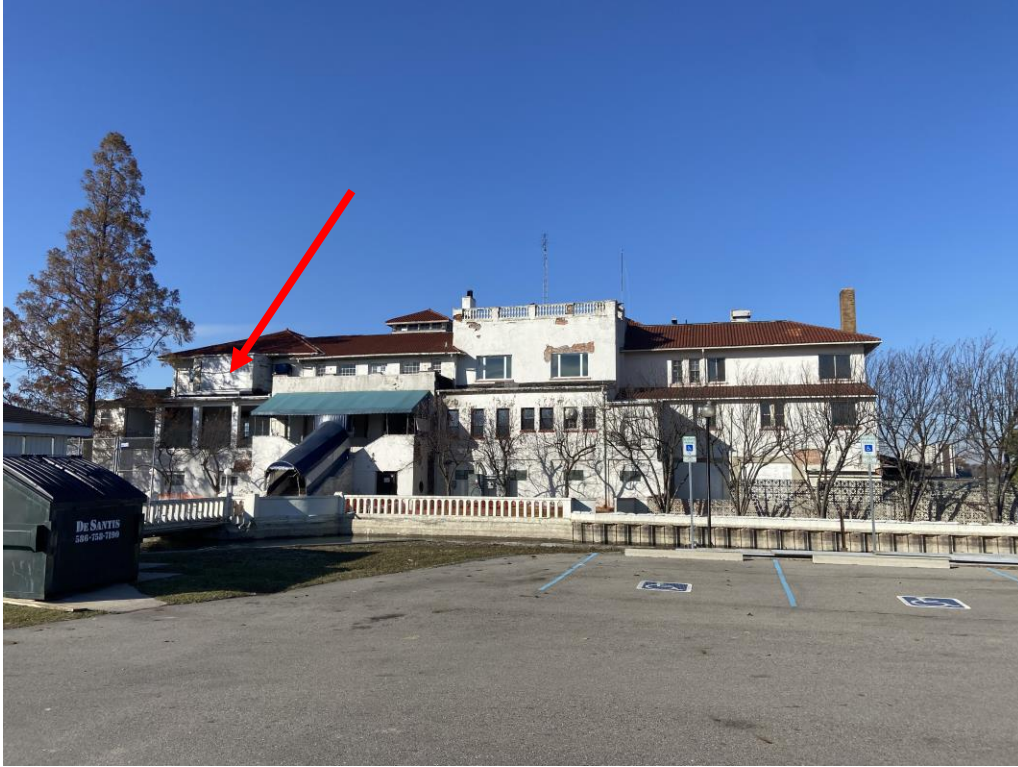
Plaster Inside Roof Housing (HA 152)

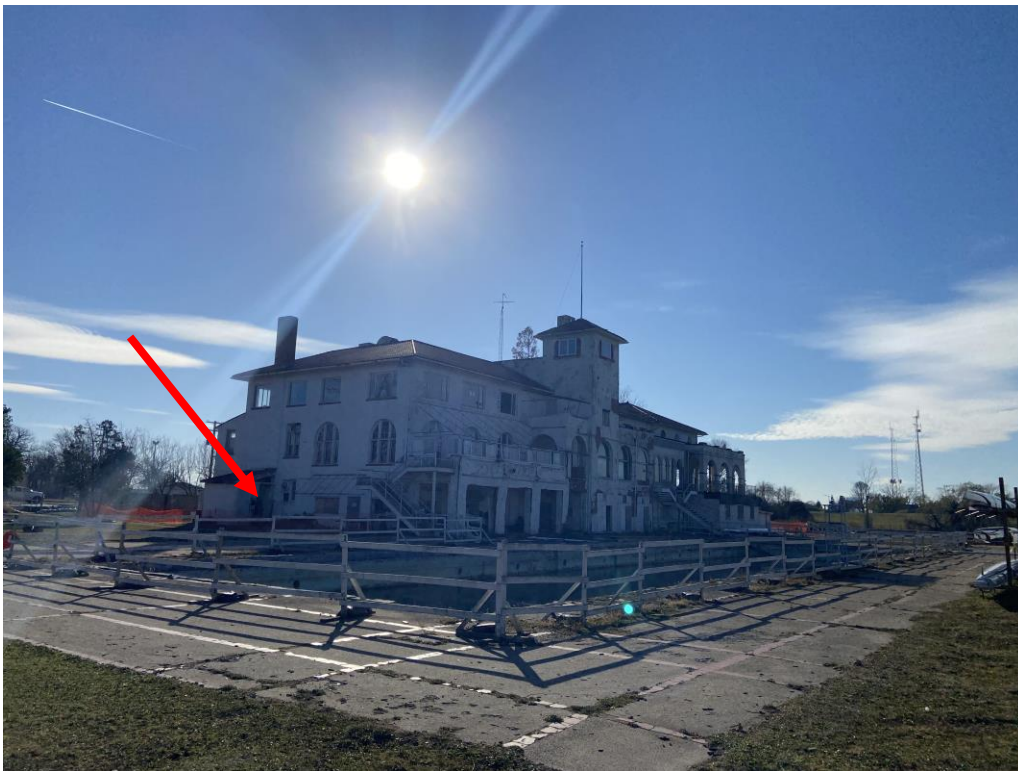
| Belle Isle State Park Boathouse<br>E Picnic Way, Detroit, MI 48207 | | | | | | |
|--|---|---|---|---|---|--|
| 17-EC-A,B,C | EA 1,2,3,4 | Exterior Caulk Penetrations | Good | No | 30 LF | Abate if impacted during future renovation |

Exterior Caulk Penetrations (HA 17)

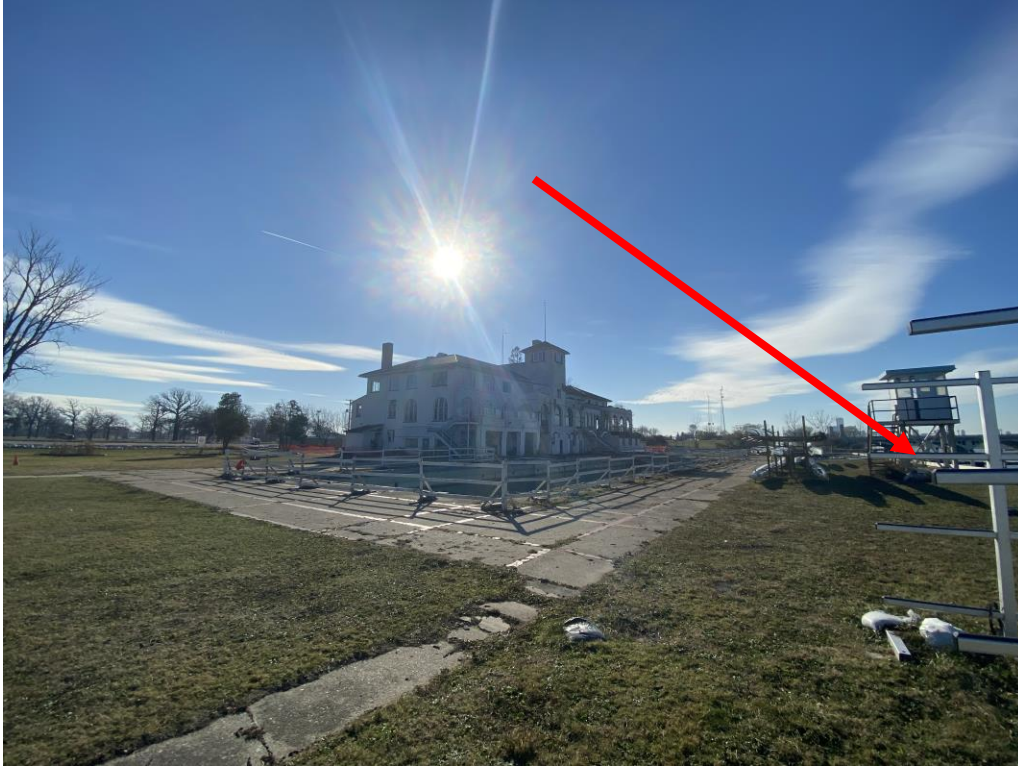
| Sample ID/Material | Location of Materials | Material | Condition | Friable Yes/No | Estimated Quantity | Recommendation |
|---|---|---|---|---|---|--|
| 102-WP-A,B,C | EA 1,2,3,4 | Water Proofing Sealer;<br>Foundation Edge and Some Areas on Walls | Good | No | 300 LF | Abate if impacted during future renovation |

Waterproofing (HA 102)

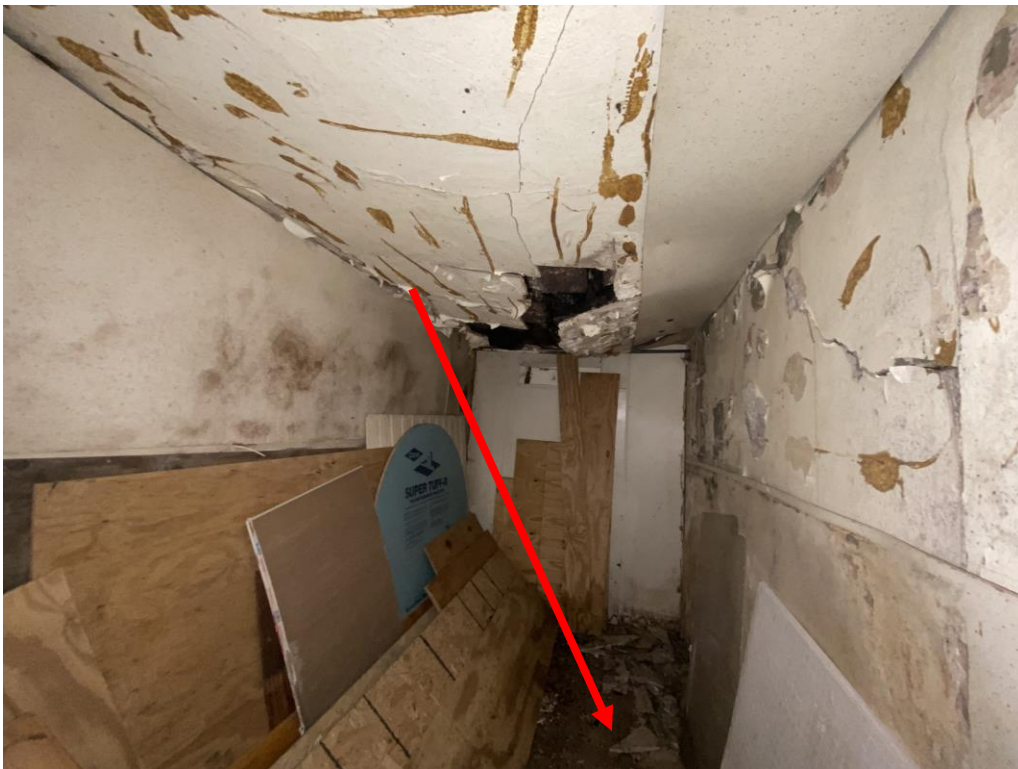
| Sample ID/Material | Location of Materials | Material | Condition | Friable Yes/No | Estimated Quantity | Recommendation |
|---|---|---|---|---|---|--|
| 96-FT-A,B,C | FS 37,38,39 | Cooler Floor Tile | Good | No | 300 SF | Abate during current planned renovation |

Cooler Floor Tile (HA 96)

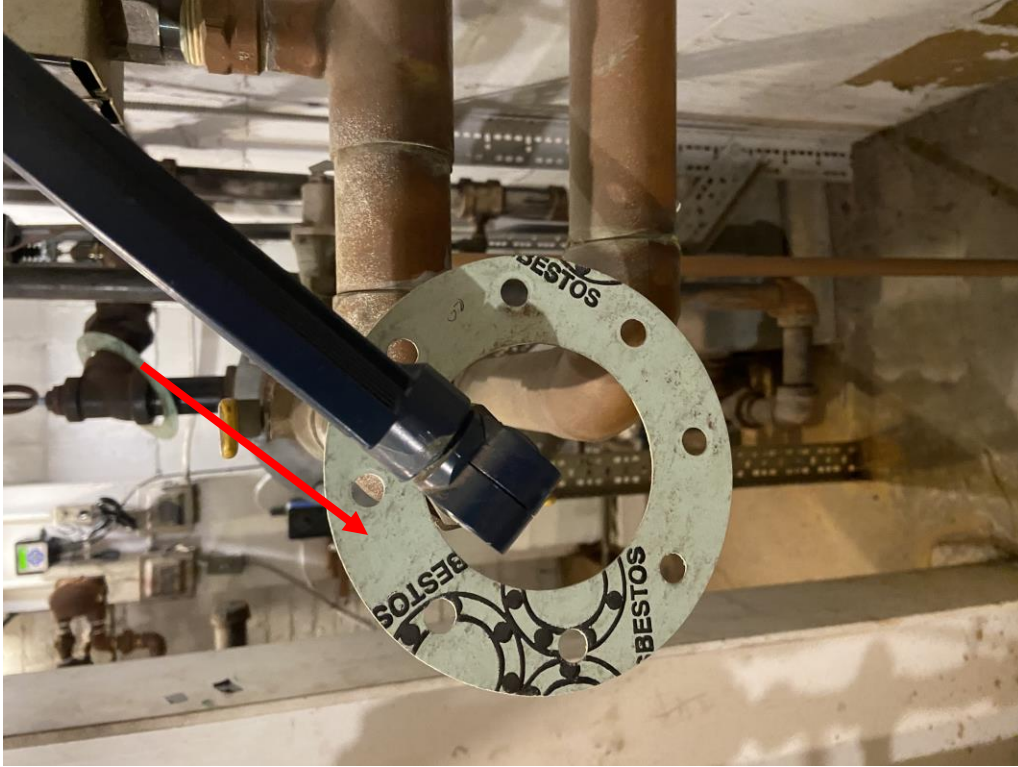
Gasket Being Used (HA 158 & 159)

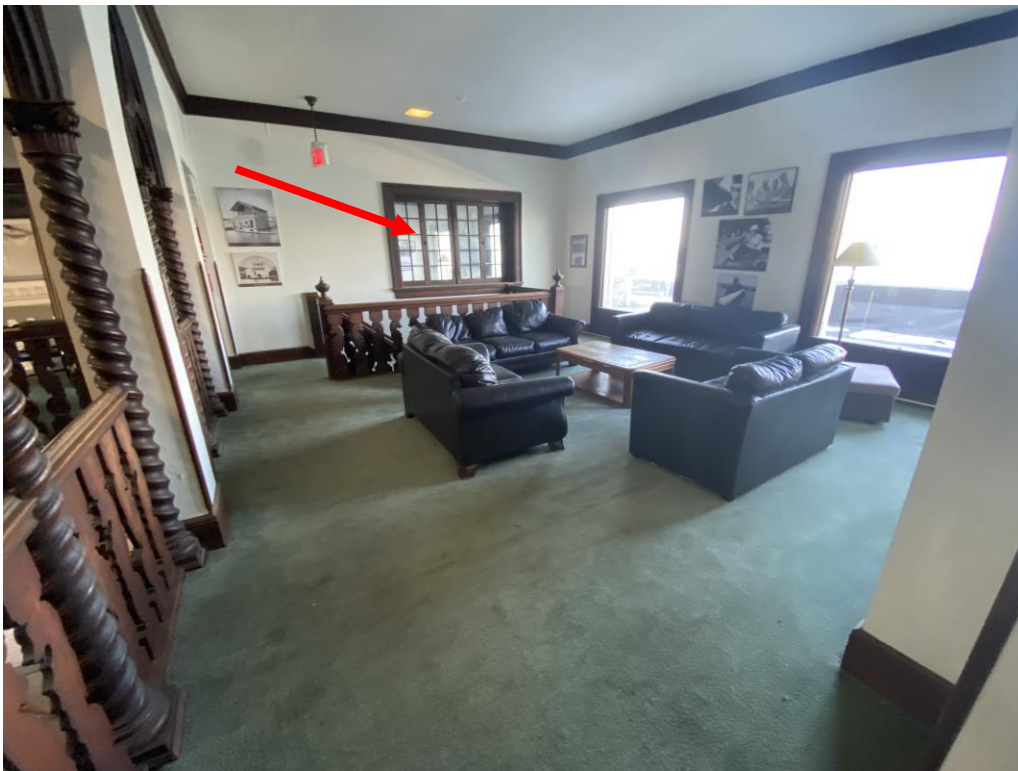
| Sample ID/Material | Location of Materials | Material | Condition | Friable Yes/No | Estimated Quantity | Recommendation |
|---|---|---|---|---|---|--|
| 73-WG-A,B,C | FS 1,17 | Interior Window Glazing | Good | Yes | 10 WINDOWS | Abate if impacted during future renovation |

Interior Window Glaze (HA 73)

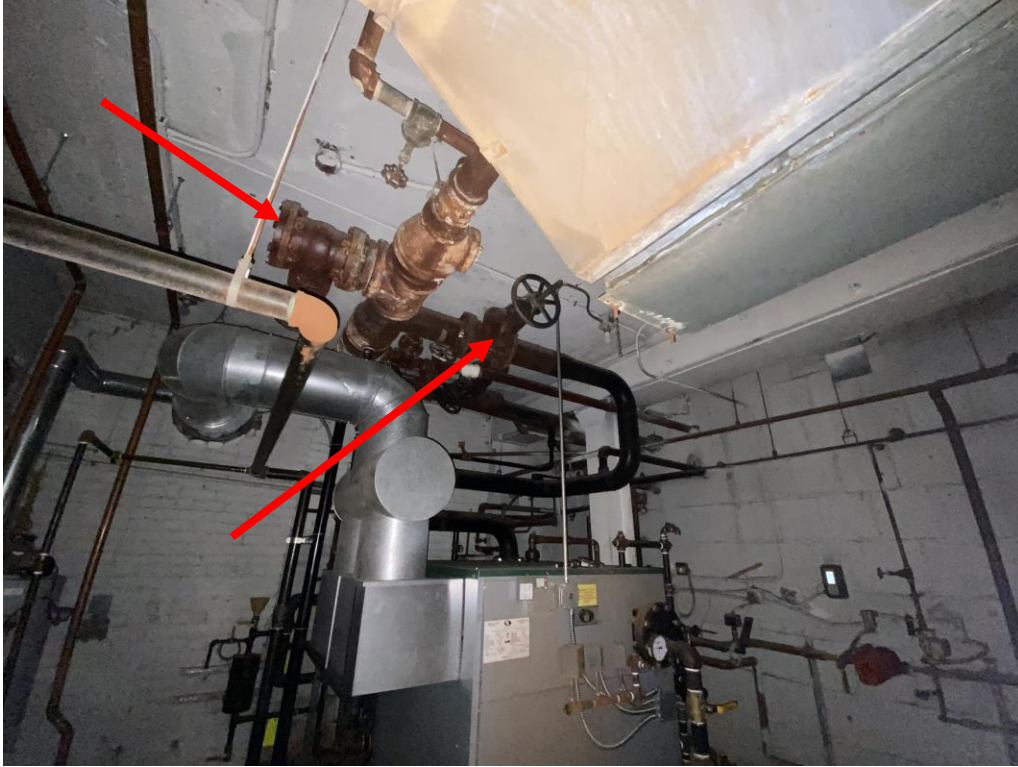
Gaskets In Use (HA 158 & 159)

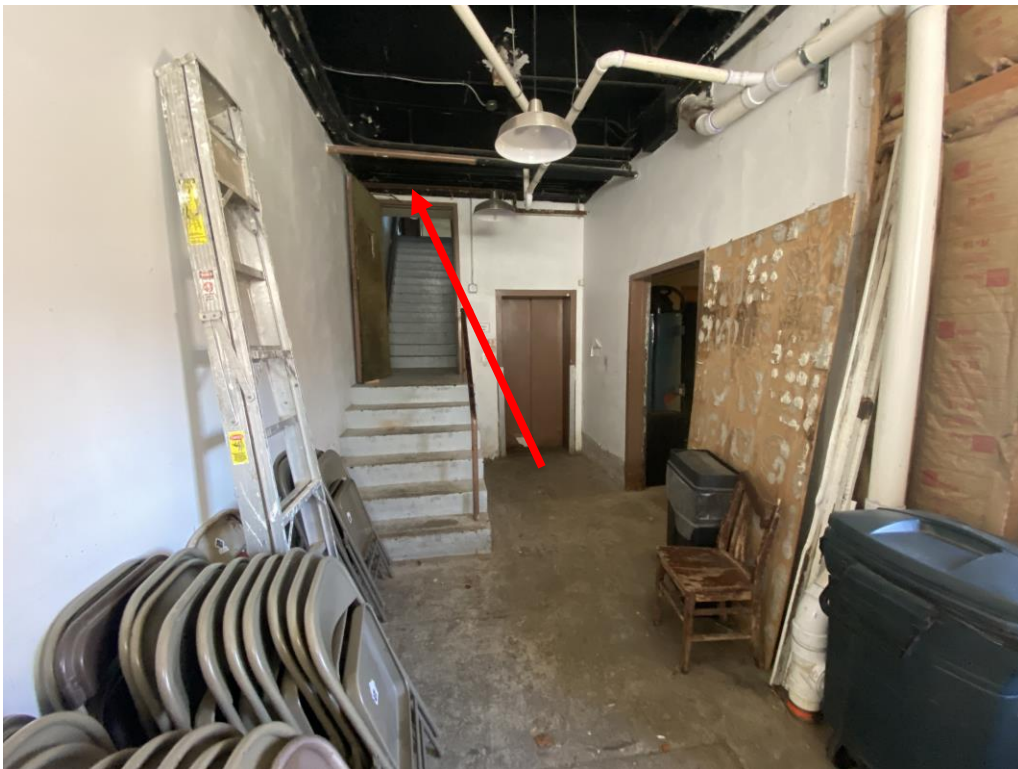
| Sample ID/Material | Location of Materials | Material | Condition | Friable Yes/No | Estimated Quantity | Recommendation |
|---|---|---|---|---|---|--|
| 87-PW-A,B,C | FS 36,40 | Pipe Wrap; Brown/White | Good | Yes | 70 LF | Abate during current planned renovation |

Pipe Wrap Brown (HA 87)

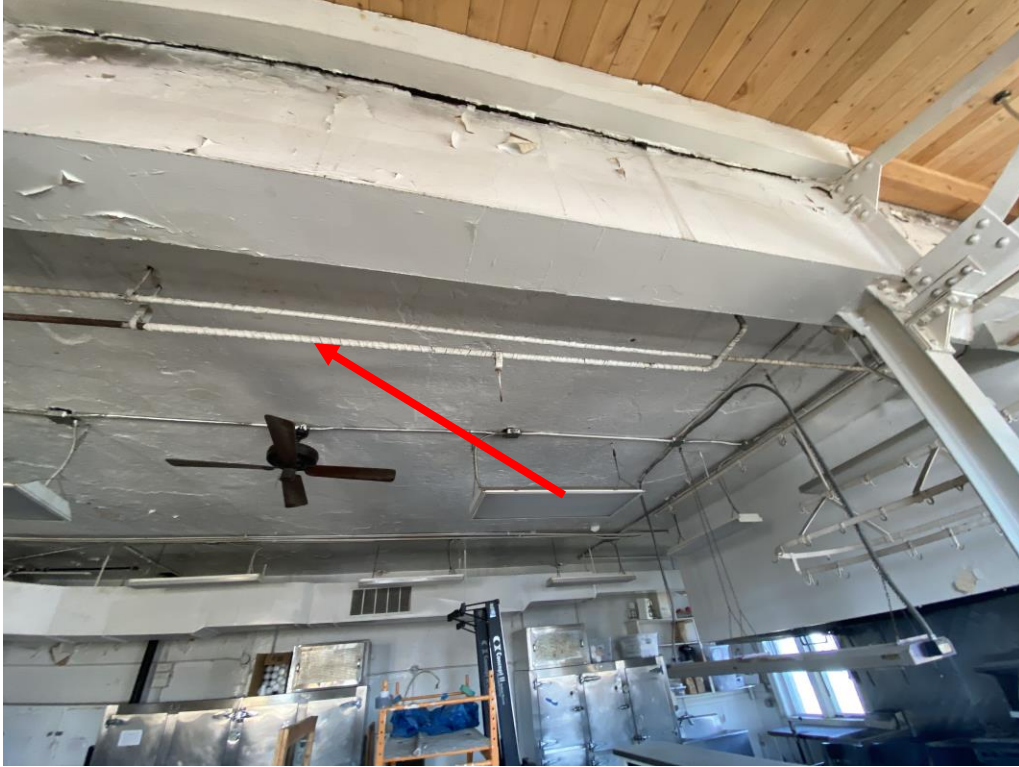
| Belle Isle State Park Boathouse<br>E Picnic Way, Detroit, MI 48207 | | | | | | |
|--|---|---|---|---|---|--|
| 68-PI-A,B,C | FS 24 | Pipe Insulation;<br>Mastic Tape; White | Good | Yes | 70 LF | Abate during current planned renovation |

Pipe Wrap White (HA 68)

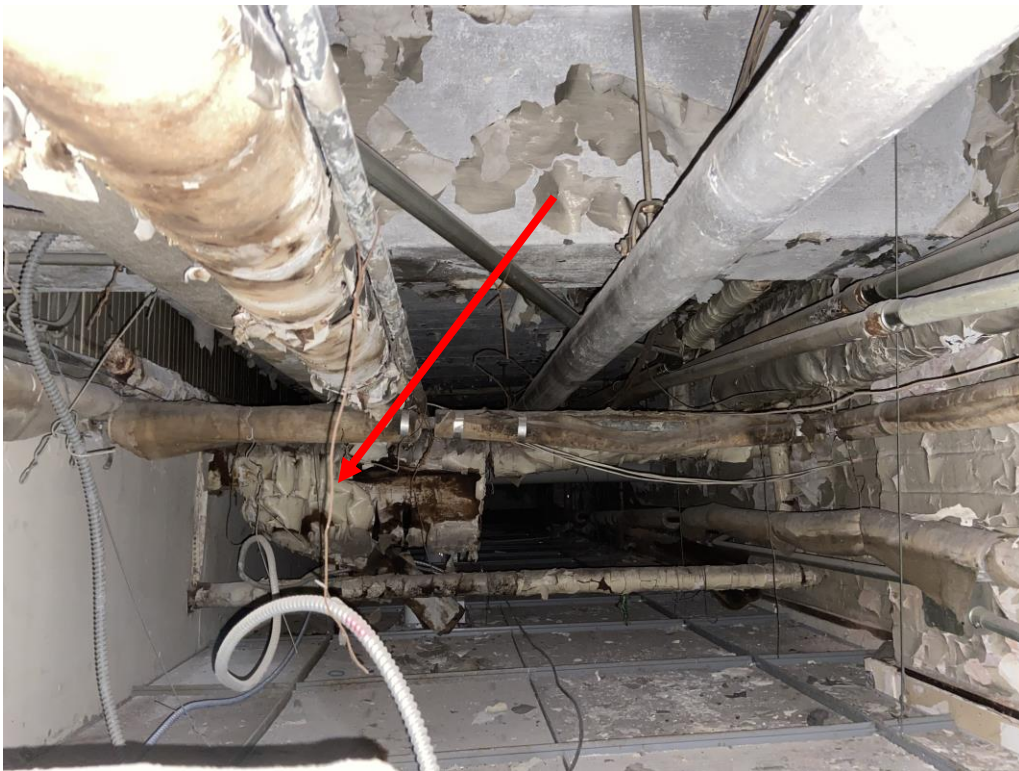
Severe ACM Damage

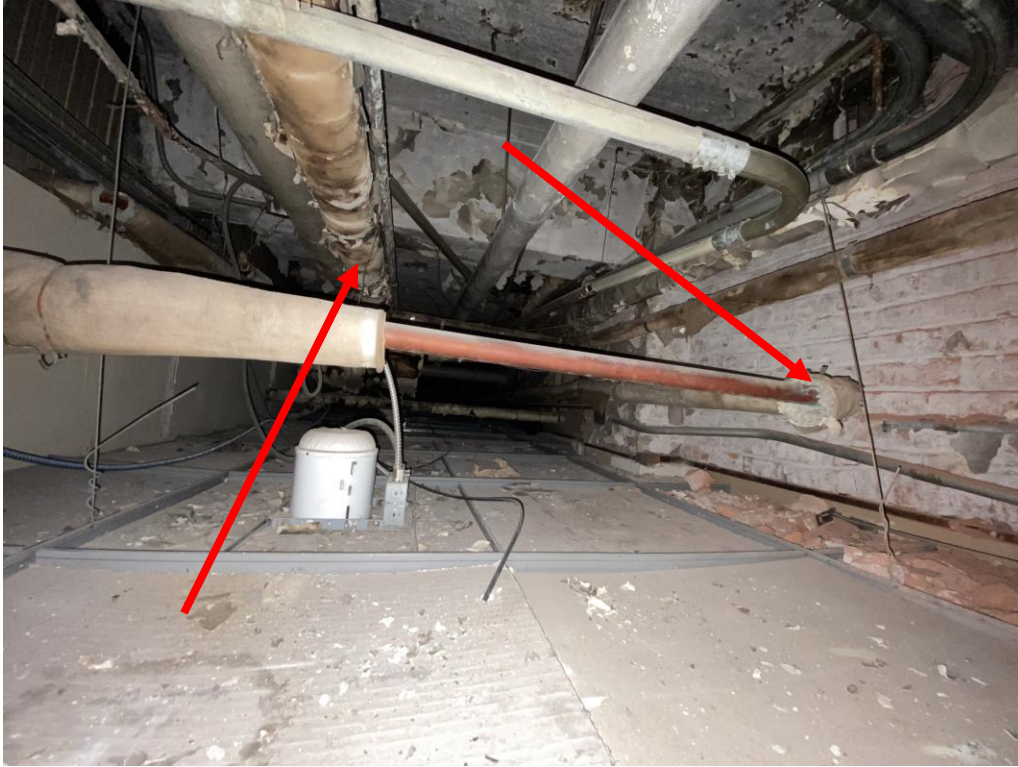
Severe ACM Damage
