# **PRE-RENOVATION HAZARDOUS MATERIALS SURVEY**

**BELLE ISLE PARK- BOATHOUSE**

**E PICNIC WAY, DETROIT, MI 48207**

188BS22746

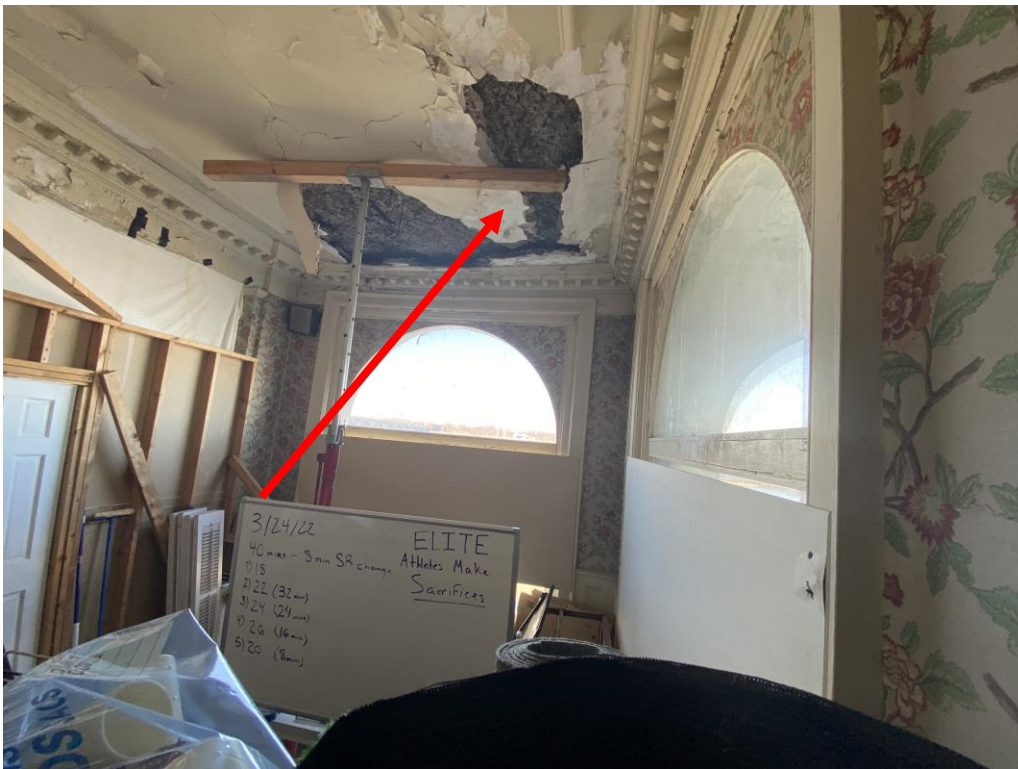
Ceilings Collapsing

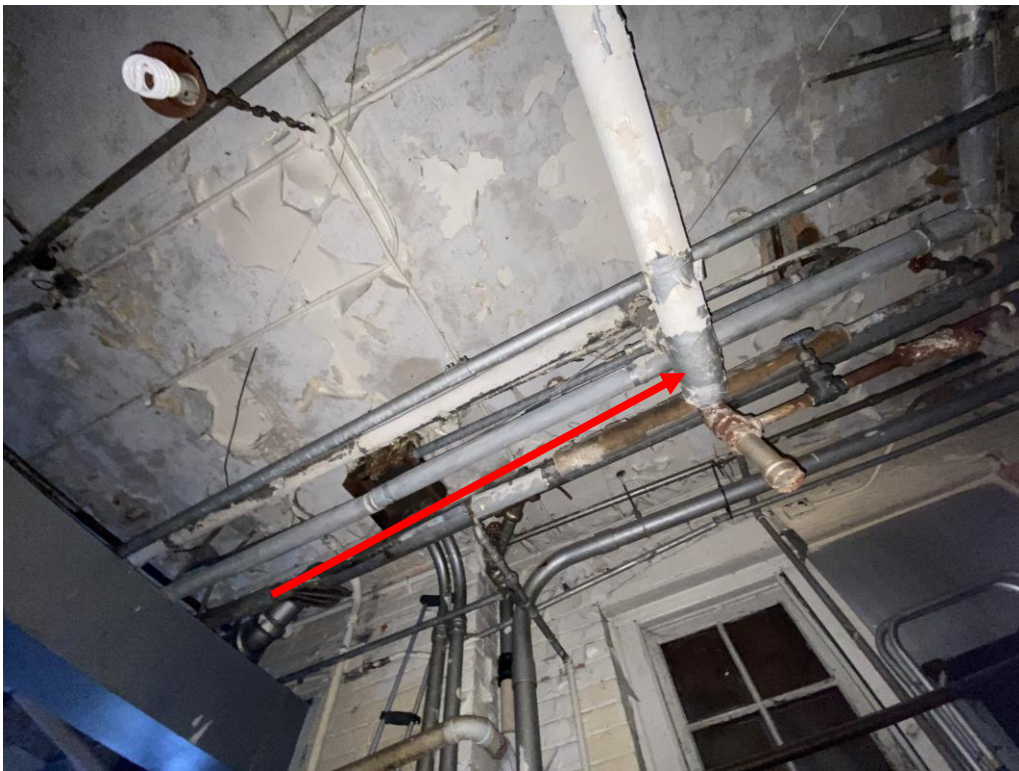
ACM Damage
