EXISTING MAIN ACCESS BRIDGE**Existing Construction**

Belle Isle – Access Fishing Location
File No.: 751/15224.MNB
Index No.: 59715

Bridge Safety Inspection Report

Facility	Federal Structure ID	Insp. Agency	Insp. Name	Insp. Date	Insp. Freq.
Main Access Bridge at Detroit Boat Club Building		NDG, LLC	J. Rintala	9/8/2016

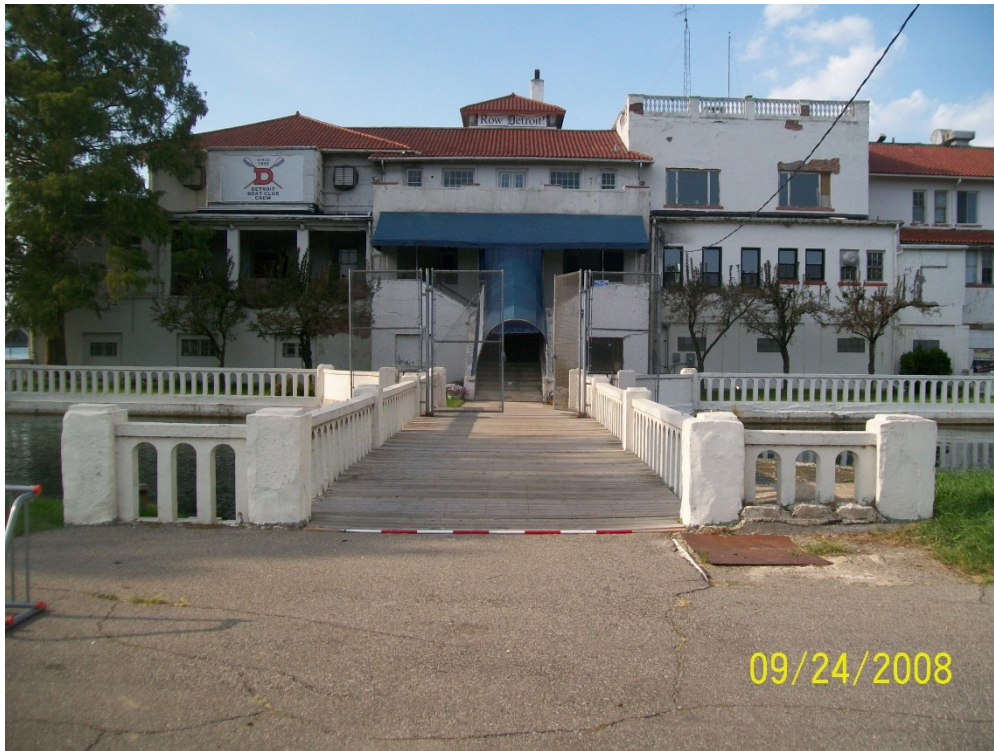
Main Access Bridge South Approach (Looking North)

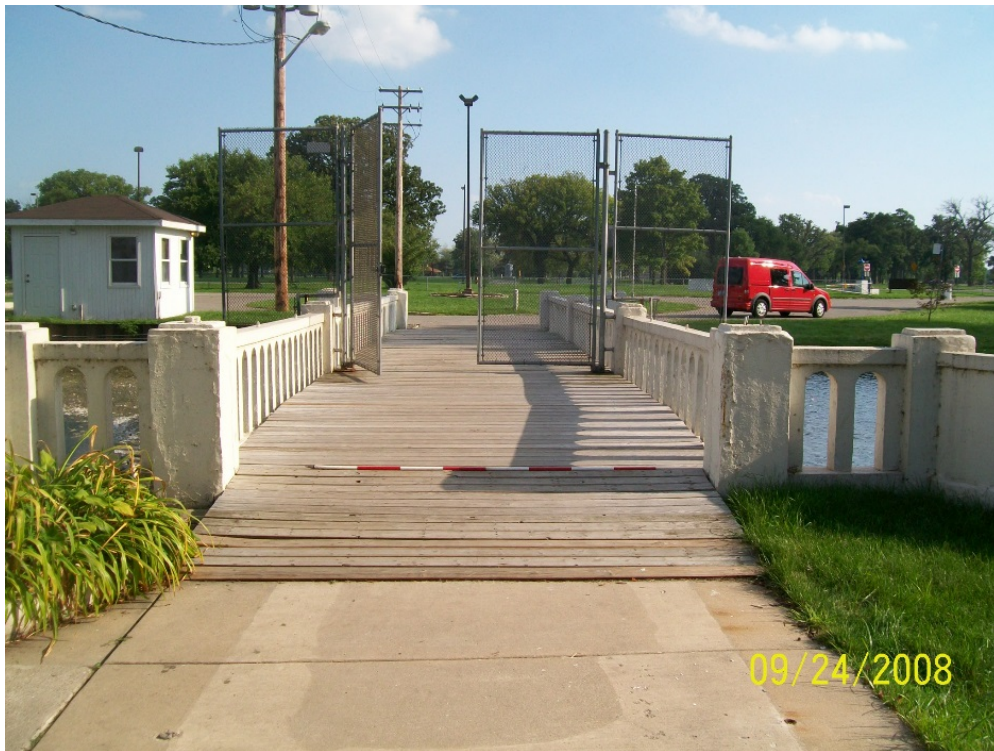
Main Access Bridge North Approach (Looking South)

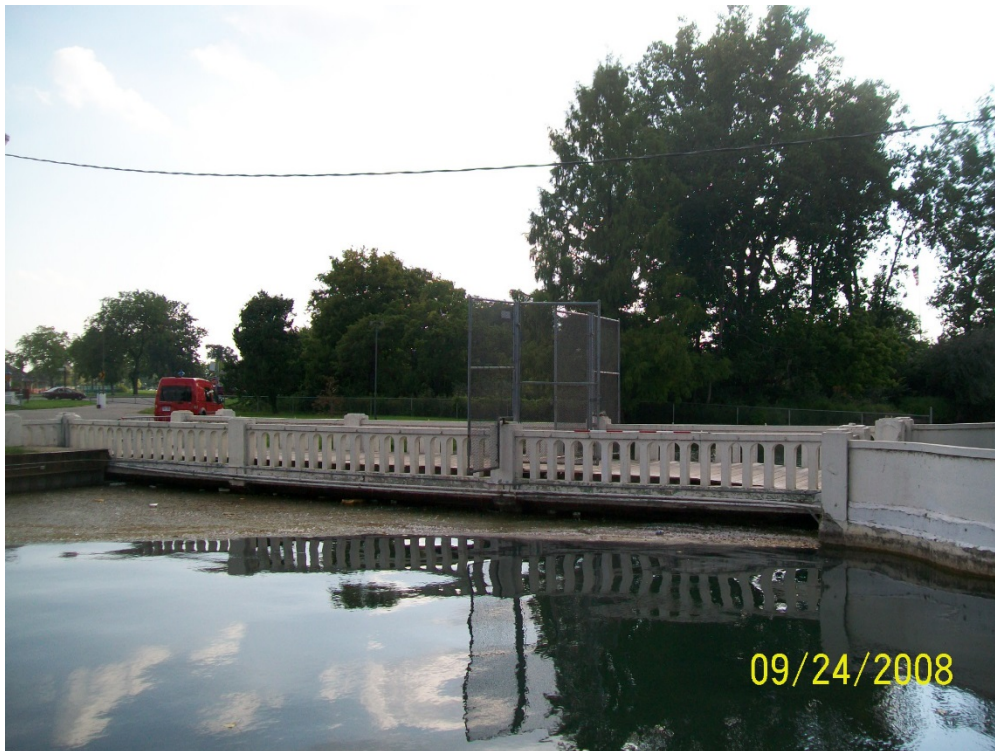
Main Access Bridge East Elevation (Looking West)
