Belle Isle Boathouse**Renovations**

Detroit, Michigan

Belle Isle Boathouse Building and Site Assessment

December 2019

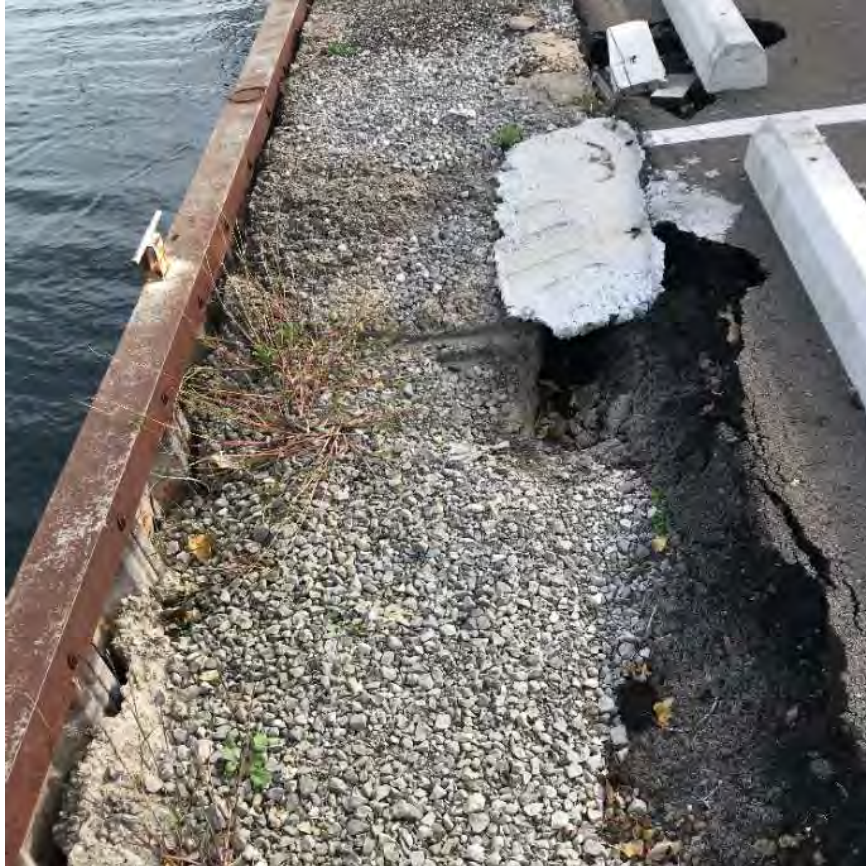
Photo 1

- Typical condition behind sheet pile wall **[Photo #1, #2, #3]**.
- Non-structured shoreline, rubble present **[Photo #4, #5]**.

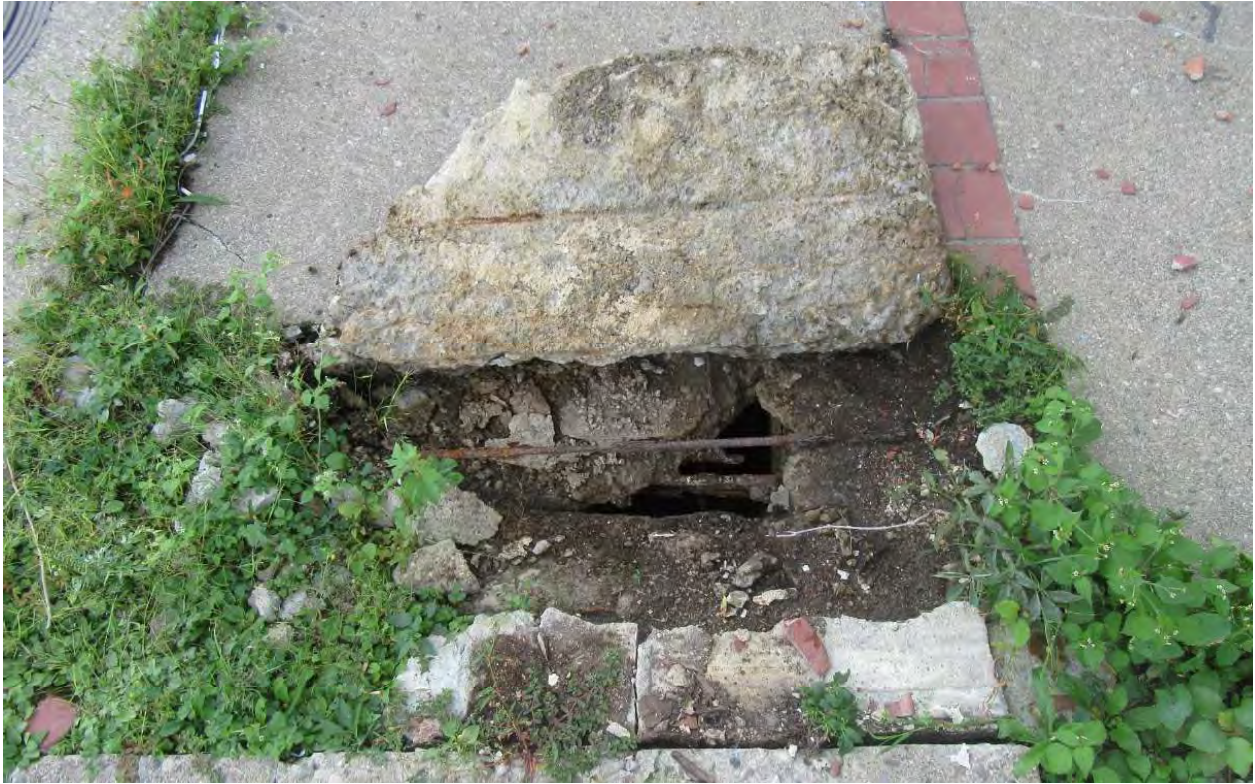
Photo 7

- Representative condition of pool decking **[Photo #6, #7]**.
- View of pool condition **[Photo #8]**.
- Close up of pool wall deterioration **[Photo #9]**.
- Spalling, tile breakage in smaller pool **[Photo #10]**.

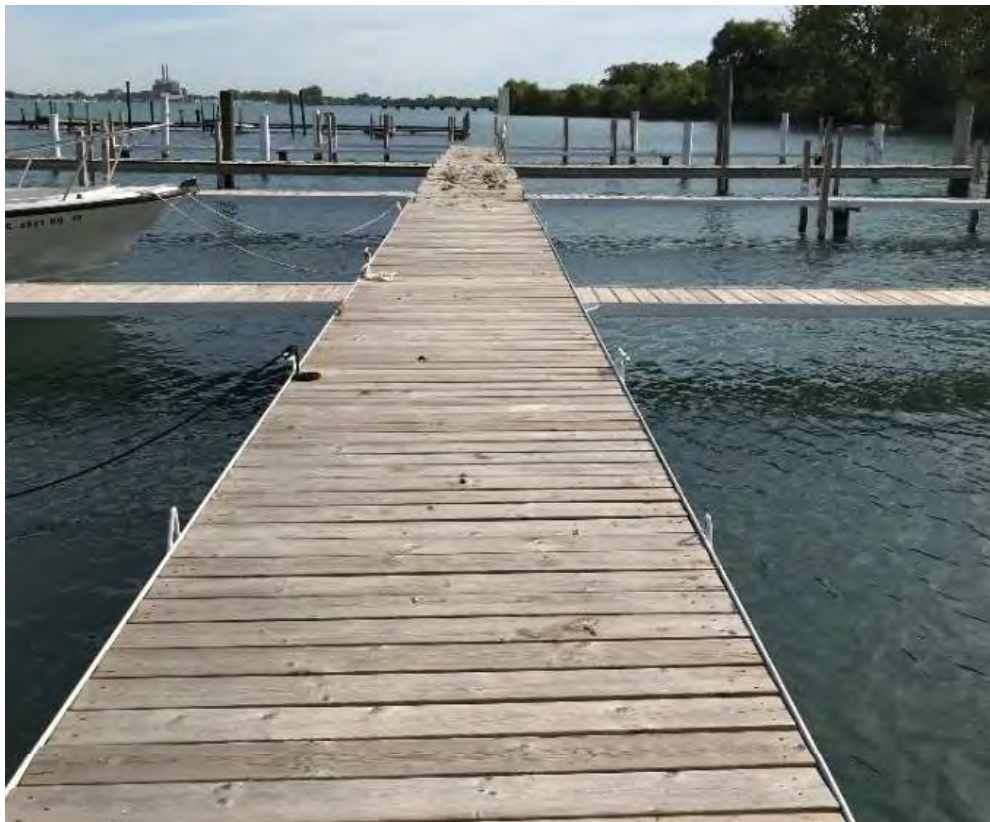
Photo 14

- Dock system on east side, some decking recently replaced **[Photo #14]**.
- Representative condition of docks on north side of island. These docks are not safe for use **[Photo #15]**.
- West side docks are a combination of formats. Newer metal portions may be salvageable **[Photo #16]**.

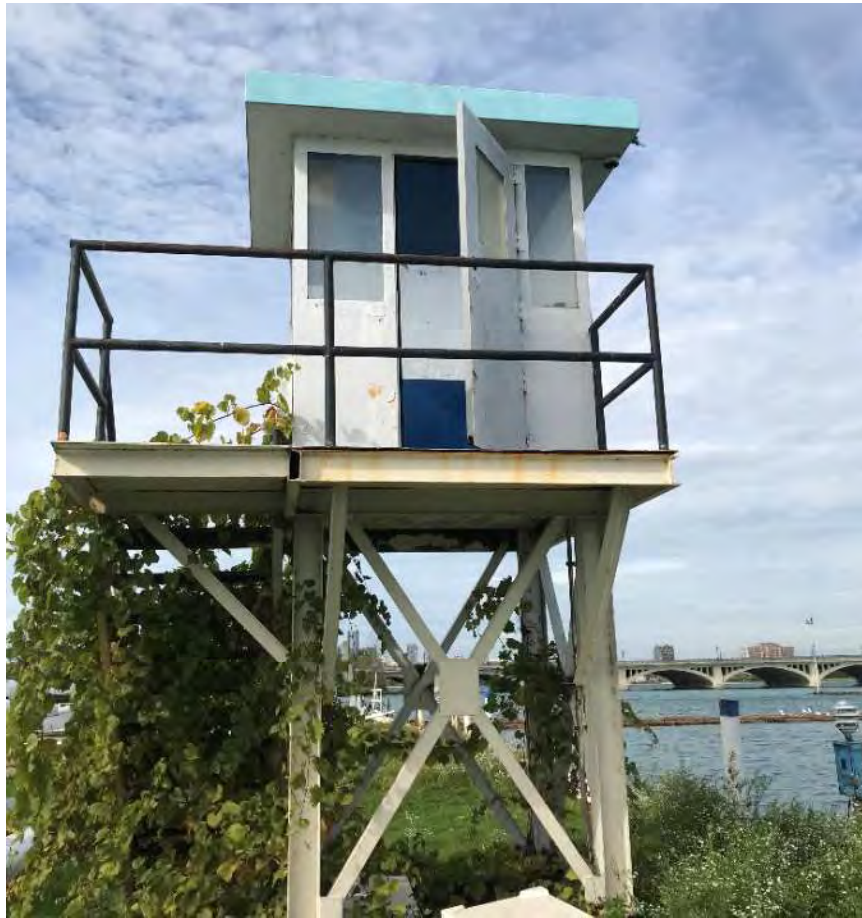
Photo 17

- Lifeguard Structure and Stand have surface rust and deterioration. Removal of both is recommended, though the main structure could be repurposed depending on future programming needs **[Photos #17]**.
- Band Shelter Structure. Overall the structure is in fair shape and appears to have been maintained. However, its removal is necessary to facilitate stabilization of island. It is

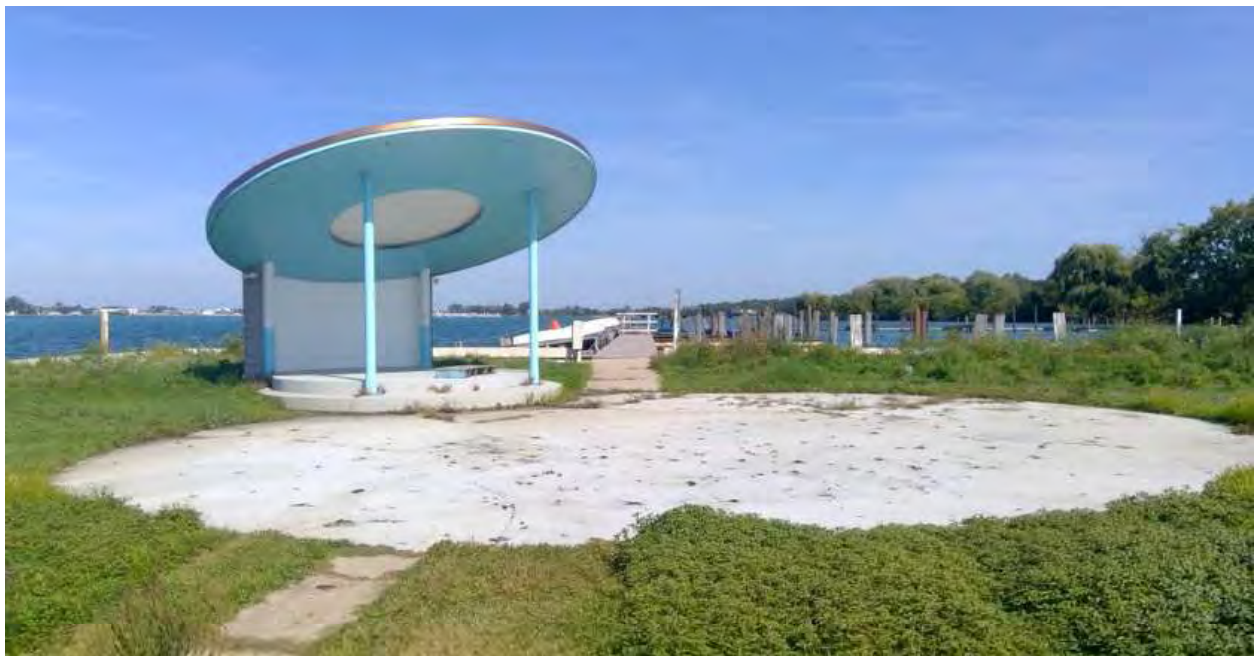
Photo 18

recommended that the shelter be saved for potential reuse, pending programming [Photo #18].

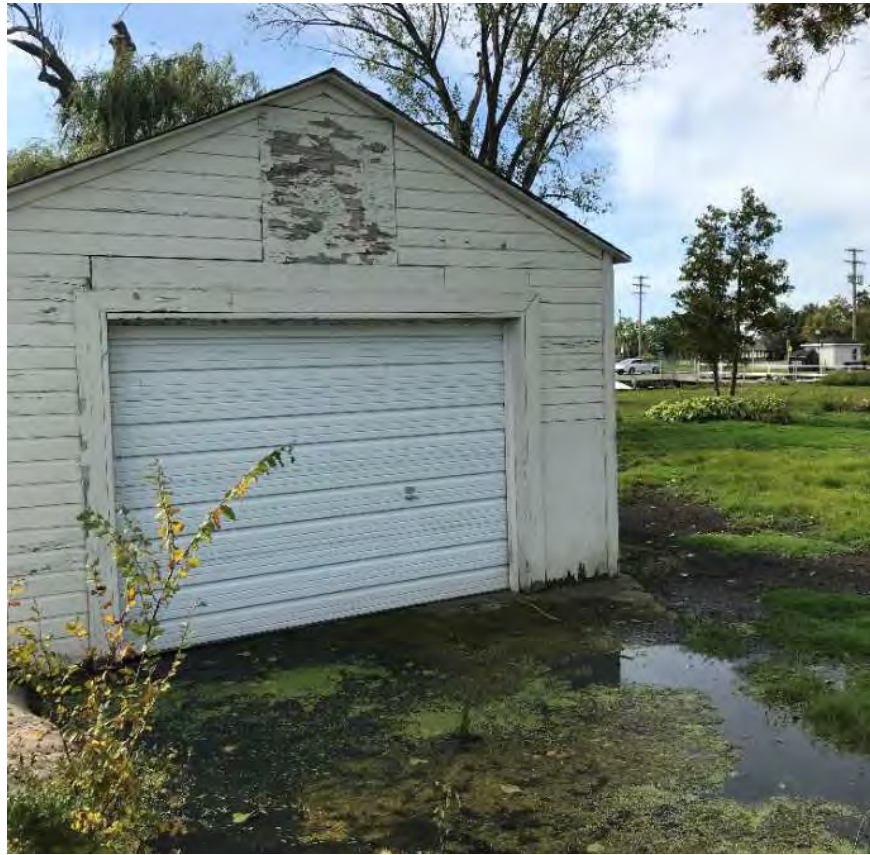
Photo 19

- Storage Building on west end of property is in poor condition, likely further impacted by standing water present this season [Photo #19].
- Entry / Gate House is in fair condition. Removal is recommended to facilitate island stabilization.
- Concrete and Tile Raised Planters are found in several locations on site – near pools and entry being most visible. All are showing wear with cracked and falling tilework, deteriorating concrete. Overall, they are in poor condition. Removal is recommended [Photo #20].
- Concrete block wall near the SE corner of the main structure is in fair condition. Removal is recommended to facilitate island stabilization

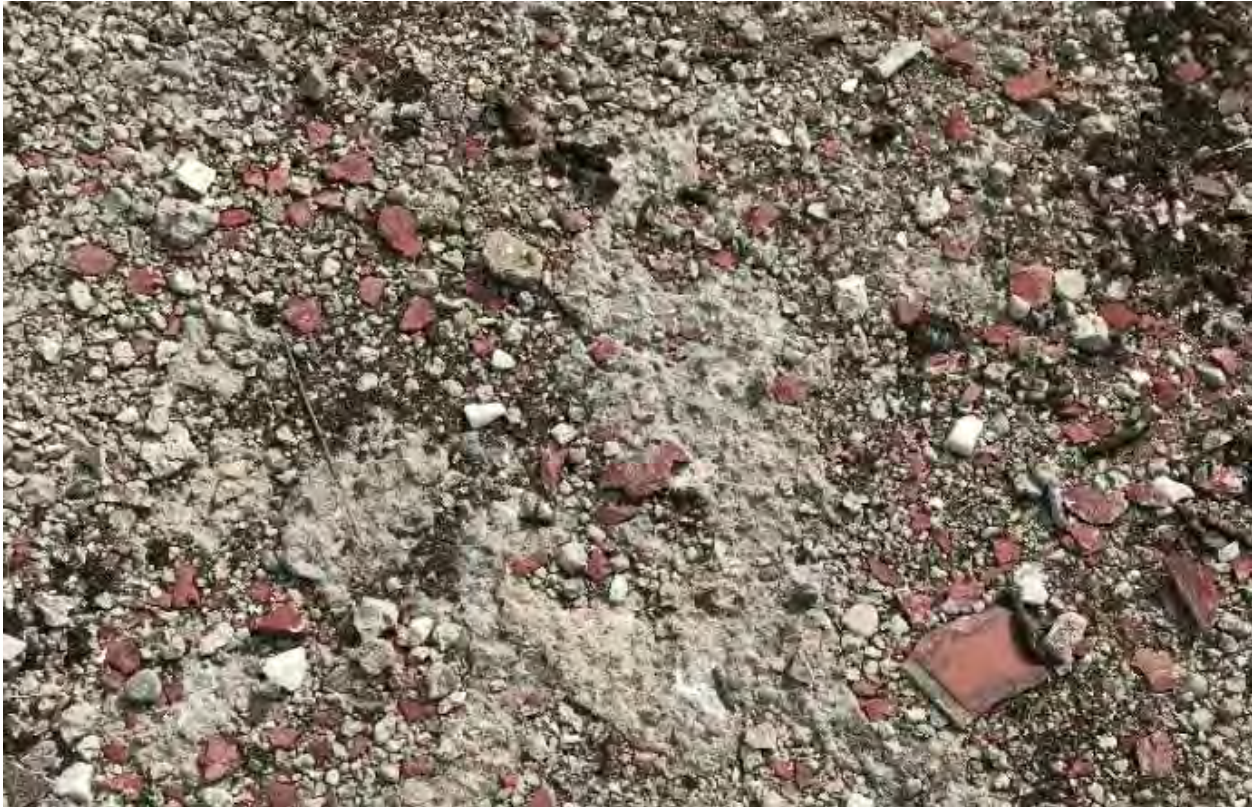
Photo 21

- Concrete spalling, cracking and damage is evident throughout the site [Photo #21].
- Heaving concrete walk at connection to north docks [Photo #22].

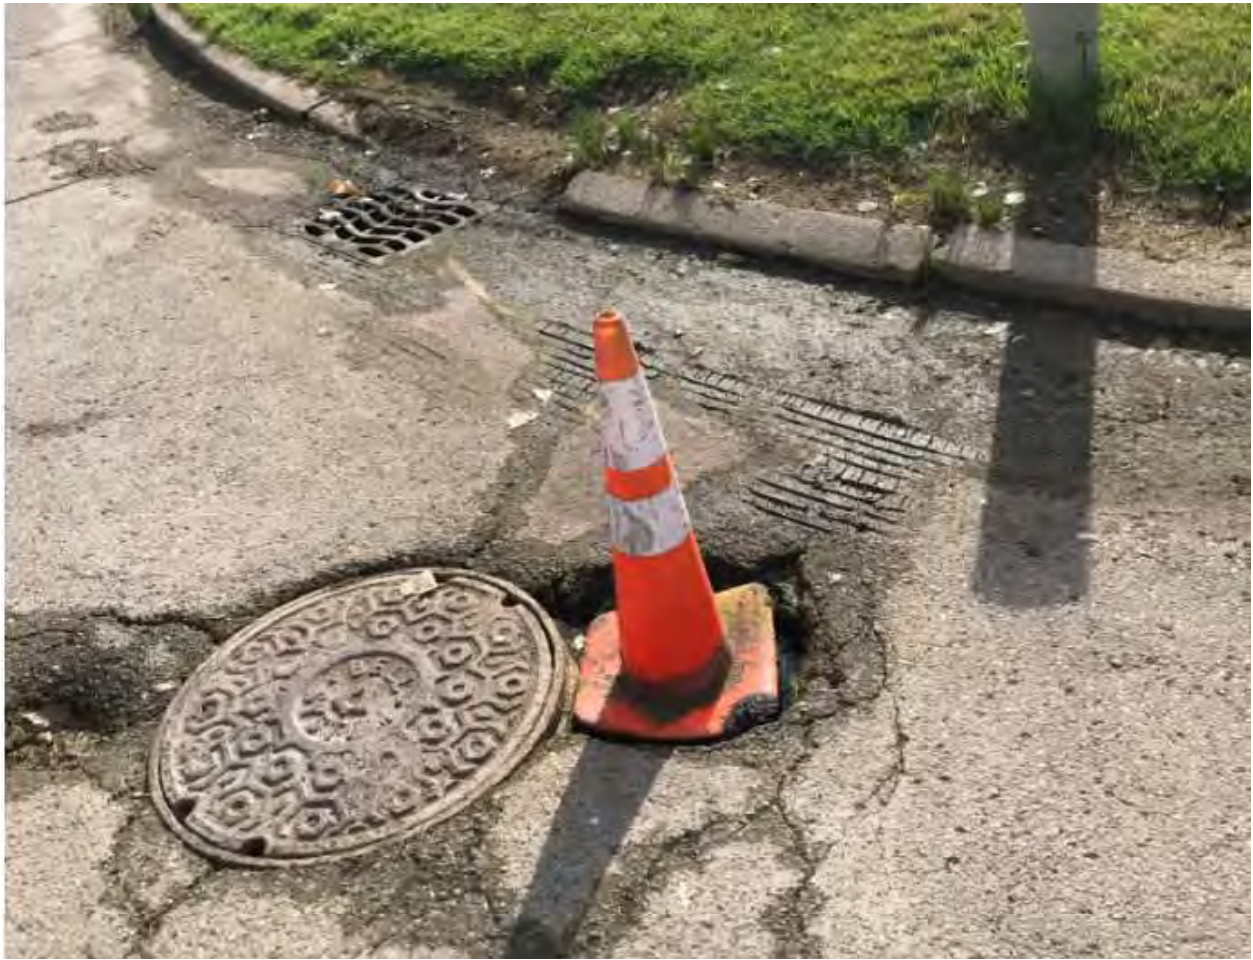
Photo 23

- Structure in need of adjustment, adjacent repairs [Photo #23].

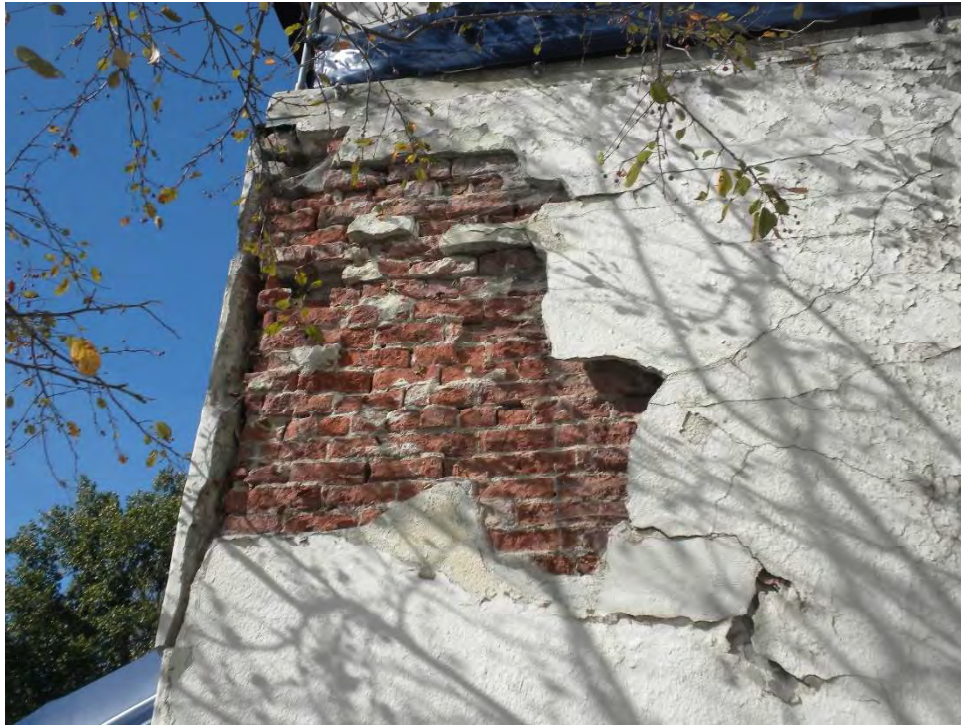
- **Stucco Finish:** Approximately 16,276 sqft, or 78% percent of the exterior stucco finish is affected by one of the following conditions:
 - a. Exposed & Deteriorated Mass Masonry Walls may comprise only a small portion of the total exterior wall area, but the severity of damage represents a structural concern and fall hazard [Photo 5].

- a. Approximately 1,765 sqft or 9% percent of the brick comprising the mass masonry walls are exposed due to missing/spalled stucco finish [Photos 5-6].

Photo 5 Damaged/Deteriorated Brick

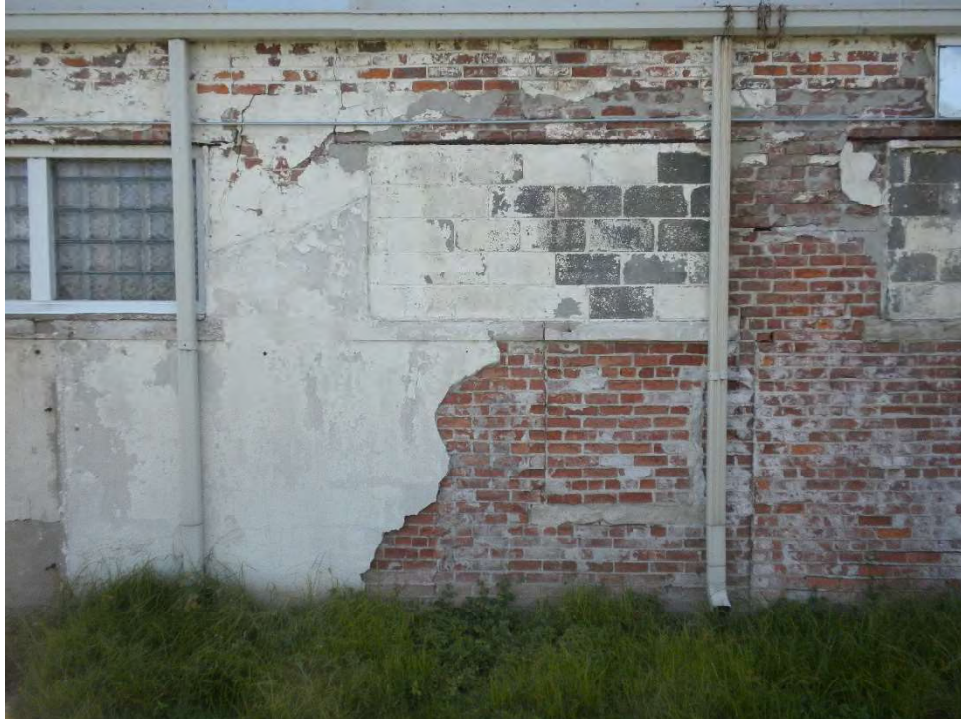
- b. Missing Stucco (i.e. stucco that has spalled or was removed) represents approximately 6 percent of the façade. With the stucco removed, the underlying brick mass masonry is subject to deterioration from exposure to the elements, [Photo 6].

Photo 6 Spalled Stucco

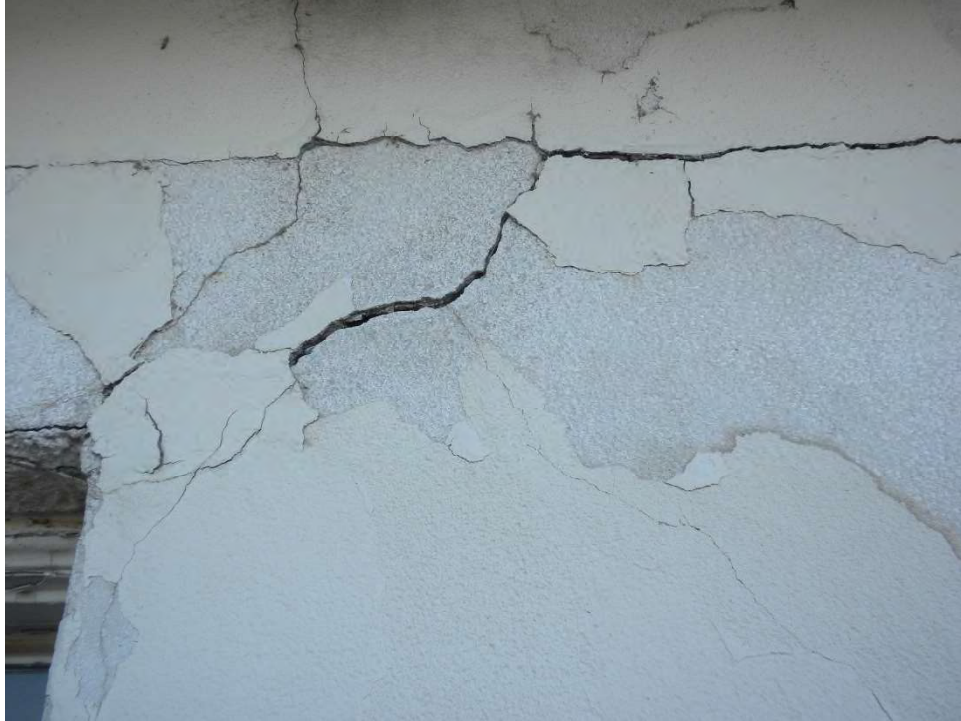
Photo 7 Debonded Stucco (Back-side of covered terraces)

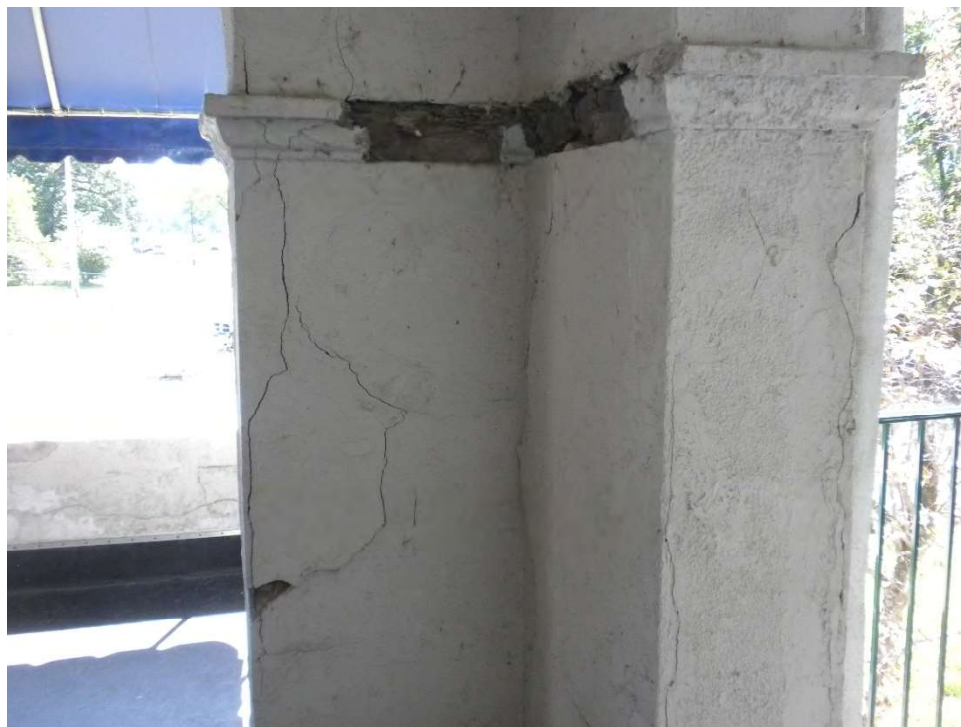
Photo 8 Damaged Stucco – Surface Scaled Finish

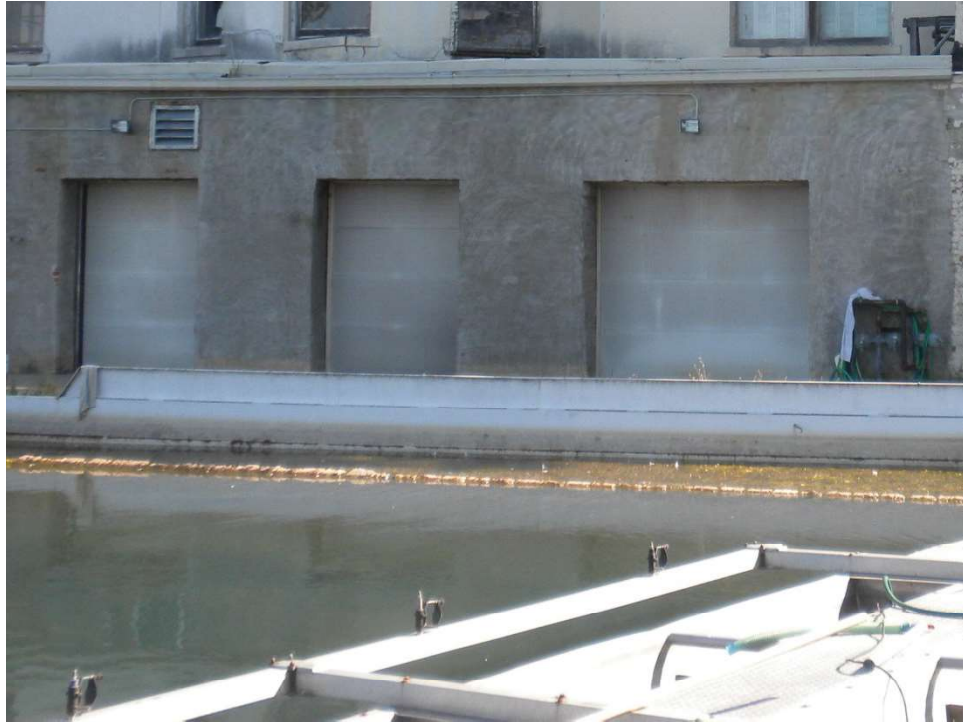
- d. Repaired Stucco exists in one area along the west elevation [Photo 9].
- **Brick Mass Masonry Walls:** The exterior walls are comprised of multi-wythe load or non-load bearing brick.

Photo 9 Previously Repaired Stucco

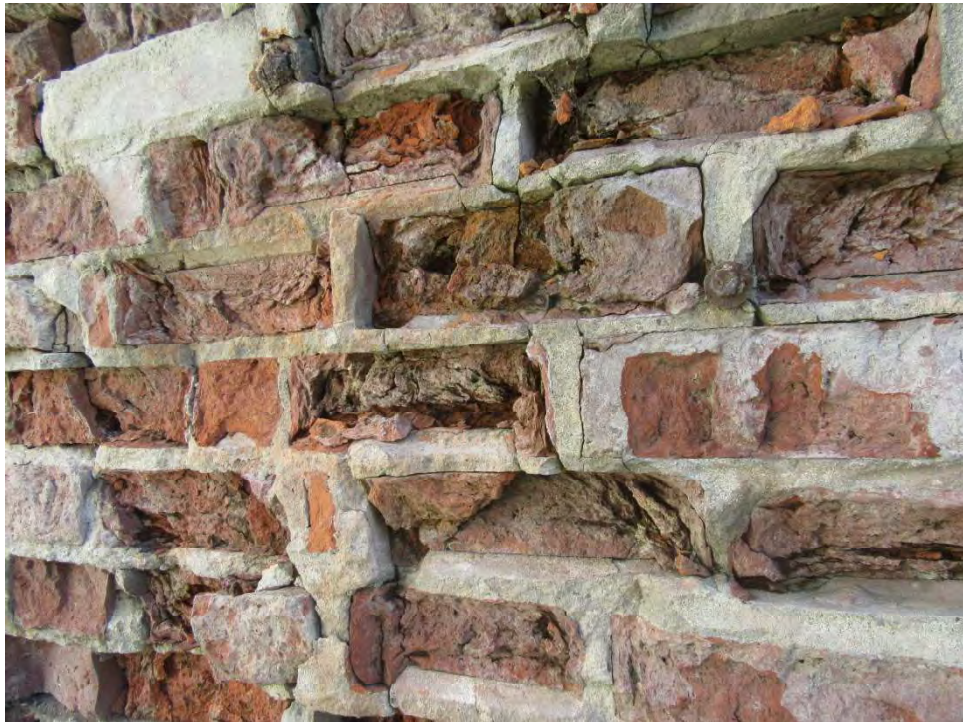
- a. Deterioration of the mass masonry due to exposure has resulted in scaling, spalled and displacement of the brick comprising the effected exterior wall [Photos 10]. These conditions may only affect a small percentage of the exterior walls, but they represent a potential structural concern.

Photo 10 Deteriorated Masonry

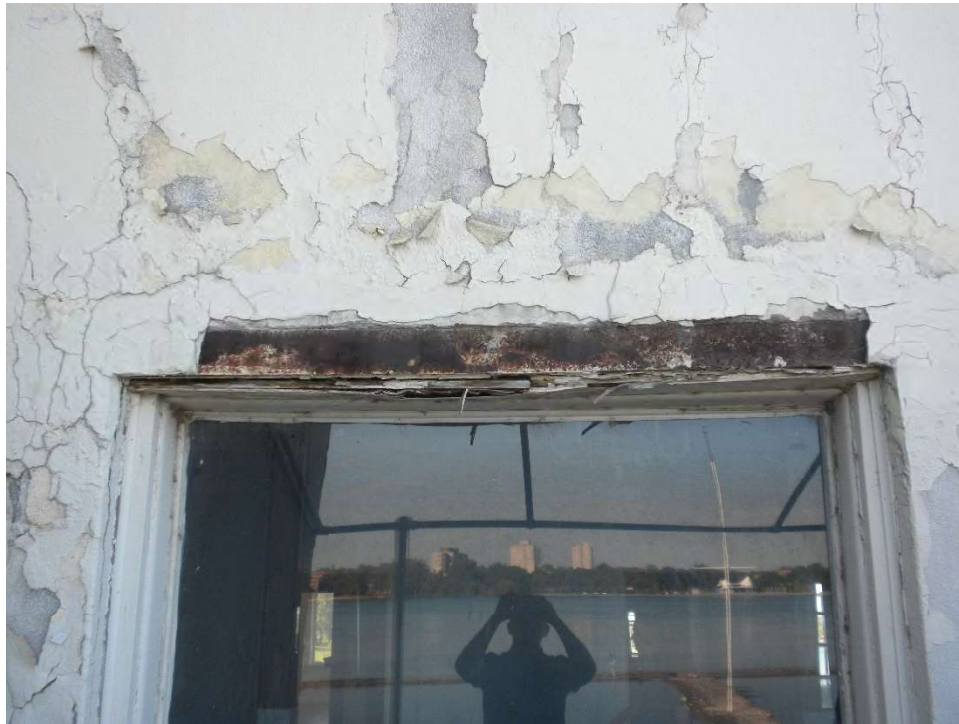
- b. **Window Lintels:** From observations of the window openings, it appears that a steel angle was anchored to the concrete frame as a lintel to carry the load of the brick above the window. Most of the lintels are corroded to the point that pack rust has displaced the brick and spalled the stucco finish. In severe instances, the lintel has bowed which and now represents a structural concern [Photo 11].

Photo 11 Damaged Lintels

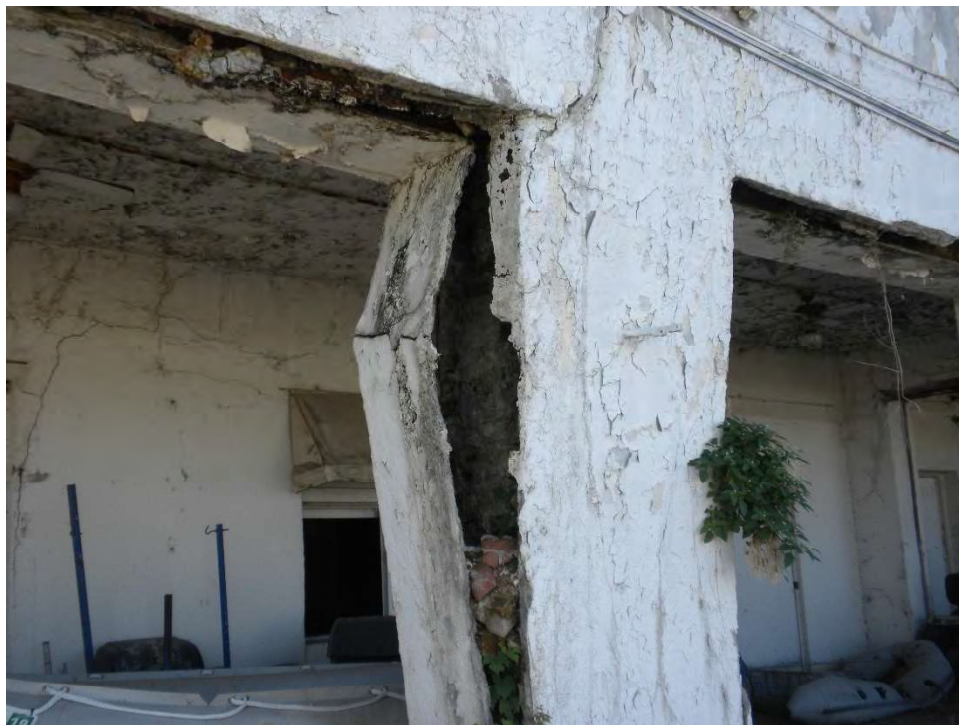
- Deteriorated stucco takes the form of cracked, debonded and spalled stucco [Photos 12].
- Tile wear surface where exposed is in fair condition [Photo 13].
- Tile wear surface was covered by an adhered EPDM membrane on most terraces [Photo 14].
- The concrete ceiling contains areas of scaled and spalled concrete and exposed reinforcing steel [Photo 15-16].
- Guard rails have been upgraded on the second level terraces to meet proper Code height, the terraces on the third level have not been upgraded. The third level terraces should be restricted to prevent occupancy.

Photo 12 Debonded Stucco (Exterior Façade)

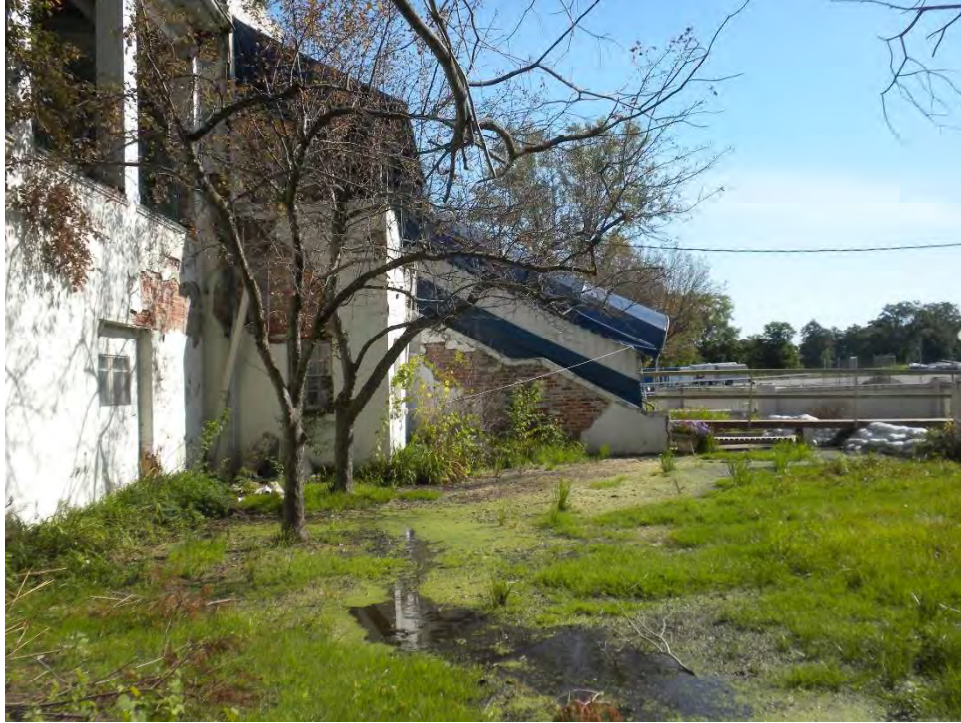
- Mass masonry walls that form the side enclosures of the stairs are deteriorated [Photo 21].
- Concrete stair steps are deteriorated [Photo 22].
- Stair and balcony guard rail concrete copings are cracked and spalled [Photo 23].

Photo 21 South Staircase Deteriorated Masonry

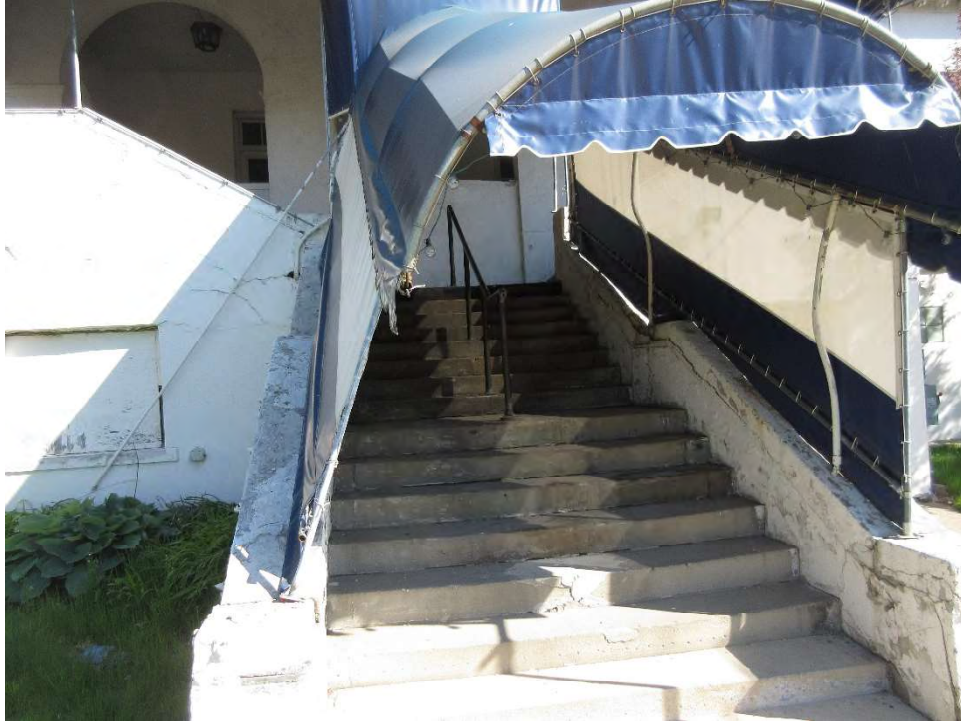
Photo 22 South Staircase Deteriorated Concrete Steps

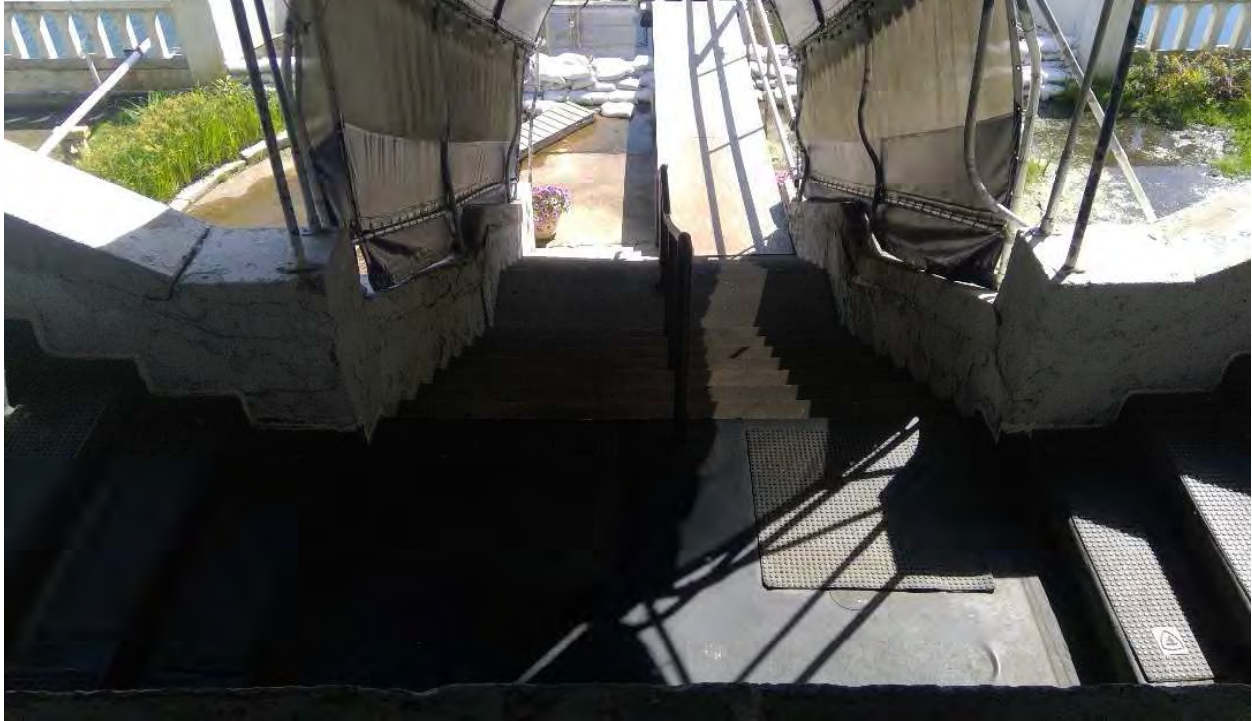
Photo 23 South Staircase Deteriorating Copings

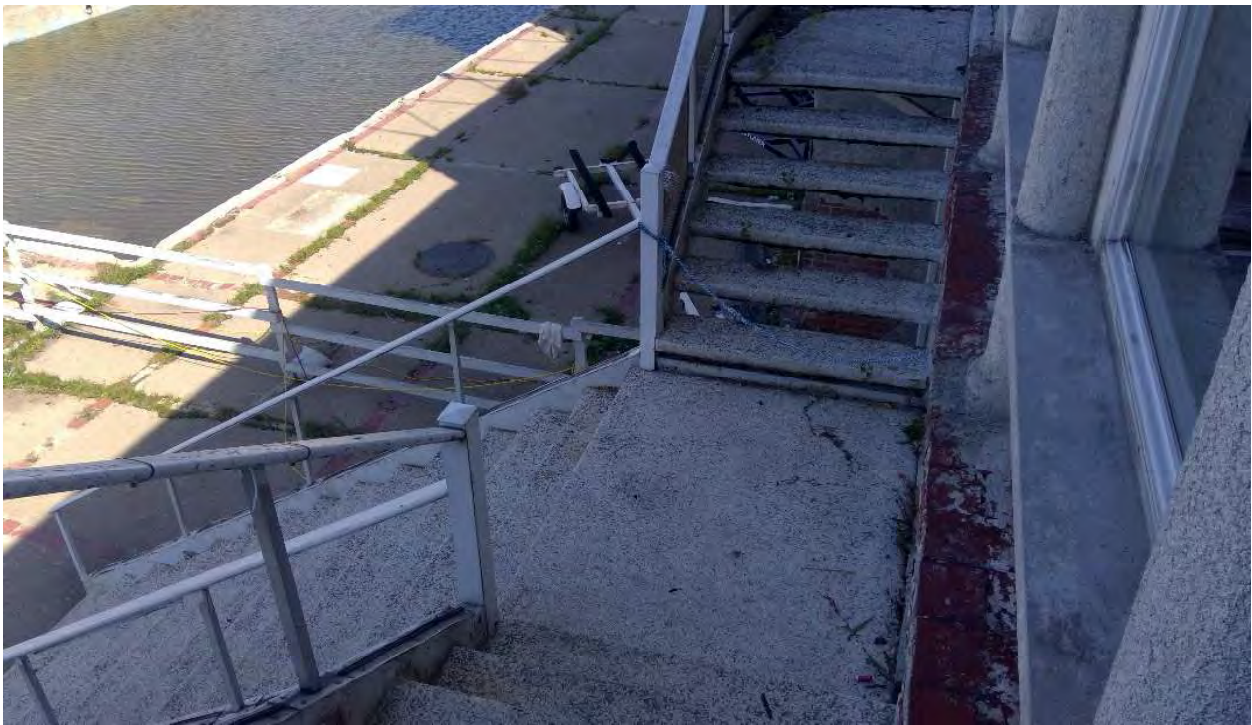
- Terrazzo threads are mostly intact but are affected by deterioration in the form of cracks, a scaled surface and minor spalled terrazzo. [Photo 24].
- Terrazzo landings are severely cracked and spalled [Photo 25].
- Steel frame and guard rails are in fair condition with only minor surface corrosion [Photo 26].

Photo 24 North Staircase Deteriorated Treads

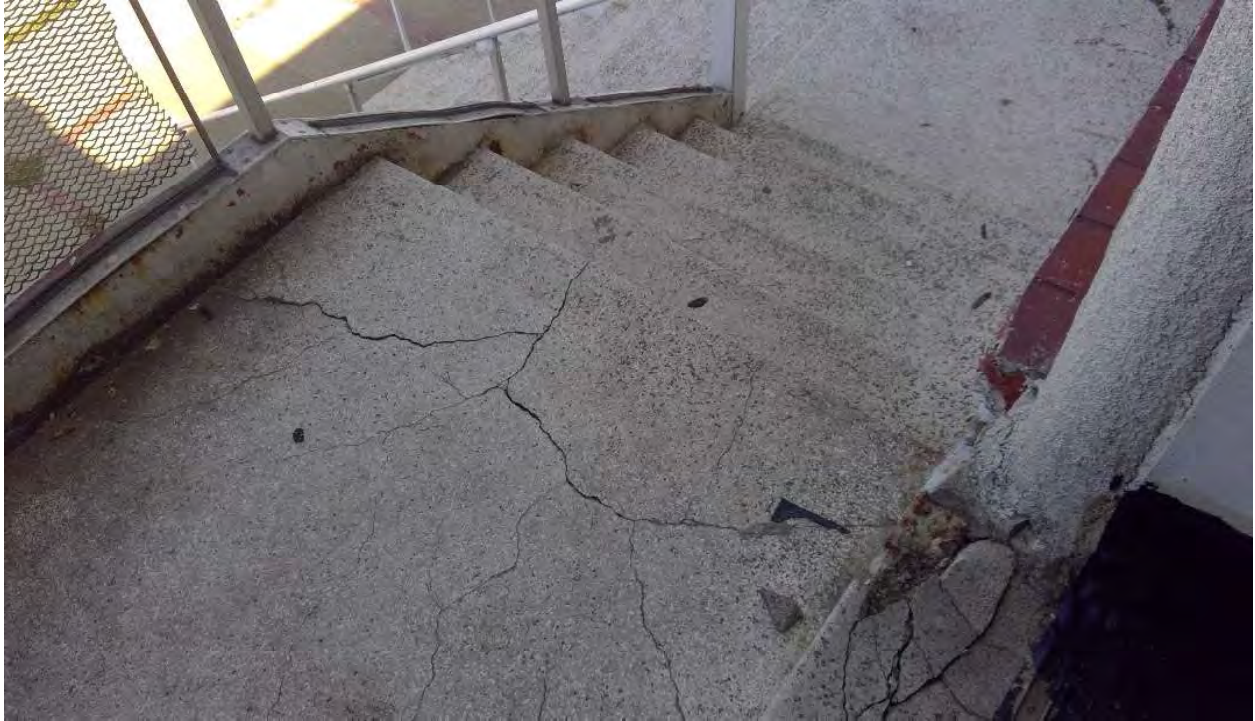
Photo 25 North Staircase Deteriorated Landing

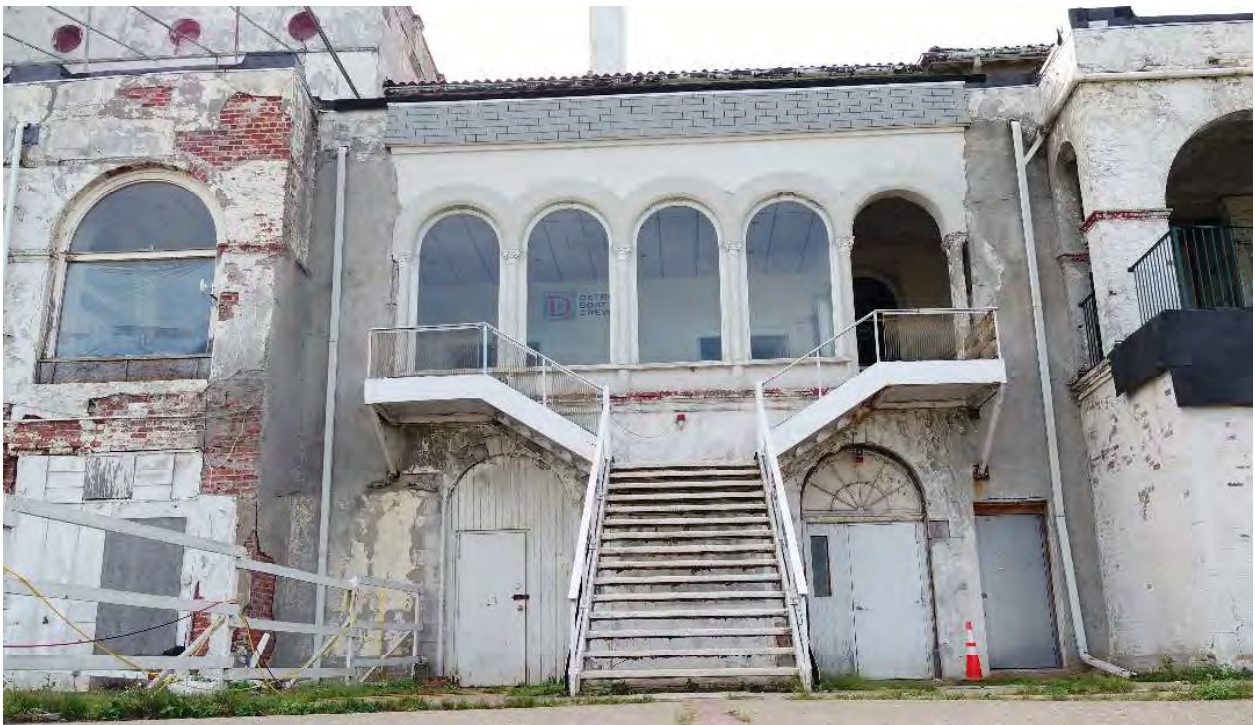
Photo 26 North Staircase Corrosion

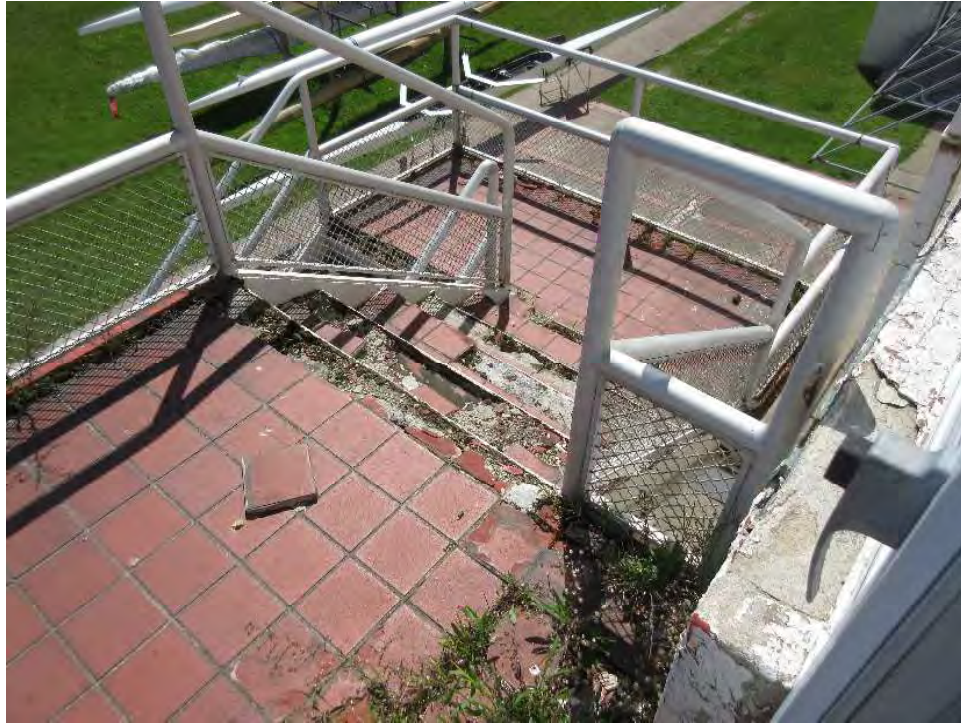
- Concrete infilled threads with tile wear surface are severely deteriorated [Photo 27].
- Steel frame and risers are severely corroded [Photo 28].

Photo 27 Northeast Staircase Deteriorated Treads

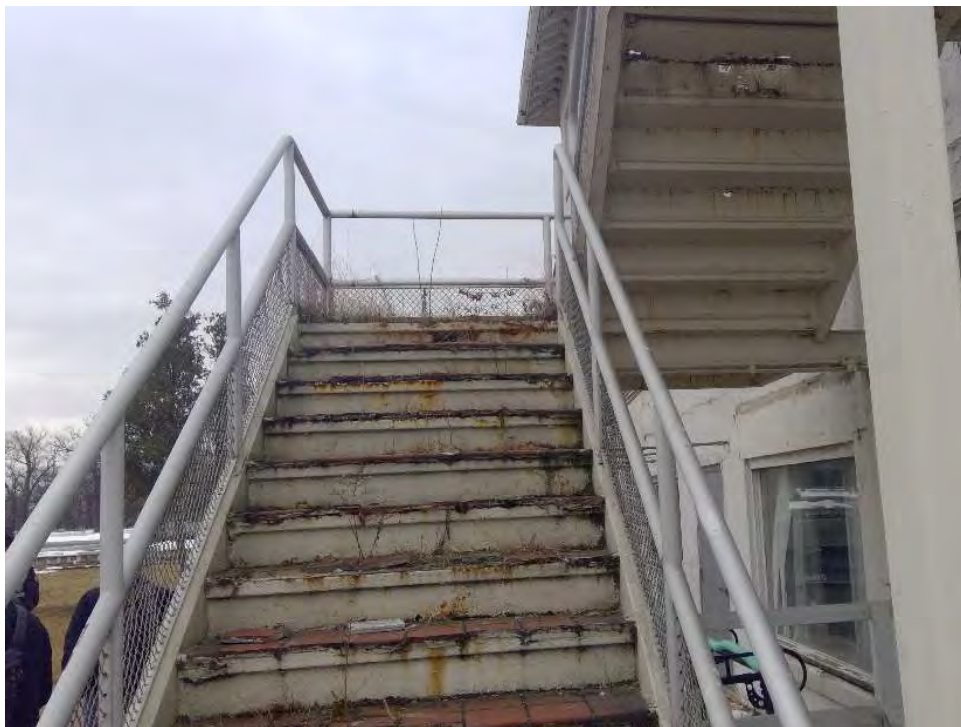
Photo 28 Northeast Staircase Corroded Steel

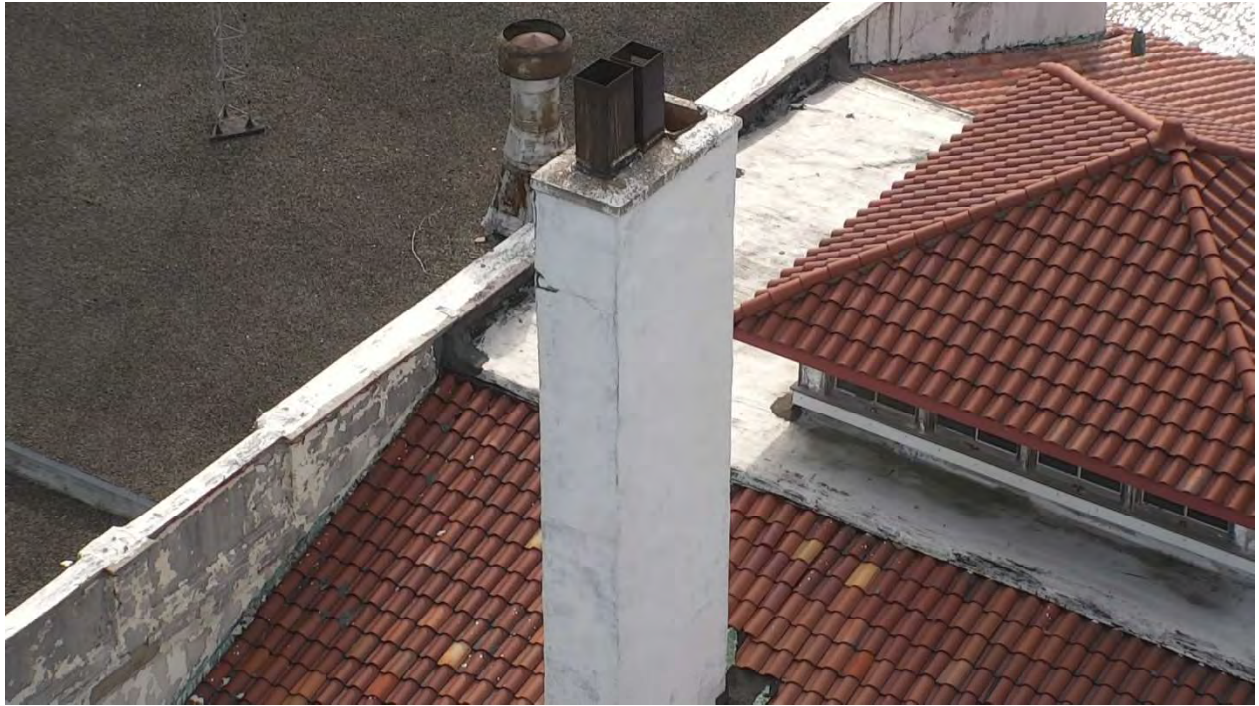
The tallest of the chimneys (west of the tower) is in fair condition with debonded stucco confined to the upper region **[Photo 29]**.

Photo 29 Debonding Stucco on Chimney

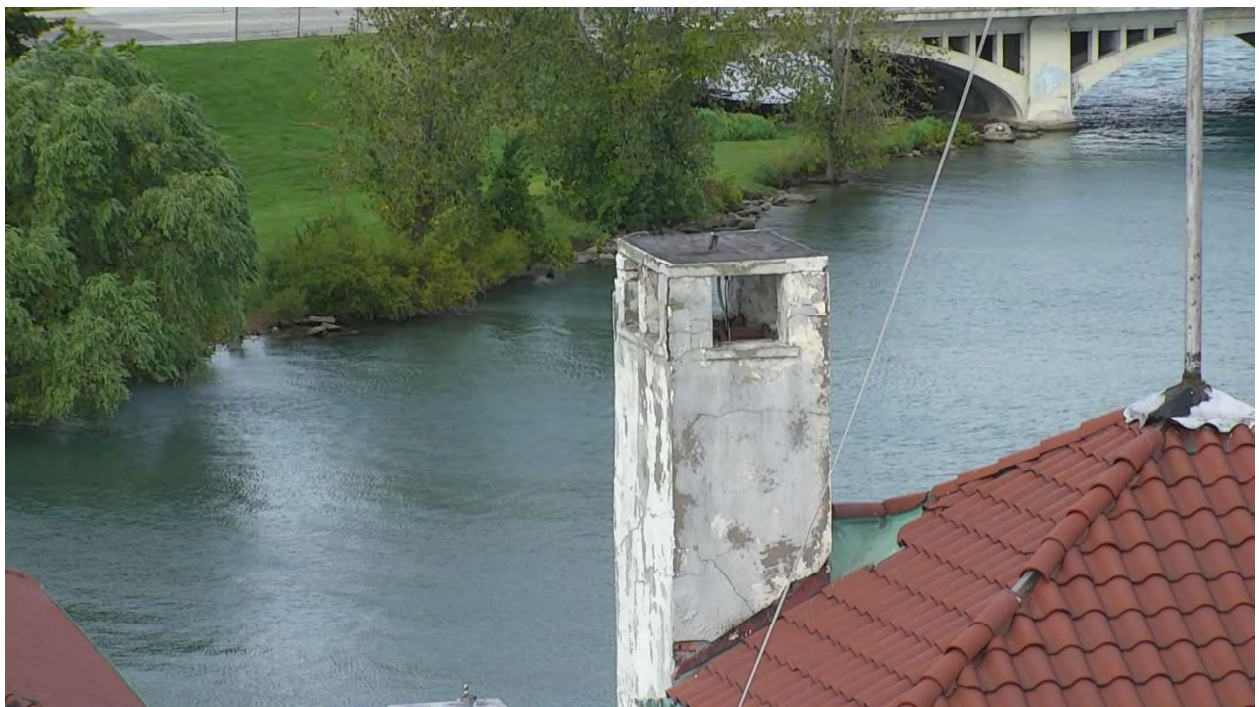
The second stucco chimney (south of the tower) is in poor condition with scaled stucco throughout its exterior **[Photo 30]**.

Photo 30 Scaled Stucco on Chimney
