Belle Isle Boathouse**Renovations**

Detroit, Michigan

Belle Isle Boathouse Building and Site Assessment

December 2019

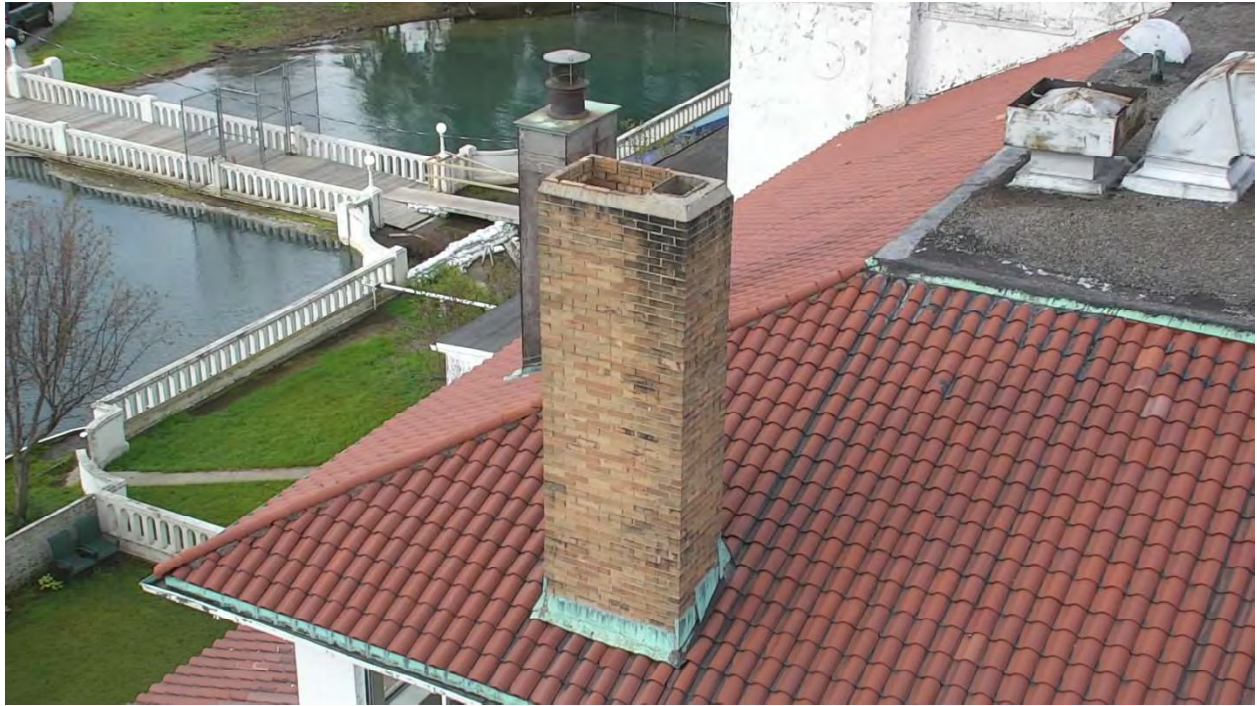
The brick chimney is in fair condition with deteriorated mortar confined to the upper regions **[Photo 31]**.

Photo 31 Brick Chimney

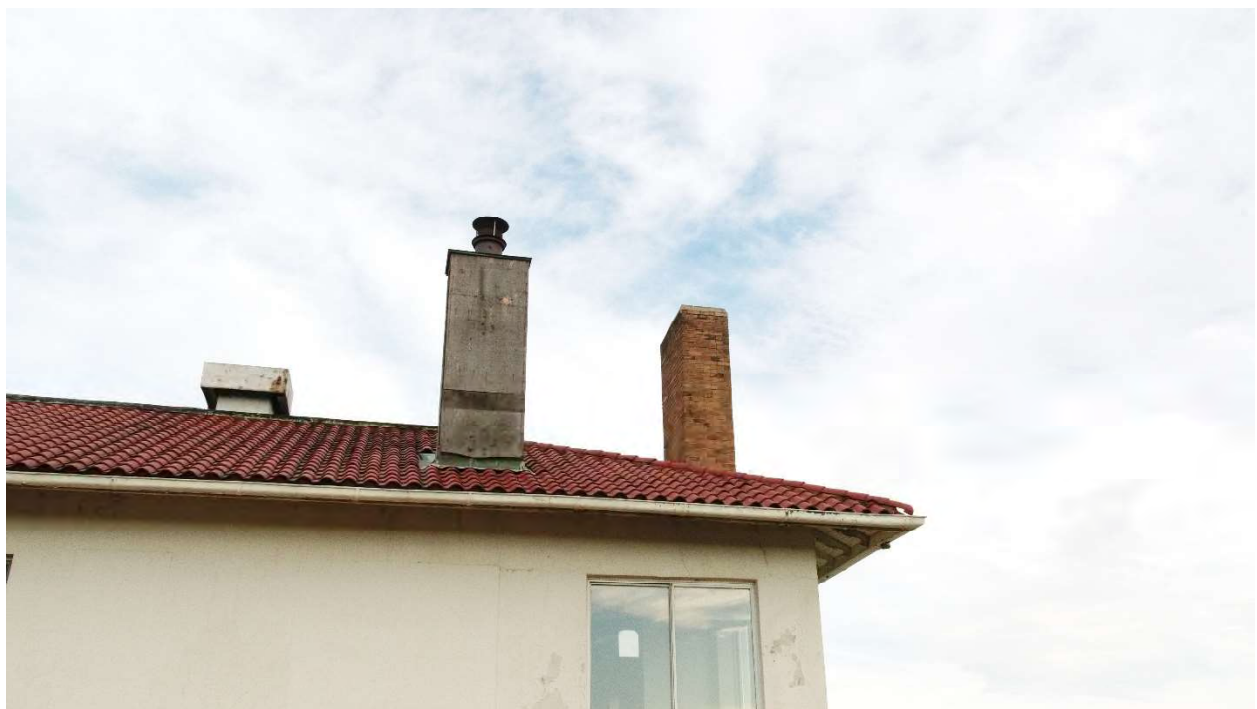
The plywood clad chimney was either constructed of wood or was repaired using wood. Either way, this chimney is in poor condition **[Photo 32]**.

Photo 32 Plywood Clad Chimney

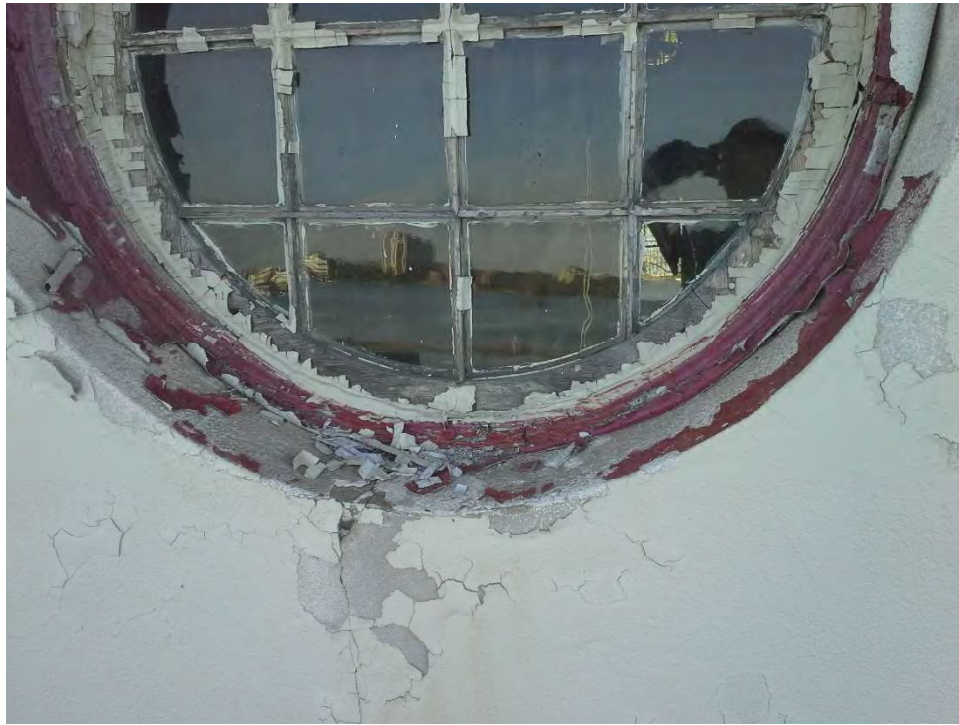
Photo 39 Deteriorated Paint and Wood

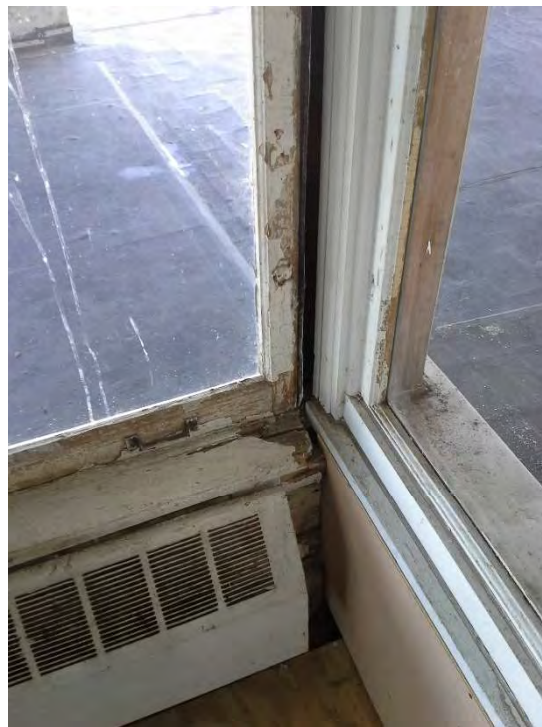
Photo 40 Splitting Wood Sill

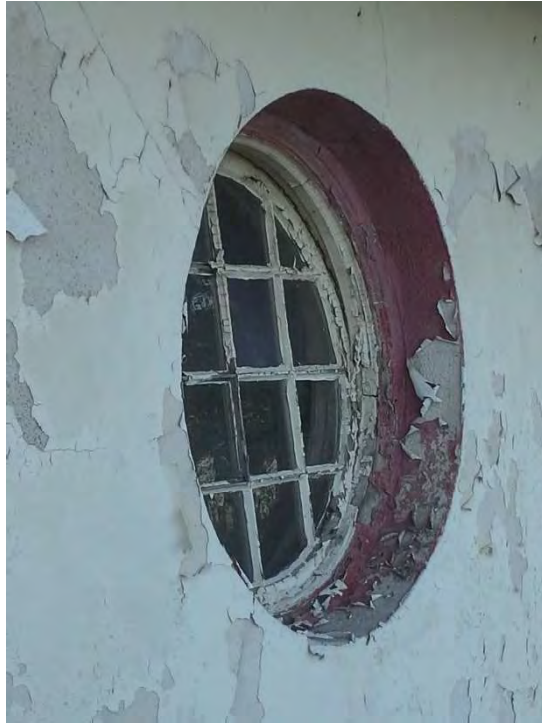
Photo 41 Weathered Condition Impeding Operation

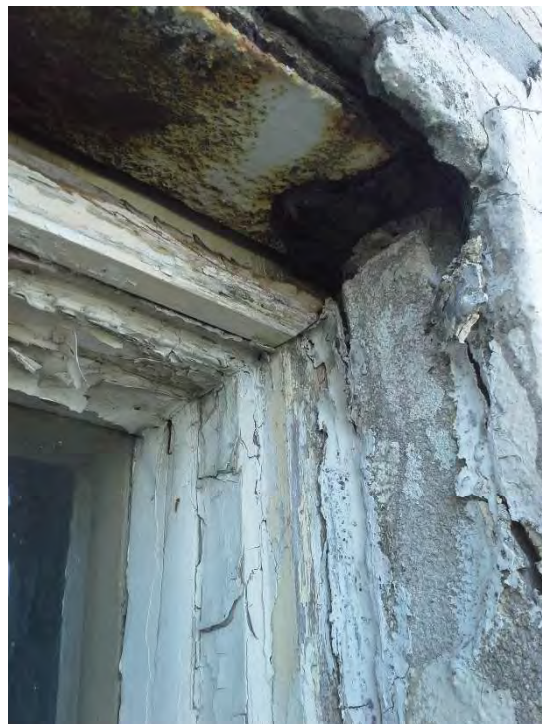
Photo 42 Water Damage

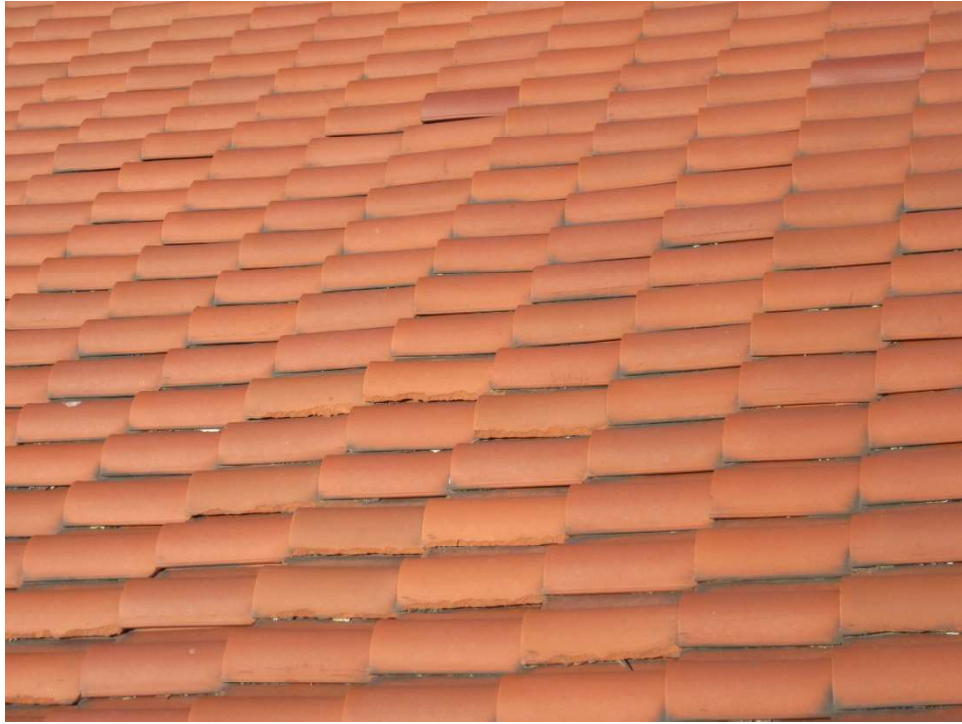
Photo 45 Damaged Spanish Tiles

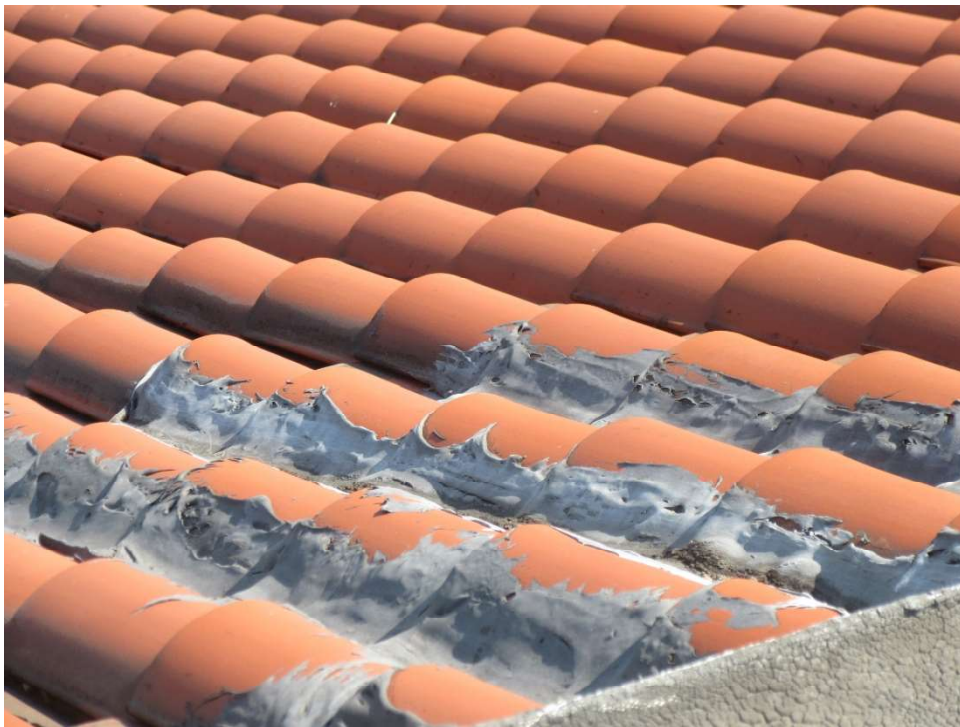
Photo 46 Roof Mastic Repair

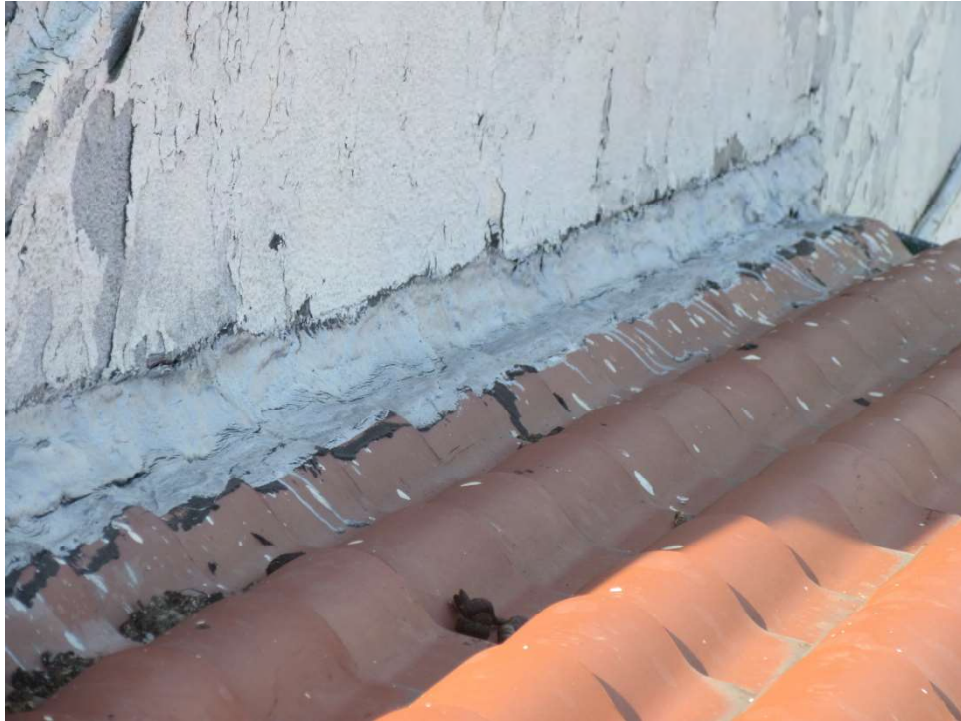
Photo 47 Rake Wall Flashing Buried Under Mastic

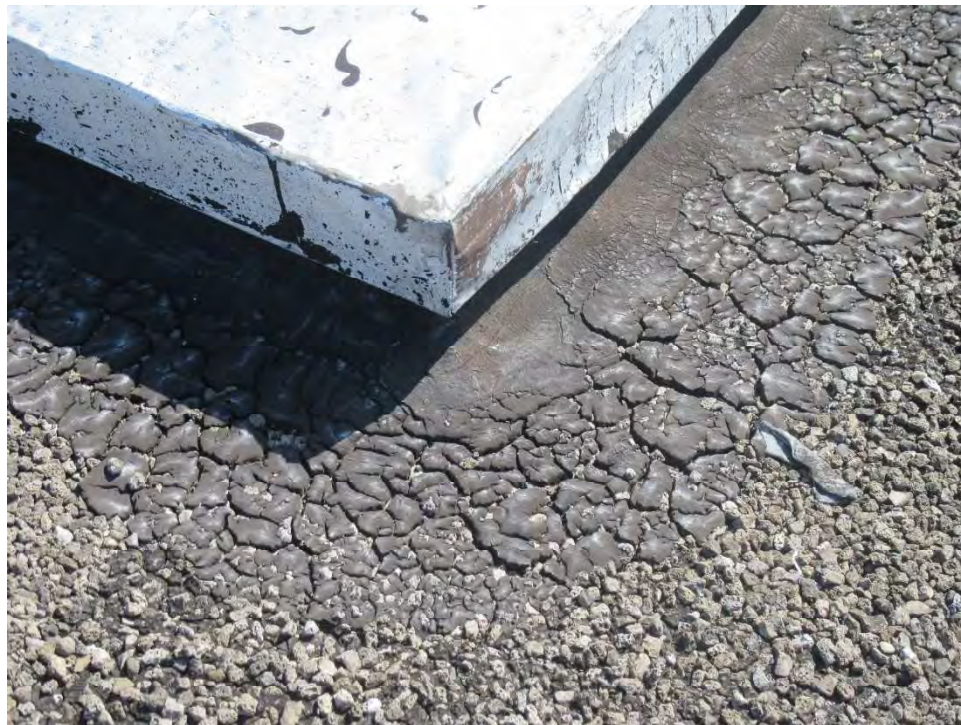
Photo 56 Damaged Flashing

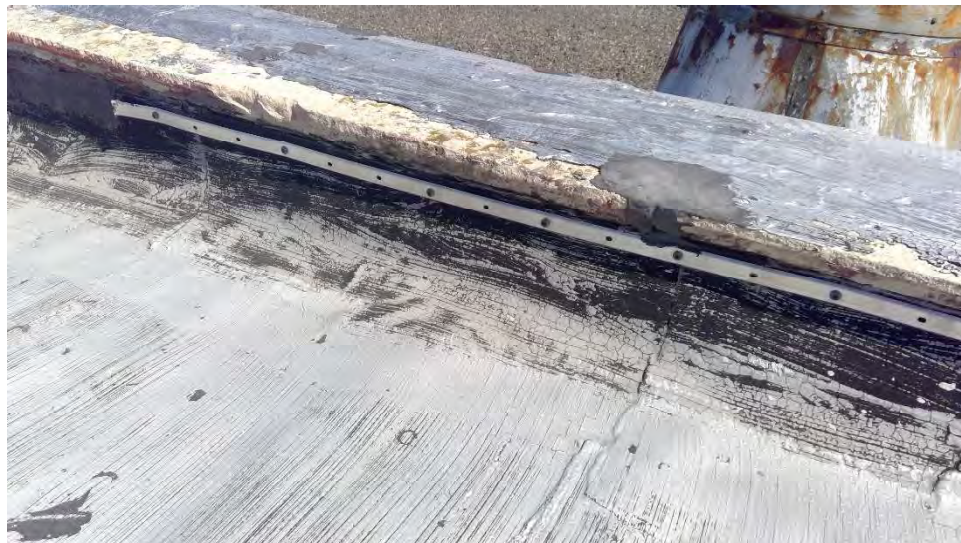
Photo 60 Improperly Installed Flashing

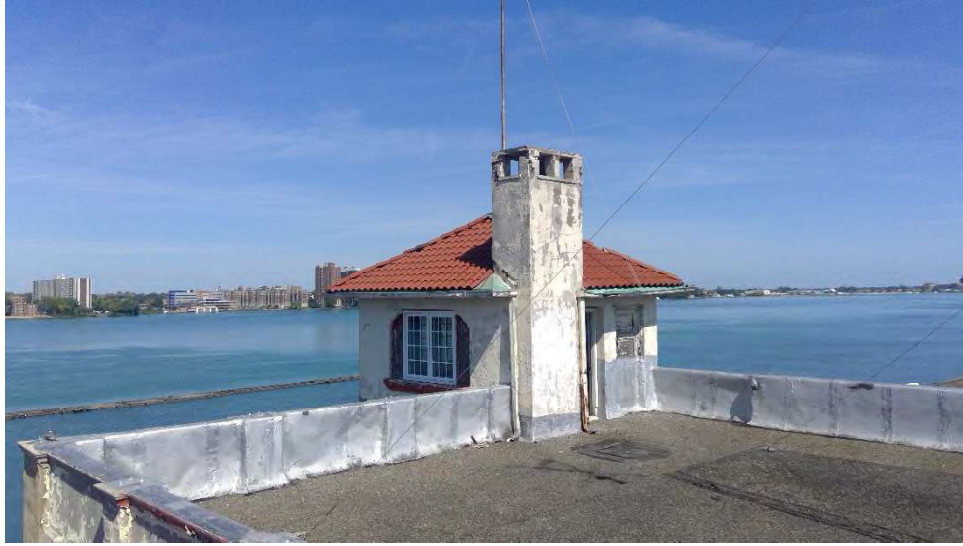
Photo 61 Improper Flashing

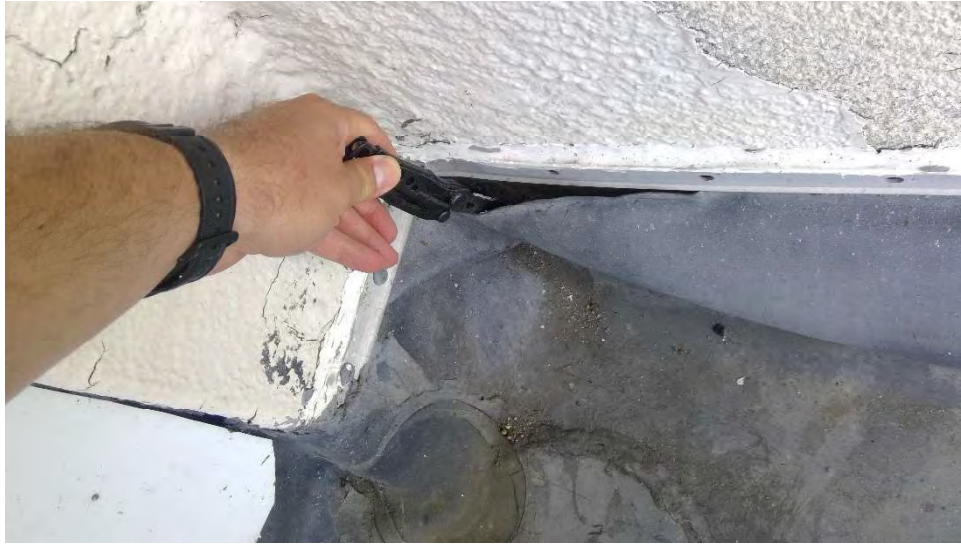
Photo 63 Loose Membrane

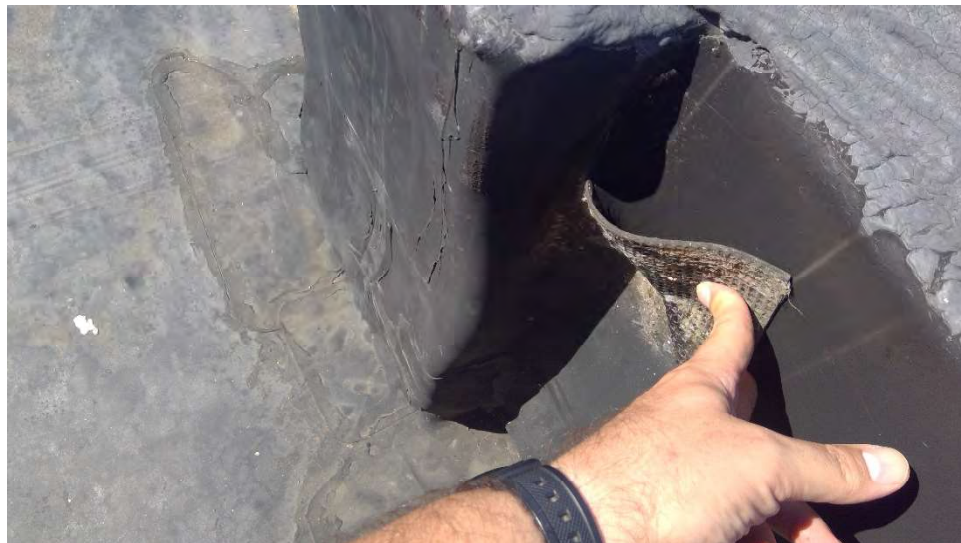
Photo 64 Loose Membrane on Low parapet

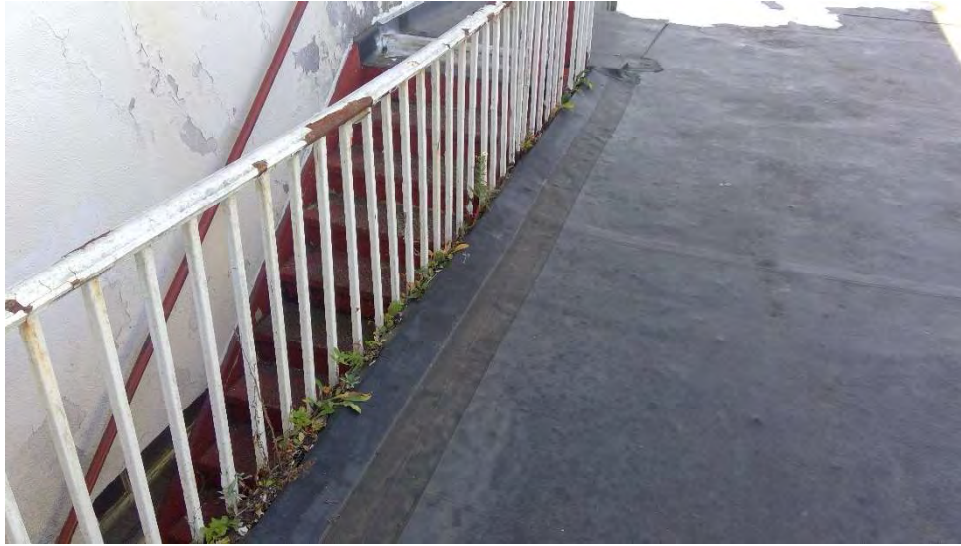
Photo 65 Damaged Railing, unattached at Bottom

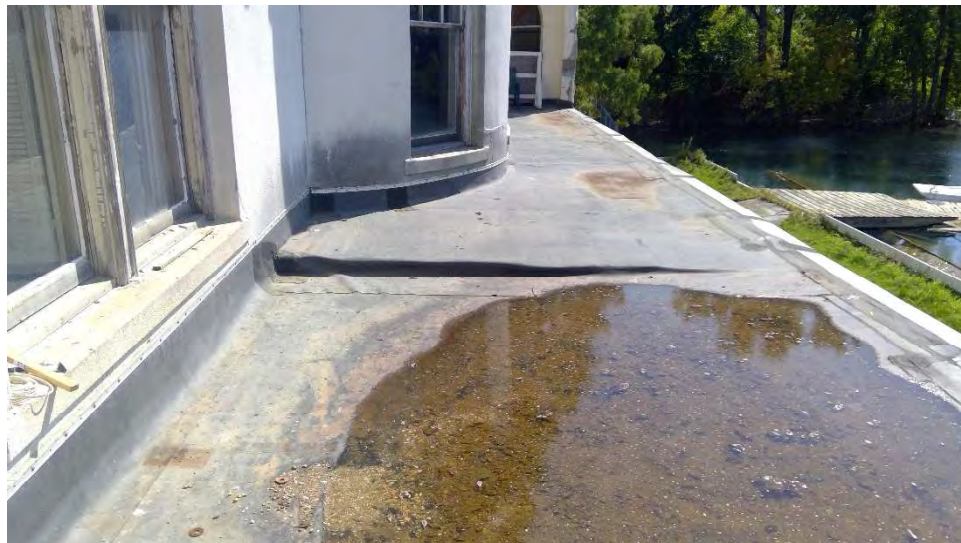
Photo 66 Ponding Water

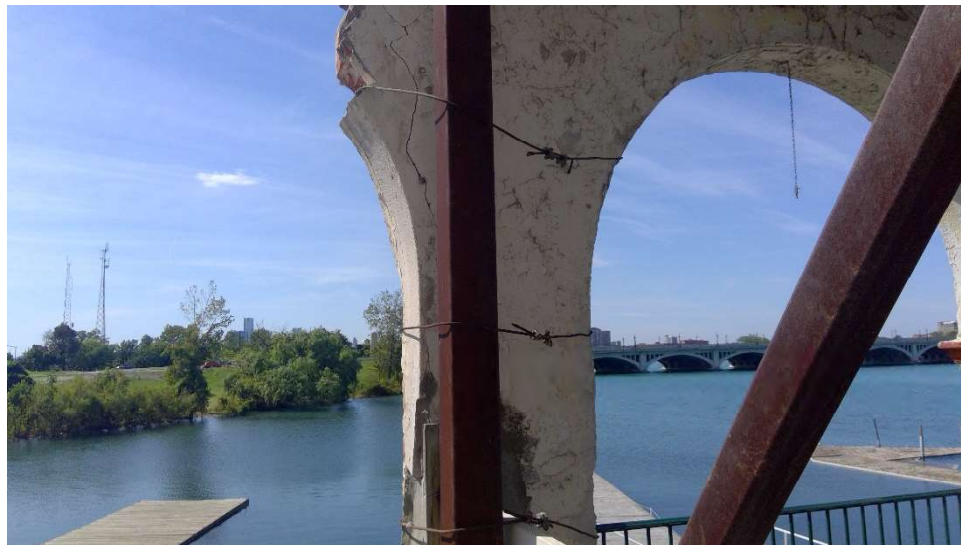
Photo 70 Masonry Column Loosely Bound to Shoring

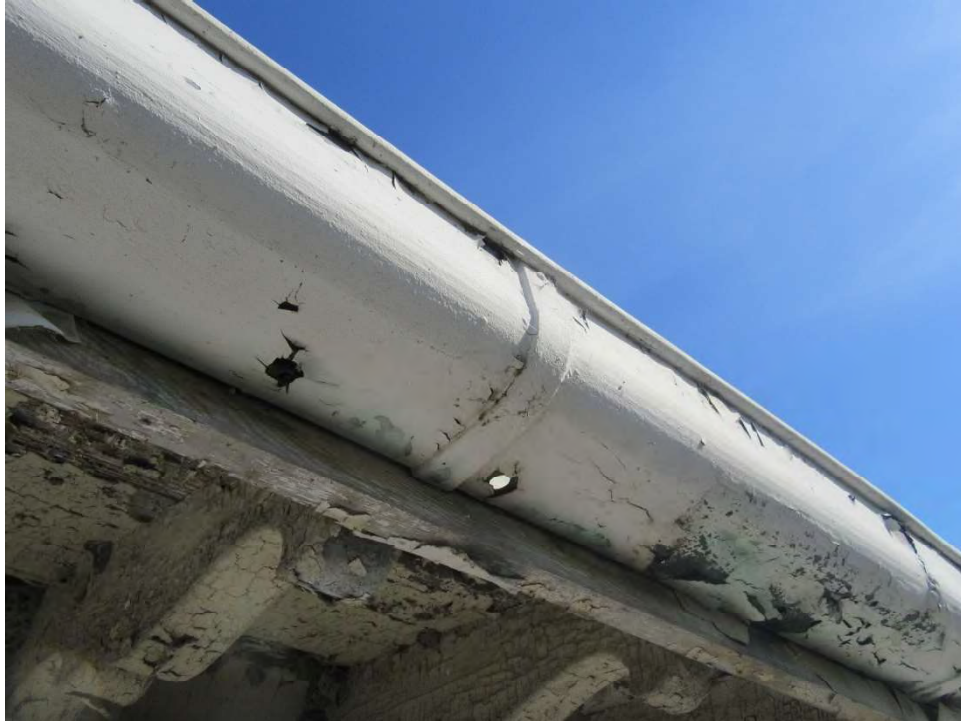
Photo 73 Typical Holes in Gutter

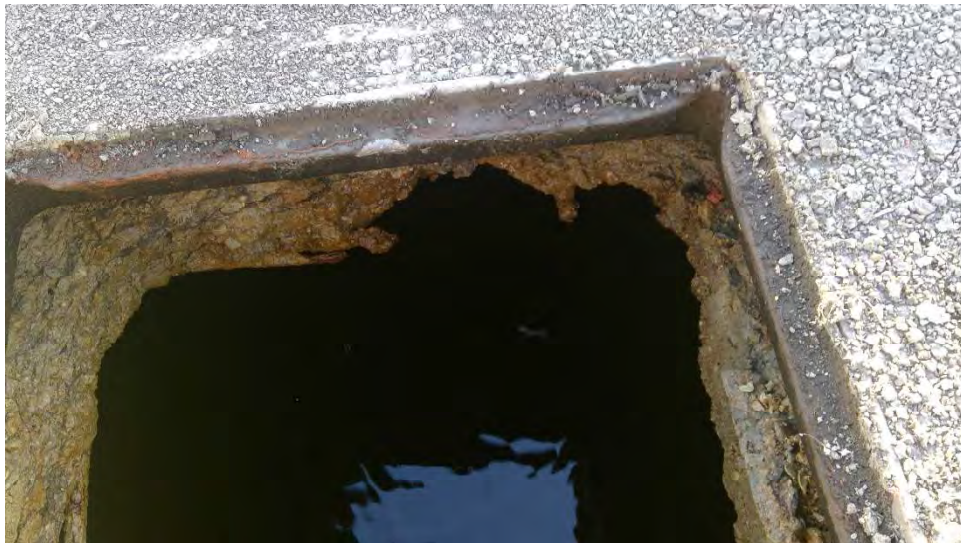
Photo 80 Deterioration Below Hatch

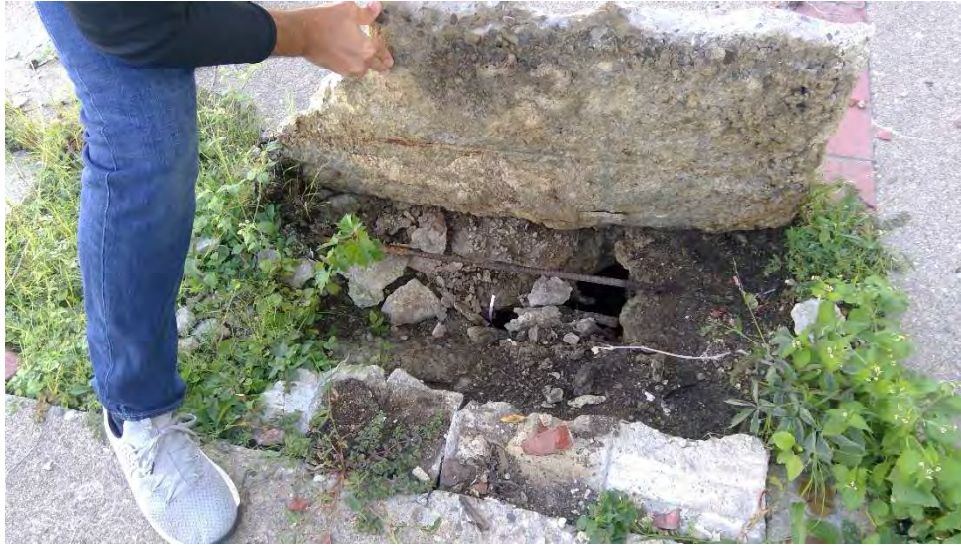
Photo 81 Hole Below Spalled Concrete

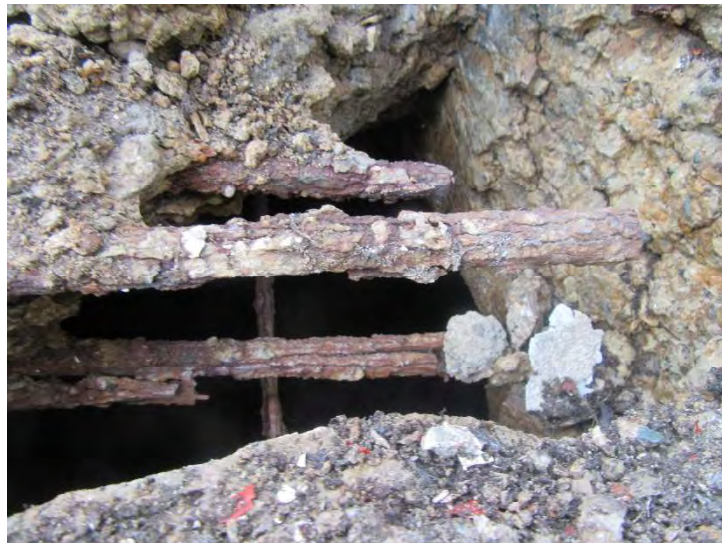
Photo 82 Badly Deteriorated Reinforcing Steel
