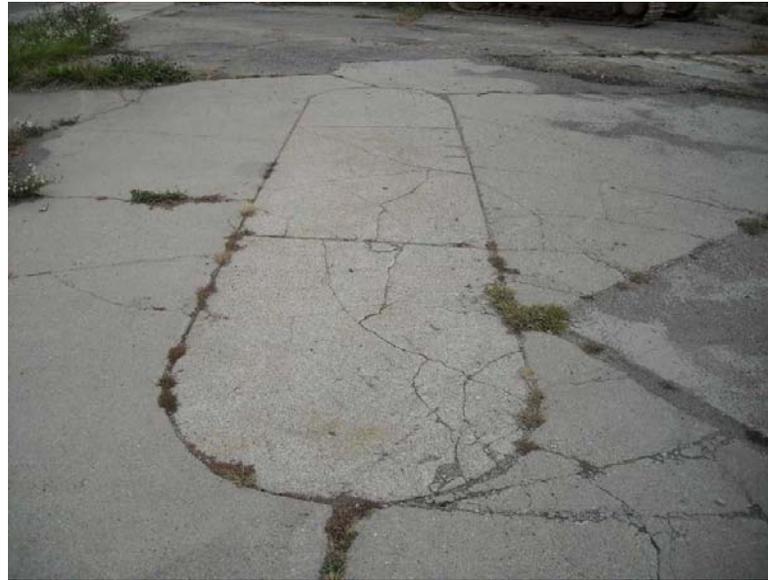
View of former southern UST pump island, looking northeast.
Photo taken by Jeffrey Guzick on October 5, 2009.

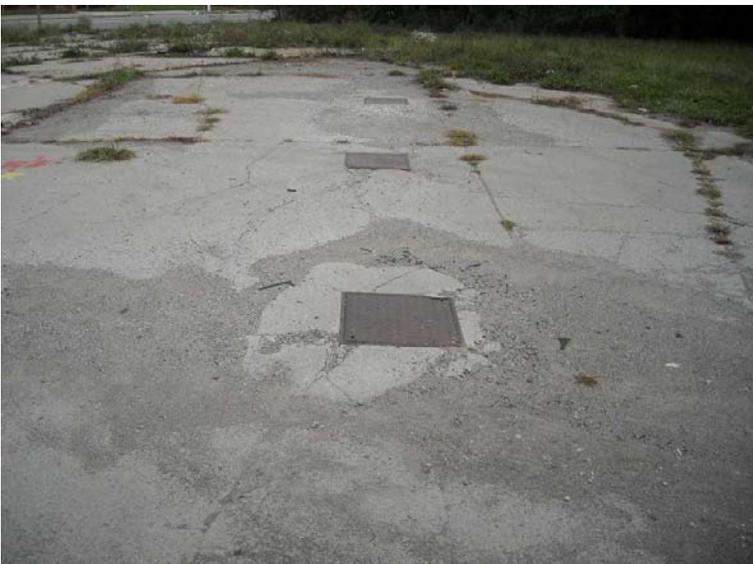
View of concrete overlying USTs, looking north.
Photo taken by Jeffrey Guzick on October 5, 2009.

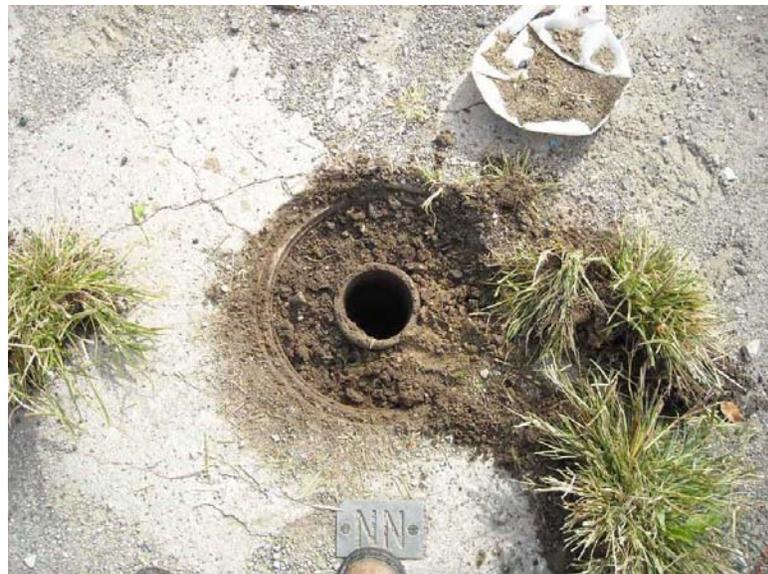
Southern UST fill port.
Photo taken by Jeffrey Guzick on October 6, 2009.

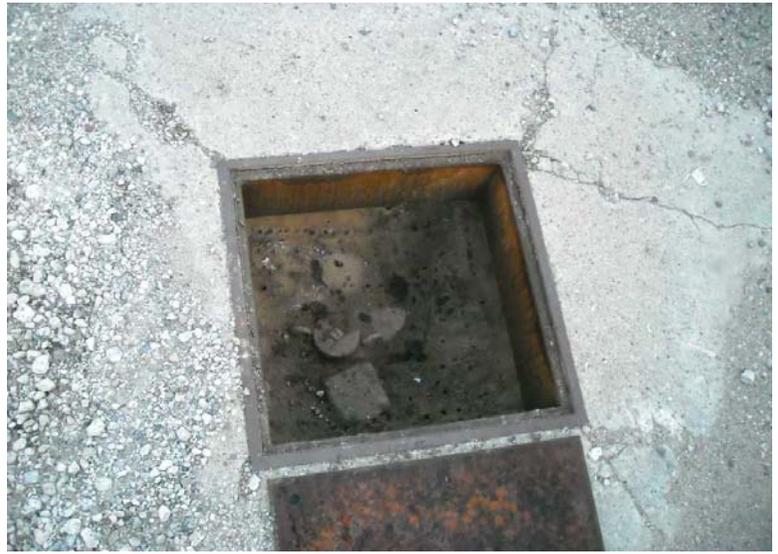
View inside vault on top of Southern UST.
Photo taken by Jeffrey Guzick on October 6, 2009.

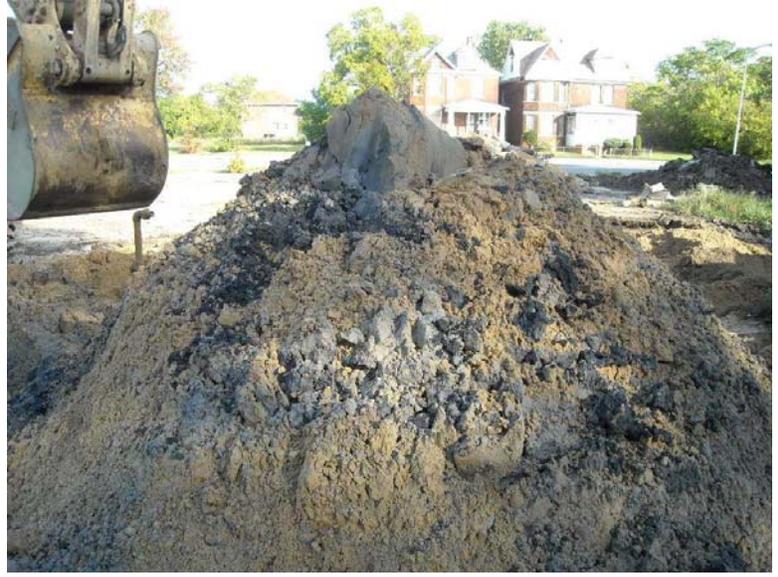
Stockpiling impacted soils overlying USTs, looking north.
Photo taken by Jeffrey Guzick on October 6, 2009.

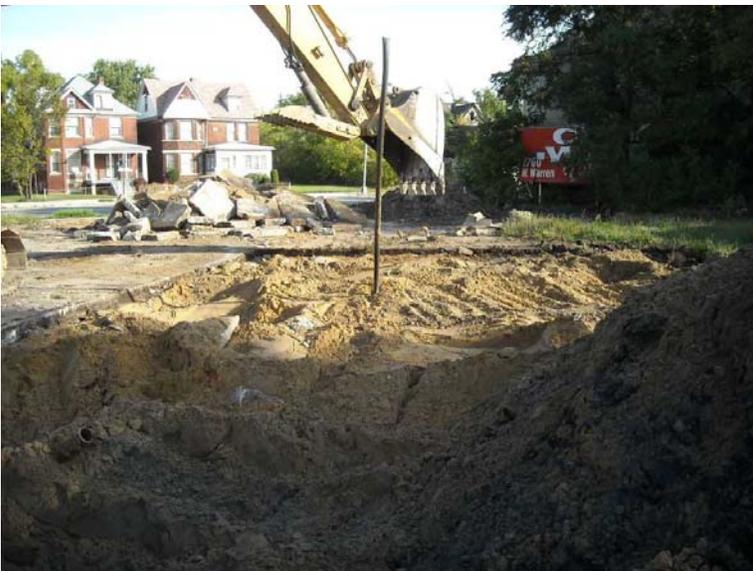
Piping associated with USTs, looking north.
Photo taken by Jeffrey Guzick on October 6, 2009.

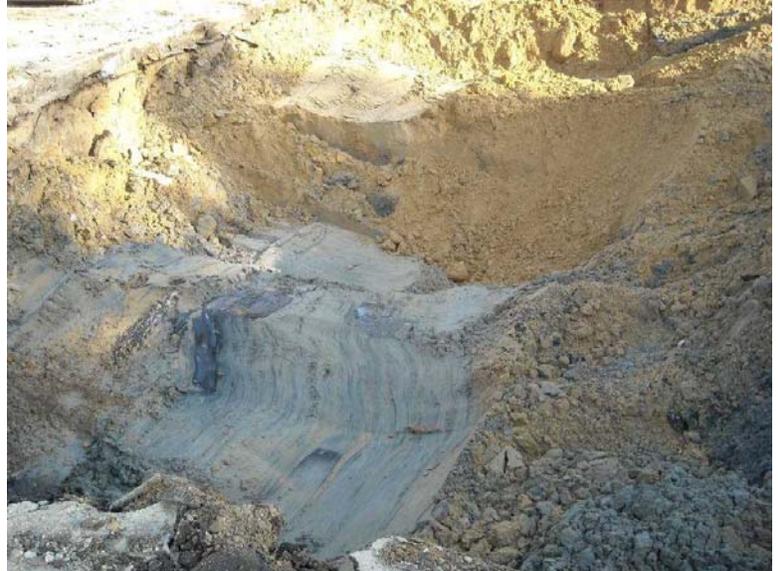
View of the top of Southern UST, looking north.
Photo taken by Jeffrey Guzick on October 6, 2009.

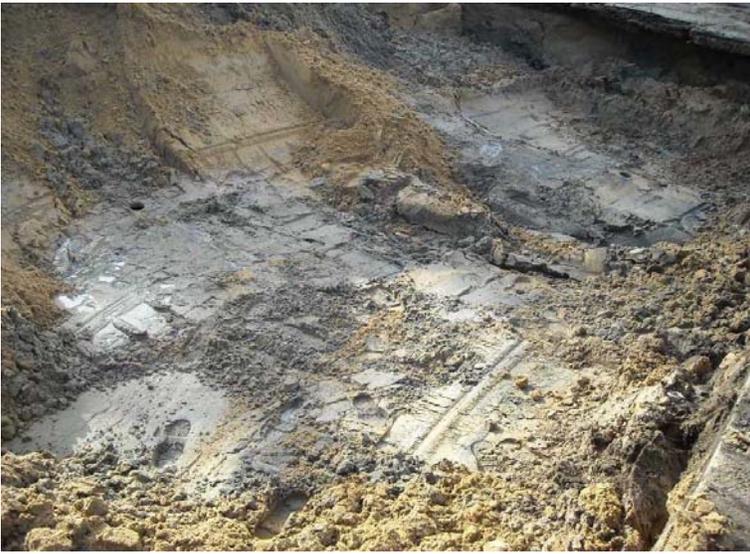
View of the top of Southern and Middle USTs.
Photo taken by Jeffrey Guzick on October 6, 2009.

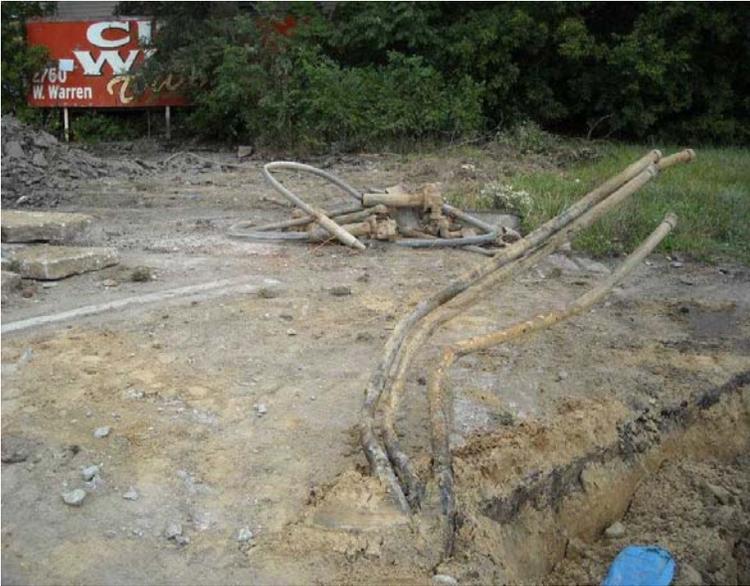
Piping associated with Northern UST, looking northeast.
Photo taken by Jeffrey Guzick on October 6, 2009.

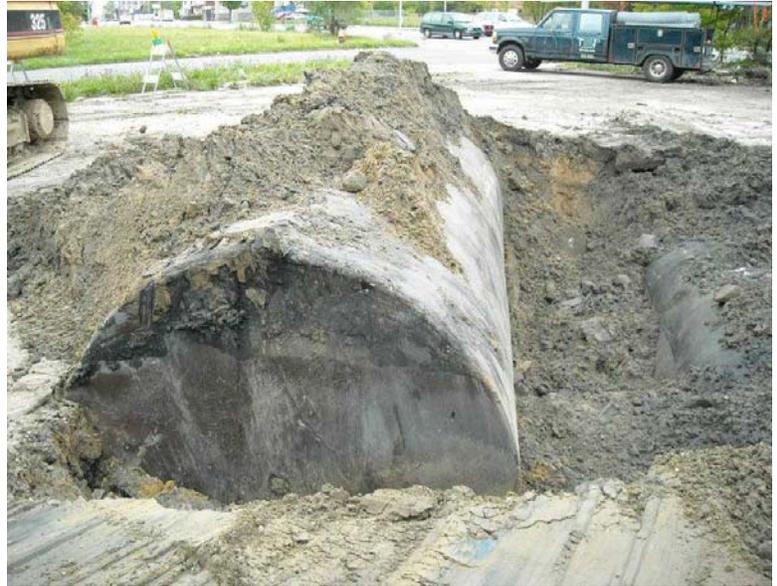
Elevating Southern UST out of excavation with view of impacted soils, looking north.
Photo taken by Jeffrey Guzick on October 8, 2009.

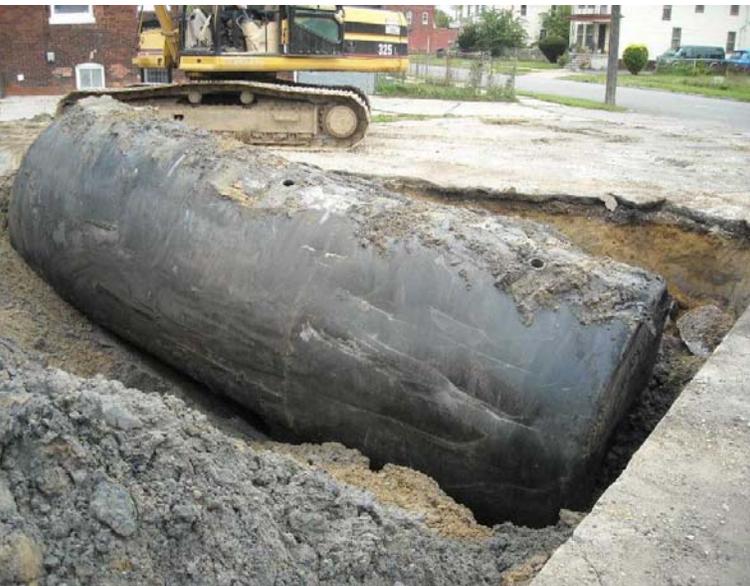
Lifting the Southern UST out of the excavation, looking south.
Photo taken by Jeffrey Guzick on October 8, 2009.

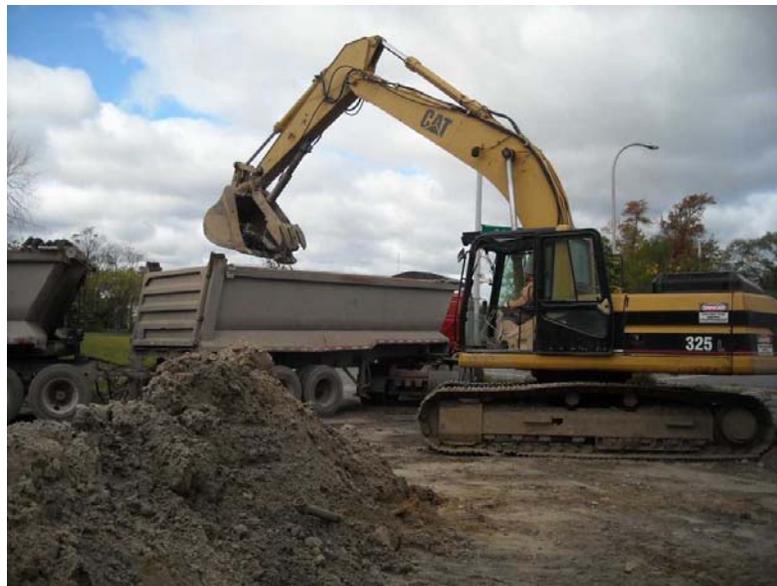
Loading impacted soils into truck for off-site disposal, looking west.
Photo taken by Jeffrey Guzick on October 8, 2009.

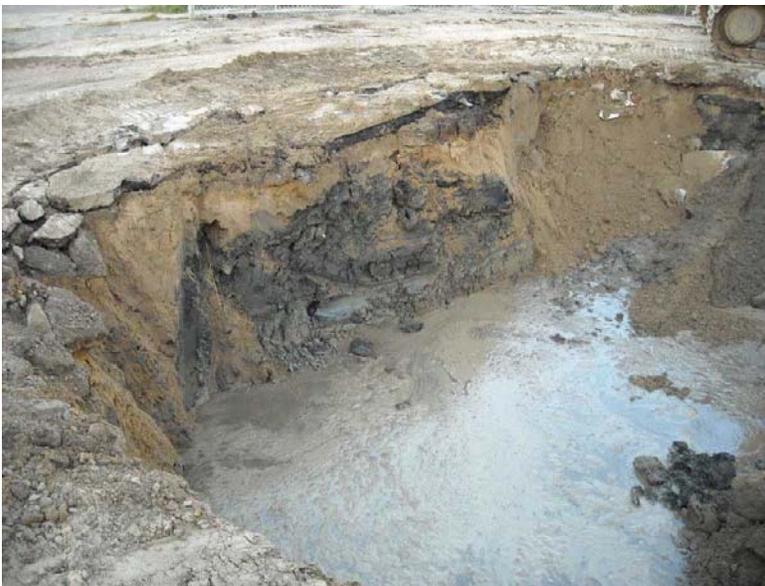
Water with visible sheen accumulating in the excavation following rainfall.
Photo taken by Jeffrey Guzick on October 12, 2009.

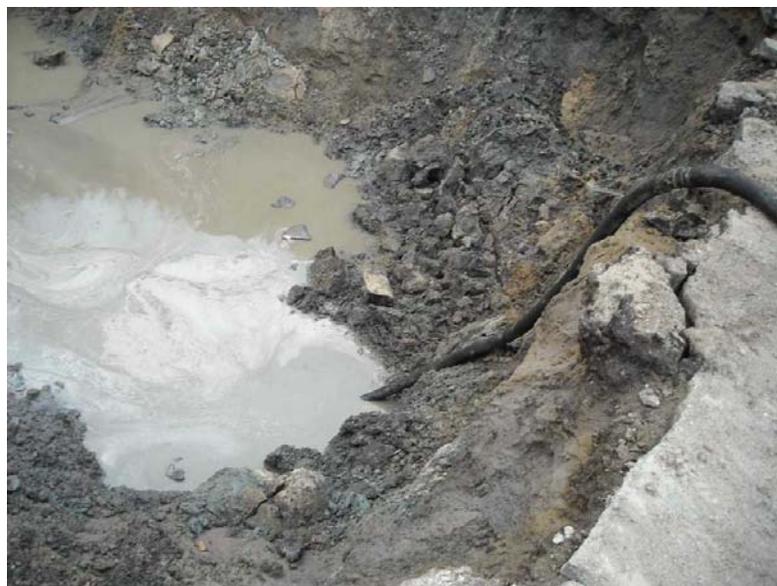
Pumping water with sheen into tanker truck.
Photo taken by Jeffrey Guzick on October 12, 2009.

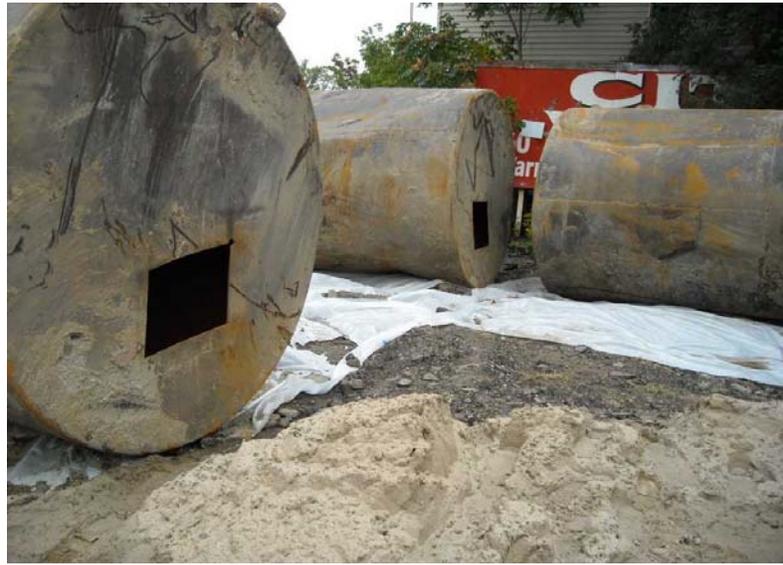
Holes cut in sides of USTs for venting fumes, looking west.
Photo taken by Jeffrey Guzick on October 8, 2009.

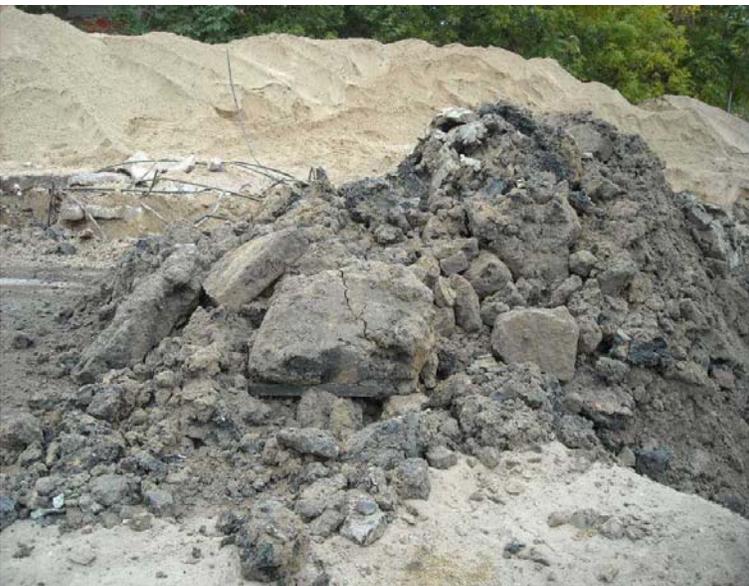
View of piping, concrete and impacted soil from northern portion of excavation.
Photo taken by Jeffrey Guzick on October 14, 2009.

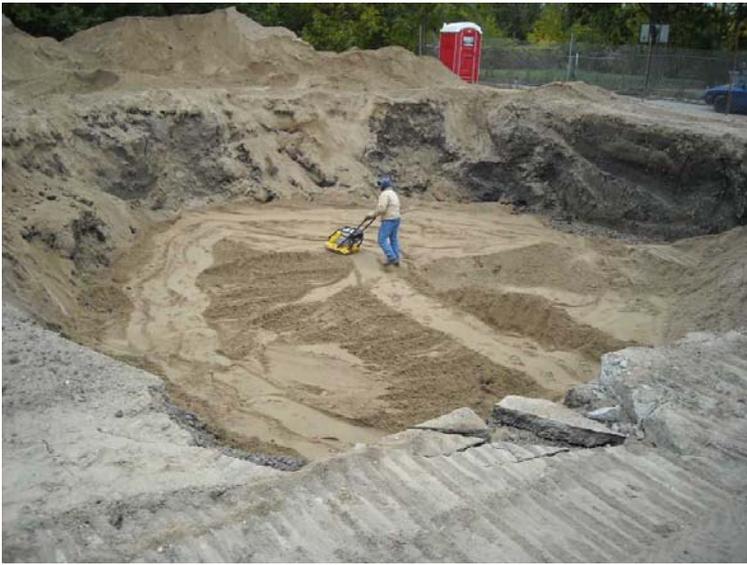
Compacting lifts of backfill in the excavation, looking east.
Photo taken by Jeffrey Guzick on October 15, 2009.

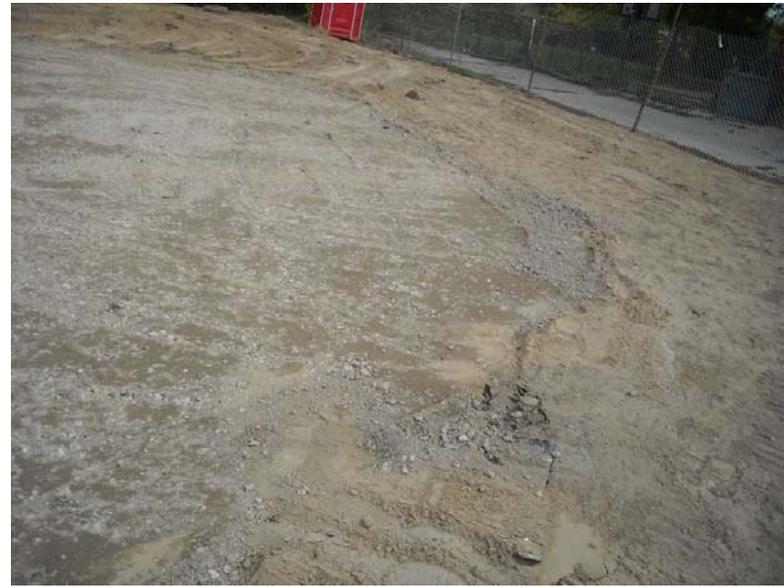
View of excavation after gravel compaction completed.
Photo taken by Jeffrey Guzick on October 16, 2009.
