**ABANDONED MINING WASTES TORCH LAKE NON-SUPERFUND SITE  
CALUMET AND HECLA – TAMARACK CITY OPERATIONS  
TARGETED INSPECTION FORM**

Inspection Date: 6/29/15 Feature Identification/Name: WOODED AREA NORTH OF THE FORMER MILL

Study Area: TAMARACK PROCESSING AREA Property Identification Number: 009-013-004-20

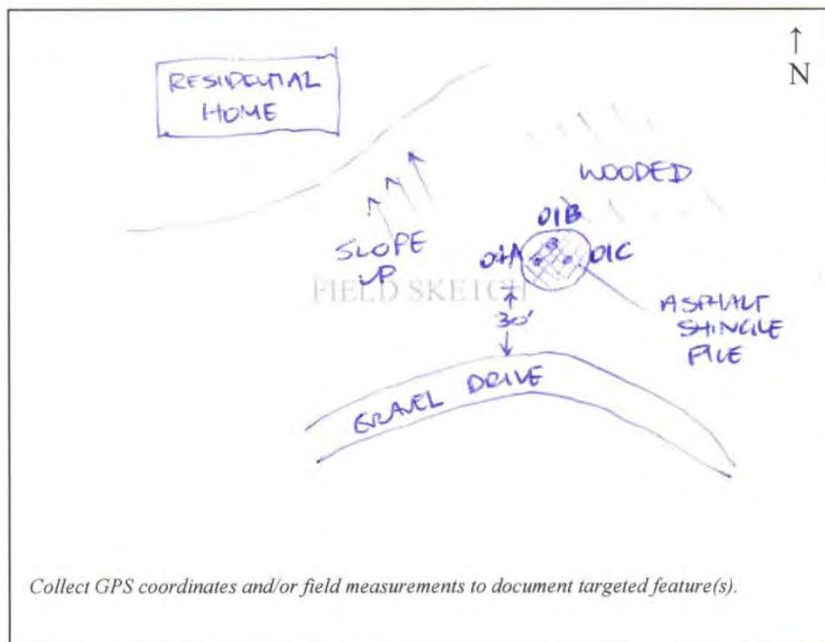
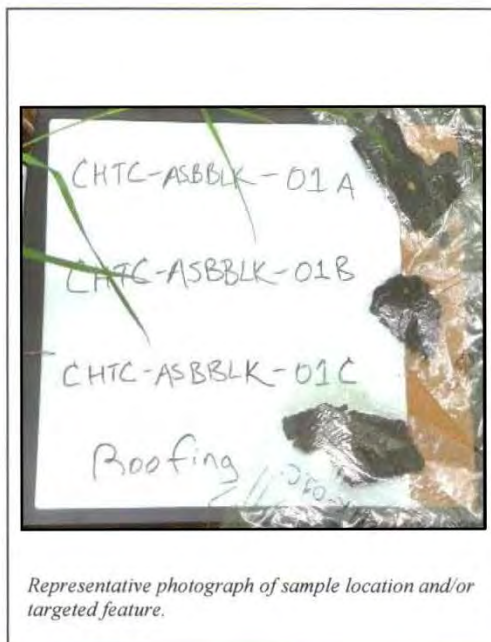
5 FT DIAMETER PILE OF ASPHALTIC ROOFING MATERIAL, BLACK WEATHERED, DAMAGED (CHTC-SACM08 FROM RECON)

MATERIALS ARE LOCATED IN A PILE IN PROXIMITY TO A RESIDENTIAL HOME. THE PROPERTY IS UNSECURED AND ACCESSIBLE TO TRAIL PASSERS

THE DEBRIS PILE IS LOCATED AT THE BOTTOM OF A HILL AND MAY BE SUBJECT TO EROSION. OTHER PHYSICAL HAZARDS ARE PRESENT IN THE VICINITY.

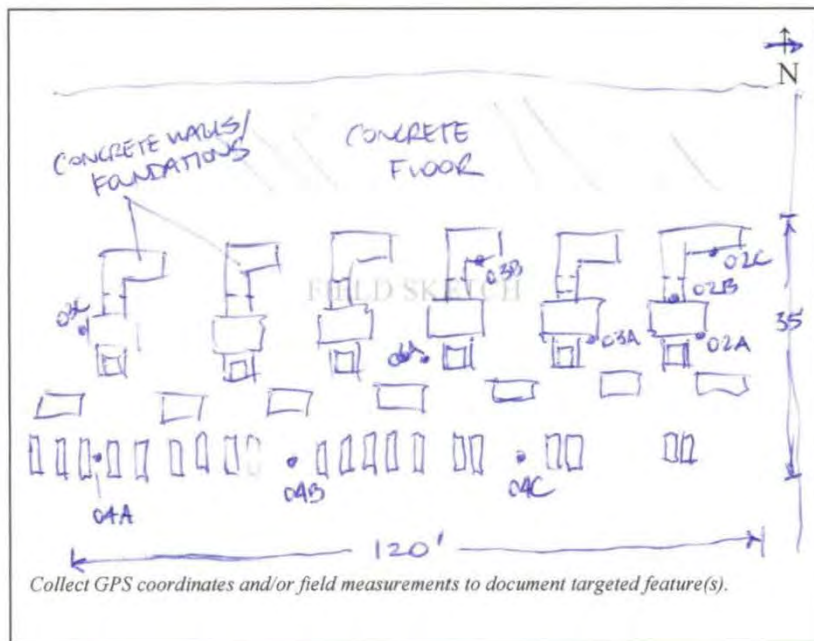
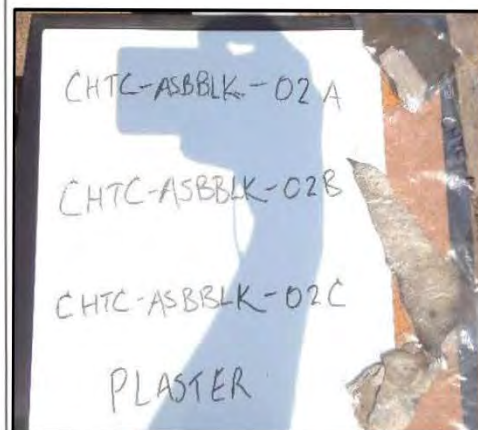
Representative photograph of sample location and/or targeted feature.

CONCRETE PILLARS AND ARCHES ASSOCIATED WITH THE FORMER STAMP MILL ARE COATED WITH A THIN PLASTER; THE MATERIAL APPEARS TO VARY IN COMPOSITION BETWEEN STRUCTURES. BROKEN TRANSITE FRAGMENTS SPREAD THROUGHOUT.  
Sampling Activities (Sample Description, Sample Time, Requested Analyses):  
CHTC-ASBBLK-02(A-C) - LIGHT GRAY PLASTER VENER ON CONCRETE, COLLECTED AT 1025  
CHTC-ASBBLK-03(A-C) - LIGHT GRAY PLASTER VENER ON CONCRETE, COLLECTED AT 1040  
CHTC-ASBBLK-04(A-C) - LIGHT GRAYISH/WHITE TRANSITE, COLLECTED AT 1050

THE FOUNDATIONS AND RELATED SURFACE COATINGS ARE WEATHERED AND FRAGILE, DEGRADING OVER TIME. THE PROPERTY IS UNSECURED AND ACCESSIBLE TO TRAIL PASSERS

THE STAMP MILL FLOOR AND FOUNDATIONS ARE ELEVATED AND BUILT INTO THE HILLSIDE. THESE AREAS MAY BE SUBJECT TO EROSION AND RUNOFF.

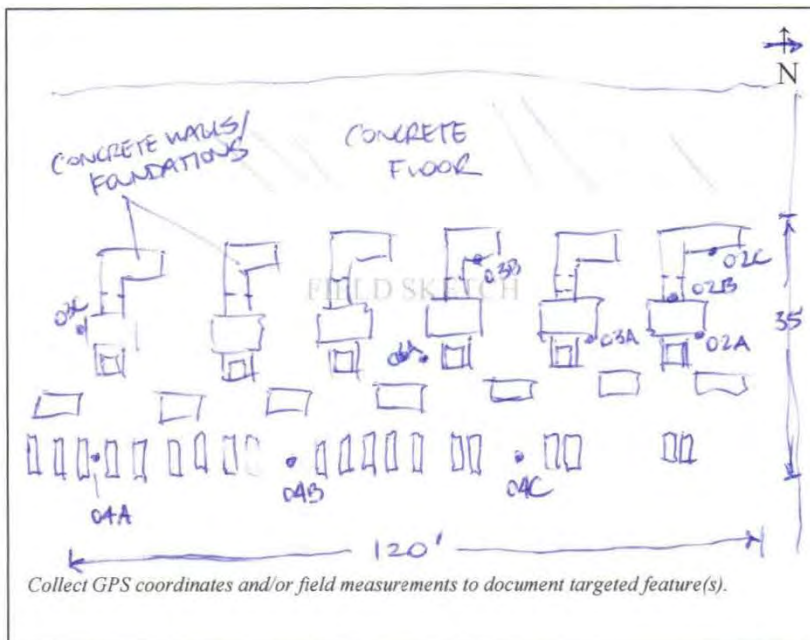
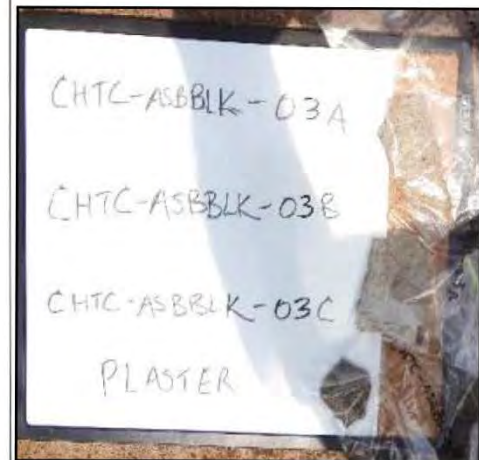
Representative photograph of sample location and/or targeted feature.

CONCRETE PILLARS AND ARCHES ASSOCIATED WITH THE FORMER STAMP MILL ARE COATED WITH A THIN PLASTER; THE MATERIAL APPEARS TO VARY IN COMPOSITION BETWEEN STRUCTURES. BROKEN TRANSITE FRAGMENTS SPREAD THROUGHOUT.  
Sampling Activities (Sample Description, Sample Time, Requested Analyses):  
CHTC-ASBBLK-02(A-C) - LIGHT GRAY PASTER VENER ON CONCRETE, COLLECTED AT 1025  
CHTC-ASBBLK-03(A-C) - LIGHT GRAY PASTER VENER ON CONCRETE, COLLECTED AT 1040  
CHTC-ASBBLK-04(A-C) - LIGHT GRAYISH/WHITE TRANSITE, COLLECTED AT 1050

THE FOUNDATIONS AND RELATED SURFACE COATINGS ARE WEATHERED AND FRAGILE, DEGRADING OVER TIME. THE PROPERTY IS UNSECURED AND ACCESSIBLE TO TRESS PASSERS

THE STAMP MILL FLOOR AND FOUNDATIONS ARE ELEVATED AND BUILT INTO THE HILLSIDE. THESE AREAS MAY BE SUBJECT TO EROSION AND RUNOFF.

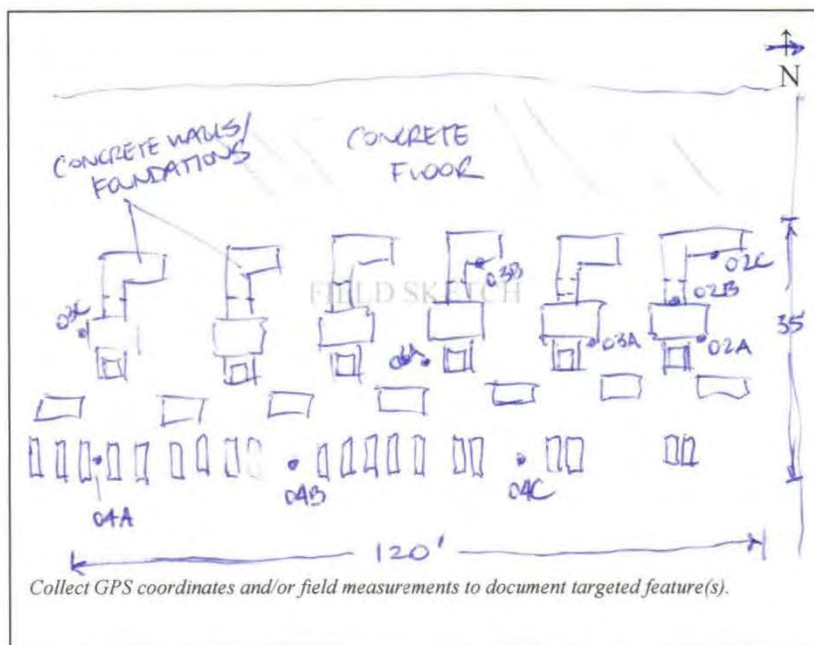
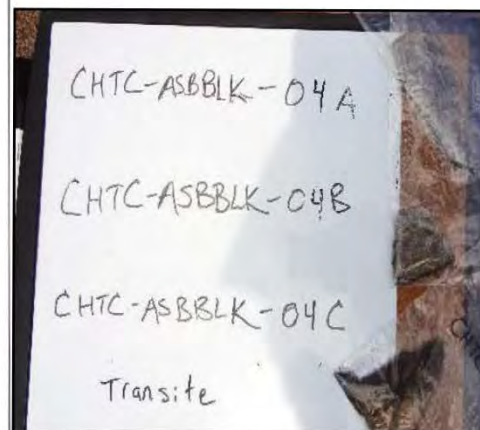
Representative photograph of sample location and/or targeted feature.

CONCRETE PILLARS AND ARCHES ASSOCIATED WITH THE FORMER STAMP MILL ARE COATED WITH A THIN PLASTER; THE MATERIAL APPEARS TO VARY IN COMPOSITION BETWEEN STRUCTURES. BROKEN TRANSITE FRAGMENTS SPREAD THROUGHOUT.  
**Sampling Activities (Sample Description, Sample Time, Requested Analyses):**  
CHTC-ASBBLK-02(A-C) - LIGHT GRAY PLASTER VENER ON CONCRETE, COLLECTED AT 1025  
CHTC-ASBBLK-03(A-C) - LIGHT GRAY PLASTER VENER ON CONCRETE, COLLECTED AT 1040  
CHTC-ASBBLK-04(A-C) - LIGHT GRAY/WHITE TRANSITE, COLLECTED AT 1050

THE FOUNDATIONS AND RELATED SURFACE COATINGS ARE WEATHERED AND FRAGILE, DEGRADING OVER TIME. THE PROPERTY IS UNSECURED AND ACCESSIBLE TO TRAIL PASSERS

THE STAMP MILL FLOOR AND FOUNDATIONS ARE ELEVATED AND BUILT INTO THE HILLSIDE. THESE AREAS MAY BE SUBJECT TO EROSION AND RUNOFF.

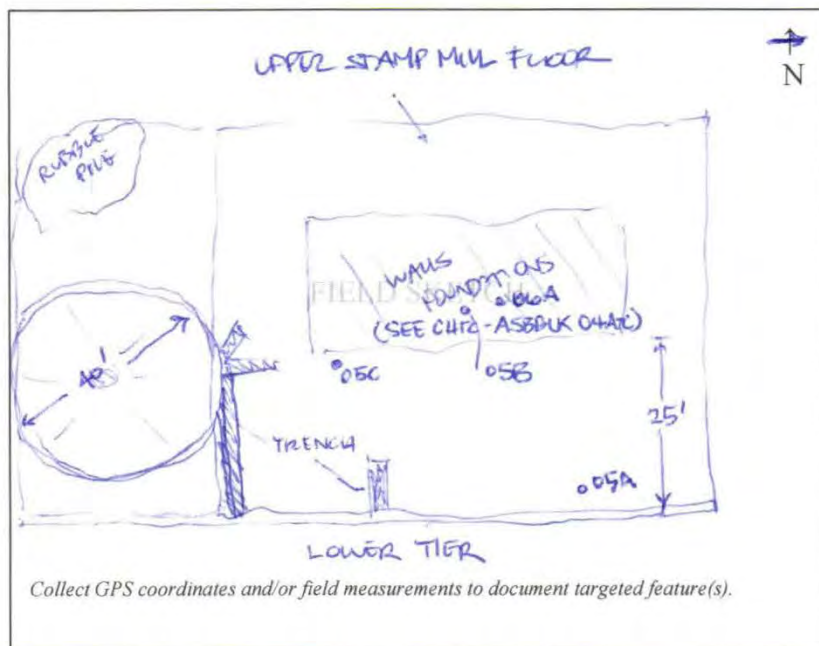
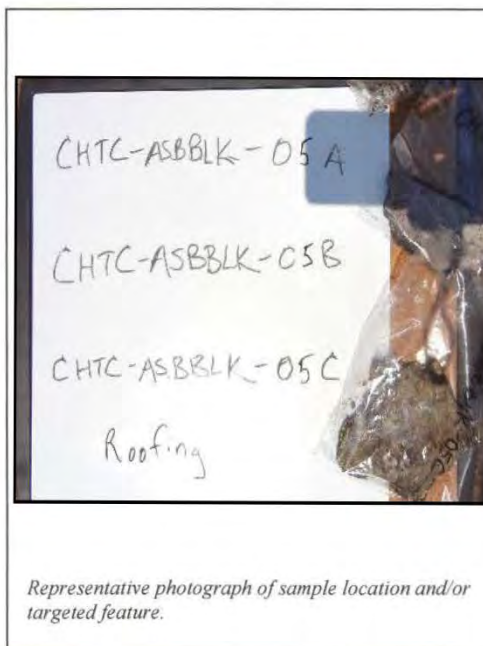
STAMP MILL FLOOR IS LITTERED WITH BROKEN DEBRIS AND RUBBLE. OBSERVED SUSPECT MATERIALS INCLUDE ROOFING MATERIALS, TRANSITE, CERAMIC, CONCRETE AND SIMILAR BUILDING DEBRIS

THE WIDE SPREAD DISTRIBUTION OF THE DEBRIS AND WEATHERED AND FRIABLE NATURE OF THE MATERIALS MAKE THEM SUSCEPTIBLE TO WIND AND WATER EROSION. THE SITE IS UNSECURED AND ACCESSIBLE

Other Relevant Below and Above Ground Features (Conduit, Drainage Swales, Culverts): TO TRESPASSERS  
A MOUND OF THE DEBRIS IS LOCATED ON THE UPPER PORTION OF THE MILL. VARIOUS TRENCHES CREATE PHYSICAL HAZARDS AND PATHWAYS FOR CONTAMINATED MATERIALS TO REACH LOWER LEVELS.

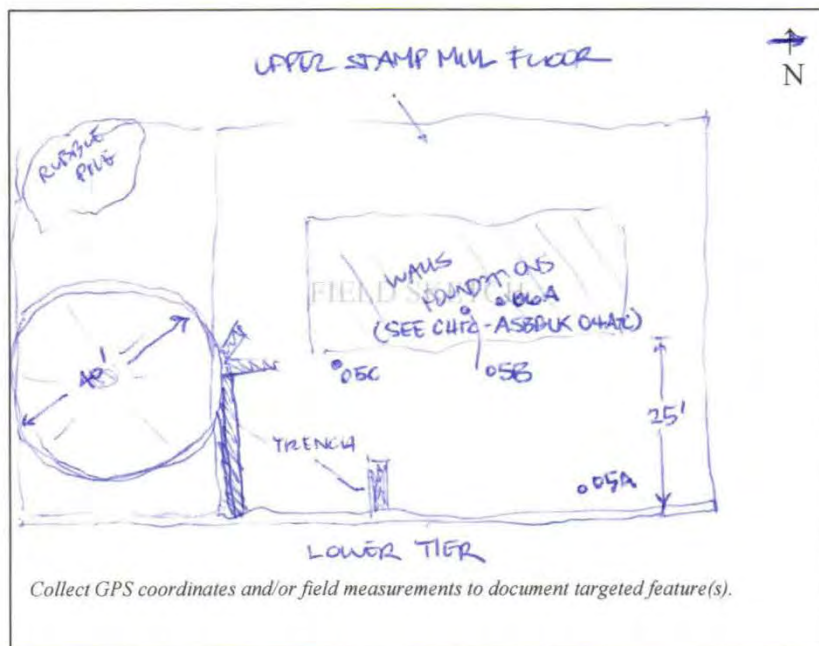
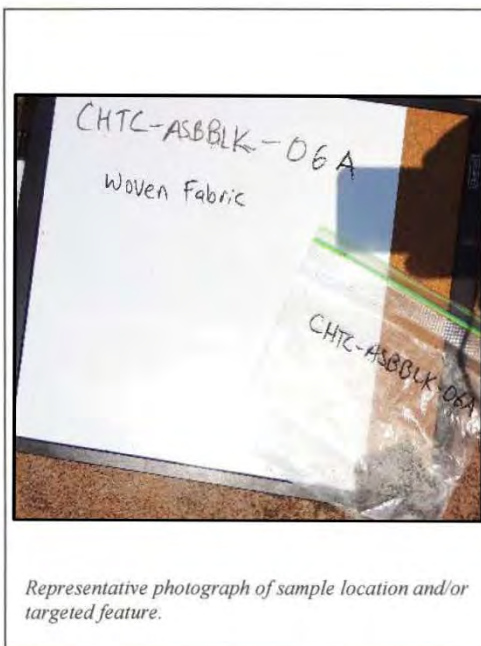
STAMP MILL FLOOR IS LITTERED WITH BROKEN DEBRIS AND RUBBLE. OBSERVED SUSPECT MATERIALS INCLUDE ROOFING MATERIALS, TRANSITE, CERAMIC, CONCRETE AND SIMILAR BUILDING DEBRIS

THE WIDE SPREAD DISTRIBUTION OF THE DEBRIS AND WEATHERED AND FRAGILE NATURE OF THE MATERIALS MAKE THEM SUSCEPTIBLE TO WIND AND WATER EROSION. THE SITE IS UNSECURED AND ACCESSIBLE

Other Relevant Below and Above Ground Features (Conduit, Drainage Swales, Culverts): TO TRESPASSERS  
A MOUND OF THE DEBRIS IS LOCATED ON THE UPPER PORTION OF THE MILL. VARIOUS TRENCHES CREATE PHYSICAL HAZARDS AND PATHWAYS FOR CONTAMINATED MATERIALS TO REACH LOWER LEVELS.

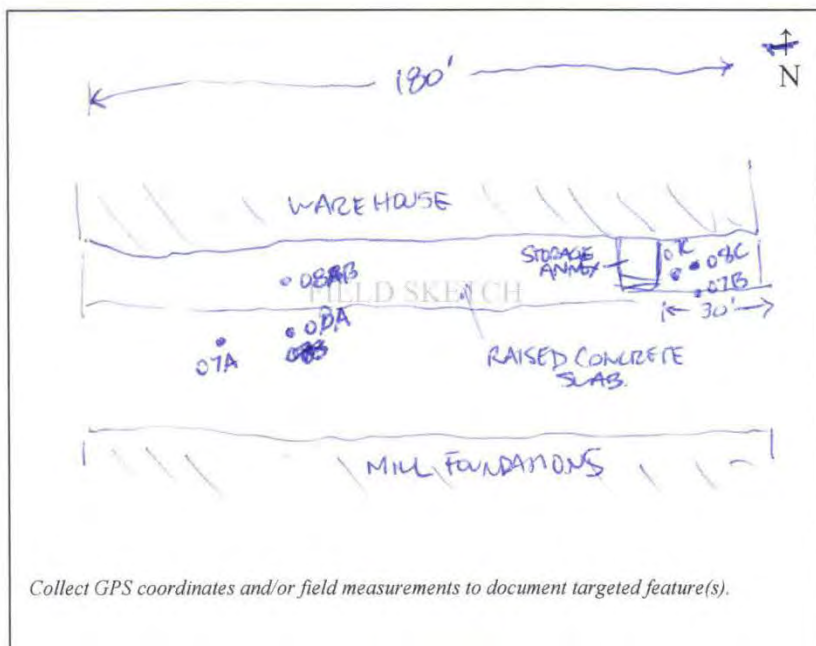
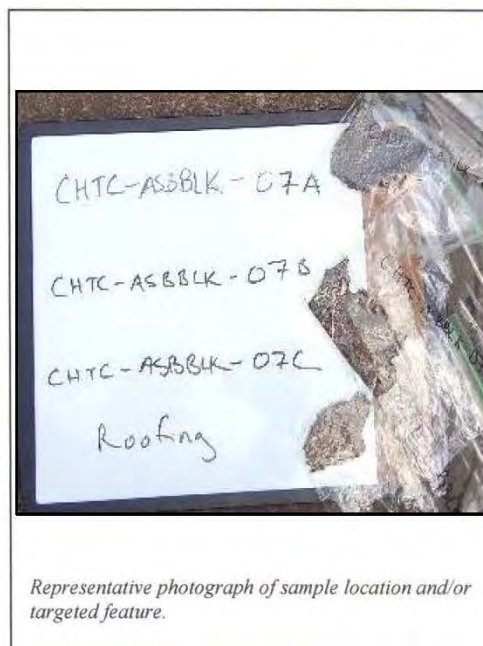
HILLSIDE IS COMPRISED OF STAMP MILL FOUNDATIONS/RUINS. WAREHOUSE LOCATED ON HIGHWAY LEVEL AT THE BASE OF THE HILL. BUILDING IS FALLING INTO DISREPAIR, ROOFING ON BUILDING IS BLowing OFF AND BEING DISTRIBUTED ON

MATERIALS ARE DISTRIBUTED ON THE GROUND SURFACE, BECOMING WEATHERED AND FRAGILE. COULD BE SUSCEPTIBLE TO WIND AND WATER EROSION. PROPERTY IS UNSECURED AND TRIPSTICKERS ARE POTENTIALLY AT RISK.

STAMP MILL RUINS ON THE HILLSIDE ARE DILAPIDATED WITH MANY PHYSICAL AND STRUCTURAL HAZARDS; ABANDONED CONTAINERS AND CONDUITS ARE ALSO DOCUMENTED THROUGHOUT.

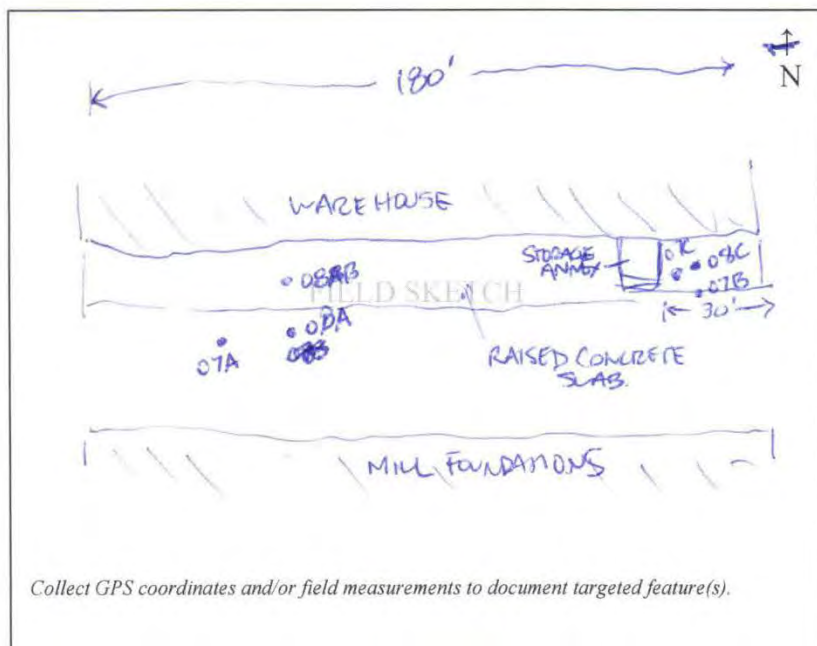
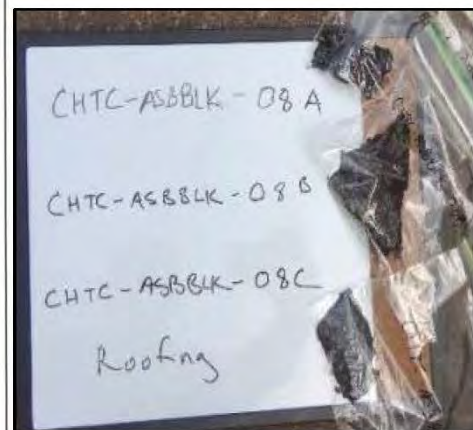
HILLSIDE IS COMPRISED OF STAMP MILL FOUNDATIONS/RUINS. WAREHOUSE LOCATED ON HIGHWAY LEVEL AT THE BASE OF THE HILL. BUILDING IS FALLING INTO DISREPAIR, ROOFING ON BUILDING IS BLowing OFF AND BEING DISTRIBUTED ON

MATERIALS ARE DISTRIBUTED ON THE GROUND SURFACE, BECOMING WEATHERED AND FRAGILE. COULD BE SUSCEPTIBLE TO WIND AND WATER EROSION. PROPERTY IS UNSECURED AND TRIPSTAFFERS ARE POTENTIALLY AT RISK

STAMP MILL RUINS ON THE HILLSIDE ARE DILAPIDATED WITH MANY PHYSICAL AND STRUCTURAL HAZARDS; ABANDONED CONTAINERS AND CONDUITS ARE ALSO DOCUMENTED THROUGHOUT.

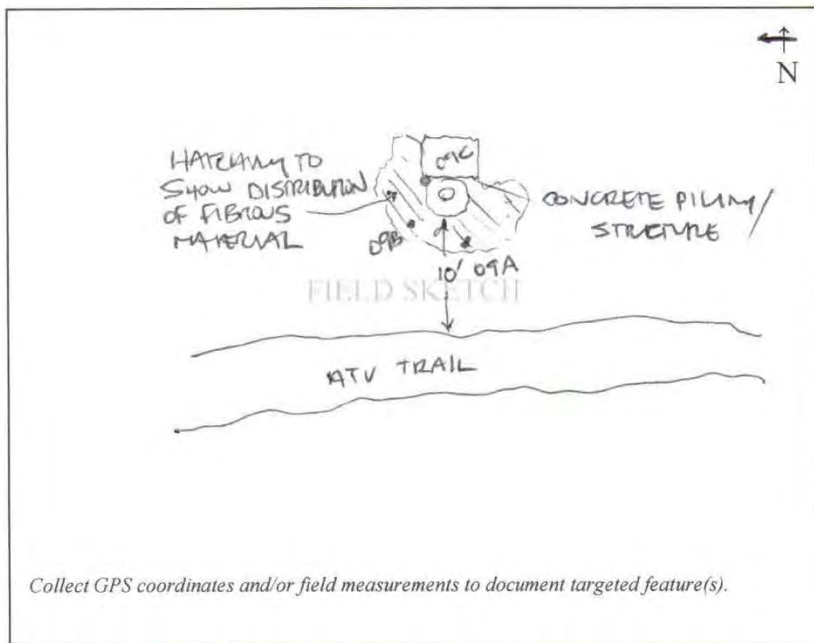
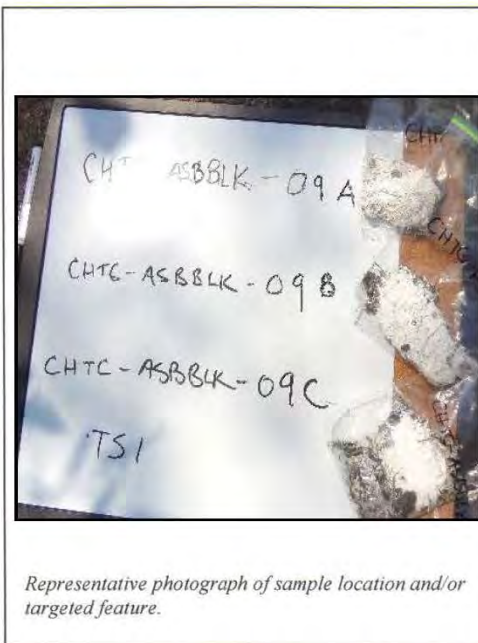
ATV AND WALKING TRAIL COMPRISED OF STAMP SANDS. CONCRETE PILING'S LOCATED ON EAST SIDE OF TRAIL. WHITE FIBROUS MATERIAL SPREAD ALONG PILING'S APPEARS TO BE WEATHERED PIPE INSULATION (TSI) CHTC-SALMOZ (REF200)  
Sampling Activities (Sample Description, Sample Time, Requested Analyses):  
CHTC-ASBBLK09(A-C) - WHITE TO WH/SH GRAY FIBROUS MATERIAL, DAMAGED WEATHERED TRIABLE, COLLECTED AT 1330

THE DAMAGED AND TRIABLE NATURE OF THE MATERIAL MAKES IT HIGHLY SCEPTIBLE TO WIND AND WATER EROSION. TRAVEL BY ATVS AND FOOT TRAFFIC COULD RESULT IN RESPIRABLE EXPOSURES.

THE AREA IS OPEN TO THE PUBLIC AND IS ADJACENT TO RESIDENTIAL PROPERTIES

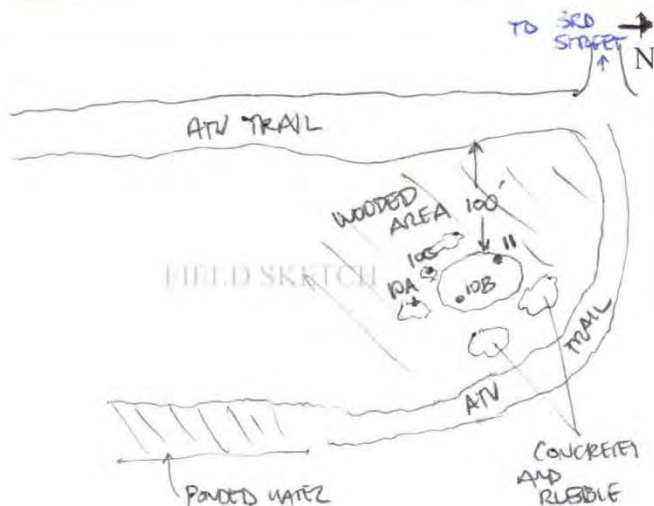
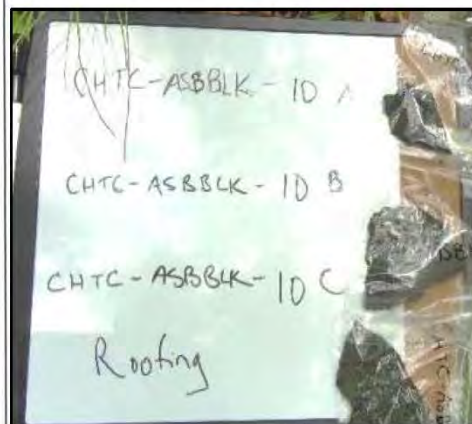
Representative photograph of sample location and/or targeted feature.

DEBRIS PILE APPROXIMATELY 15' IN DIAMETER, COMPRISED OF WOOD AND SHINGLES  
DEBRIS PILE IS IN THE VICINITY OF OTHER WASTE PILES COMPRISED OF  
CONCRETE AND OTHER DEBRIS.

DEBRIS PILES ARE LOCATED IN A WOODED AREA THAT IS OPEN TO  
THE PUBLIC. EVIDENCE OF YARD WASTE BEING DEPOSITED IN THE  
VICINITY WAS OBSERVED

THE DEBRIS PILES ARE LOCATED IN A LOW LYING MARSHY AREA.

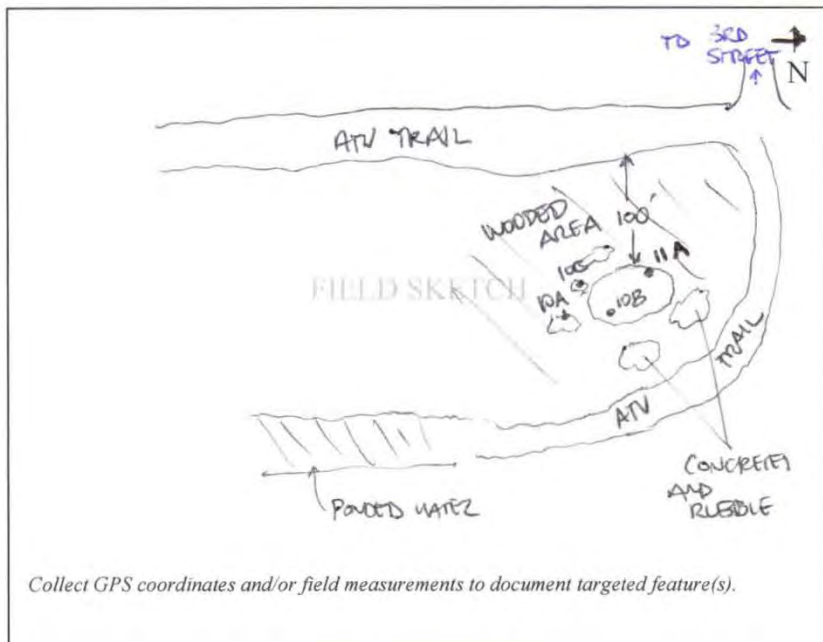
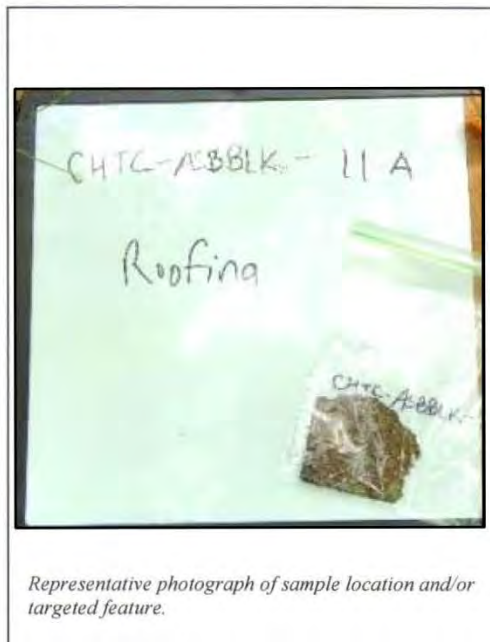
DEBRIS PILE APPROXIMATELY 15' IN DIAMETER, COMPRISED OF WOOD AND SHINGLES  
 DEBRIS PILE IS IN THE VICINITY OF OTHER WASTE PILES COMPRISED OF  
 CONCRETE AND OTHER DEBRIS.

DEBRIS PILES ARE LOCATED IN A WOODED AREA THAT IS OPEN TO  
 THE PUBLIC. EVIDENCE OF YARD WASTE BEING DEPOSITED IN THE  
 VICINITY WAS OBSERVED

THE DEBRIS PILES ARE LOCATED IN A LOW LYING MARSHY AREA.

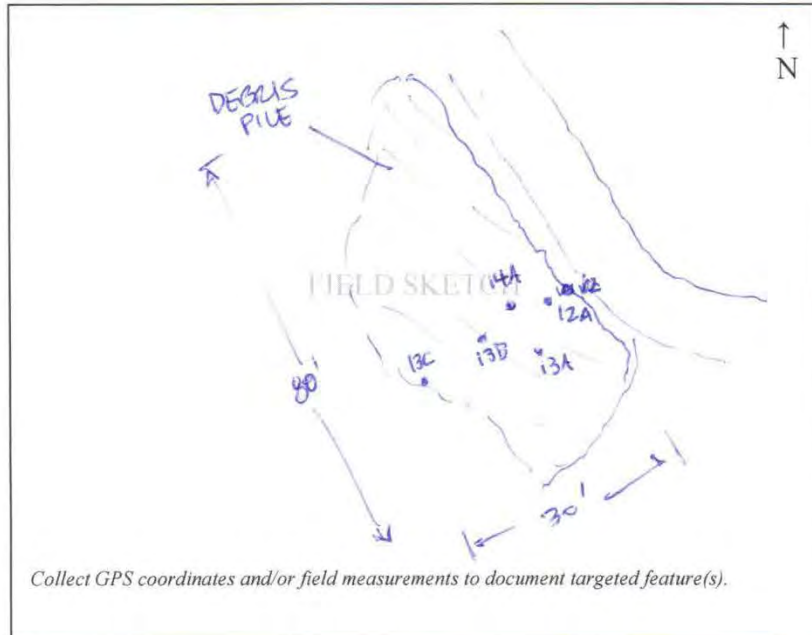
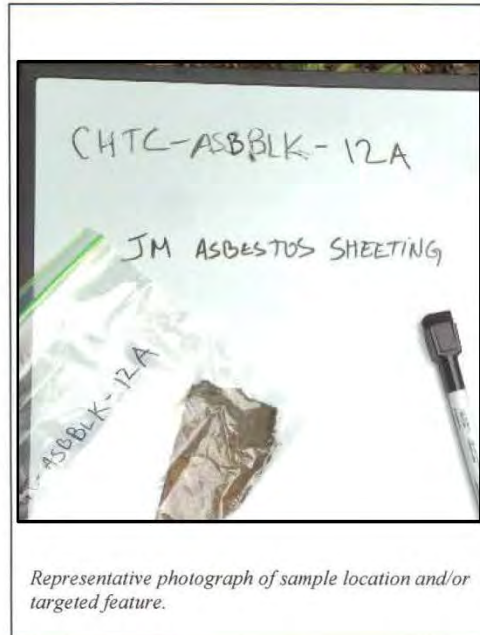
LOCATED ADJACENT TO SPRUCE STREET, SEPERATED BY A SPARSE LINE OF TREES, DEBRIS PILE INCLUDING VARIOUS BUILDING MATERIALS, CONCRETE, PLASTER, METAL, WOOD, TRANSITE, APPROX 3-5 FT DEEP. (CHTC-SACM10 RECD)

CLOSE PROXIMITY TO OSCOLA TOWNSHIP PARK - ACROSS THE STREET. POTENTIAL FOR HUMAN CONTACT WITH WEATHERED, FRILABLE, SUSPECT ASBESTOS CONTAINING MATERIAL, PROPERTY IS UNSECURED

MATERIALS ARE SUSCEPTIBLE TO WIND AND WATER EROSION.

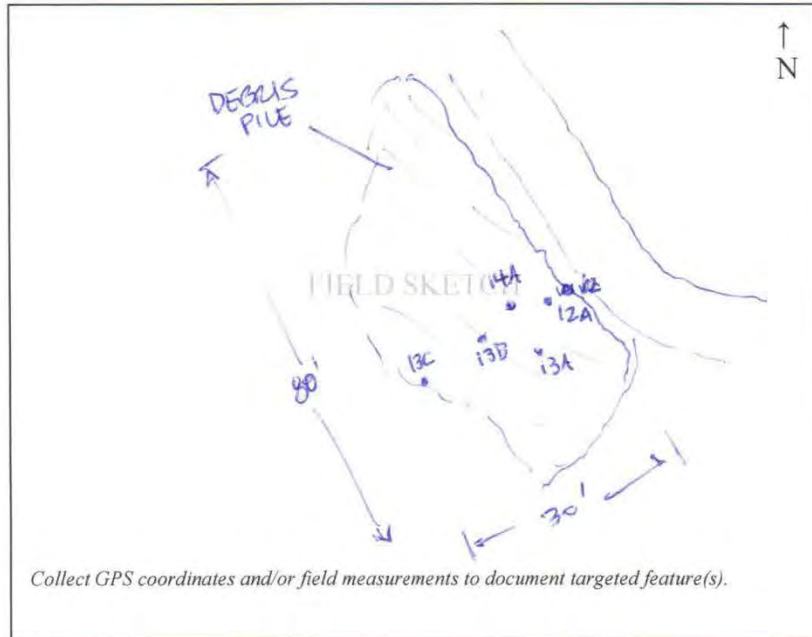
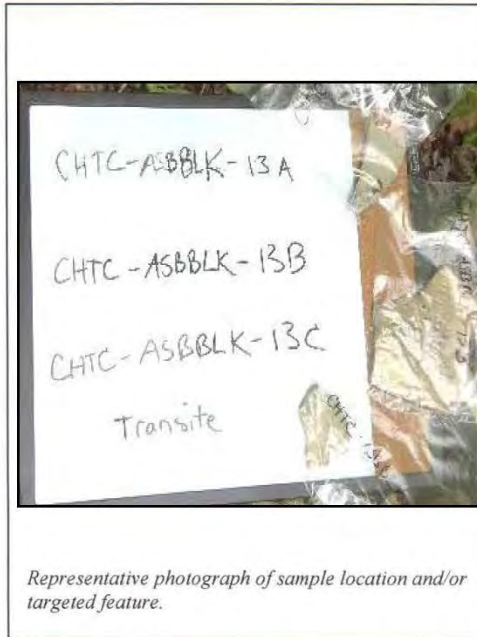
LOCATED ADJACENT TO SPRUCE STREET, SEPERATED BY A SPARSE LINE OF TREES, DEBRIS PILE INCLUDING VARIOUS BUILDING MATERIALS, CONCRETE, PLASTER, METAL, WOOD, TRANSITE, APPROX 3-5 FT DEEP. (CHTC-SACM10 RECON)

CLOSE PROXIMITY TO OSCOLA TOWNSHIP PARK - ACROSS THE STREET. POTENTIAL FOR HUMAN CONTACT WITH WEATHERED, FRILABLE, SUSPECT ASBESTOS CONTAINING MATERIAL, PROPERTY IS UNSECURED

MATERIALS ARE SUSCEPTIBLE TO WIND AND WATER EROSION.

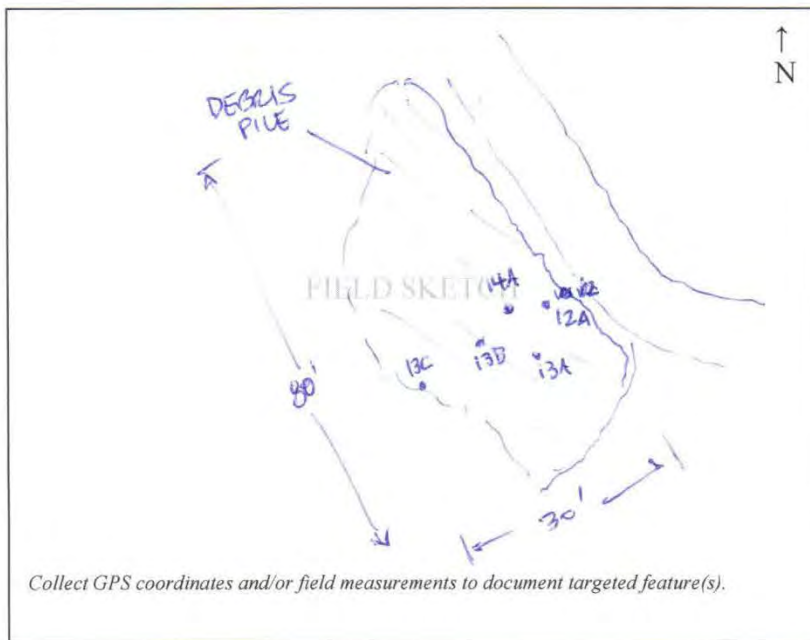
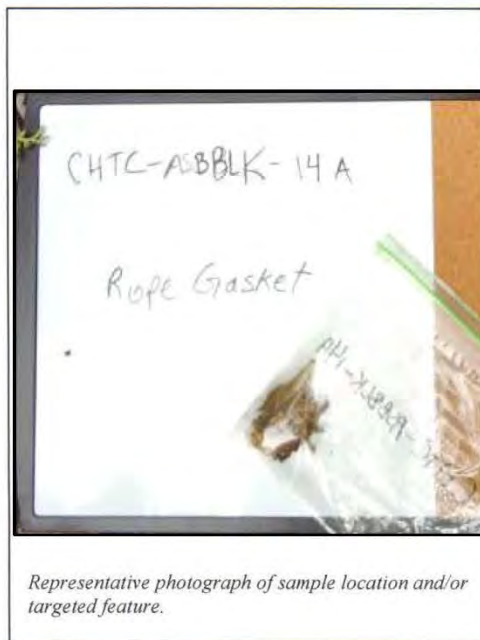
LOCATED ADJACENT TO SPRUCE STREET SEPERATED BY A SPARSE LINE OF TREES, DEBRIS PILE INCLUDING VARIOUS BUILDING MATERIALS CONCRETE, PLASTER, METAL, WOOD, TRANSIRE, APPROX 3-5 FT DEEP. (CHTC-SACHIO RECON)

CLOSE PROXIMITY TO OSCOLA TOWNSHIP PARK - ACROSS THE STREET.  
POTENTIAL FOR HUMAN CONTACT WITH WEATHERED, FRIZABLE, SUSPECT ASBESTOS CONTAINING MATERIAL, PROPERTY IS UNSECURED

MATERIALS ARE SUSCEPTIBLE TO WIND AND WATER EROSION.
