Presented to the Michigan Department of Environmental Quality:

Landfill Construction Quality Assurance: Beyond the Routine

April 14, 2016

By: DEQ – Gary Schwerin
Golder Associates Inc. - David List, P.E.

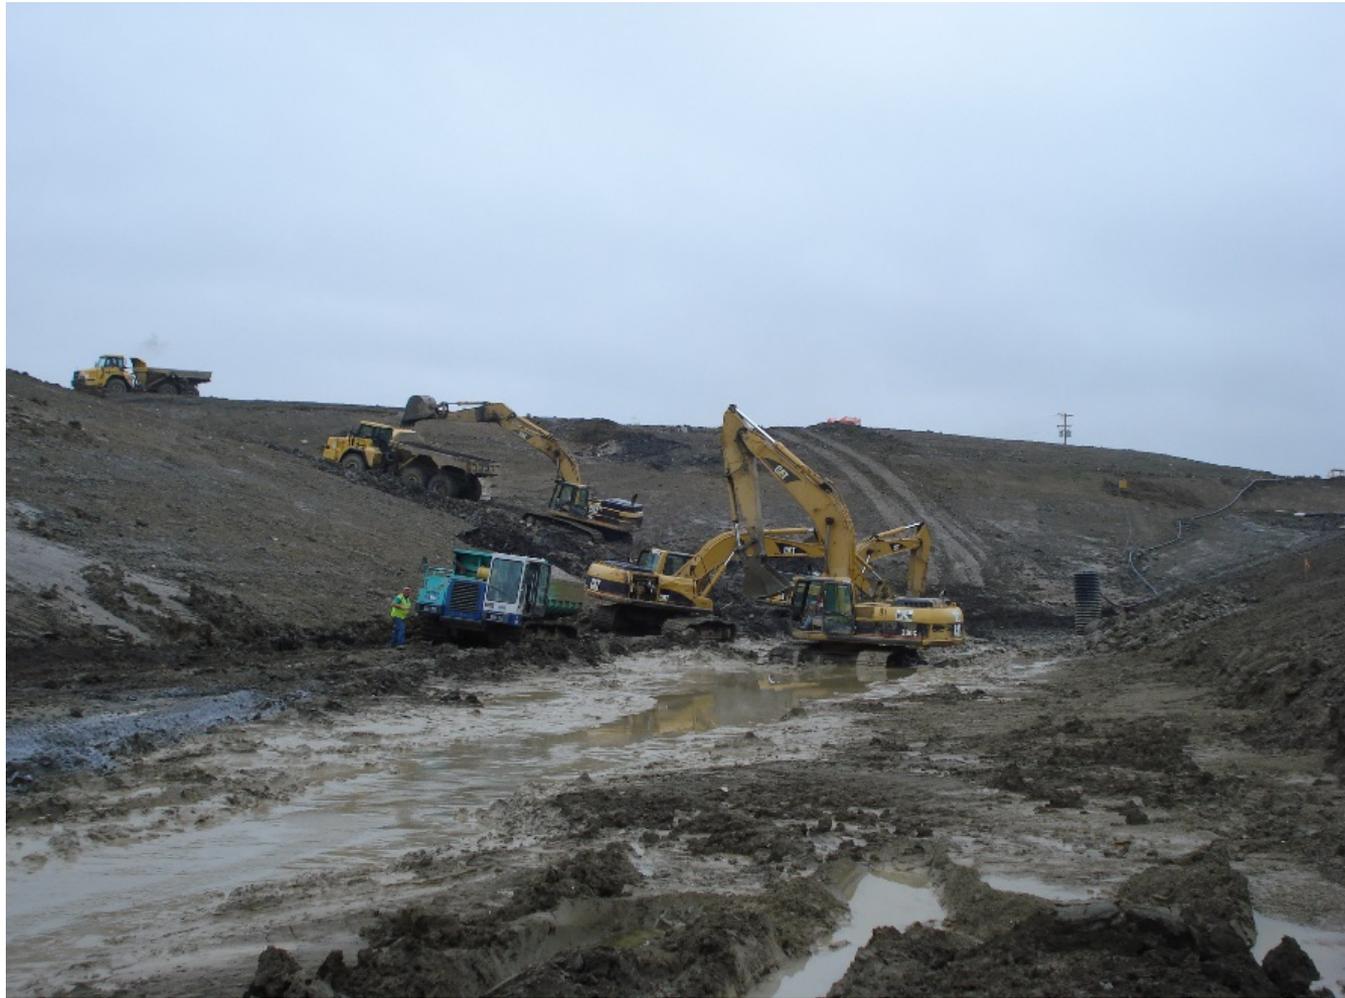
Poor Subgrade

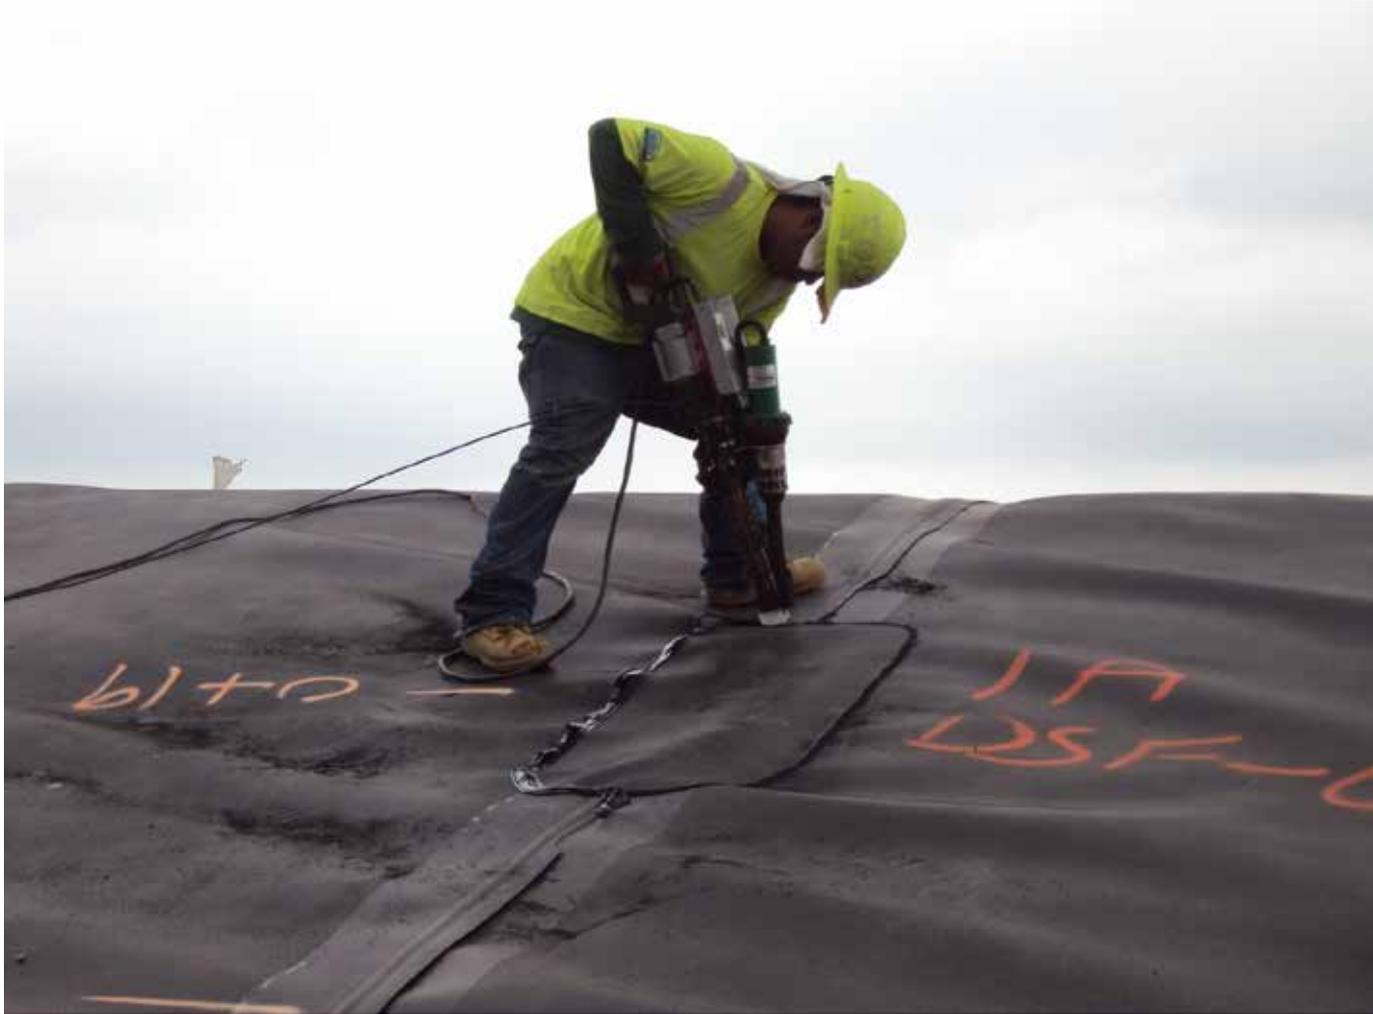
Footing

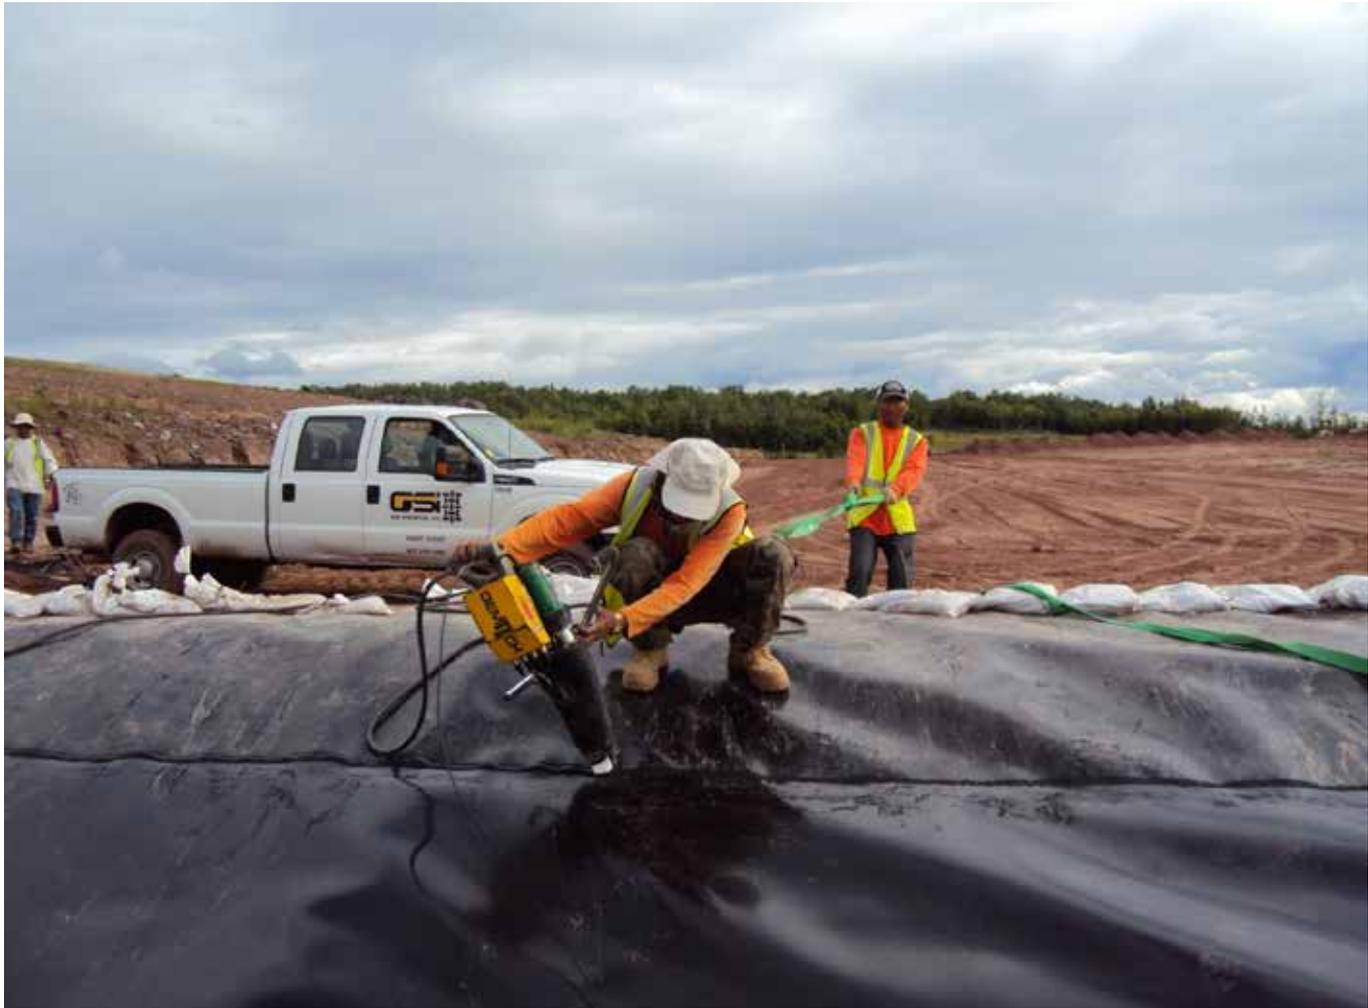
Creative but...

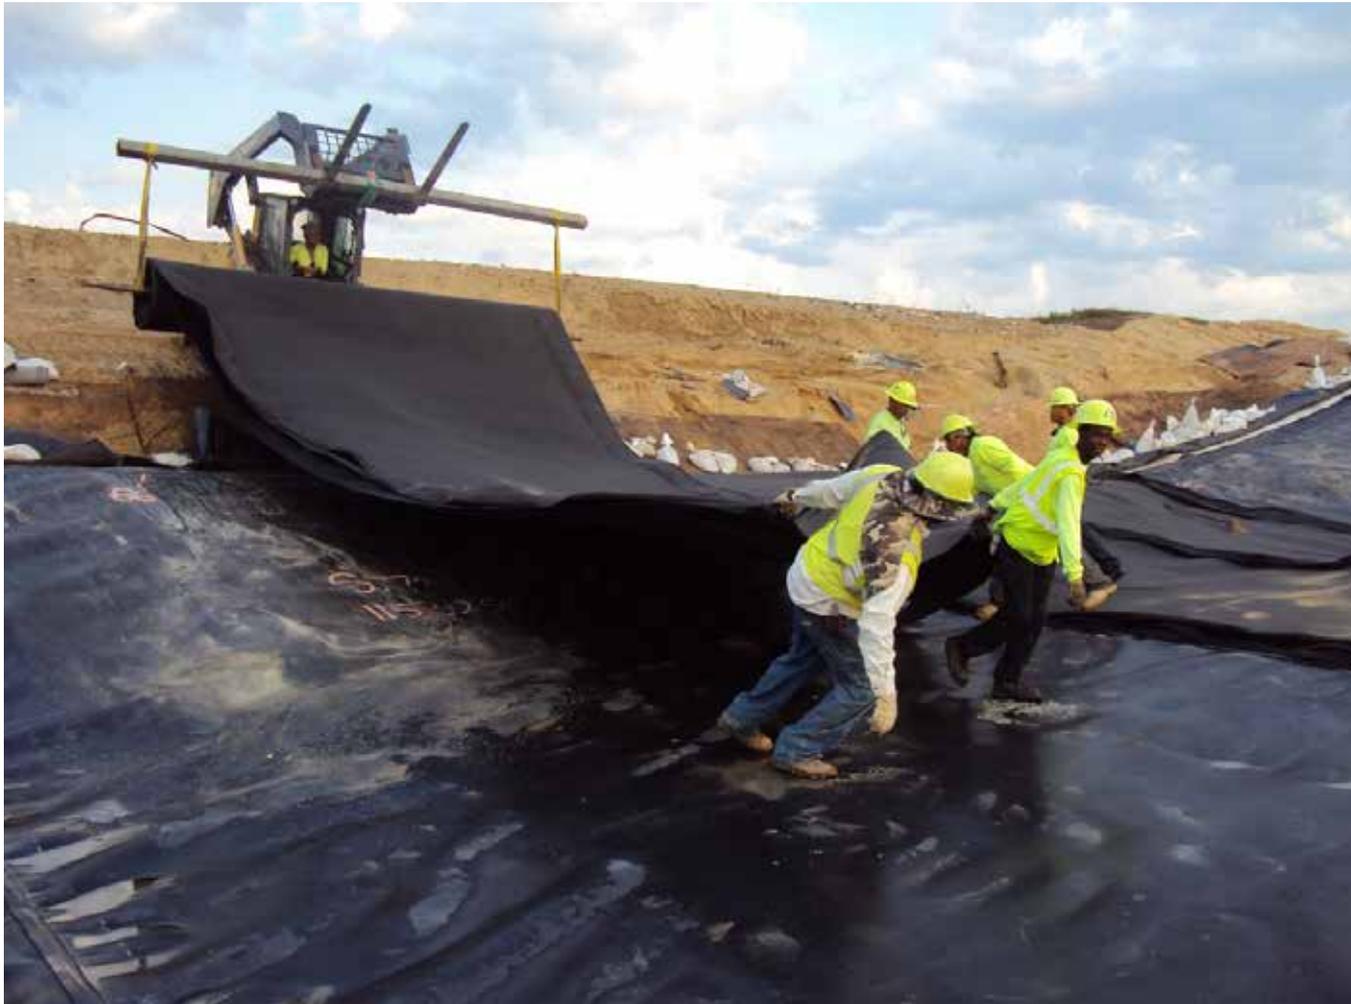
Rocks Mean Repair

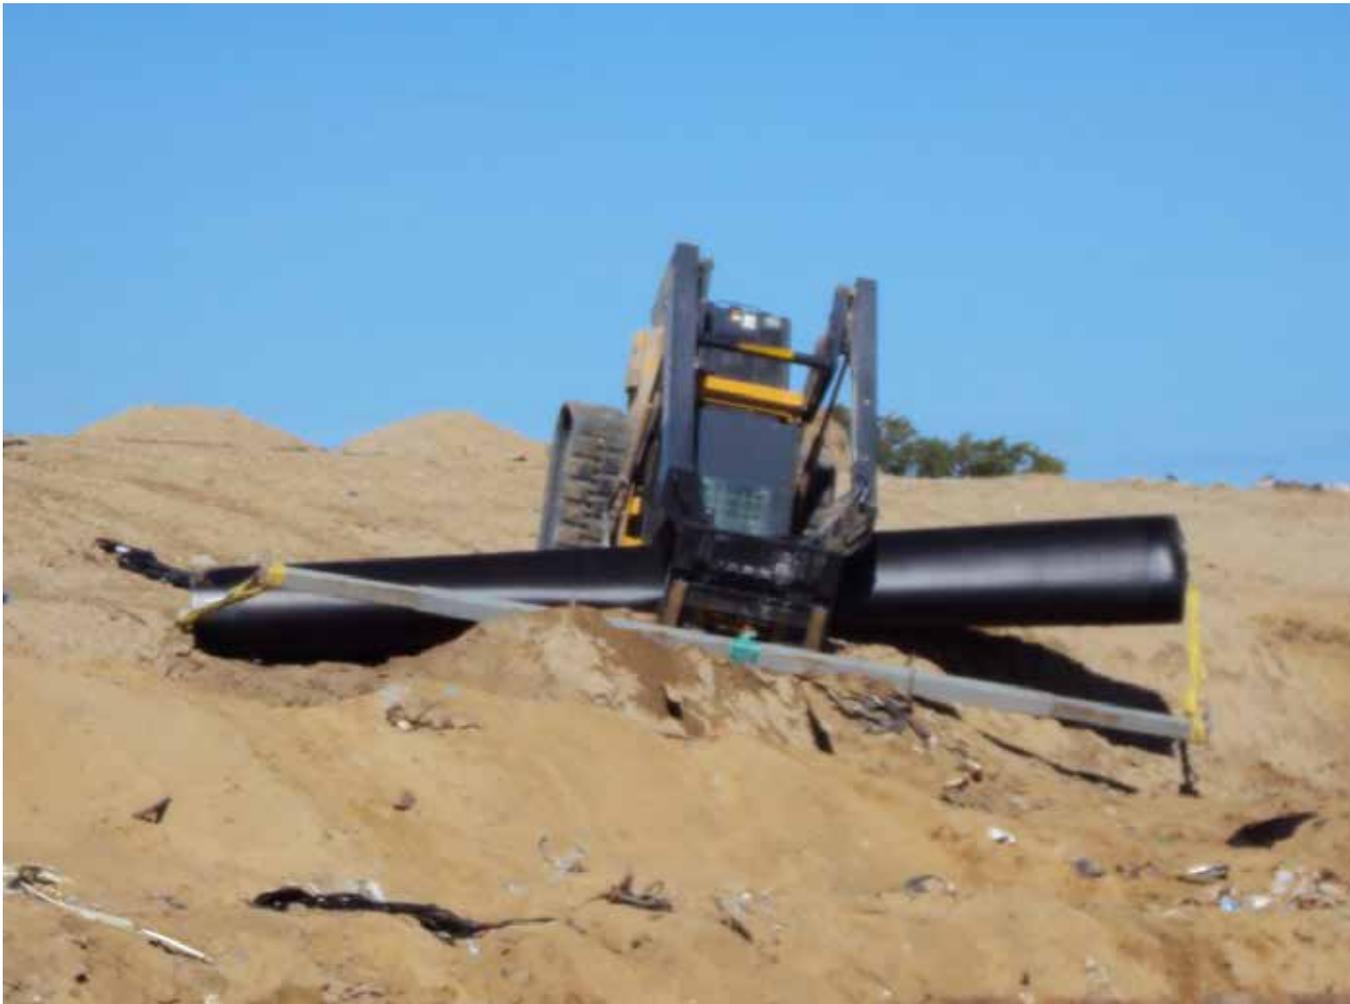
Delivered from Agru fine, but...

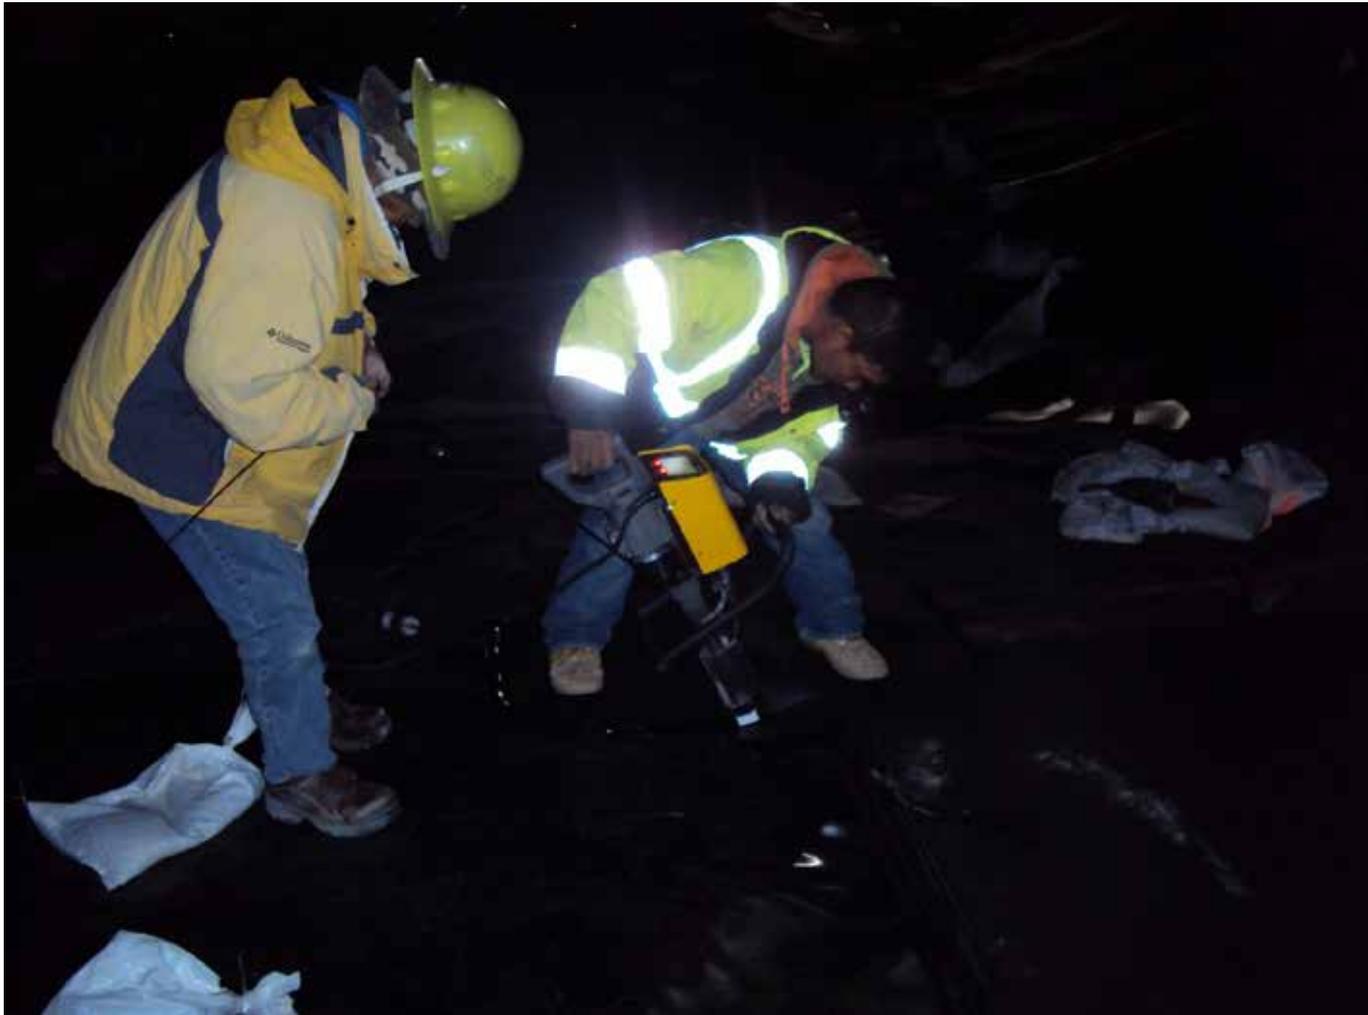
Reason for Reflective Tape

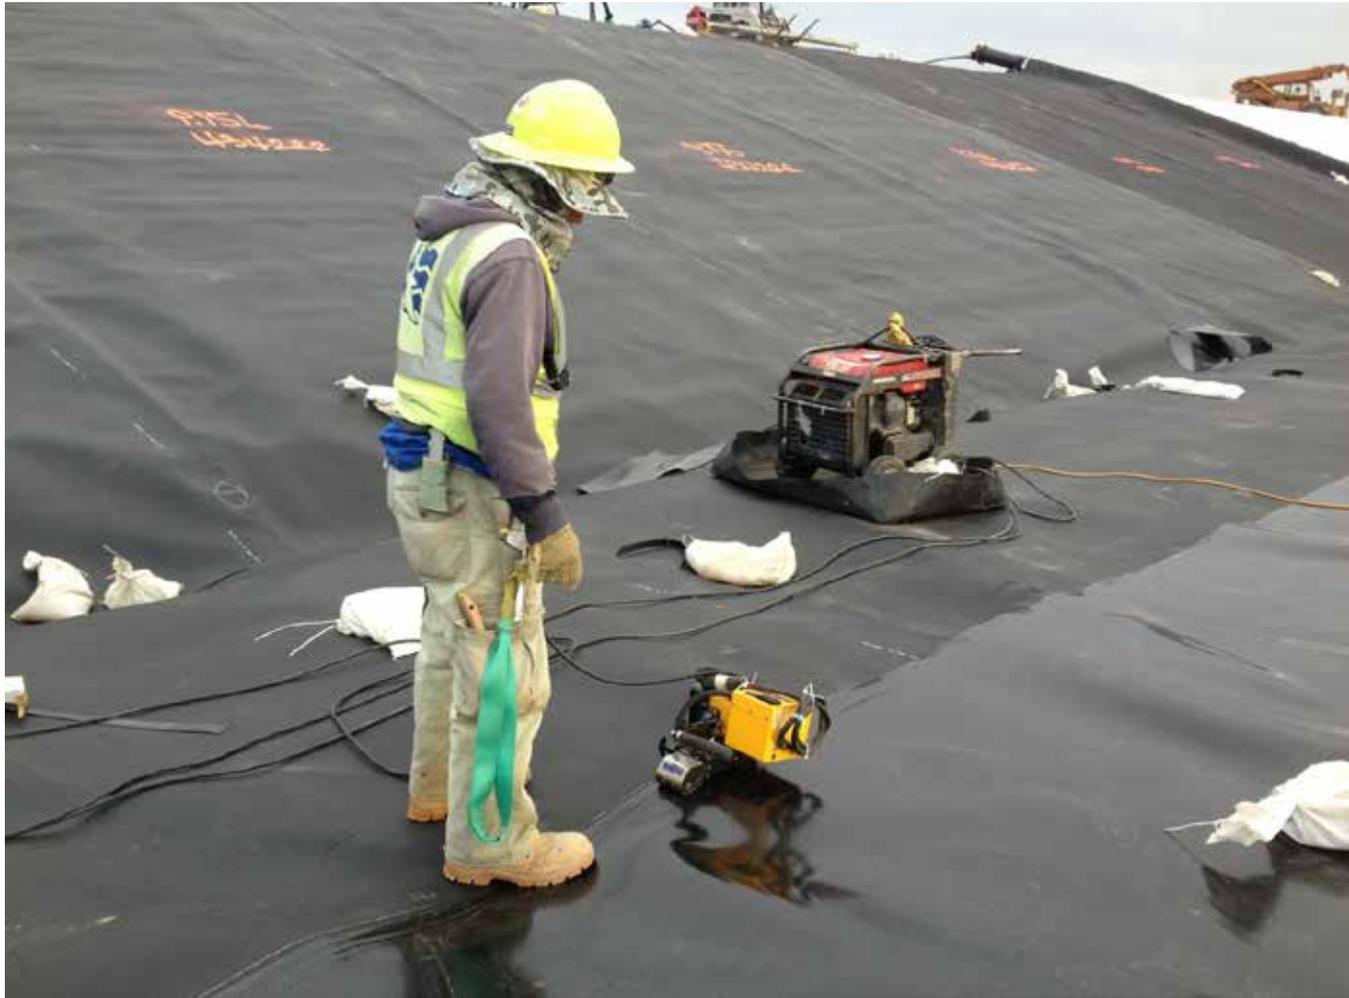
Shingle Downslope

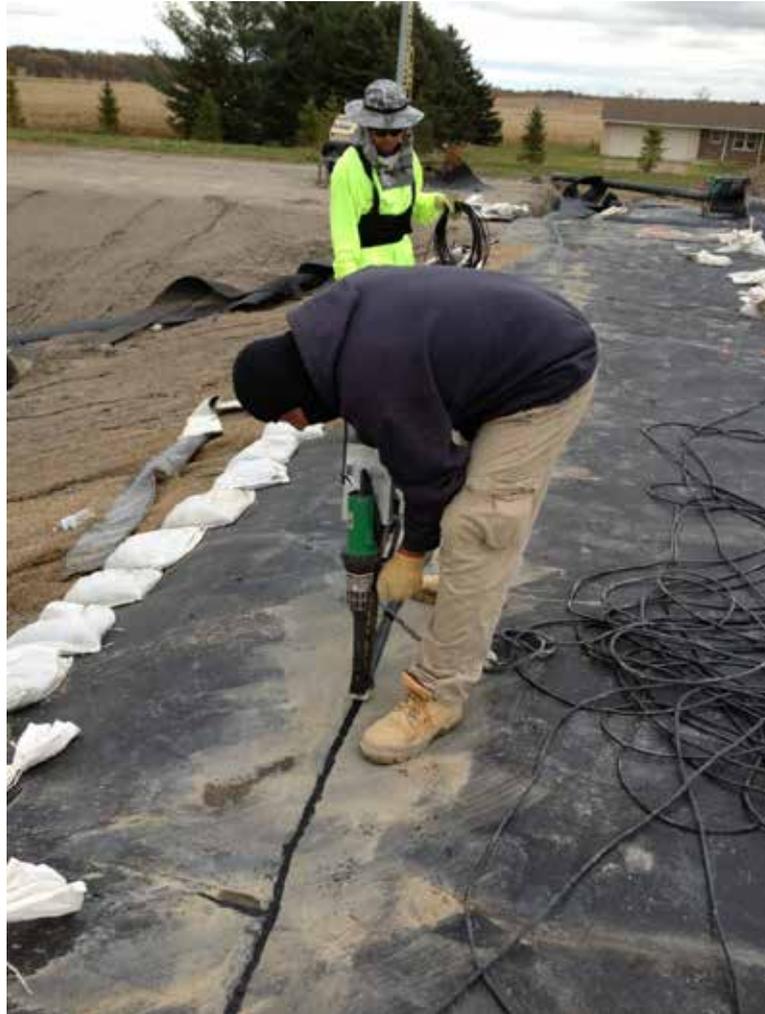
Wash Seam Before Grinding

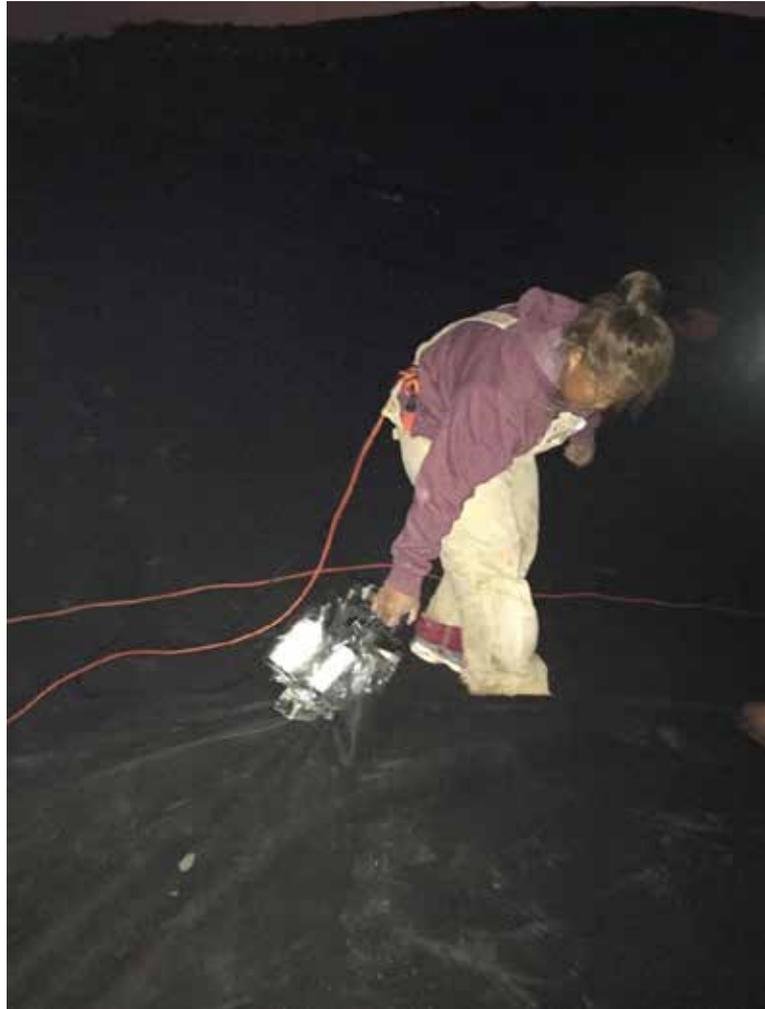
Had to Fix Spots Next Day

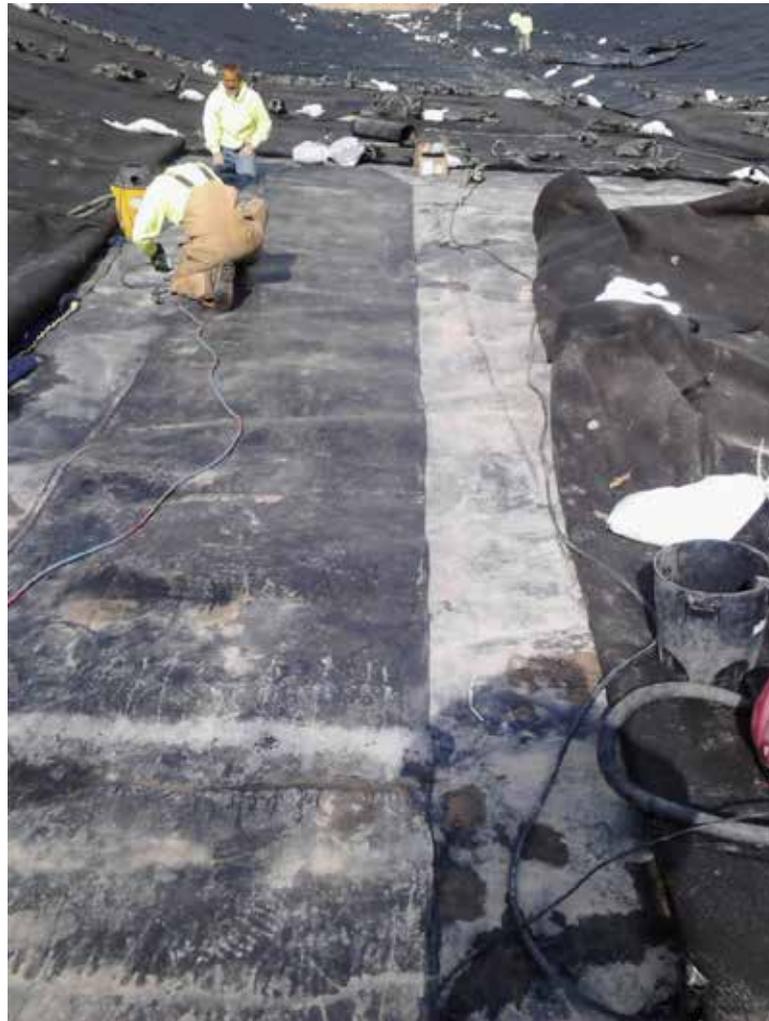
Deployed Over Failing Destructive

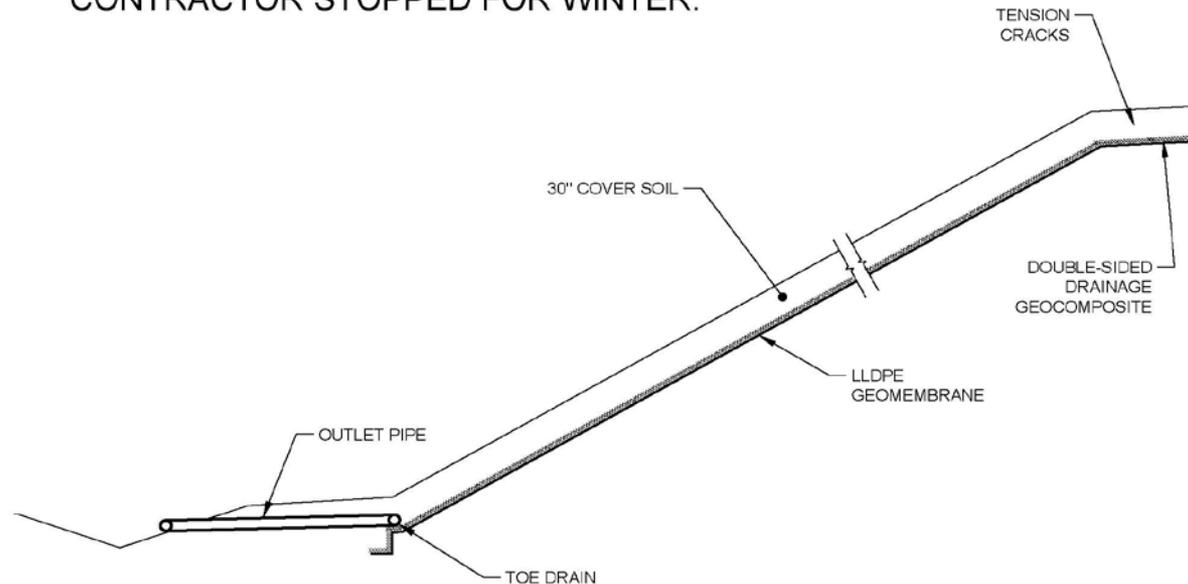
TIMING AND SEQUENCE OF CONSTRUCTION MAY BE IMPORTANT. FOLLOWING SOIL COVER PLACEMENT, CONTRACTOR STOPPED FOR WINTER.

TENSION CRACKS FORMED IN SPRING PRIOR TO COMPLETING TOE DRAIN AND OUTLET PIPES

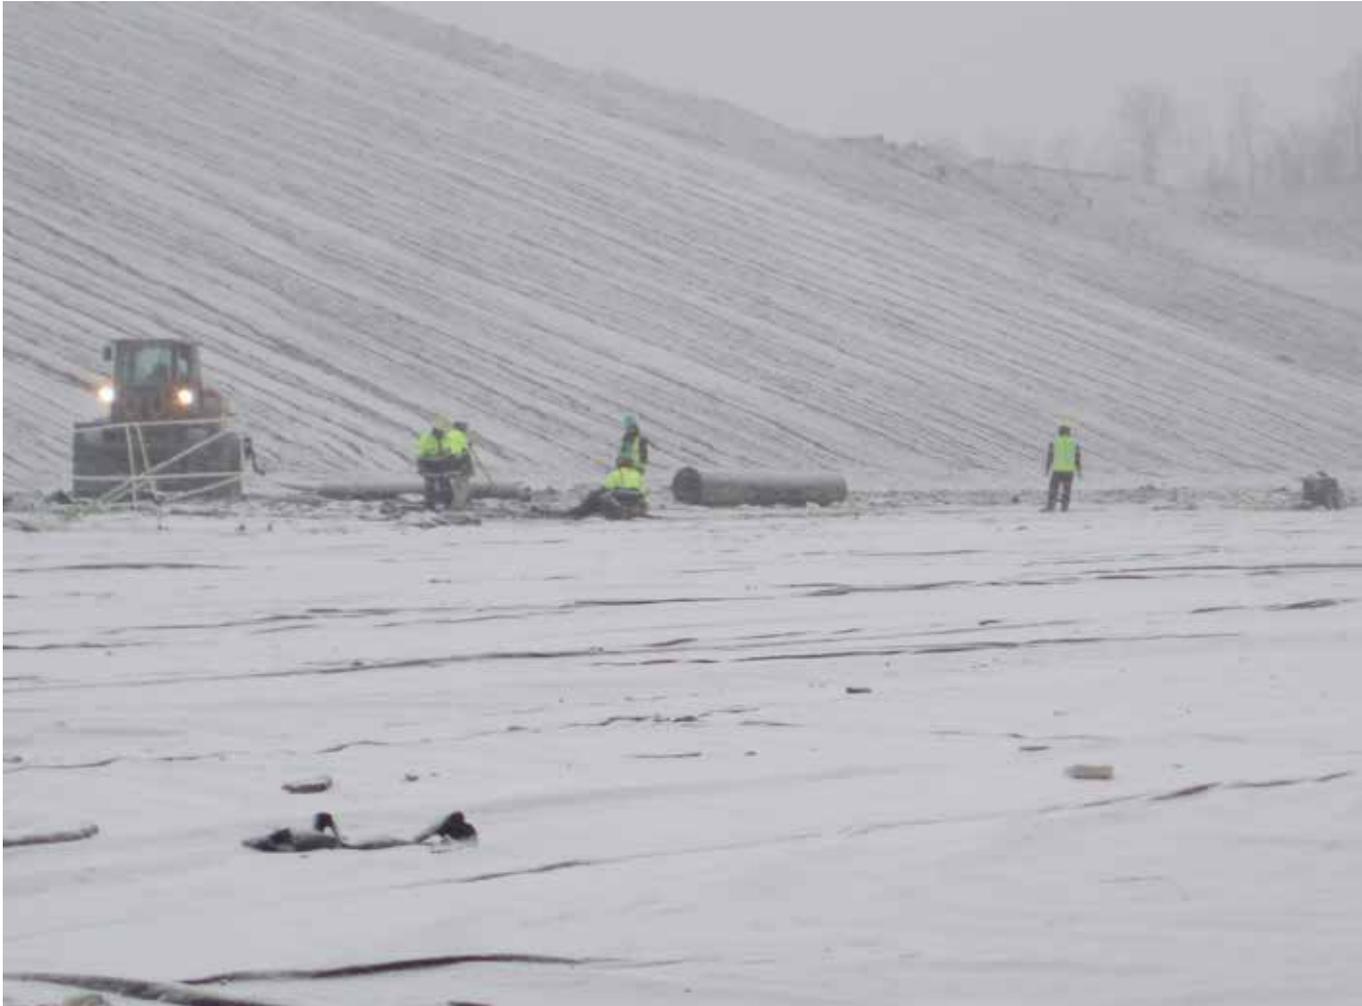
Where Was That Defect?

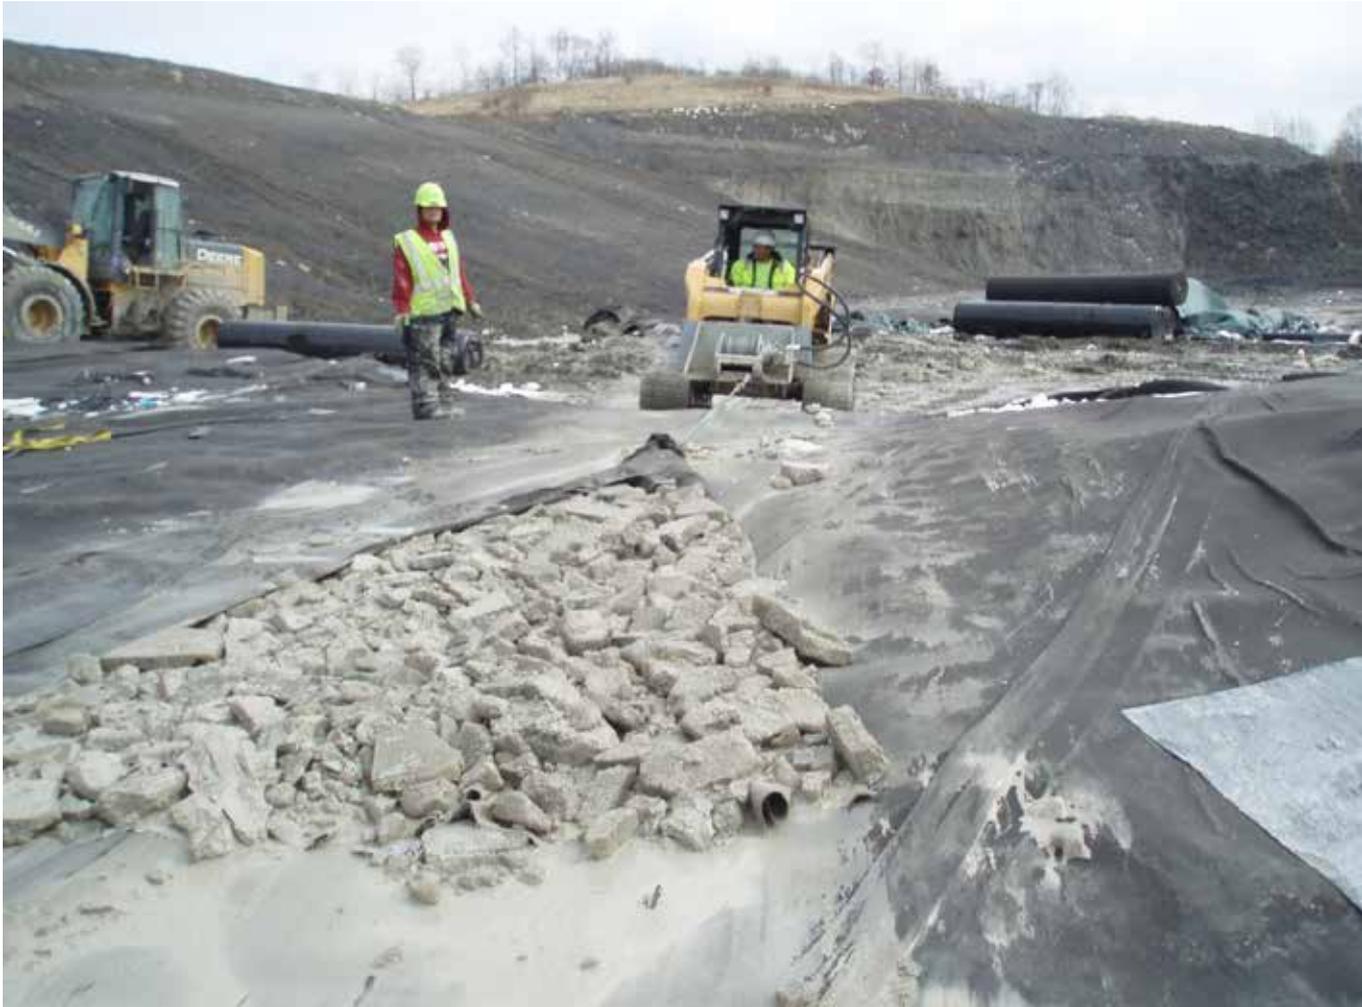
Winter Issues

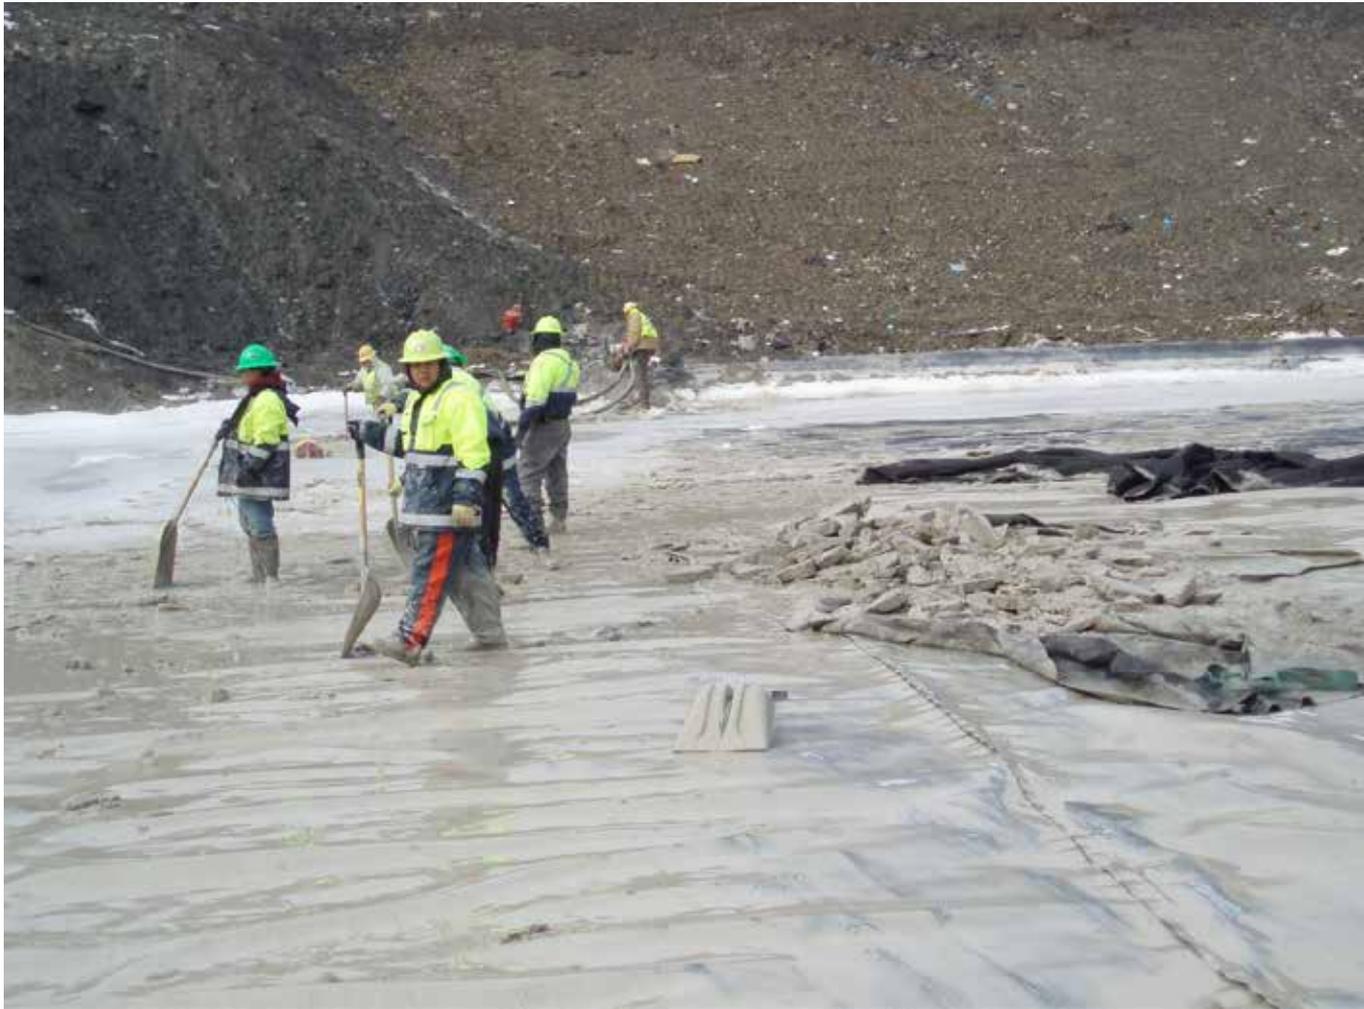
Winter Issues

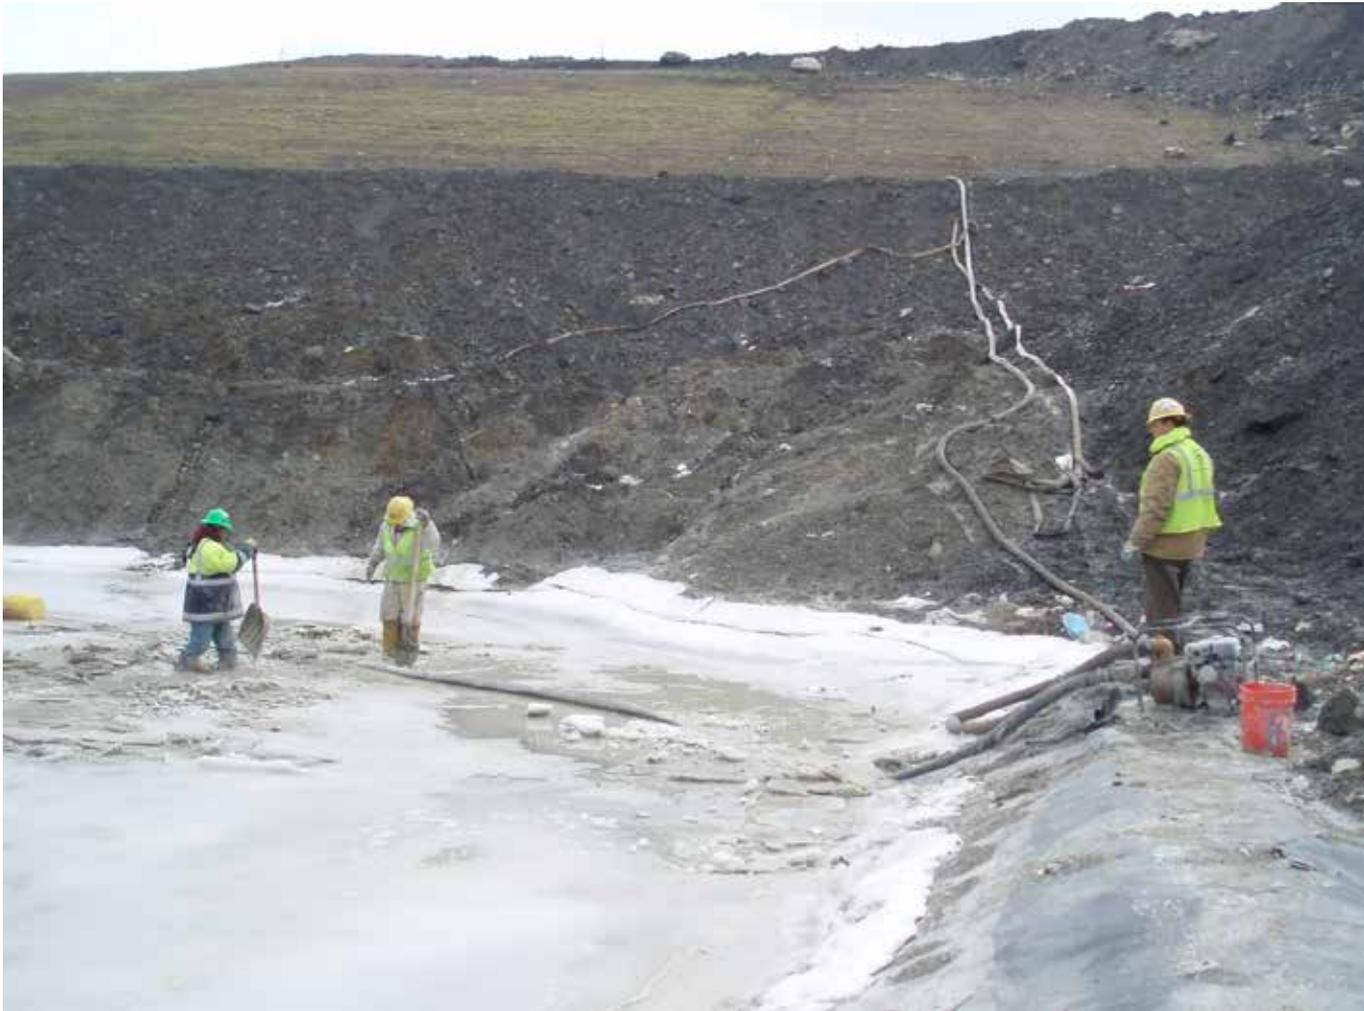
Winter Issues

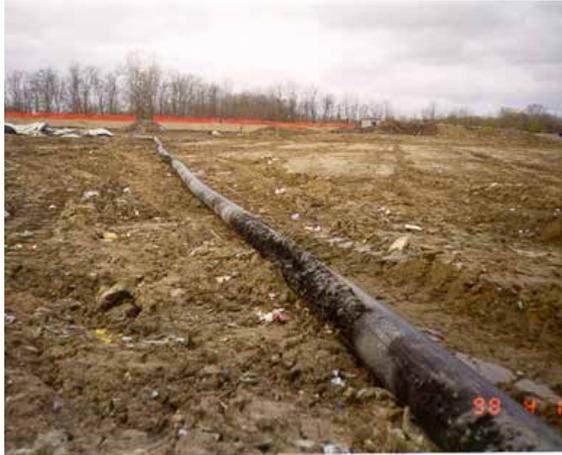
Post-Construction Fire

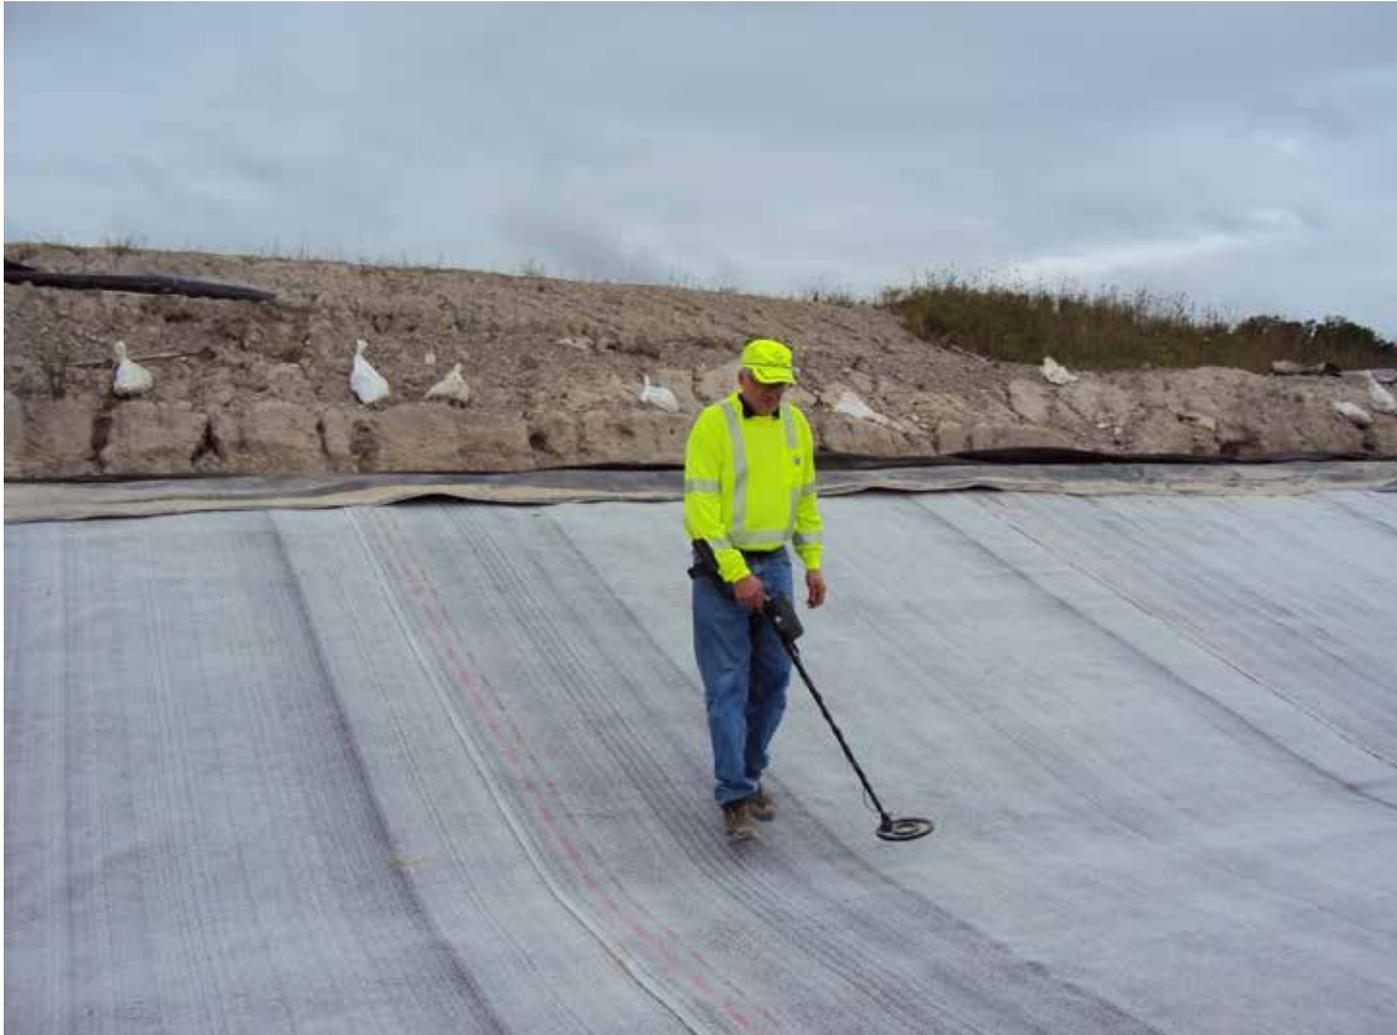
GCL - Needles

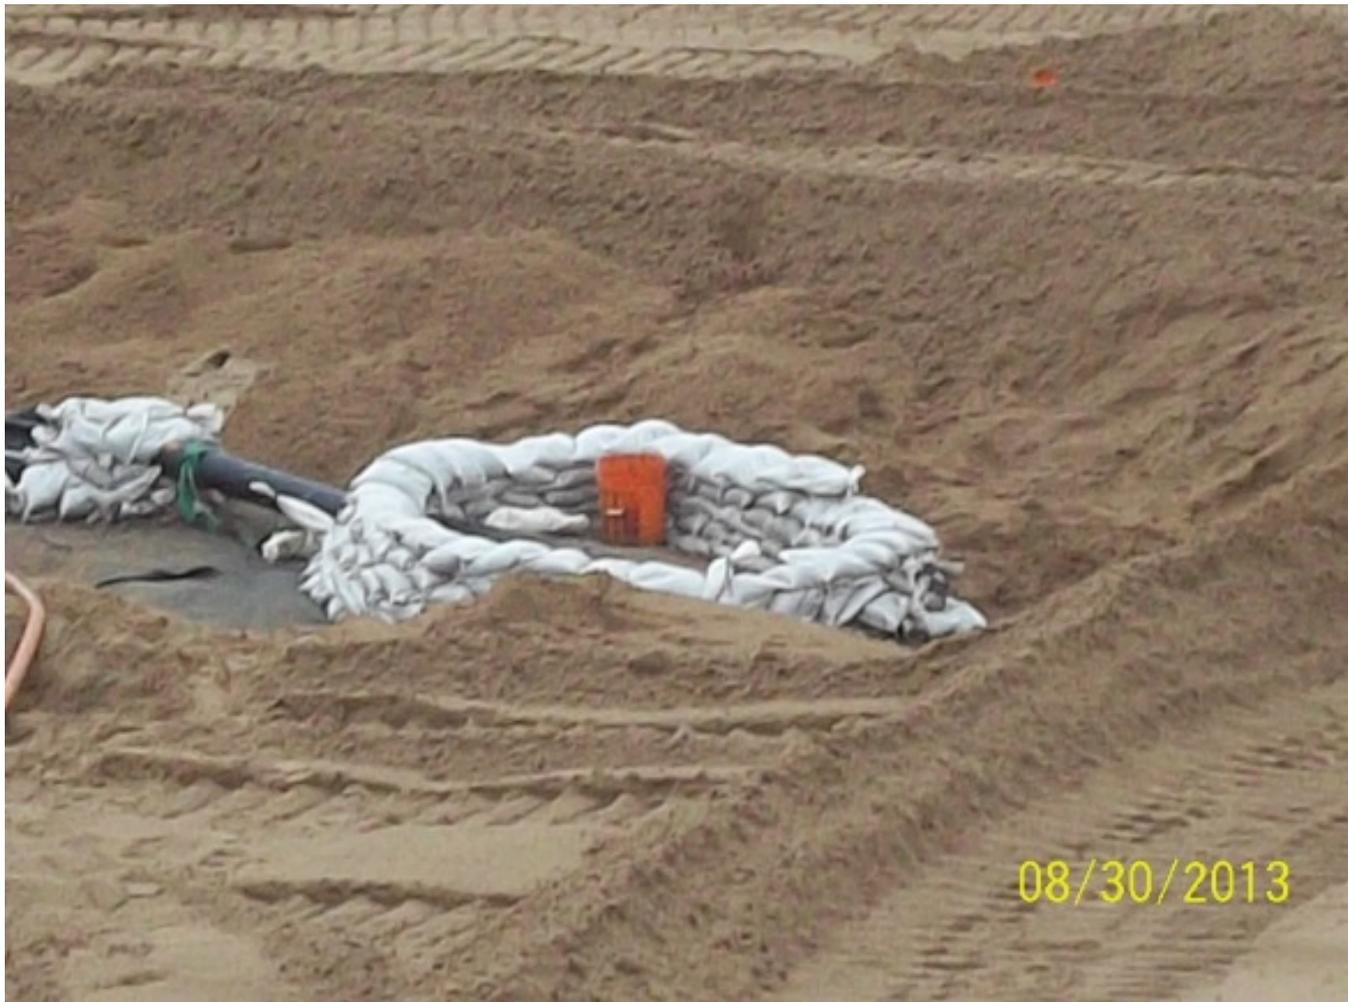
Water Under Liner

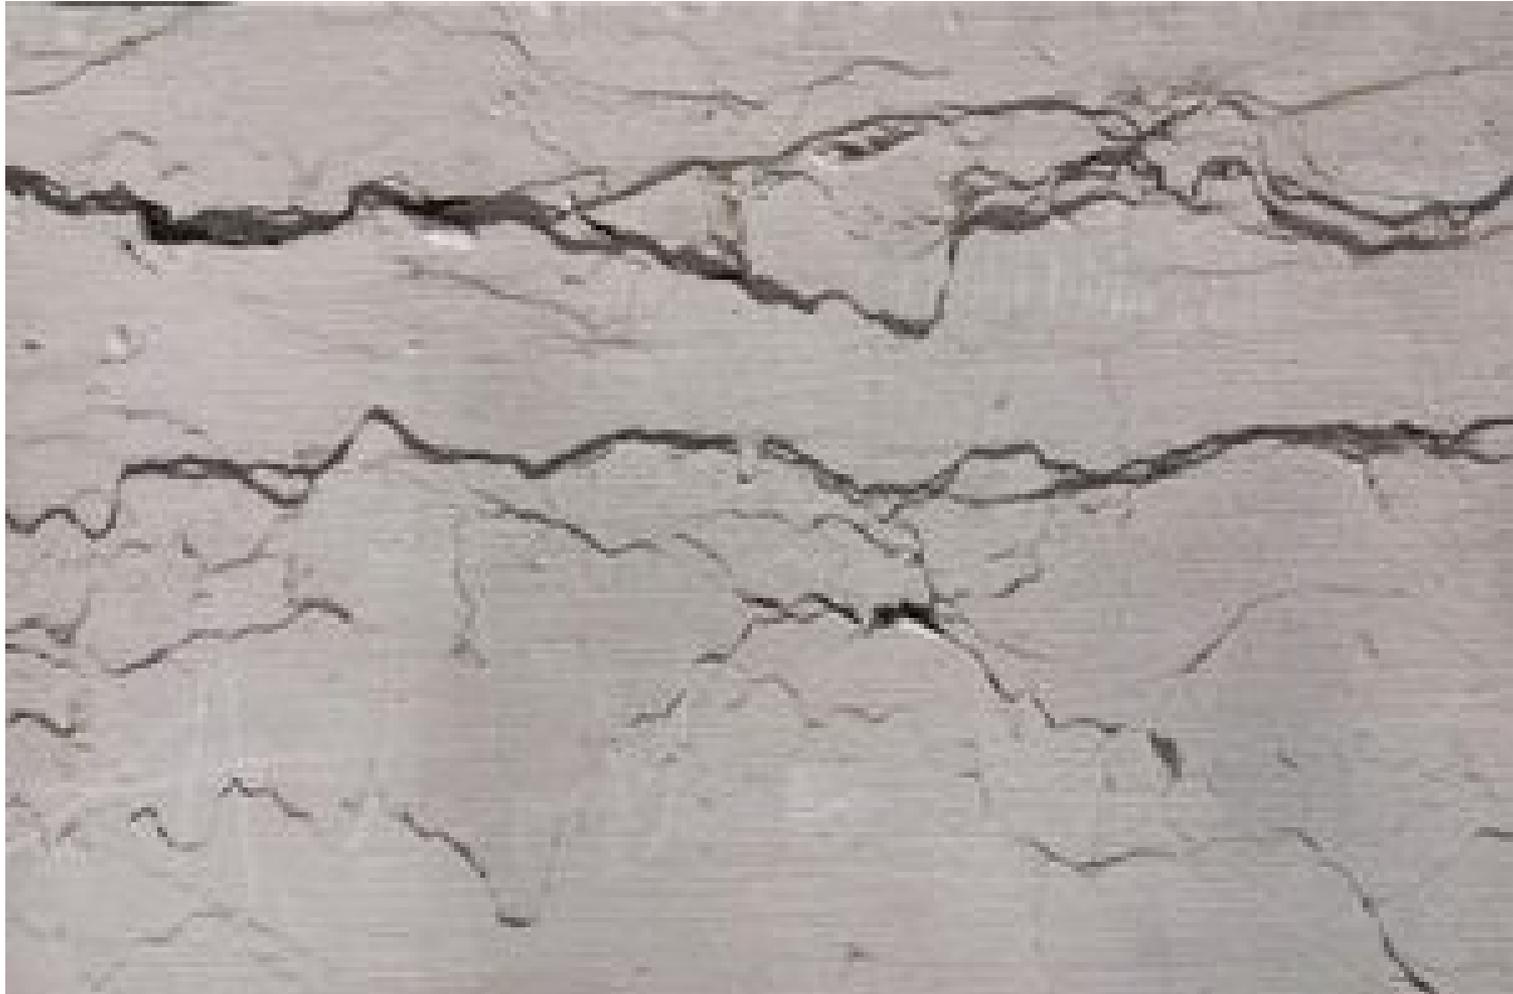
Uplift Happens: NSBs, 2ndaries , Underdrains
