Presented to the Michigan Department of Environmental Quality:

Landfill Construction Quality Assurance: Beyond the Routine

April 14, 2016

By: DEQ – Gary Schwerin
Golder Associates Inc. - David List, P.E.

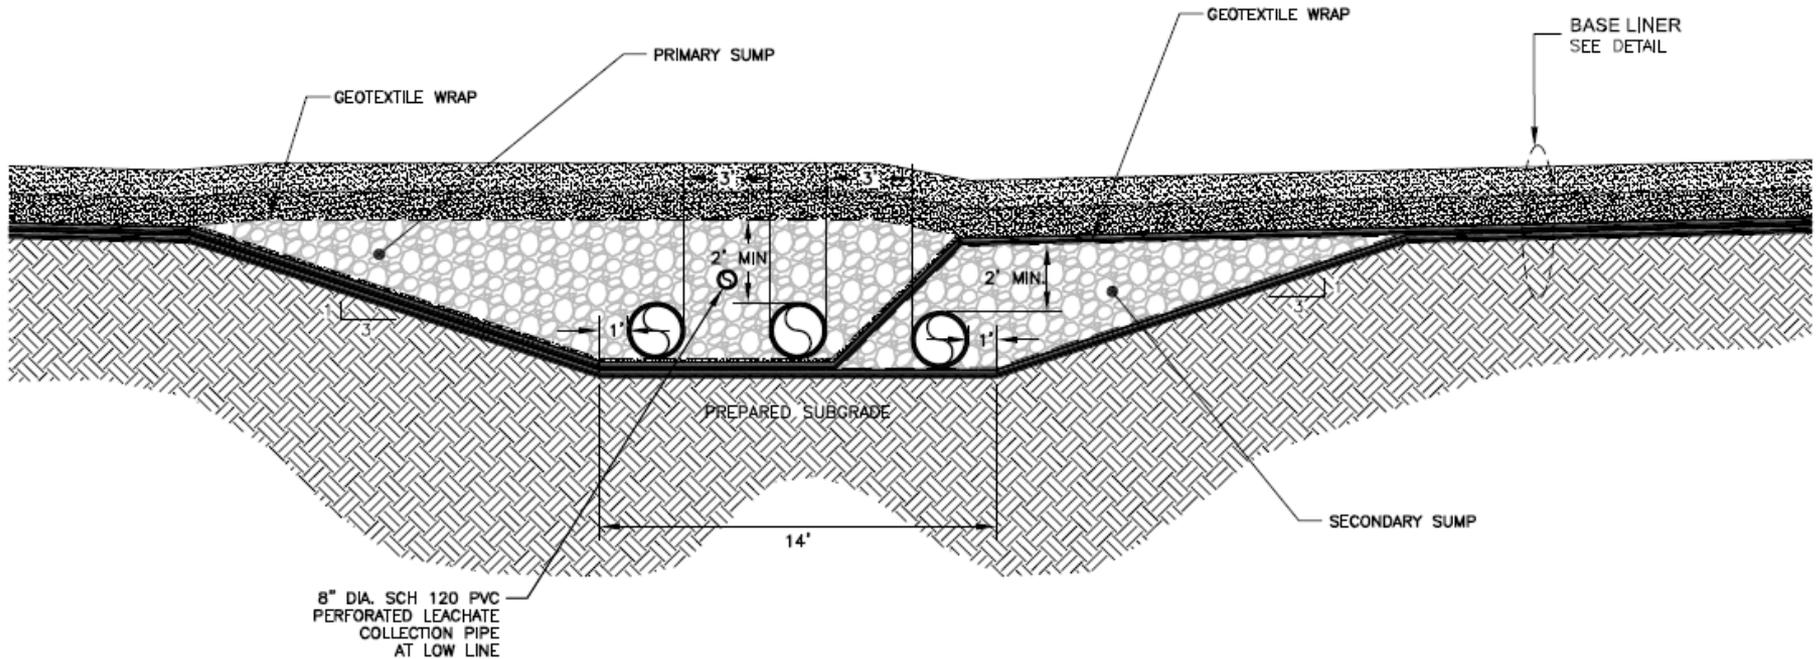
B-B'

Uplift from Secondary Sump is Possible

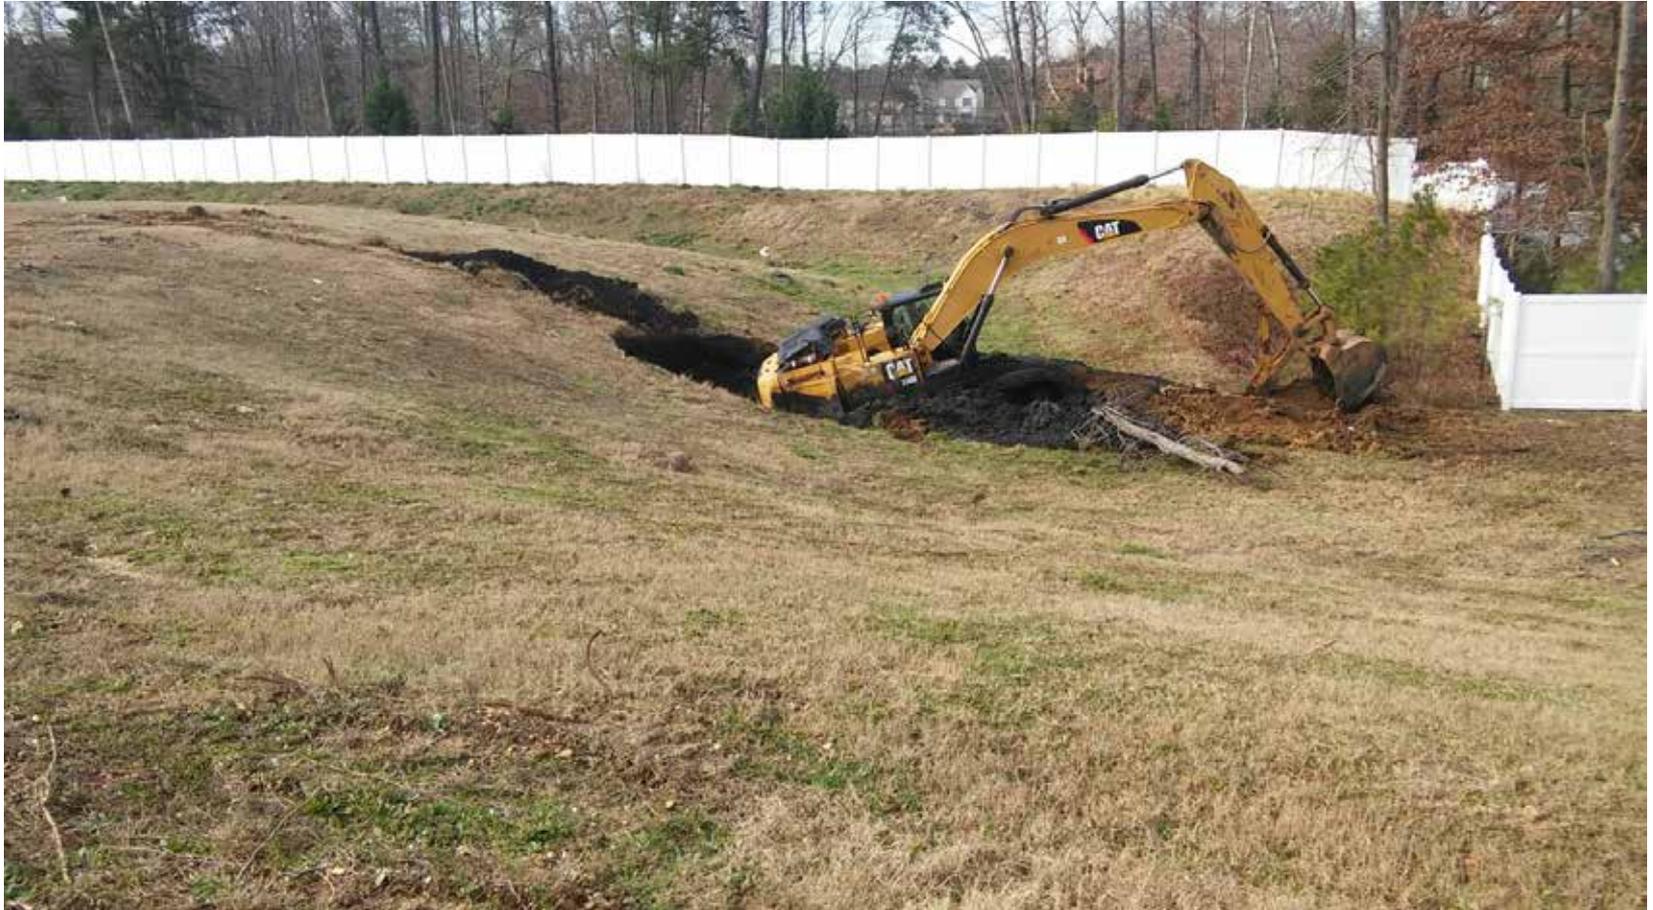
Saturated Uncemented Ash

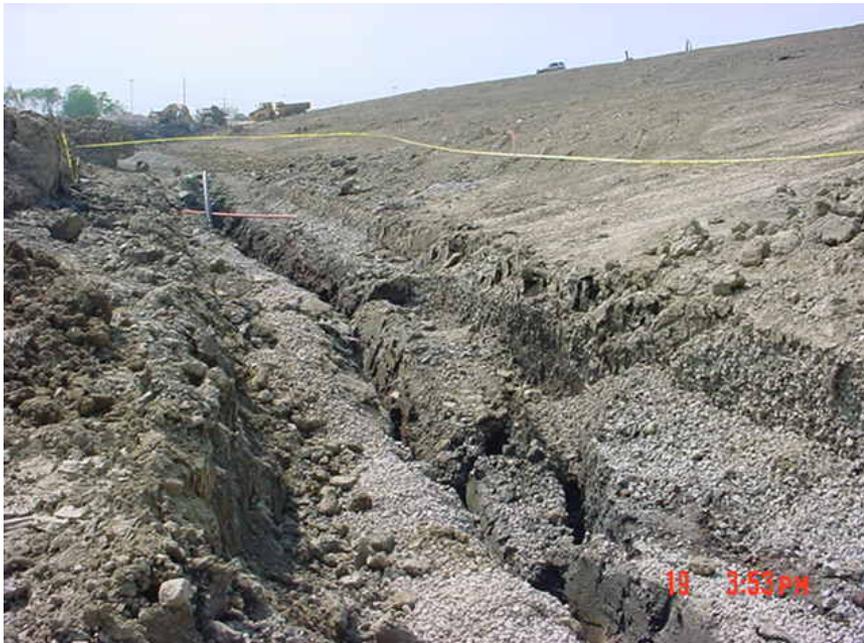
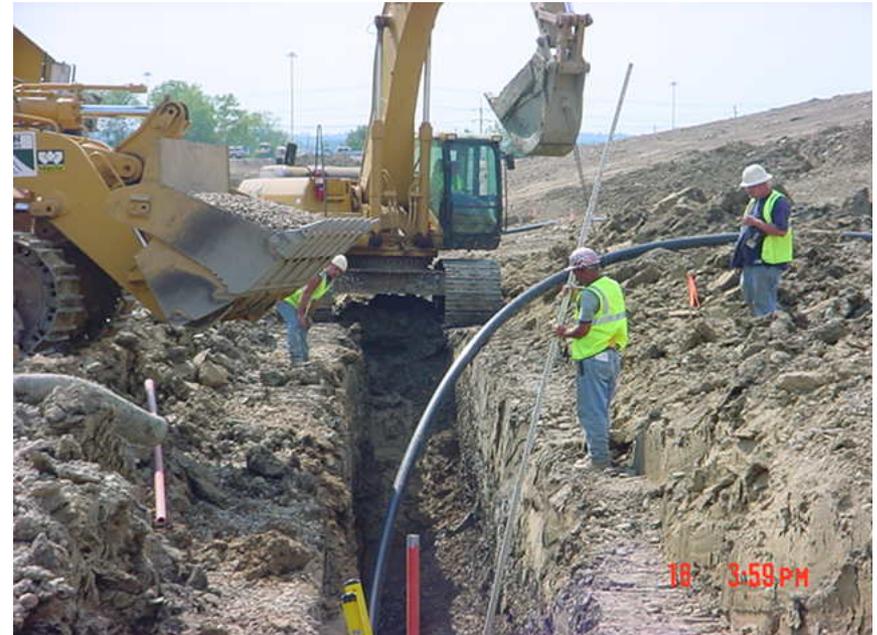
Not According to Plan

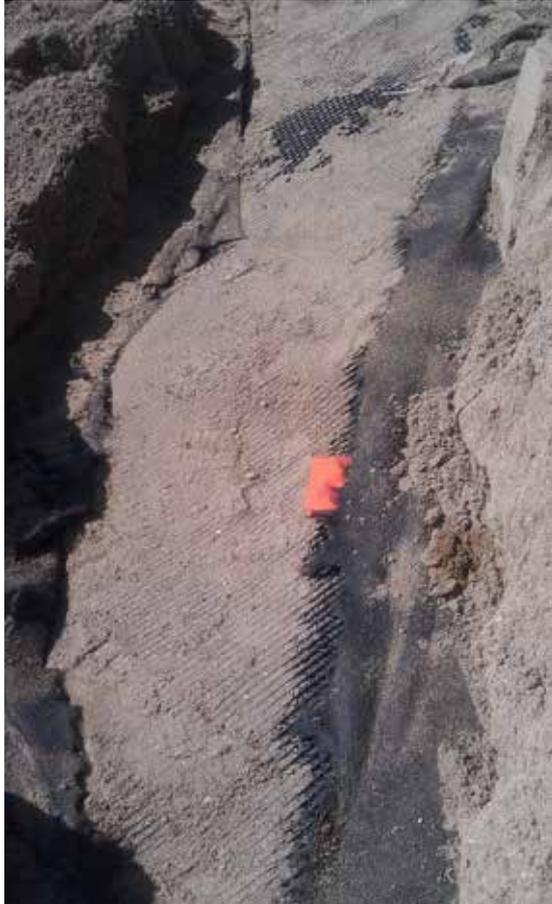
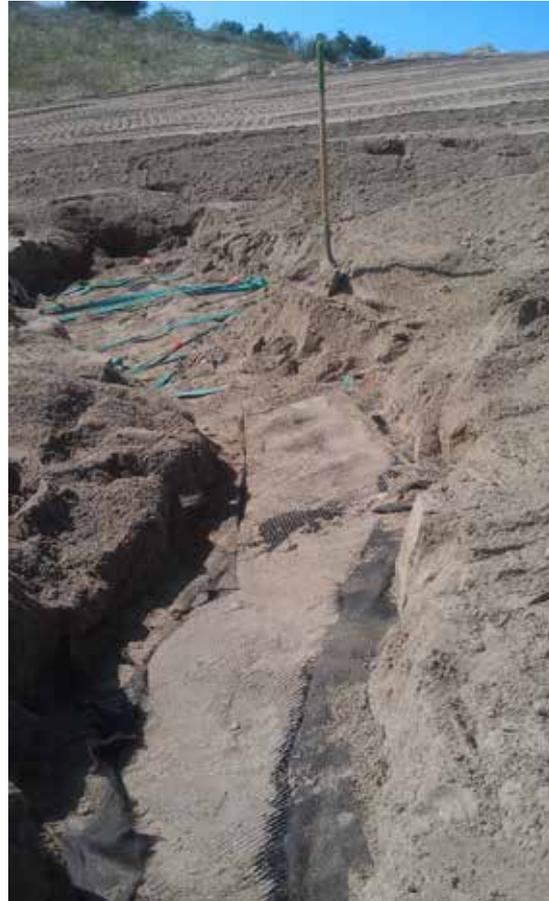
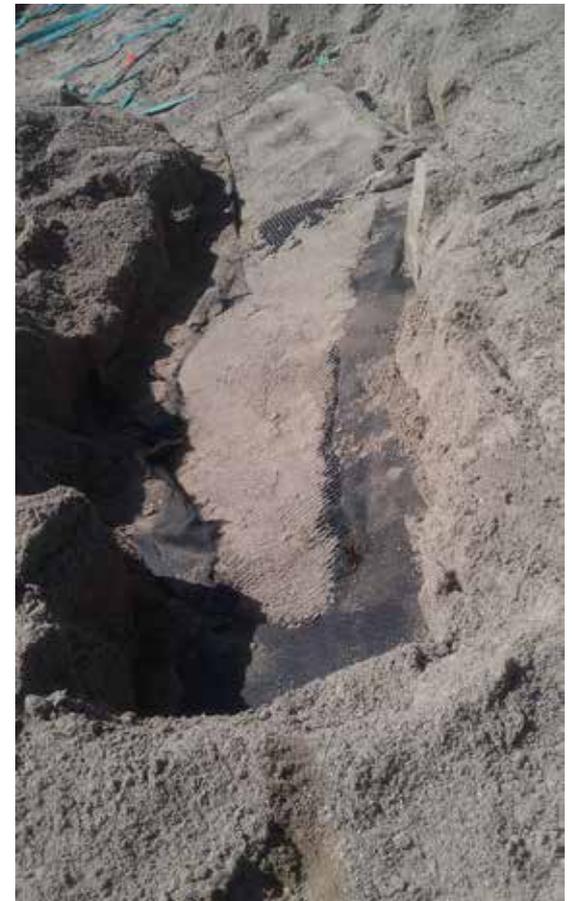
Unbonded

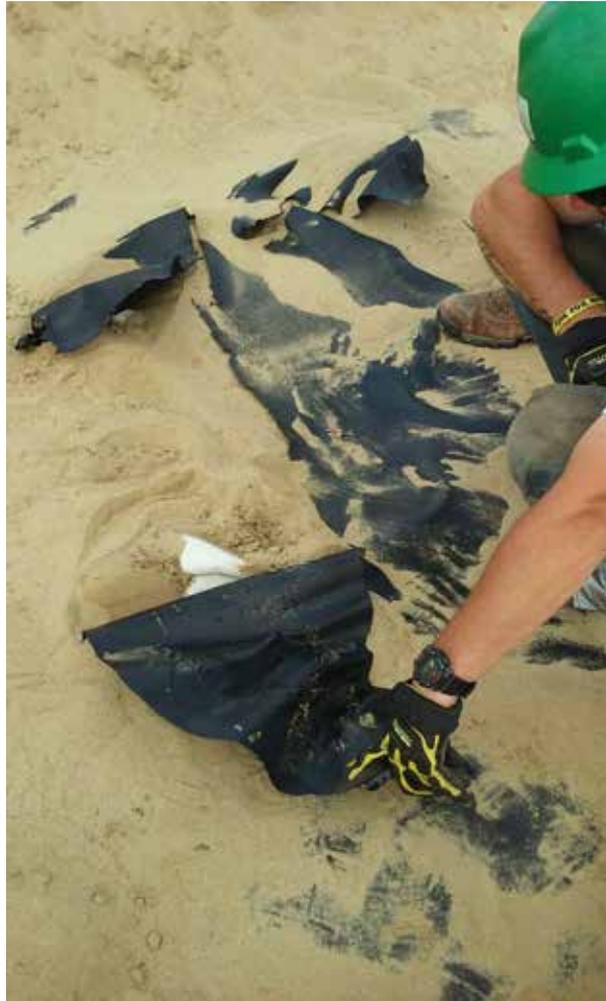
Dozer 1, Liner 0
