INTERIM RESPONSE CONSTRUCTION SUMMARY REPORT FOR FENCING

ABANDONED MINING WASTES – TORCH LAKE NON-SUPERFUND SITE
CHLL HUBBELL PROCESSING AREA
HOUGHTON COUNTY, MICHIGAN
SITE ID# 31000098

DECEMBER 2016

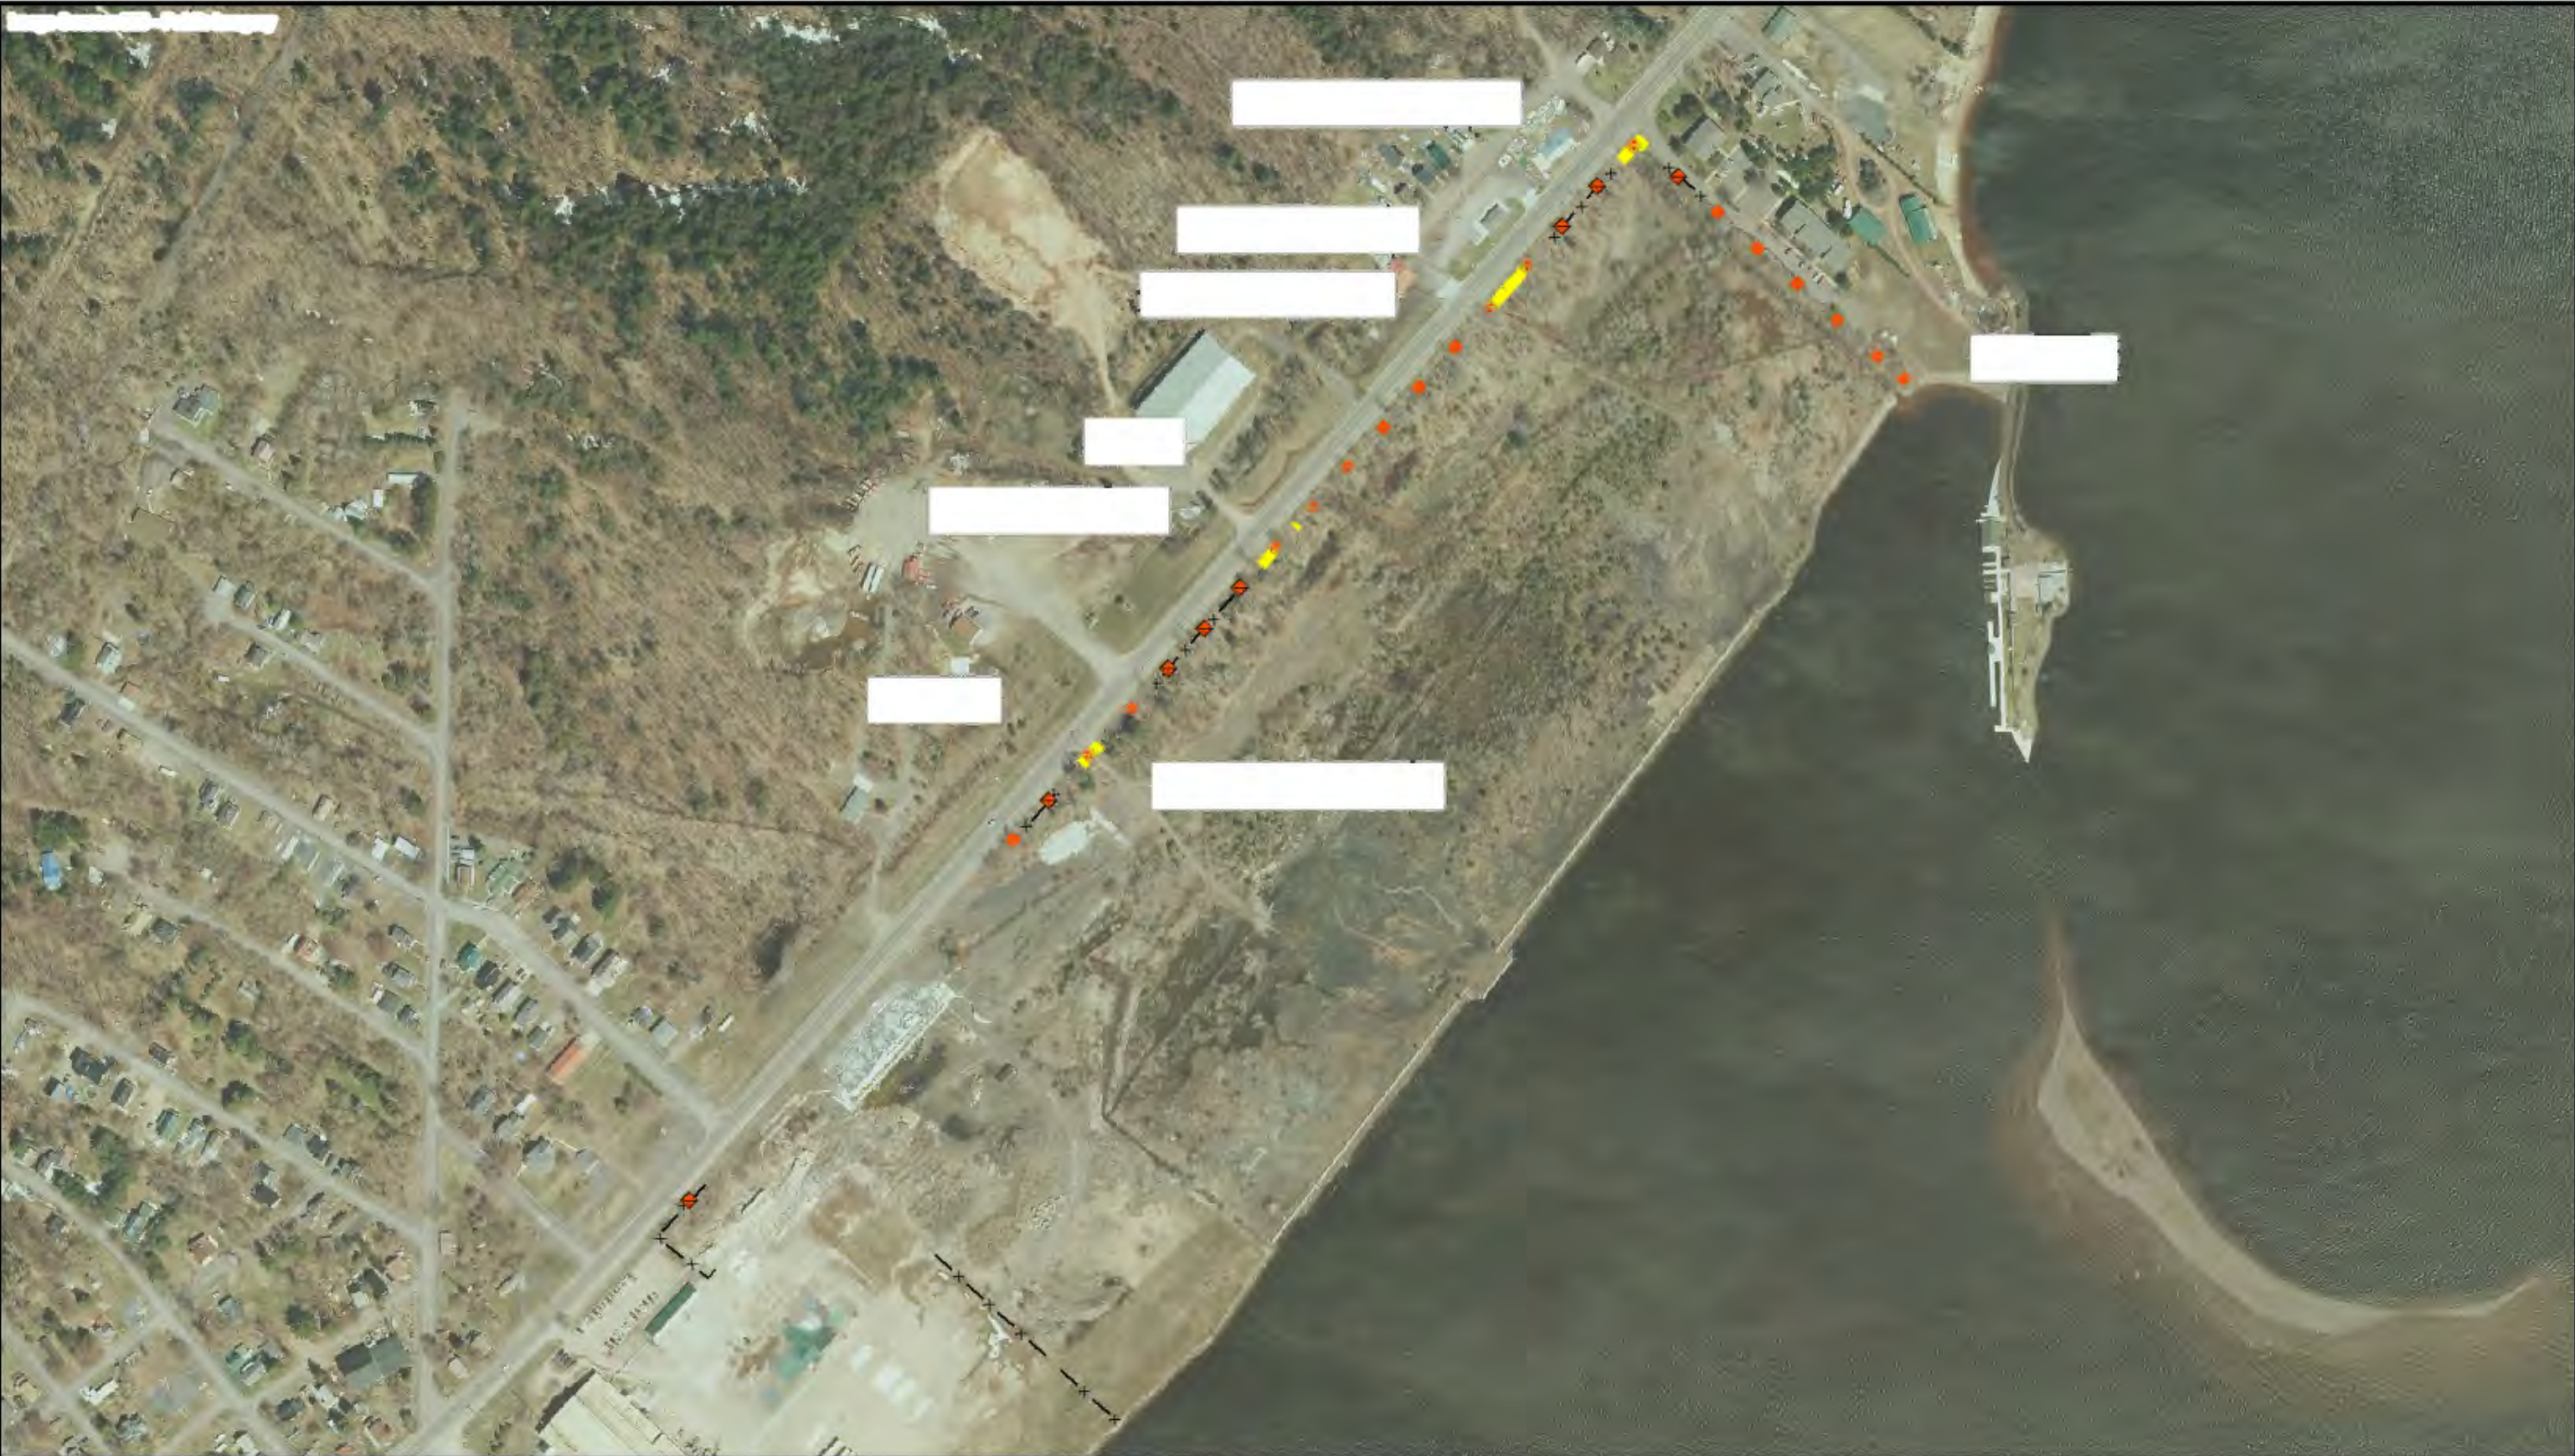
Figure 2
Proposed Fence Repairs
Hubbell Coal Dock and Mineral Building Properties
Hubbell, Houghton County, Michigan

To inhibit trespassing and warn entrants of hazards at the properties, MDEQ intends to repair breaches in the existing perimeter fence, install and repair gates at access points, and install signage. Existing breaches, points of access, and limits of fencing are depicted on **Figure 2**.

The following tasks will be required of the Contractor to complete the work at the locations identified on **Figure 2**, inclusive of all materials, equipment, tools, labor, and incidentals:

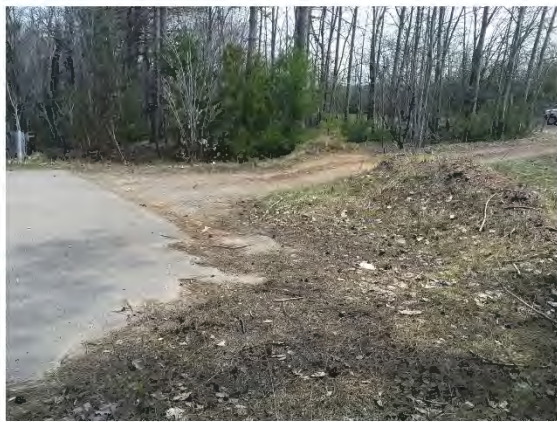
Photo 1: Middle Coal Dock entrance prior to gate installation. Photo taken on 5/6/16.

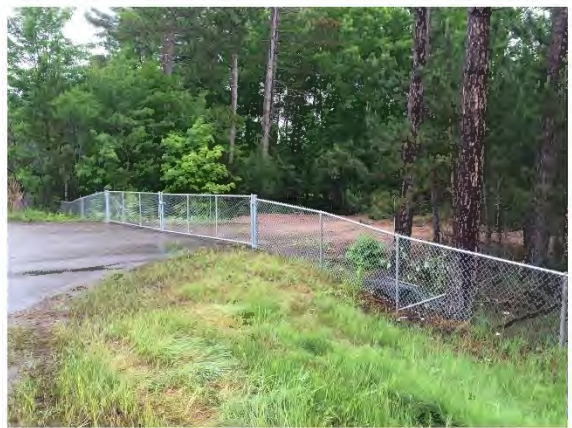
Photo 2: Middle Coal Dock entrance after fencing repairs and gate installation. Photo taken on 6/27/16.

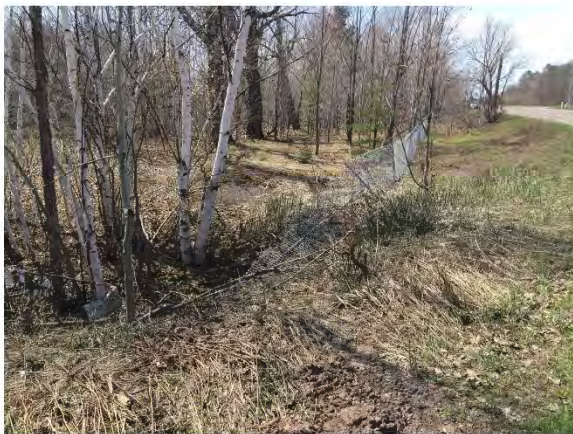
Photo 3: Damaged/missing fencing in northwest corner of Coal Dock. Photo taken on 5/6/16.

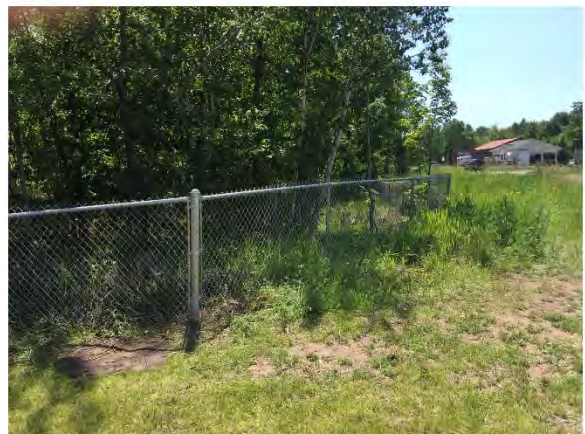
Photo 4: New fencing in northwest corner of Coal Dock. Photo taken on 6/23/16.

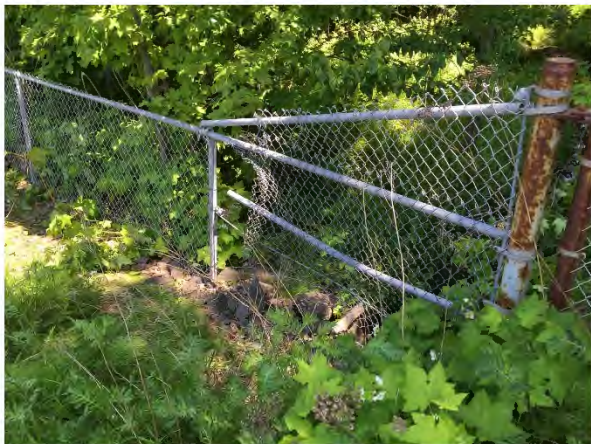
Photo 5: Breach in fence near north Coal Dock gate prior to repairs. Photo taken on 6/23/16.

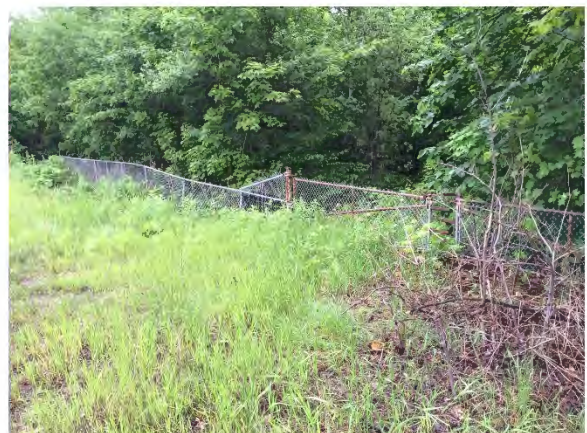
Photo 6: View of north Coal Dock gate following repairs. Photo taken on 6/27/16.
