PHOTOGRAPHIC LOG

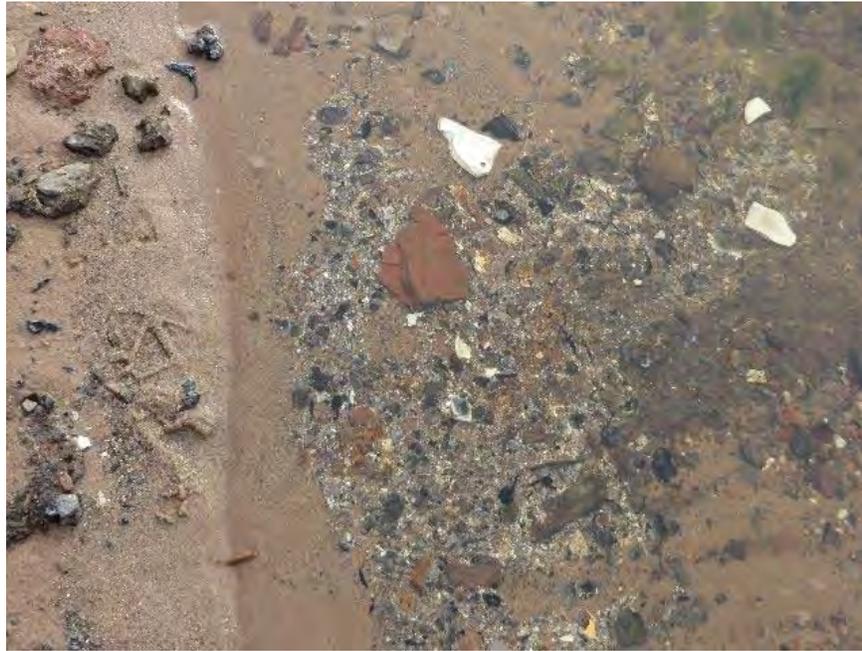
Photograph 1: 6/12/14: View looking north/down at brick and ceramic-like fragments located at the public beach in the Hubbell Beach and Slag Dump Area. Photograph taken by A. Keranen.

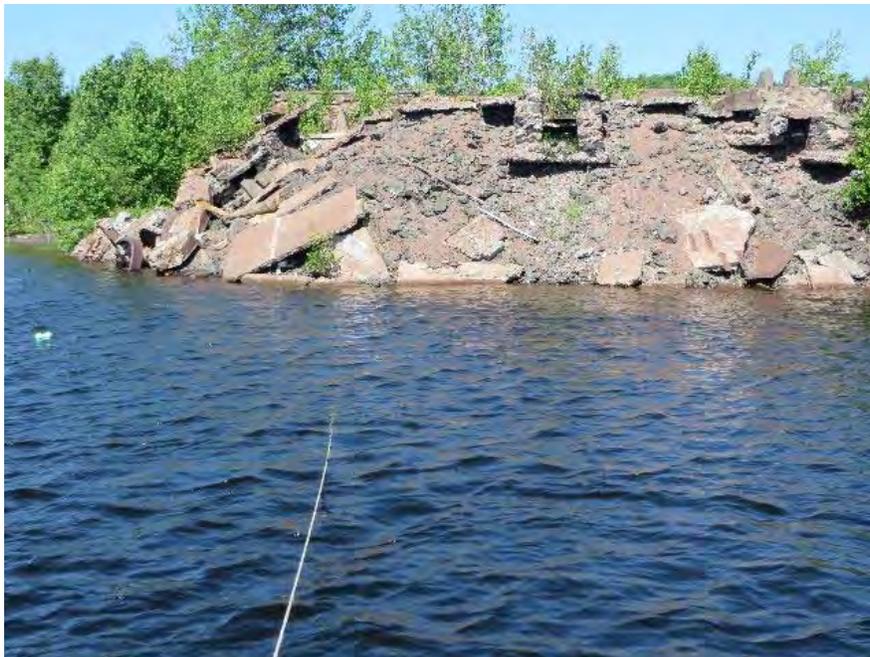
Photograph 8: 7/13/14: View looking west/southwest at rubble and debris associated with the former stamp mill located in the Lake Linden Processing Area. Photograph taken by A. Keranen.

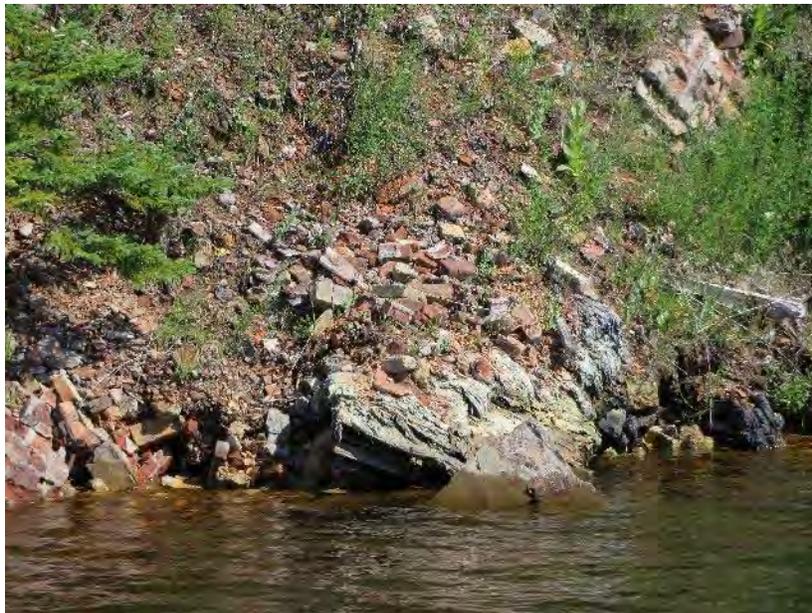
Photograph 10: 7/13/14: View looking west/northwest at rubble, debris, and a pallet of deteriorated bags of copper chemical products located along the shoreline of the Lake Linden Processing Area. Photograph taken by A. Keranen.

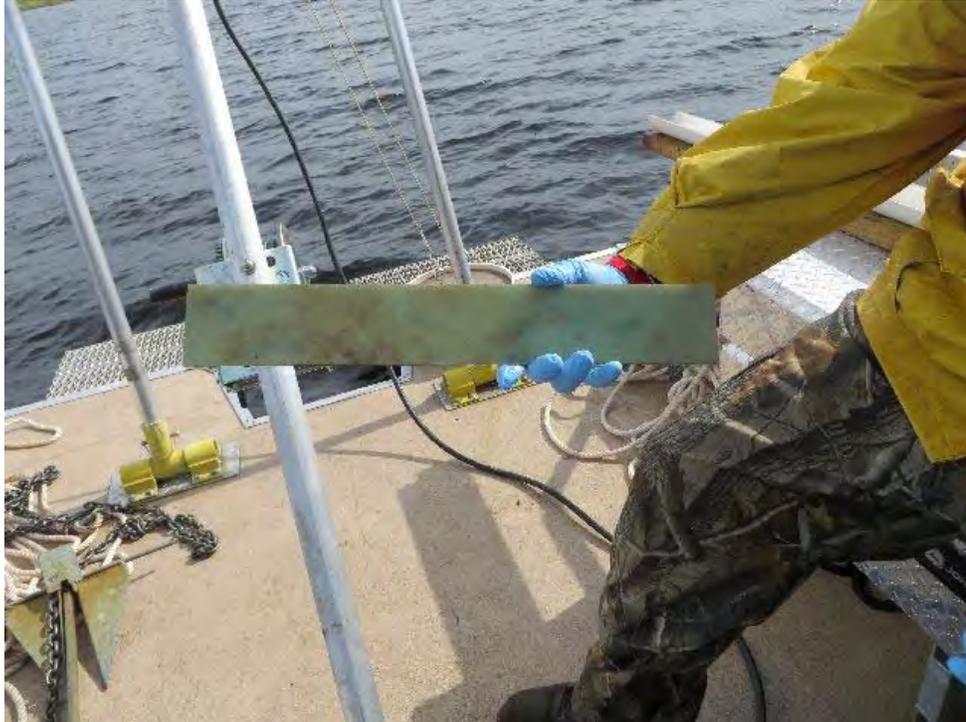
Photograph 11: 7/15/14: View looking down at circuit board material collected during offshore sampling operations in the Hubbell Processing Area. Photograph taken by A. Keranen.

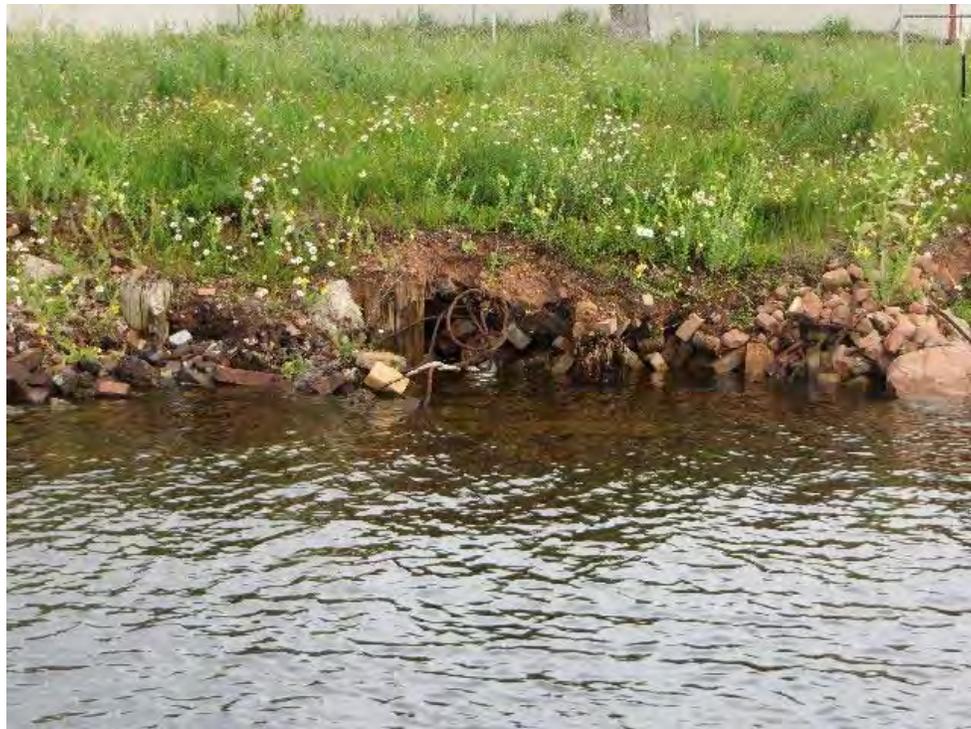
Photograph 14: 7/15/14: View looking west at rubble and debris along the shoreline of the Hubbell Processing Area. Photograph taken by D. Liebau.

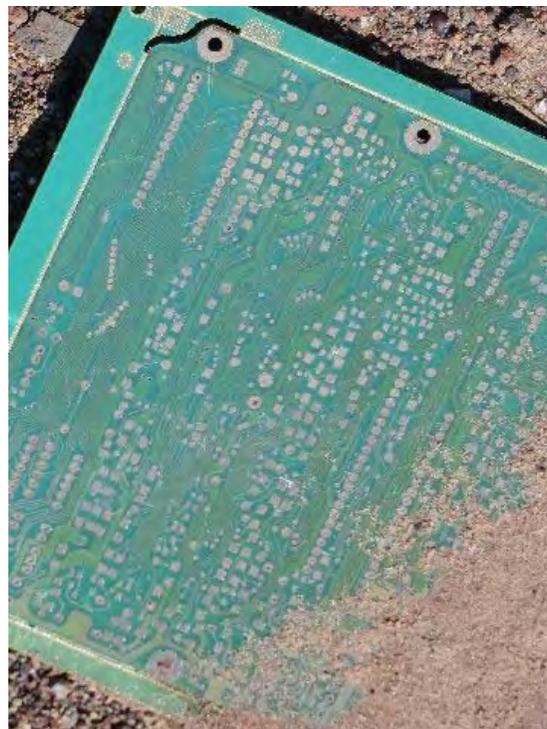
Photograph 16: 7/23/14: View looking down at an example of circuit board waste that is distributed on the ground surface and offshore of the Hubbell Processing Area. Photograph taken by A. Keranen.

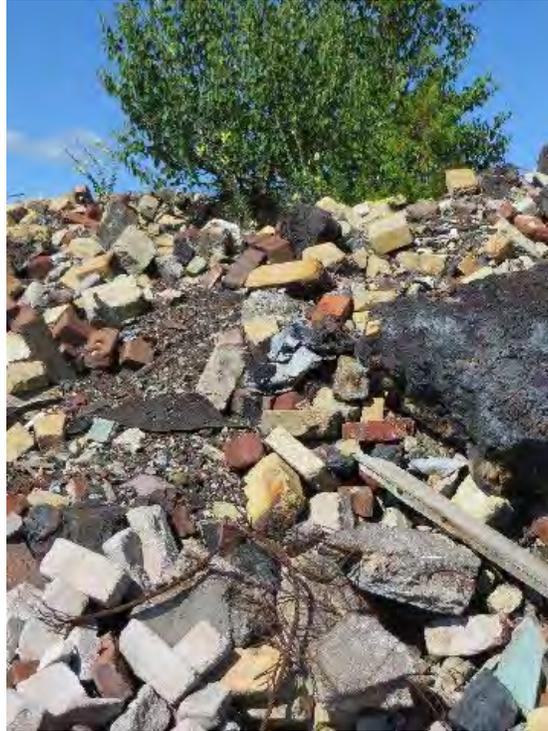
Photograph 17: 7/23/14: View looking south at a debris pile located in the Hubbell Processing Area. Photograph taken by A. Keranen.

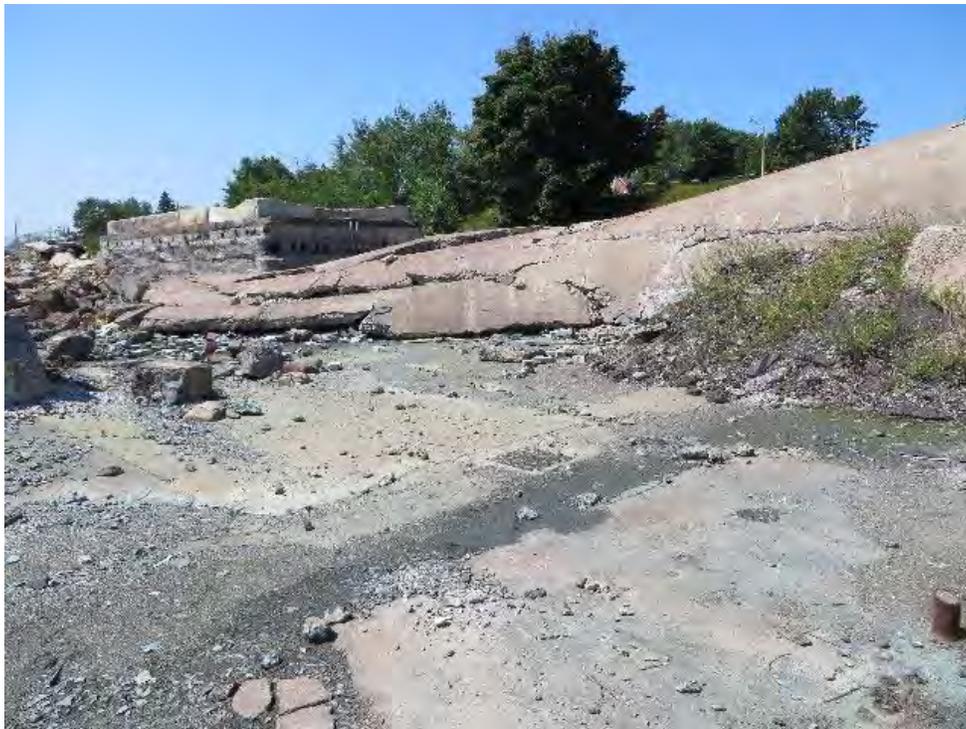
Photograph 18: 7/23/14: View looking southwest at the fallen stack and debris located in the Hubbell Processing Area. Photograph taken by A. Keranen.

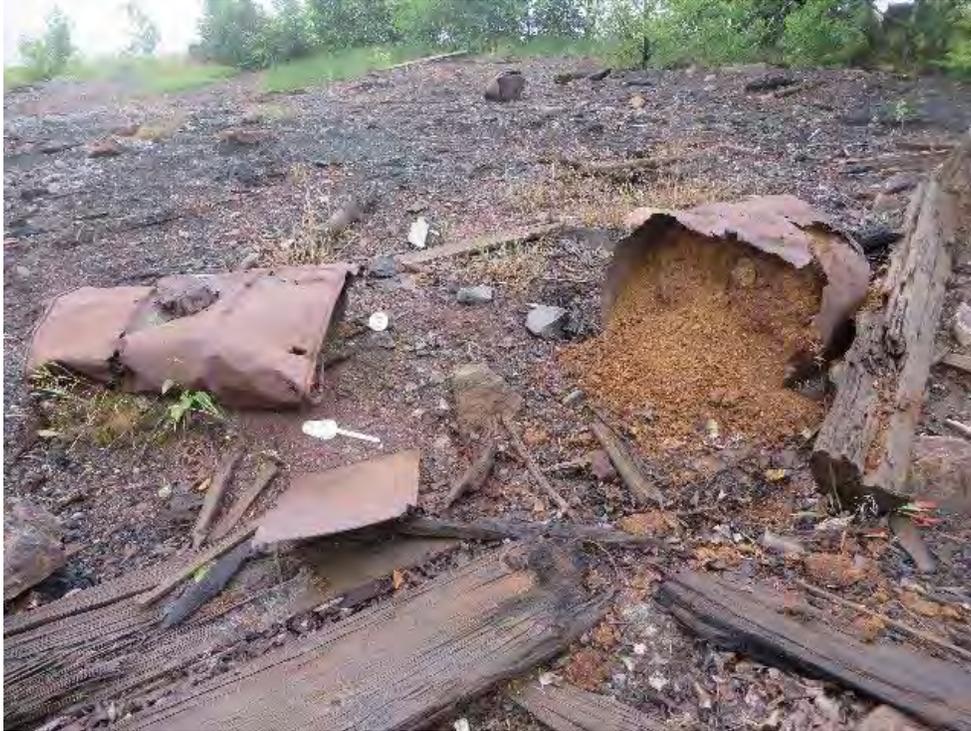
Photograph 23: 8/20/14: View looking south/southeast at deteriorated abandoned containers located in the Hubbell Processing Area. Samples were collected from the contents of each container. Photograph taken by A. Keranen.

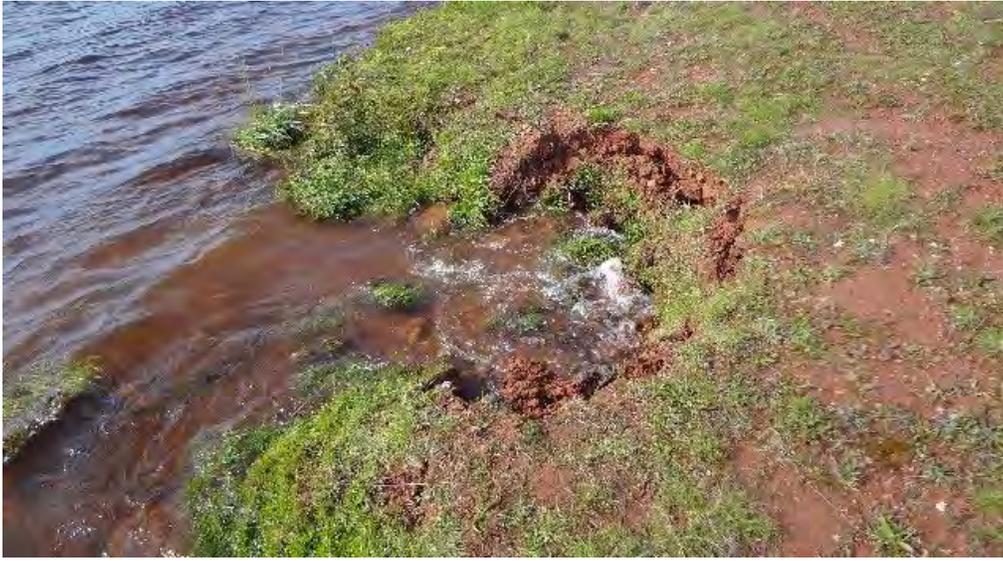
Photograph 25: 10/06/14: View looking down/south at cap erosion along the shoreline in the Lake Linden Recreation Area. Photograph taken by D. Liebau.

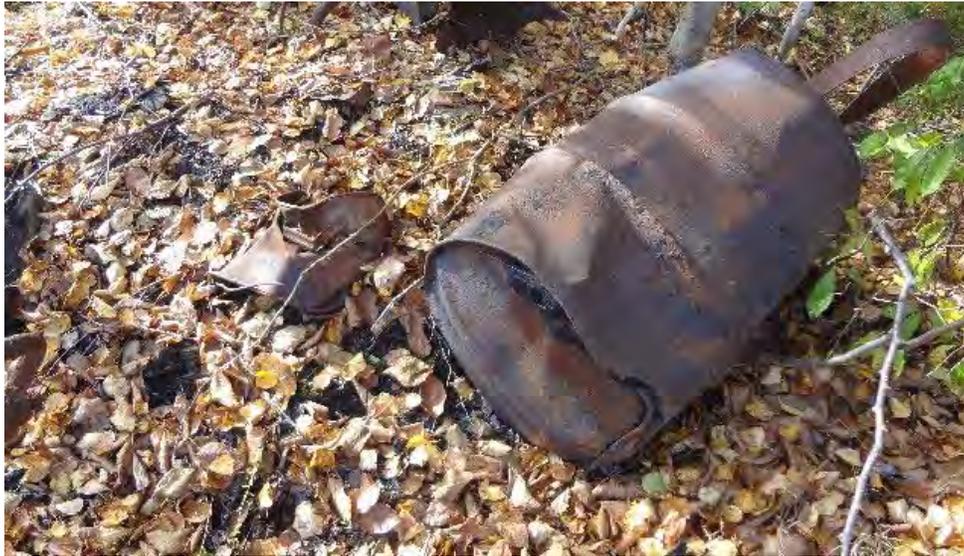
Photograph 26: 10/06/14: View looking down/southwest at abandoned containers located in a wooded area in the Hubbell Processing Area. Photograph taken by D. Liebau.

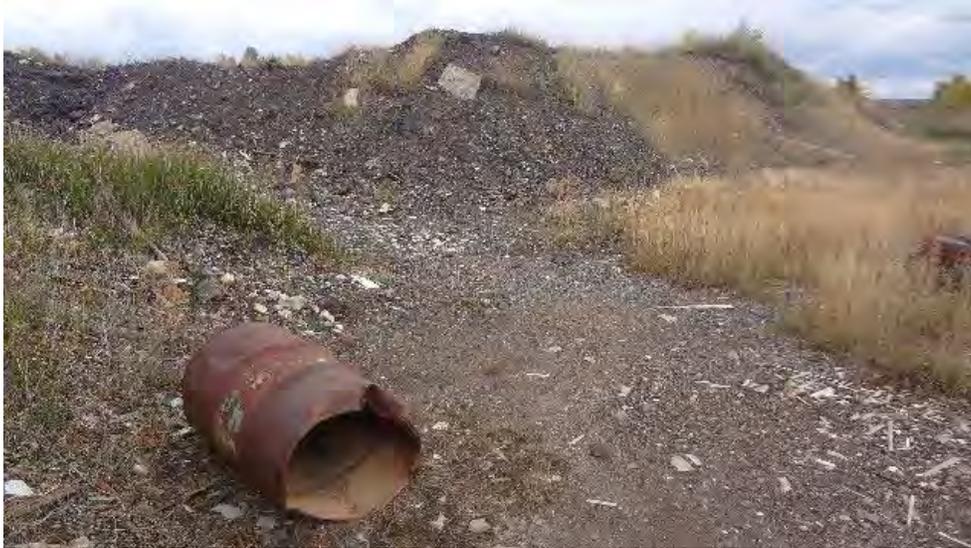
Photograph 27: 10/07/14: View looking south/southeast at a debris pile and abandoned container located in the Hubbell Processing Area. Photograph taken by D. Liebau.

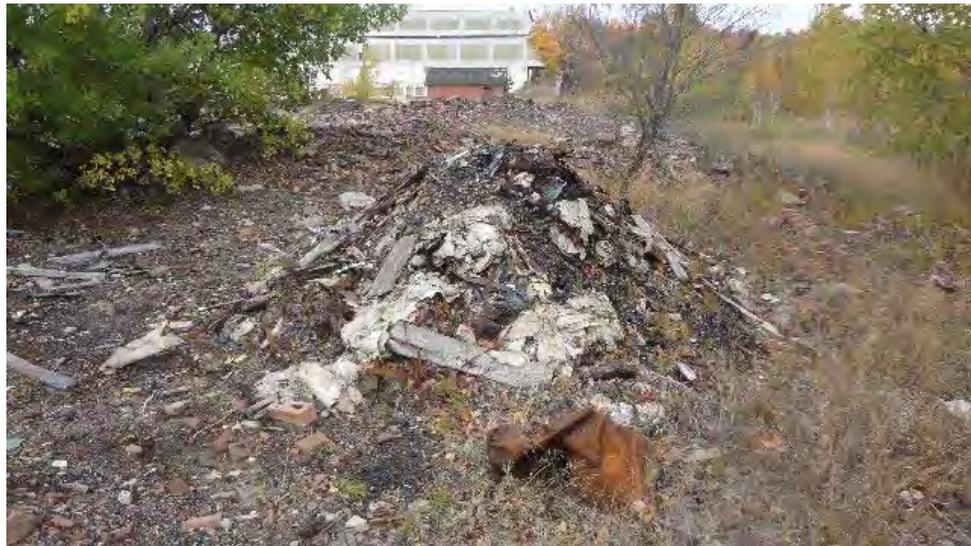
Photograph 28: 10/07/14: View looking west at a debris pile in the Hubbell Processing Area. The former Mineral Building is visible in the background of the photograph. Photograph taken by D. Liebau.

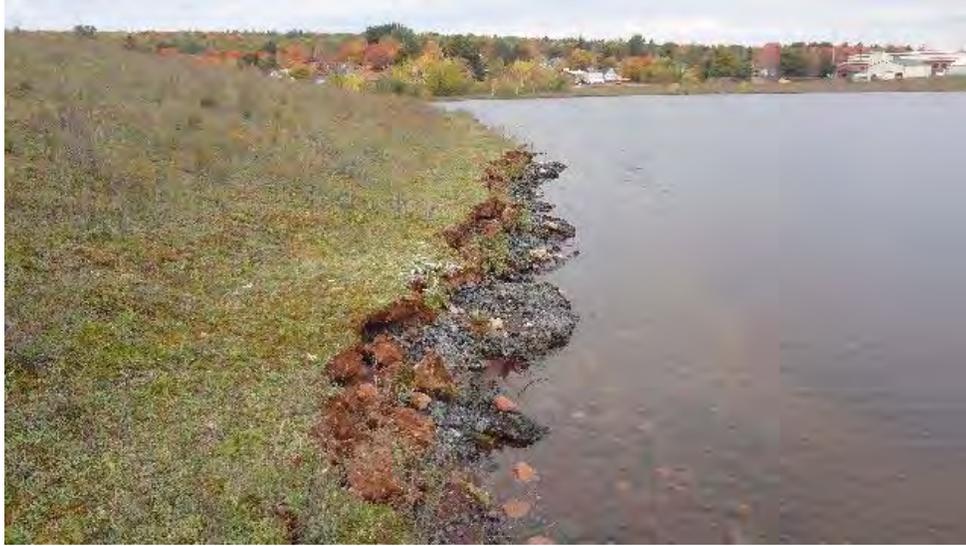
Photograph 31: 10/07/14: View looking northwest at exposed slag in the Hubbell Beach and Slag Dump Area. Elevated lake levels have resulted in the erosion of cap material along the shoreline of Torch Lake. Photograph taken by D. Liebau.

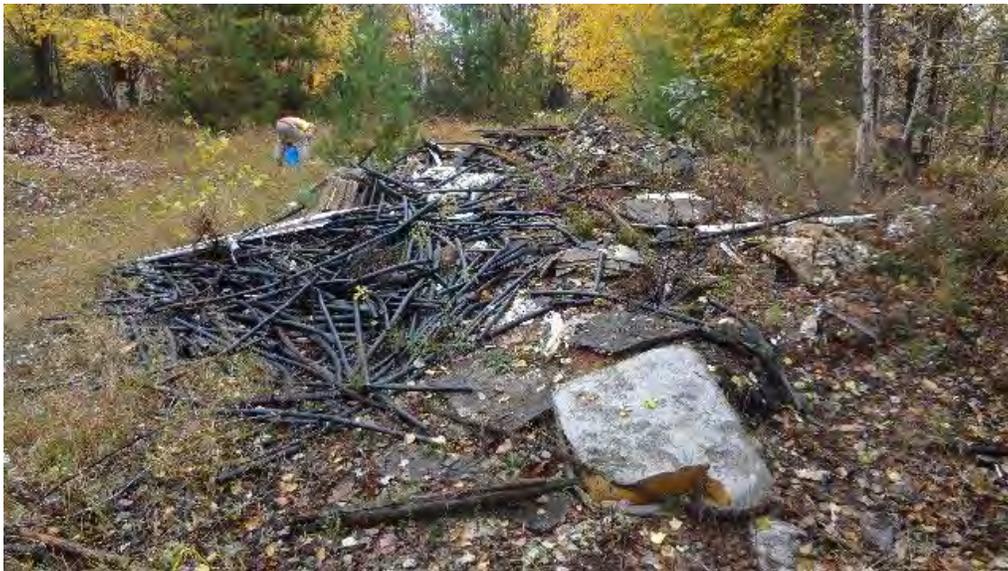
Photograph 32: 10/14/14: View looking northwest at a debris pile located in the wooded area of the Hubbell Processing Area. Photograph taken by D. Liebau.

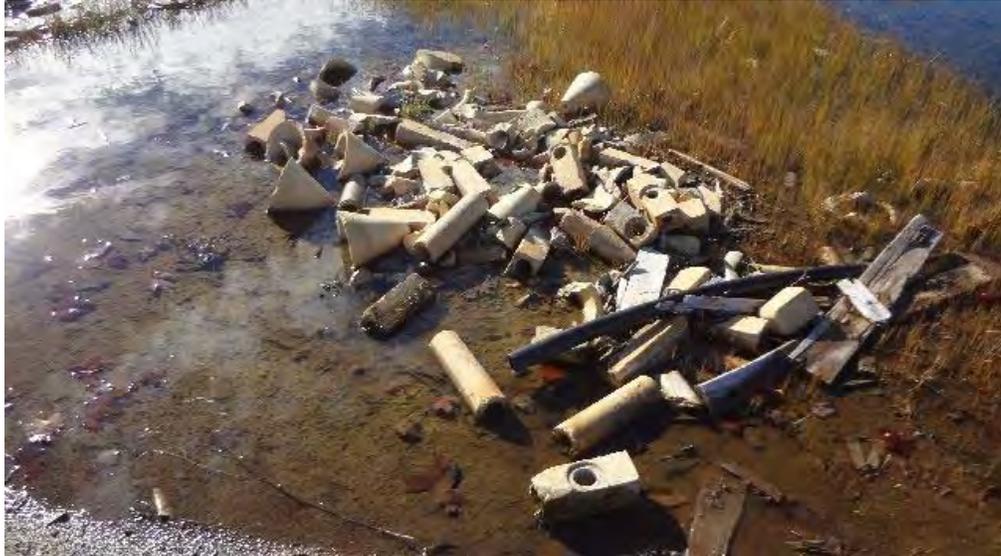
Photograph 33: 10/15/14: View looking down/southeast at a debris pile in the Hubbell Processing Area. The materials were sampled and analyzed for asbestos content. Photograph taken by D. Liebau.

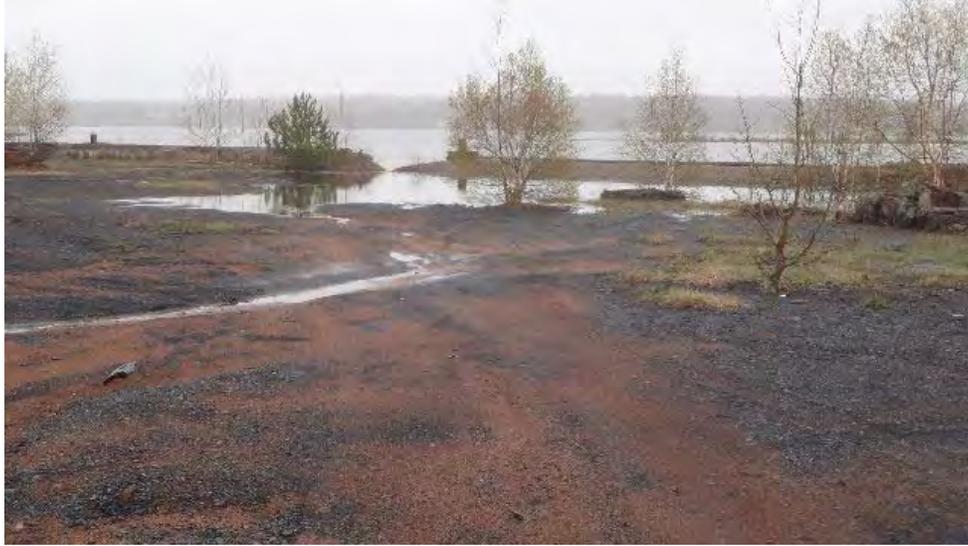
Photograph 35: 5/12/15: View looking northeast at storm water draining from the former C&H Coal Dock property to a depression adjacent to the bulkhead along the shoreline of Torch Lake. Photograph taken by A. Keranen.

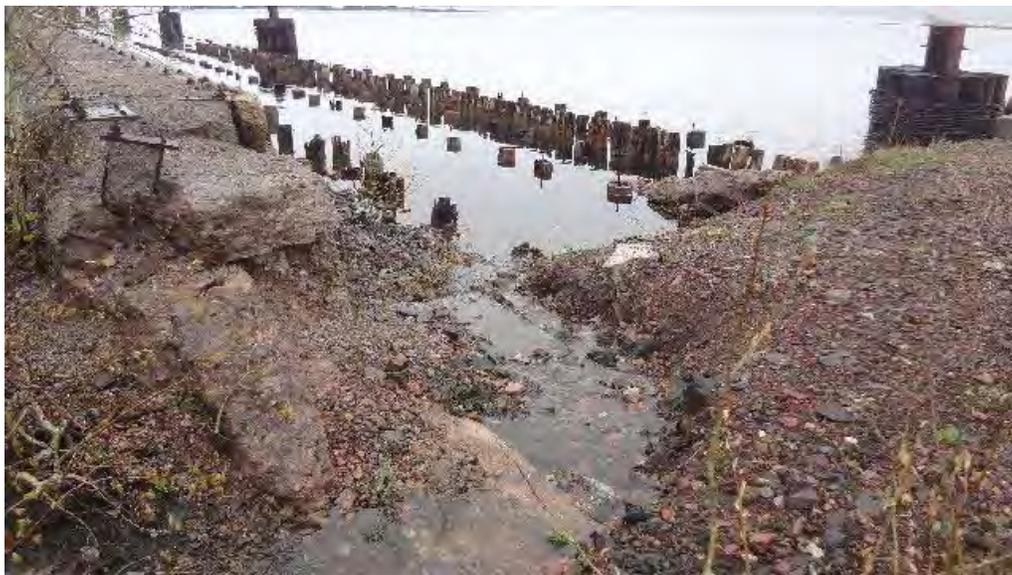
Photograph 36: 5/12/15: View looking northeast at collected storm water at the former Coal Dock property discharging to Torch Lake through eroded channels along the bulkhead. Photograph taken by D. Liebau.

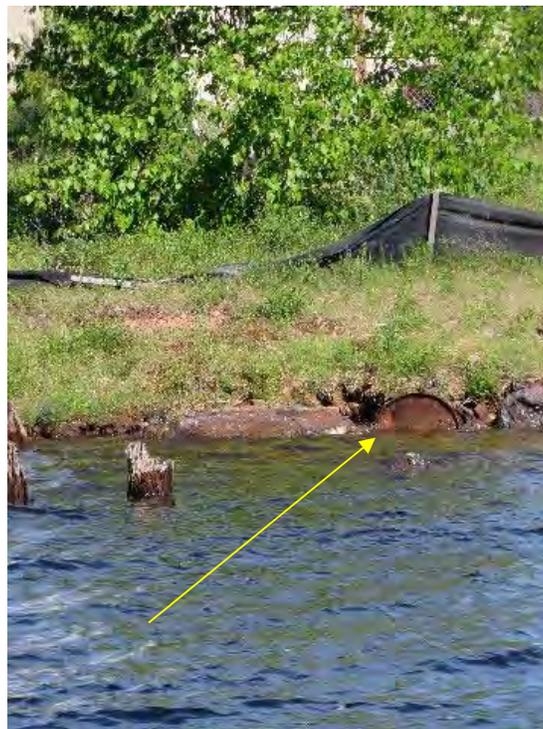
Photograph 38: 5/31/15: View looking west at a partially buried/submerged drum (identified by the yellow arrow) beneath cap material along the shoreline of Torch Lake in the Hubbell Processing Area. Photograph taken by A. Keranen.

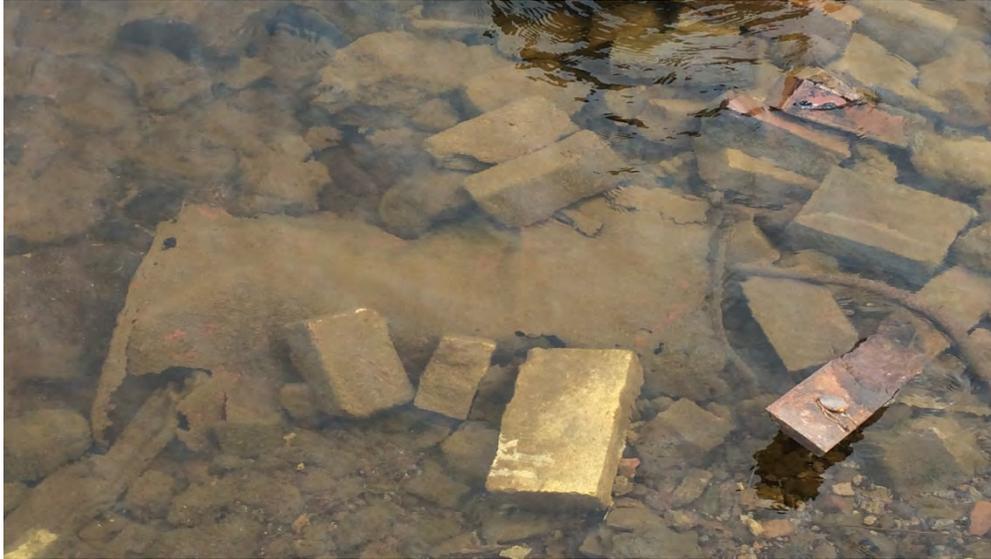
Photograph 39: 7/02/15: View looking east at a submerged drum observed offshore of the former Hubbell Smelter property in the Hubbell Processing Area. Photograph taken by D. Liebau.

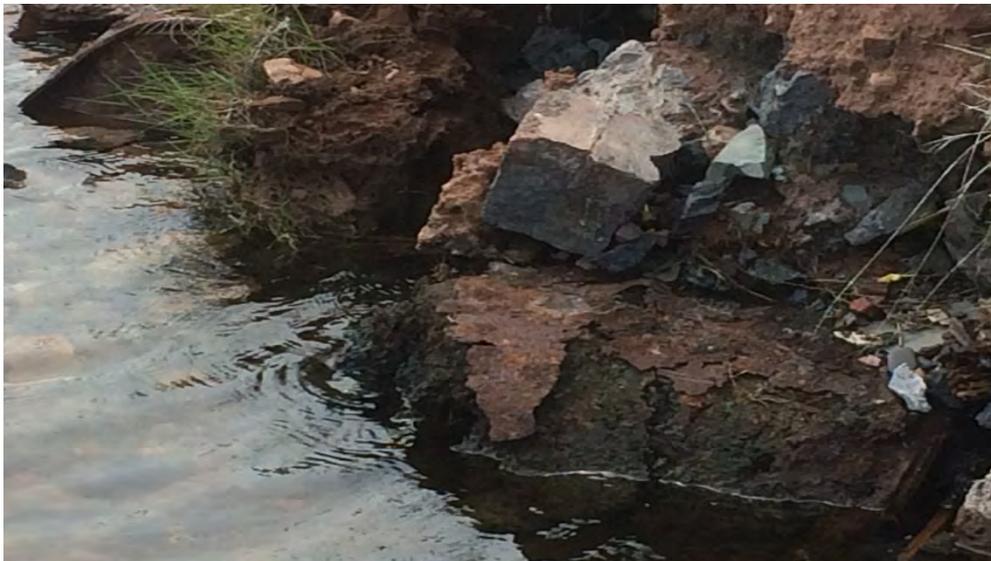
Photograph 40: 7/02/15: View looking down/south at a partially submerged dilapidated drum with contents still intact offshore of the former Hubbell Smelter property in the Hubbell Processing Area. Photograph taken by D. Liebau.

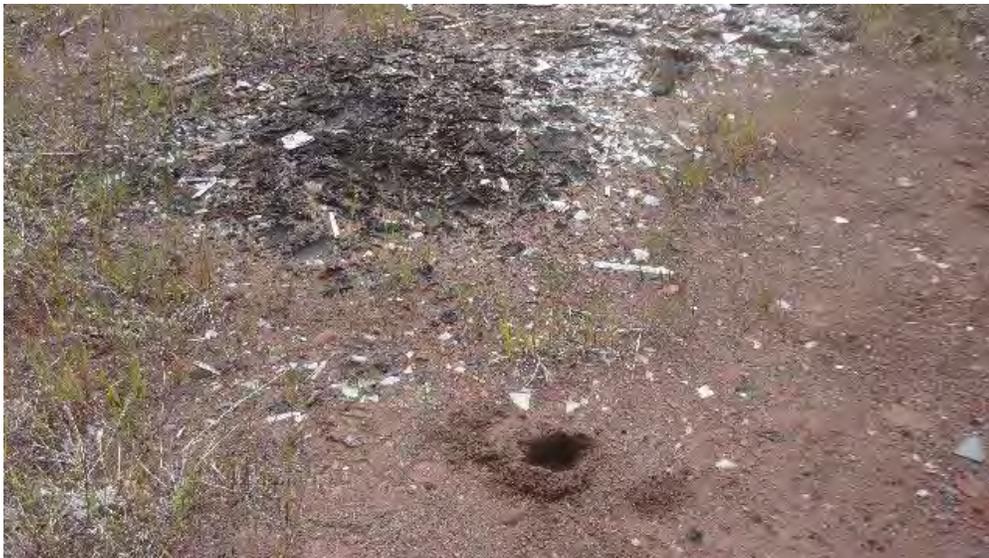
Photograph 42: 6/30/15: View looking down/southwest at surface soil sampling location SS-13 located in the Lake Linden Processing Area. The soil sample was collected to assess the presence of asbestos in soil in the vicinity of apparently burnt asphaltic roofing material and debris. Photograph taken by D. Liebau.

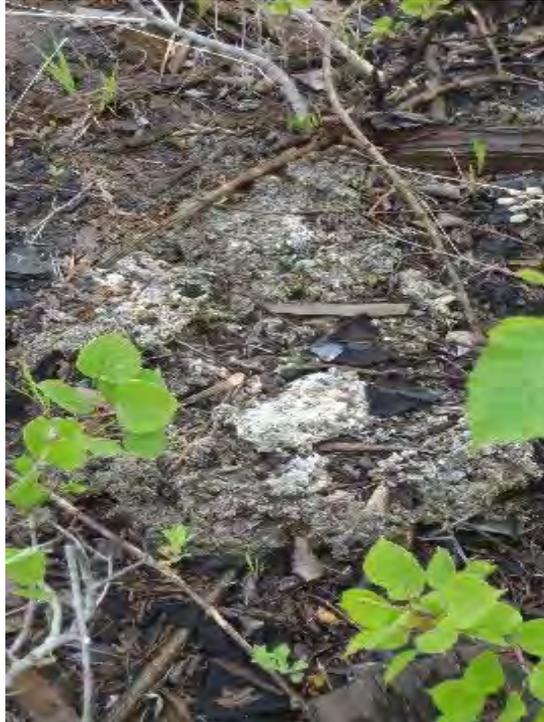
Photograph 43: 6/30/15: View looking down/northwest at suspect thermal system insulating material and asphaltic roofing material located in the center of a concrete table at the former Calumet Mill. Analytical samples CHLL-ASBBLK-38A, CHLL-ASBBLK-39A, and CHLL-ASBBLK-40A were collected from this location in the Lake Linden Processing Area. Photograph taken by D. Liebau.

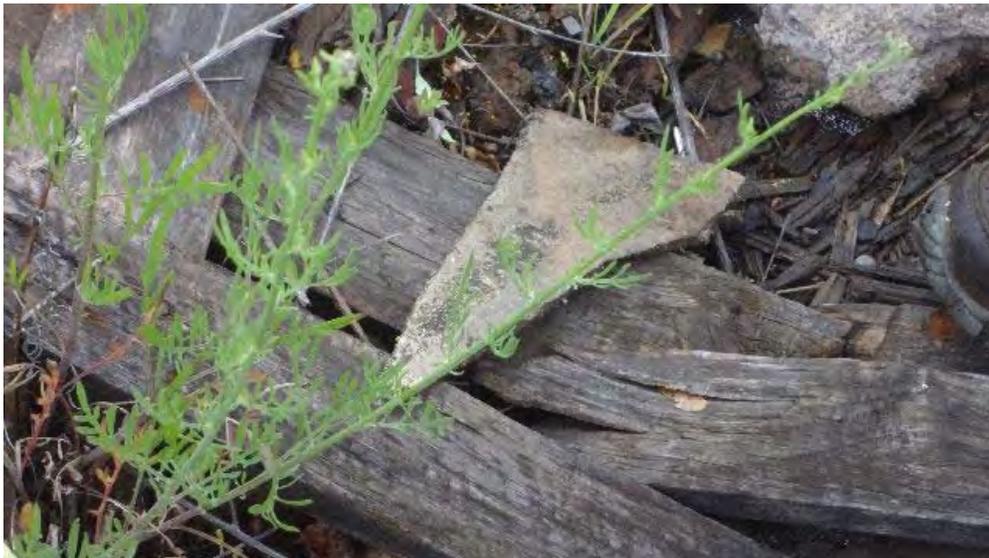
Photograph 44: 6/30/15: View looking down/southwest at a suspect transite fragment located in a concrete depression at the Calumet Mill. Analytical sample CHLL-ASBBLK-43A is representative of this material located in the Lake Linden Processing Area. Photograph taken by D. Liebau.

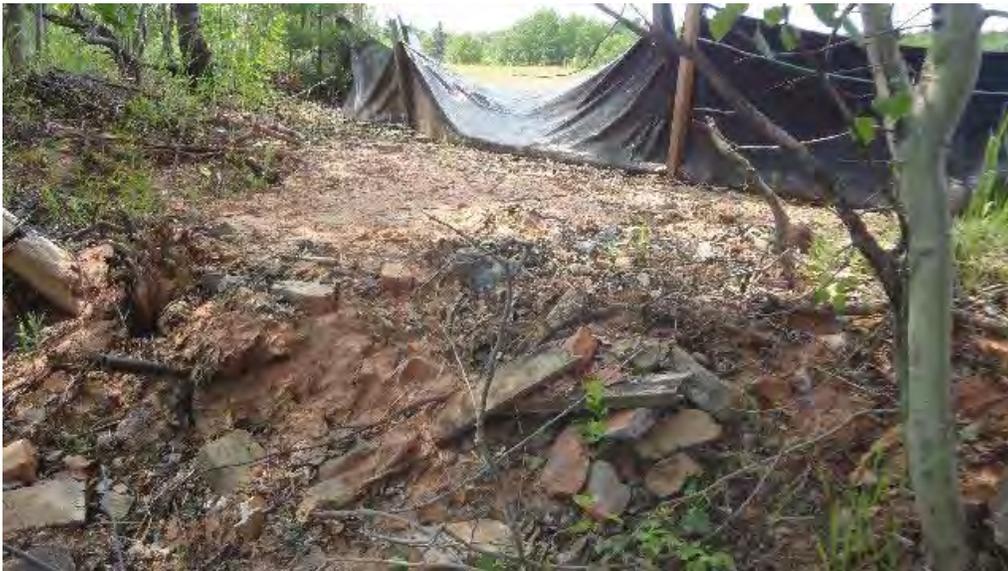
Photograph 46: 07/01/15: View looking west/southwest at debris including suspect asbestos containing material and degraded bags of copper concentrate commingled with apparent sand backfill along the eastern limits of the former Hecla Stamp Mill. Analytical samples CHLL-ASBBLK-59A, CHLL-ASBBLK-60A, CHLL-ASBBLK-61A, CHLL-ASBBLK-62A, and CHLL-ASBBLK-63A were collected from this area and are representative of the materials present in this area of the Lake Linden Processing Area. Photograph taken by D. Liebau.
